Little Pine & Brush Creek

2004 Annual Monitoring Report

2004 Little Pine & Brush Creek Monitoring Abstract

This is the 3rd year of the 5-year monitoring plan for both Little Pine and Brush Creeks.

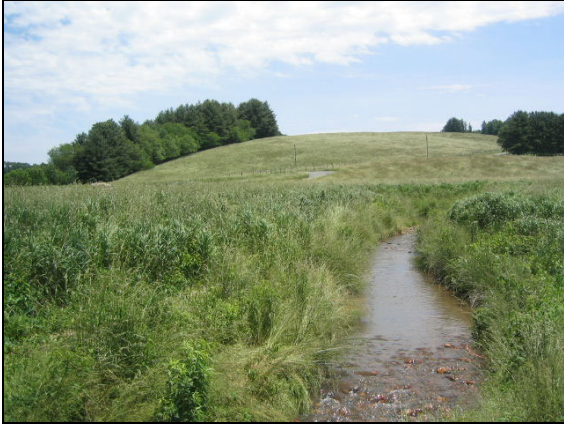
Typical Photo 1.
Typical Riffle along Little Pine Creek.

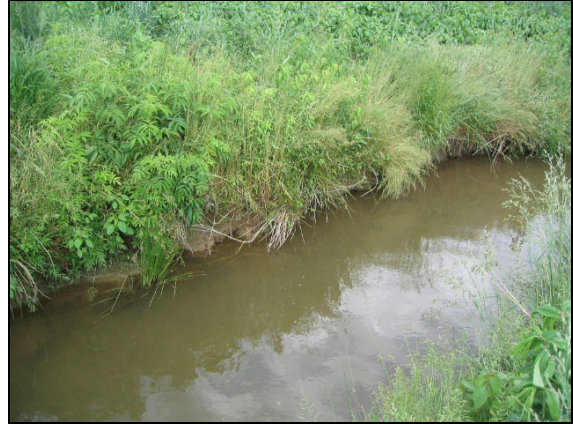
Typical Photo 2.
Typical Pool along Little Pine Creek.

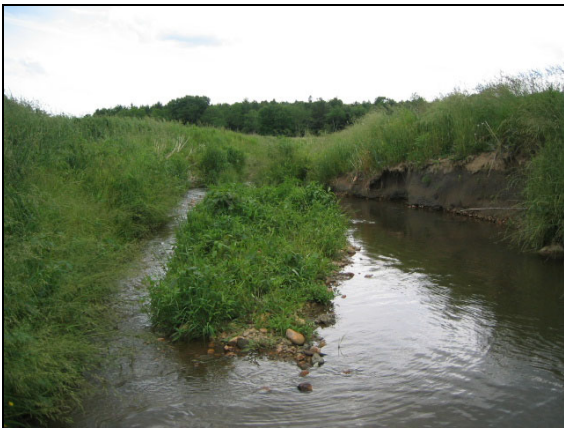
- 1.) Areas with bank slumping
 - These areas (Table 3 below) have continued to degrade. Additional stabilization is needed in most areas. Root Wads are recommended. The area around station 0+50 has developed a substantial central bar causing scour to both banks and downstream. Additional measures should be taken to stabilize this area.

Issue Photo 1.
Little Pine near Station 0+60.
Central Bar and Right Bank Scour

- These areas have continued to degrade. Additional stabilization is needed in most areas. Root Wads are recommended. The area around station 0+60 has developed a substantial central bar causing scour to both banks and downstream. Additional measures should be taken to stabilize this area.

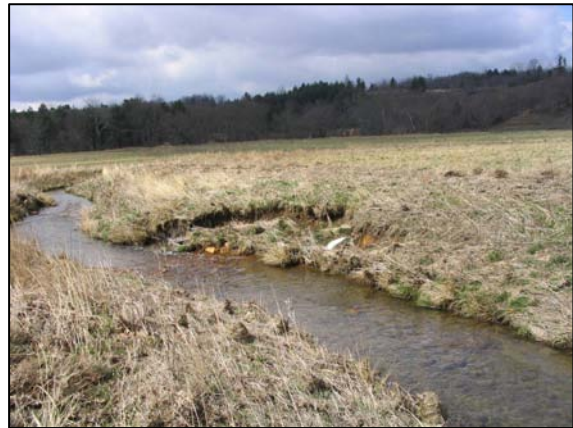
Issue Photo 2.
Little Pine near Station 1+80.
Bank slump on left bank.

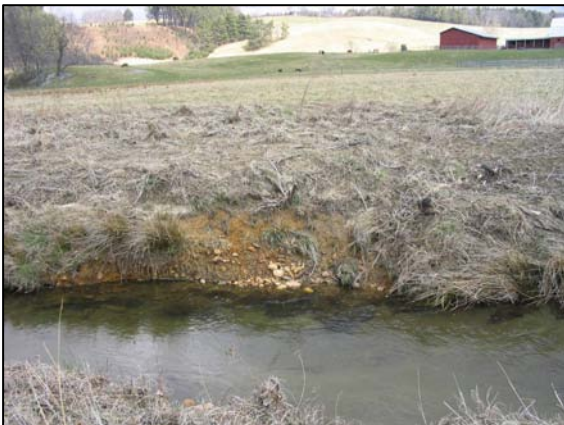
Issue Photo 3. Little Pine near station 7+80.
Bank Scour on Right Bank

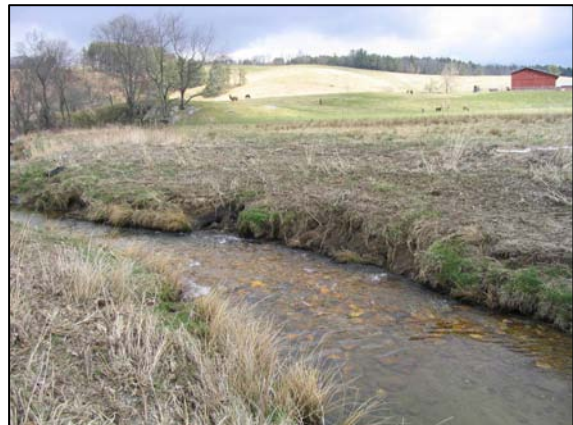
Issue Photo 4. Little Pine near station 6+00.
Toe Scour along Right Bank

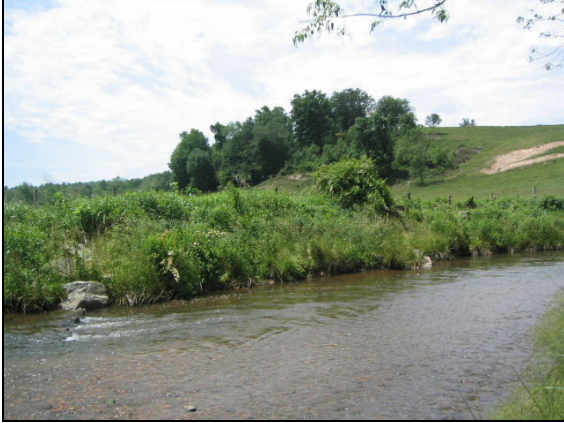
Typical Photo 1.
Typical Riffle along Brush Creek.

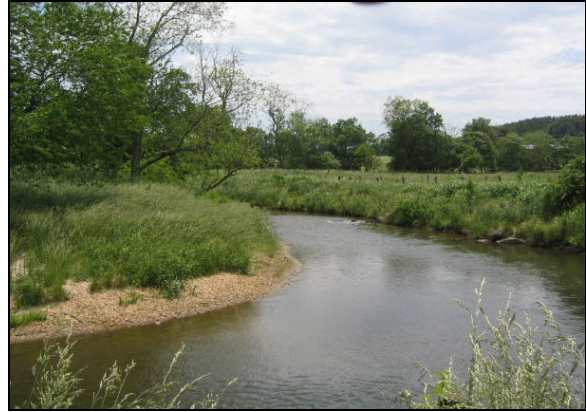
Typical Photo 2.
Typical Pool along Brush Creek.

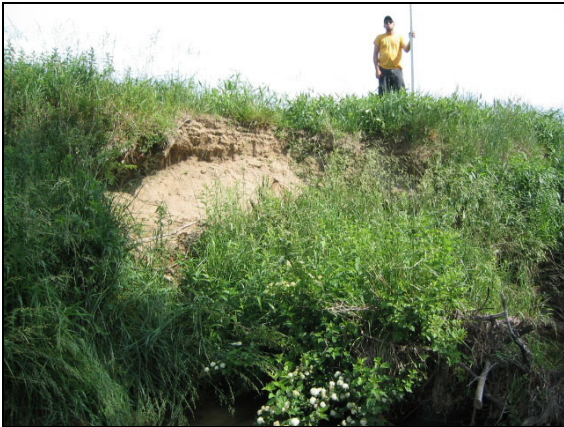
- 1.) Brush creek has several areas upstream of the confluence with Little Pine creek with bank slumping and indications of meander migration.
 - These areas should be addressed to limit further degradation. See recommendations below.

Issue Photo 1.
Brush Creek near Station 1+50.
Left Bank slump and scour.

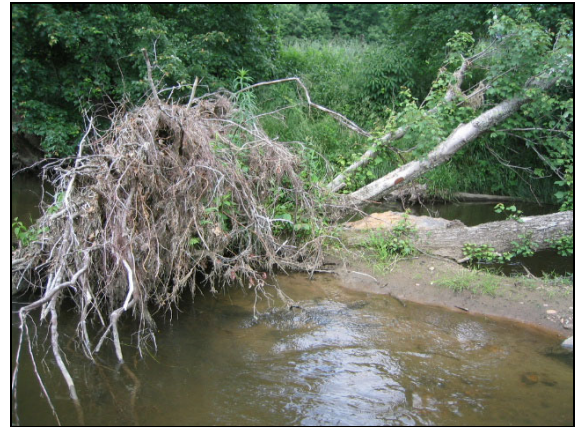
Issue Photo 2.
Brush Creek near Station 0+50.
Transverse bar at start of project.

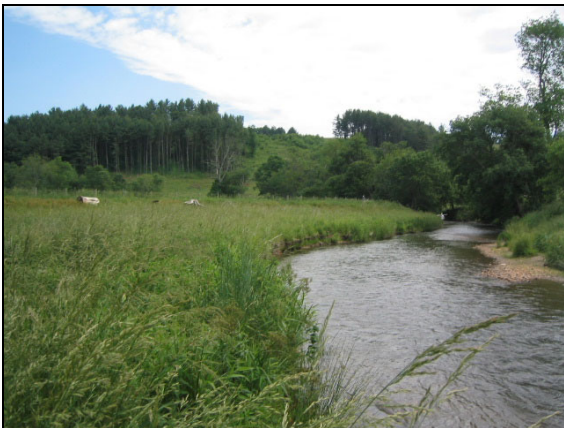
- 2.) The left bank along the relocated section (station 9+00 to 10+00) is showing signs of scouring.
 - This area should be monitored during upcoming site visits.

Issue Photo 3.
Brush Creek near Station 9+50.
Left bank scour.

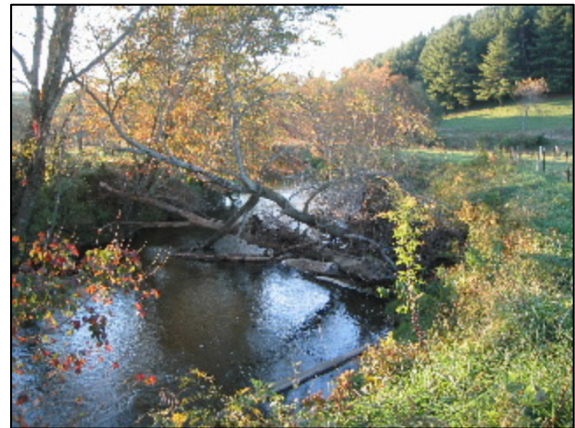
Issue Photo 4.
Brush Creek near Station 5+00.
Large Woody Debris in channel.

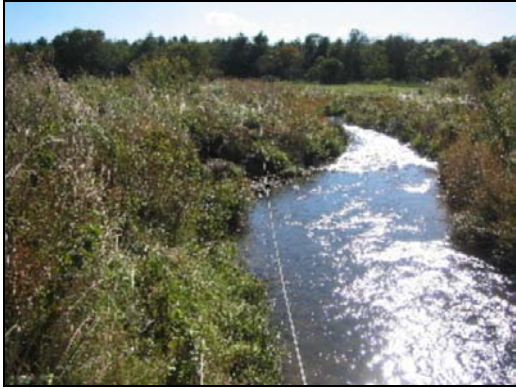
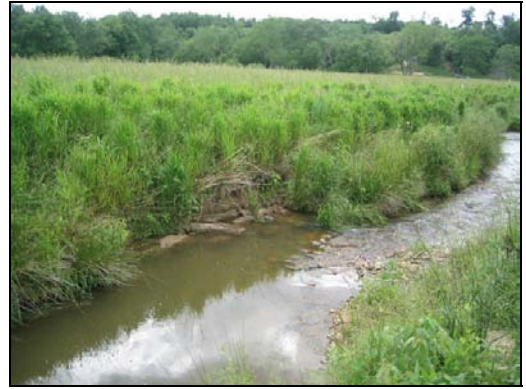
Little Pine Vegetation Plot Quad 1 on Little Pine Creek

Little to no natural regeneration was noted this year. It was noted that a few large planted sycamores and walnuts were thriving and appeared not to have been browsed. Overall, the area appeared to be in an early successional state.

Recommendations include replanting larger containerized trees to meet mitigation requirements and stake only in areas where erosion is problematic. Although invasive vegetation is not a major issue on this project site, the fescue in the adjacent field should be monitored. The riparian buffer should be extended to its rightful width in that area. Lastly, deer are an issue on this site. Measures should be taken to prevent deer browse of planted vegetation.

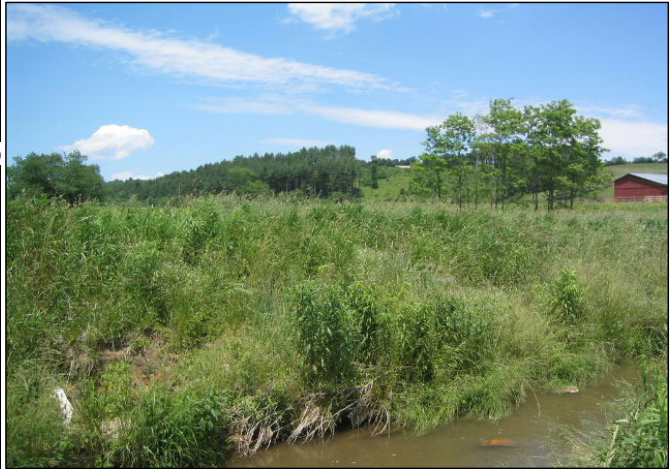
Photo of Cross-Section #1 - Looking Upstream

All channel cross-sections remained similar to 2003 conditions. Cross sections 1 and 3 decreased slightly in cross sectional area. Section 2 increased slightly.

As-Built	2002	2003	2004
Area	86.7	90.55	101.74	97.08
Width	31.5	31.2	31.5	31.5
Mean Depth	2.8	2.9	3.2	3.1
Max Depth	5.0	5.2	5.0	4.9

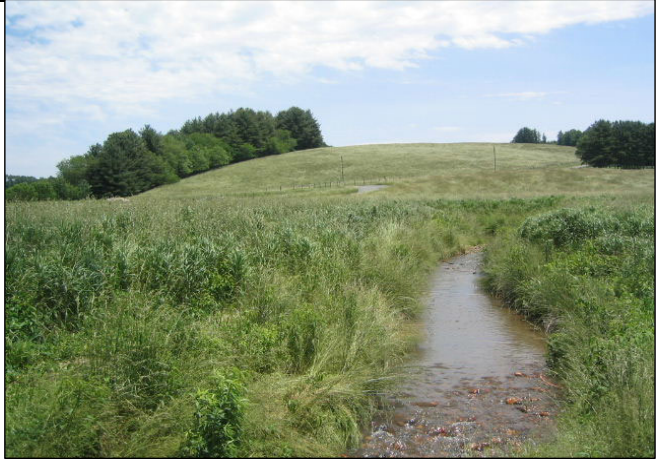
Photo of Cross-Section #2 - Looking Upstream

As-Built	2002	2003	2004
Area	88.7	92.42	87.80	94.46
Width	33.7	33.7	32.6	32.2
Mean Dept	2.6	2.7	2.7	2.9
Max Depth	4.8	4.9	5.5	6.0

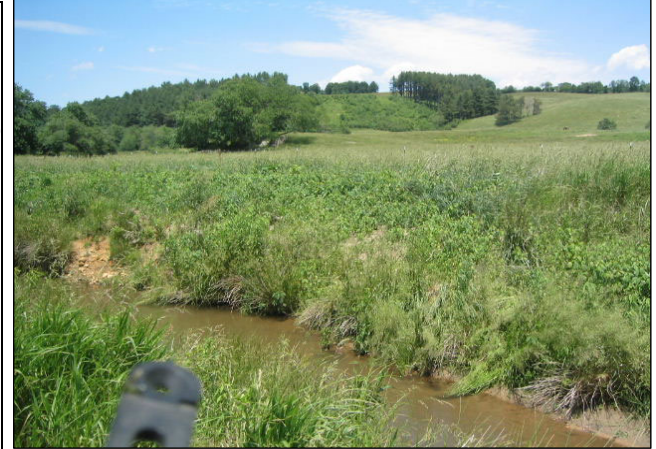
Photo of Cross-Section #3 - Looking Downstream

As-Built	2002	2003	2004
Area	86.6	96.63	100.41	86.42
Width	35.4	37.0	40.4	36.8
Mean Depth	2.4	2.6	2.5	2.3
Max Depth	4.5	5.3	6.4	4.9

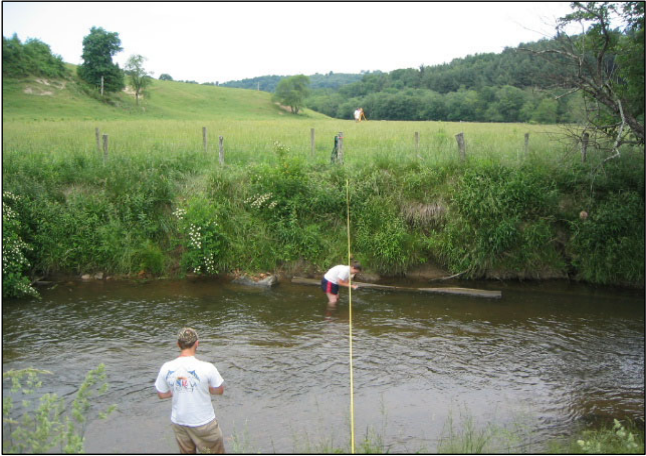
Photo of Cross-Section #4 - Looking Left Bank

As-Built	2002	2003	2004
Area	266.9	283.59	305.71	300.06
Width	55.3	47.4	53.2	58.2
Mean Dept	4.8	6.0	5.7	5.2
Max Depth	8.0	8.1	8.4	7.7

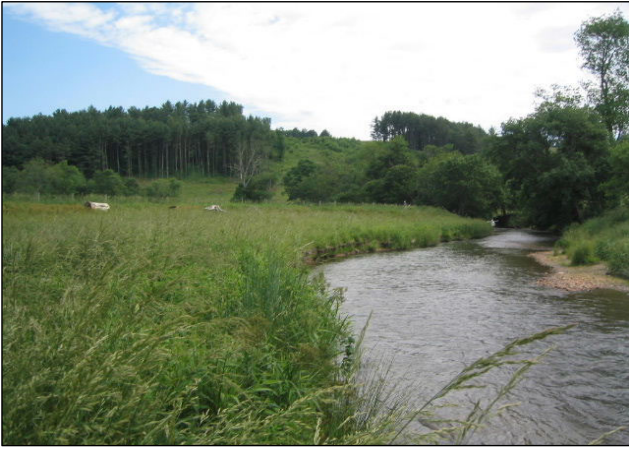
Photo of Cross-Section #5 - Looking Downstream

As-Built	2002	2003	2004
Area	392.0	387.12	384.62	398.92
Width	104.3	106.0	105.4	107.7
Mean Deptl	3.8	3.7	3.6	3.7
Max Depth	6.1	6.1	6.6	6.3

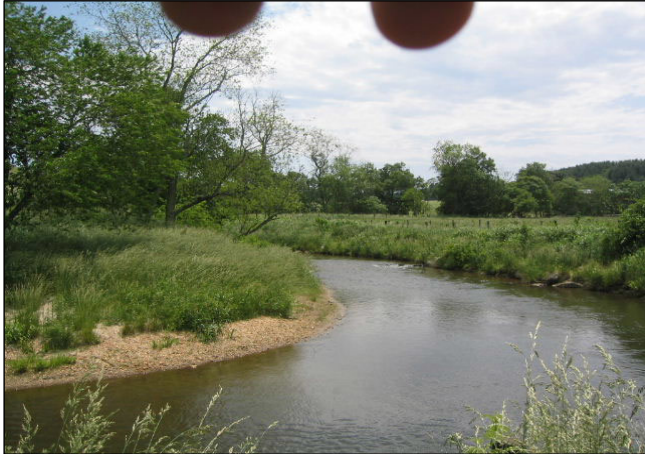
Photo of Cross-Section #6 - Looking Upstream

As-Built	2002	2003	2004
Area	305.0	285.27	297.58	288.95
Width	67.3	67.0	68.0	61.0
Mean Depth	4.5	4.3	4.4	4.7
Max Depth	6.9	6.9	7.2	7.4
