BRUSH CREEK – PROJECT NO. 54

MONITORING YEAR 8

2009

March 2010

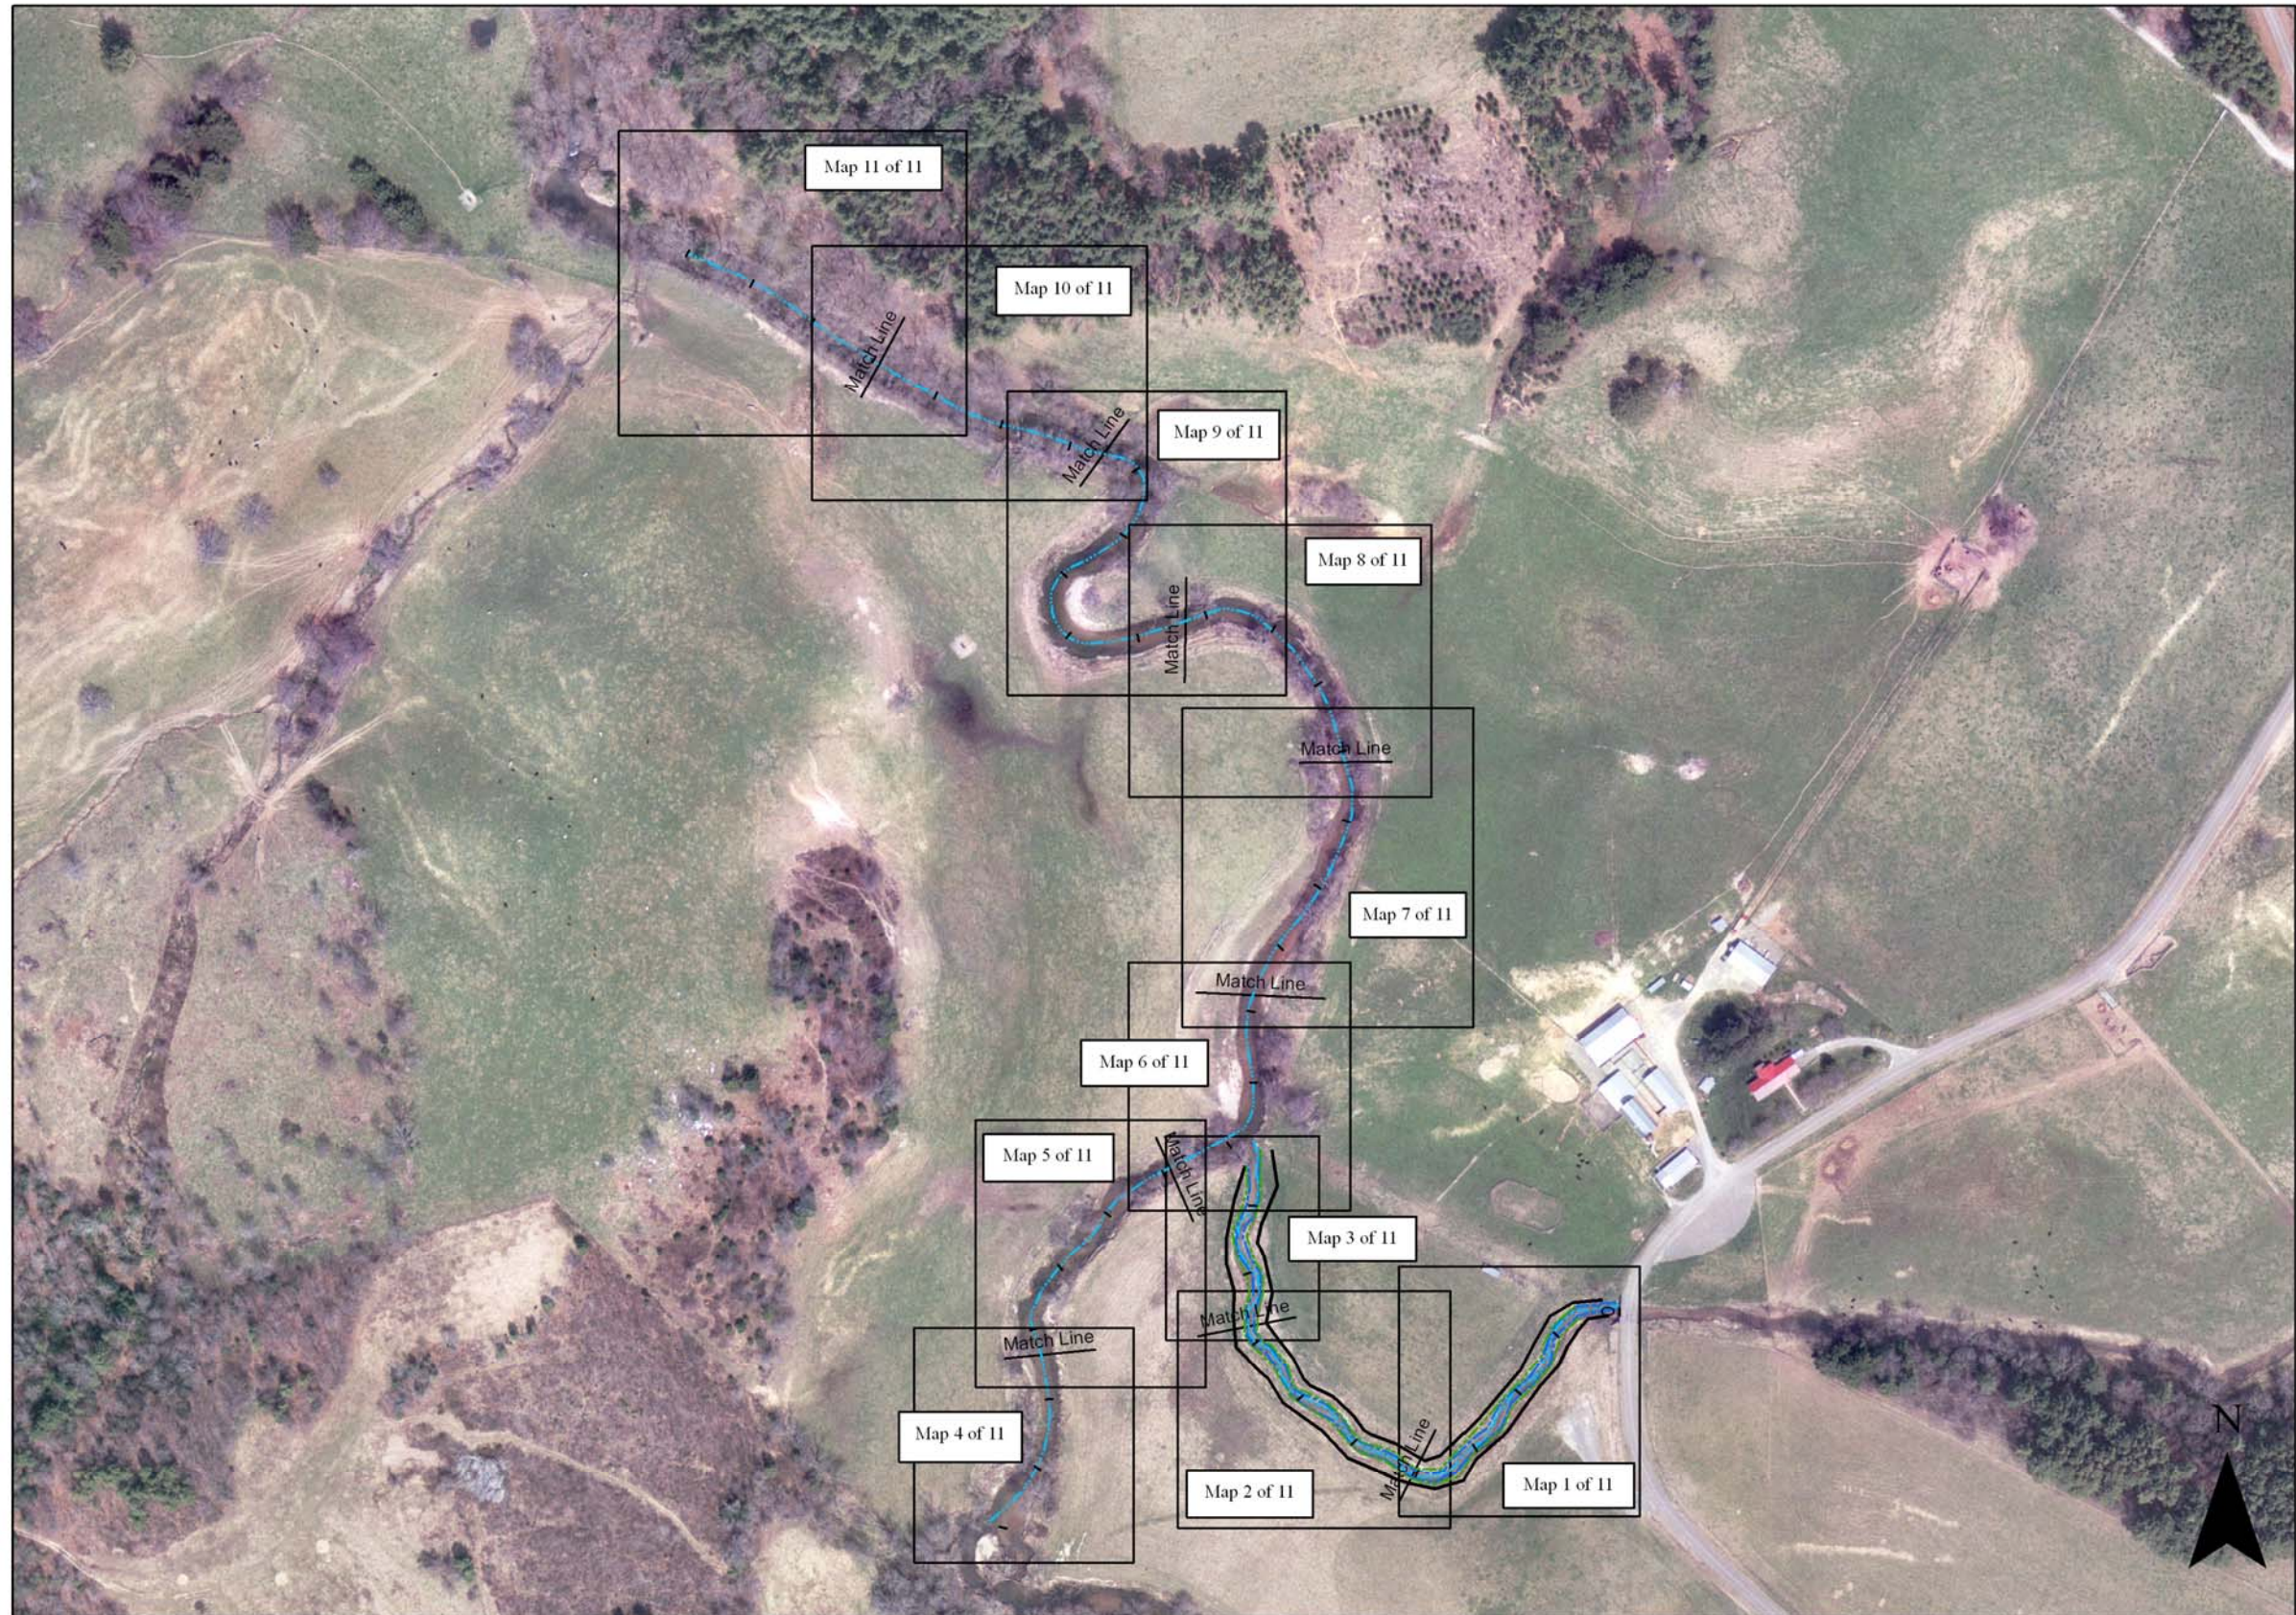
Current Condition
Plan View

Centerline and stationing for Brush Creek was obtained from recent aerial photography.

Centerline and stationing for Little Pine Creek came from MY8 survey data.

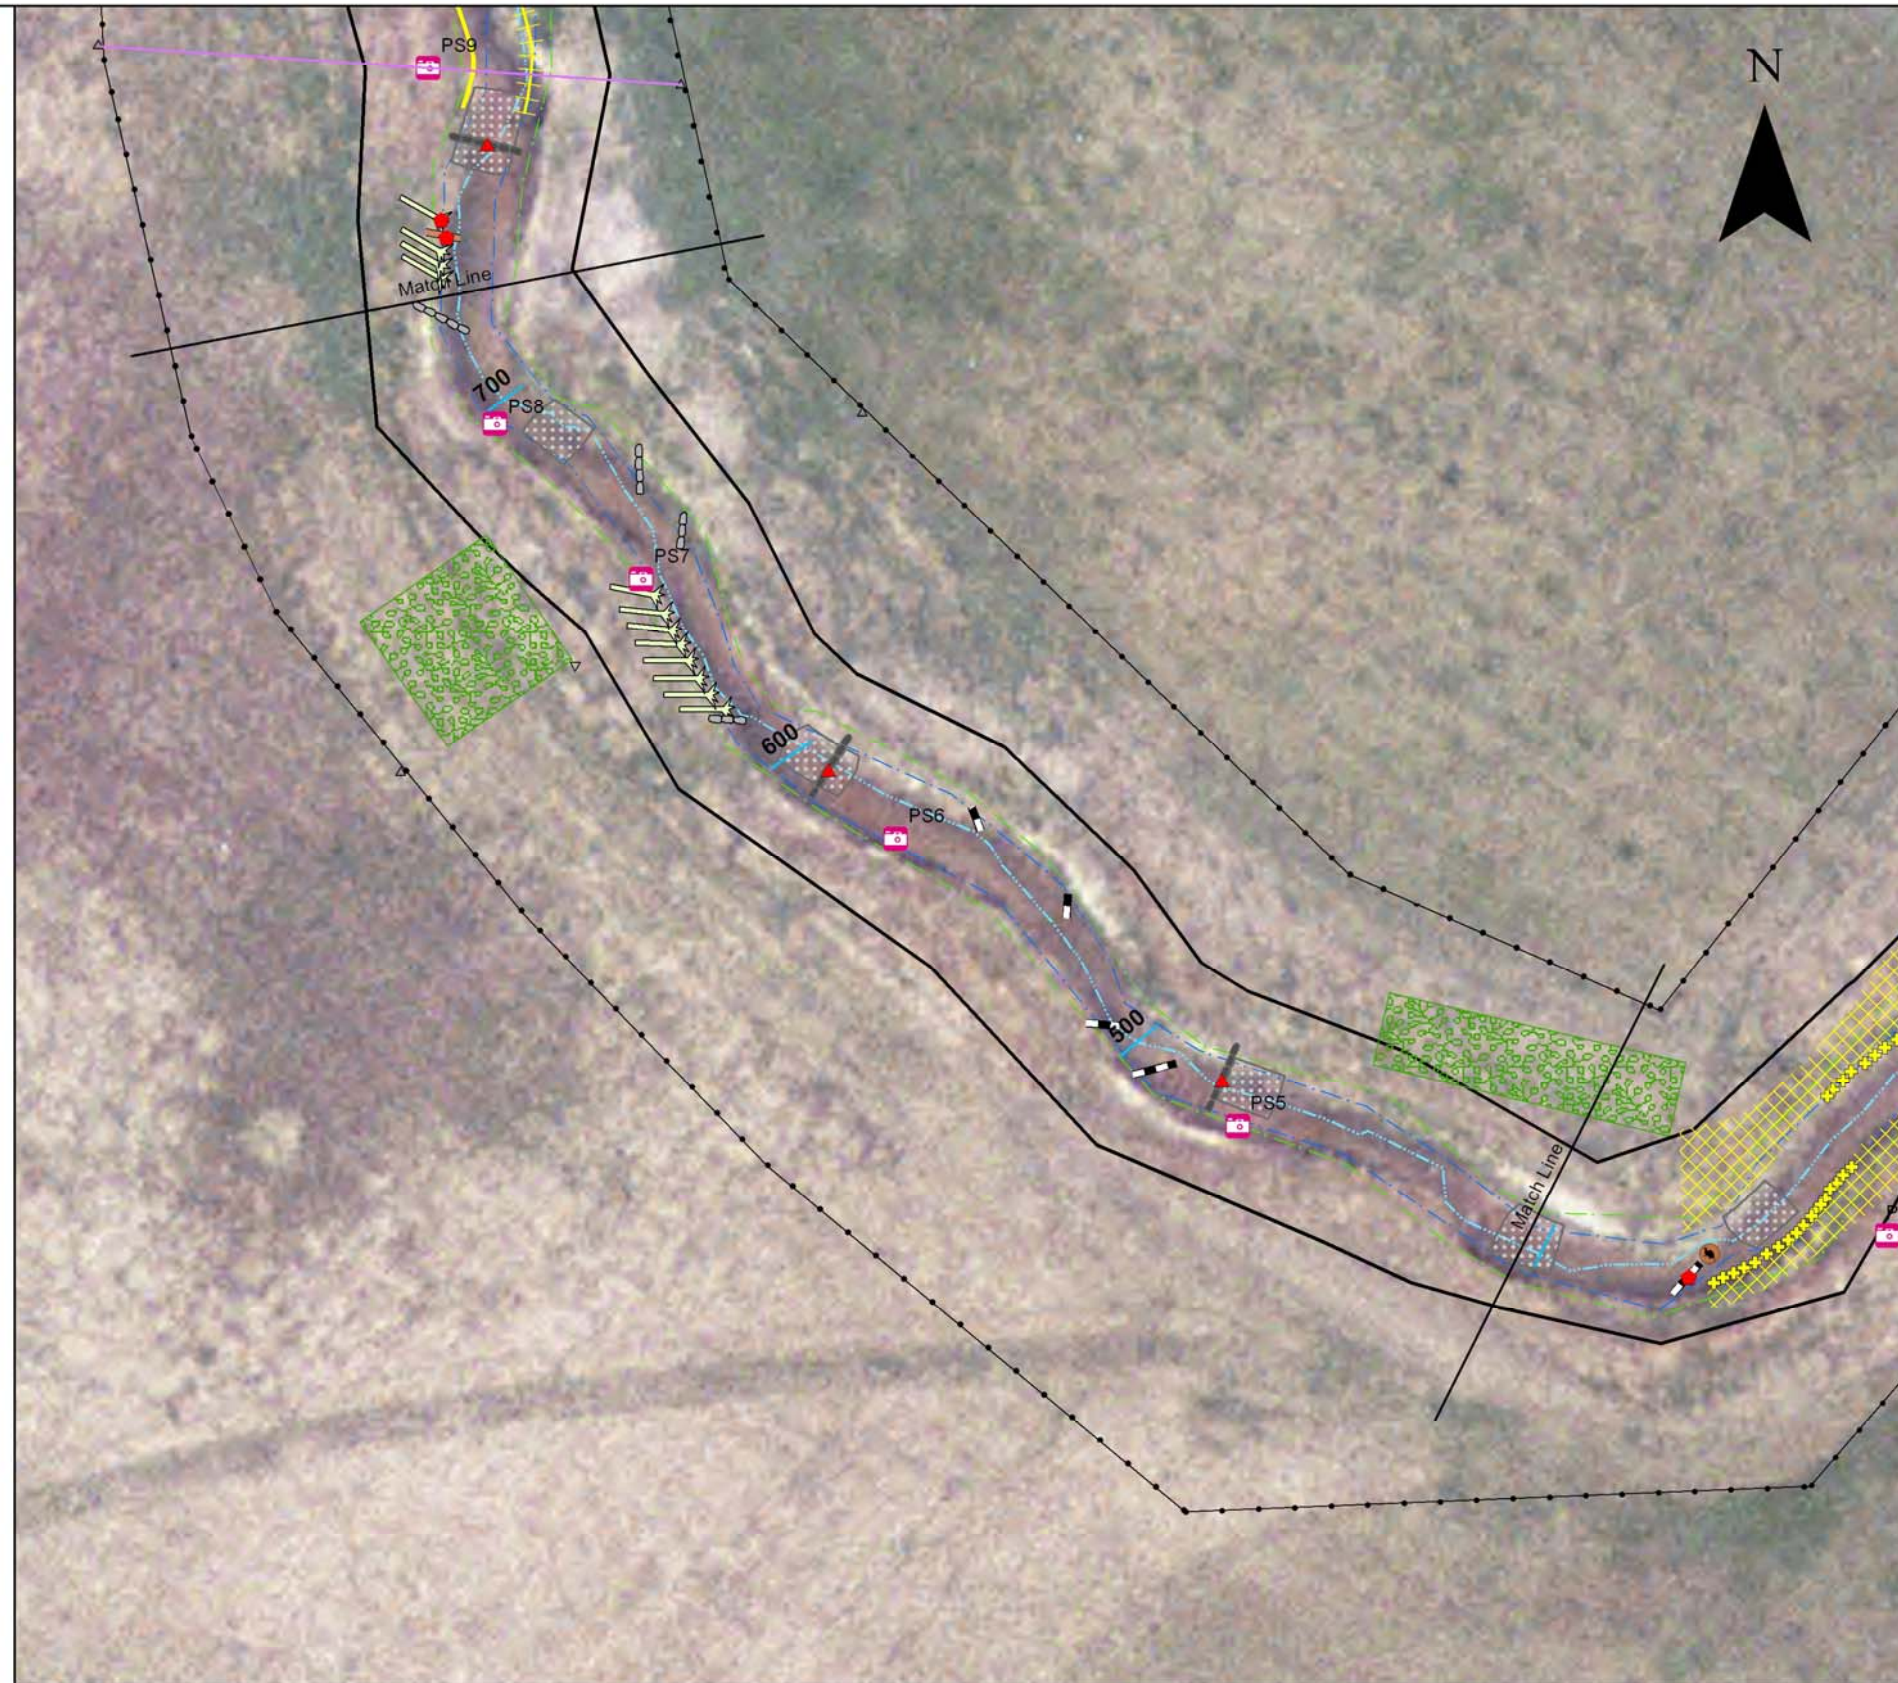
Current Condition Plan View

- Bare Bank**
 - To be watched
- Invasive Population**
 - To be watched
- Beaver Damage**
 - To be watched

- Beaver Dam
- Engineered Structures Grade**
 - Failed
- Engineered Structures Other**
 - To be watched
 - Failed
- Aggradation/Bar Formation**
 - To be watched
- Bank Scour**
 - To be watched

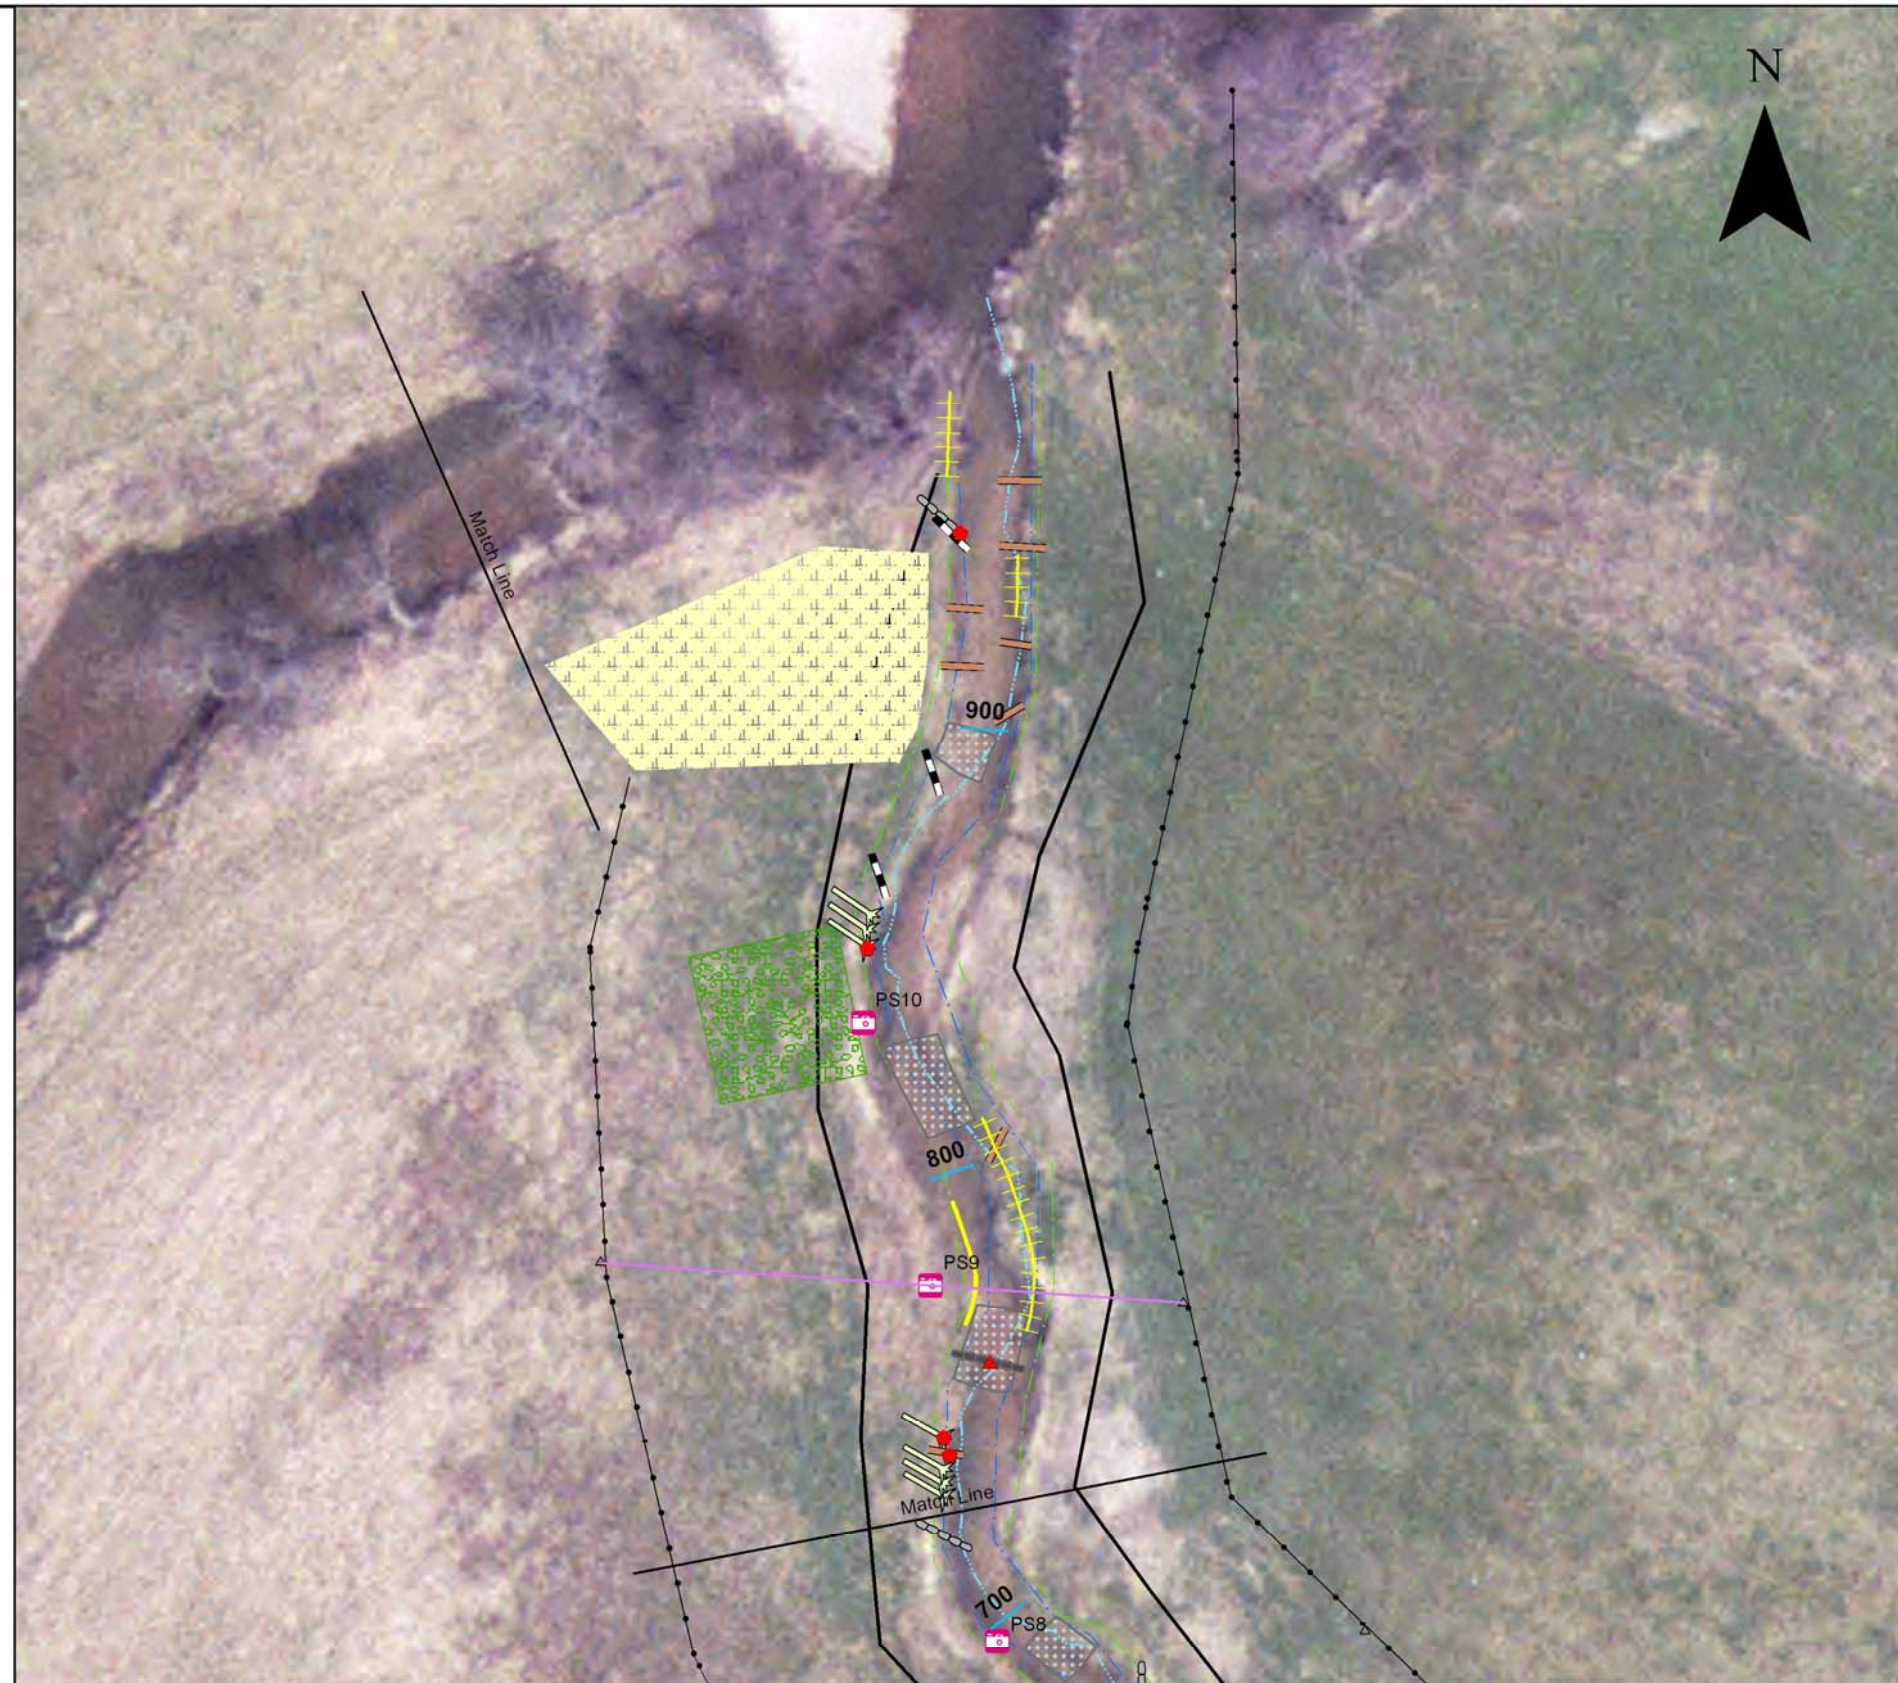
Current Condition Plan View

- Bare Bank**
- To be watched
- Invasive Population**
- Invasive Population
- Beaver Damage**
- Beaver Damage

- Beaver Dam
- Engineered Structures Grade**
- Failed
- Engineered Structures Other**
- To be watched
- Failed
- Aggradation/Bar Formation**
- To be watched
- Bank Scour**
- To be watched

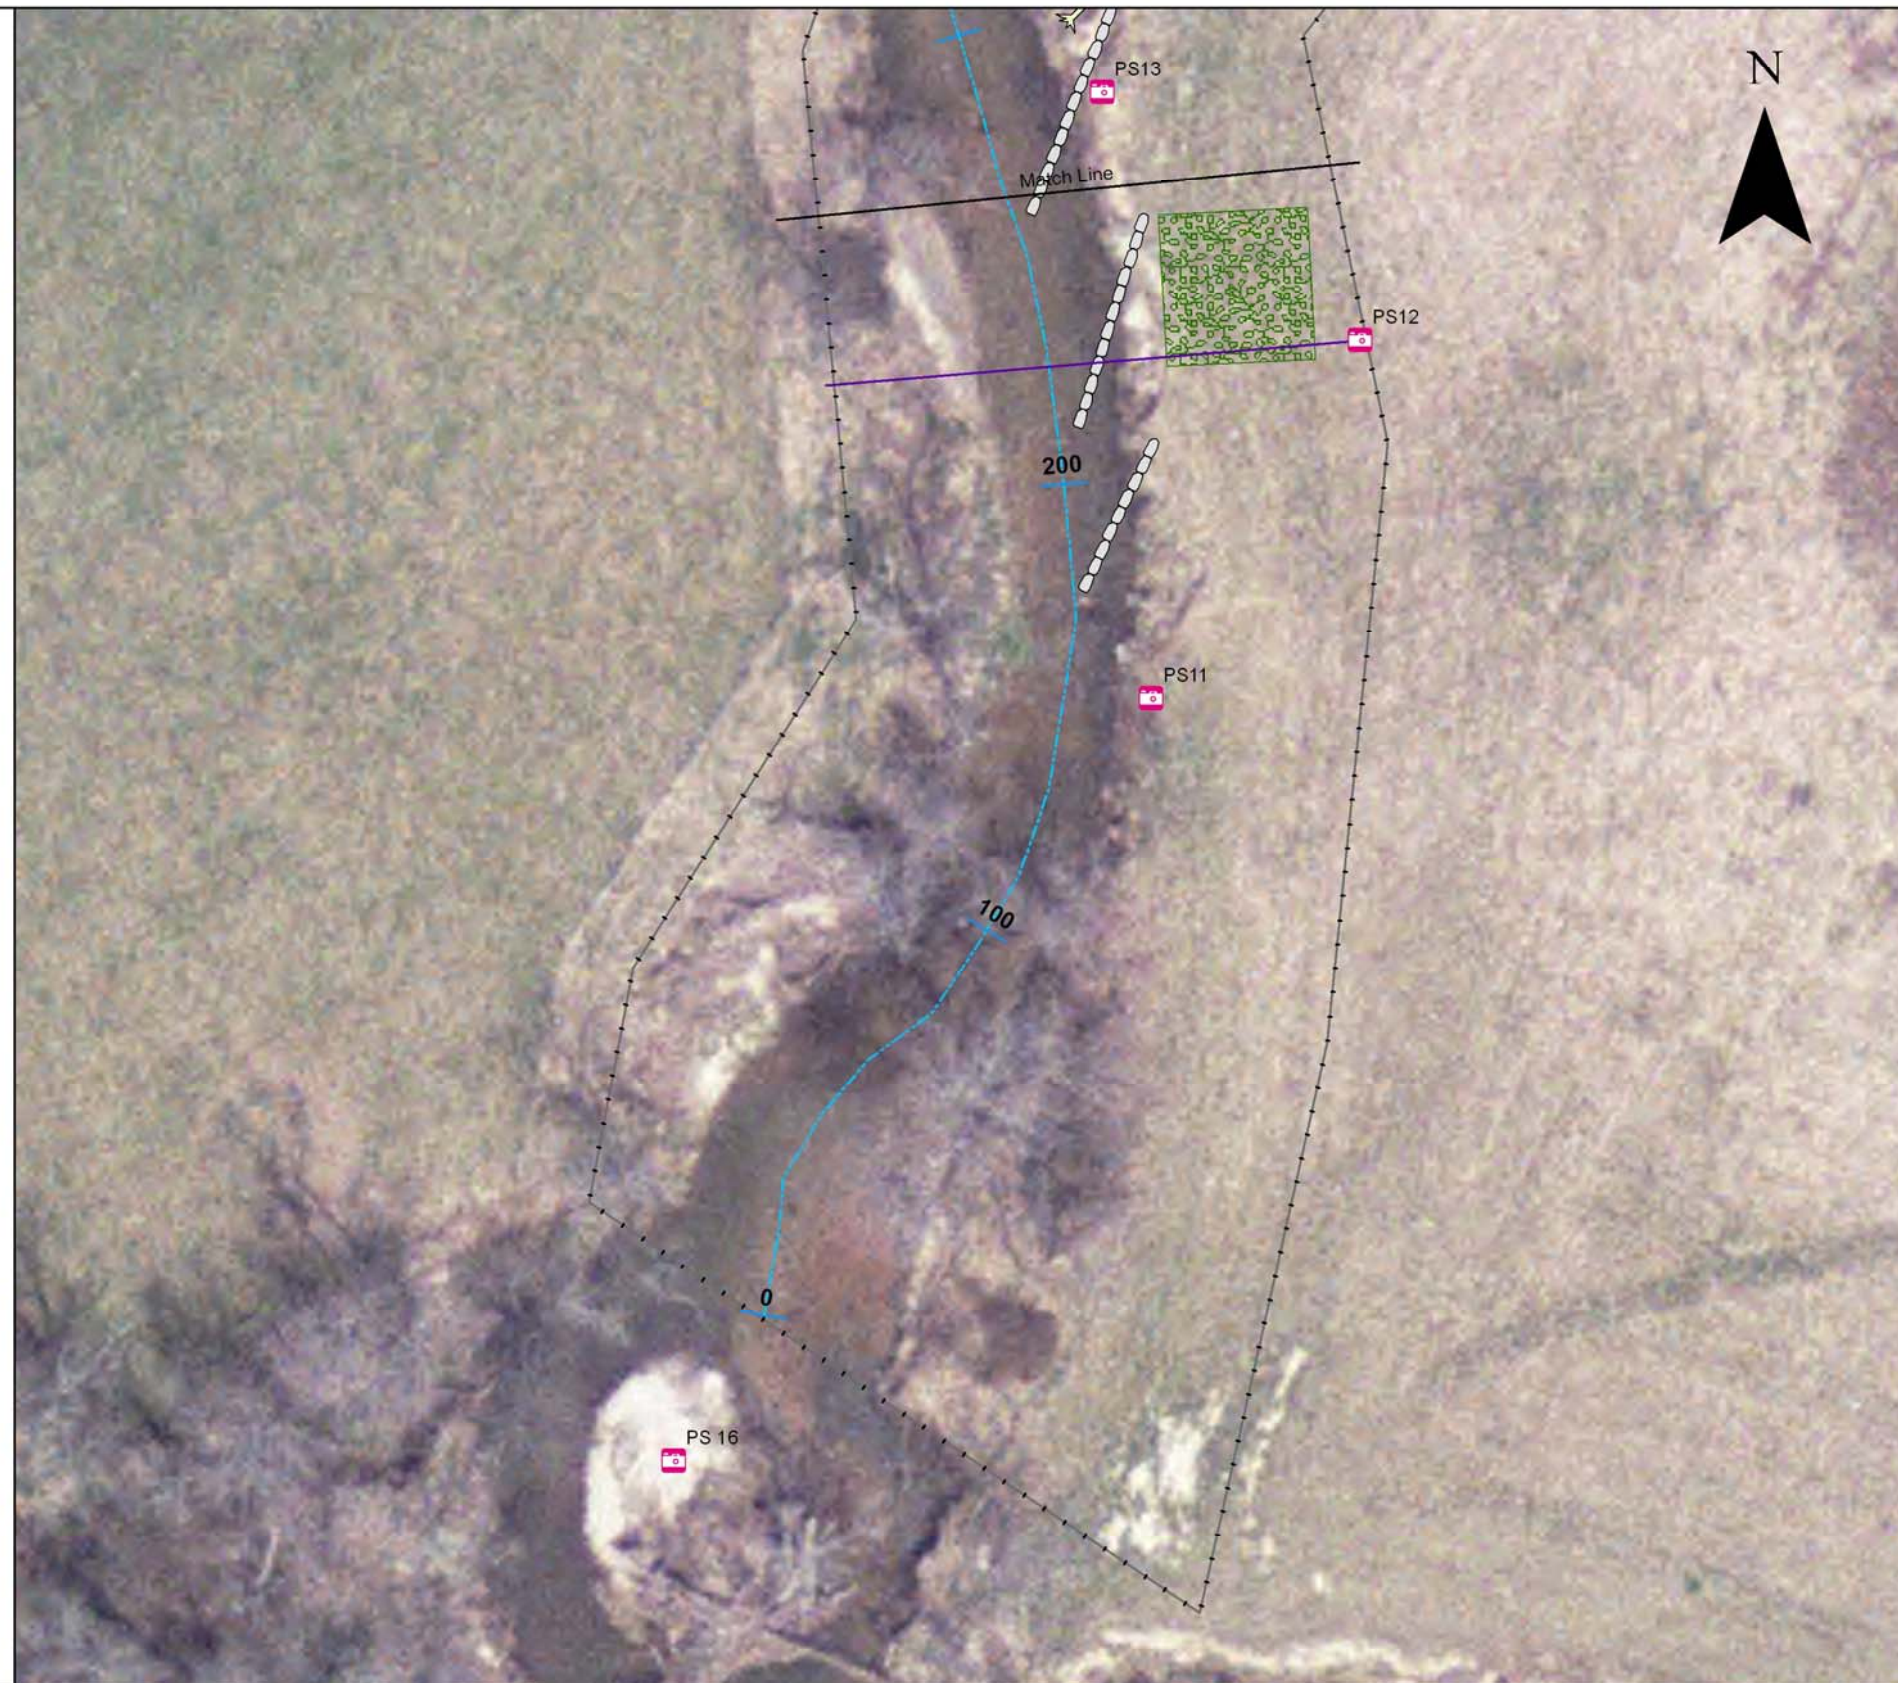
Current Condition Plan View

- Bare Bank**
 To be watched
- Invasive Population**
 To be watched
- Beaver Damage**
 To be watched

- Beaver Dam
- Engineered Structures Grade**
 Failed
- Engineered Structures Other**
 To be watched
 Failed
- Aggradation/Bar Formation**
 To be watched
- Bank Scour**
 To be watched

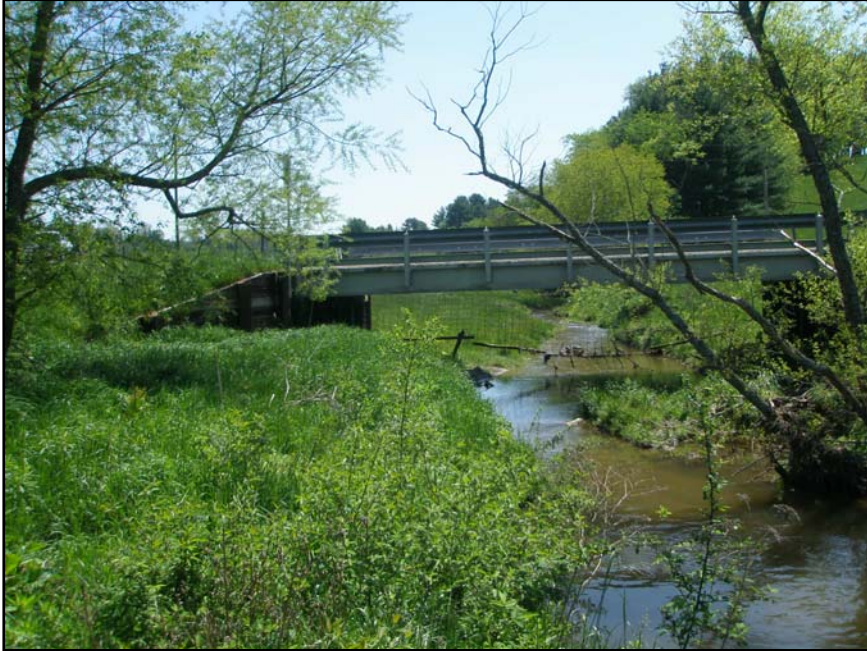
Site: Little Pine Creek
Project No: 54
Photo Station: 2
Date: May 12, 2009
Photographed by: C. Lawson
Description: Taken 70 degrees from north, facing upstream. Midbar forming under bridge (station 00+10-00+22).

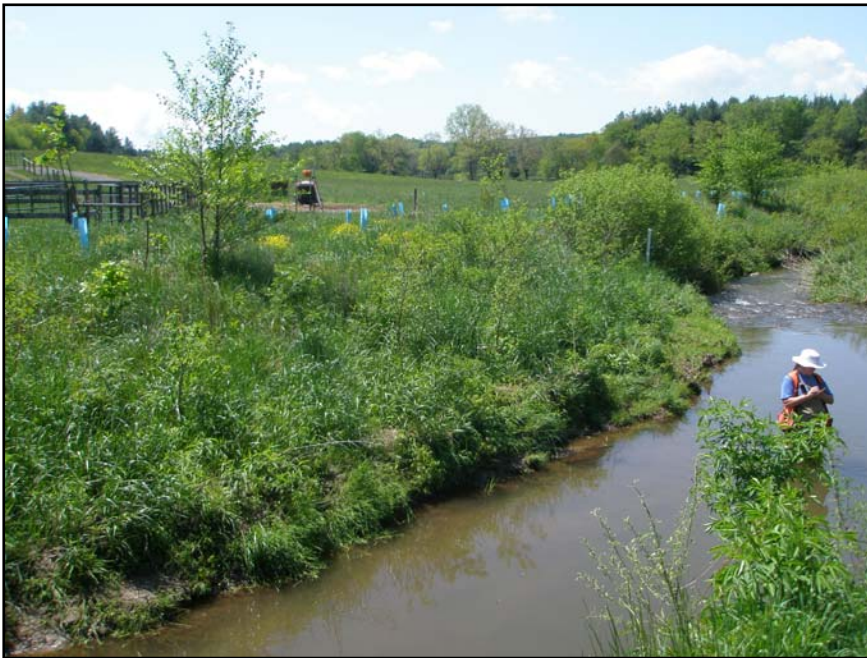
Site: Little Pine Creek
Project No: 54
Photo Station: 2
Date: May 12, 2009
Photographed by: C. Lawson
Description: Taken 200 degrees from north. Facing downstream towards riffle cross section 1.

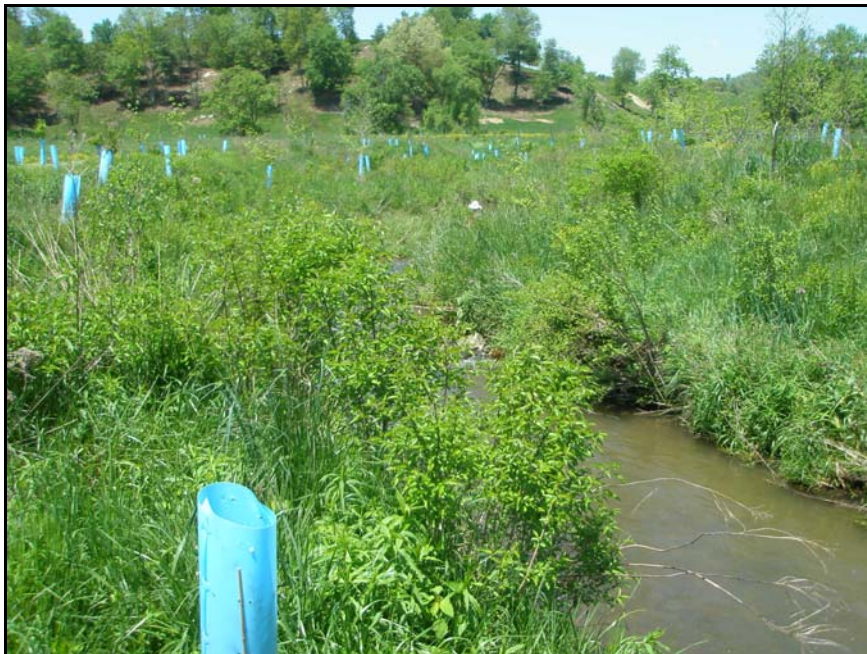
Site: Little Pine Creek
Project No: 54
Photo Station: 5
Date: May 12, 2009
Photographed by: C. Lawson
Description: Taken 300 degrees from north, facing downstream towards breached rock sill.

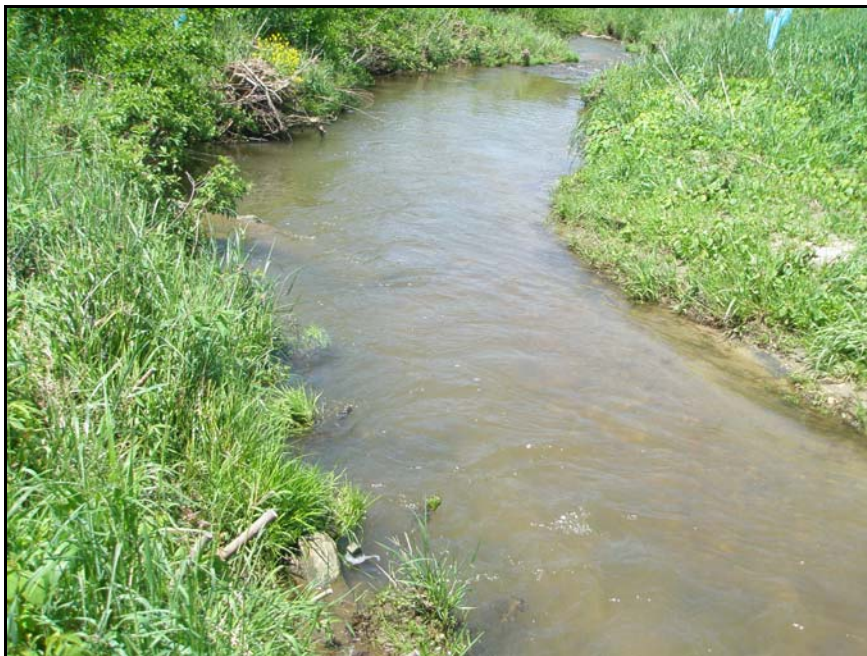
Site: Little Pine Creek
Project No: 54
Photo Station: 8
Date: May 12, 2009
Photographed by: C. Lawson
Description: Taken 350 degrees from north, muskrat holes along the left descending bank.

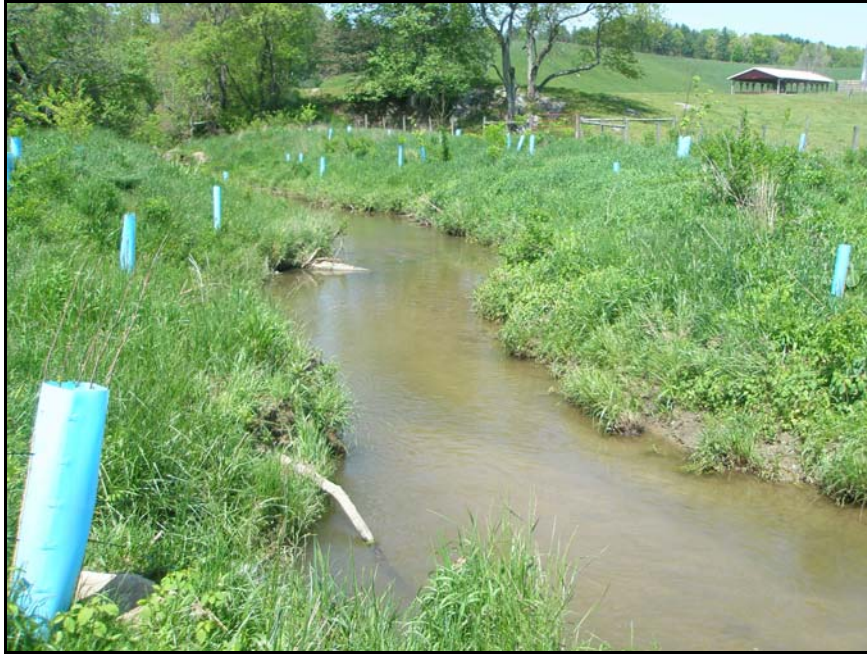
Site: Little Pine Creek
Project No: 54
Photo Station: 10
Date: May 12, 2009
Photographed by: C. Lawson
Description: Taken 20 degrees from north, water flowing under root wads along left descending bank.

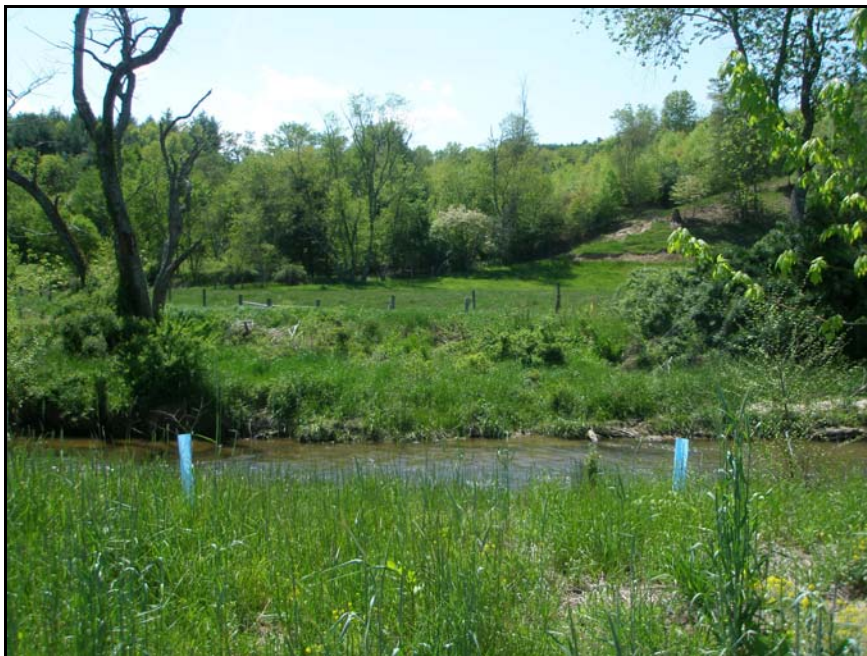
Site: Brush Creek
Project No: 54
Photo Station: 12
Date: May 12, 2009
Photographed by: C. Lawson
Description: Taken 270 degrees from north, showing a portion of the Brush Creek Vegetation Plot.

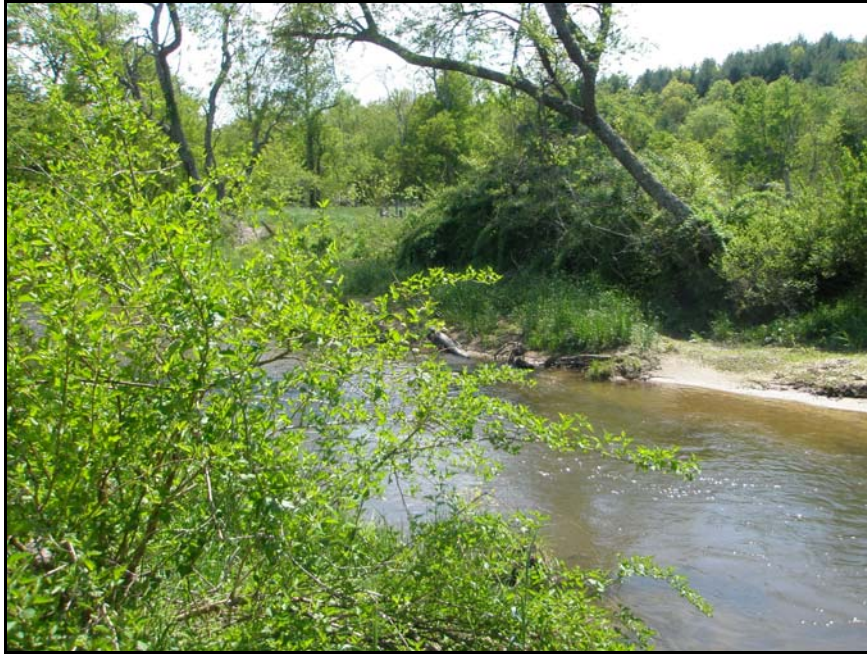
Site: Brush Creek
Project No: 54
Photo Station: 14
Date: May 12, 2009
Photographed by: C. Lawson
Description: Taken 190 degrees from north, facing upstream, bank scour is visible along the right descending bank.

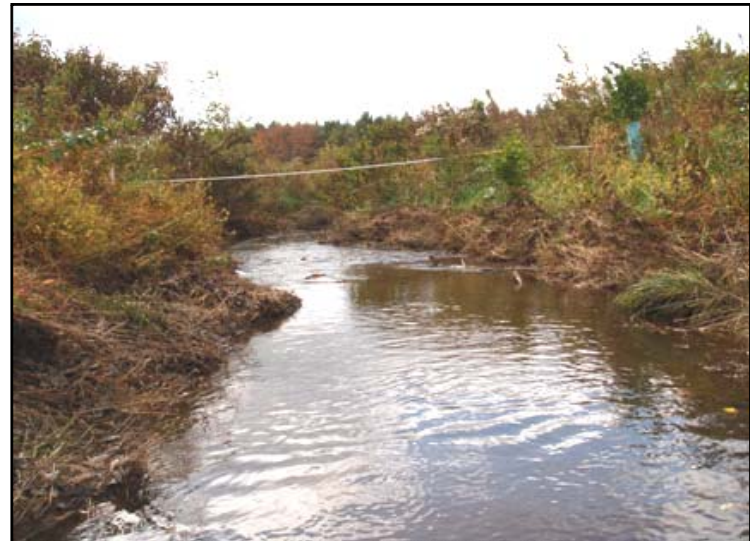
Facing downstream x-section #1

Project Name	Brush Creek Project 54
Cross Section	Little Pine Creek 1 of 3
Feature	Riffle
Date Surveyed	10/13/2009
Crew	Bilbrey, L., Lawson, C.

Bankfull Area				
	AB2	MY6	MY7	MY8
Area	45.3	44.4	47.9	31.3
Width	24.9	25.4	25.4	20.4
Mean Depth	1.8	1.7	1.9	1.5
Max Depth	2.8	2.8	3.0	2.5
w/d ratio	13.7	14.5	13.5	13.4
FPW	105.1	>100	171.0	39.6
ER	4.2	3.9	6.7	1.9

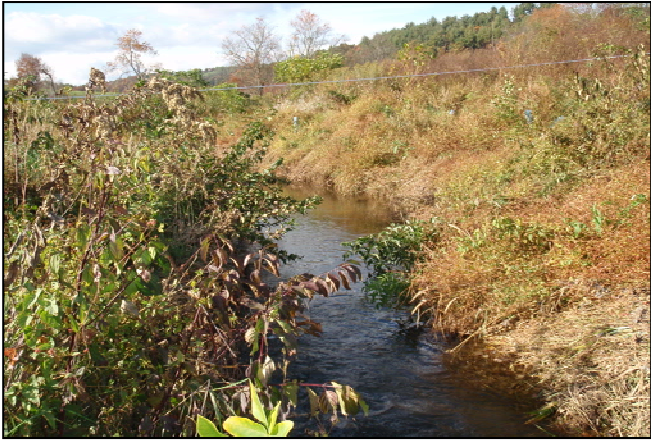
Facing down stream x-section #2

Project Name	Brush Creek Project 54
Cross Section	Little Pine Creek 2 of 3
Feature	Pool
Date Surveyed	10/13/2009
Crew	Bilbrey, L., Lawson, C.

Bankfull Area				
	AB2	MY6	MY7	MY8
Area	54.4	51.9	40.2	50.8
Width	24.7	26.4	20.6	16.5
Mean Depth	2.2	2.0	1.9	3.1
Max Depth	3.9	3.8	3.7	4.4
w/d ratio	11.2	13.4	n/a	n/a
FPW	126.1	>100	n/a	n/a
ER	5.1	3.8	n/a	n/a

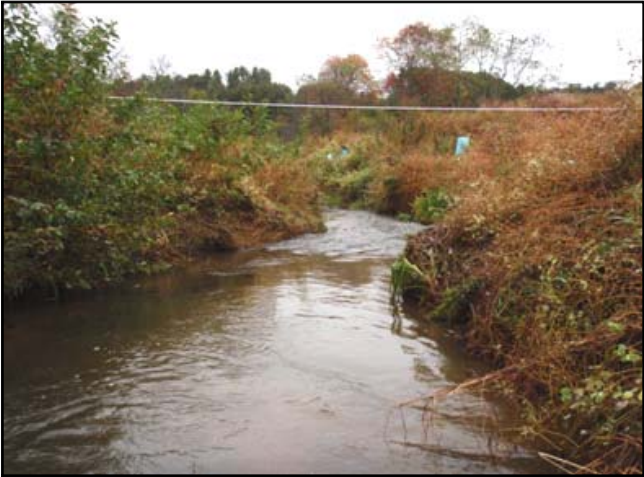
Facing down stream x-section #3

Project Name	Brush Creek Project 54
Cross Section	Little Pine Creek 3 of 3
Feature	Riffle
Date Surveyed	10/13/2009
Crew	Bilbrey, L., Lawson, C.

Bankfull Area				
	AB2	MY6	MY7	MY8
Area	45.1	45.97	48.3	37.8
Width	30.3	34.0	30.3	26.0
Mean Depth	1.8	1.4	1.6	1.5
Max Depth	2.8	2.8	3.0	2.9
w/d ratio	20.3	25.1	19.1	17.9
FPW	110.0	>100	73.9	79.2
ER	2.7	2.9	2.4	3.0

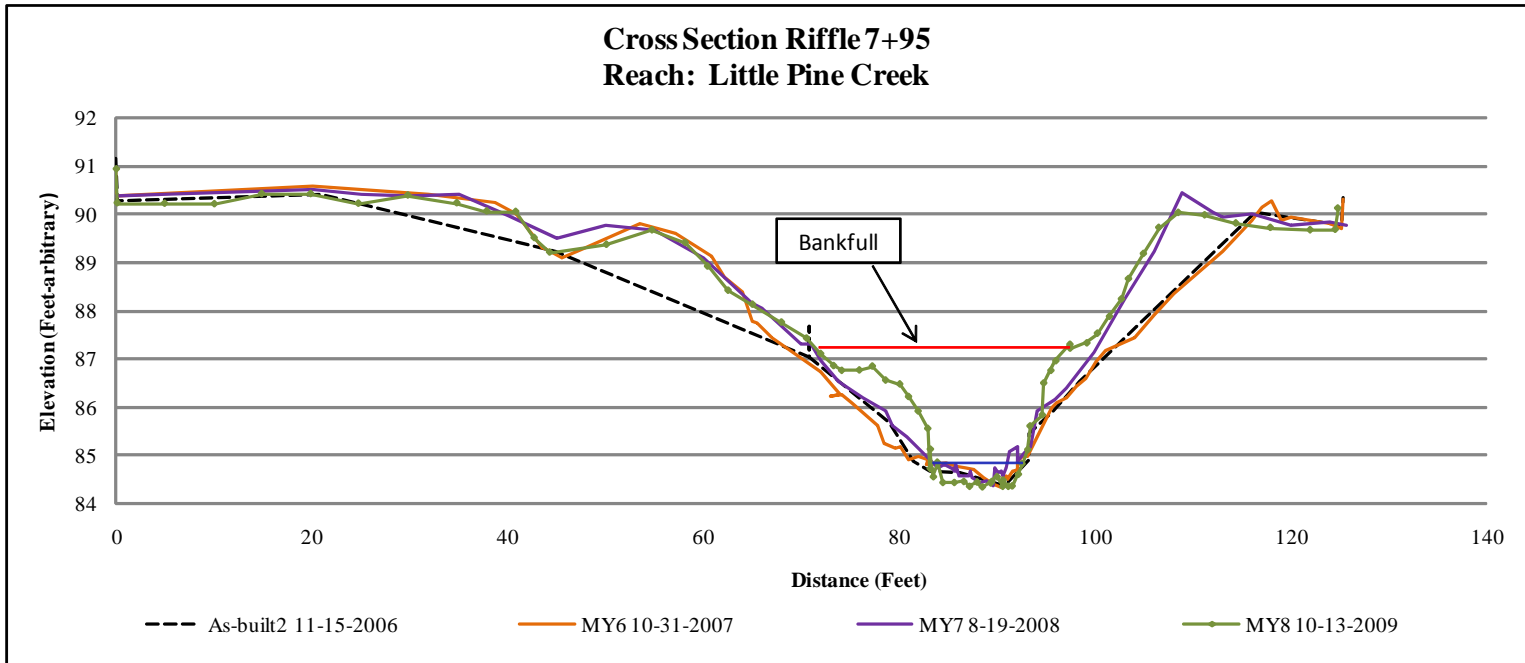
Project Name Brush Creek Project 54											
Cross Section Little Pine Creek 3 of 3											
Feature Riffle											
Date Surveyed 10/13/2009											
Crew Bilbrey, L., Lawson, C.											
10/13/2009 MY8 Survey			10/13/2009 MY8 Survey (cont'd)			MY9 Survey			MY10 Survey		
Station	Elev	Notes	Station	Elev	Notes	Station	Elev	Notes	Station	Elev	Notes
0	90.93	x3lp	85.58	84.44	x3

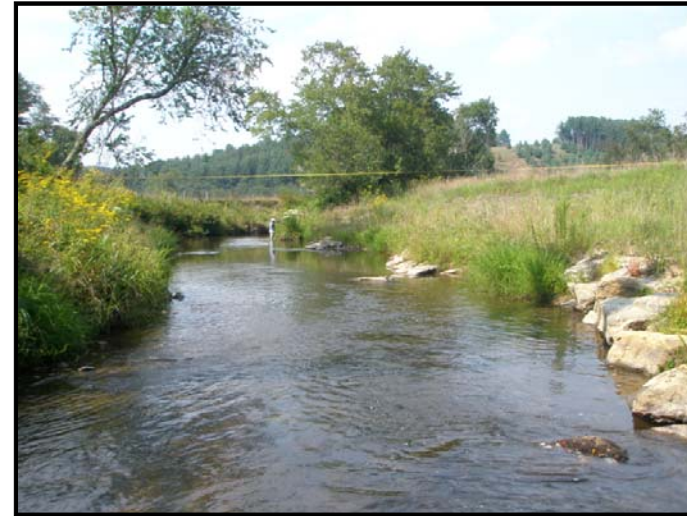
Facing down stream x-section #1

Project Name	Brush Creek Project 54
Cross Section	Brush Creek 1 of 1
Feature	Run
Date Surveyed	10/13/2009
Crew	Bilbrey, L., Lawson, C.

Bankfull Area			
	AB2	MY6	MY7	MY8
Area	177.5	146.00	128.8	170.8
Width	63.5	65.0	56.6	63.8
Mean Depth	2.8	2.2	2.3	2.7
Max Depth	5.5	3.3	4.8	5.8
w/d ratio	22.8	28.9	24.9	23.8
FPW	181.8	>100	225.0	225.0
ER	2.9	2.9	4.0	3.5

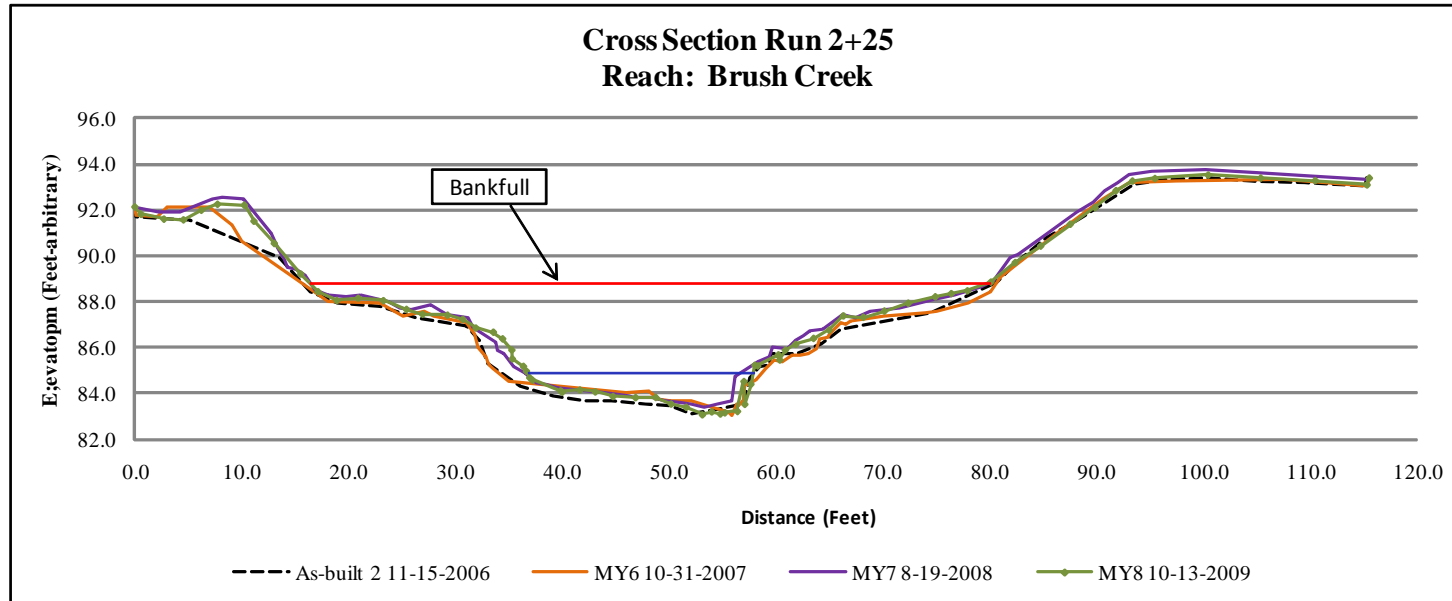
Project Name			Brush Creek Project 54								
Cross Section			Brush Creek 1 of 1								
Feature			Run								
Date Surveyed			10/13/09								
Crew			Bilbrey, L., Lawson, C.								
10/13/09 MY8 Survey			10/13/09 MY8 Survey (cont'd)			MY9 Survey			MY10 Survey		
Station	Elev	Notes	Station	Elev	Notes	Station	Elev	Notes	Station	Elev	Notes
0	92.13	x4lp	53.07	83.08	x4

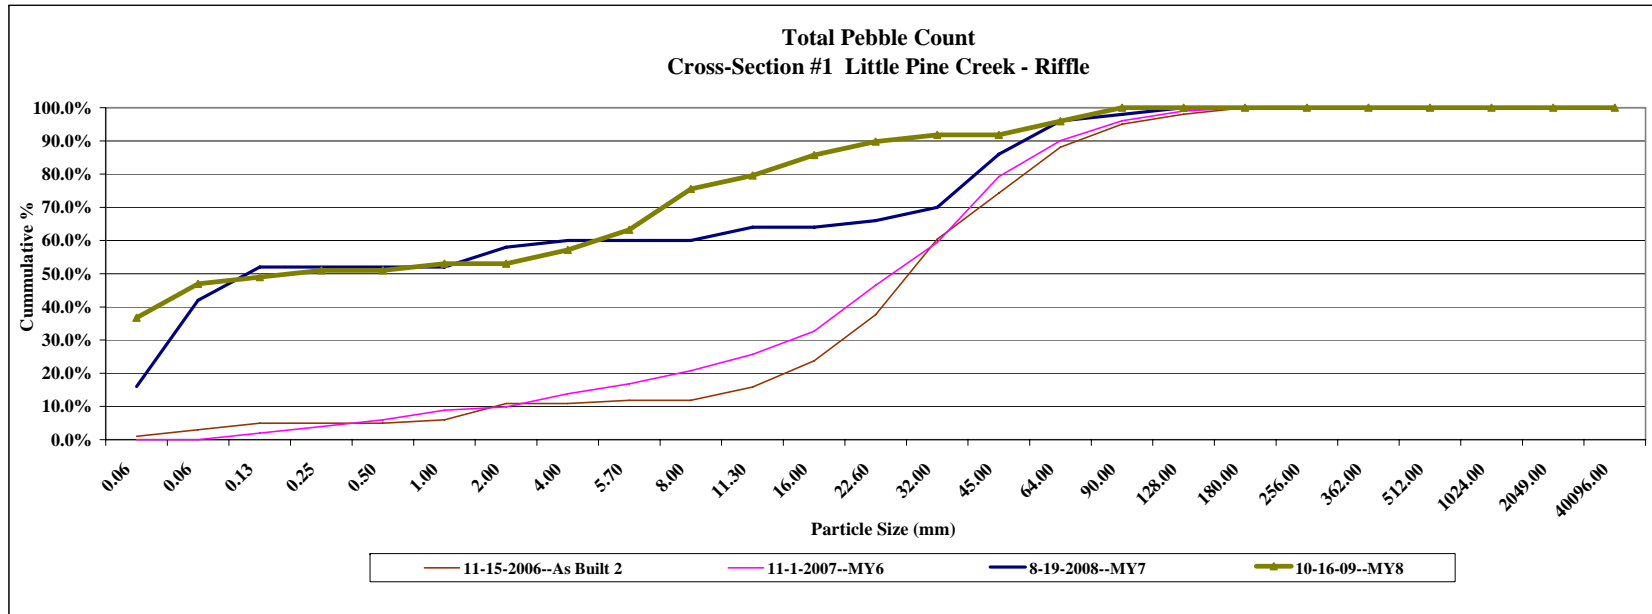
Project Name	Brush Creek Project 54
Cross Section	#1
Feature	Riffle
Date	10/16/09
Crew	Bilbrey, L., Lawson, C.
Notes	Pebble count data from As Built 2 to MY8
