BRUSH CREEK – PROJECT NO. 54

MONITORING YEAR 8

2009

March 2010

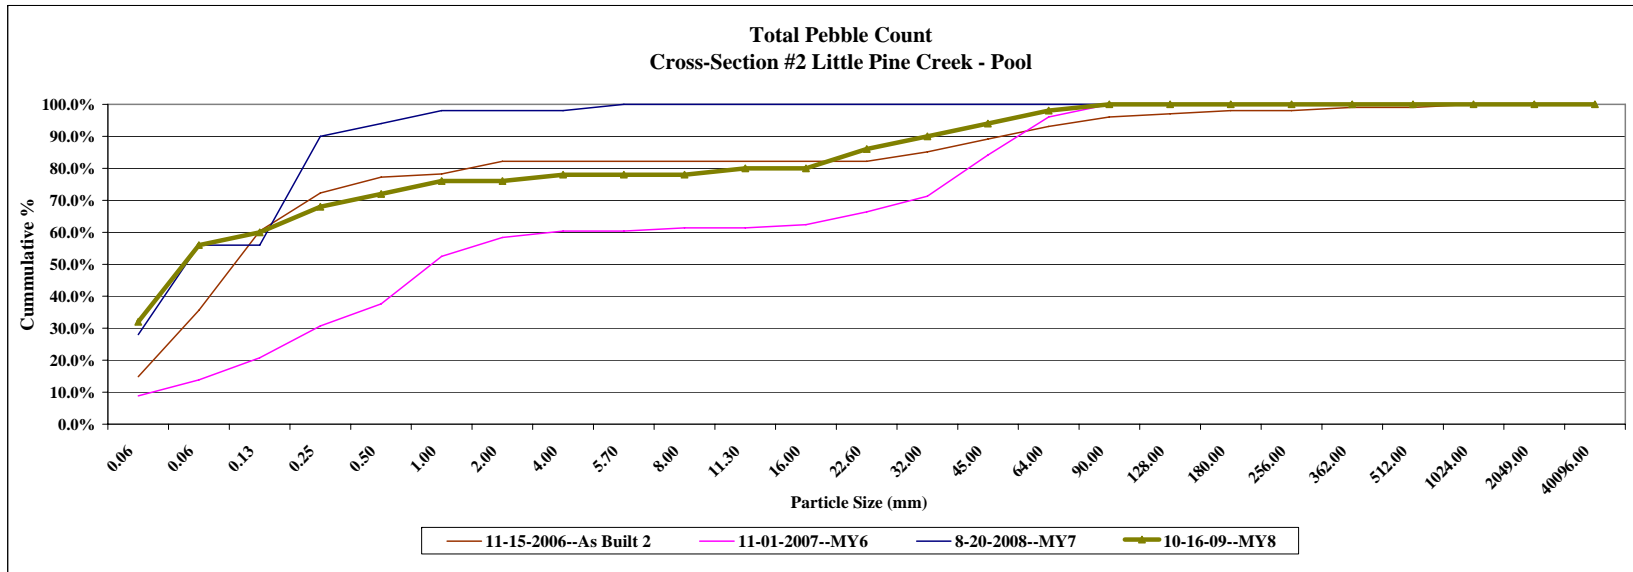
Project Name	Brush Creek Project 54
Cross Section	#2
Feature	Pool
Date	10/16/09
Crew	Bilbrey, L., Lawson, C.
Notes	Pebble count data from As Built 2 to MY8
