**MONITORING YEAR 5  
ANNUAL REPORT**  
Final

**BUCKWATER BUFFER MITIGATION SITE**

Orange County, NC  
NCDEQ Contract No. 006829  
DMS Project Number 97084  
NCDWR Project Number 2016-0406v1

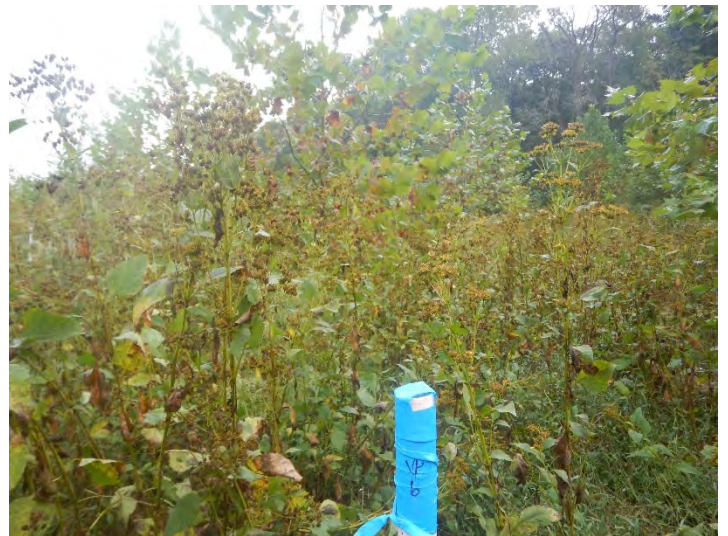
**VEG PLOT 6** (10/03/2023)

A total of 15 of the 19 vegetation plots exceeded the MY5 final success criteria. However, vegetation plots 6, 7, and 18 are only failing to meet requirements by less than 10% with 243 stems per acre each. Vegetation has become well established along the stream banks providing shade, stability, and a source of organic material. Replanting of the repair areas' limits of disturbance has been partially completed and will be fully completed in winter 2023-2024. Management actions were completed in MY5 to ensure tree survivability and growth. An invasive vegetation treatment was completed in March 2023 and remaining Chinese privet will continue to be treated. Summary information/data related to the performance of various project and monitoring elements can be found in the tables and figures in the report appendices. Narrative background and supporting information, formerly found in these reports, can be found in the Mitigation Plan (Wildlands, 2017) available on DMS's website. All raw data supporting the tables and figures in the appendices are available from DMS upon request.

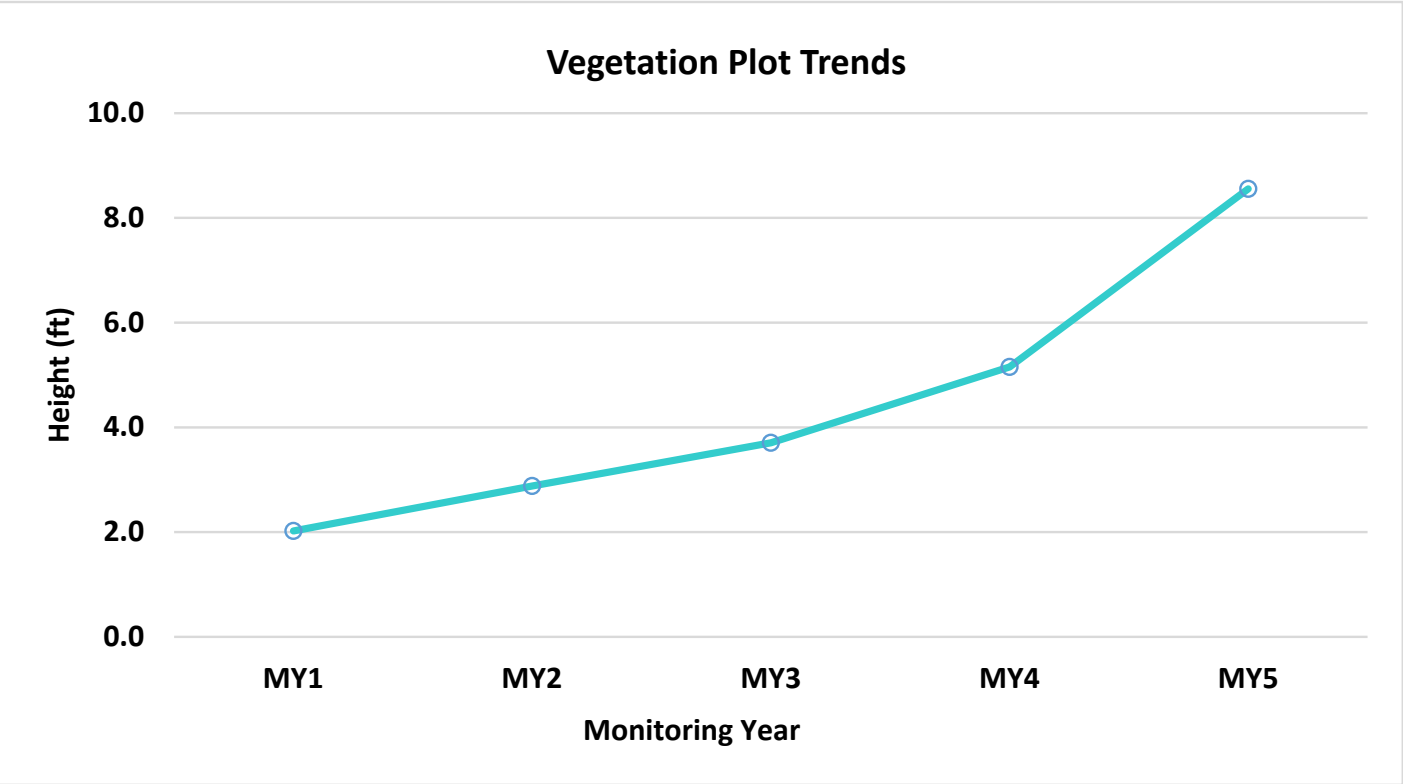
*Response: Table 8b: Average Vegetation Height by Plot and Graph 1: Vegetation Plot Trends are now included in the report.*
