**MONITORING YEAR 4
ANNUAL REPORT
Final**

BUCKWATER BUFFER MITIGATION SITE
Orange County, NC

NCDEQ Contract No. 006829
DMS Project Number 97084
NCDWR Project Number 2016-0406

Monitoring Year 4 Report

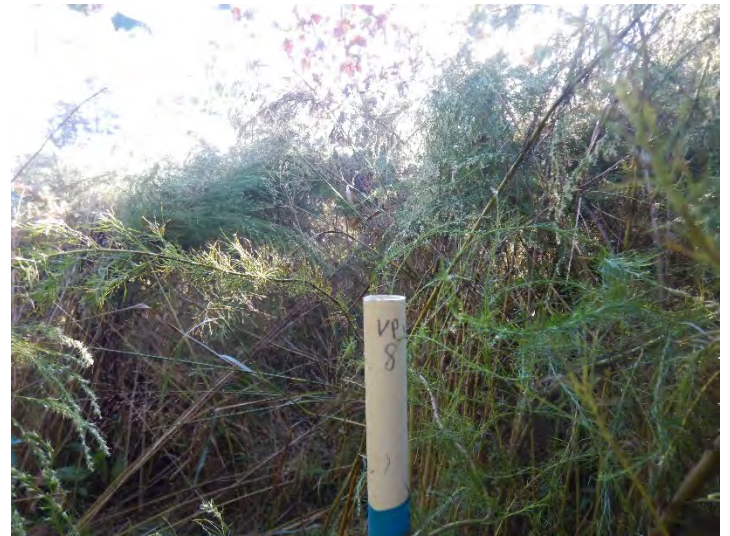
VEG PLOT 8 (10/11/2022)

*Vegetation Plots 8 and 18 do not meet the MY5 success criteria of 260 stems per acre. However, when including volunteers, both Vegetation Plots 8 and 18 do meet the MY5 success criteria for 260 stems per acre.
