Mitigation Plan

Buffalo Creek Tributaries Mitigation Project

Johnston County, North Carolina

FINAL VERSION

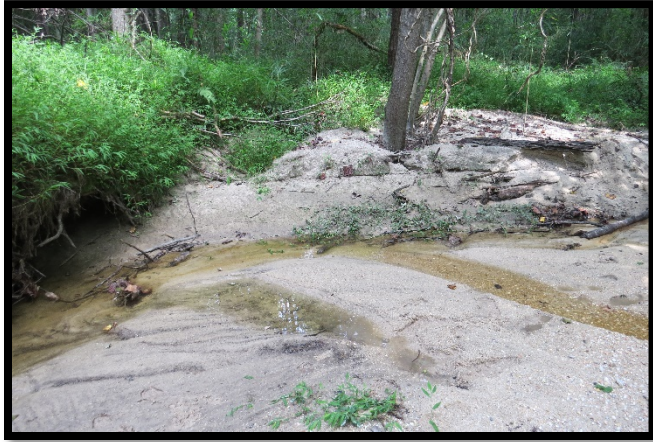
Photo of MS-R1 showing excess aggradation resulting from active stream bank erosion.

MS-R1: MS-R1 is the main stem perennial tributary that begins at an existing bedrock outcrop downstream of a pond and flows to the confluence with MS-R2 and an existing culvert crossing. MS-R1 has an average valley slope of 0.7 percent and drainage area of approximately 442 acres. Based on watershed reconnaissance, field observations, depositional patterns and landscape position, the excess sediment appears to be fine grained material mostly from active bank erosion and surface runoff from adjacent fields and impervious surface from a nearby high school.

The channel in this section lacks a floodplain connection and is laterally unstable as mechanical bank failures were observed in many of the meander bends. According to the landowner and historic aerials, portions of the stream have been manipulated to accommodate silvicultural and agricultural practices. In this area, the degree of incision is severe, with bank height ratios exceeding 2.0 and a low to moderate sinuosity ($k=1.17$). Woody riparian vegetation has re-established and is mostly present throughout the reach. However, MS-R1 is actively subject to water quality stressors, mainly in the form of high sediment inputs from severe bank erosion. Based on the existing channel conditions and anthropogenic disturbances, the reach is classified as Rosgen 'G4c' stream type throughout most of its length.

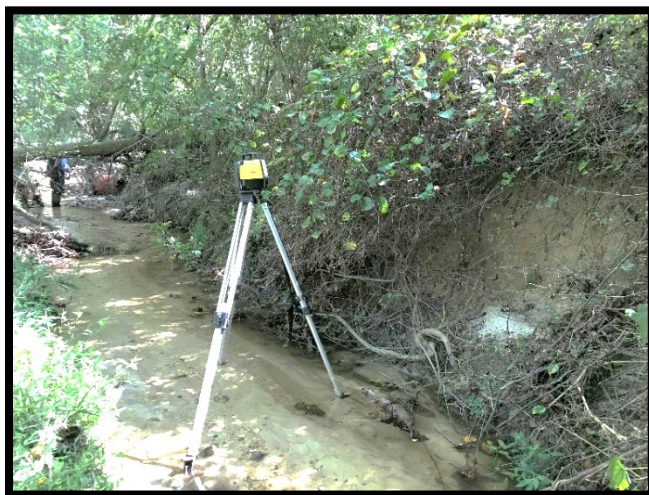
Looking downstream at lateral instability and stream bank erosion along MS-R2.

MS-R2: MS-R2 begins downstream of MS-R1 at an existing (2) 54 inch concrete pipe culvert crossing and flows south. The valley slope in this area is approximately 0.6 percent and the channel is vertically stable; however, most of the reach appears to be moderately-to-severely incised, with active bank erosion and bank height ratios averaging 1.6. The sinuosity is low ($k= 1.08$) and active bank erosion was observed over 70 percent of the stream banks. The lateral instability is caused by near bank stresses during storm flows and the lack of deep rooting vegetation.

Throughout MS-R2, portions of the stream appear to be overly widened and historically manipulated. However, the riparian buffer is greater than 50 feet throughout its entire length. The reach has mature trees interspersed along the streambanks and floodplain; any large canopy trees will be saved and incorporated as part of the restoration design. Based on the existing conditions and coarse gravel material, MS-R2 is classified as a

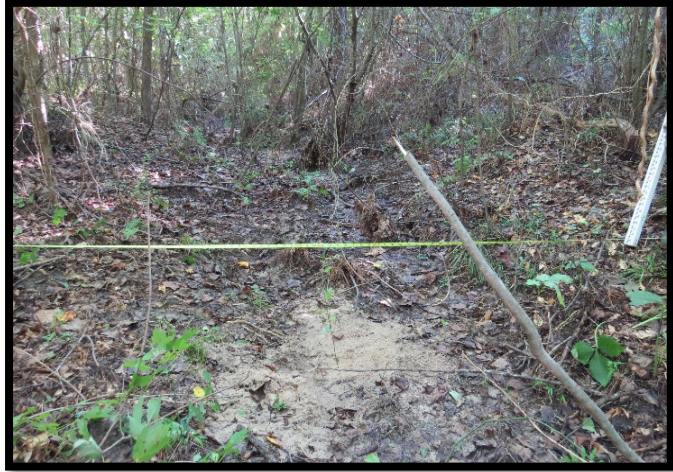
Looking upstream at stable bed form and bank conditions along R3 (upper).

R3: R3 begins near the top of the project and flows southwest towards its confluence with MS-R1. The valley slope is approximately 2.6 percent and the channel in the upper section is currently stable, bedform diversity is abundant, and the degree of incision is low, with bank height ratios near 1.1. Stream bank erosion is minor, and most the reach has deep rooting vegetation. Along this upper portion of R3, the reach is classified as Rosgen 'C5b'. The lower portion of R3 is experiencing an active headcut and the channel condition worsens as observed by downcutting and stream bank erosion. The conditions will likely continue to degrade further if not addressed during the restoration design. R3 is classified as Rosgen 'G5' stream type along its lower reach.

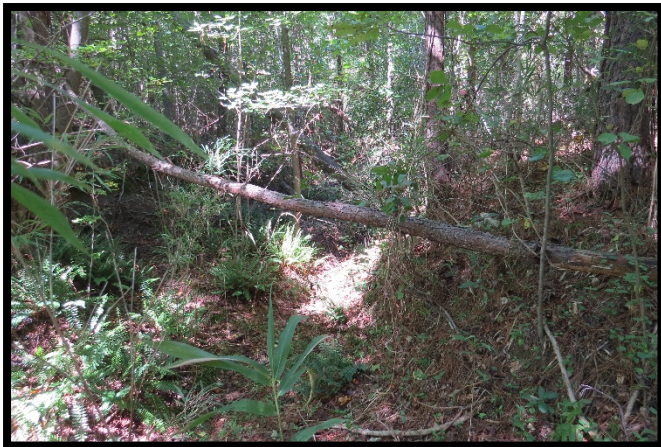
Looking at R4 below an existing stormwater BMP. Note the stable channel conditions, but dry conditions and absence of base flow.

R4: R4 begins as a small headwater tributary that originates from a stormwater BMP pipe outlet. The channel below the pipe outlet was classified as ephemeral, however the historic base flow has been redirected from the natural stream valley to R5 through a stormwater outfall pipe. R4 has a drainage area of approximately 30 acres and the valley slope is 3.1 percent. This reach has experienced historic manipulation and has been excavated to accommodate a drainage pipe outlet. Based on a review of historic aerials, the headwaters of R4 originated at a farm pond prior to being converted as a stormwater BMP to treat runoff from Corinth Holders High School.

The reach is slightly-to-moderately incised in the upper portion and is classified as a Rosgen 'G5c/C5' stream type. The channel condition improves towards the downstream end as the valley widens and flattens before its confluence with MS-R1. The reach has mature trees interspersed along the stream banks and floodplain; any trees of significance will be saved and incorporated as part of the restoration design.

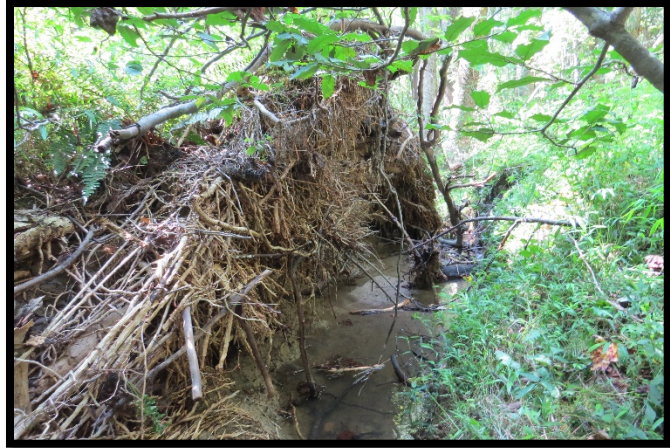
Photo illustrates active bank erosion and degraded wetland area along lower R5.

The lower portion of R5 is experiencing an active headcut, and the channel condition worsens as observed by downcutting and stream bank erosion. The conditions will likely continue to degrade further if not addressed during the restoration design. The existing buffer contains mature trees interspersed along the stream banks and floodplain; any trees of significance will be saved and incorporated as part of the restoration design. The lower reach of R5 is the reach is classified as a Rosgen 'G5c' stream type.

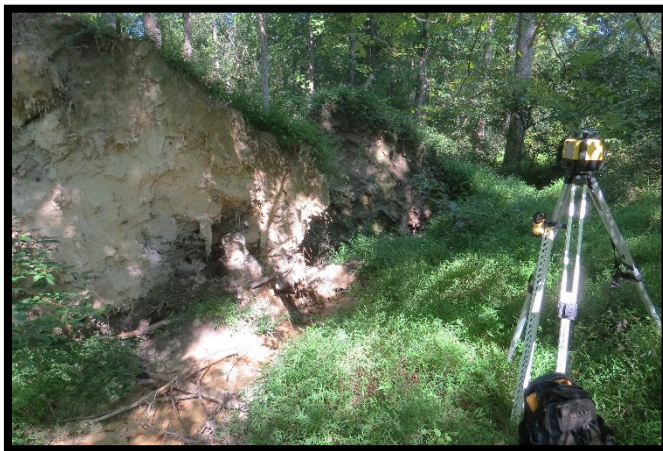
Looking downstream below pond at poor channel definition and stream bank erosion along R6.

The pond excavation has degraded the in-stream habitat, and poor definition was observed below the pond in upper R6. Lower R6 is slightly-to-moderately incised and is classified as a Rosgen 'B5a' stream type. The channel condition improves towards the downstream end as the valley widens and flattens before its confluence with MS-R2. The reach has mature trees interspersed along the stream banks and floodplain; any trees of significance will be saved and incorporated as part of the restoration design.
