**Buffalo Flats Restoration Site
Monitoring Report MY02
EEP Project # 94647
EEP Contract # 003273**

**Construction Completed: October 2011
Data Collection: October 2013
Submitted: January 2014**

**Project Manager: Adam Spiller
Email: adam.spiller@kci.com
Project No: 20100798**

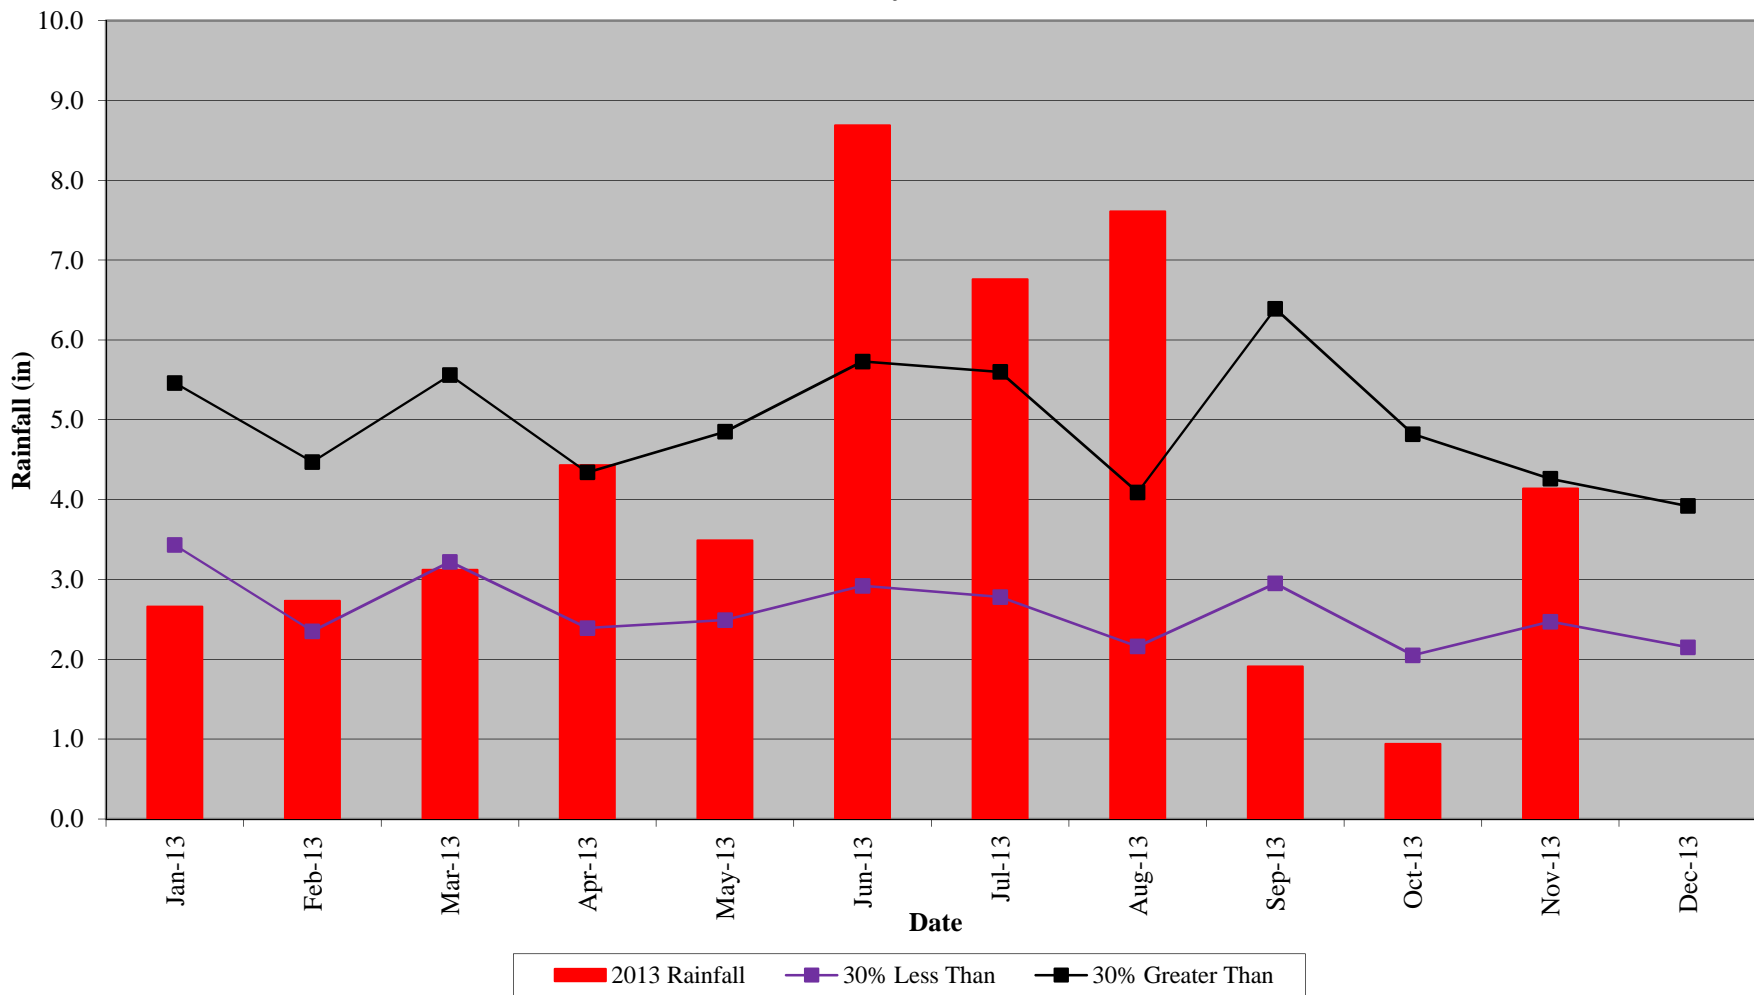
**Buffalo Flats Restoration Site
30-70 Percentile Graph
Kannapolis, NC
2013 Monthly Rainfall**

The daily rainfall data was obtained from a local weather station in Kannapolis, NC; provided by the NC State Climate Office. For the 2013-year, the months of June, July, and August experienced above average rainfall, while February, March, April, May, and November experienced average rainfall. The months of January, September, and October recorded below average rainfall for the site. Overall, the area experienced an average rainfall during the 2013 growing season.

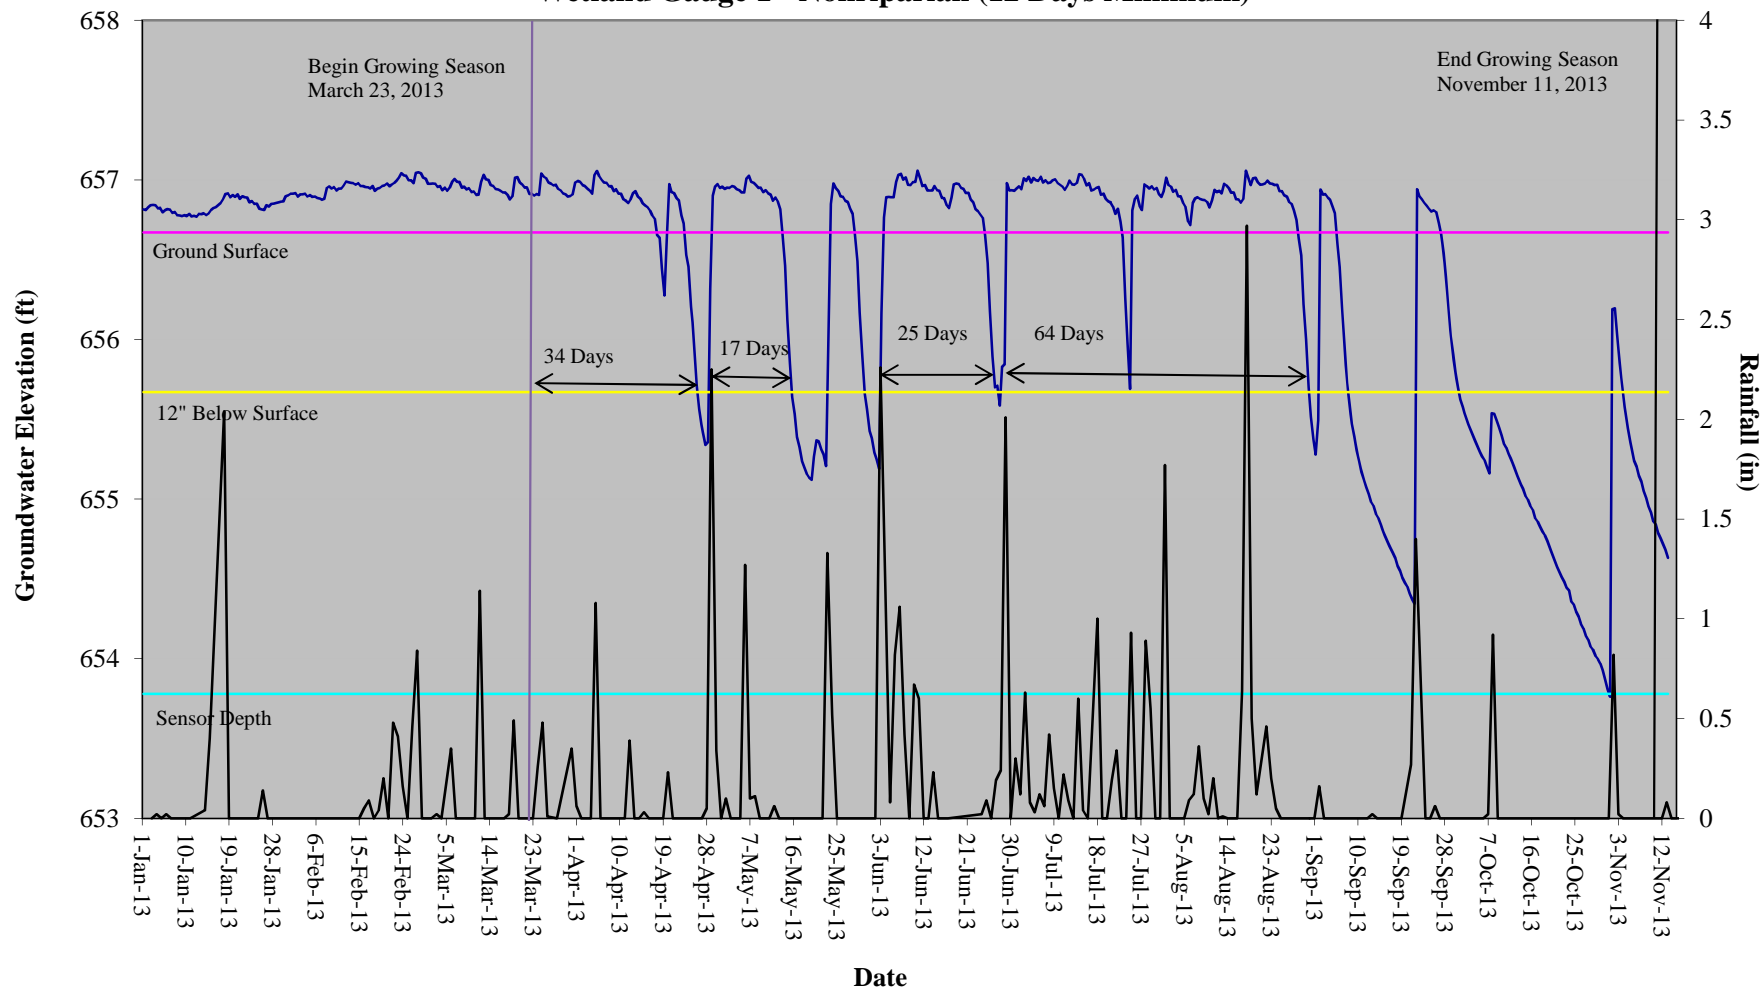
Buffalo Flats Restoration Site Hydrograph Wetland Gauge 1 - Nonriparian (12 Days Minimum)

During the site's second growing season, all seven wells in the riparian areas met the success criterion of having saturated soil conditions occurring within 12 inches of the ground surface for a minimum continuous period of 10% (23 days) of the 233 day growing season (March 10 to November 28) during average climatic conditions. Two of the three wells in the non-riparian areas met the success criterion of 5% (12 days) of the growing season. Gauge 10 experienced a malfunction during the growing season. The date was reset and did not correlate with the onsite barologger for absolute pressure data comparison. The well will be closely monitored during the 2014 growing season. Overall, wetland hydrology was achieved at nine of the ten groundwater monitoring gauges in the riparian and non-riparian restoration areas.
