**Buffalo Flats Restoration Site
Monitoring Report MY04
DMS Project # 94647
DMS Contract # 003273**

Construction Completed: October 2011

Data Collection: July 2015

Submitted: December 2015

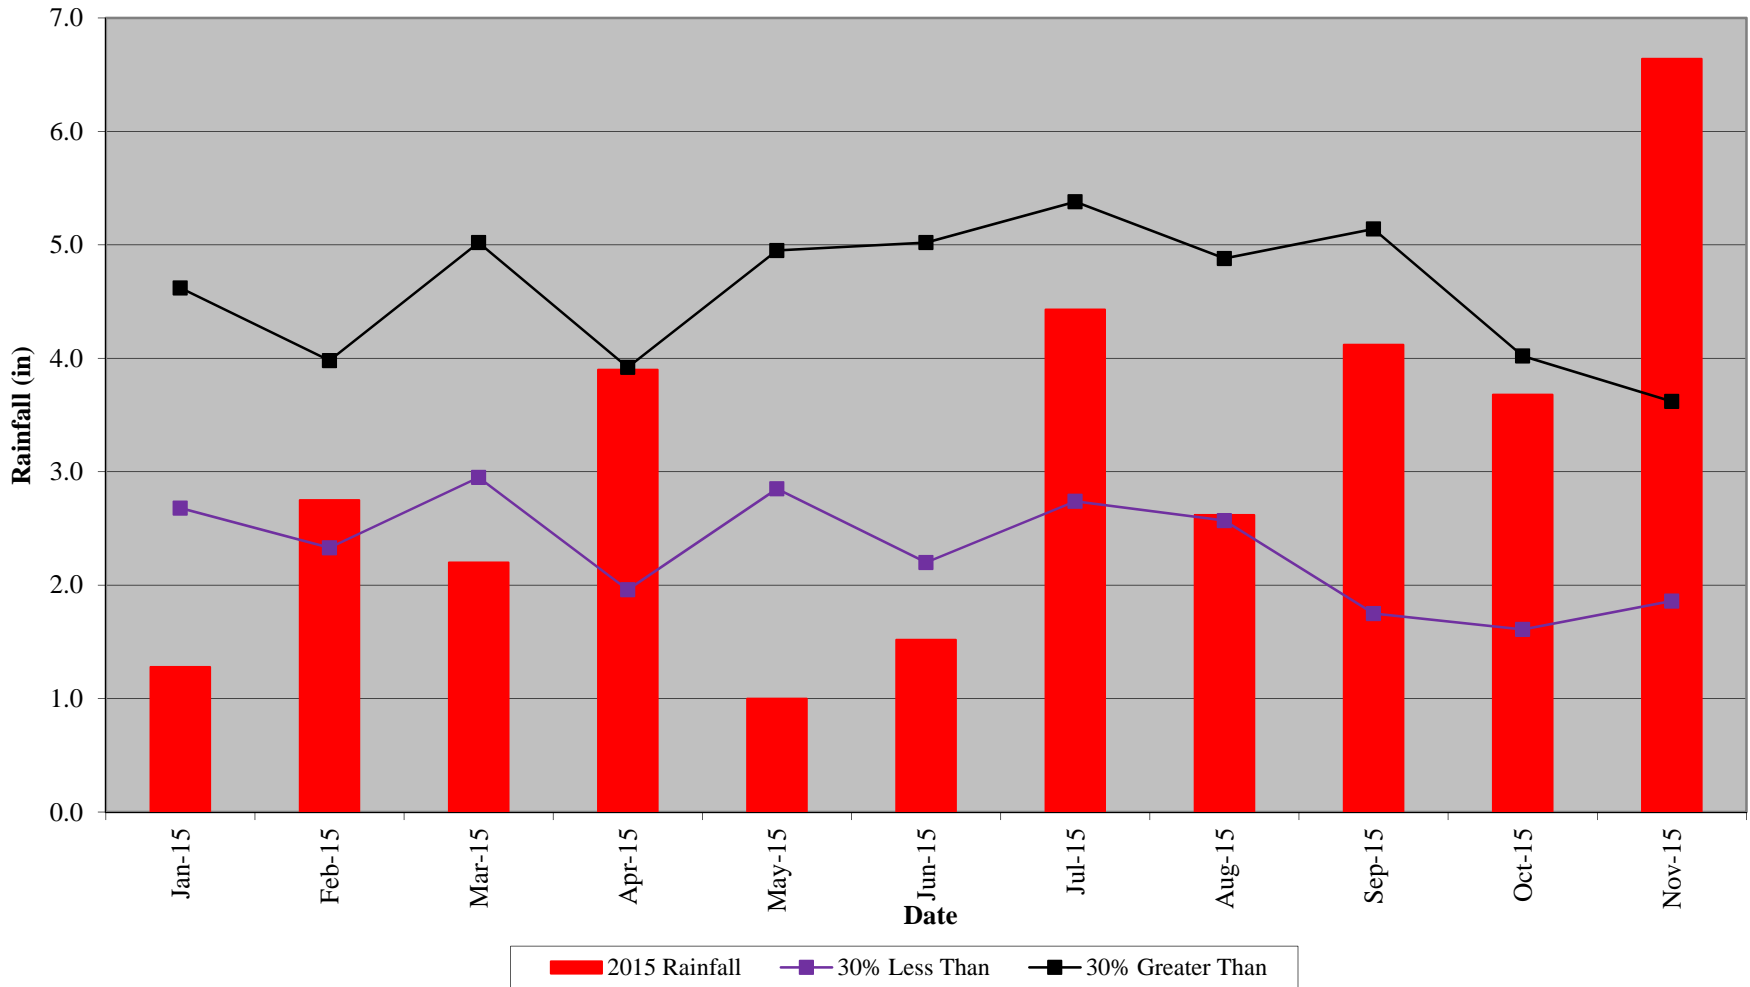
**Buffalo Flats Restoration Site
30-70 Percentile Graph
WETS Station Name: KRUQ - Rowan County Airport**

The daily rainfall data was obtained from a local weather station in Kannapolis, NC; provided by the NC State Climate Office. For the 2015-year, November experienced above average rainfall, while February, April, July, August, September, and October experienced average rainfall. The months of January, March, May, and June recorded below average rainfall for the site. Overall, the area experienced average rainfall during the 2015 growing season.
