BURNETTS CHAPEL BUFFER MITIGATION SITE

NCEEP Project Number 95009

Monitoring Year 2 Annual Report

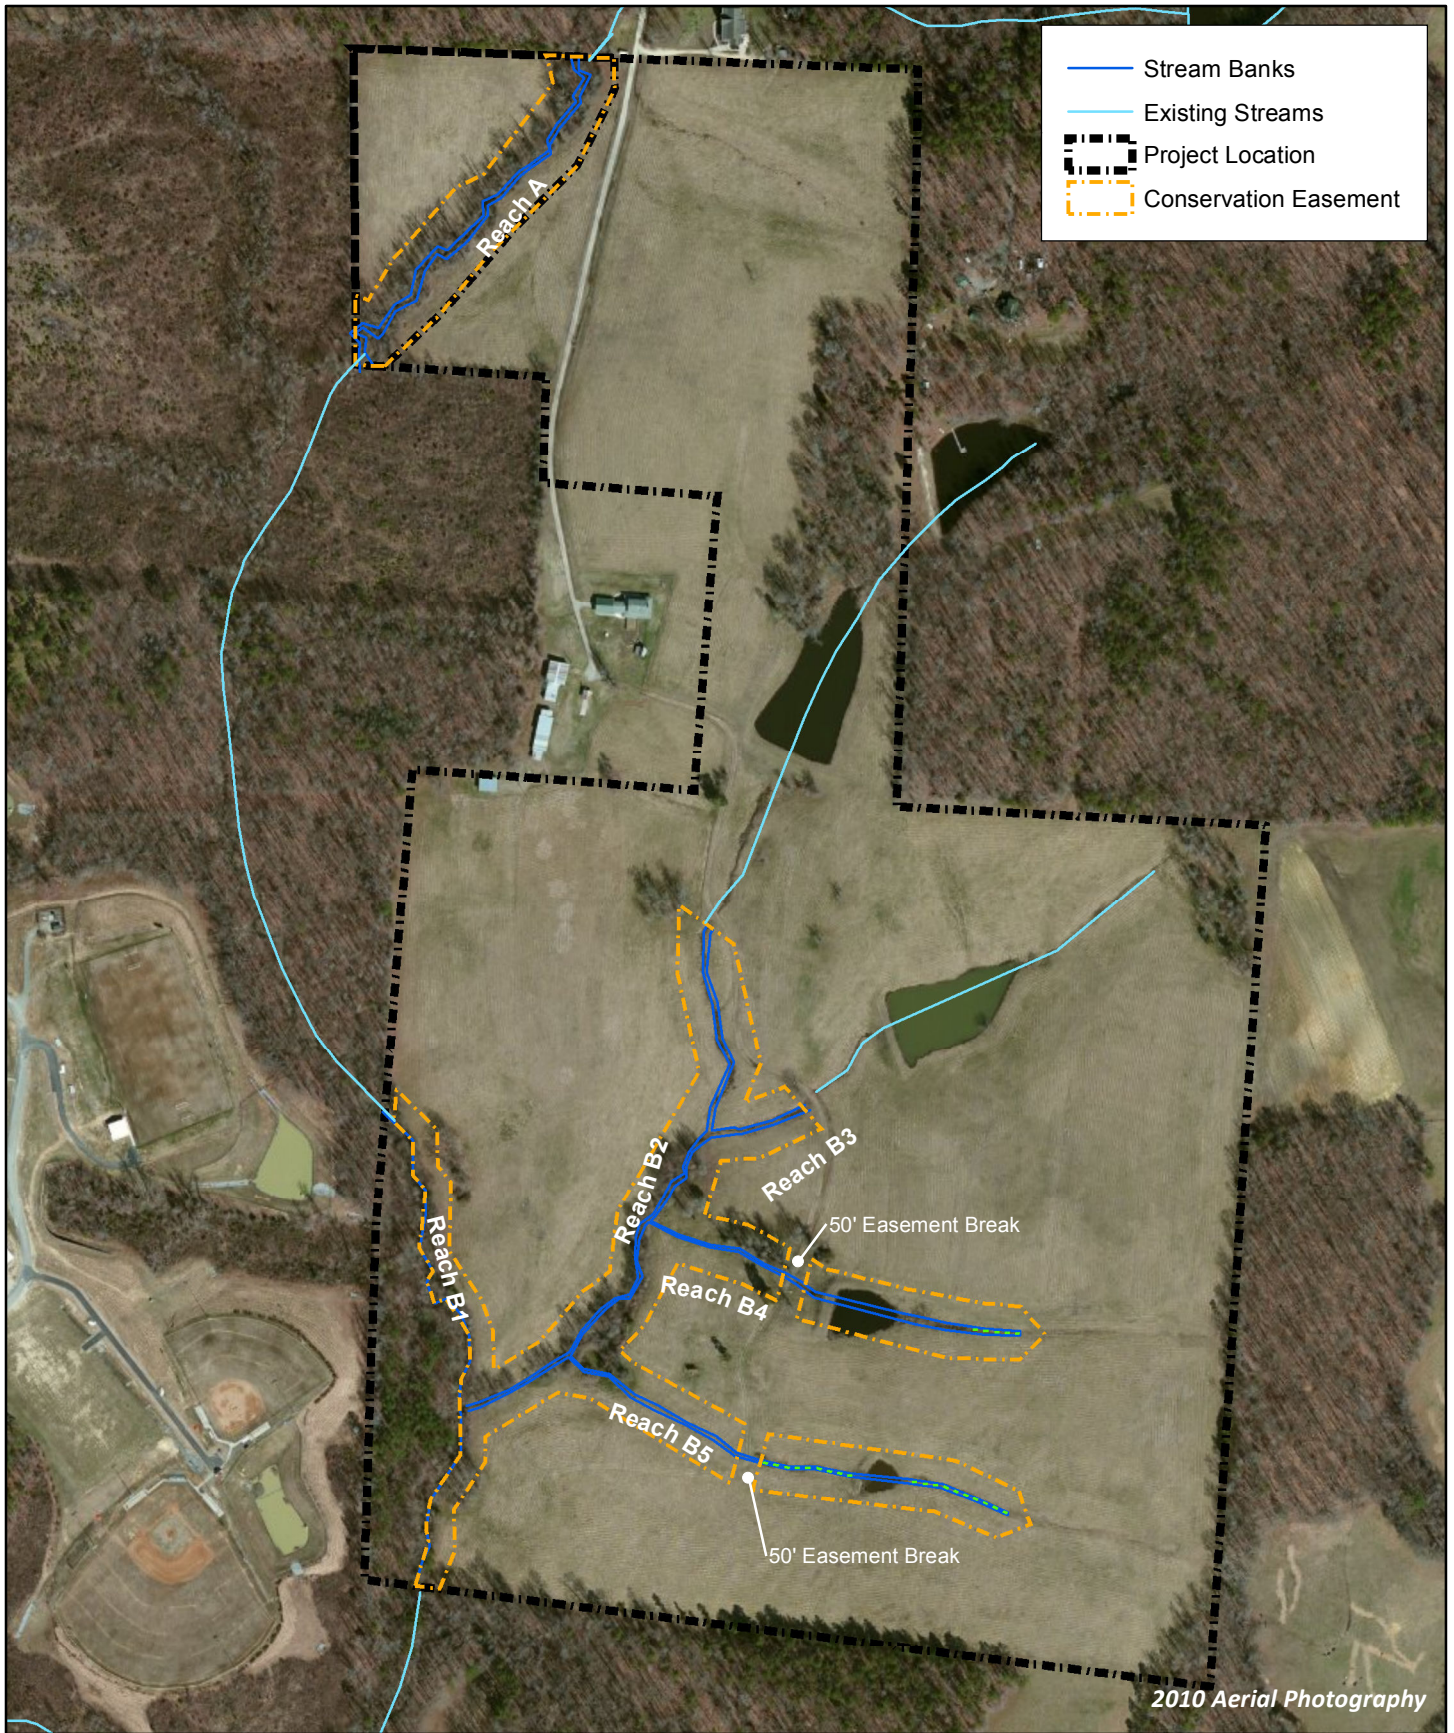
Figure 2 Project Component/Asset Map
 Burnetts Chapel Buffer Mitigation Site
 NCEP Project Number 95009
 Monitoring Year 2

The project restoration activities completed provides 9.2 buffer mitigation units (BMUs) in the Cape Fear River Basin (Table 1, Appendix 1). As part of the parcel preparation, two small surface water impoundments, located on Reaches B4 and B5, were removed in order to allow for stable stream channels to be constructed and for these areas to qualify for buffer restoration credit. Riparian stream buffers were planted and restored to the dominant natural plant community that exists within the project watershed. This natural community within and adjacent to the project easement is classified as Piedmont Bottomland Forest and was determined based on existing canopy and herbaceous species (Schafale and Weakley, 1990). Plant and seed materials were installed on stream banks out to the project easement limits. These areas were planted with bare root trees and a seed mixture of permanent herbaceous vegetation ground cover.

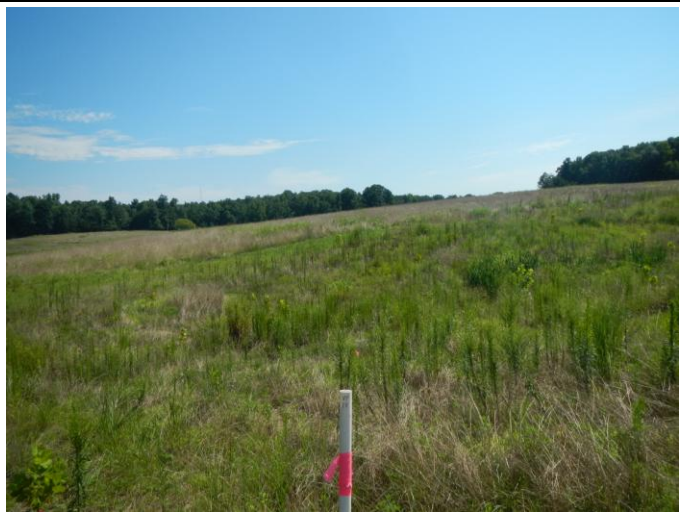
Vegetation Plot 17 (07/24/2013)

Overall, the Site has met the required buffer mitigation success criteria for MY2. Although one plot did not meet the MY2 success criteria, the average stem density of the Site is greater than

Plot	Criteria Met (Y/N)	Tract Mean
1	Y	95%
2	Y	
3	Y	
4	Y	
5	Y	
6	Y	
7	Y	
8	Y	
9	Y	
10	Y	
11	Y	
12	Y	
13	Y	
14	Y	
15	Y	
16	Y	
17	N	
18	Y	
19	Y	
20	Y	
21	Y	
22	Y

the required MY2 success criteria. Continual maintenance checks on the Site and spot treatment with herbicide is planned for the upcoming monitoring.
