# **MONITORING YEAR 3 ANNUAL REPORT**

## **BURNETTS CHAPEL BUFFER MITIGATION SITE**

Guilford County, NC  
NCDENR Contract No. 003996  
NCEEP ID No. 95009

Data Collection Period: July 2014  
Draft Submission Date: August 4, 2014  
Final Submission Date: August 12, 2014

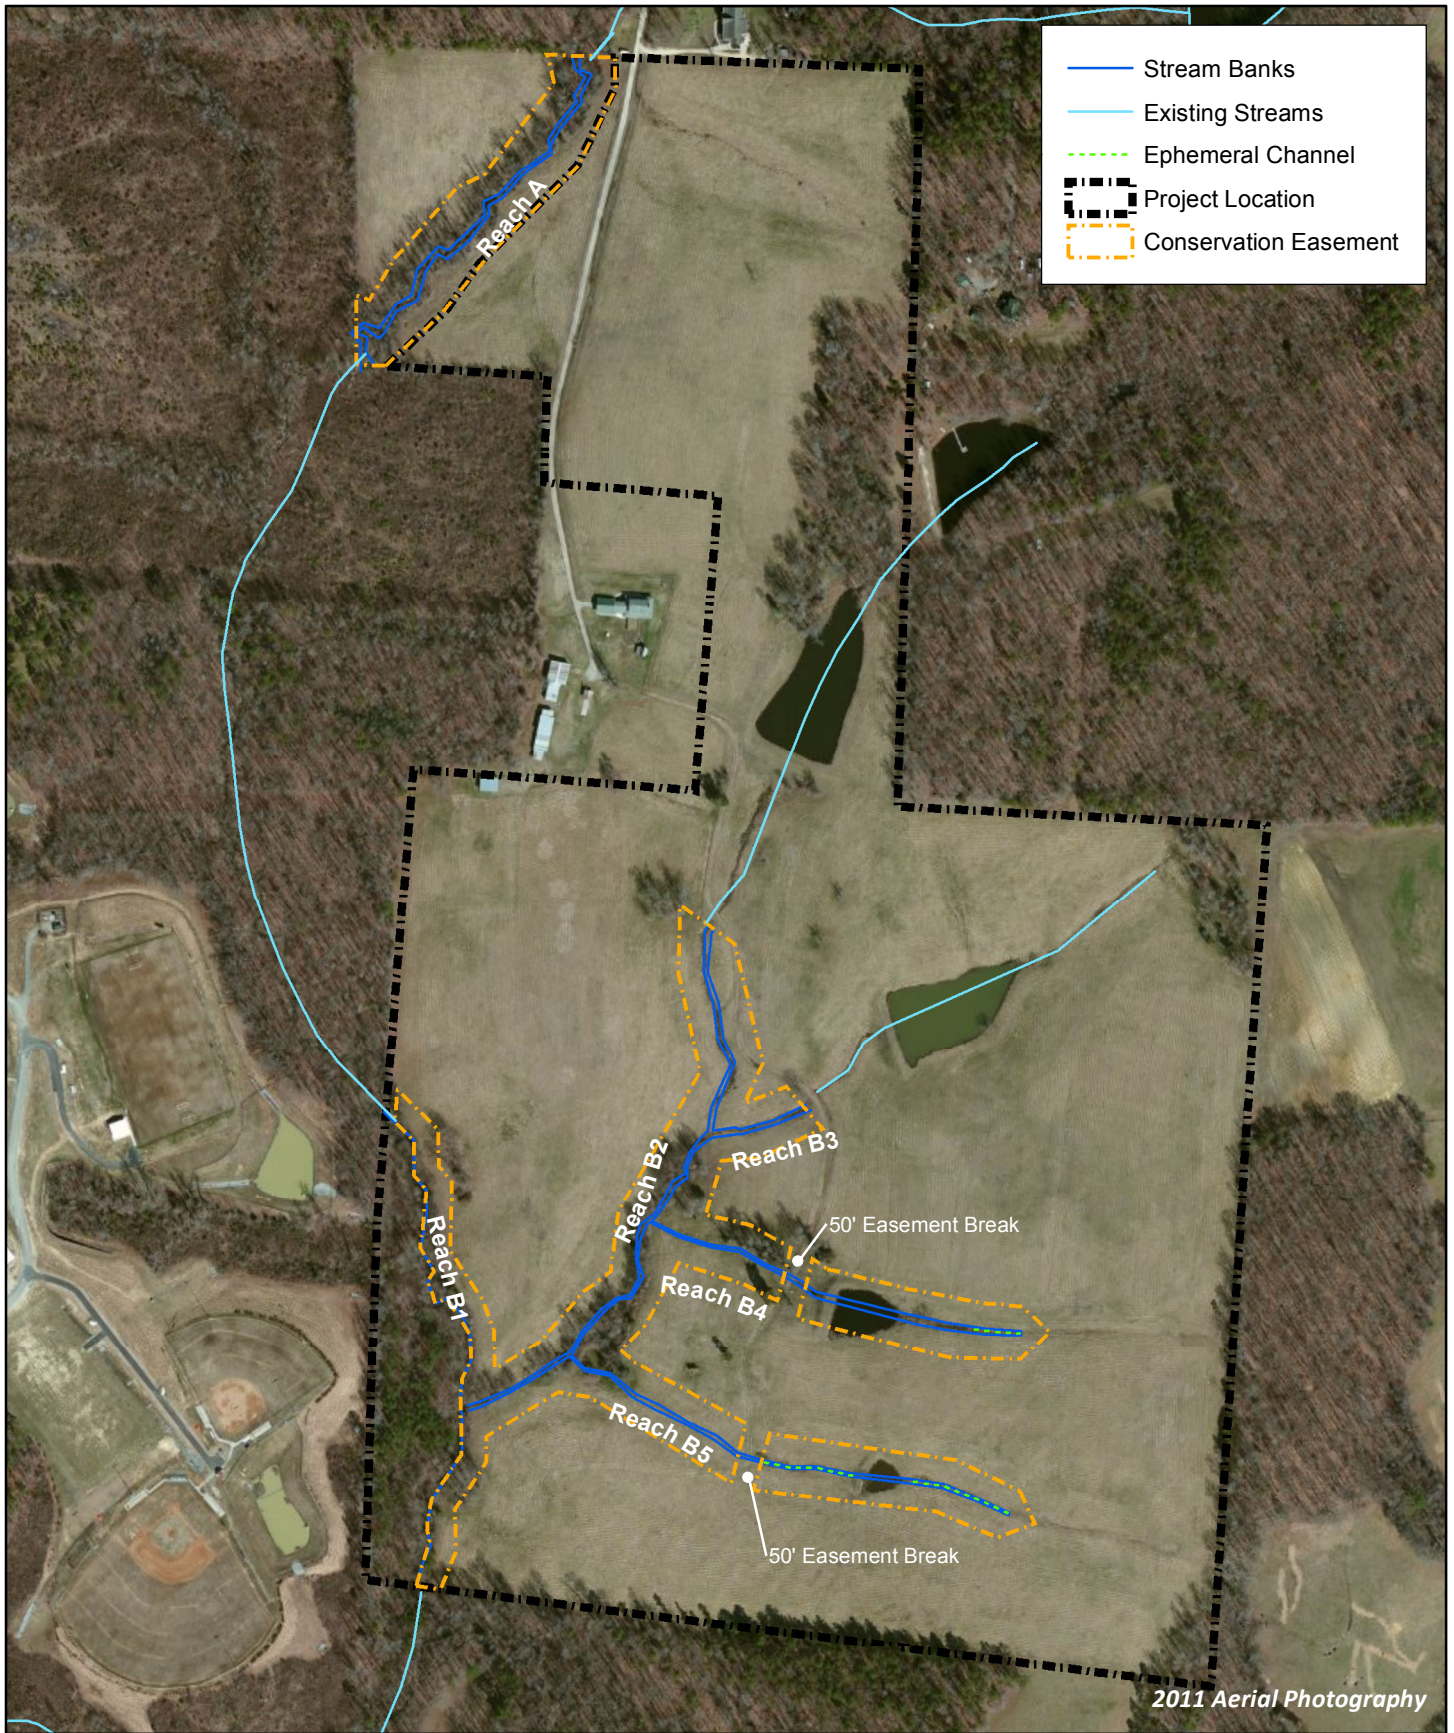
Figure 2 Project Component/Asset Map  
 Burnetts Chapel Buffer Mitigation Site  
 NCEEP Project Number 95009  
 Monitoring Year 3

- Stream Banks
- Existing Streams
- - - Ephemeral Channel
- - - Project Location
- - - Conservation Easement

A conservation easement has been recorded to protect 12.0 acres of riparian corridor resources in perpetuity. The project is being completed to provide buffer mitigation units (BMUs) in the Cape Fear River Basin, and will include 9.2 acres in buffer restoration. The remaining protected acreage is buffer preservation not sought for credit. See Table 1 (Appendix 1) for a summary of project components and mitigation credits. A map of the conservation easement and project reaches is provided in Figure 2 (Appendix 1).

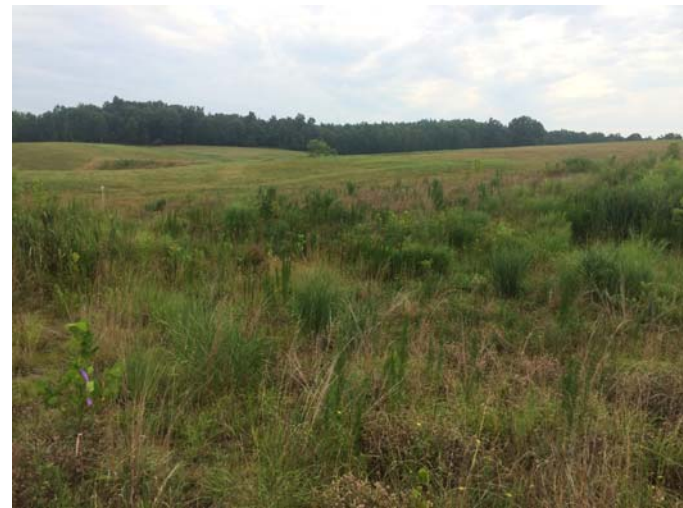
Vegetation Plot 17 (07/08/2014)

Overall, the Site has met the required buffer mitigation success criteria for MY3. Although one vegetation plot (17) did not meet the MY3 stem density criteria, the average stem density of the Site is greater than the required MY3 success criteria. Continual maintenance checks on the Site and spot treatment with herbicide is planned for the upcoming monitoring year.
