# **MONITORING YEAR 5 ANNUAL REPORT**

## **BURNETTS CHAPEL BUFFER MITIGATION SITE**

Guilford County, NC  
NCDEQ Contract No. 003996  
DMS ID No. 95009

Data Collection Period: July 2016  
Final Submission Date: October 7, 2106

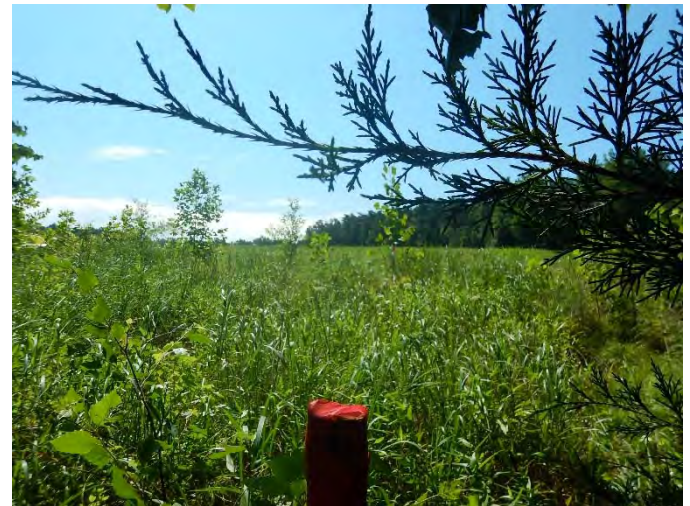
**Vegetation Plot 6** (07/06/2016)

- Vegetation in plot 6 has experienced low growth rates and vigor ratings throughout the entire monitoring period which is uncharacteristic of the rest of the Site. These results are likely due to the presence of a large black walnut tree (*Juglans nigra*) in the adjacent preservation area, as there have been no other stressors identified in that area. The plot is on track to meet the final mitigation success requirements with the inclusion of volunteer species.
- To improve the stem density in plot 17 after MY4, supplemental planting was done in Reach B4, which increased the average stems for plot 17 for MY5.
- Overall all vegetation plots met stem density requirements for MY5
