# MONITORING YEAR 1 ANNUAL REPORT

## BURNETTS CHAPEL MITIGATION SITE-PHASE II

Guilford County, NC  
NCDEQ Contract No. 7430  
DMS ID No. 100045  
DWR Project Number 2011-0841

Data Collection Period: September - October  
2019 Draft Submission Date: October 24, 2019

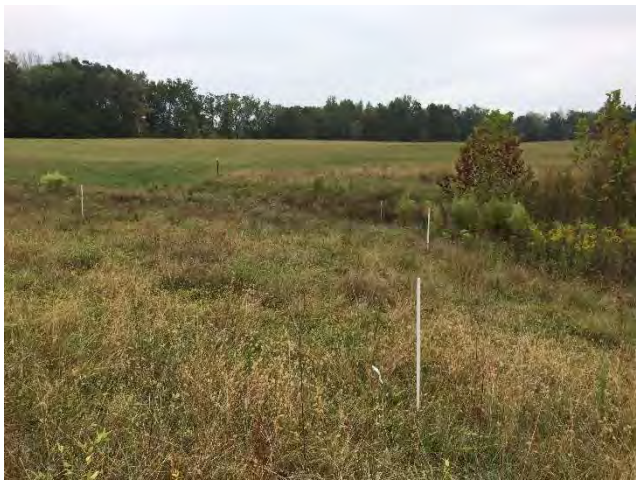
**Photo Point 6** – Looking upstream across top of B4 (09/30/2019)

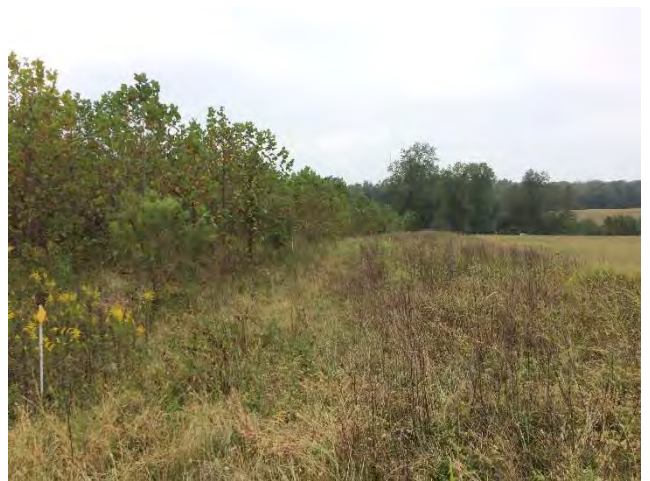
**Photo Point 6** – Looking downstream B4 (09/30/2019)
