**Kerr Avenue/Burnt Mill Creek
Stormwater Wetland
Wilmington, New Hanover County, North Carolina**

*2005 Annual Monitoring Report
Year 5 of 5*

NCEEP Project Number: .00012
BLWI Project Number: 050027
NCDENR contract: D05056S

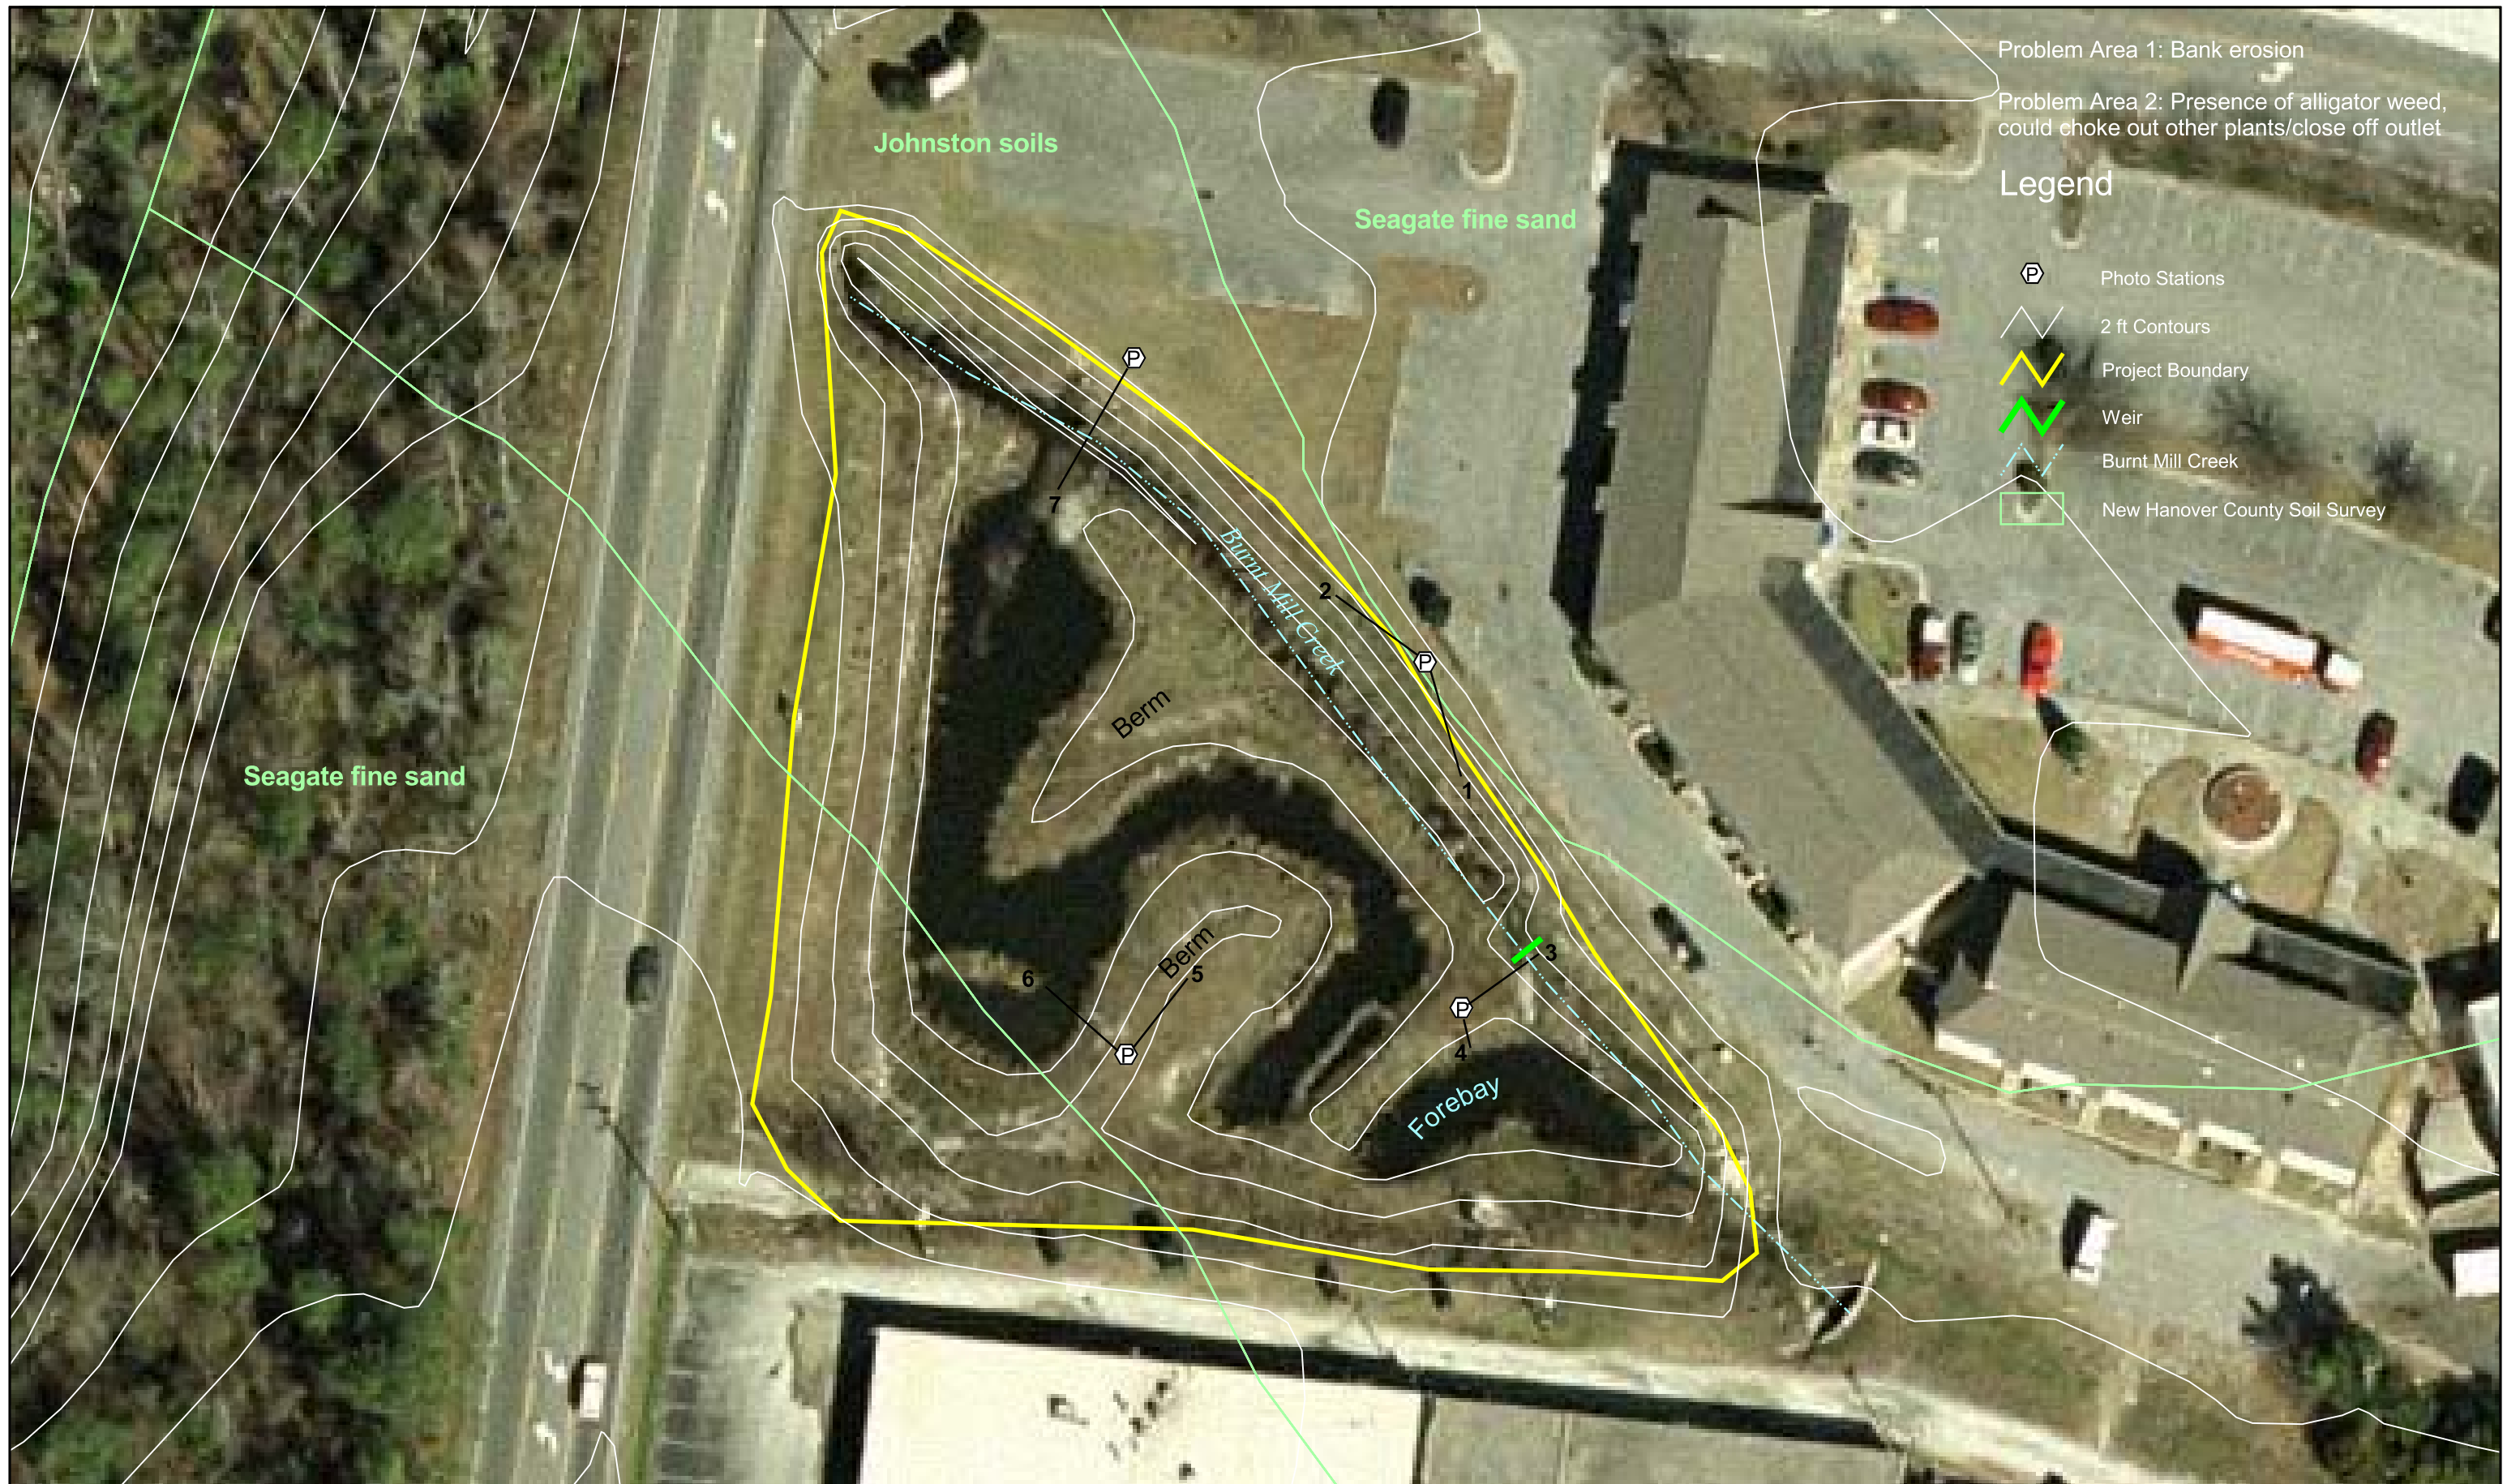
Figure 2. Monitoring Plan View
 Burnt Mill Creek (Kerr Avenue Stormwater Wetland)
 Wilmington, New Hanover County, NC
 2005 Annual Monitoring

Problem Area 1: Bank erosion
 Problem Area 2: Presence of alligator weed, could choke out other plants/close off outlet

The plan view shows the location of the noted problems. Potential problems exist from the presence of invasive vegetation, *Ludwigia sp.* blocking the outlet channel, bank erosion depositing sediment in the wetland and trash from the nearby parking lots/shopping center.

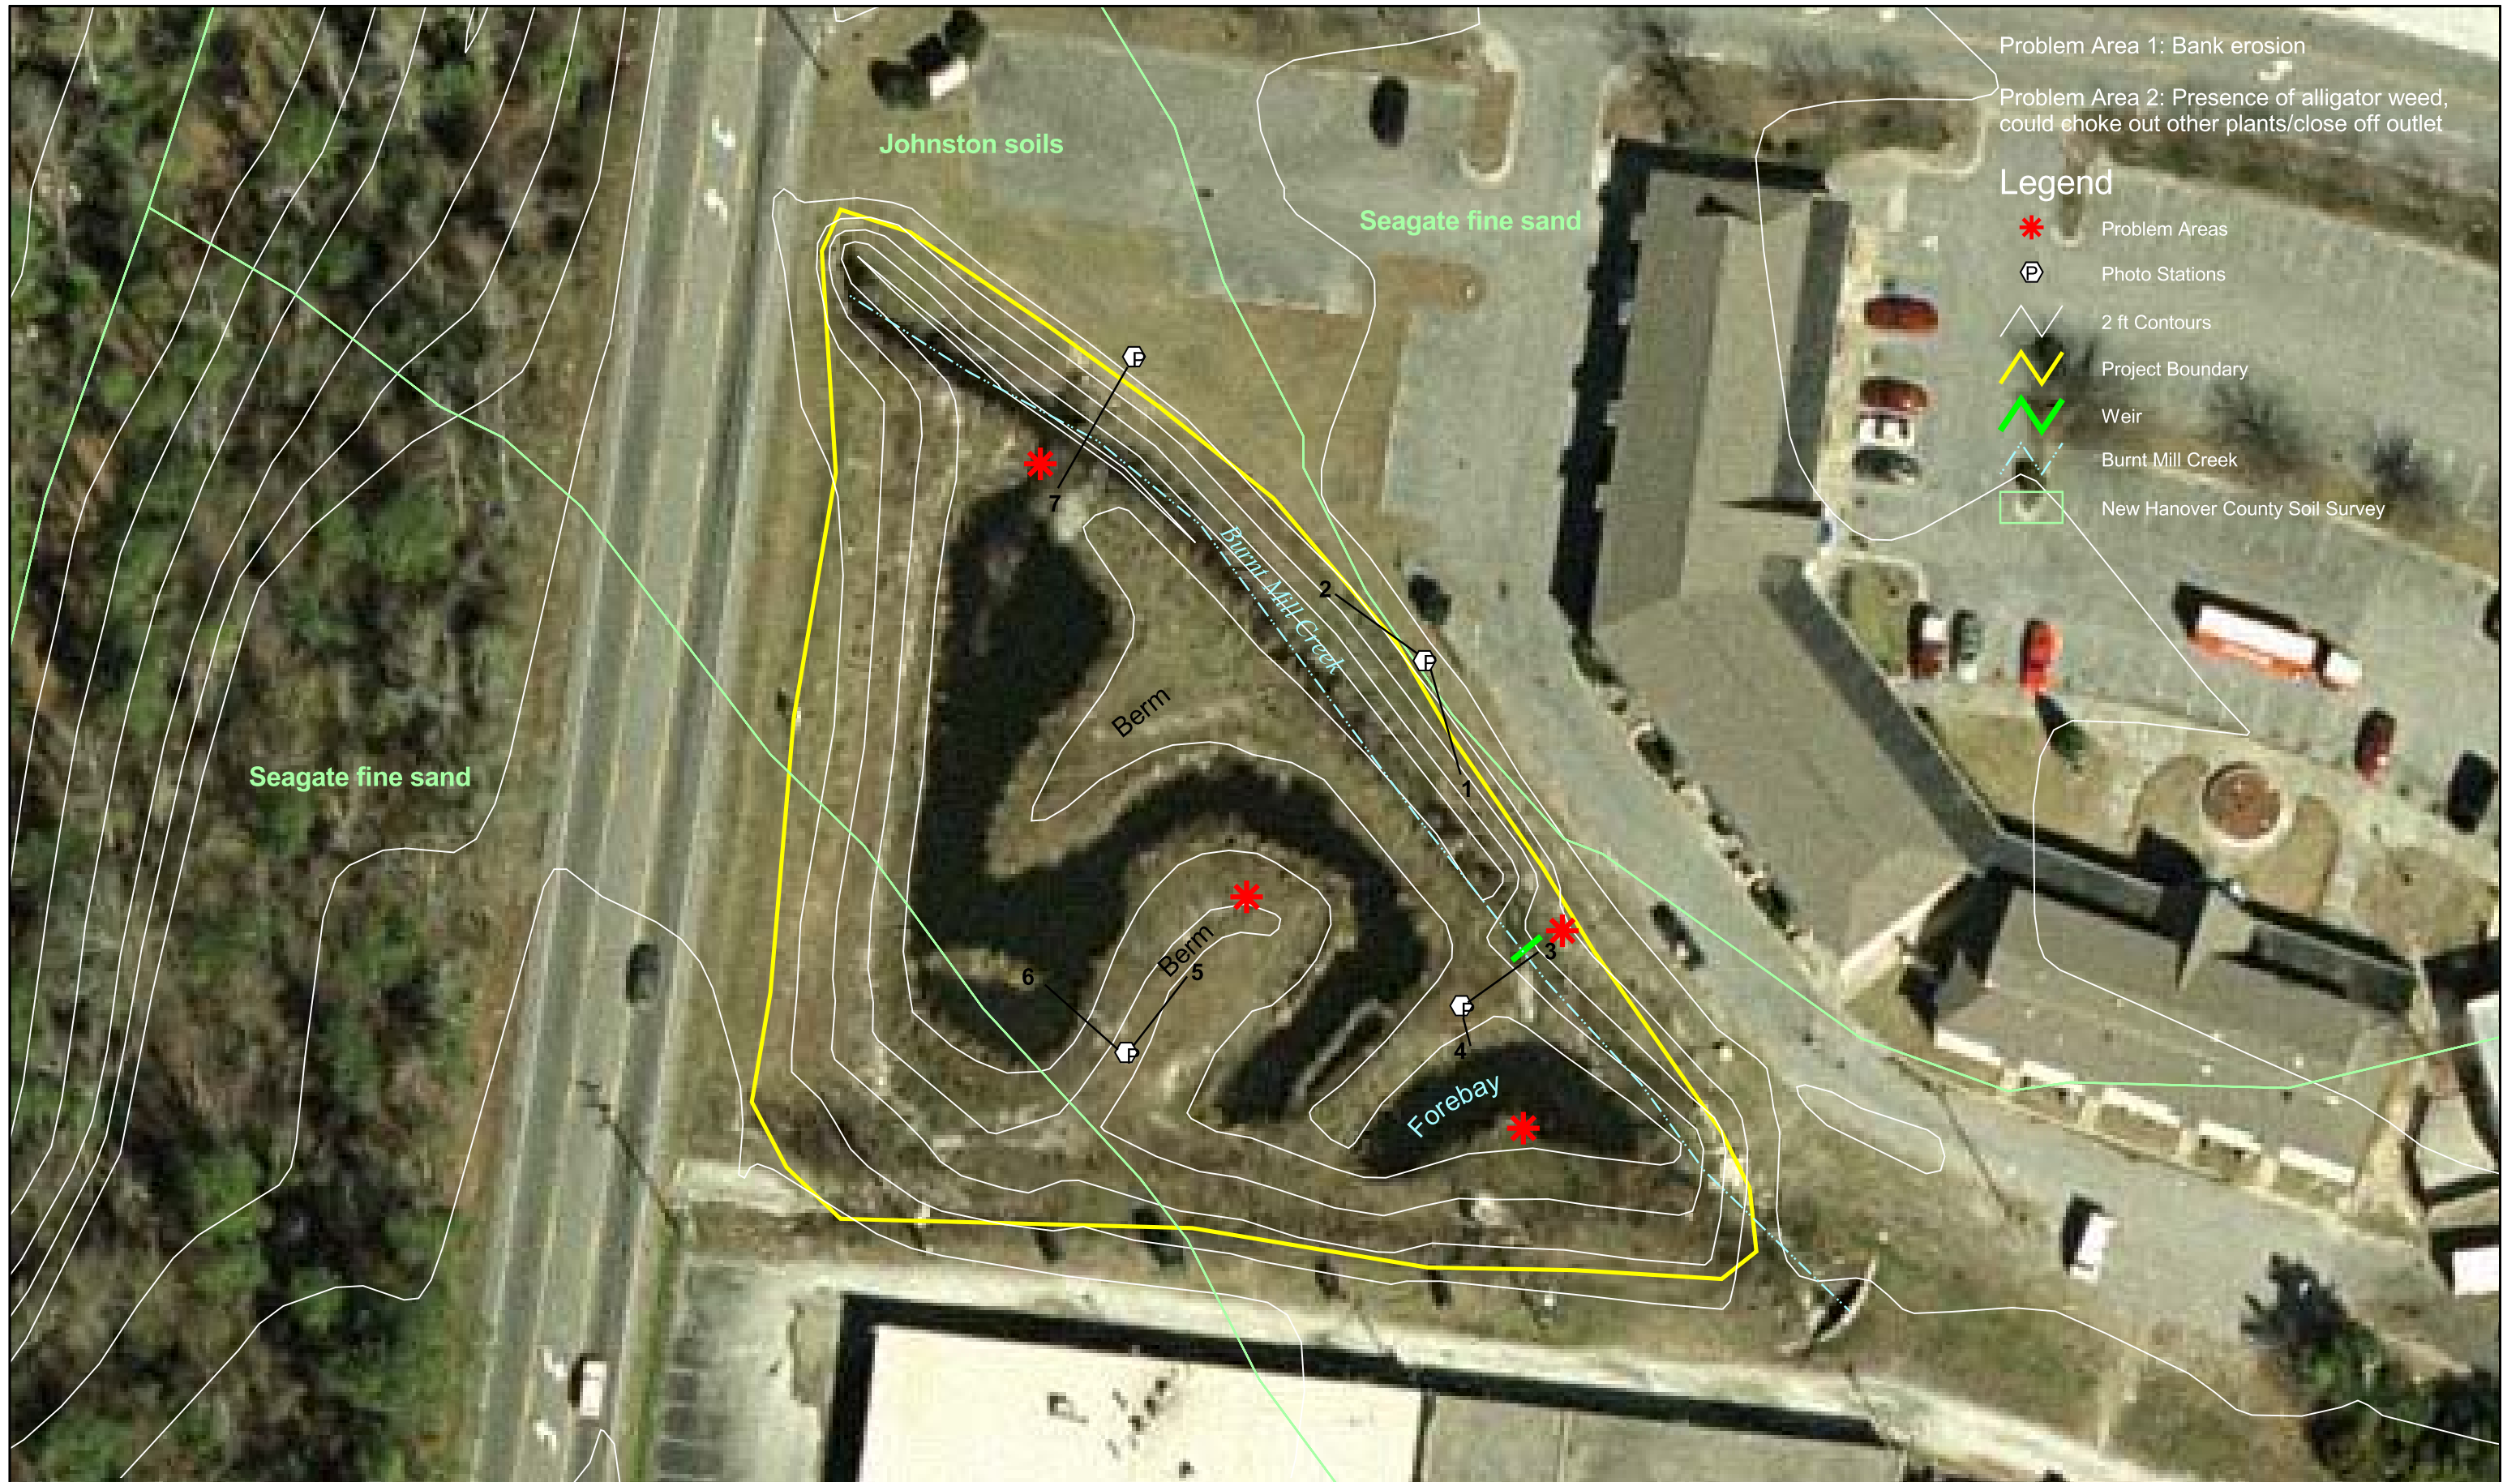
Burnt Mill Creek (Kerr Avenue Stormwater Wetland)
 Wilmington, New Hanover County, NC
 2005 Annual Monitoring - Year ?

Problem Area 1: Bank erosion
 Problem Area 2: Presence of alligator weed, could choke out other plants/close off outlet

It is recommended that during the next year, attempts be made to document what modifications the River Keeper Program have implemented. Three 5m X 5m plots should be established in the upland area to document existing vegetation. Discussions should continue with the River Keeper Program to insure that the site is being properly maintained, if any water quality sampling is currently on-going and if any vegetative plantings will occur. Spraying of herbicides may be necessary to maintain channel opening an unrestricted flow of the water.

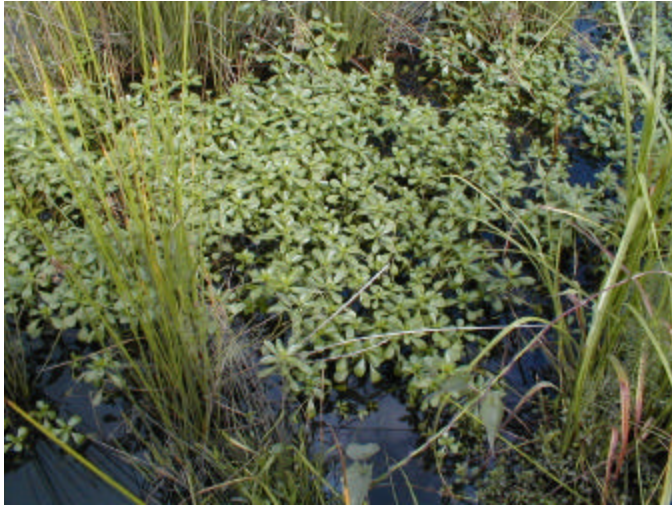
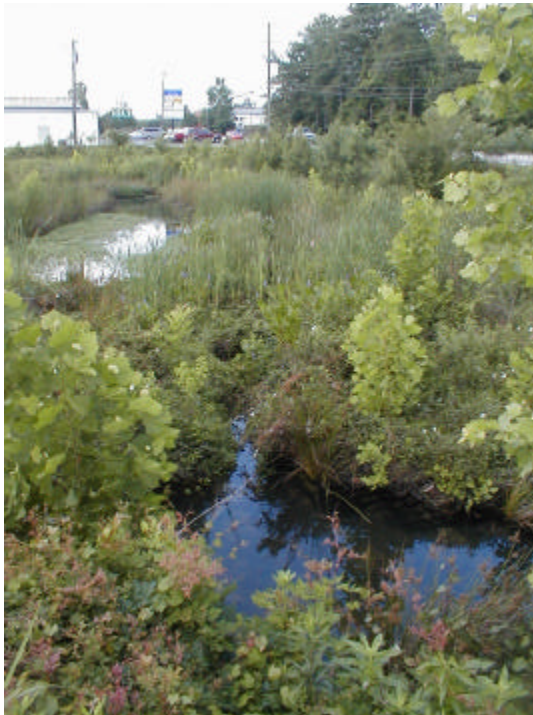
VPA-1 Invasive vegetation

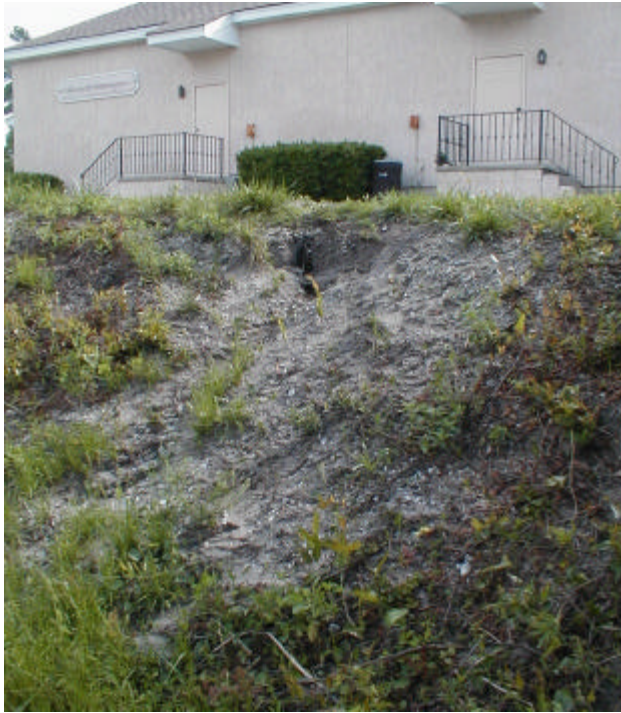
VPA-2 Bank erosion

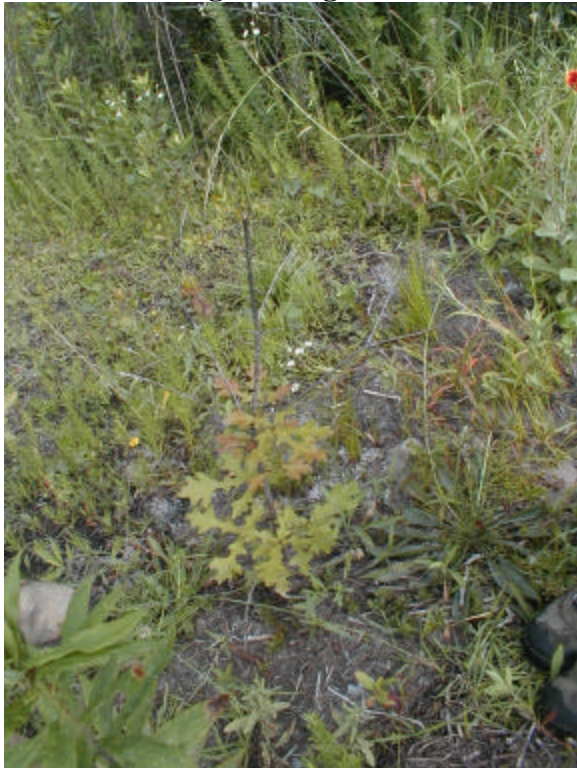
VPA-3 Poor vegetative growth

The vegetative problem areas would be mainly in the upland fringe/border. Survival of the planted trees and shrubs was poor. Supplemental plantings of native and non – native plants have been ongoing through the efforts of the Cape Fear River Keeper. Survival of the plantings is fair.

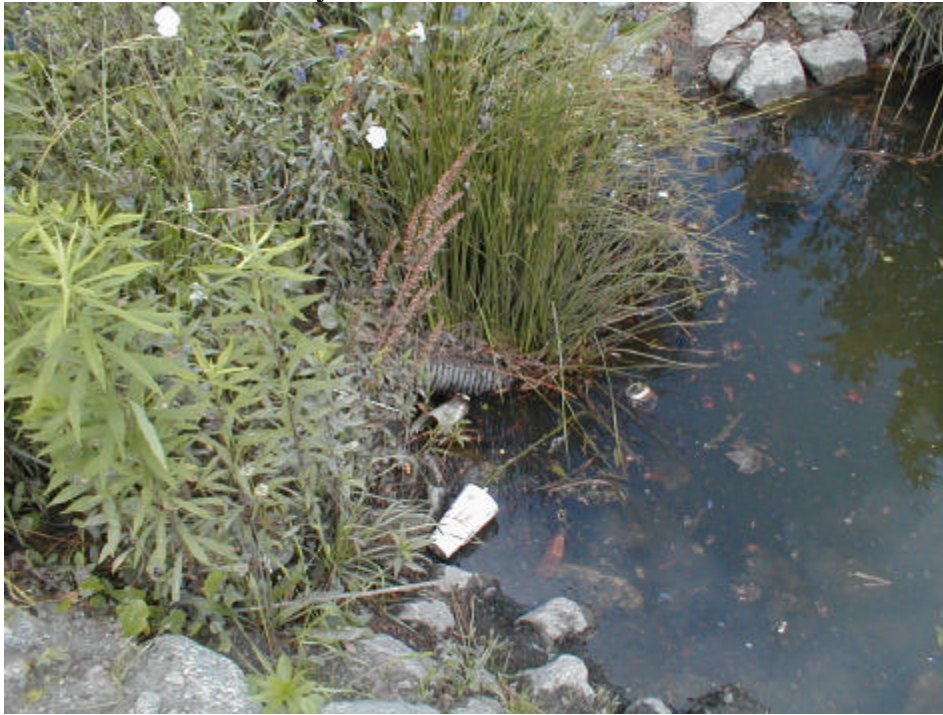
VPA-4 Trash in forebay

Potential problems come from maintenance issues and the presence of undesirable plant species. Located in a shopping center, the site is a receptacle for trash, both water and wind born. The forebay is a trap for sediment. Routine maintenance must occur for the stormwater wetland to perform efficiently. *Ludwigia sp.* (alligator weed) is present though out the channel and restricts the flow back into the stream network. Removal or control may be necessary in the future.
