MITIGATION PLAN

Byrds Creek Mitigation Site
Person County, North Carolina
EEP ID #95020

Neuse River Basin
HUC 03020201

January, 2013

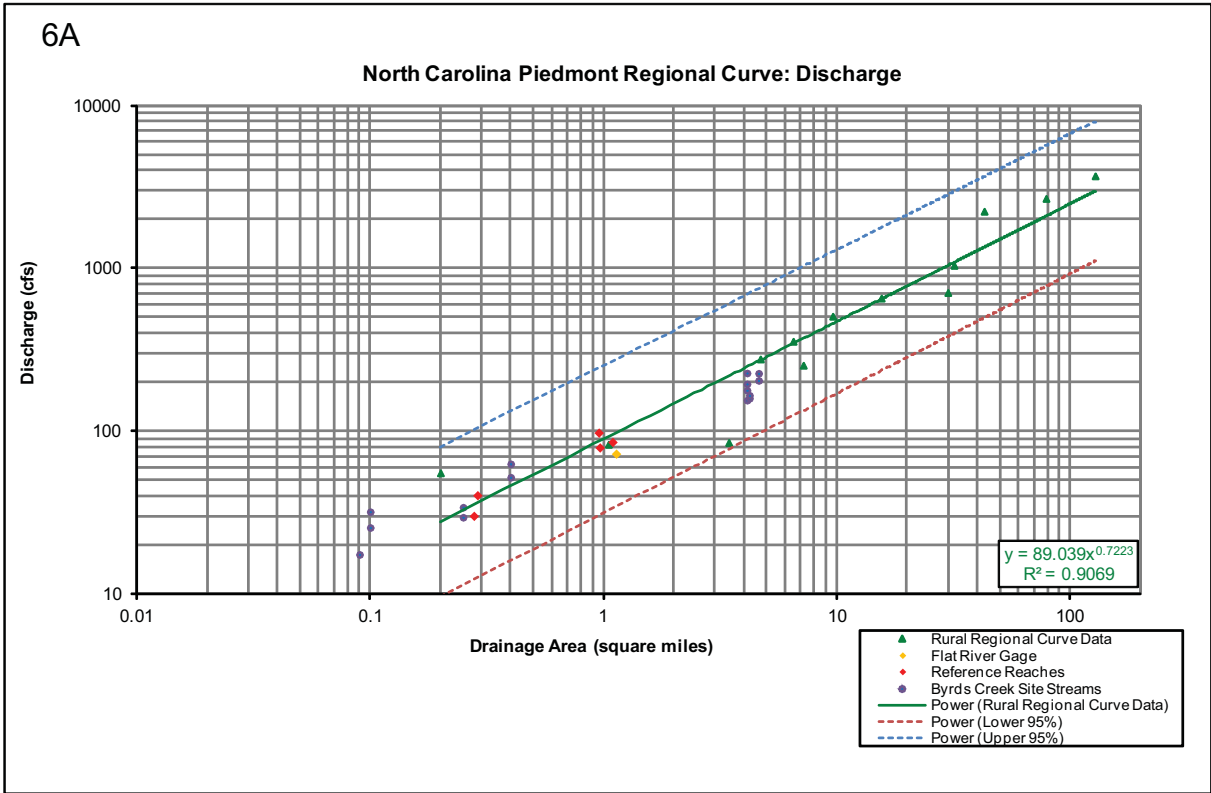
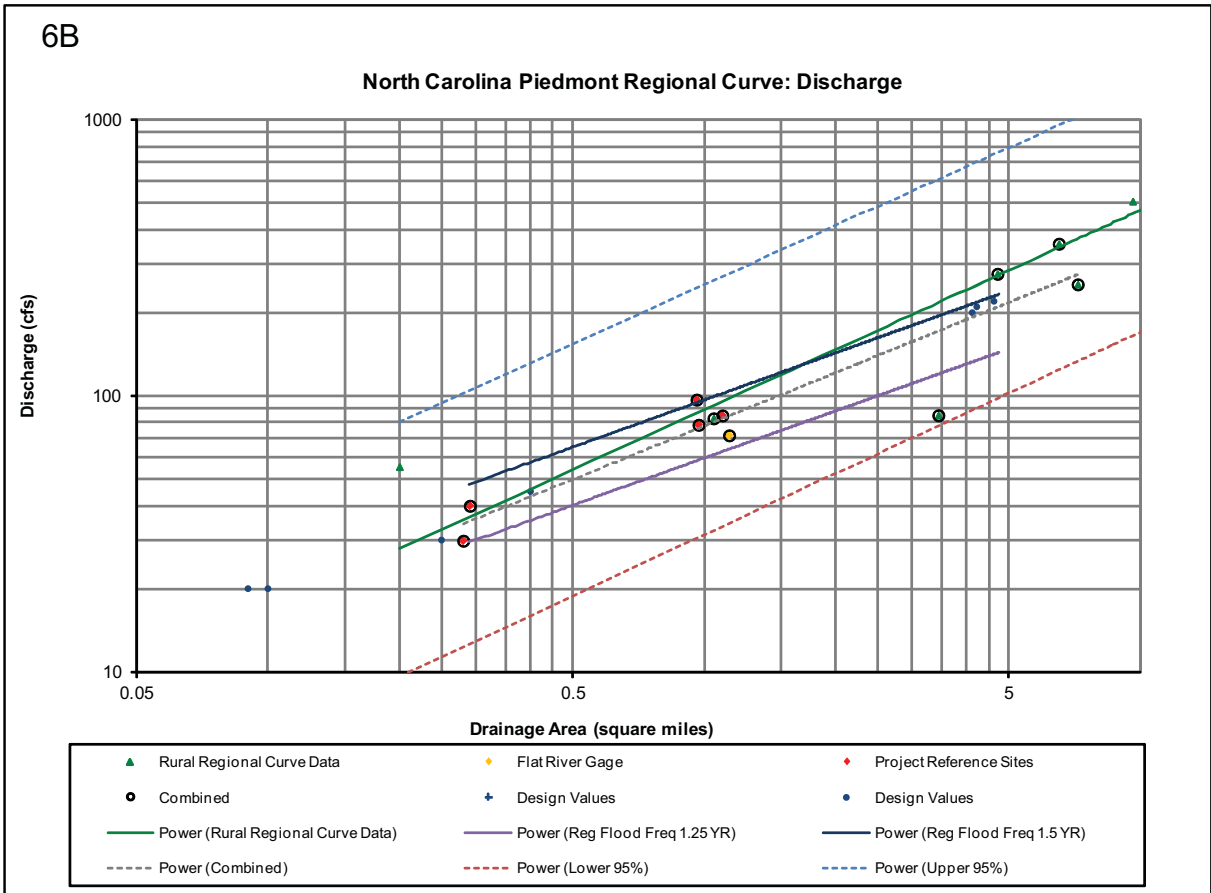
Figure 6 Regional Curve
Byrds Creek Mitigation Site
Mitigation Plan
Neuse River Basin (03020201)
Person County, NC

A nearby USGS gauging station (station 02008650112 – Flat River Tributary Near Willardville, NC) was used to develop a calibrated estimate of bankfull discharge for use in verifying the existing conditions discharges calculated at the project site. The bankfull discharge of the Flat River gauge site was determined to be 72 cfs with a recurrence interval of 1.31 years. Bankfull data for the gauge site, the surveyed project reaches, and the project reference reaches (see Section 7) are plotted with the North Carolina rural Piedmont regional curves and are shown overlaid with the rural curves for discharge in Figure 6a.

Analysis of the bankfull discharges for the project reaches, reference reaches, and gauge survey reveals that the data consistently plot within the 95% confidence intervals of the regional curve in all cases where the points are within the range of drainage areas (independent variable) covered by the regional curves. This information indicates that the bankfull indicators identified during the existing conditions assessment provide reasonable estimates of bankfull discharge and associated hydraulic geometry for the existing conditions.

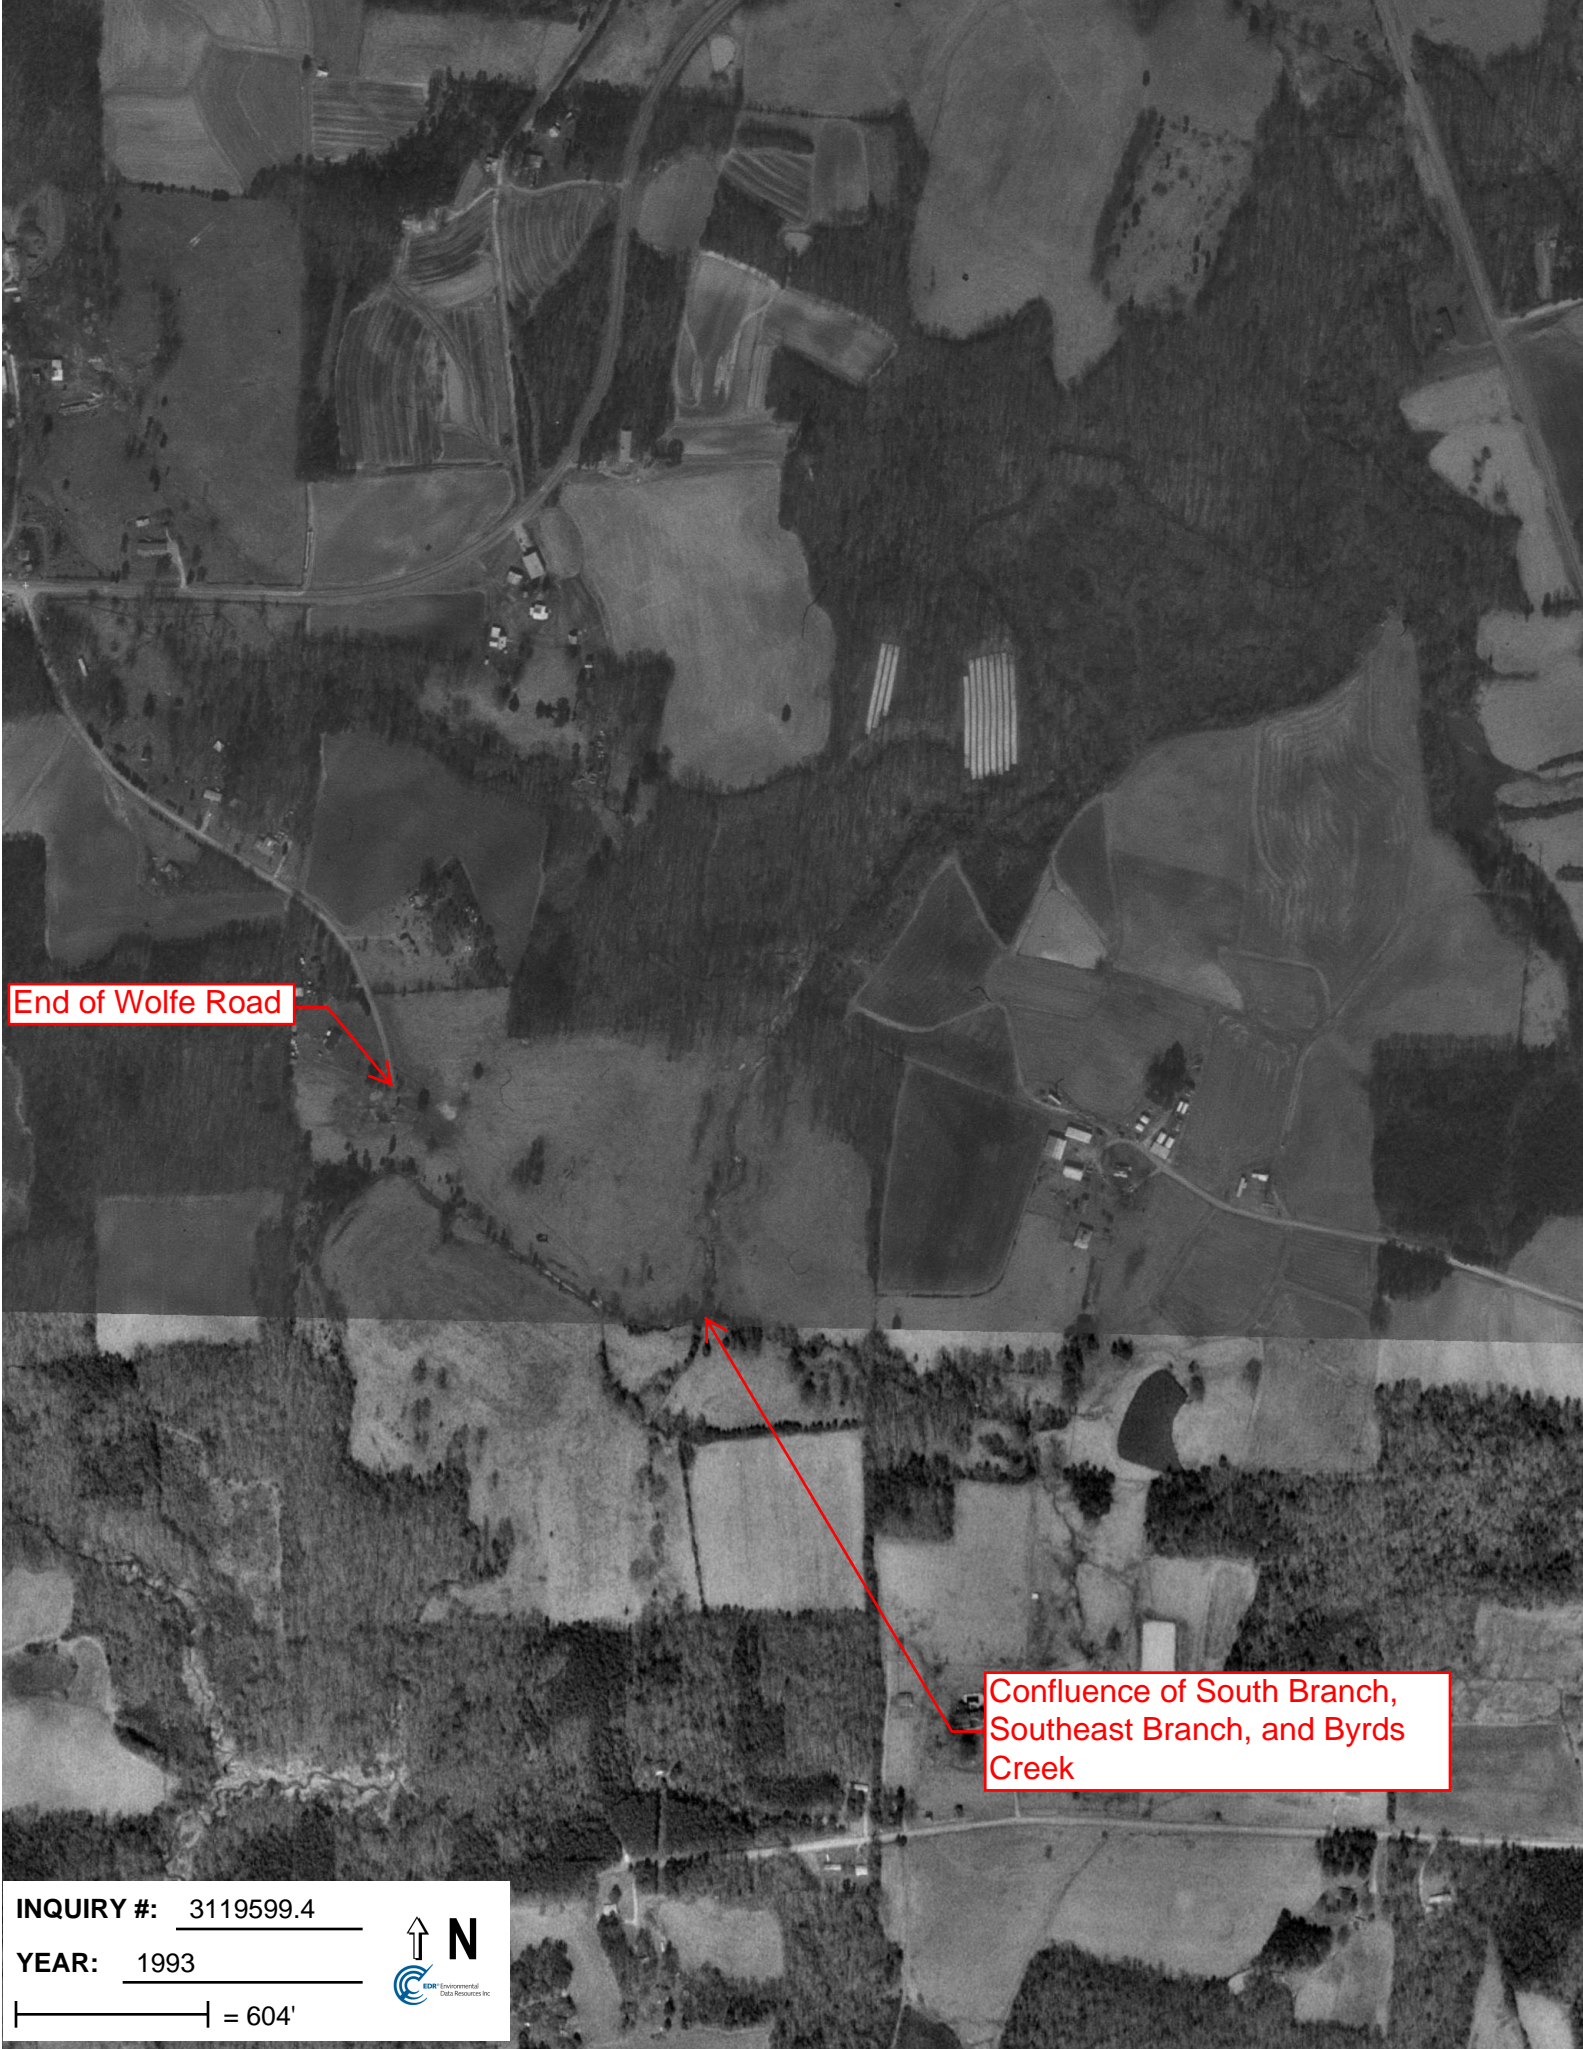
1955 Aerial (Source USDA)

Confluence of South Branch,
Southeast Branch, and Byrds
Creek

Approximate Scale
1" = 1346'

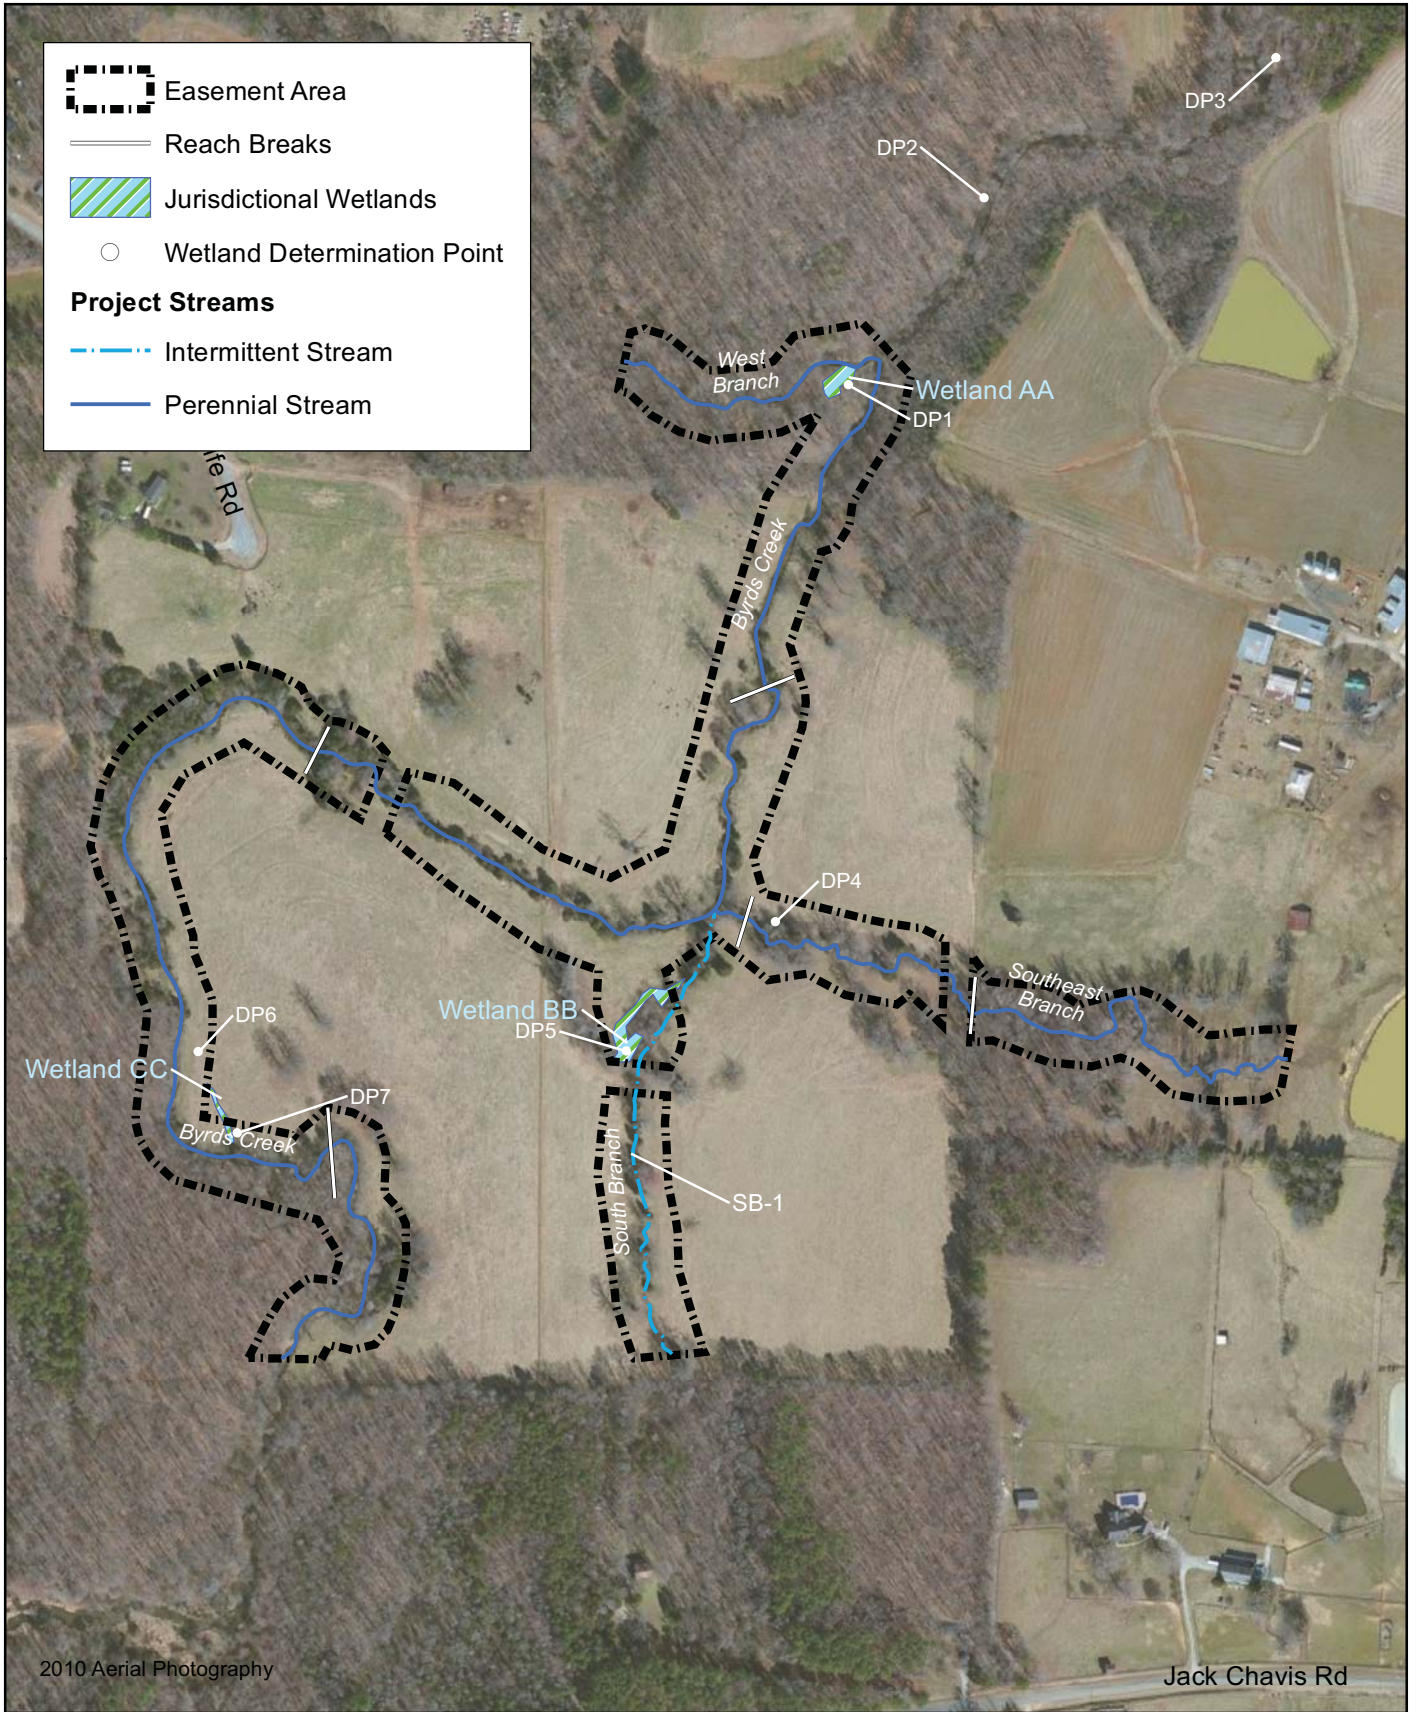
Wetland Determination Points
 Byrds Creek Mitigation Site
 Mitigation Plan
 Neuse River Basin (03020201)
 Person County, NC

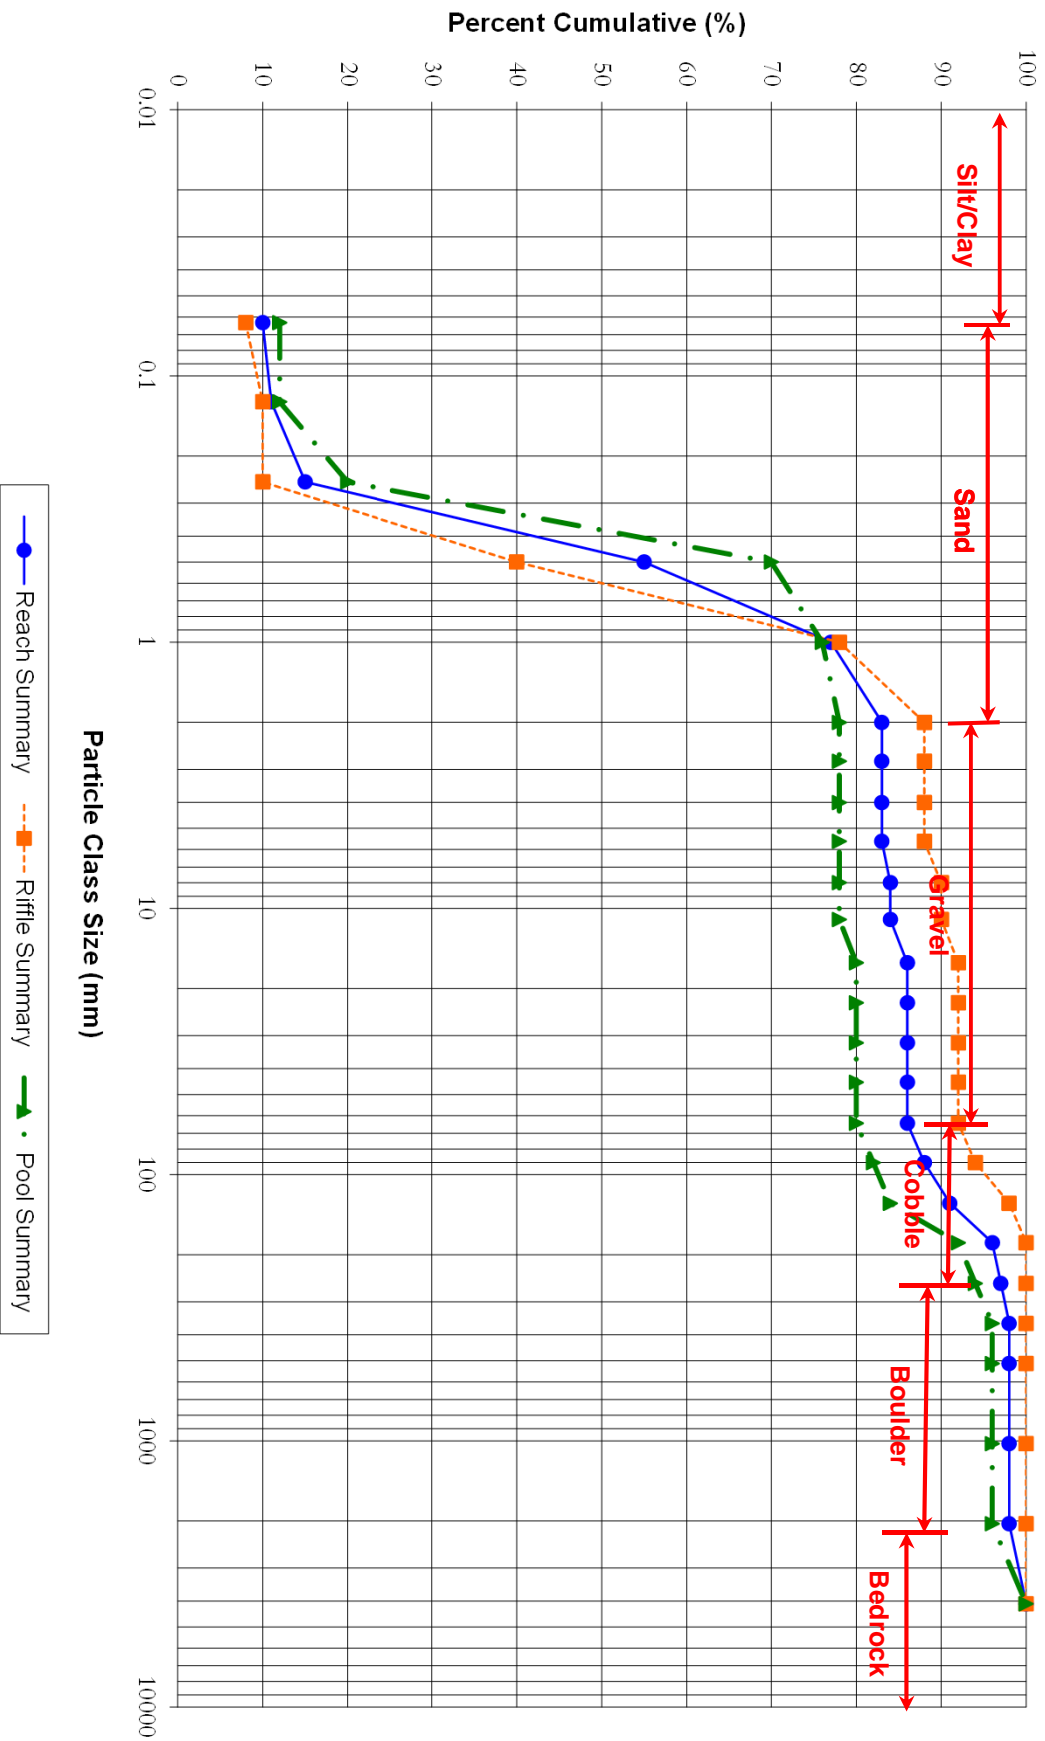
Byrds Creek Reach 1 Reach-Wide Pebble Count Particle Distribution

Riffle Channel materials (mm)		Pool Channel materials		Cumulative Channel materials	
D ₁₆ =	0.29	D ₁₆ =	0.18	D ₁₆ =	0.25
D ₃₅ =	0.45	D ₃₅ =	0.31	D ₃₅ =	0.35
D ₅₀ =	0.60	D ₅₀ =	0.38	D ₅₀ =	0.46
D ₈₄ =	1.52	D ₈₄ =	128.00	D ₈₄ =	11.00
D ₉₅ =	98.28	D ₉₅ =	304.42	D ₉₅ =	168.14
D ₁₀₀ =	180	D ₉₉ =	>2048	D ₉₉ =	>2048

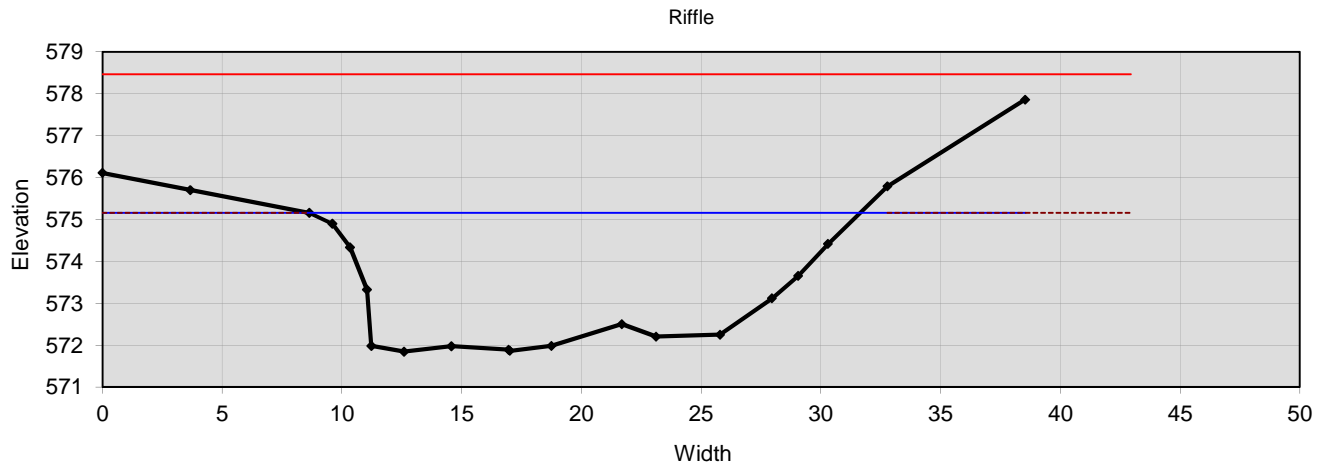
Cross Section BC-1A

Bankfull Dimensions

55.8	x-section area (ft.sq.)
23.0	width (ft)
2.4	mean depth (ft)
3.3	max depth (ft)
25.7	wetted perimeter (ft)
2.2	hyd radi (ft)
9.5	width-depth ratio

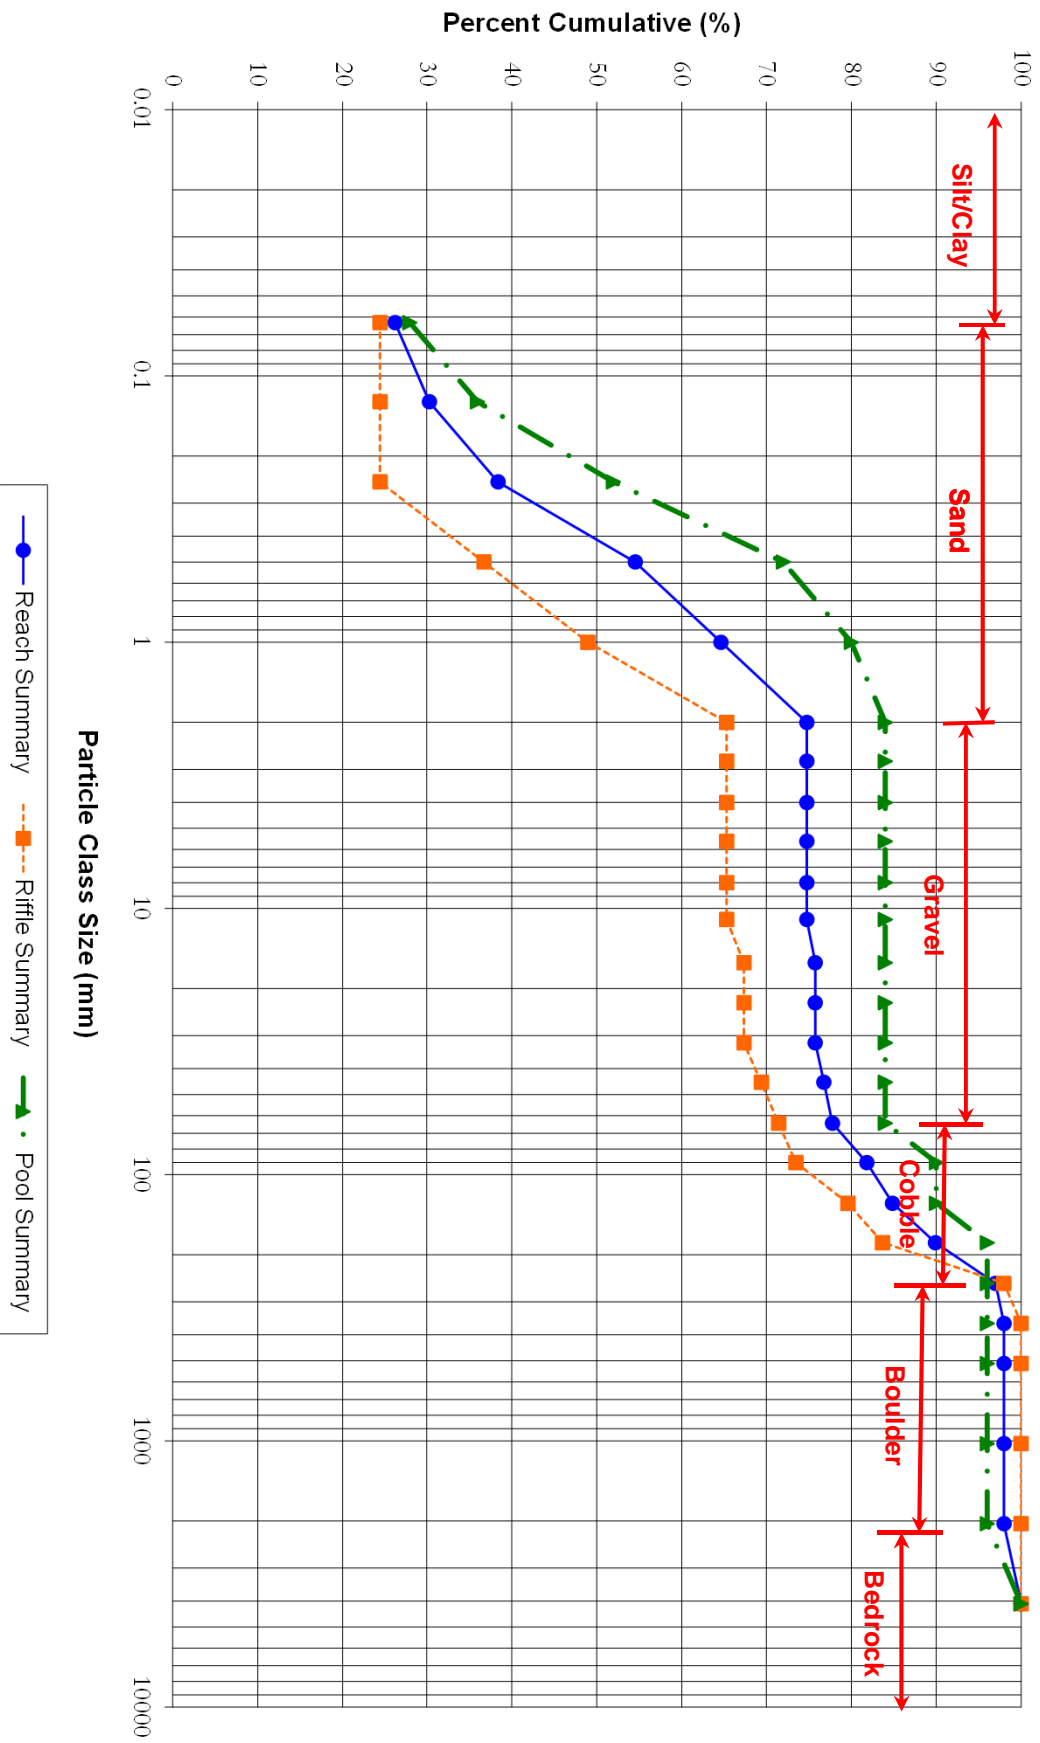
Byrds Creek Reach 2 Reach-Wide Pebble Count Particle Distribution

Riffle Channel materials (mm)		Pool Channel materials		Cumulative Channel materials	
D ₁₆ =	Silt/Clay	D ₁₆ =	Silt/Clay	D ₁₆ =	Silt/Clay
D ₃₅ =	0.45	D ₃₅ =	0.11	D ₃₅ =	0.19
D ₅₀ =	1.04	D ₅₀ =	0.23	D ₅₀ =	0.41
D ₈₄ =	181.45	D ₈₄ =	64.00	D ₈₄ =	115.98
D ₉₅ =	237.99	D ₉₅ =	170.06	D ₉₅ =	232.07
D ₁₀₀ =	362	D ₉₉ =	>2048	D ₉₉ =	>2048

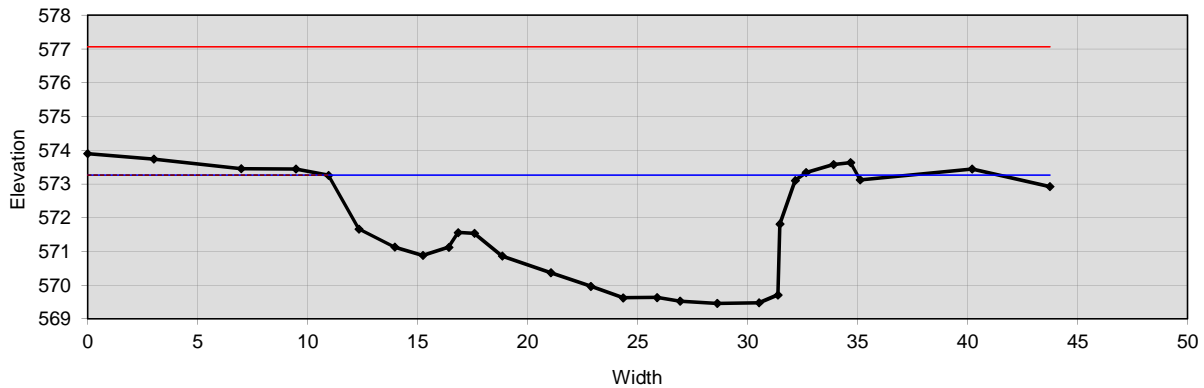
Cross Section BC-2A

Bankfull Dimensions	
58.4	x-section area (ft.sq.)
26.1	width (ft)
2.2	mean depth (ft)
3.8	max depth (ft)
30.4	wetted parimeter (ft)
1.9	hyd radi (ft)
11.7	width-depth ratio

Flood Dimensions	
144.8	W flood prone area (ft)
5.5	entrenchment ratio
3.8	low bank height (ft)
1.0	low bank height ratio

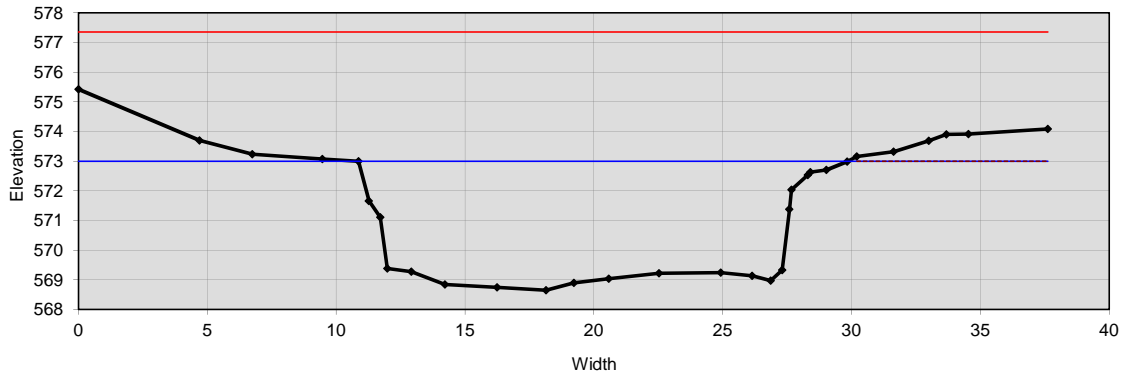
Cross Section BC-2B

Bankfull Dimensions	
64.5	x-section area (ft.sq.)
19.0	width (ft)
3.4	mean depth (ft)
4.4	max depth (ft)
24.6	wetted perimeter (ft)
2.6	hyd radi (ft)
5.6	width-depth ratio

Flood Dimensions	
230.6	W flood prone area (ft)
12.1	entrenchment ratio
4.4	low bank height (ft)
1.0	low bank height ratio

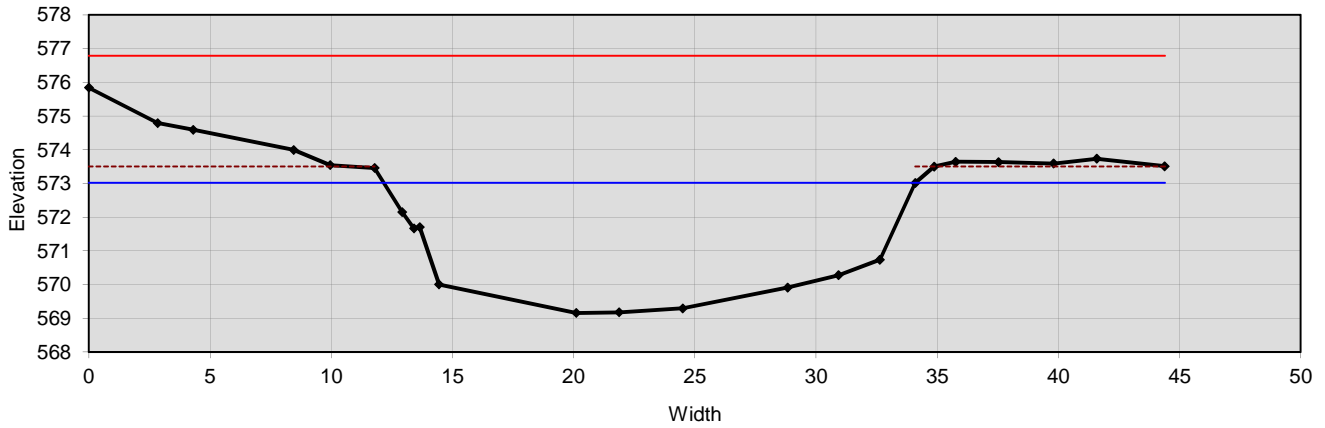
Cross Section BC-2C

Bankfull Dimensions

65.9	x-section area (ft.sq.)
21.9	width (ft)
3.0	mean depth (ft)
3.9	max depth (ft)
25.1	wetted parimeter (ft)
2.6	hyd radi (ft)
7.3	width-depth ratio

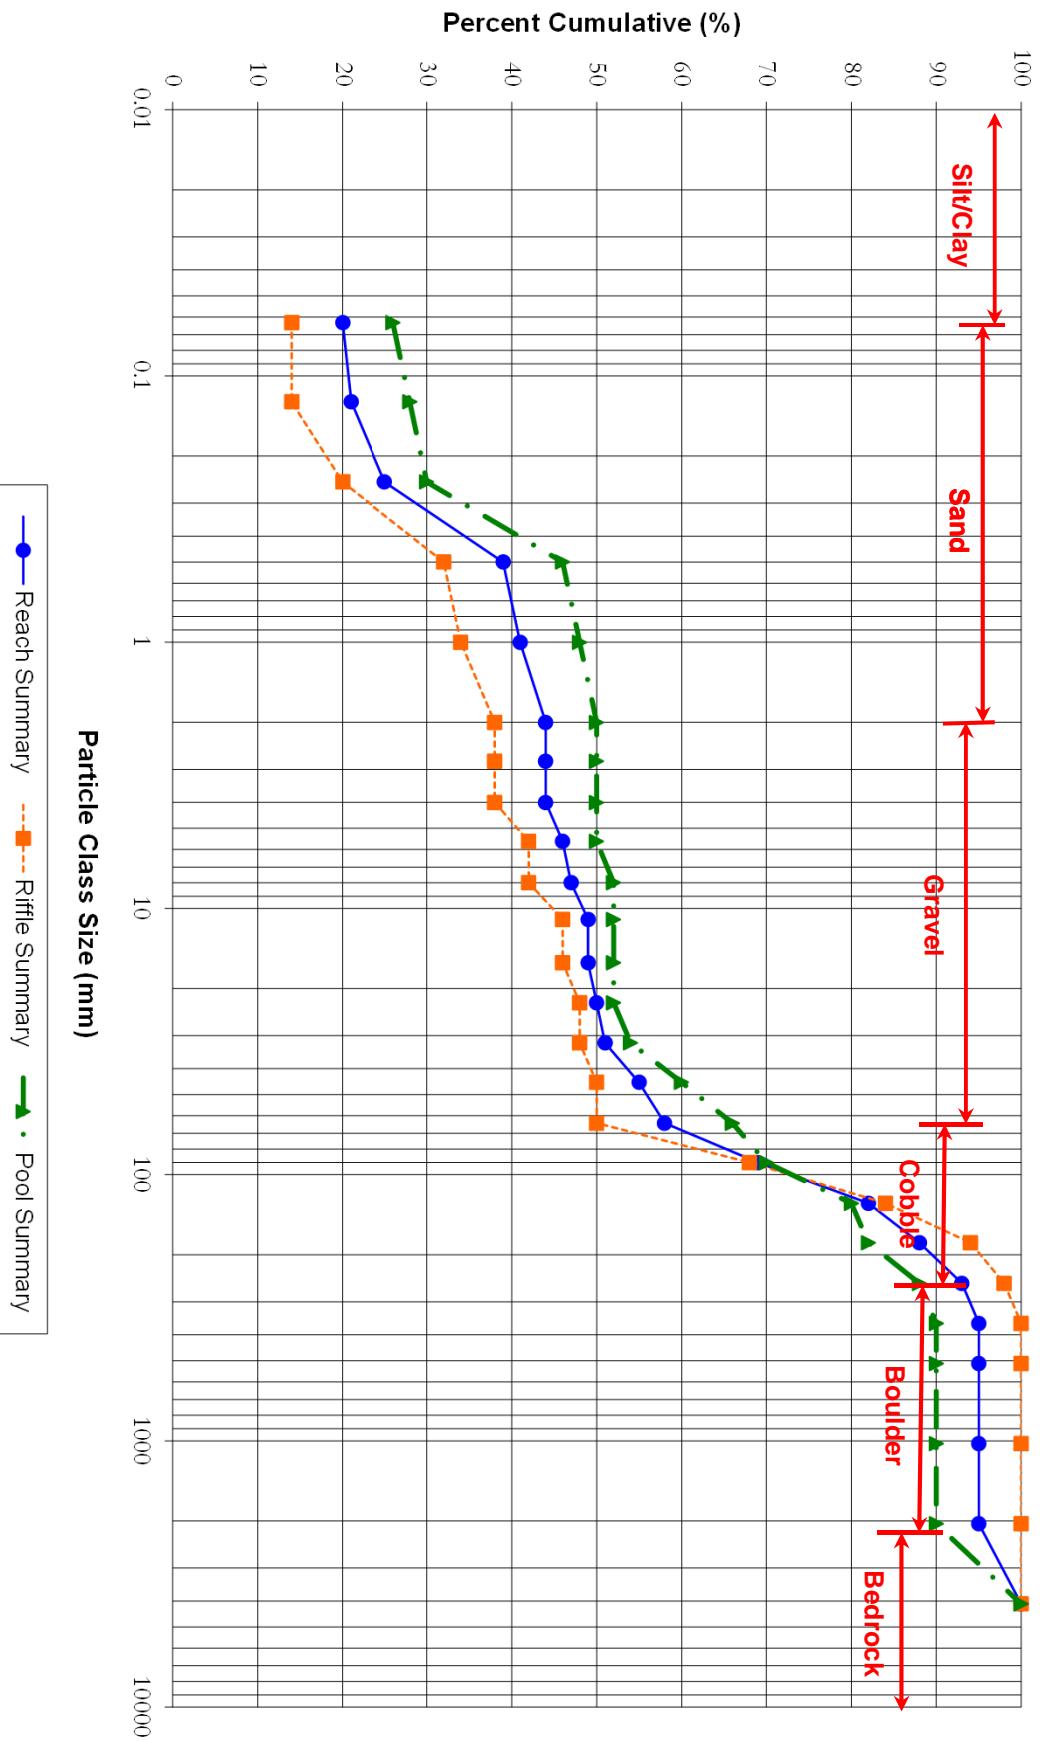
Byrds Creek Reach 3 Reach-Wide Pebble Count Particle Distribution

Riffle Channel materials (mm)		Pool Channel materials		Cumulative Channel materials	
D ₁₆ =	0.16	D ₁₆ =	Silt/Clay	D ₁₆ =	Silt/Clay
D ₃₅ =	1.19	D ₃₅ =	0.31	D ₃₅ =	0.41
D ₅₀ =	64.00	D ₅₀ =	5.60	D ₅₀ =	22.60
D ₈₄ =	128.00	D ₈₄ =	202.42	D ₈₄ =	143.40
D ₉₅ =	196.57	D ₉₅ =	2896.31	D ₉₅ =	2048.00
D ₁₀₀ =	362	D ₉₉ =	>2048	D ₉₉ =	>2048

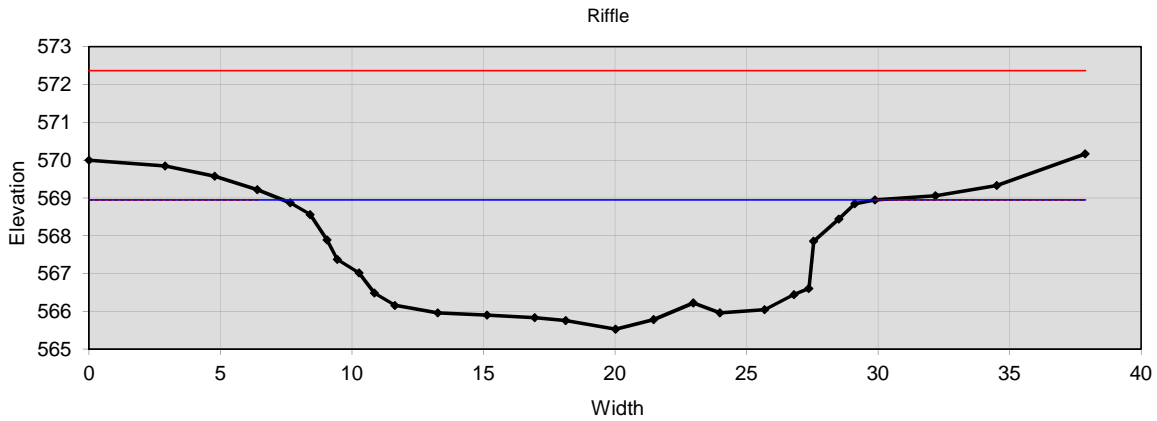
Cross Section BC-3A

Bankfull Dimensions

54.7	x-section area (ft.sq.)
22.5	width (ft)
2.4	mean depth (ft)
3.4	max depth (ft)
25.1	wetted parimeter (ft)
2.2	hyd radi (ft)
9.3	width-depth ratio

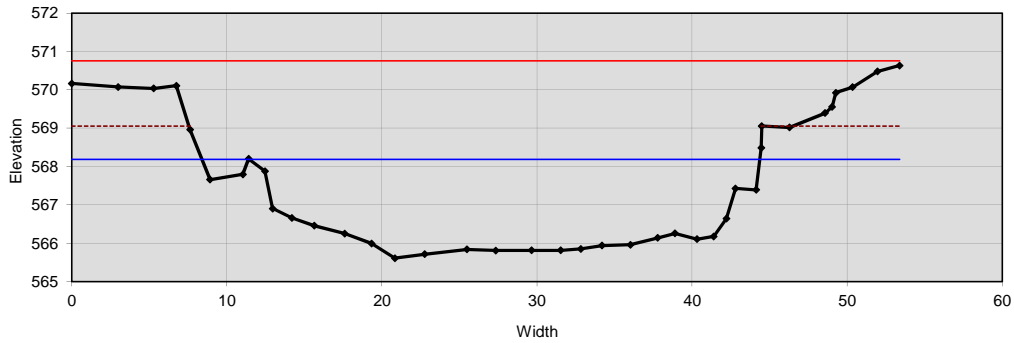
Cross Section BC-3B

Bankfull Dimensions

66.7	x-section area (ft.sq.)
35.9	width (ft)
1.9	mean depth (ft)
2.6	max depth (ft)
38.2	wetted perimeter (ft)
1.7	hyd radi (ft)
19.3	width-depth ratio

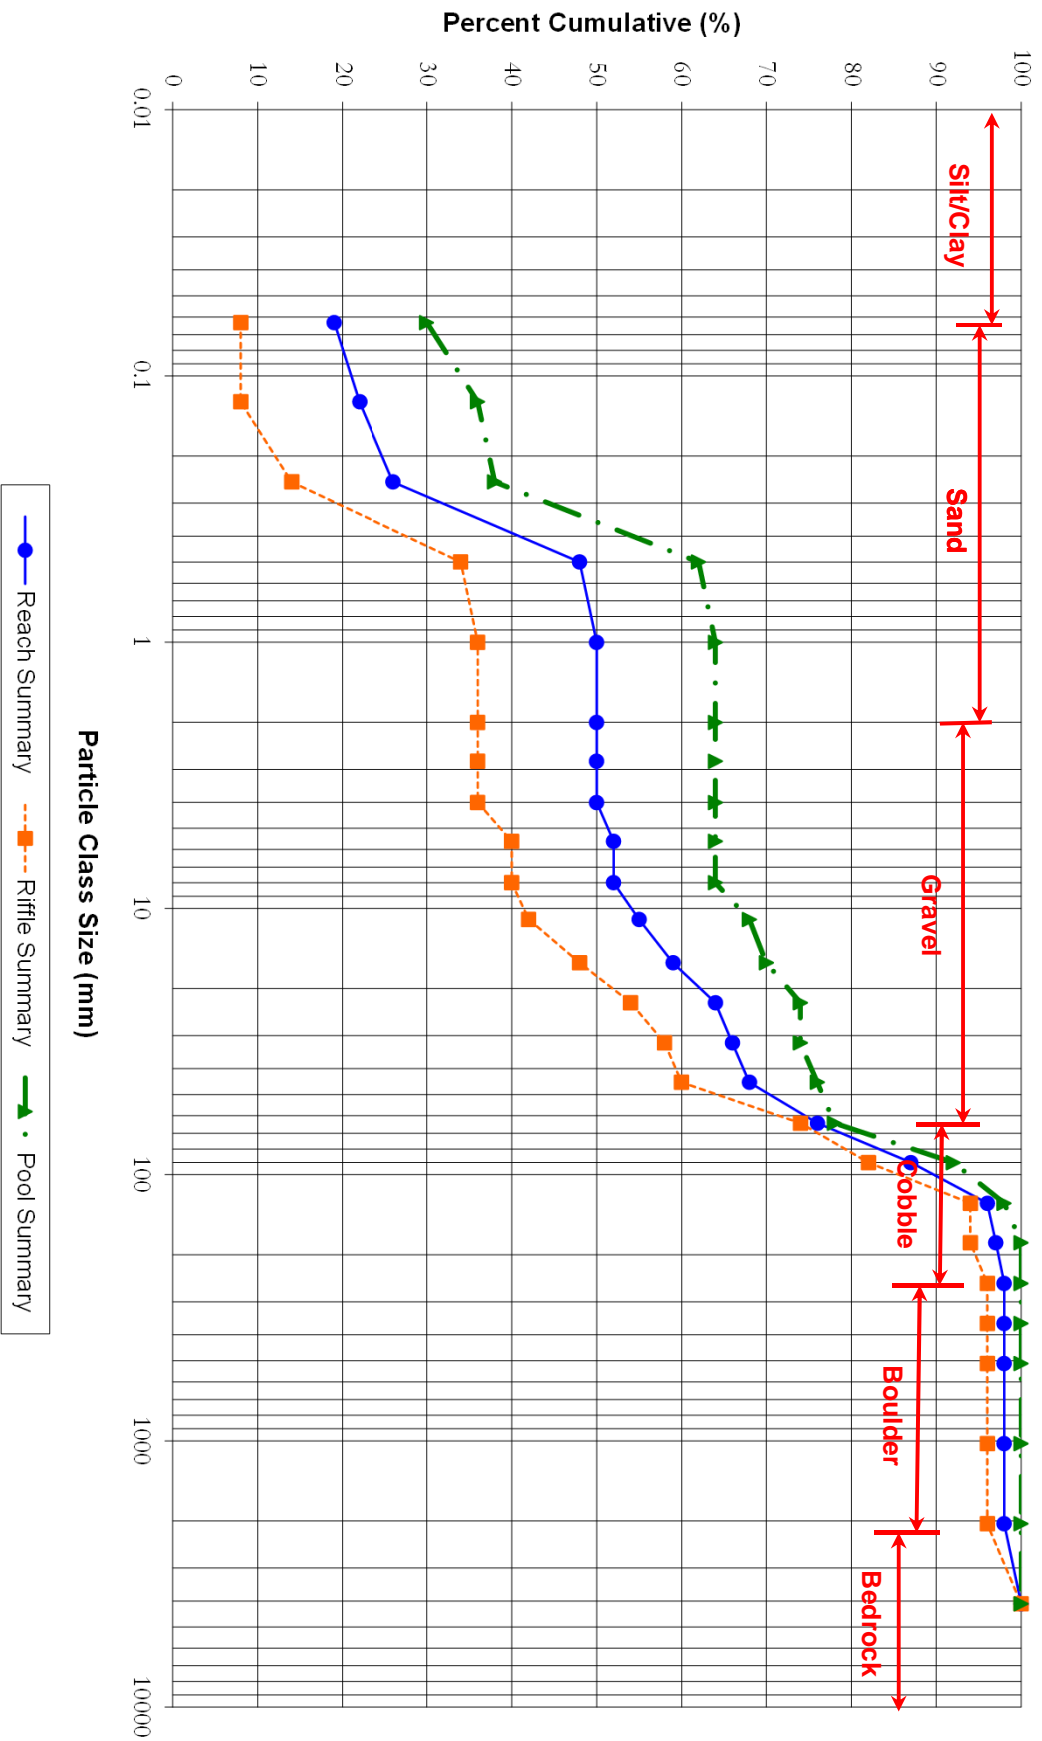
Byrds Creek Reach 4 Reach-Wide Pebble Count Particle Distribution

Riffle Channel materials (mm)		Pool Channel materials		Cumulative Channel materials	
D ₁₆ =	0.27	D ₁₆ =	Silt/Clay	D ₁₆ =	Silt/Clay
D ₃₅ =	0.71	D ₃₅ =	0.11	D ₃₅ =	0.33
D ₅₀ =	17.95	D ₅₀ =	0.35	D ₅₀ =	4.00
D ₈₄ =	95.44	D ₈₄ =	74.07	D ₈₄ =	82.01
D ₉₅ =	214.66	D ₉₅ =	107.33	D ₉₅ =	123.09
D ₁₀₀ =	>2048	D ₉₉ =	180	D ₉₉ =	>2048

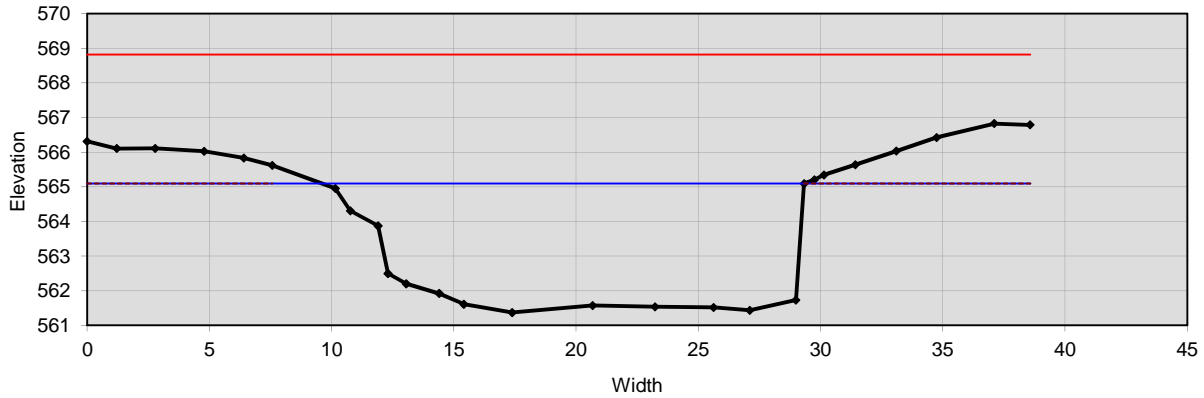
Cross Section BC-4A

Bankfull Dimensions

60.9	x-section area (ft.sq.)
19.7	width (ft)
3.1	mean depth (ft)
3.7	max depth (ft)
24.4	wetted parimeter (ft)
2.5	hyd radi (ft)
6.4	width-depth ratio

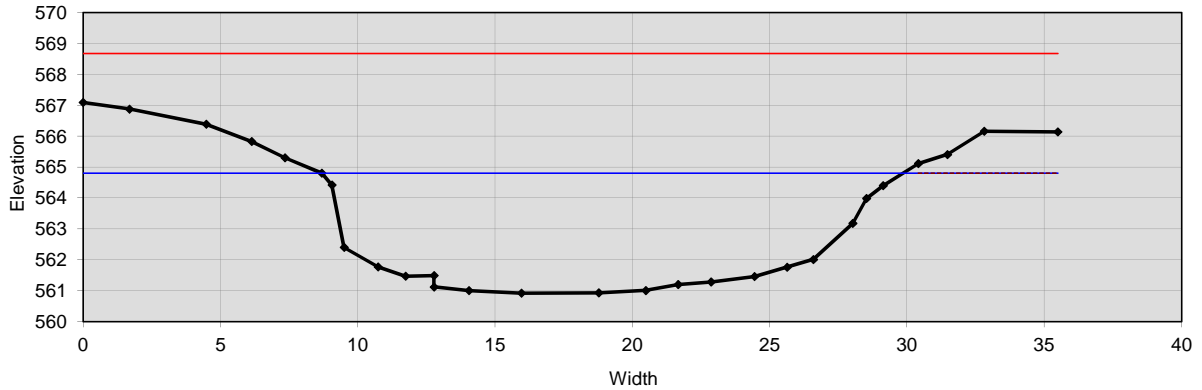
Cross Section BC-4B

Bankfull Dimensions	
65.1	x-section area (ft.sq.)
21.2	width (ft)
3.1	mean depth (ft)
3.9	max depth (ft)
24.7	wetted parimeter (ft)
2.6	hyd radi (ft)
6.9	width-depth ratio

Flood Dimensions	
138.0	W flood prone area (ft)
6.5	entrenchment ratio
3.9	low bank height (ft)
1.0	low bank height ratio

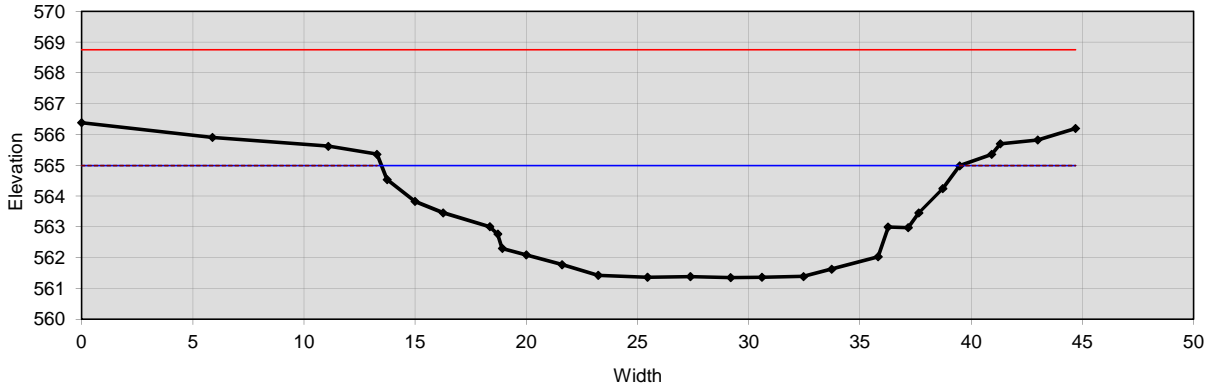
Cross Section BC-4C

Bankfull Dimensions

70.8	x-section area (ft.sq.)
26.0	width (ft)
2.7	mean depth (ft)
3.6	max depth (ft)
28.5	wetted parimeter (ft)
2.5	hyd radi (ft)
9.5	width-depth ratio

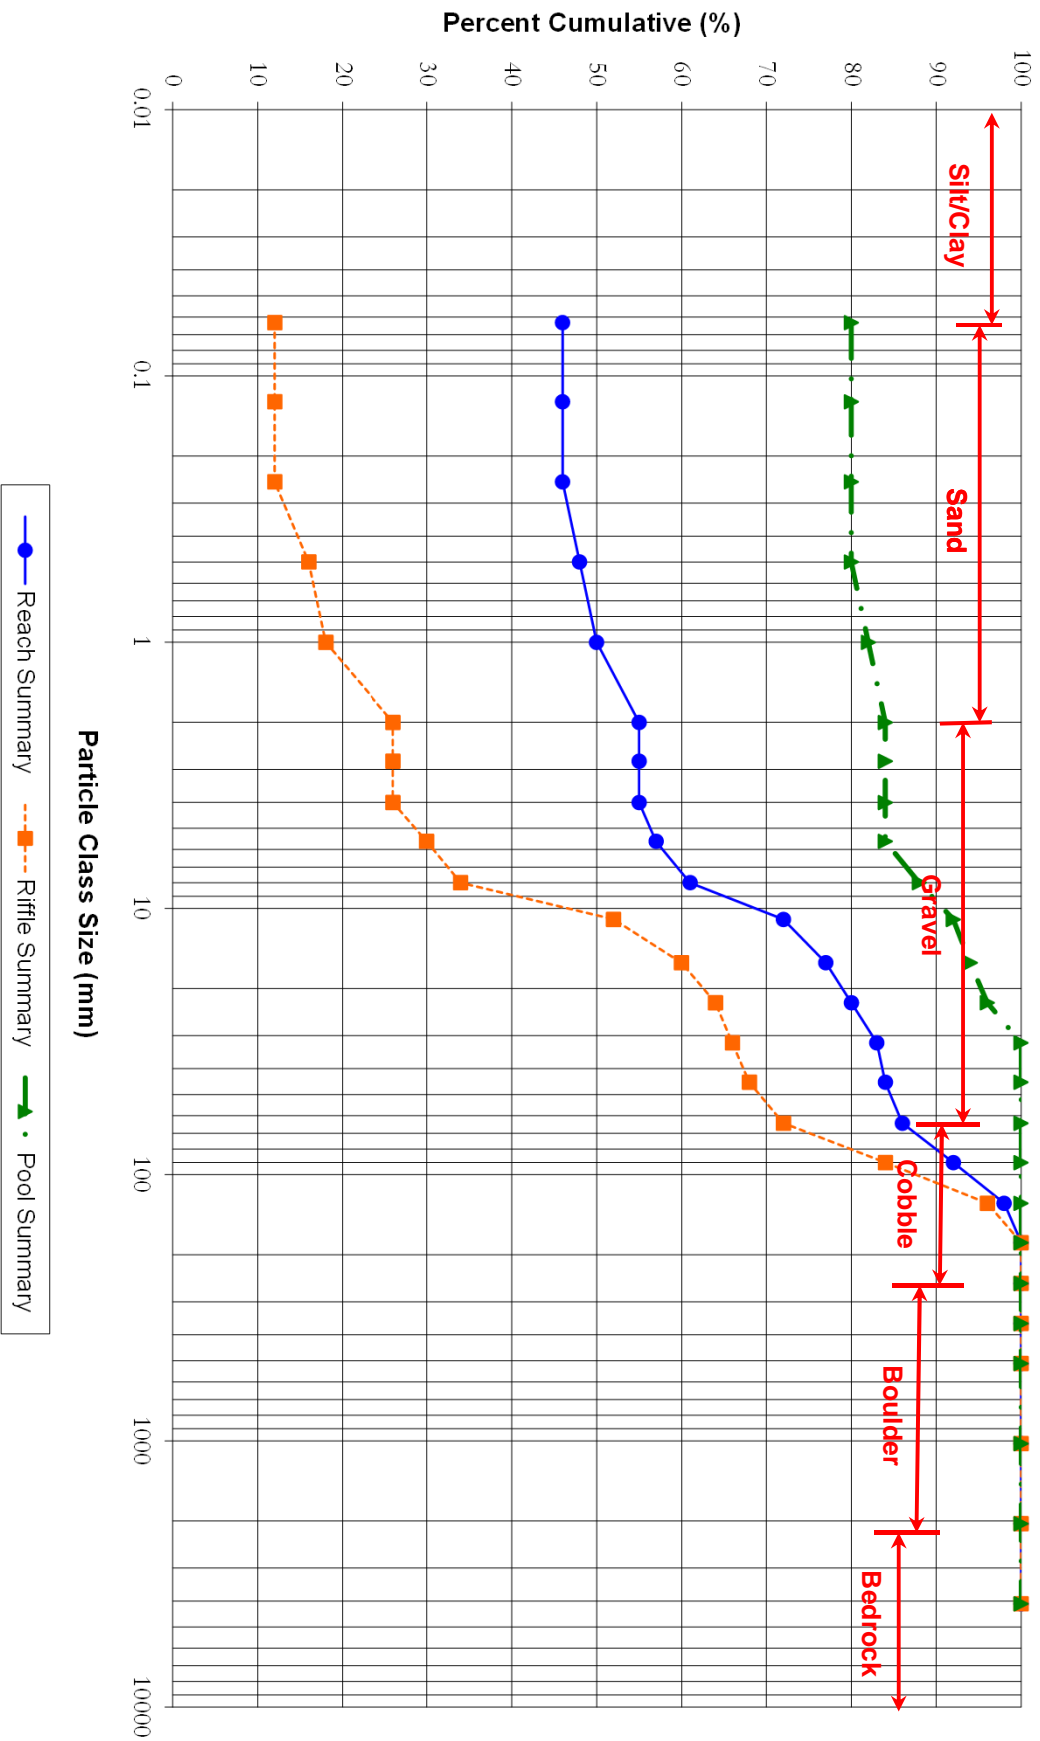
South Branch Reach-Wide Pebble Count Particle Distribution

Riffle Channel materials (mm)		Pool Channel materials		Cumulative Channel materials	
D ₁₆ =	Silt/Clay	D ₁₆ =	Silt/Clay	D ₁₆ =	Silt/Clay
D ₃₅ =	8.14	D ₃₅ =	Silt/Clay	D ₃₅ =	Silt/Clay
D ₅₀ =	10.62	D ₅₀ =	Silt/Clay	D ₅₀ =	1.00
D ₈₄ =	90.00	D ₈₄ =	5.60	D ₈₄ =	45.00
D ₉₅ =	124.30	D ₉₅ =	19.02	D ₉₅ =	107.33
D ₁₀₀ =	180	D ₉₉ =	32	D ₉₉ =	180

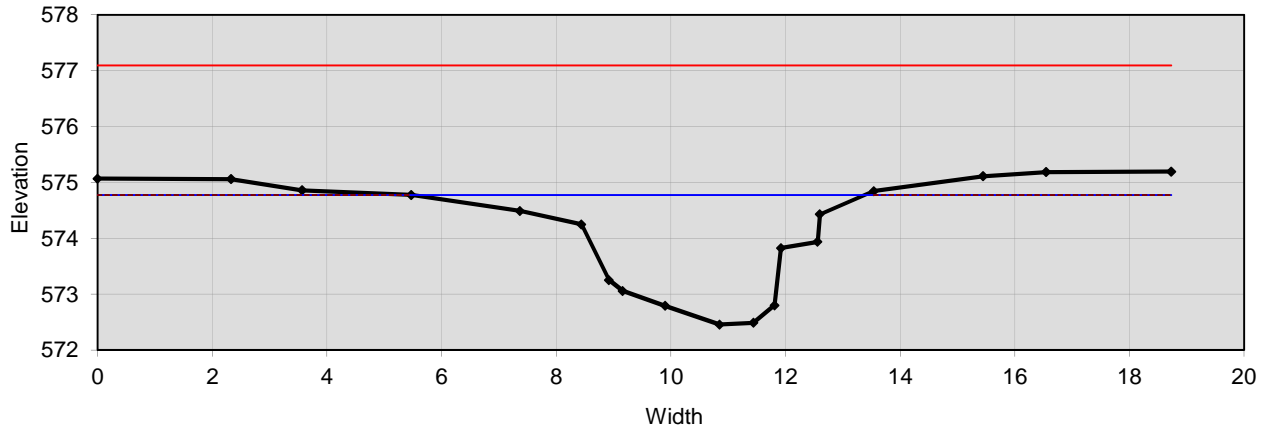
Cross Section SB-1A

Bankfull Dimensions

8.0	x-section area (ft.sq.)
7.9	width (ft)
1.0	mean depth (ft)
2.3	max depth (ft)
10.3	wetted perimeter (ft)
0.8	hyd radi (ft)
7.8	width-depth ratio
