MITIGATION PLAN

Byrds Creek Mitigation Site
Person County, North Carolina
EEP ID #95020

Neuse River Basin
HUC 03020201

January, 2013

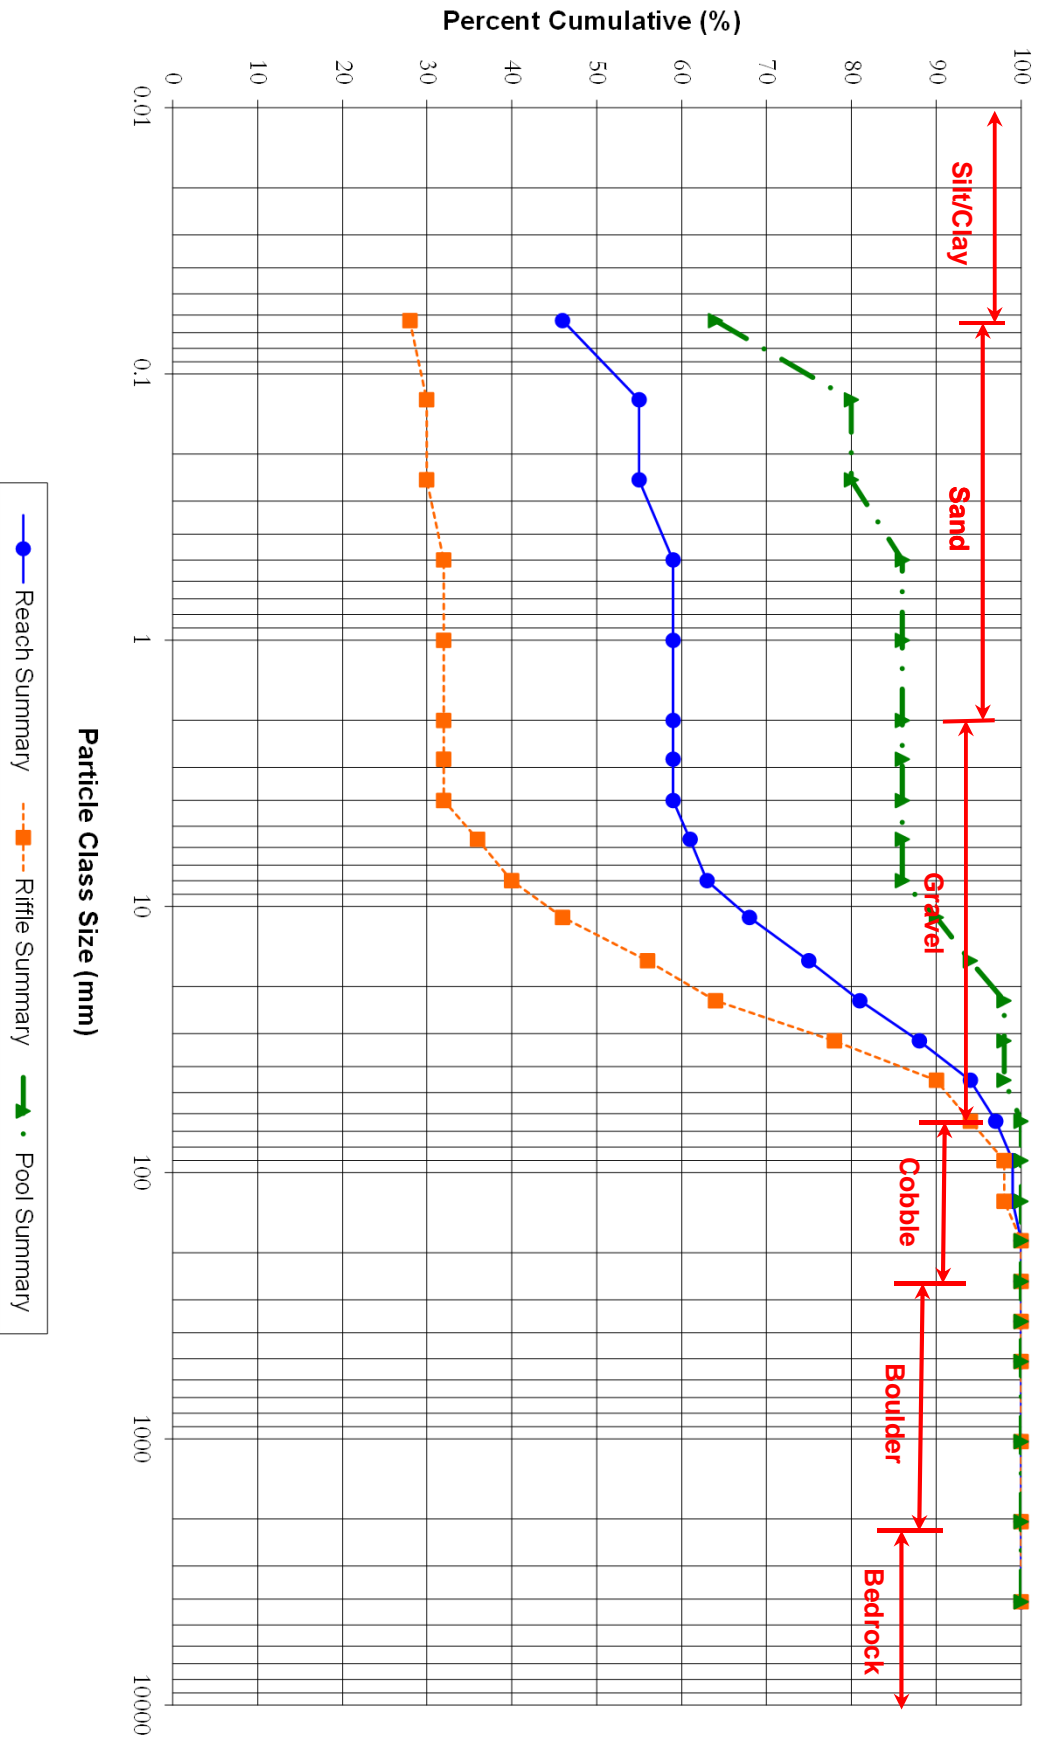
Southeast Reach-Wide Pebble Count Particle Distribution

Riffle Channel materials (mm)		Pool Channel materials		Cumulative Channel materials	
D ₁₆ =	Silt/Clay	D ₁₆ =	Silt/Clay	D ₁₆ =	Silt/Clay
D ₃₅ =	5.15	D ₃₅ =	Silt/Clay	D ₃₅ =	Silt/Clay
D ₅₀ =	12.78	D ₅₀ =	Silt/Clay	D ₅₀ =	0.09
D ₈₄ =	37.95	D ₈₄ =	0.40	D ₈₄ =	26.23
D ₉₅ =	69.69	D ₉₅ =	17.44	D ₉₅ =	50.61
D ₁₀₀ =	180	D ₉₉ =	64	D ₉₉ =	180

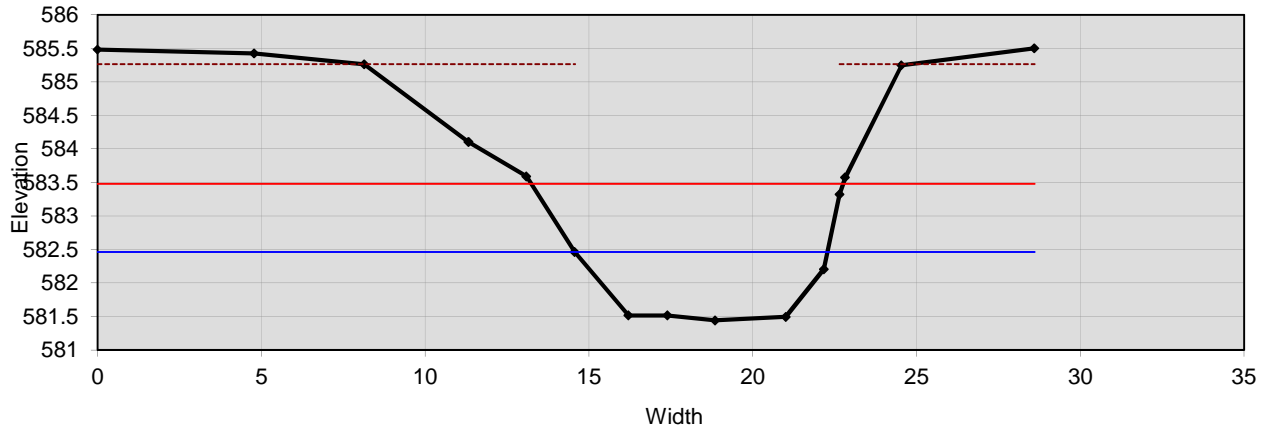
Cross Section SE-1A

Bankfull Dimensions

6.2	x-section area (ft.sq.)
7.7	width (ft)
0.8	mean depth (ft)
1.0	max depth (ft)
8.3	wetted parimeter (ft)
0.7	hyd radi (ft)
9.6	width-depth ratio

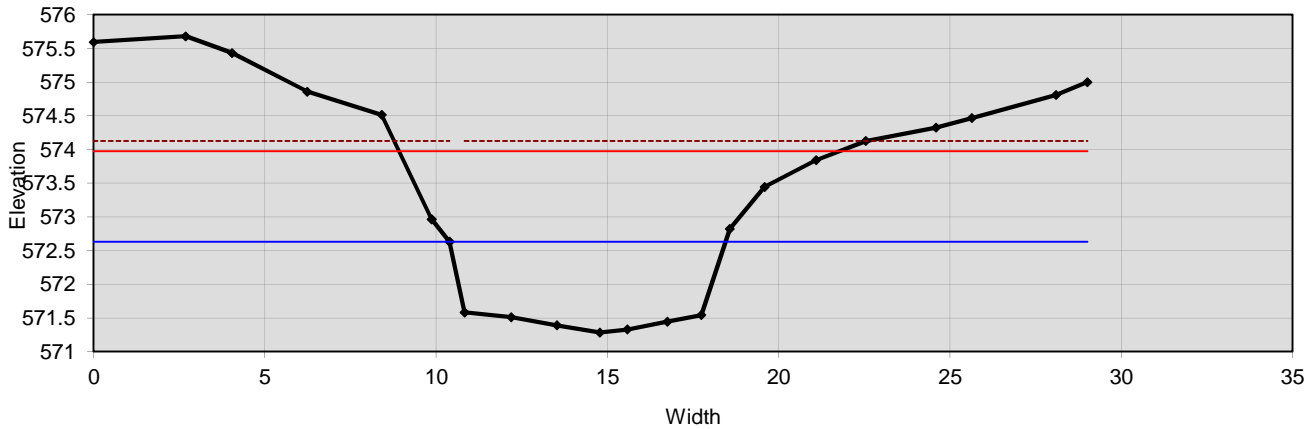
Cross Section SE-2B

Bankfull Dimensions

8.9	x-section area (ft.sq.)
8.1	width (ft)
1.1	mean depth (ft)
1.3	max depth (ft)
9.4	wetted parimeter (ft)
1.0	hyd radi (ft)
7.3	width-depth ratio

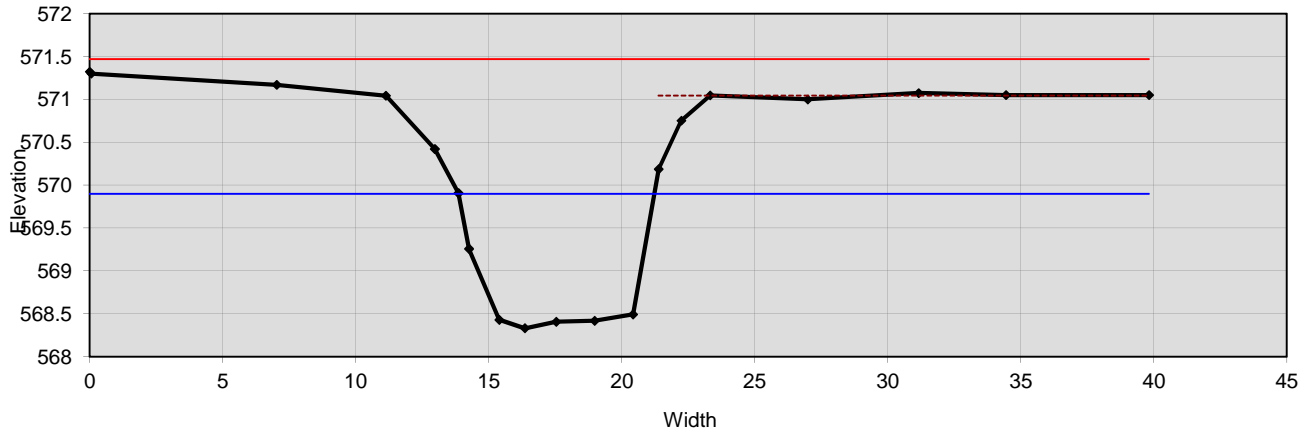
Cross Section SE-2C

Bankfull Dimensions

9.4	x-section area (ft.sq.)
7.4	width (ft)
1.3	mean depth (ft)
1.6	max depth (ft)
8.8	wetted parimeter (ft)
1.1	hyd radi (ft)
5.8	width-depth ratio

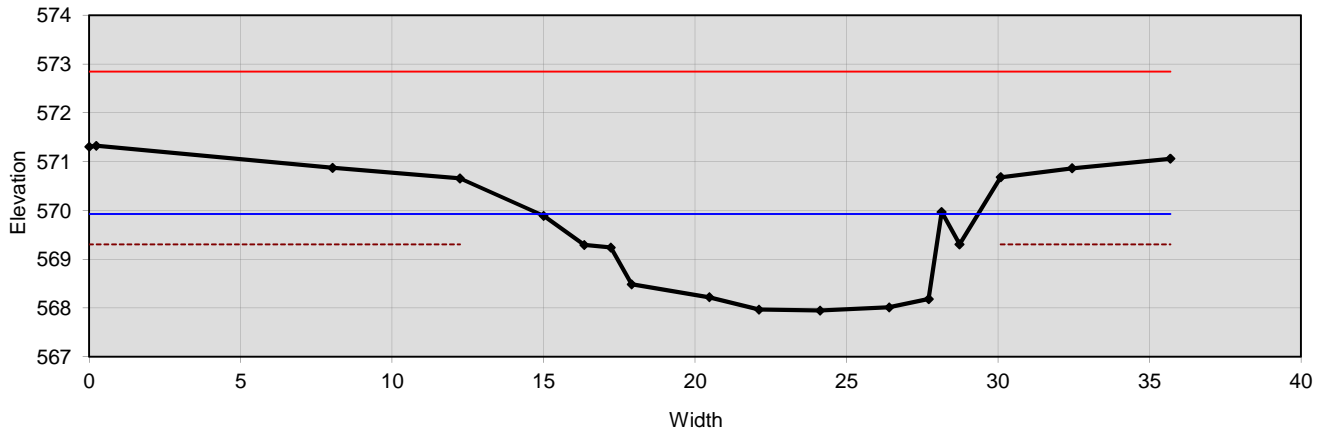
Cross Section SE-2D

Bankfull Dimensions

20.3	x-section area (ft.sq.)
14.4	width (ft)
1.4	mean depth (ft)
2.0	max depth (ft)
16.9	wetted perimeter (ft)
1.2	hyd radi (ft)
10.3	width-depth ratio

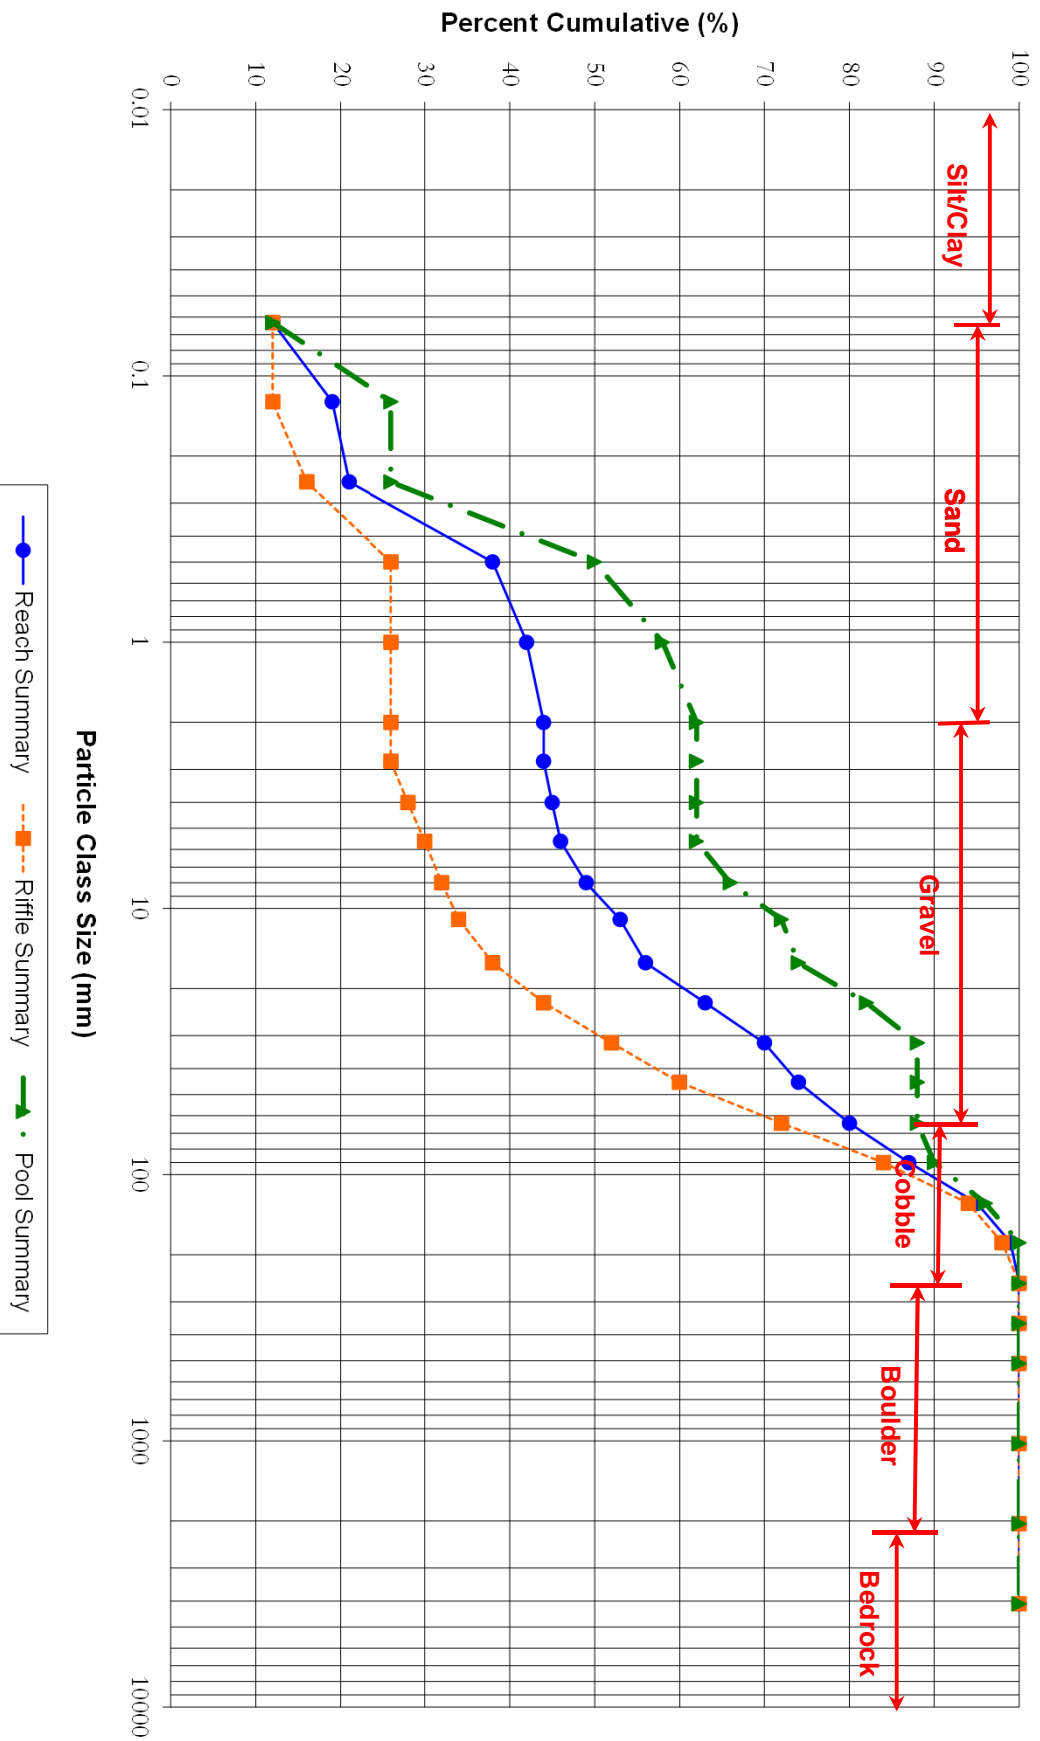
West Branch Reach-Wide Pebble Count Particle Distribution

Riffle Channel materials (mm)		Pool Channel materials		Cumulative Channel materials	
D ₁₆ =	0.25	D ₁₆ =	Silt/Clay	D ₁₆ =	Silt/Clay
D ₃₅ =	12.08	D ₃₅ =	0.32	D ₃₅ =	0.44
D ₅₀ =	29.34	D ₅₀ =	0.50	D ₅₀ =	8.66
D ₈₄ =	90.00	D ₈₄ =	25.38	D ₈₄ =	77.77
D ₉₅ =	139.39	D ₉₅ =	120.70	D ₉₅ =	128.00
D ₁₀₀ =	256	D ₉₉ =	180	D ₉₉ =	256

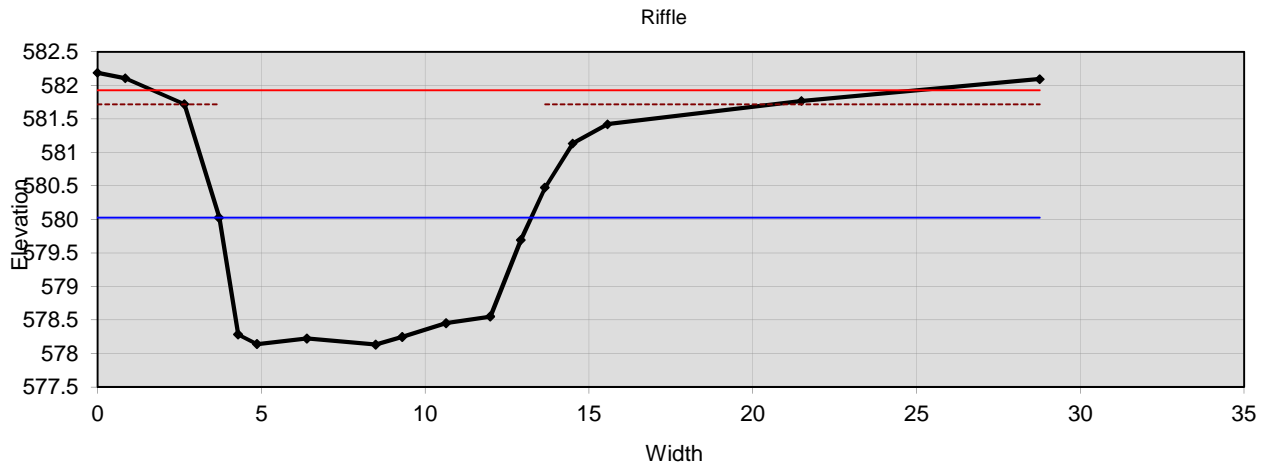
Cross Section WB-1A

Bankfull Dimensions

15.0	x-section area (ft.sq.)
9.5	width (ft)
1.6	mean depth (ft)
1.9	max depth (ft)
11.5	wetted parimeter (ft)
1.3	hyd radi (ft)
6.1	width-depth ratio
