SUPPLEMENTAL CLOSEOUT REPORT

BYRDS CREEK MITIGATION SITE

Person County, NC

DMS Project Number 95020

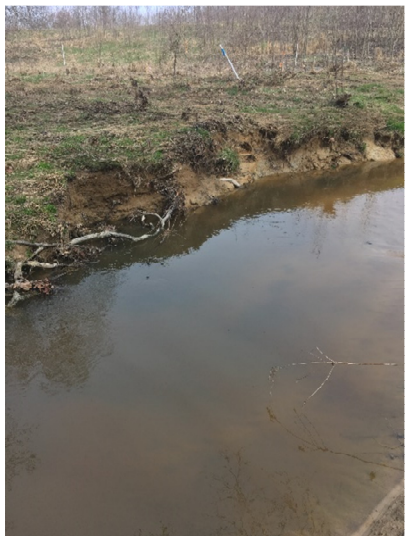
Byrds Creek Reach 1 (2/28/2019)

During August 2019 one bend on Byrds Creek Reach 1 and three isolated areas along West Branch were repaired using an excavator. The outside of a bend along Byrds Creek Reach 1 (enhancement II) had scoured the previous fall/winter during several large storm events, including two hurricanes. The bank along this bend was graded, matted, sod mats were installed, and live stakes were planted. On West Branch (enhancement II), three areas experienced bank scour on the outside of bends. These areas were lined with rock, filled with dirt, and planted with live stakes. These repairs were stable during January of 2020. Photographs of the repaired areas are in Appendix 1.
