ANNUAL REPORT FOR 2001

**U. S. Marine Corps Mitigation Site
Onslow County
Project No. 6.269010T
TIP No. U-2107 WM**

Prepared By:
Natural Systems Unit & Roadside Environmental Unit
North Carolina Department of Transportation
December 2001

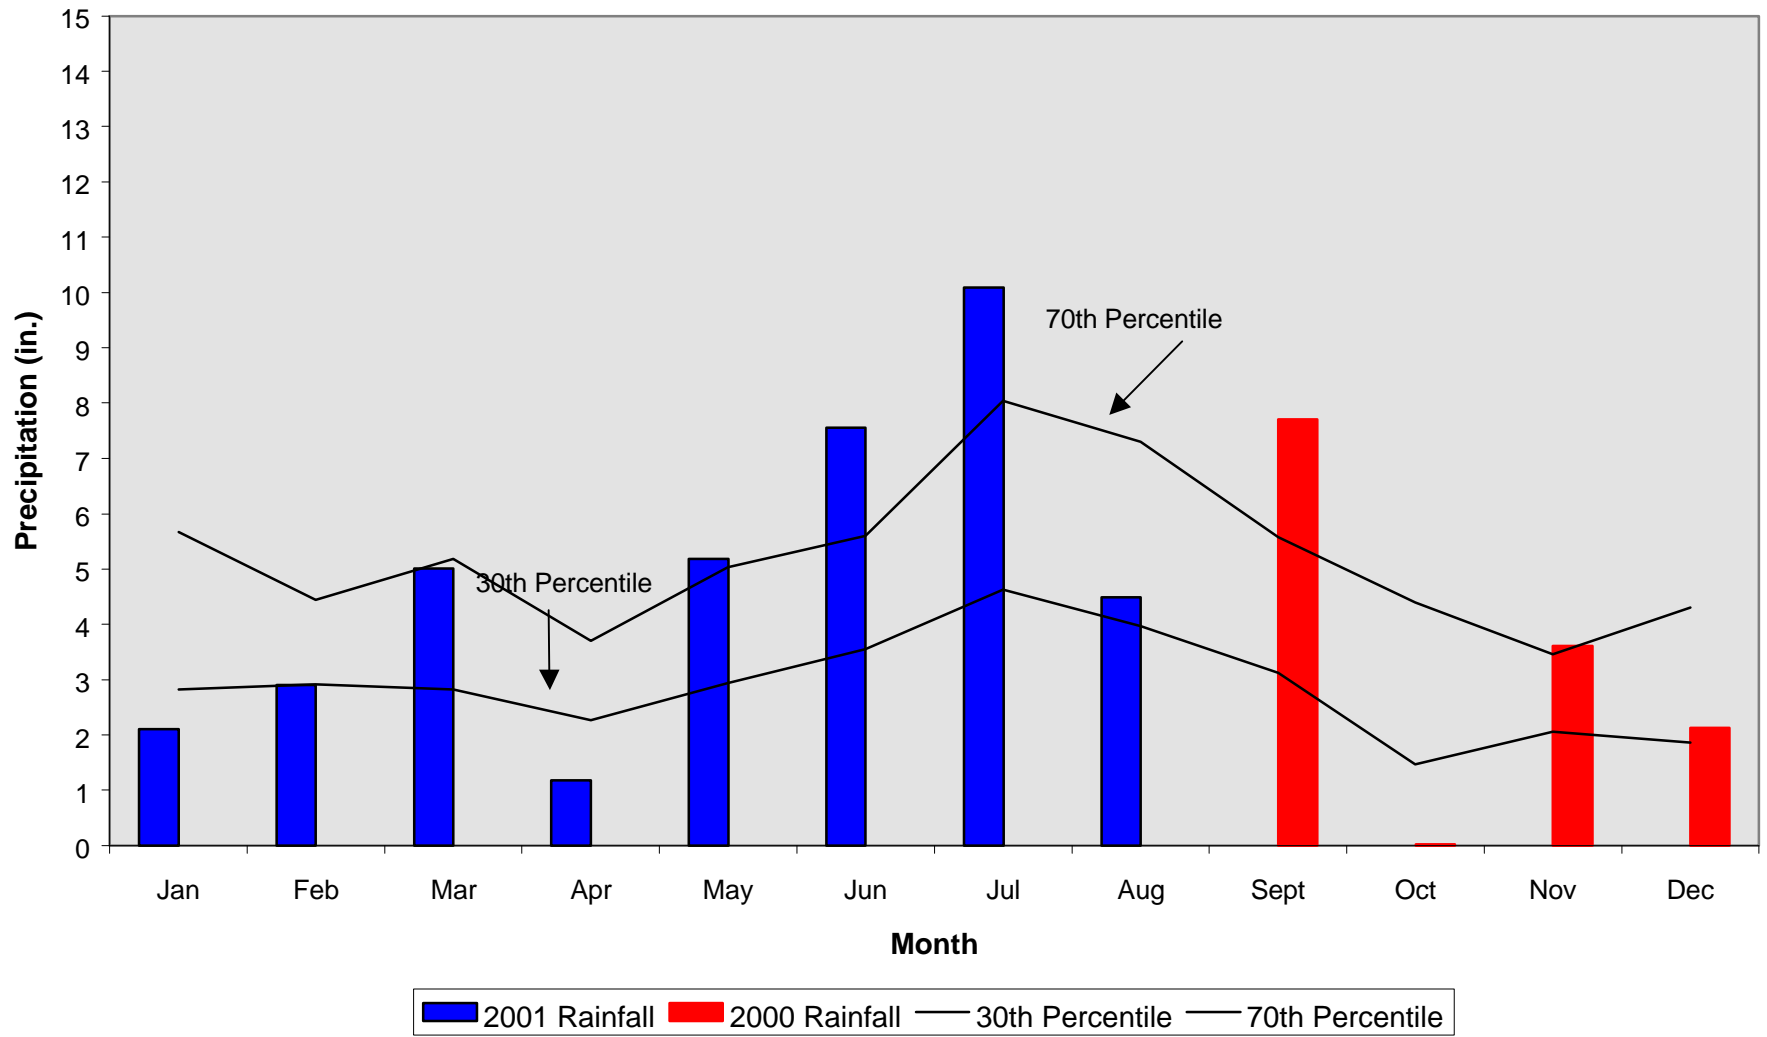
Figure 4. USMC 30-70 Graph
Trenton, NC

Figure 4 represents an examination of the local climate in comparison with historical data in order to determine whether 2001 was “average” in terms of climate conditions. The figure compares the rainfall from January to August 2001 with that of historical rainfall (data collected between 1931 and 2001). All rainfall data was collected from the NC State Climate Office, Trenton weather station. The graph shows 2000 monthly totals from September to December. Rainfall data for September through December 2001 will be presented in the 2002 Annual Monitoring Report.

For 2000, rainfall was above average in September, below average in October, and within average limits in November and December. For 2001, rainfall was below average in January, February, and April; within average limits in March and August; and above average in May, June, and July.

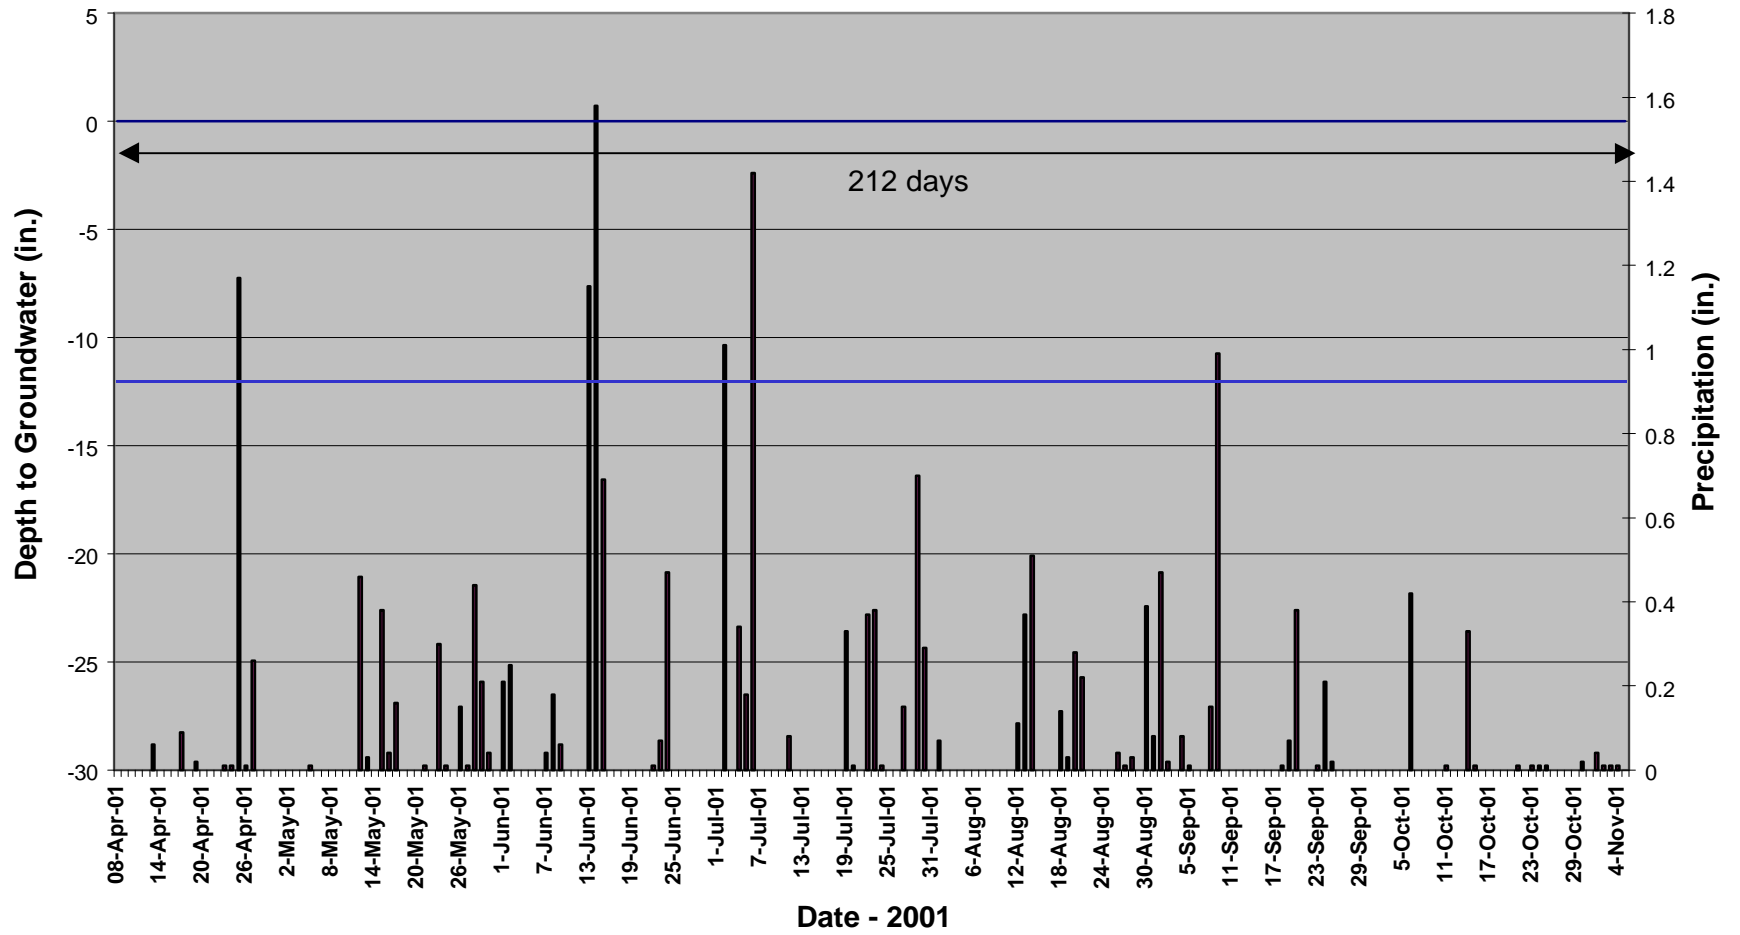
USMC - G3 (Groundwater Gauge)

Appendix A contains a plot of the water depth for each groundwater monitoring gauge and surface gauge during the growing season. Precipitation events are included on each groundwater gauge graphs as bars. The precipitation data on each groundwater gauge graph is from the on-site Infinity rain gauge.

Monitoring Gauge	< 5%	5% - 8%	8% - 12.5%	> 12.5%	Actual %	Success Dates
USMC-G3				✓	100.0	4/8-11/5
USMC-G4				✓	39.6	8/14-11/5
USMC-G5*				✓	25.0	4/8-5/3

The groundwater gauges, all three gauges indicate hydrologic data that meets and exceeds project specifications during 2001.

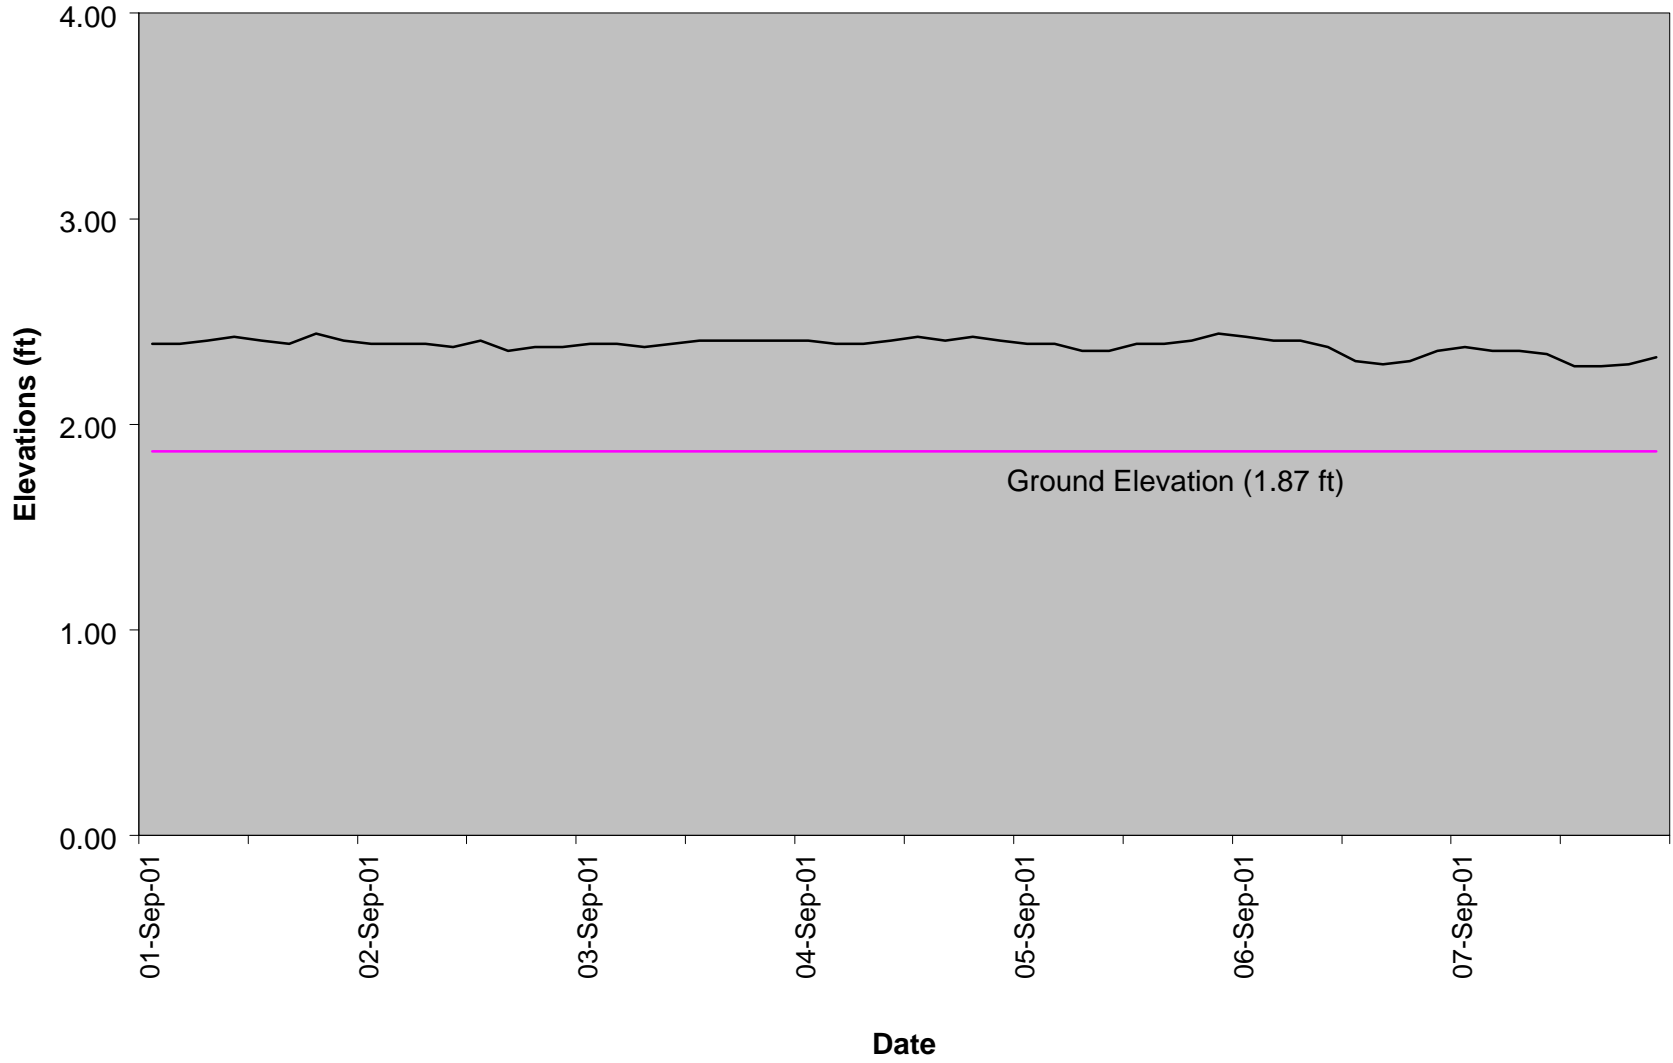
USMC-S1 (Surface Gauge) Water Surface Elevation

For the surface water gauges, the surface water gauge data was erratic and unreliable in 2000. It was discovered that corrosion in the gauges had affected the data. As a result, all four surface water gauges were replaced with similar units following the 2000 growing season. Unfortunately, the new surface water gauges have also proved unreliable. To supplement the onsite data, an Infinity tidal gauge was installed. All four gauges show consistent inundation but no strong tidal fluctuations that match the reference USMC-9 tide gauge. Despite these problems with the gauges, it is apparent from other observations that the marsh area is not being flooded twice daily.

The entire marsh area will be regraded and replanted in spring 2002 to correct problems. After reconstruction new Infinity style surface water gauges will be installed to correct problems with the old style units.

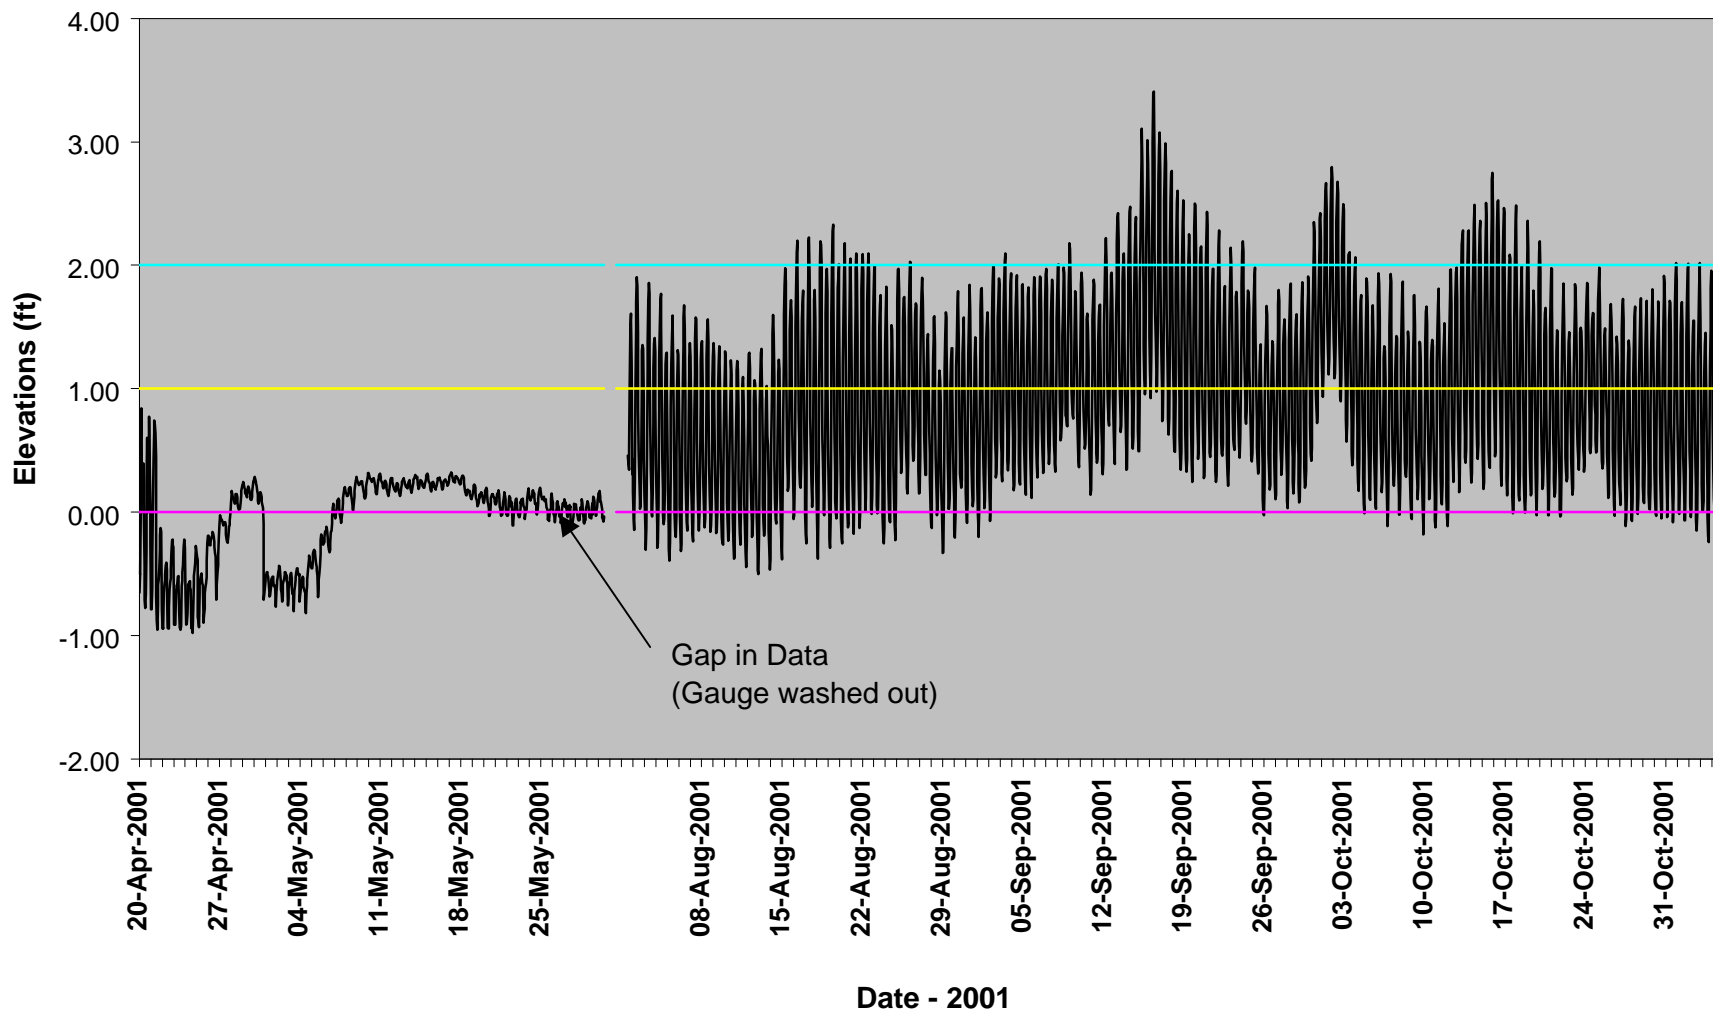
USMC - S9 (Tidal Gauge) Water Surface Elevation

Hydrologic monitoring indicates that the site has not met the overall success criteria during the 2001 monitoring year. Although the surface water gauges show inundation, the lack of vegetation and the tidal gauge data all confirm that the site is not being flooded twice daily as required. The groundwater gauges in the shrub area were all successful.

2001 represent the third full growing season that the hydrologic monitoring data has been examined. For this year, all three groundwater gauges met the jurisdictional wetland hydrology for 12.5% of the growing season. While the surface gauges show success, the tidal marsh area of the site is not really meeting the success criteria of flooding twice daily, based on tidal gauges information and lack of vegetation.
