ANNUAL REPORT FOR 2002

**U. S. Marine Corps Mitigation Site
Onslow County
Project No. 6.269010T
TIP No. U-2107 WM**

Prepared By:
Office of Natural Environment & Roadside Environmental Unit
North Carolina Department of Transportation
December 2002

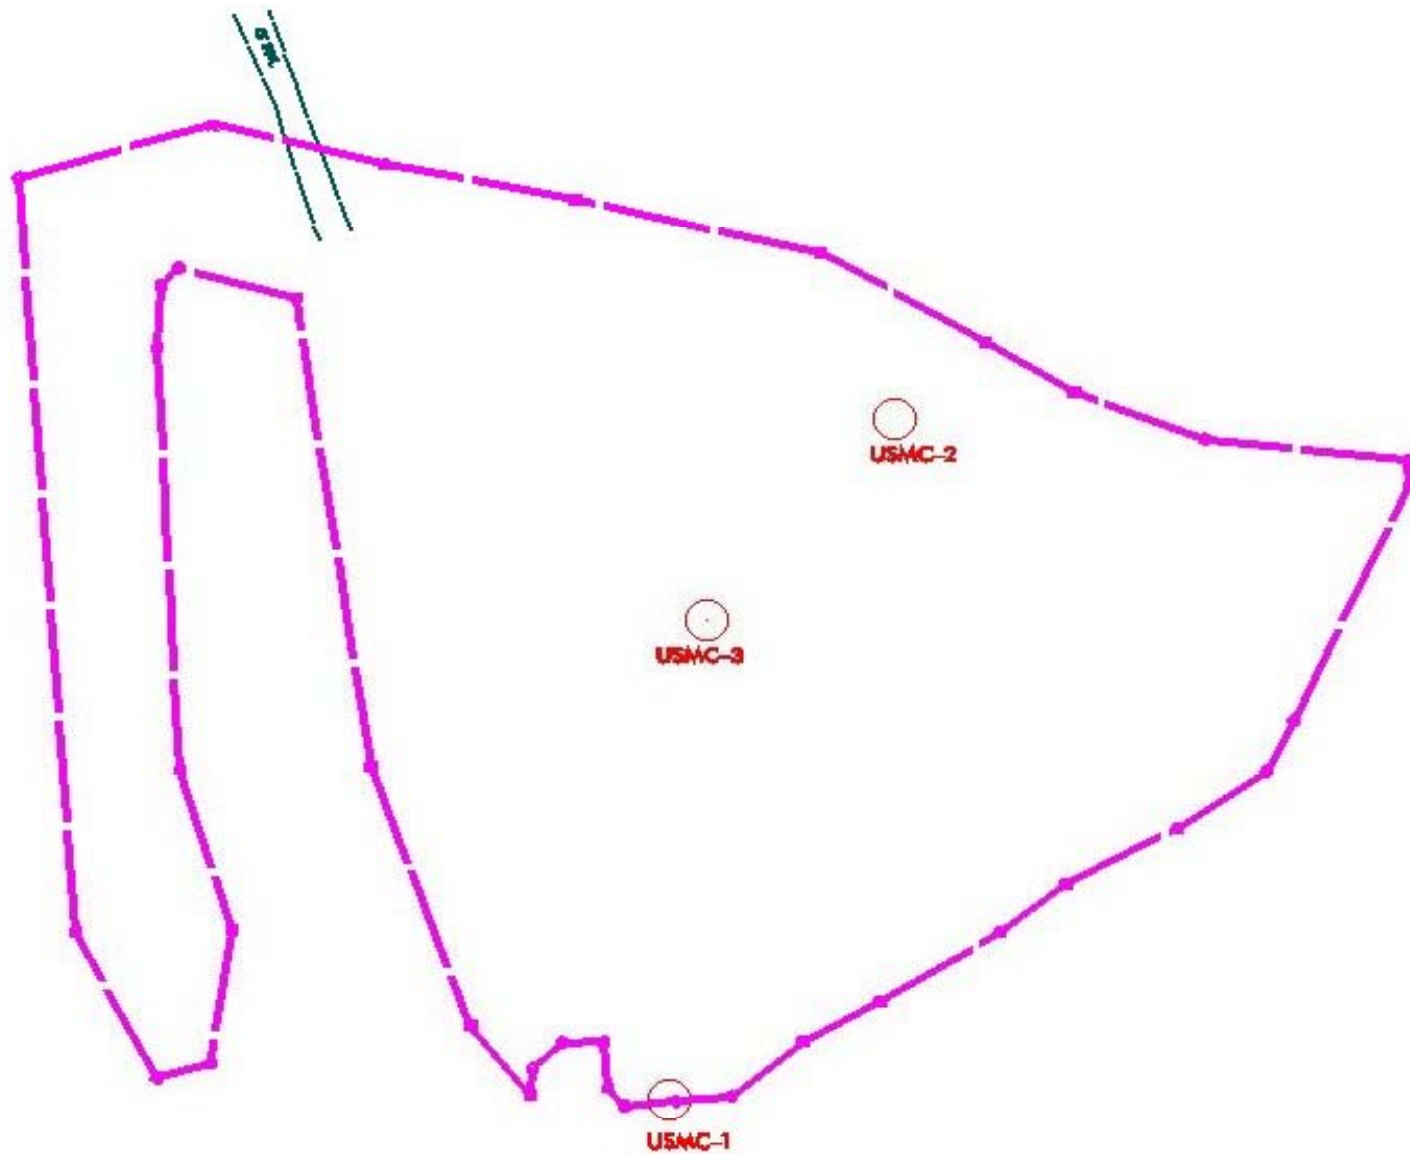
Figure 2: 2002 Gauge Location Map

Following site construction in April 2002, three groundwater monitoring gauges, one rain gauge, and four surface water gauges were removed from the site. The Infinity tidal gauge, which was installed in spring of 2001, was left in place while 2 additional surface water gauges were installed. (Figure 2). The tidal gauge measures water elevation every three hours while the surface water gauges record every hour.
