ANNUAL REPORT FOR 2003

**U. S. Marine Corps Mitigation Site
Onslow County
Project No. 6.269010T
TIP No. U-2107 WM**

Prepared By:
Office of Natural Environment & Roadside Environmental Unit
North Carolina Department of Transportation
December 2003

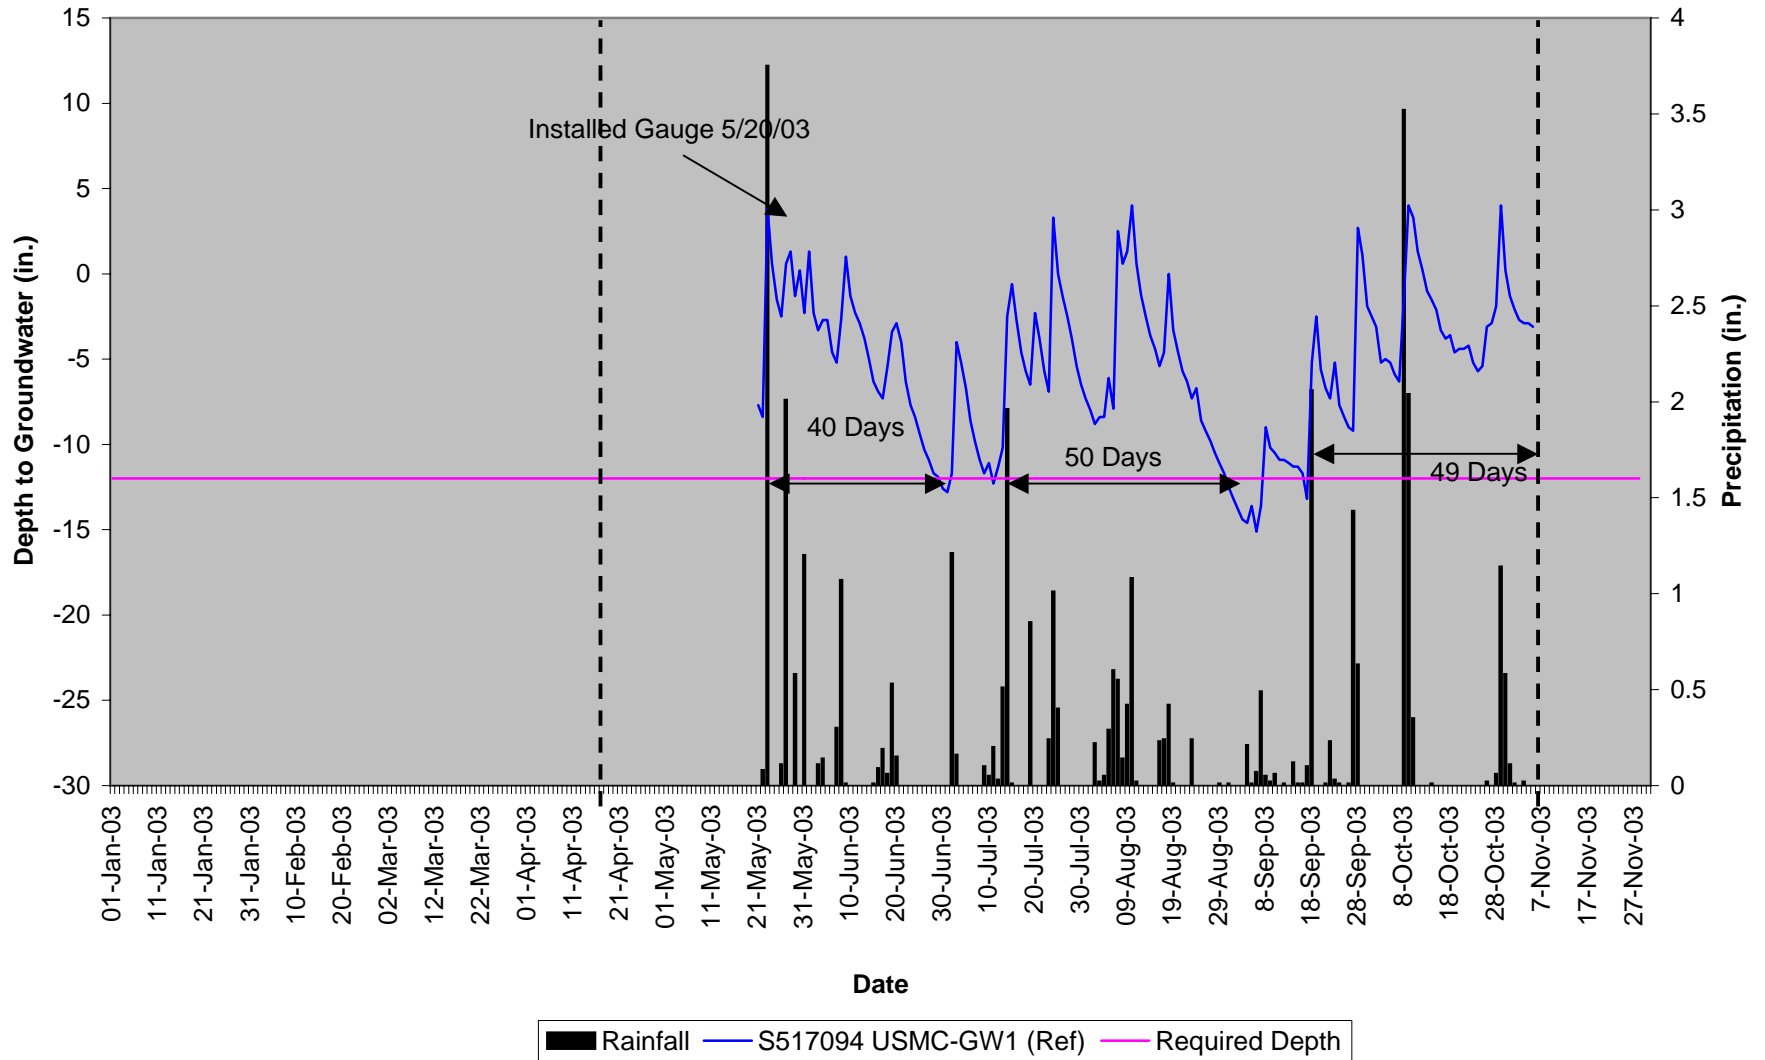
USMC-GW1 Reference 40" Groundwater

Monitoring Gauge	<5%	5%-8%	8%-12.5%	>12.5%	Actual %	Success Dates
GW-1 (Ref)+				X	23.6	May 21-June 29 July 12-August 30 Sept 18-Nov 5
GW-2+				X	53.3	May 21-July 9 July 16- Nov 5

The two groundwater gauges demonstrated successful hydrologic results, with GW-1 (reference) indicating 23.6% and GW-2 53.3% saturation periods during the growing season, respectively.

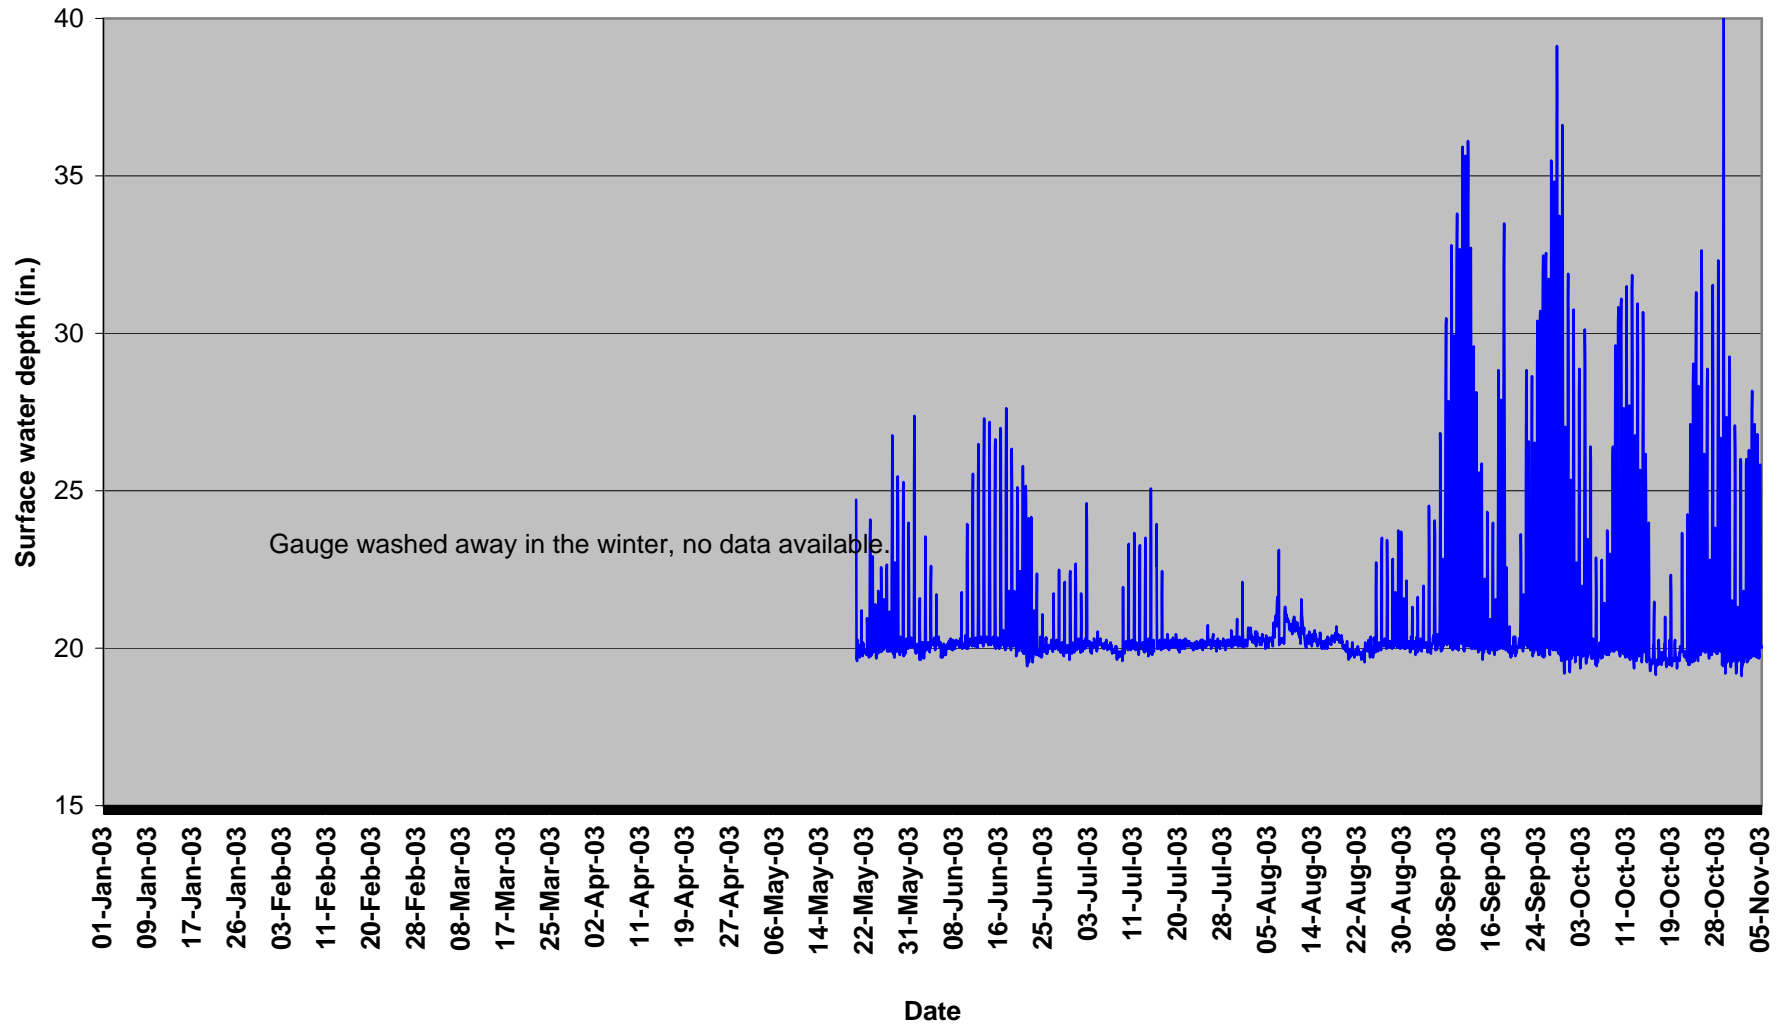
USMC-SG1 Tide Gauge

All five surface gauges (including both reference gauges) and the tidal gauge indicated inundation throughout the growing season. This is consistent with the hydrology success criteria outlined for the marsh restoration area.

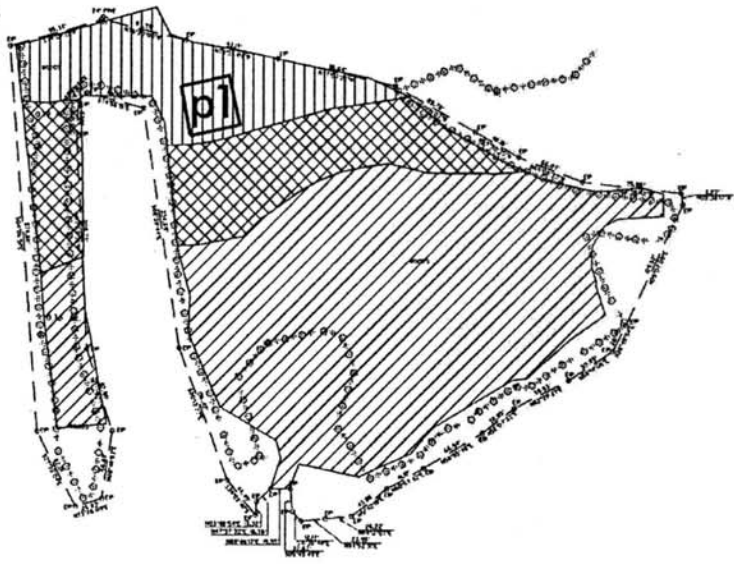
USMC Marsh/Shrub Site Onslow County, U-2107 WM PLANTING PLAN

Zone 1: (approximately 0.56 acres)

Zone 1: (approximately 0.7 acres)

Zone 2: (approximately 2.23 acres)

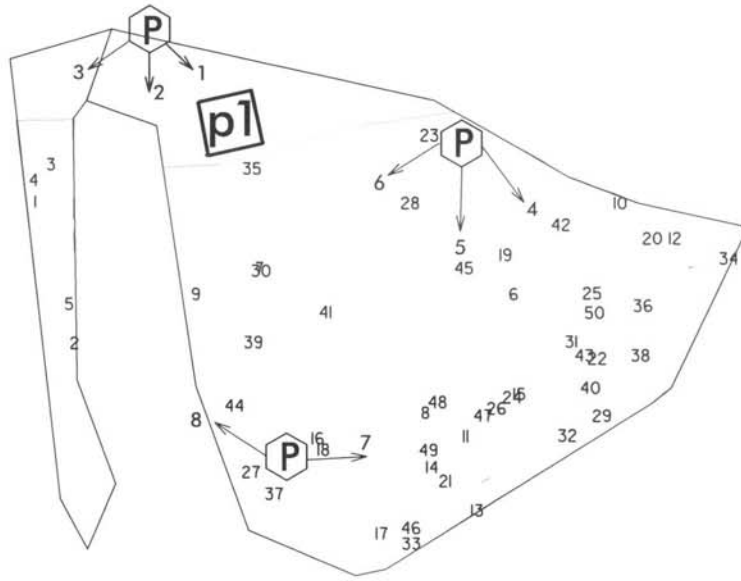
PHOTO AND VEGETATION PLOT LOCATIONS

Of the 3.5 acres on this site, approximately 2.93 acres involved marsh grass planting. There were 50 random plots established throughout the planting area and they were located using GPS. The vegetative coverage and frequency do not currently meet the success criteria. However, vegetation coverage and frequency appear to be improving in the second year of monitoring.
