ANNUAL REPORT FOR 2004

**U. S. Marine Corps Mitigation Site
Onslow County
Project No. 6.269010T
TIP No. U-2107 WM**

Prepared By:
Office of Natural Environment & Roadside Environmental Unit
North Carolina Department of Transportation
December 2004

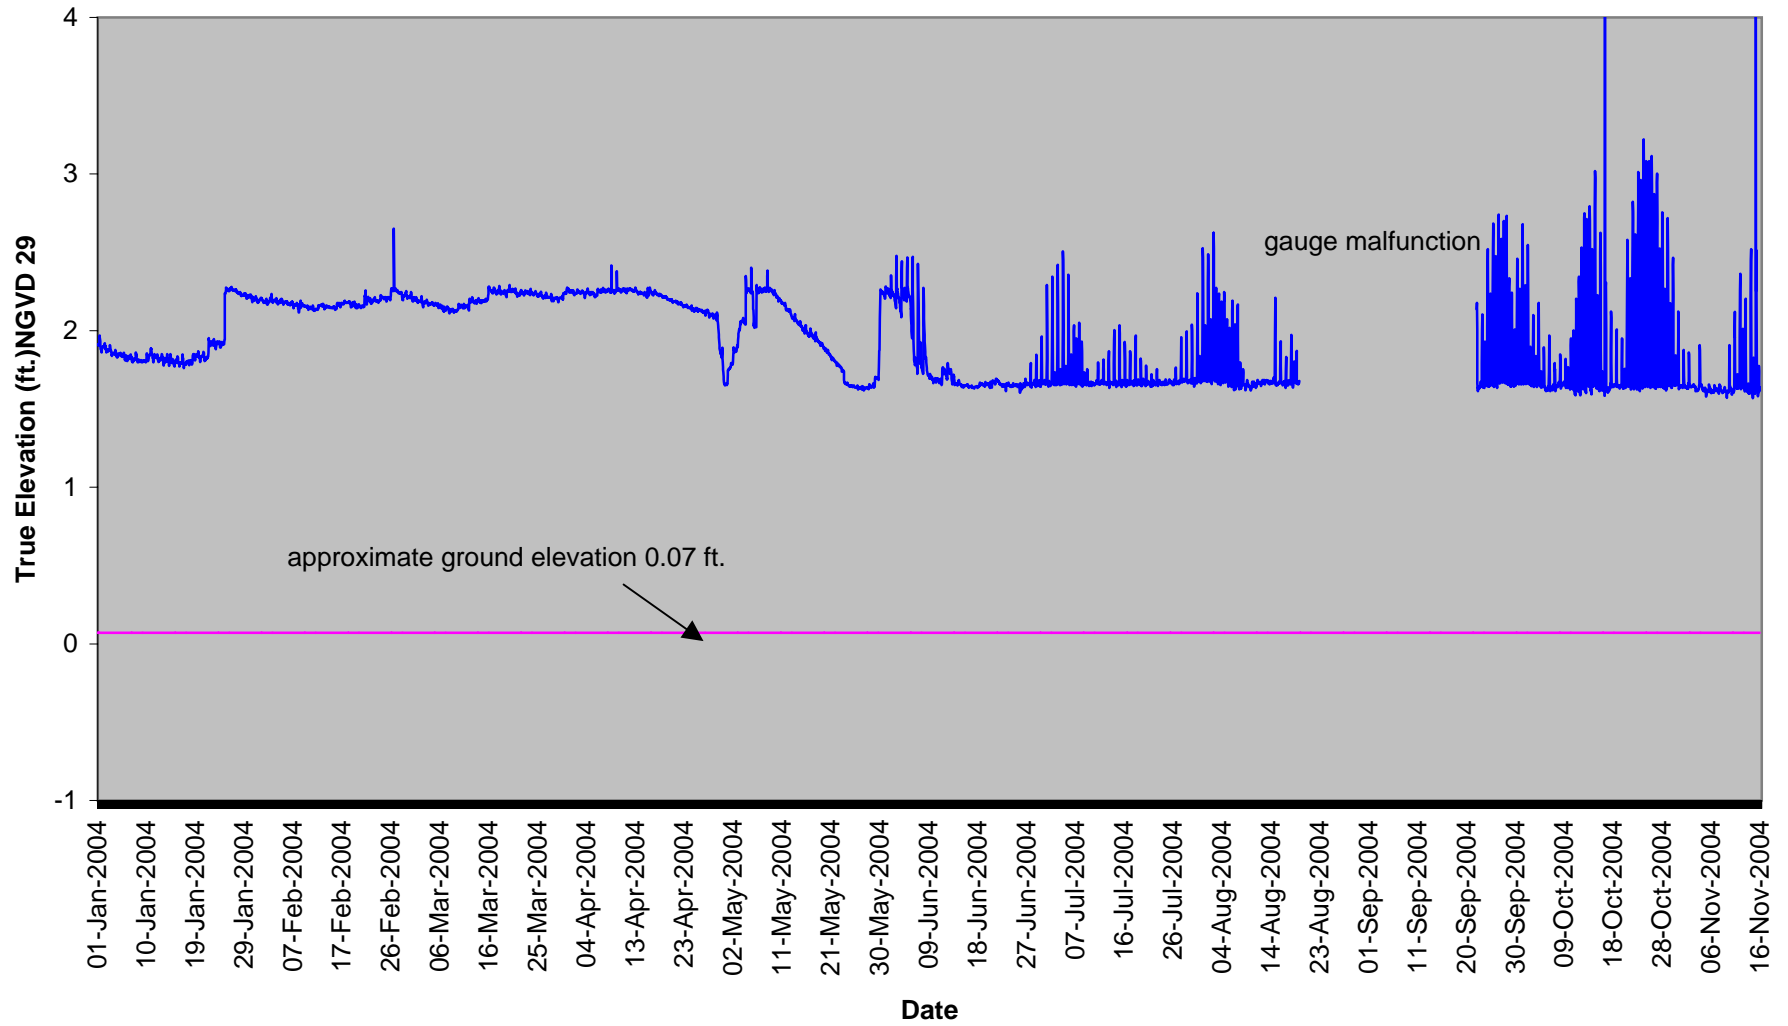
USMC-SG1 Tide Gauge

All five surface gauges (including both reference gauges) and the tidal gauge indicated inundation throughout the growing season. This is consistent with the hydrology success criteria outlined for the marsh restoration area.

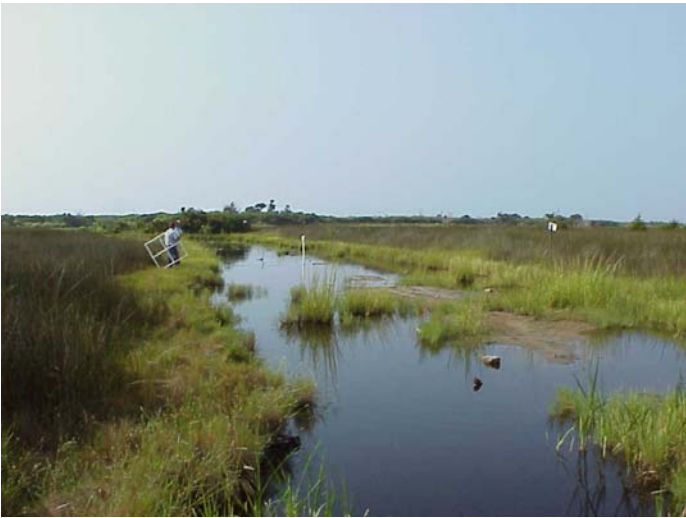
Photo 9

NCDOT regraded portions of the site in 2002. The marsh portion of the site was replanted in April 2002 and supplemental planted in May 2003. The site was treated for phragmites in June 2004. Photographs 9 through 12 show that the rock structure on the shoreline has stabilized and *Spartina alterniflora* is coming in naturally.
