ANNUAL MONITORING REPORT FOR 2006 CAMP LEJEUNE

**US MARINE CORPS MITIGATION SITE
ONSLow COUNTY, NORTH CAROLINA
TIP No. U-2107 WM
NCDOT Project No. 6.269010T
(EEP Project Number .00013)
2006 Annual Monitoring Report (Year 5 of 5)**

February 2007

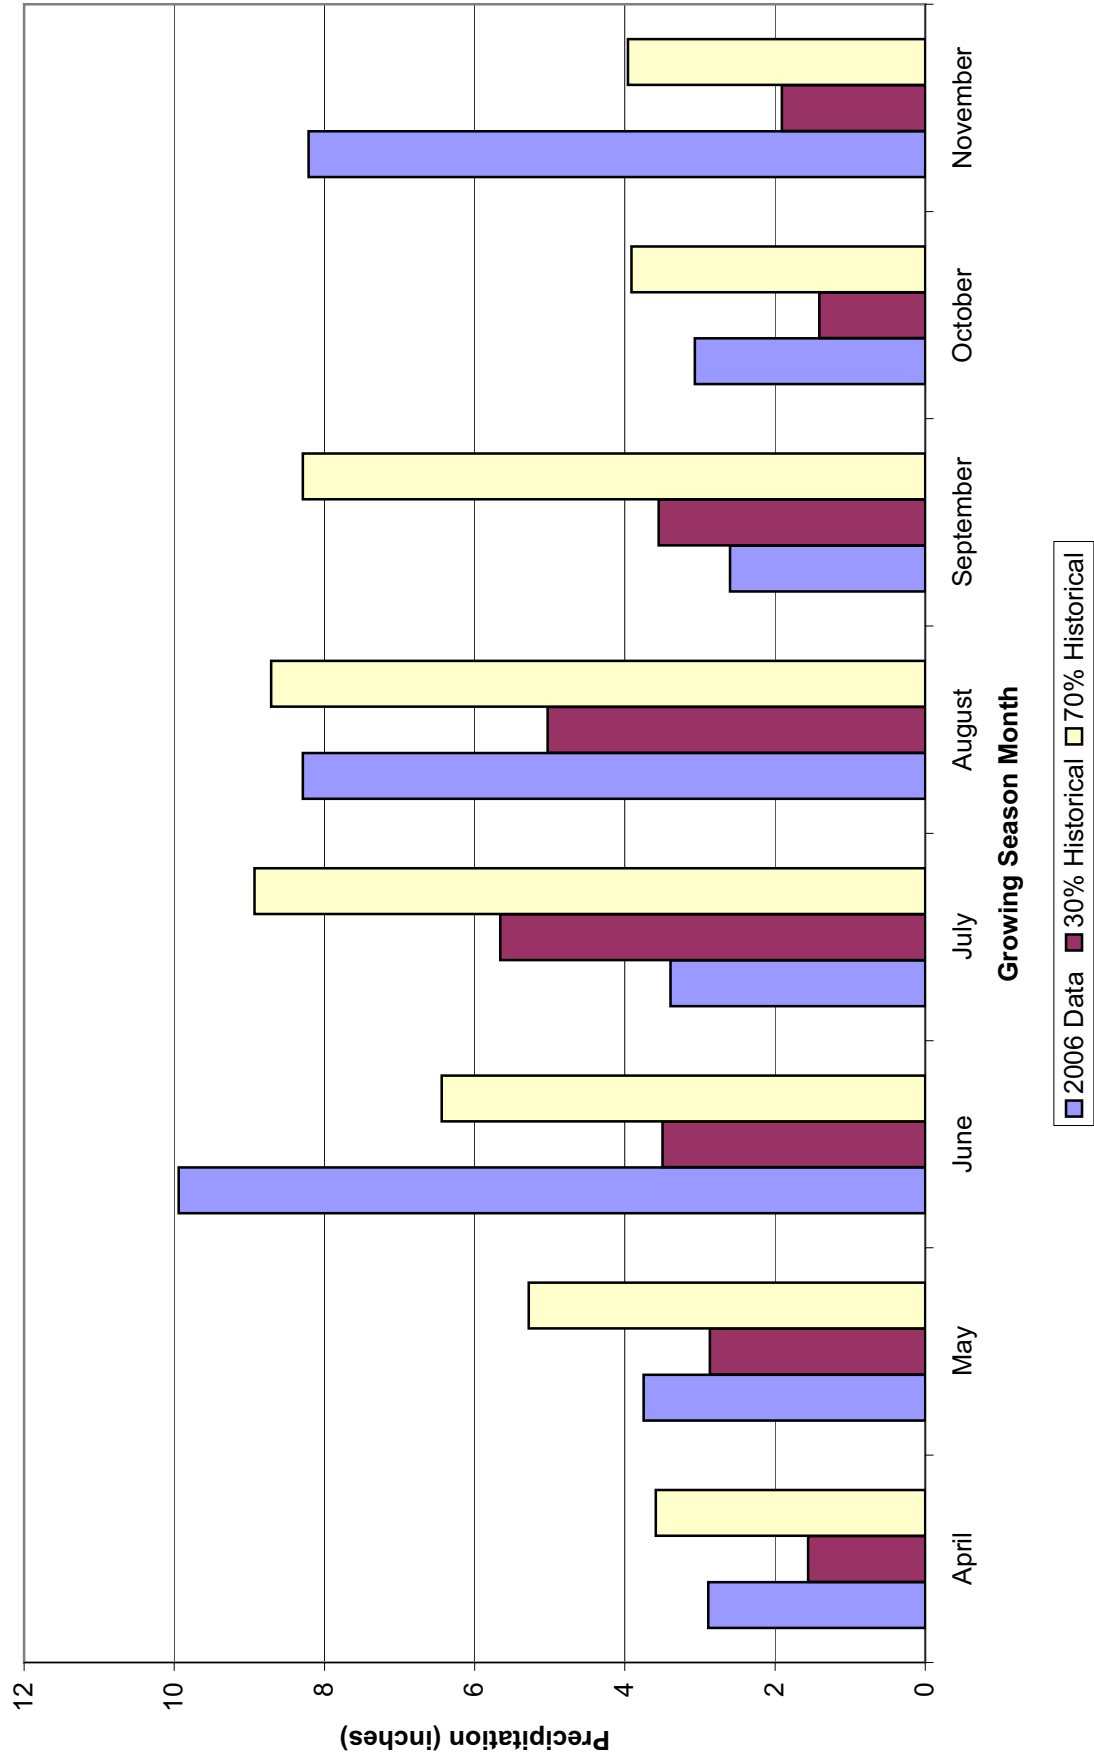
Figure 3. 2006 Climatic Data vs. 30-year Historic Data

Climatic data for the year 5 (2006) growing season is compared to 30-year historical data from the New Hanover Airport in Wilmington, North Carolina (Figure 3) (NOAA 2004). The Site experienced above normal rainfall for the months of June and November 2006. The remainder of the growing season for year 5 (2006) experienced rainfall totals that fell within the average 30-year historic range.

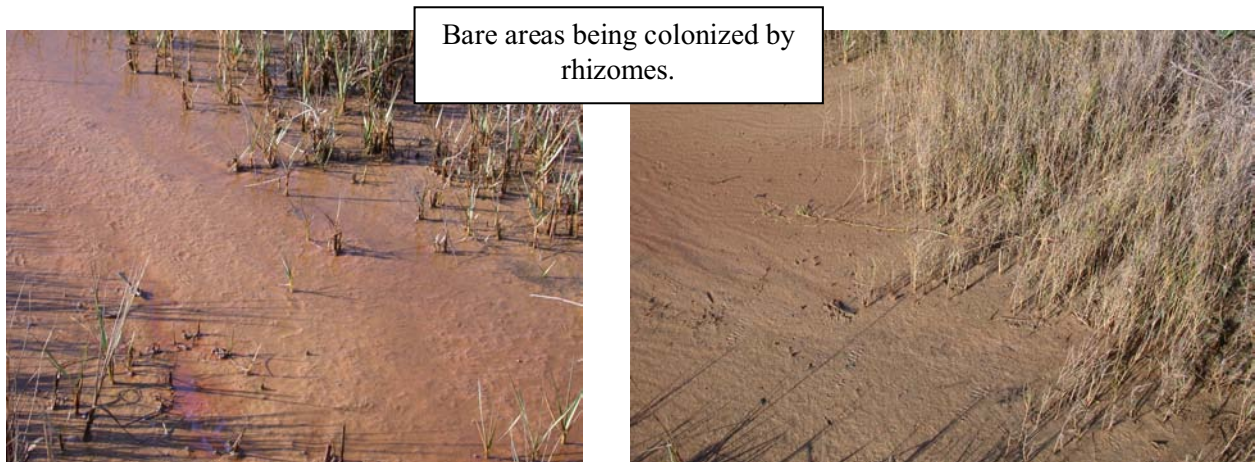
The overall aspect of the marsh area is that it is doing well; however, the planted zone of black needle rush (*Juncus roemerianus*) is dominated by smooth cordgrass (*Spartina alterniflora*), pockets of open water, and brackish species. The planted zone of smooth cordgrass (*Spartina alterniflora*) has grown well and is consistent with that of a natural marsh although some bare spots persist. Rhizomes of marsh plants are slowly colonizing these areas as can be seen in the following photographs.

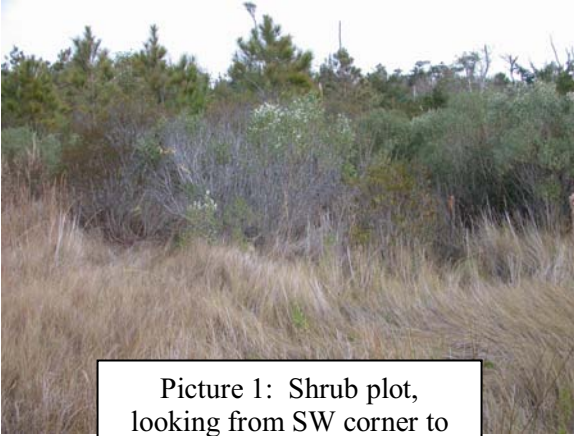
Picture 1: Shrub plot,
looking from SW corner to
NE corner

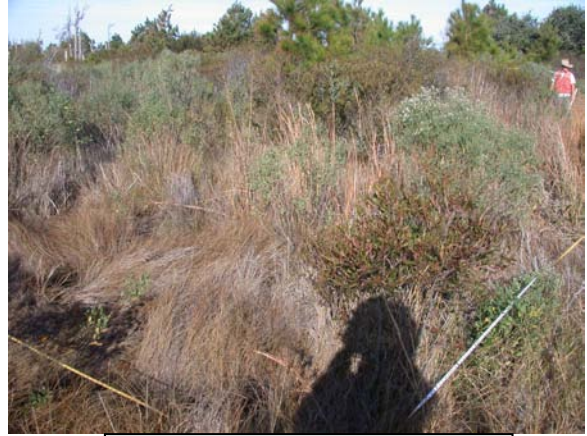
Picture 2: Shrub plot, looking
from plot origin to NW corner

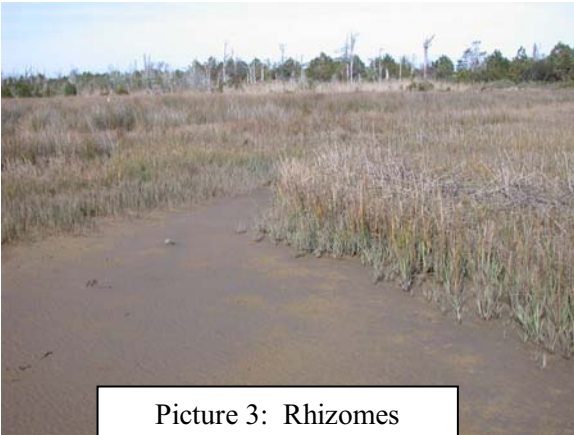
Picture 3: Rhizomes
spreading into bare area

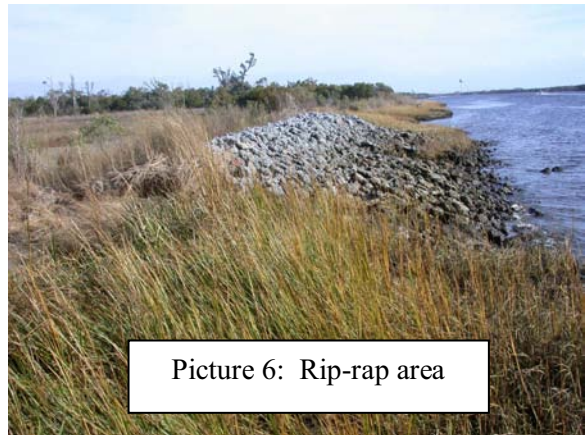
Picture 6: Rip-rap area

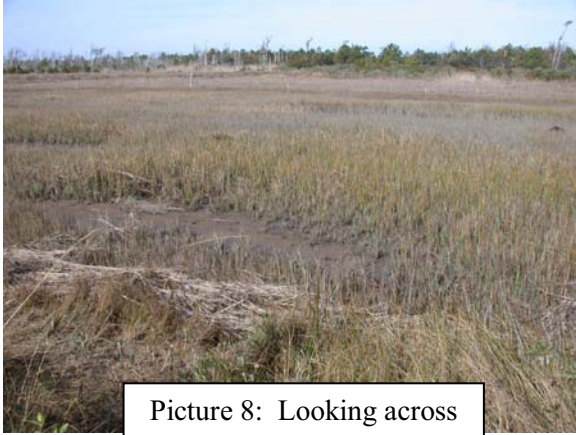
Picture 8: Looking across marsh

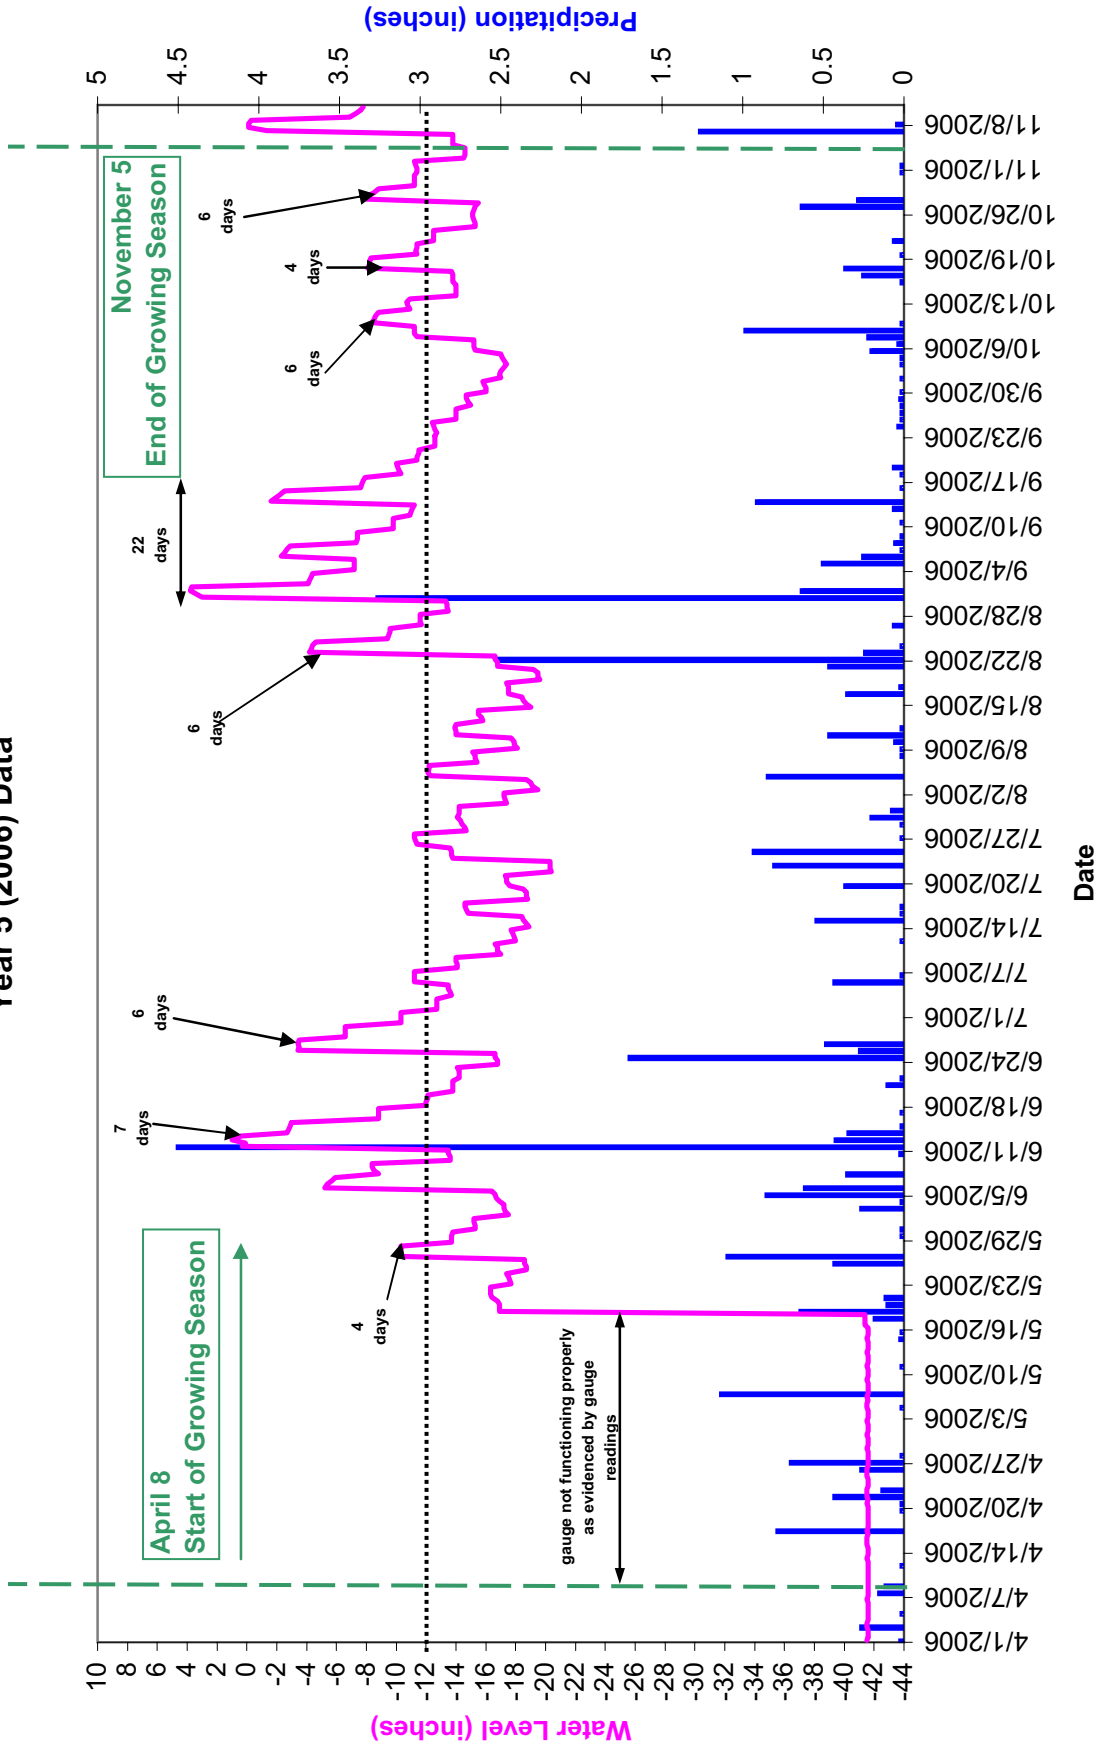
Camp Lejeune Groundwater Gauge 1 (Reference) Year 5 (2006) Data

Groundwater hydrology within 12 inches of the soil surface is occurring for greater than 12.5 percent of the growing season for the year 5 (2006) growing season for the mitigation area gauge (GW2) with 76 consecutive days (35.8 percent) of saturation or inundation; however, the reference area groundwater gauge (GW1: Reference) was slightly low with 22 consecutive days (10.4 percent) of saturation or inundation.

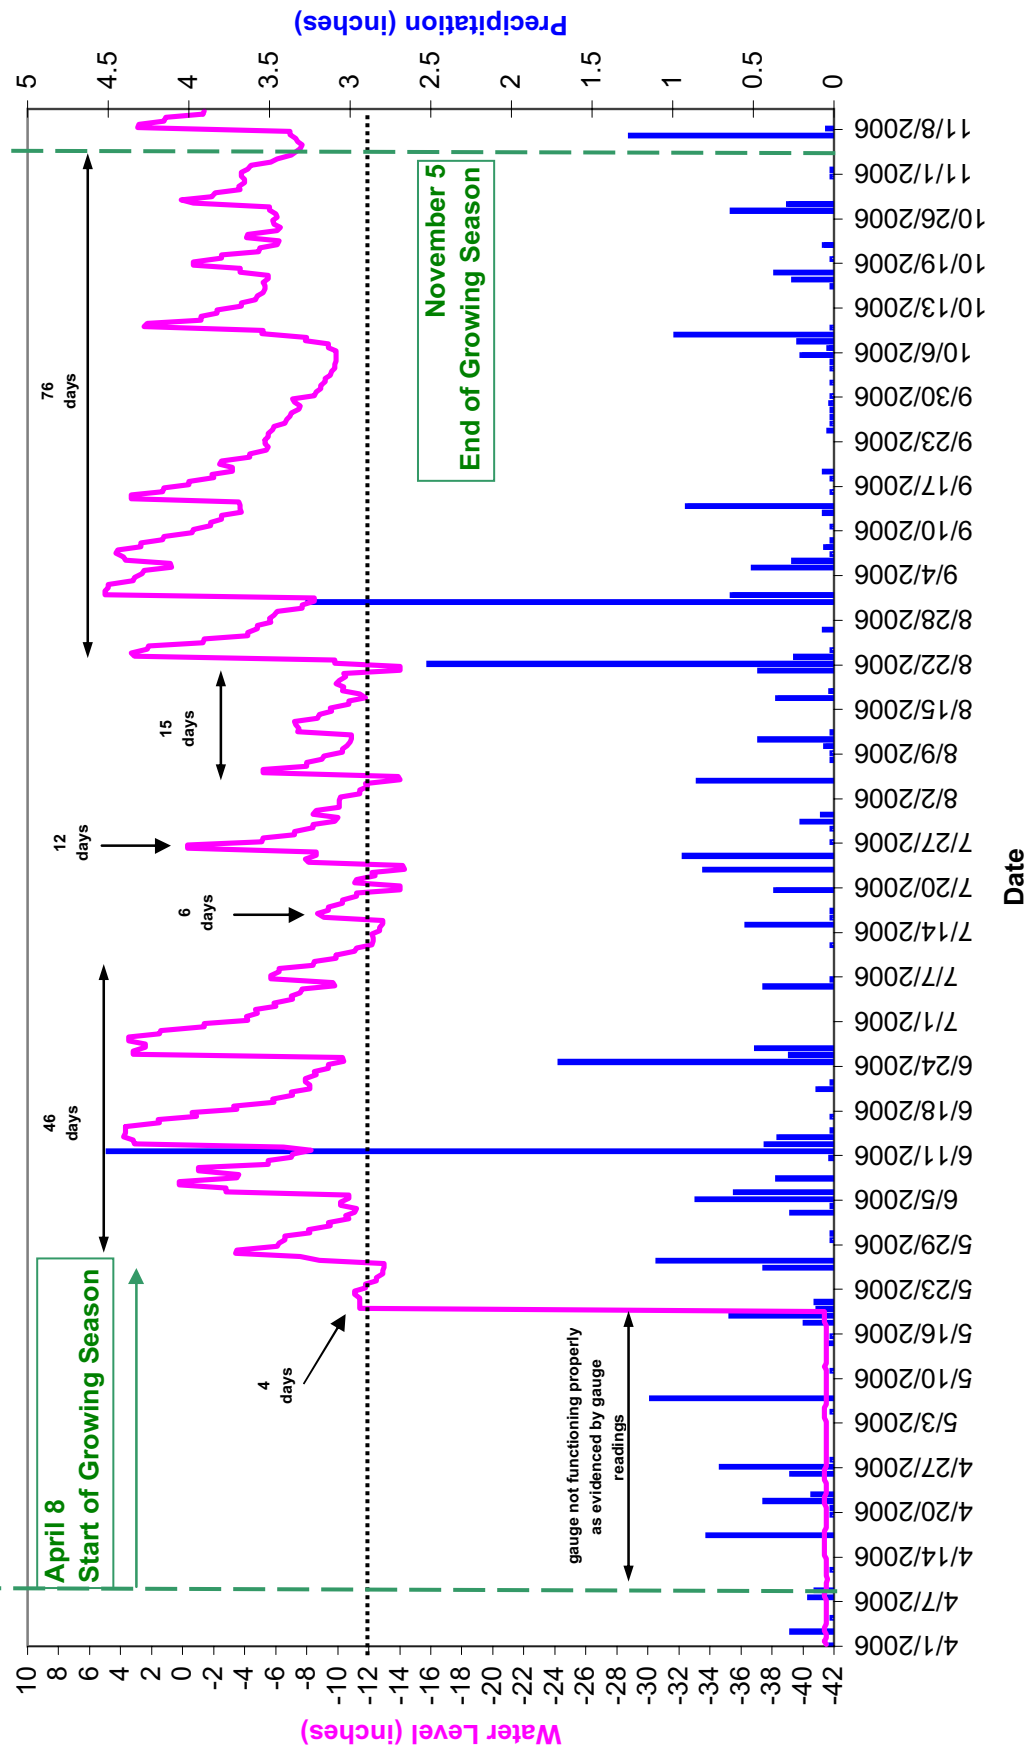
Camp Lejeune Groundwater Gauge 2 Year 5 (2006) Data

The groundwater gauge within the mitigation area (GW2) demonstrated successful hydrologic results, with 76 consecutive days (35.8 percent) of saturation or inundation; however, the reference area groundwater gauge (GW1: Reference) was slightly low with 22 consecutive days (10.4 percent) of saturation or inundation.

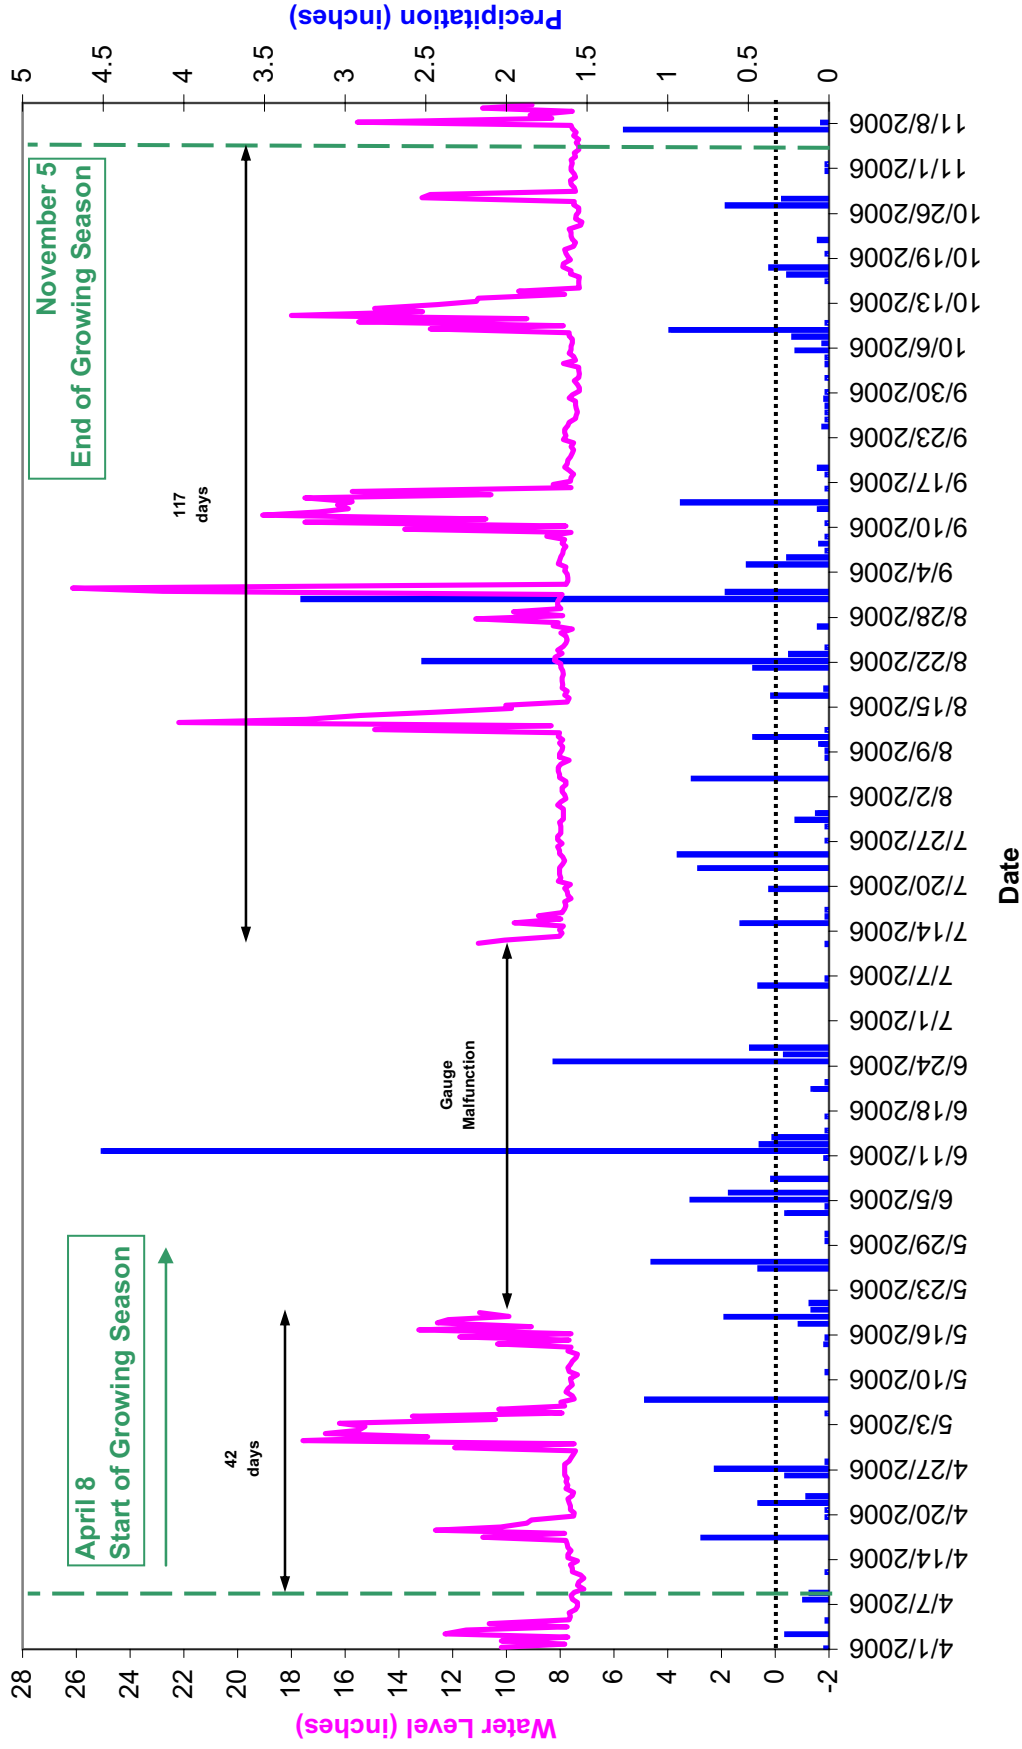
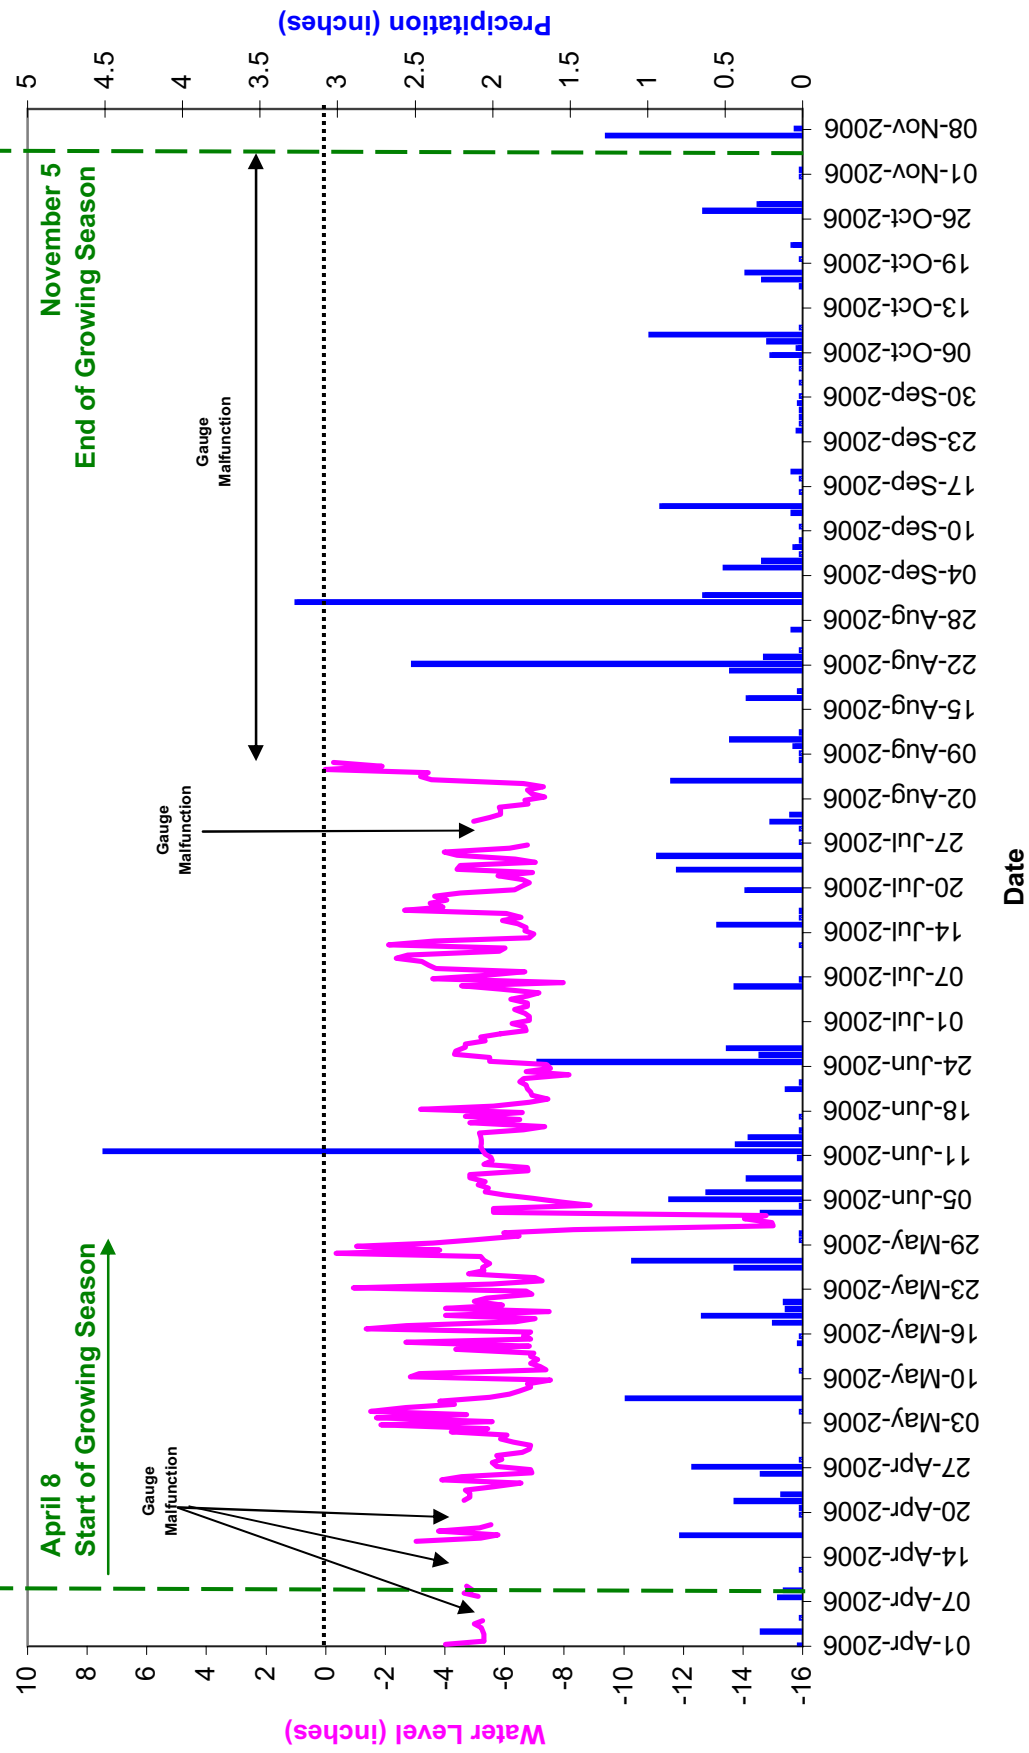
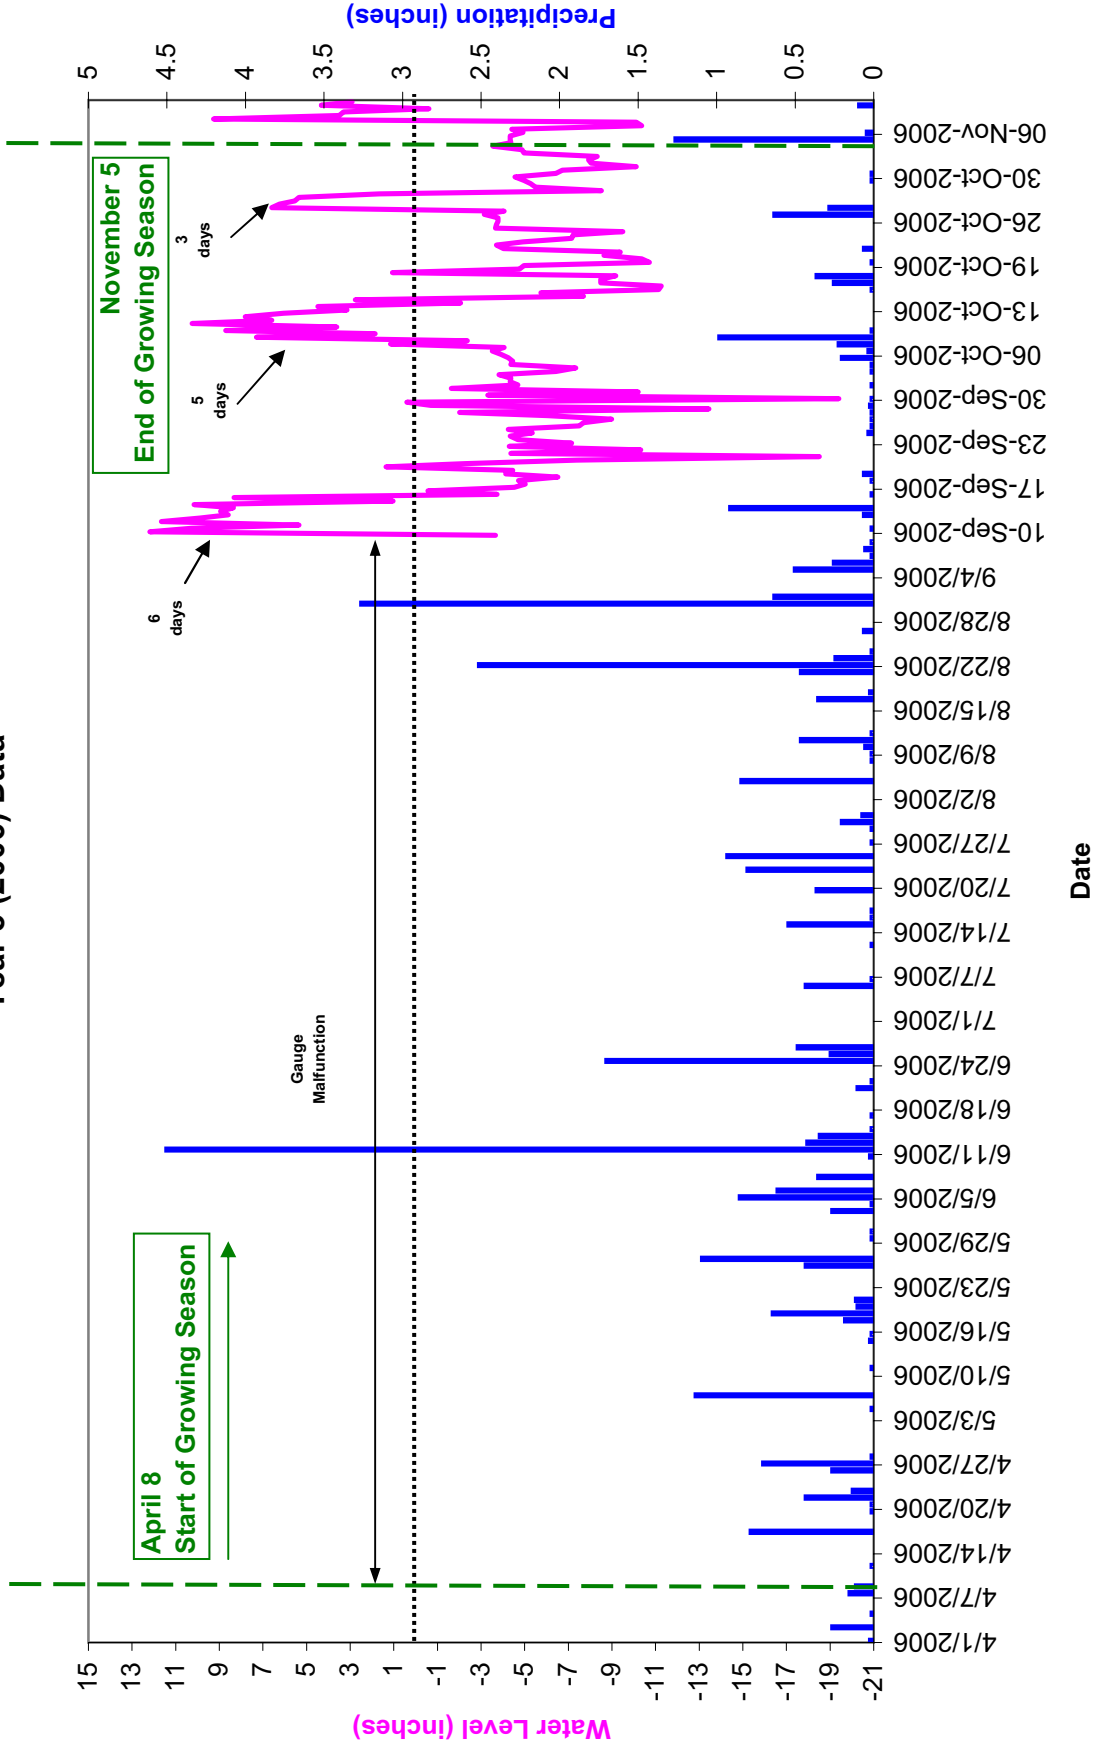
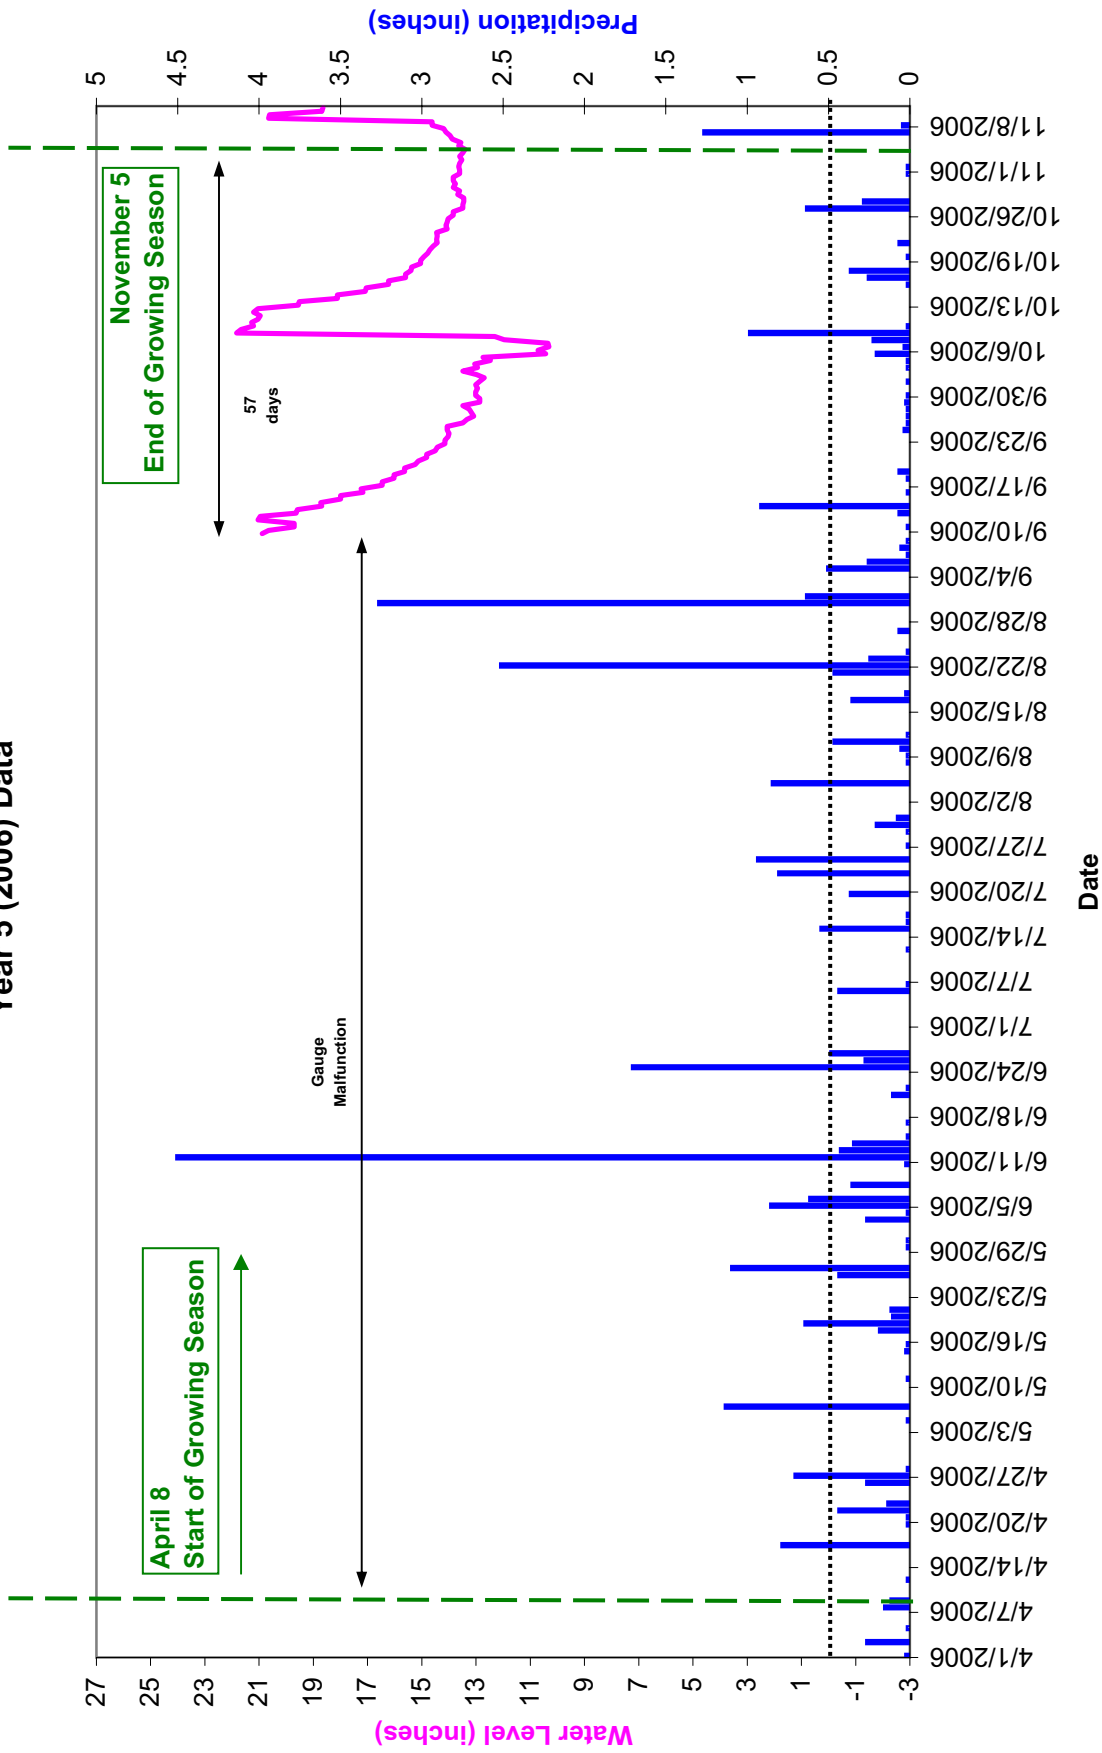
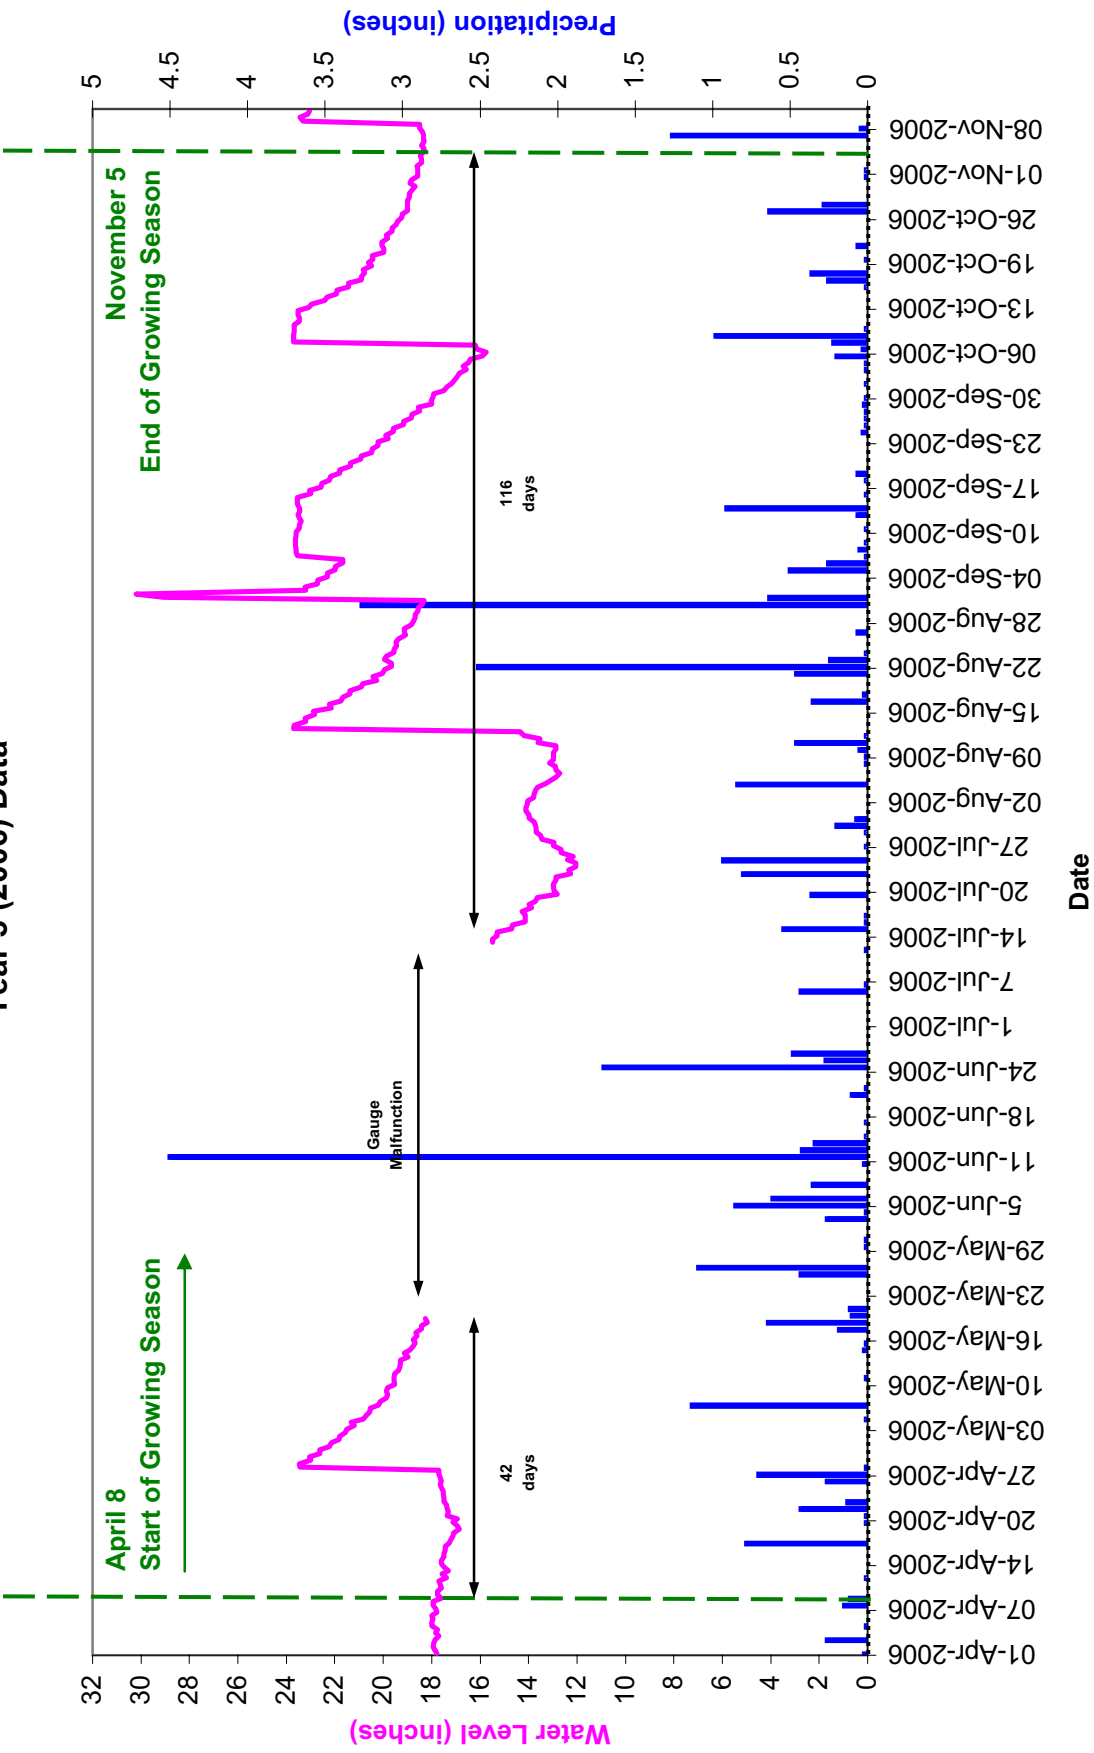
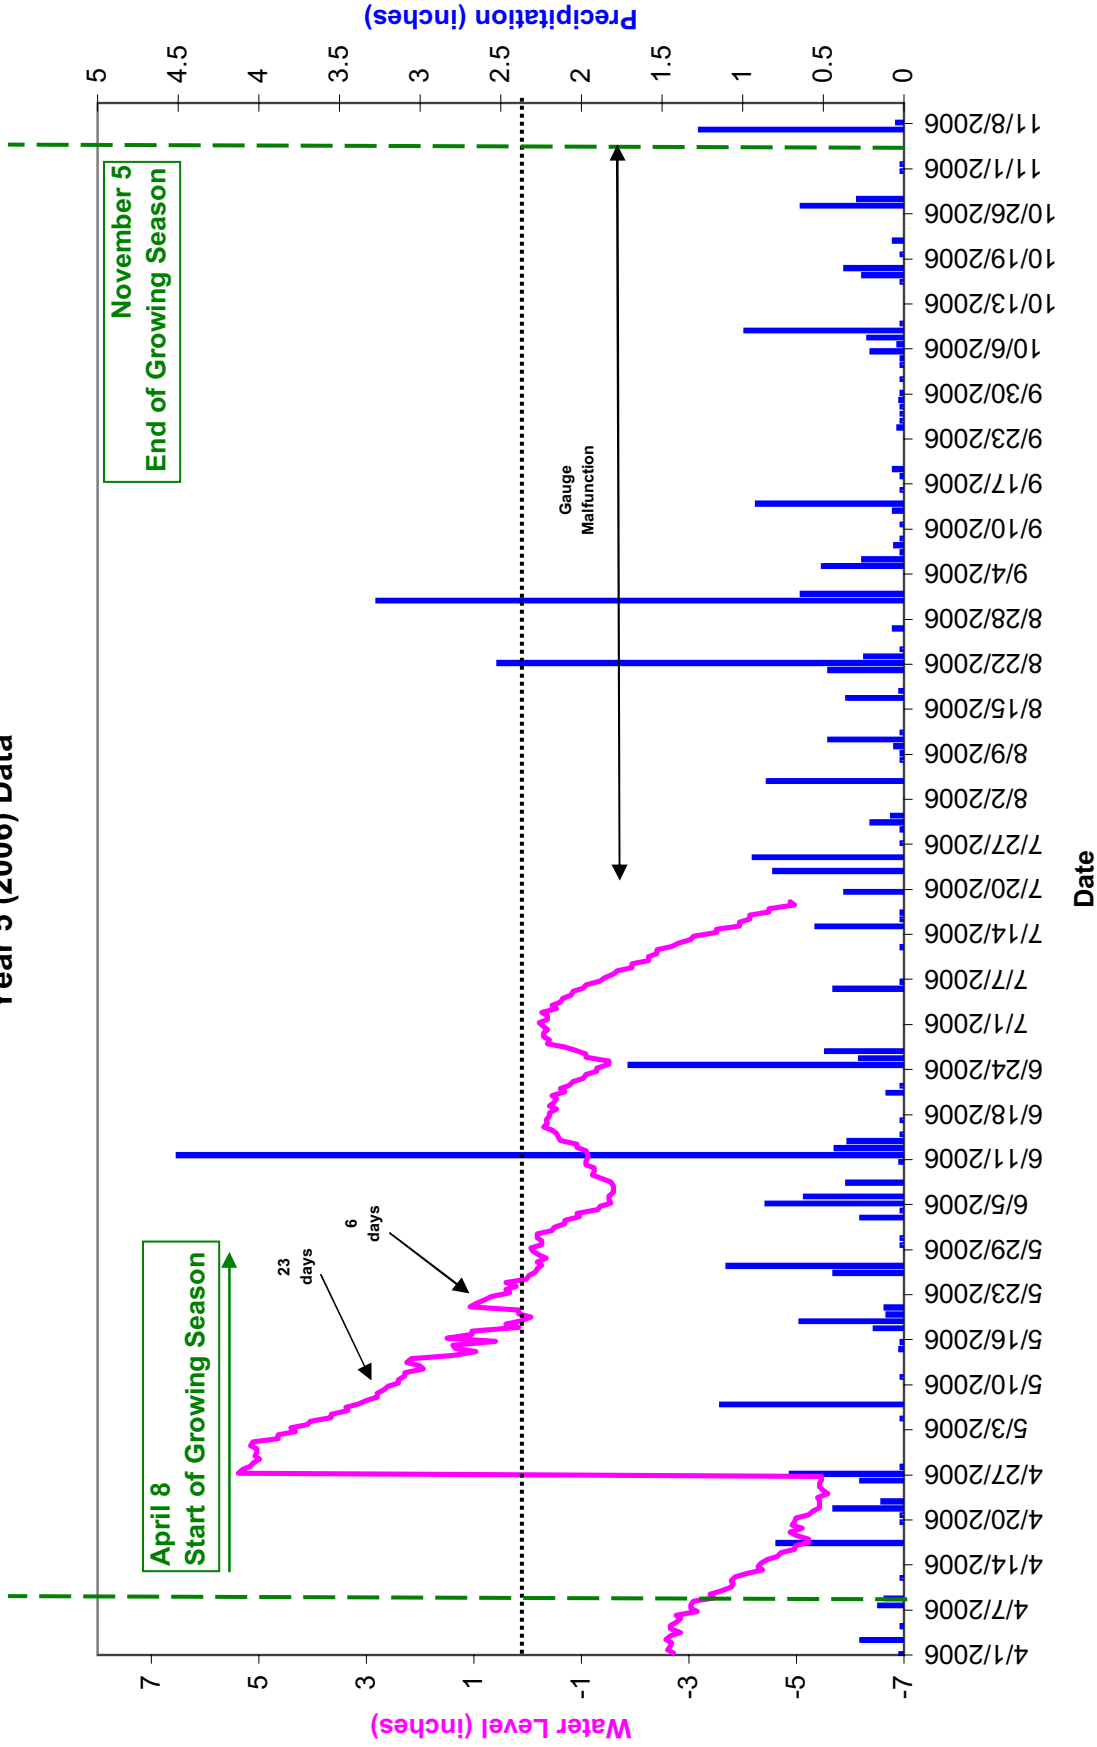
Results from all surfacewater gauges indicate that the Site is adequately flooded to support marsh vegetation; which is consistent with success criteria outlined for the marsh restoration area.
