# Candiff Creek Restoration Project Stream Mitigation Plan Surry County, North Carolina

**NCEEP Project Number 92767**

**August 2010**

# Candiff Creek Restoration Project Mitigation Plan Surry County, North Carolina

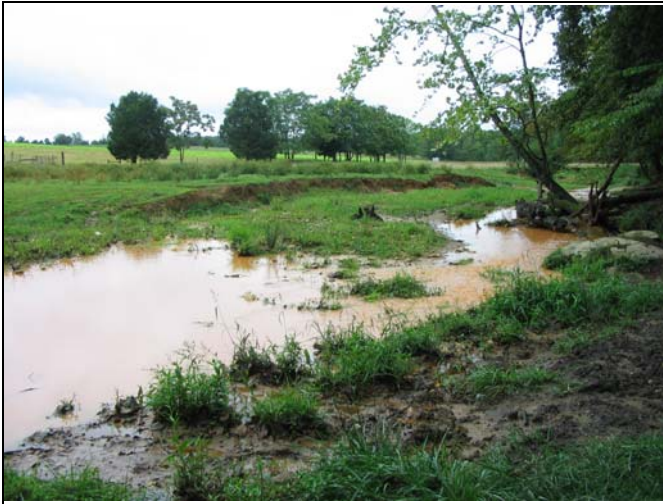
Overly wide channel through pasture

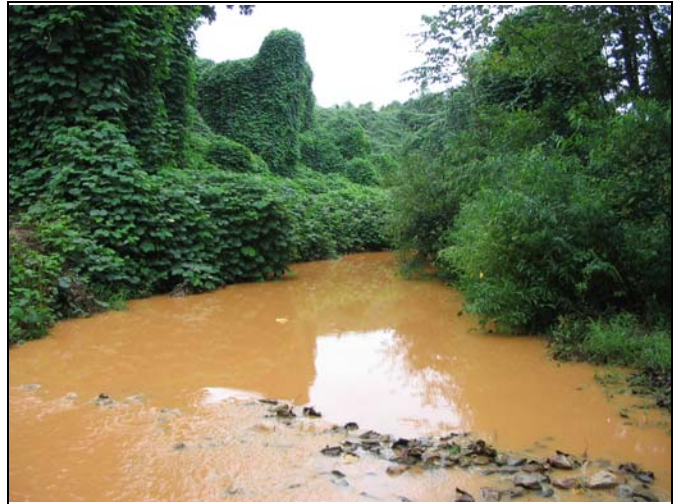
Kudzu on mainstem near crossing

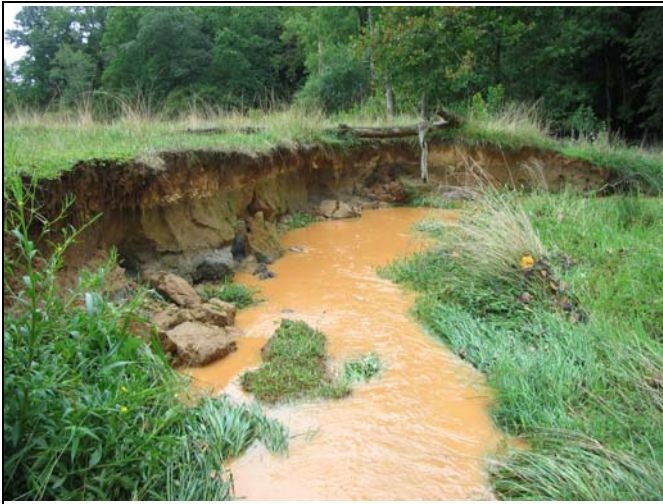
Bank slumping

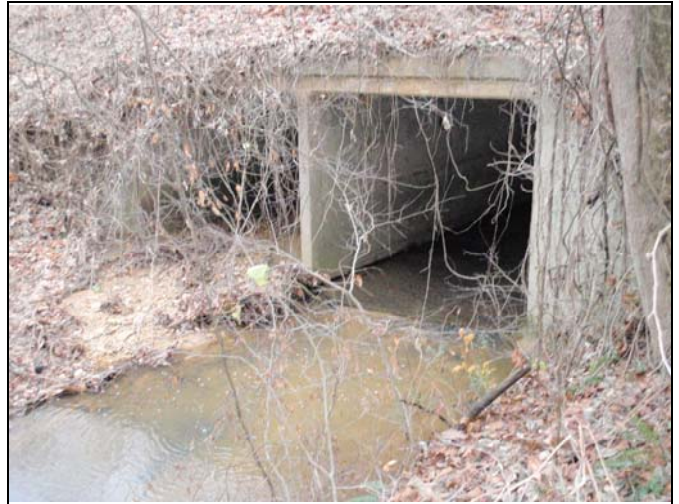
Box culvert under River Siloam Rd

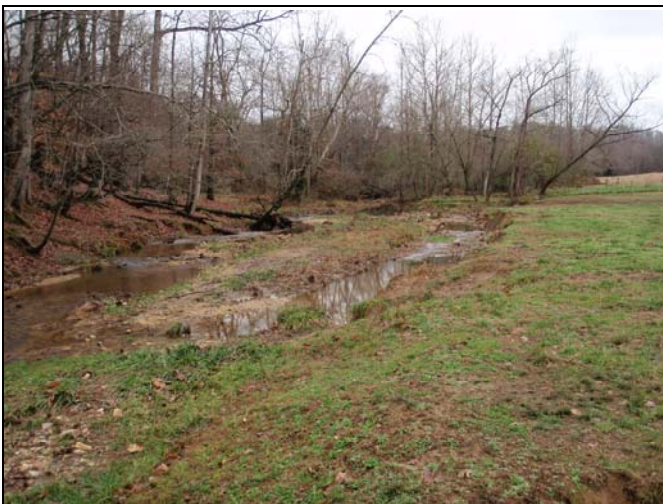
Overly wide channel with falling trees

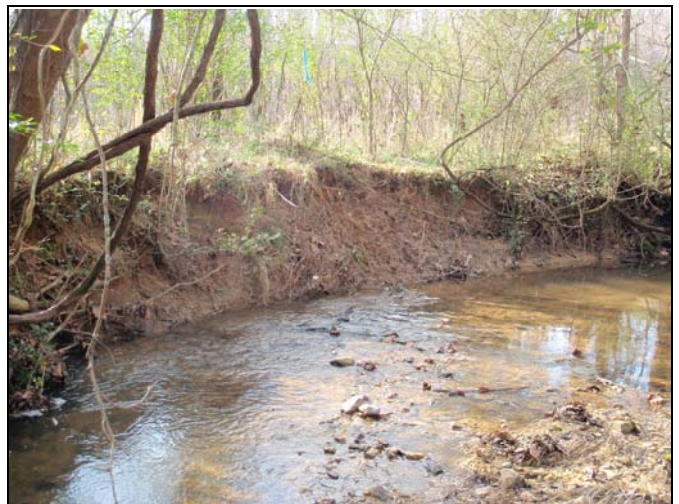
Near vertical banks on mainstem

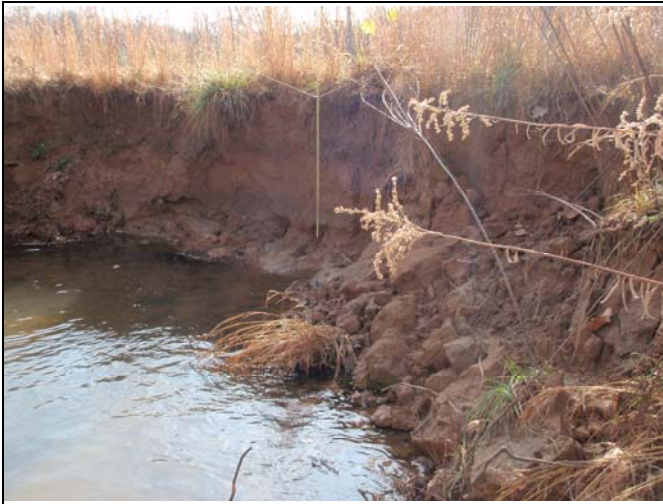
Severe bank failure on mainstem

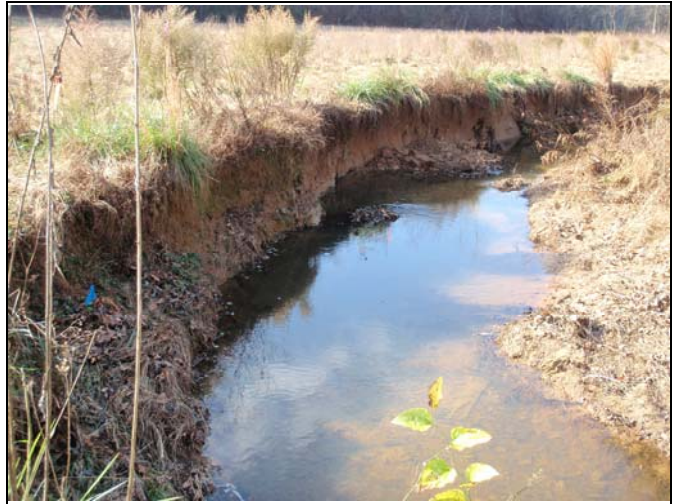
Vertical bank on mainstem

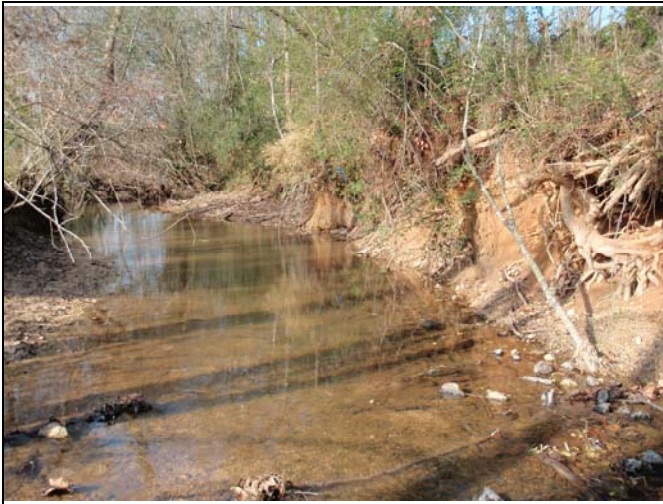
Vertical bank on mainstem

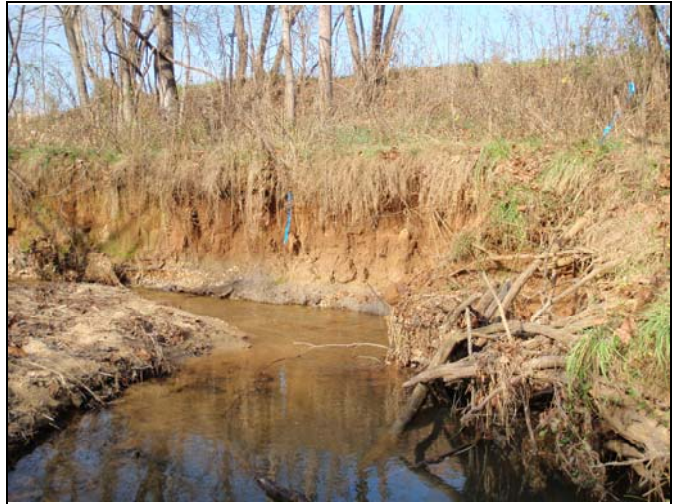
Vertical bank on mainstem

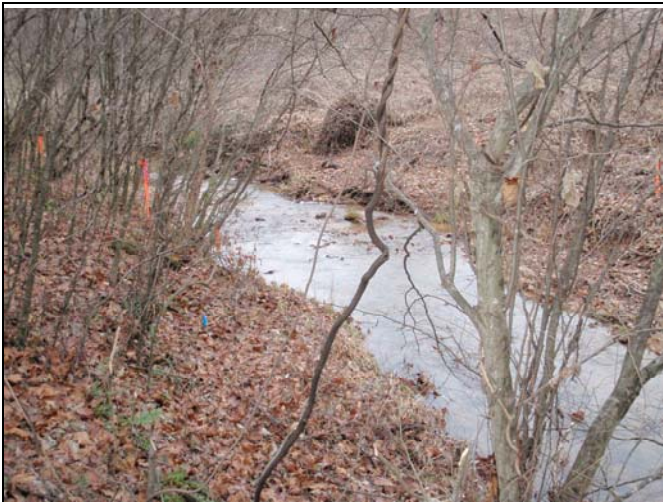
Stable riffle on mainstem

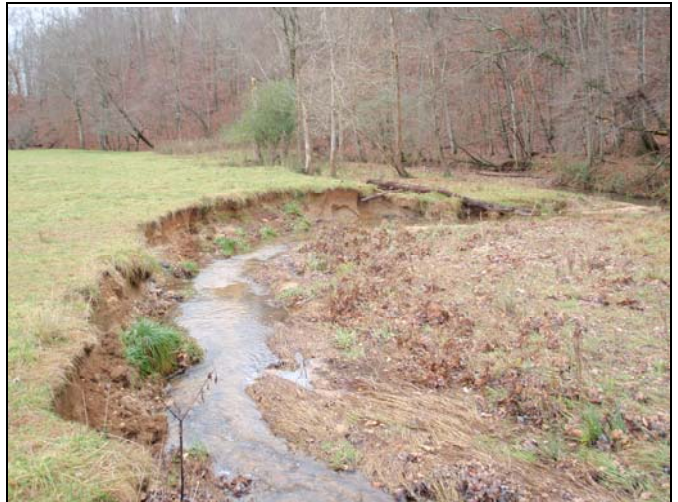
Channel regaining sinuosity

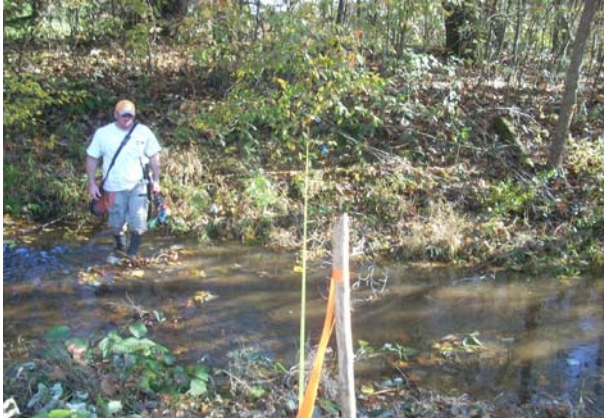
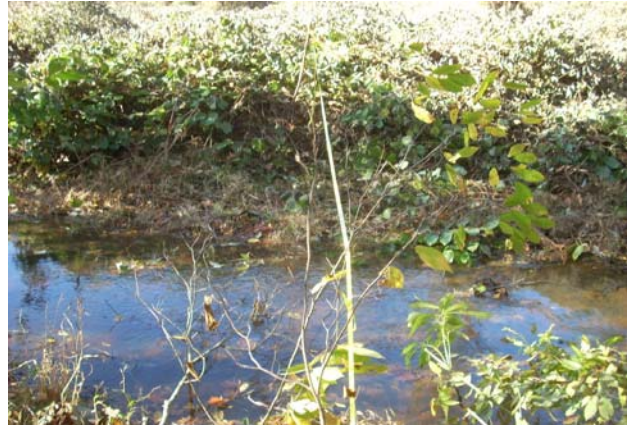
### Cross-section #1

Feature	Stream Type	BKF Area	BKF Width	BKF Depth	Max BKF Depth	W/D	BH Ratio	ER	BKF Elev	TOB Elev
Riffle	F	32.6	23.79	1.37	2.09	17.38	2.4	1.3	823.96	826.85

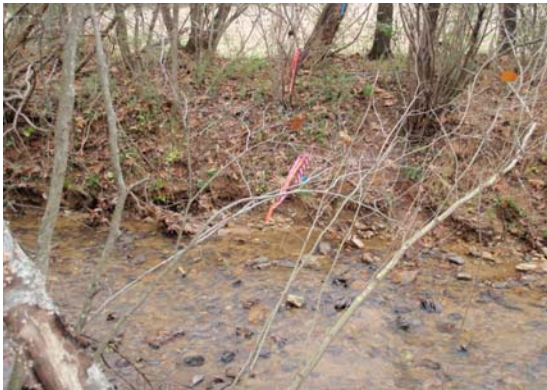
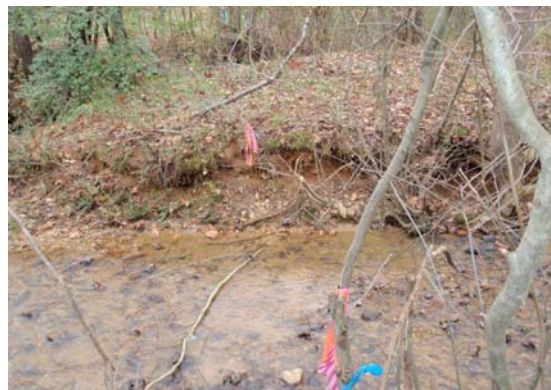
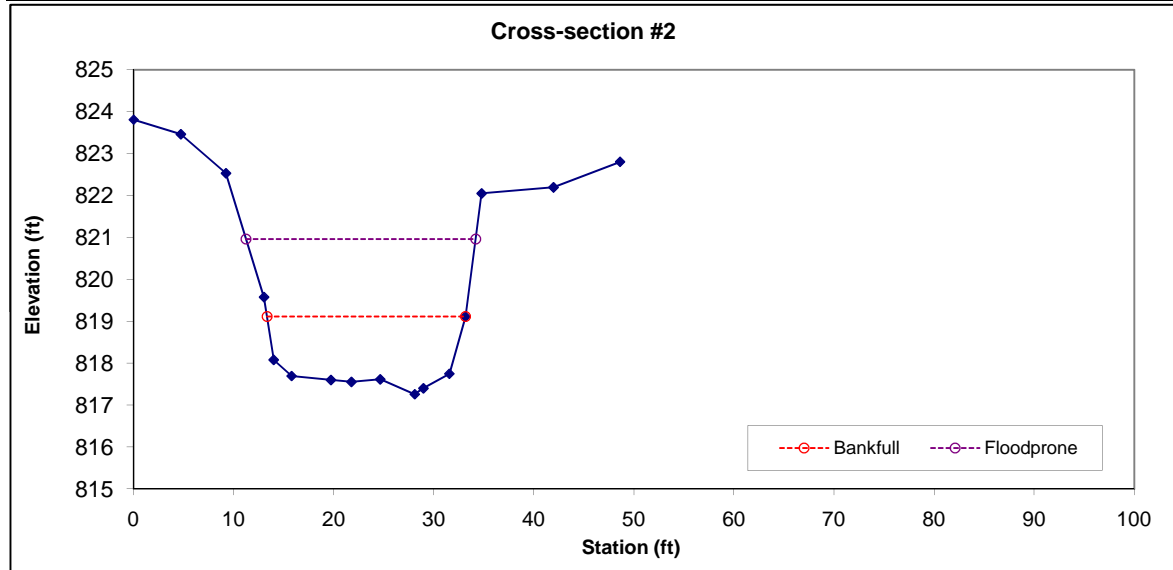
### Cross-section #2

Feature	Stream Type	BKF Area	BKF Width	BKF Depth	Max BKF Depth	W/D	BH Ratio	ER	BKF Elev	TOB Elev
Riffle	F	28.2	19.83	1.42	1.85	13.94	2.6	1.2	819.11	822.05

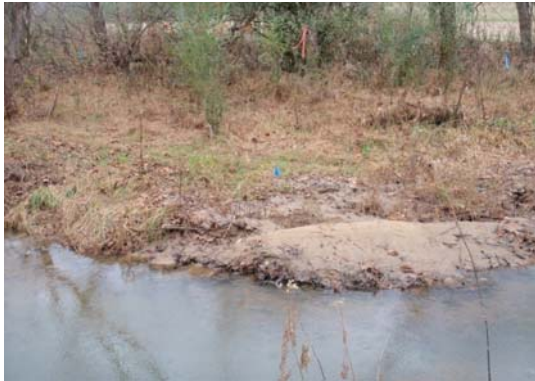
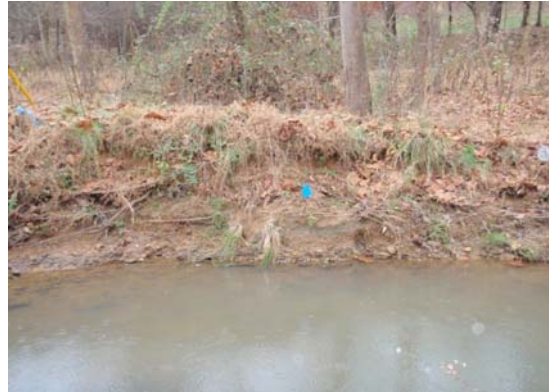
**Cross-section #3**  
(Existing Condition Data - collected December 2009)

Feature	Stream Type	BKF Area	BKF Width	BKF Depth	Max BKF Depth	W/D	BH Ratio	ER	BKF Elev	TOB Elev
Pool		47	29.49	1.59	3.67	18.52	1.1	3.3	816.3	816.84

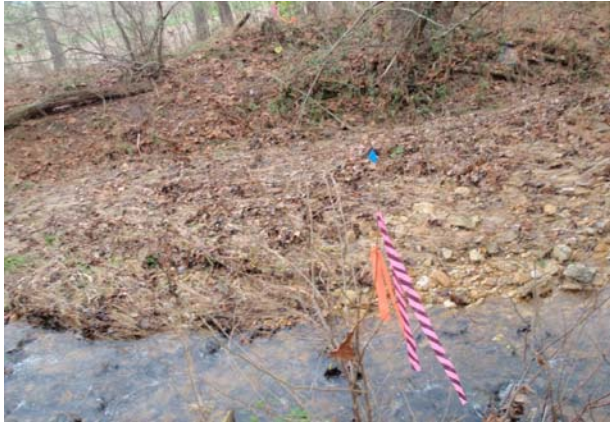
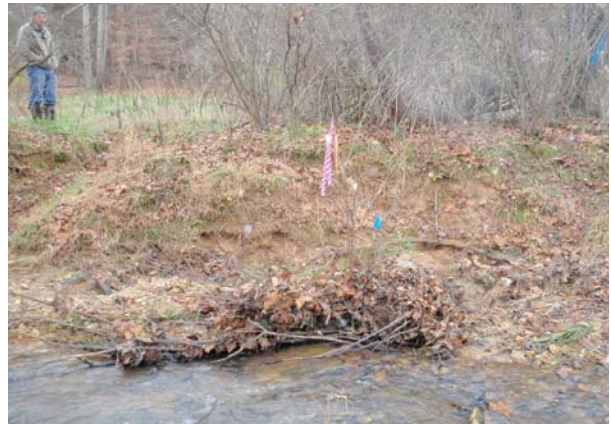
### Cross-section #4

Feature	Stream Type	BKF Area	BKF Width	BKF Depth	Max BKF Depth	W/D	BH Ratio	ER	BKF Elev	TOB Elev
Riffle	F	30	32.23	0.93	1.96	34.63	2.5	1.1	814.6	817.45

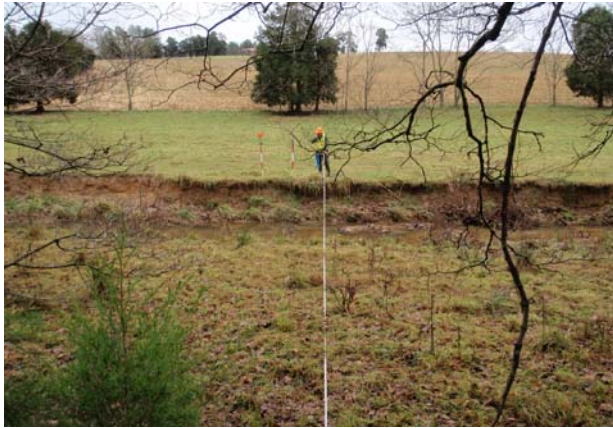
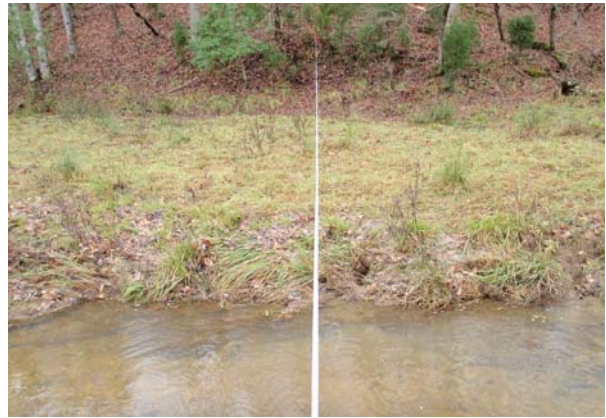
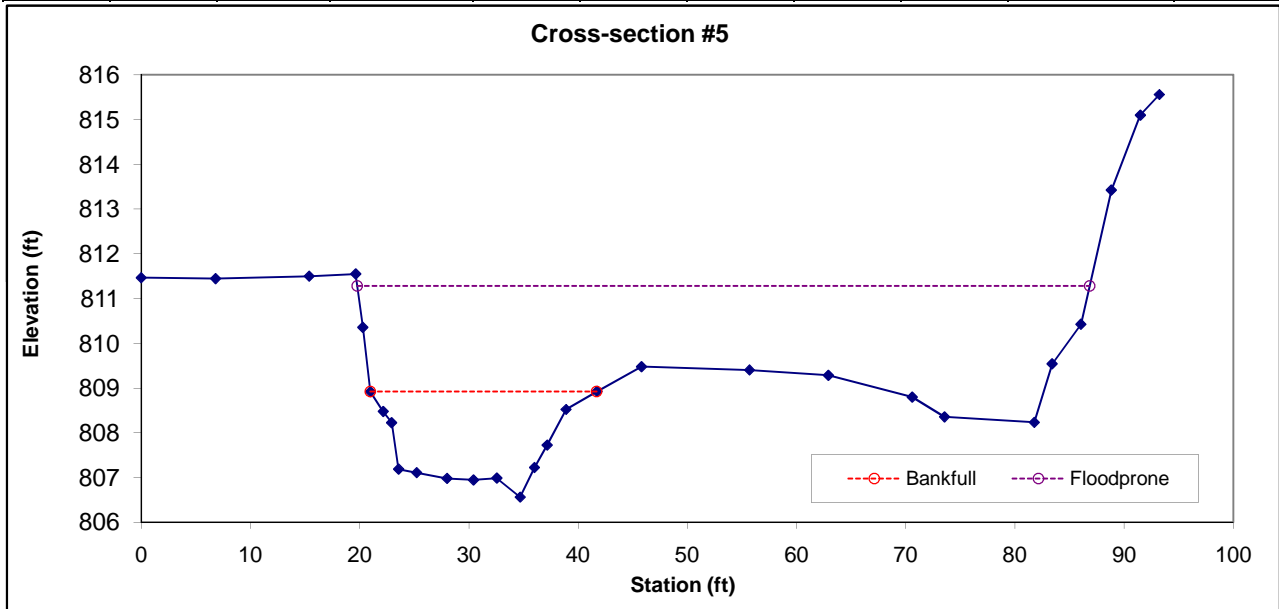
### Cross-section #5

Feature	Stream Type	BKF Area	BKF Width	BKF Depth	Max BKF Depth	W/D	BH Ratio	ER	BKF Elev	TOB Elev
Riffle	C	29.4	20.72	1.42	2.36	14.59	2.1	3.2	808.92	811.55

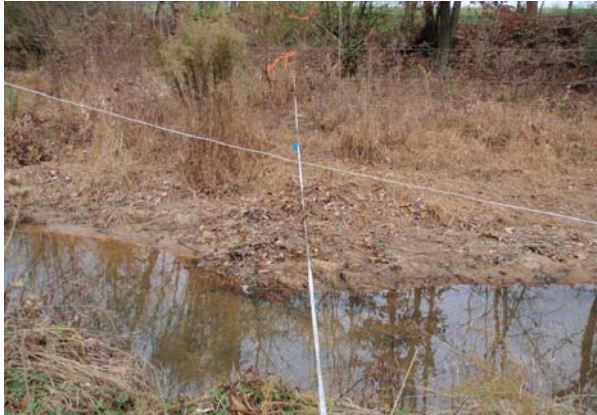
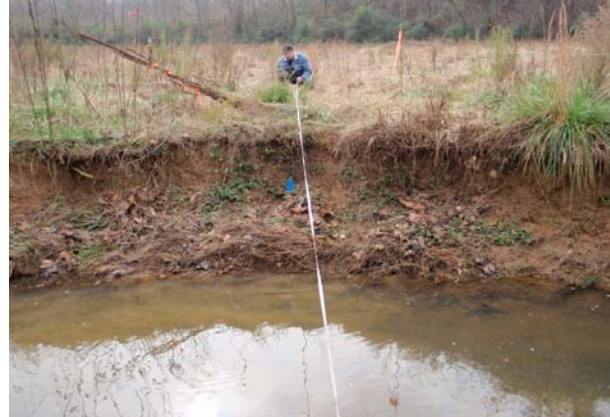
### Cross-section #6

Feature	Stream Type	BKF Area	BKF Width	BKF Depth	Max BKF Depth	W/D	BH Ratio	ER	BKF Elev	TOB Elev
Pool		40.6	35.62	1.14	3.05	31.23	1	2.6	801.37	801.37

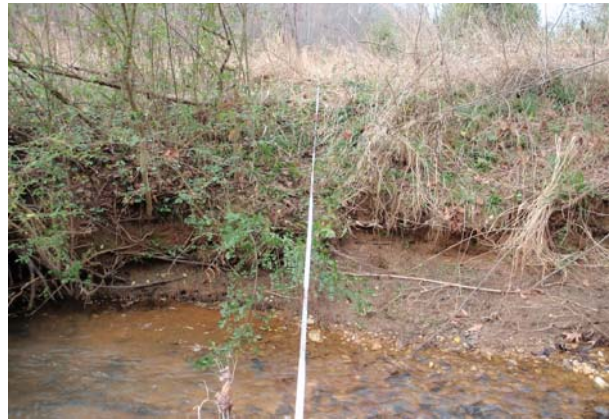
### Cross-section #7

Feature	Stream Type	BKF Area	BKF Width	BKF Depth	Max BKF Depth	W/D	BH Ratio	ER	BKF Elev	TOB Elev
Riffle	C	29.2	22.49	1.3	2.39	17.32	1	2.5	799.79	799.79
