RESTORATION PLAN

**CANE CREEK RESTORATION SITE
RUTHERFORD COUNTY, NORTH CAROLINA
(Contract #16-D06027-E)**

**FULL DELIVERY PROJECT
TO PROVIDE STREAM AND WETLAND MITIGATION
IN THE BROAD RIVER BASIN
CATALOGING UNIT 03050105**

RESTORATION PLAN
CANE CREEK RESTORATION SITE
RUTHERFORD COUNTY, NORTH CAROLINA
(Contract #16-D06027-E)

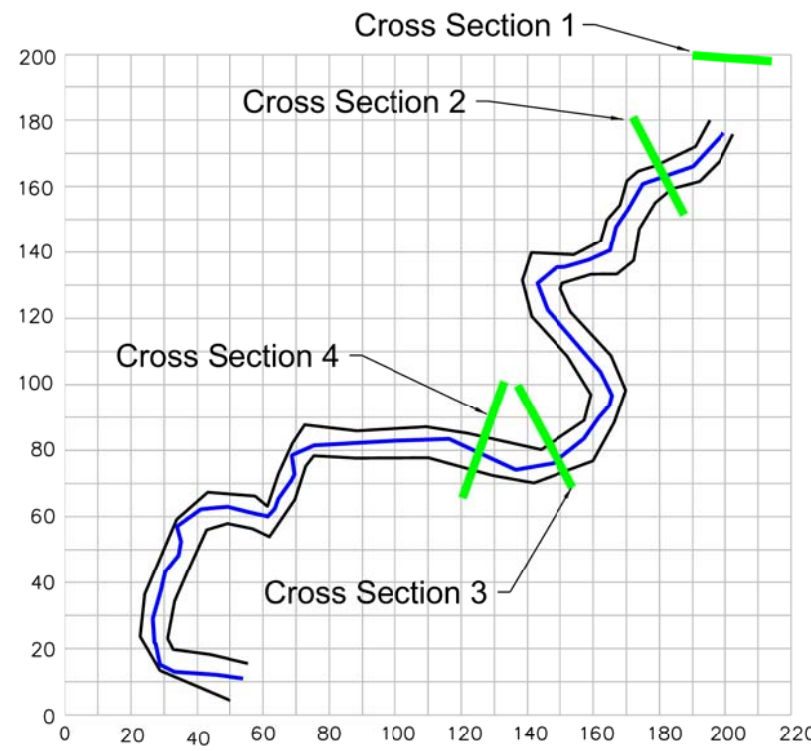
Reference Pattern
 Lp-p = 42 (23 - 89) ft
 Lm = 59 (36 - 88) ft
 Wbelt = 37 (19 - 60) ft
 Rc = 12.9 (7 - 26) ft
 Lp-p/Wbkf = 5 (2.8 - 10.6)
 Lm/Wbkf = 7 (4.3 - 10.5)
 Wbelt/Wbkf = 4.4 (2.3 - 7.1)
 Rc/Wbkf = 1.5 (0.8 - 4.3)
 SIN = 1.5

The reference stream reach is located onsite on the preservation reach (upstream reach of Tributary 1) (Figure 4, Appendix A). Distinct bankfull indicators were present within the channel. In addition, dimension, pattern, and profile variables have not been altered or degraded, allowing for assistance with the proposed restoration reaches (Figure 5, Appendix A).

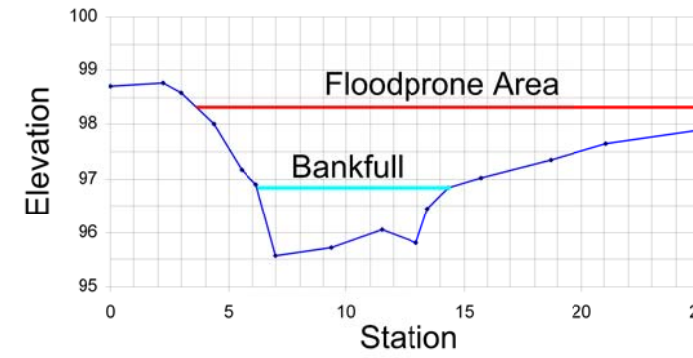
Cross Section 1 - Riffle
 Abkf = 7.7 ft
 Dave = 0.9 ft
 Wbkf = 8.7 ft
 Dmax = 1.3 ft
 Bank Height = 1.3 ft
 W/D = 9.7
 FPA = 25
 ENT = 2.9
 Stream Type = E

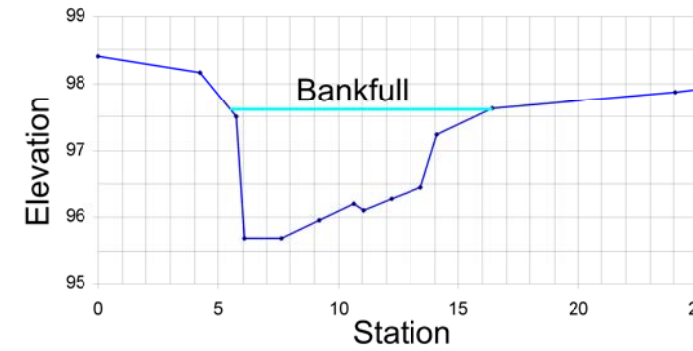
Cross Section 2 - Pool
 Abkf = 12.9 ft
 Wbkf = 10.7 ft
 Dmax = 1.9 ft

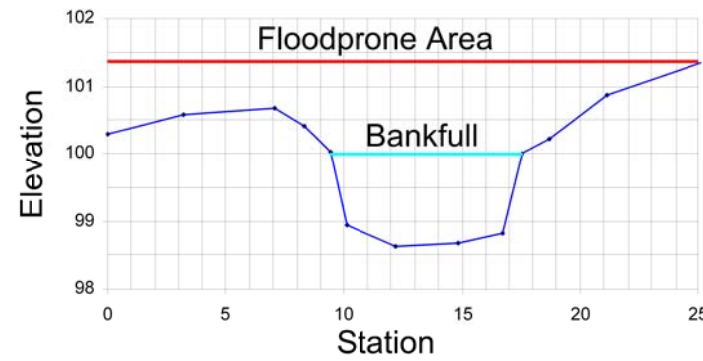
Cross Section 4 - Riffle
 Abkf = 9.3 ft
 Dave = 1.2 ft
 Wbkf = 8.1 ft
 Dmax = 1.4 ft
 Bank Height = 1.4 ft
 W/D = 7.1
 FPA = 150
 ENT = 18.5
 Stream Type = E

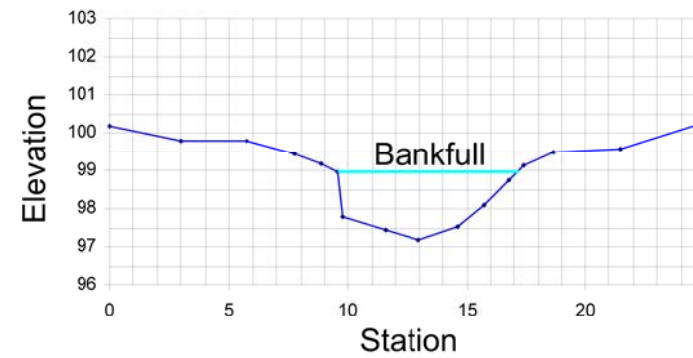
Cross Section 3 - Pool
 Abkf = 14.1 ft
 Wbkf = 11.8 ft
 Dmax = 2.3 ft
