**MITIGATION PLAN**

**FULL DELIVERY PROJECT TO PROVIDE STREAM RESTORATION  
CAPE FEAR RIVER BASIN CATALOGING UNIT-03030003**

**CARBONTON DAM – DEEP RIVER WATERSHED  
RESTORATION SITE**

**JUNE 2006**

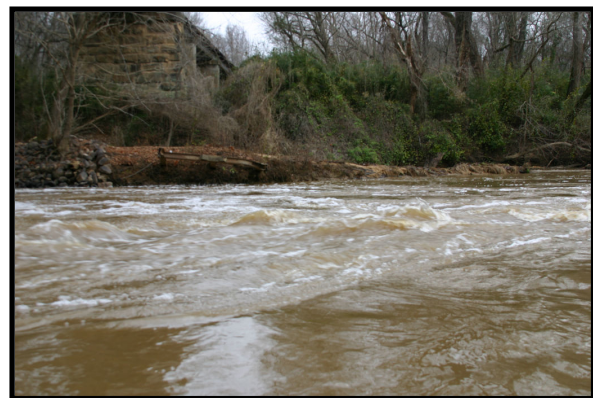
*Re-established riffles within the former Carbonton Dam Impoundment  
Source: EcoScience Corporation 2005 and 2006*

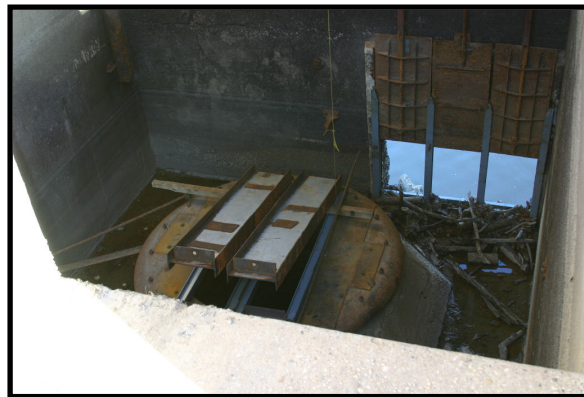
*Photo 1: Repaired mud gates and flap covers on draft tube  
In southern water well  
Source: Restoration Systems 2005*

Before dewatering began the previous dam owner refurbished the powerhouse head gates, the southern turbine draft tube, and the mud gates to enable discharge of the Site Impoundment through the powerhouse in a controlled manner. The head gates were rearranged so that the southern water room (wet well) could be closed off and repairs could be made to the mud gates to make them operational. The southern turbine was also removed, and its draft tube fitted with two fabricated "flap" covers, each covering one-half the tube diameter (Photo 1). Excess trash was dredged behind the intake trash racks to facilitate free flow to the full depth of the trash rack and head gates. Prior to this, sediment and woody debris had blocked all but the upper one- to four-feet of the southern trash racks.

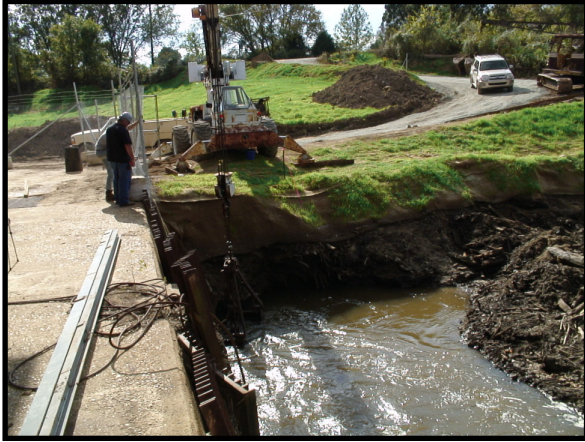
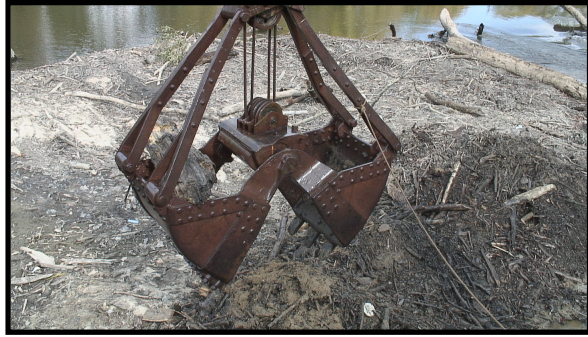
Photo 2

*Photos 2 and 3. Cleaning trash racks protecting southern water well during dewatering  
Source: Restoration Systems 2005*

Once the Site had been prepared, final coordination and approval was sought from regulatory agencies for dewatering of the Site Impoundment. The Restoration Plan (Restoration Systems 2005) described that the dewatering was primarily going to occur through the mud gates. However, during the preparation activities within the powerhouse, it was determined that the initial dewatering should be directed through the southern wet well draft tube by raising the new flap covers, which allowed river discharge through the submerged exit race on the downstream side of the powerhouse. The southern draft tube, with the new flap covers, was deemed to provide better control over the initial dewatering, in case a situation arose that forced the cessation of the dewatering process. In addition, by raising and lowering the flap covers, there was sufficient control to throttle the discharge as desired. While water from the Site Impoundment was being discharged through the powerhouse, the trash racks protecting the water wells required nearly continuous cleaning to reduce blockages and pressure (head) loss at the upstream end of the powerhouse (Photos 2 and 3).

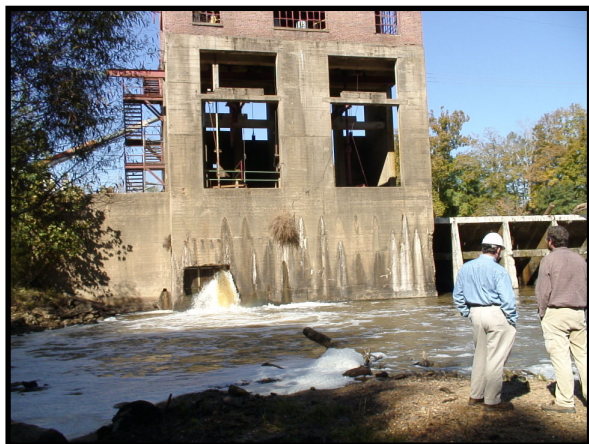
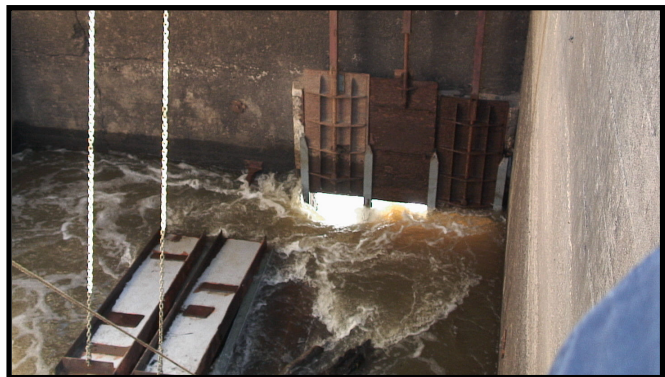
*Photos 4 and 5. Dewatering through the mud gates within the powerhouse  
November 2005  
Source: Restoration Systems*

Dewatering exclusively through the southern draft tube continued until the end of October 2005, when the level in the water room fell to the top of the draft tube (approximately four feet above the bottom of the water well). Due to the dewatering pathway through the powerhouse, approximately three feet of pressure (head) loss occurred while draining exclusively through the southern draft tube. Thus, the lowest level that the Site Impoundment could be drained through the southern draft tube was still several feet higher than the minimum level possible in the southern wet well. Although much of the sediment that had accumulated immediately behind the dam became visible, the water level of the Site Impoundment was still too high to facilitate inspection of the powerhouse and the spillway, and also too high to allow for satisfactory investigation of the substrate behind the spillway. To reduce the level of the Site Impoundment further, the mud gates located at the base of the southern water well were raised to increase flow through the powerhouse (Photos 4 and 5).

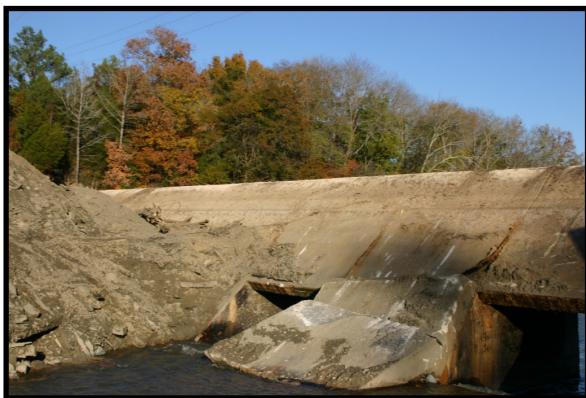
*Photo 6. Uncovered mud gates on dam spillway*

In early November 2005, a tracked backhoe was used to uncover the southernmost mud gate on the dam spillway and slide the gate aside (Photo 6). This action successfully increased the river discharge by a substantial amount, further dewatering the Site Impoundment. Consultations with the FWS and other resource agencies ensued to discuss the contingency of locating and opening the other two mud gates that were located on the dam spillway. The project planning team believed that opening the other two gates would facilitate dewatering of the Site Impoundment much more efficiently, and would provide additional flow capacity for higher river stage events. It was determined that the increased capacity could facilitate the substrate investigations, dam demolition planning, and dam demolition activities, even at higher river stages. All three mud gates located on the dam spillway were ultimately removed, contributing to the dewatering of the Site Impoundment by mid-November (Photo 7). Once all three spillway mud gates were opened, further inspection of the spillway revealed that an approximate four-foot

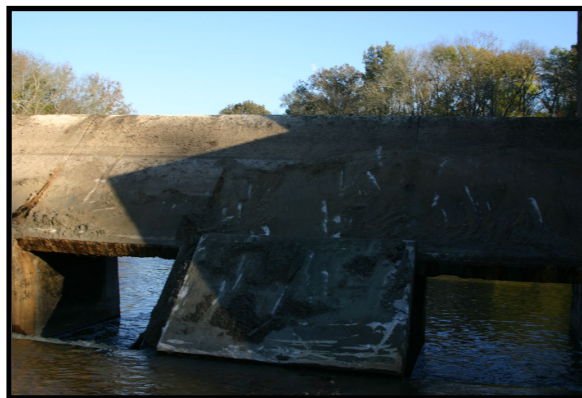
*Photo 7. Dewatering through mud gates on dam spillway*

high concrete ledge at the base of the mud gate openings restricted the river discharge and caused a backwater into the impoundment. The project planning team determined that the Site Impoundment could be lowered nearly another four feet if the ledge was removed, which would eliminate the head loss through the mud gates on the dam spillway. Additional coordination was undertaken with the resource agencies to determine whether the dam spillway should be breached in addition to the ongoing dewatering effort through the mud gates. After the successful coordination with the local agencies and FERC, approximately 85 feet of the southern end of the spillway (cells 1 through 5 [See Sheet 8, Appendix C]) were demolished using backhoes and a backhoe-mounted hydraulic hammer (Photo 8). These fully removed cells of the spillway restored the Deep River to lotic conditions during normal base flow periods (Photo 9).

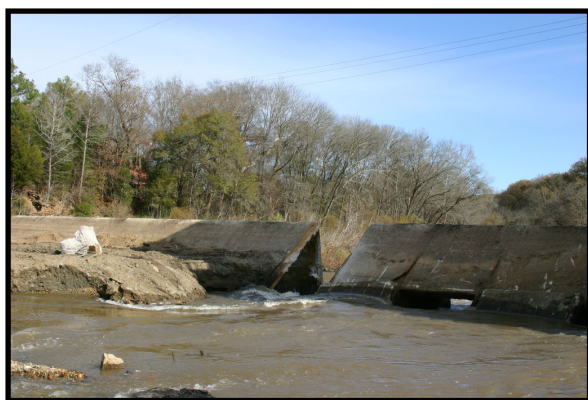
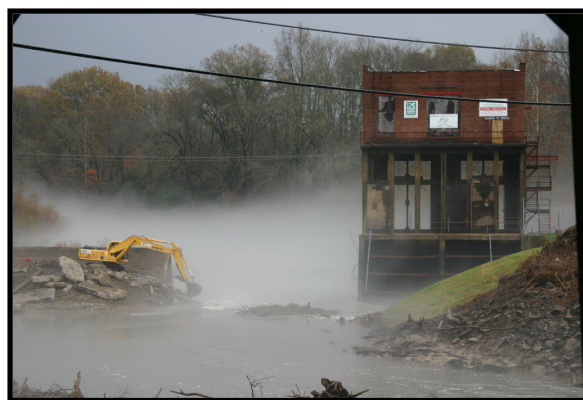
*Photos 8 and 9. Constructed notch in cell 1-5 on the southern end of the buttress spillway  
Source: Restoration Systems 2005*

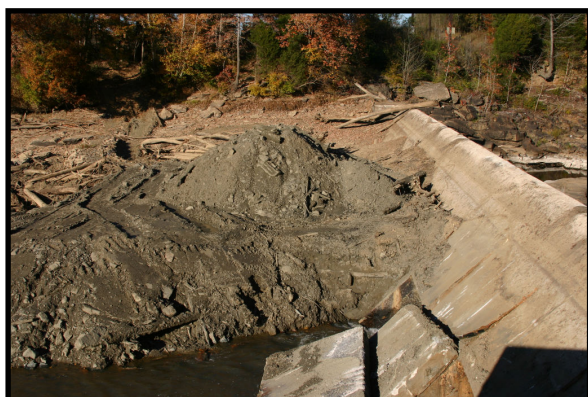
*Photo 10. Substrate behind dam spillway after*

The spillway sediment wedge was investigated using test pits, soil augers, and visual physical characterization. The upstream river substrate was also investigated by hand probing and soil augers where possible. The major feature encountered was the large woody debris island, which extended from just above the NC42 highway bridge to approximately 100 feet above the spillway sediment wedge (see Sheet 6, Appendix D). The debris island was composed of tree trunks, tree limbs, sand, and gravel. The debris island was a concern because of the perceived risk that a high river stage could dislodge and transport the debris downstream, possibly causing blockages in the Deep River below the dam Site.

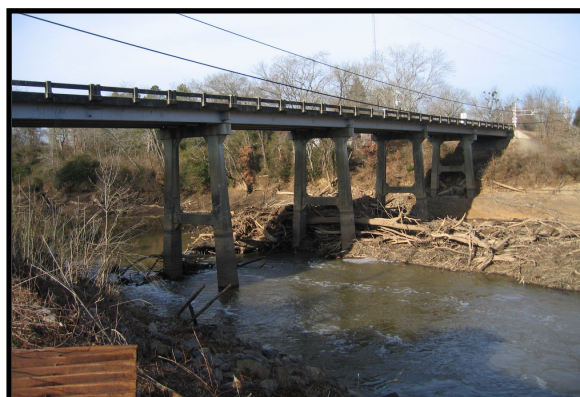
*Photo 11. Woody debris island near NC42 bridge dewatering*

- Woody remains from logs, brush, tree trunks, and other items that had washed down the Deep River and accumulated into a 1/4-acre woody debris "island" above and below the NC42 bridge (Photo 11).
- Timber and rock remaining from the crib cofferdams that were used during the spillway and powerhouse construction during the 1920's.
- Bedrock outcrops along the north riverbank.
- Sand and fine to medium gravel that had been transported down the Deep River and settled into a wedge covering the face of the spillway (Photo 10).

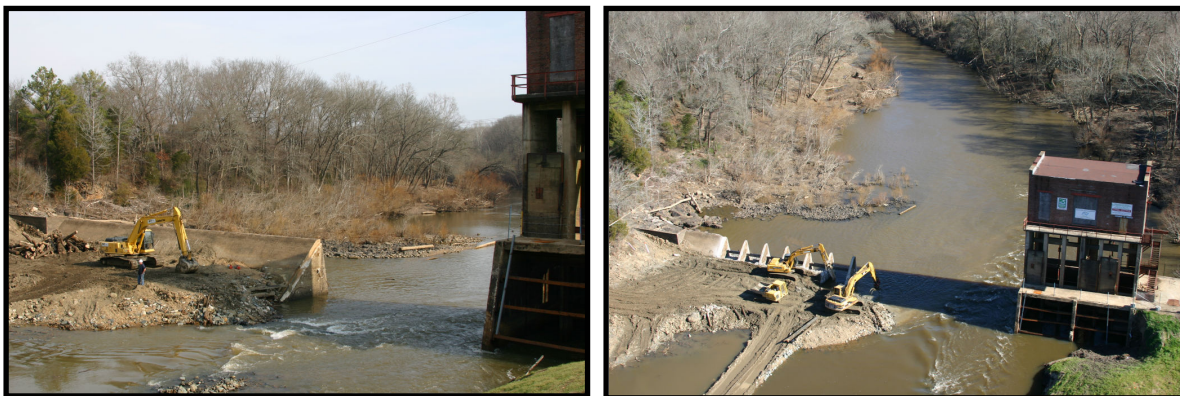
*Photos 12 and 13. Two stages of spillway breach to facilitate dewatering  
Source: Restoration Systems 2006*

Demolition activities began when the spillway was breached at the end of November 2005. Demolition occurred in stages from the powerhouse toward the northern bank, with tracked backhoes operating upstream of the dam spillway on top of the sediment wedge and bedrock (Photos 12 and 13). During the demolition, large concrete rubble pieces were transported to the staging area above the river via tracked trucks.

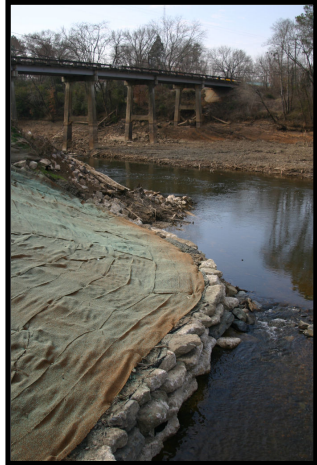
*Photo 14. Bank toe protection created from dam spillway debris*

The buttress spillway was completely demolished and removed by February 3, 2006. Approximately 800 cubic yards of concrete in the spillway were removed from the river, and portions of the spillway concrete were used to construct a toe wall (Photo 14). This revetment was built along the toe of the southern bank, directly upstream of the powerhouse where the slope was re-graded and the riverbed was dredged to prepare for dewatering (Photo 15).

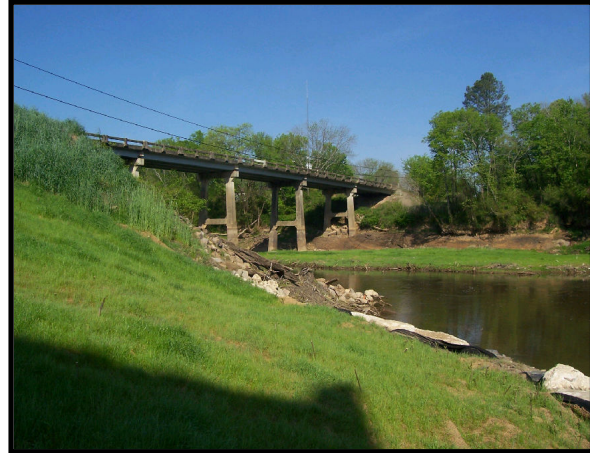
*Photo 15. Regraded southern bank of the Deep River behind the powerhouse. Slope was revegetated*

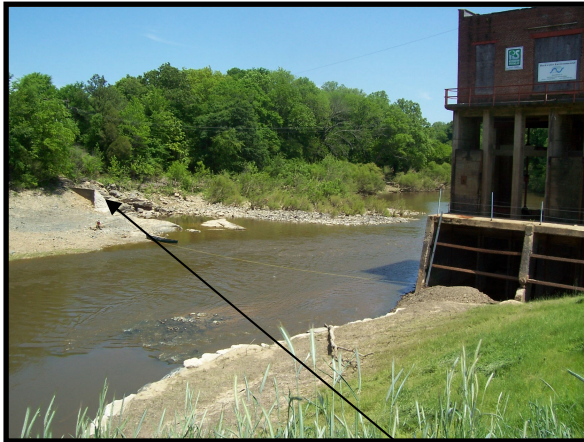
Photo 16. After dam removal, the ogee spillway was retained

During demolition, RS decided to avoid demolition of the concrete ogee spillway that was constructed on bedrock at the left riverbank was retained (Photo 16). The ogee spillway is 30 feet long, and its base lies above the normal flow of the river and will not interfere with the flow conditions or with the reintroduction of sediment from the substrate island back into the river. Retaining the ogee spillway saves an element of the historic Carbondon Dam, and it will be visible from the future public park on the south riverbank (Photo 17).

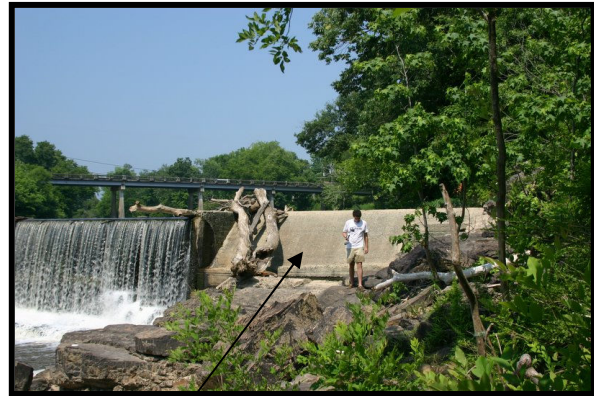
Photo 17/ Ogee spillway in pre-removal photo

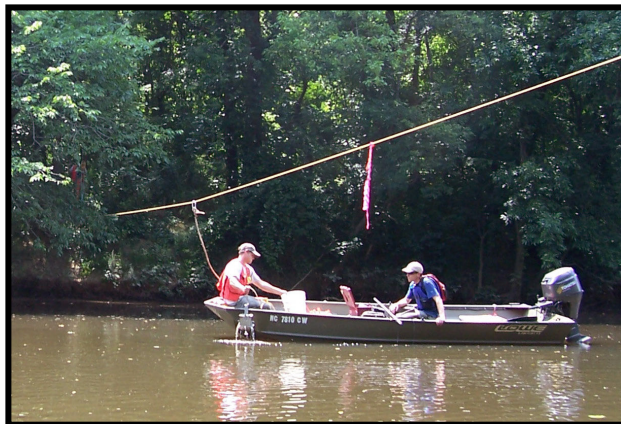
*Photo 18. Sediment sampling within the Site Impoundment  
Source: EcoScience Corporation 2005*

For deeper water areas, the bulk material method will be used to assess sediment grain size distribution (Photo 18). This method entails using a Ponar (or similar) dredge to take five sediment samples evenly spaced along each monitoring cross-section. Sediment from each of the five dredge samples will be combined in one composite sample and sorted using sieves to determine the sediment grain size distribution by weight.

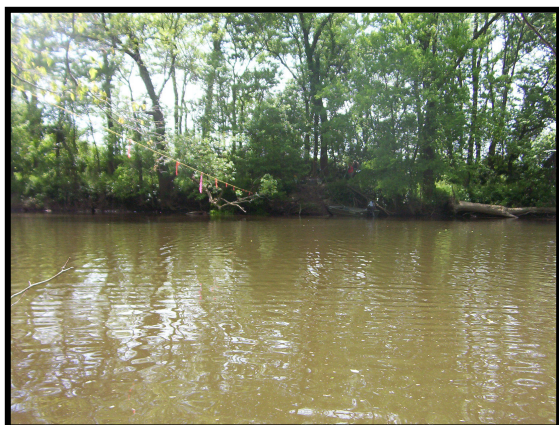
*Photo 19. Impounded (lentic)*

Flow velocity was analyzed at all 51 monitoring stations during 2005 (Photos 19 and 20). Using similar methods, flow velocity measurements will be made at each monitoring station during each subsequent year of the monitoring period. It is anticipated that flow velocities will increase in each formerly impounded stream reach and that variability in flow between pools and riffles will be established. To collect these data, a Swoffer velocity probe is used to measure the velocity in five different locations along the channel cross-section of each station. The probe measurement is made 1 foot below the water surface. If water depths exceed 4 feet, then two measurements are made at each location, where the first measurement is made 1 foot below the water surface, and the second measurement is made 1 foot above the channel bottom.

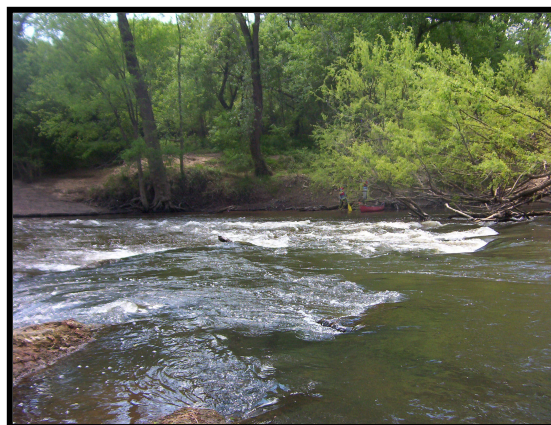
*Photo 20. Lotic reference*

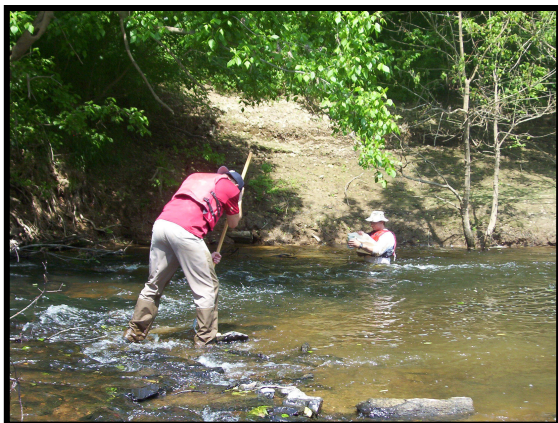
*Photos 21 and 22. Sweep net and rock wash sampling for benthic macroinvertebrates at a reference station  
Source: EcoScience Corporation 2005*

Benthic macroinvertebrates were collected at seventeen (17) of the monitoring stations in 2005. The pre-removal Year 2005 monitoring occurred in April and May. The stations sampled for benthic macroinvertebrates occur on the Deep River and its tributaries, in both the former Site Impoundment and in reference lotic reaches. The sampling method utilized was the Standard Qualitative Method as described in NCDWQ (2003), with modification for deep water (boat) sampling implemented within the Site Impoundment and deep pools in reference reaches (Photos 21 and 22). It is expected that deep water sampling will be used less frequently during future sampling efforts. All collected samples during the monitoring period will be sent to a NCDWQ certified laboratory for identification.

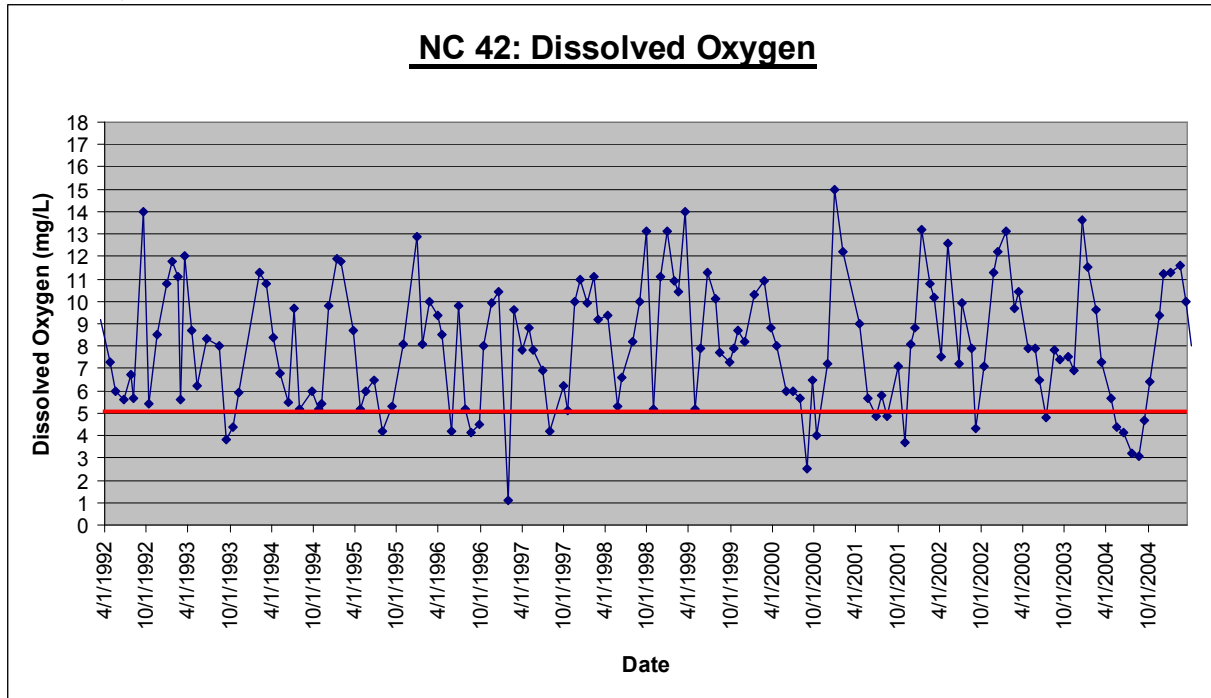
Graph 1. Recorded dissolved oxygen levels at NC42 over the Deep River from March 16, 1992 through October 14, 2005.

Throughout the five-year monitoring period following dam removal, it is expected that mean dissolved oxygen values recorded at NC42 will increase as the river returns to lotic conditions. It is also expected that the number of days below the state standard will decrease as free-flowing conditions replace lake-like flows.

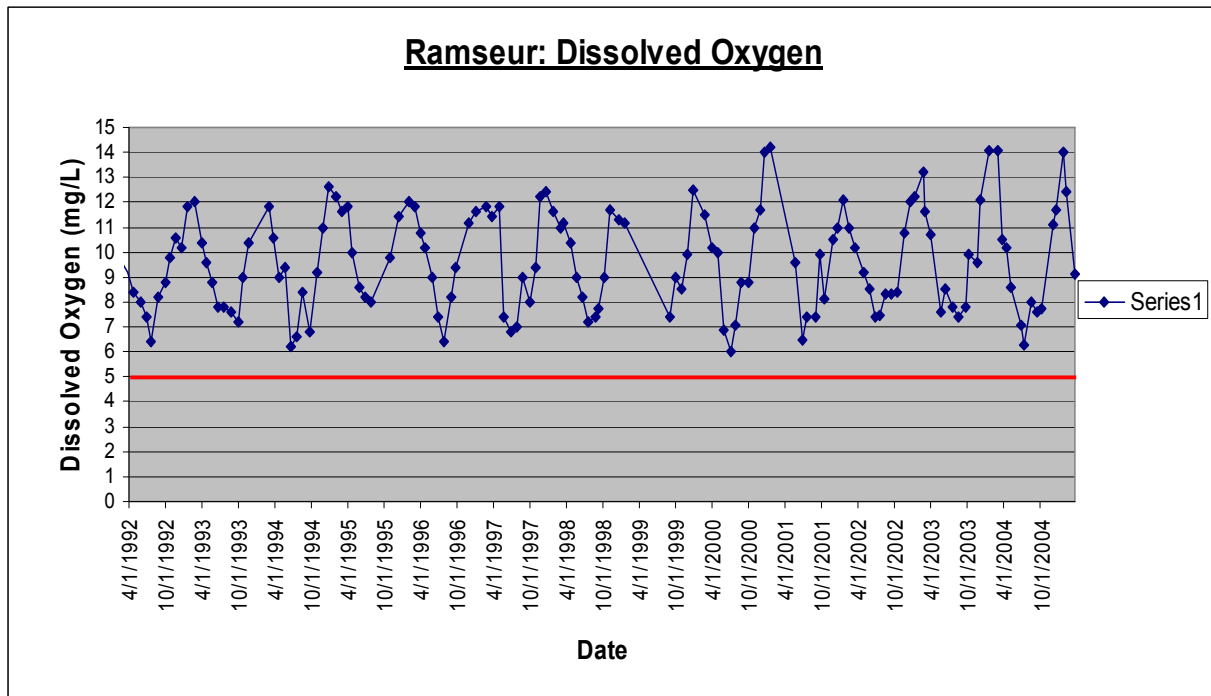
Graph 2. Recorded dissolved oxygen levels at Ramseur on the Deep River from March 16, 1992 through October 14, 2005.

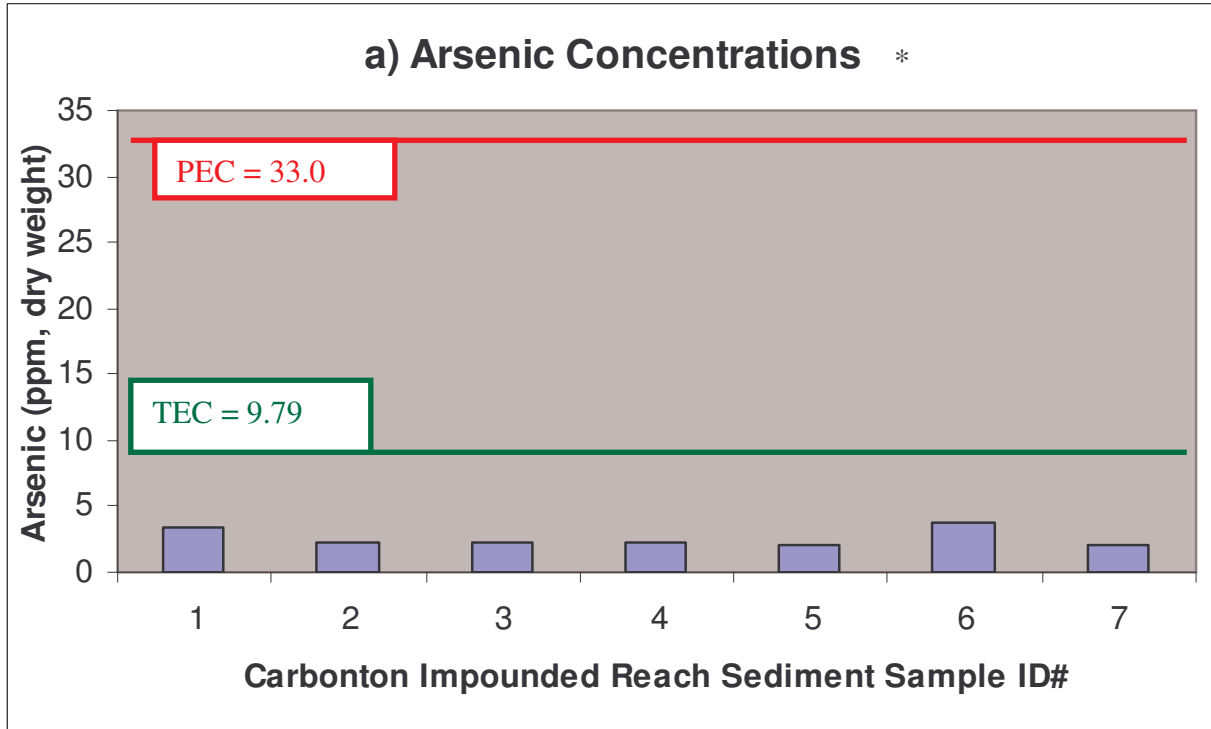
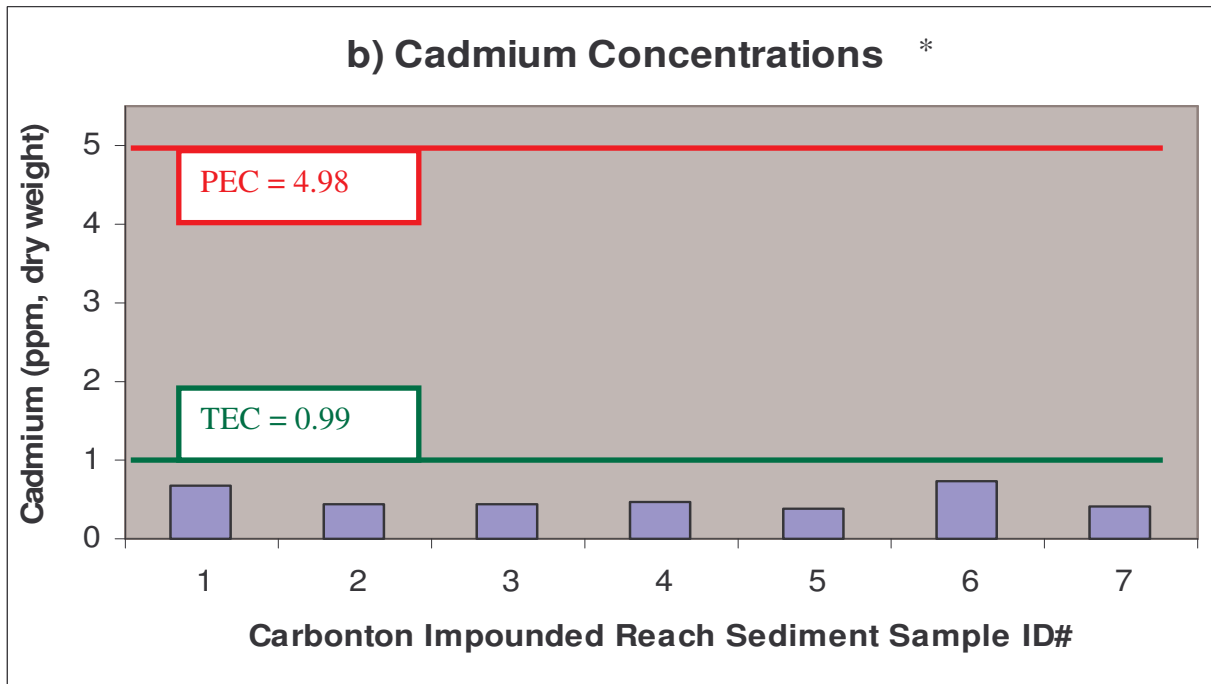
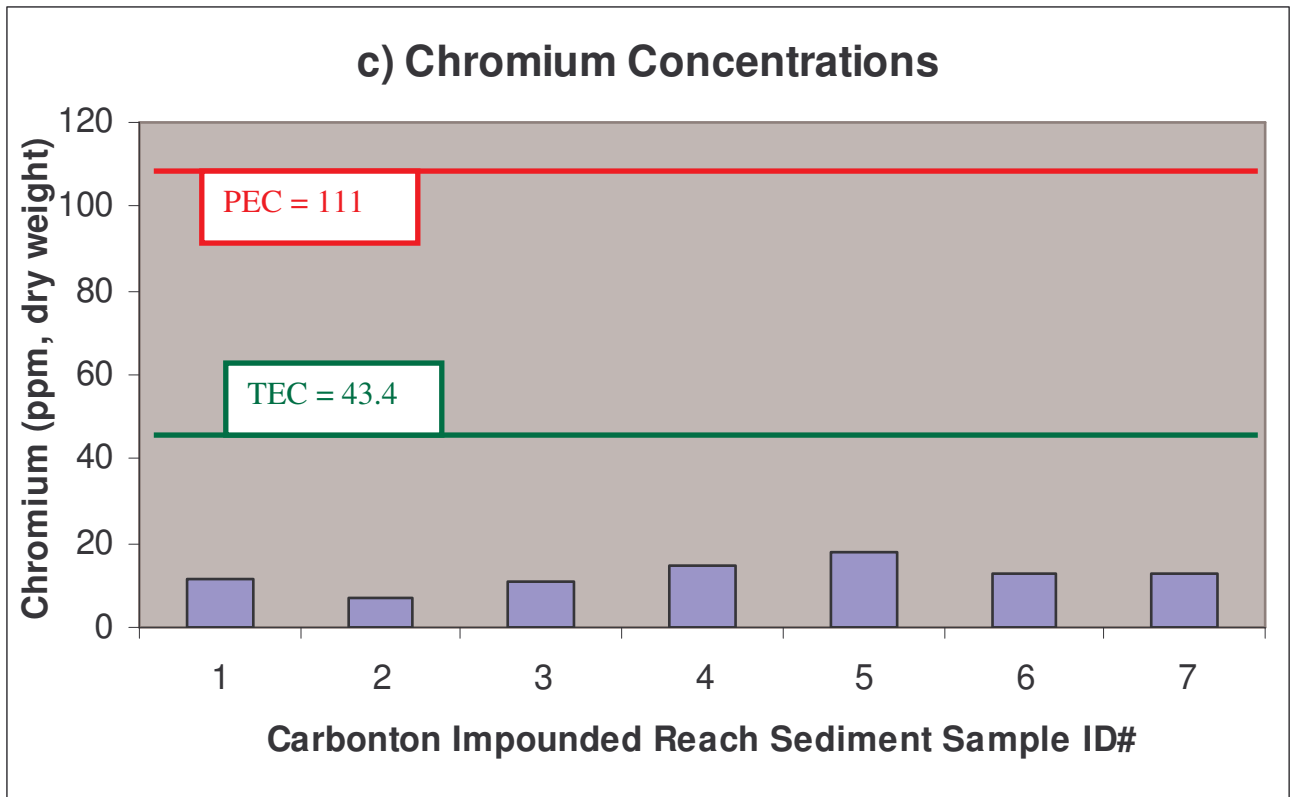
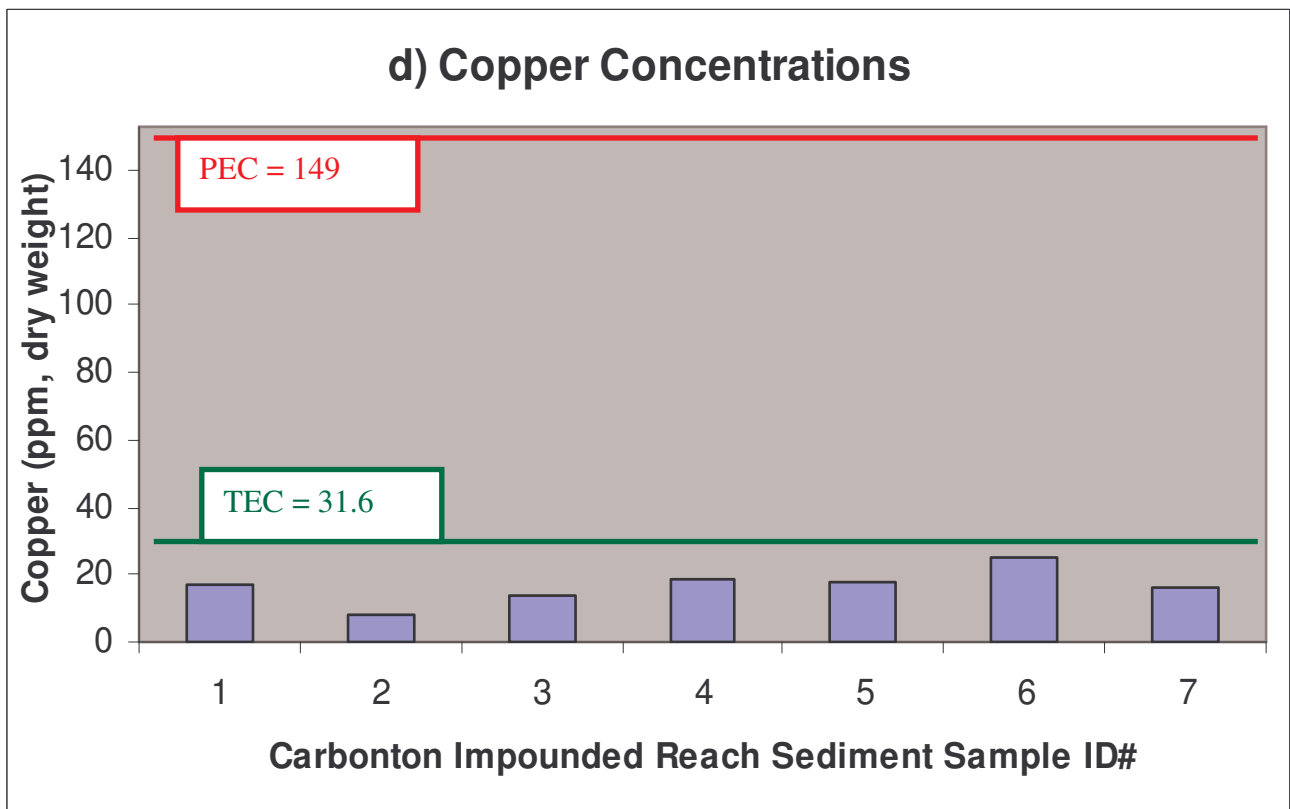
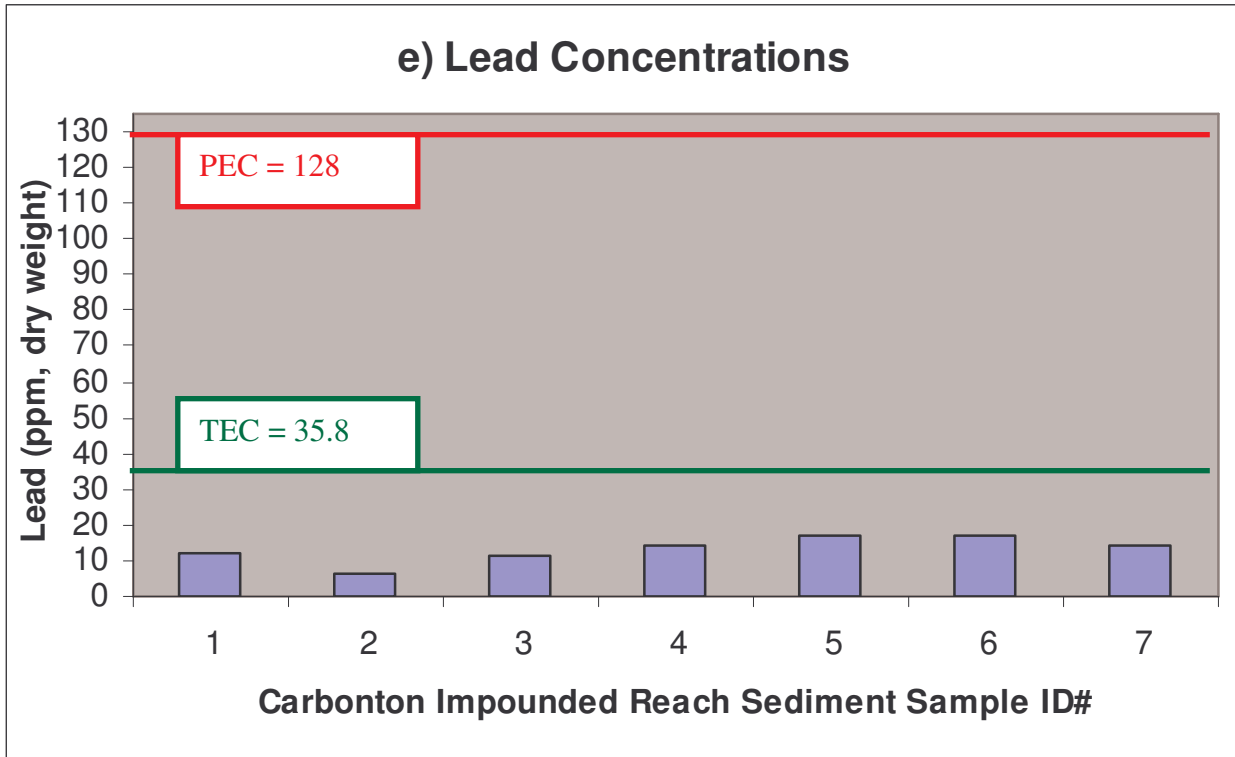
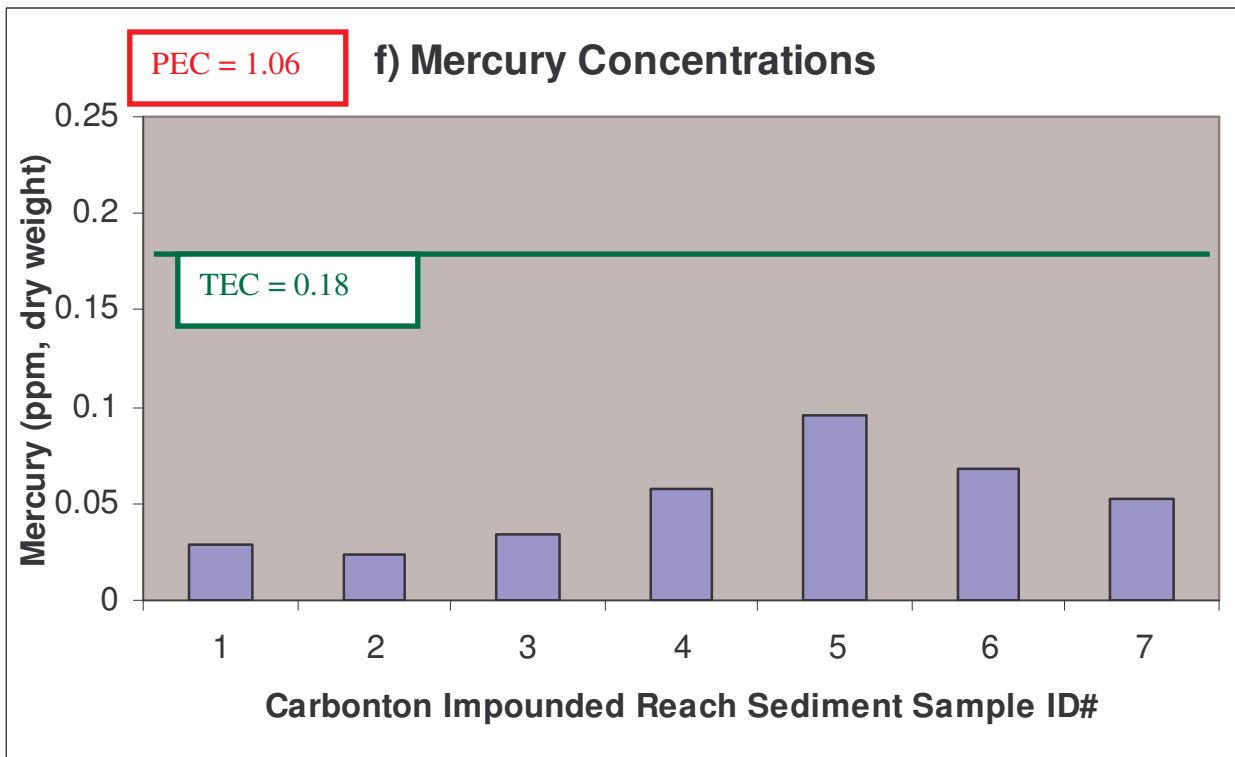
Figure 2 (a-h). Elemental contaminant concentrations of sediments collected within the Carbonton Dam impounded reach. For each element, results are compared to threshold-effects concentration (TEC) guidelines of MacDonald et al. (2000) -- values below which adverse effects to sensitive aquatic organisms should not occur, and probable effects concentrations (PECs) -- values above which adverse effects to sediment dwelling organisms may be expected. Figure g) also has a “median effects concentration” (MEC), the geometric mean of the TEC and PEC, for reference.

\* Arsenic was only detected in sample 5, and cadmium was not detected in any sample, the results provided are the sample-specific detection limits (i.e., arsenic and cadmium are known to be less than these values)

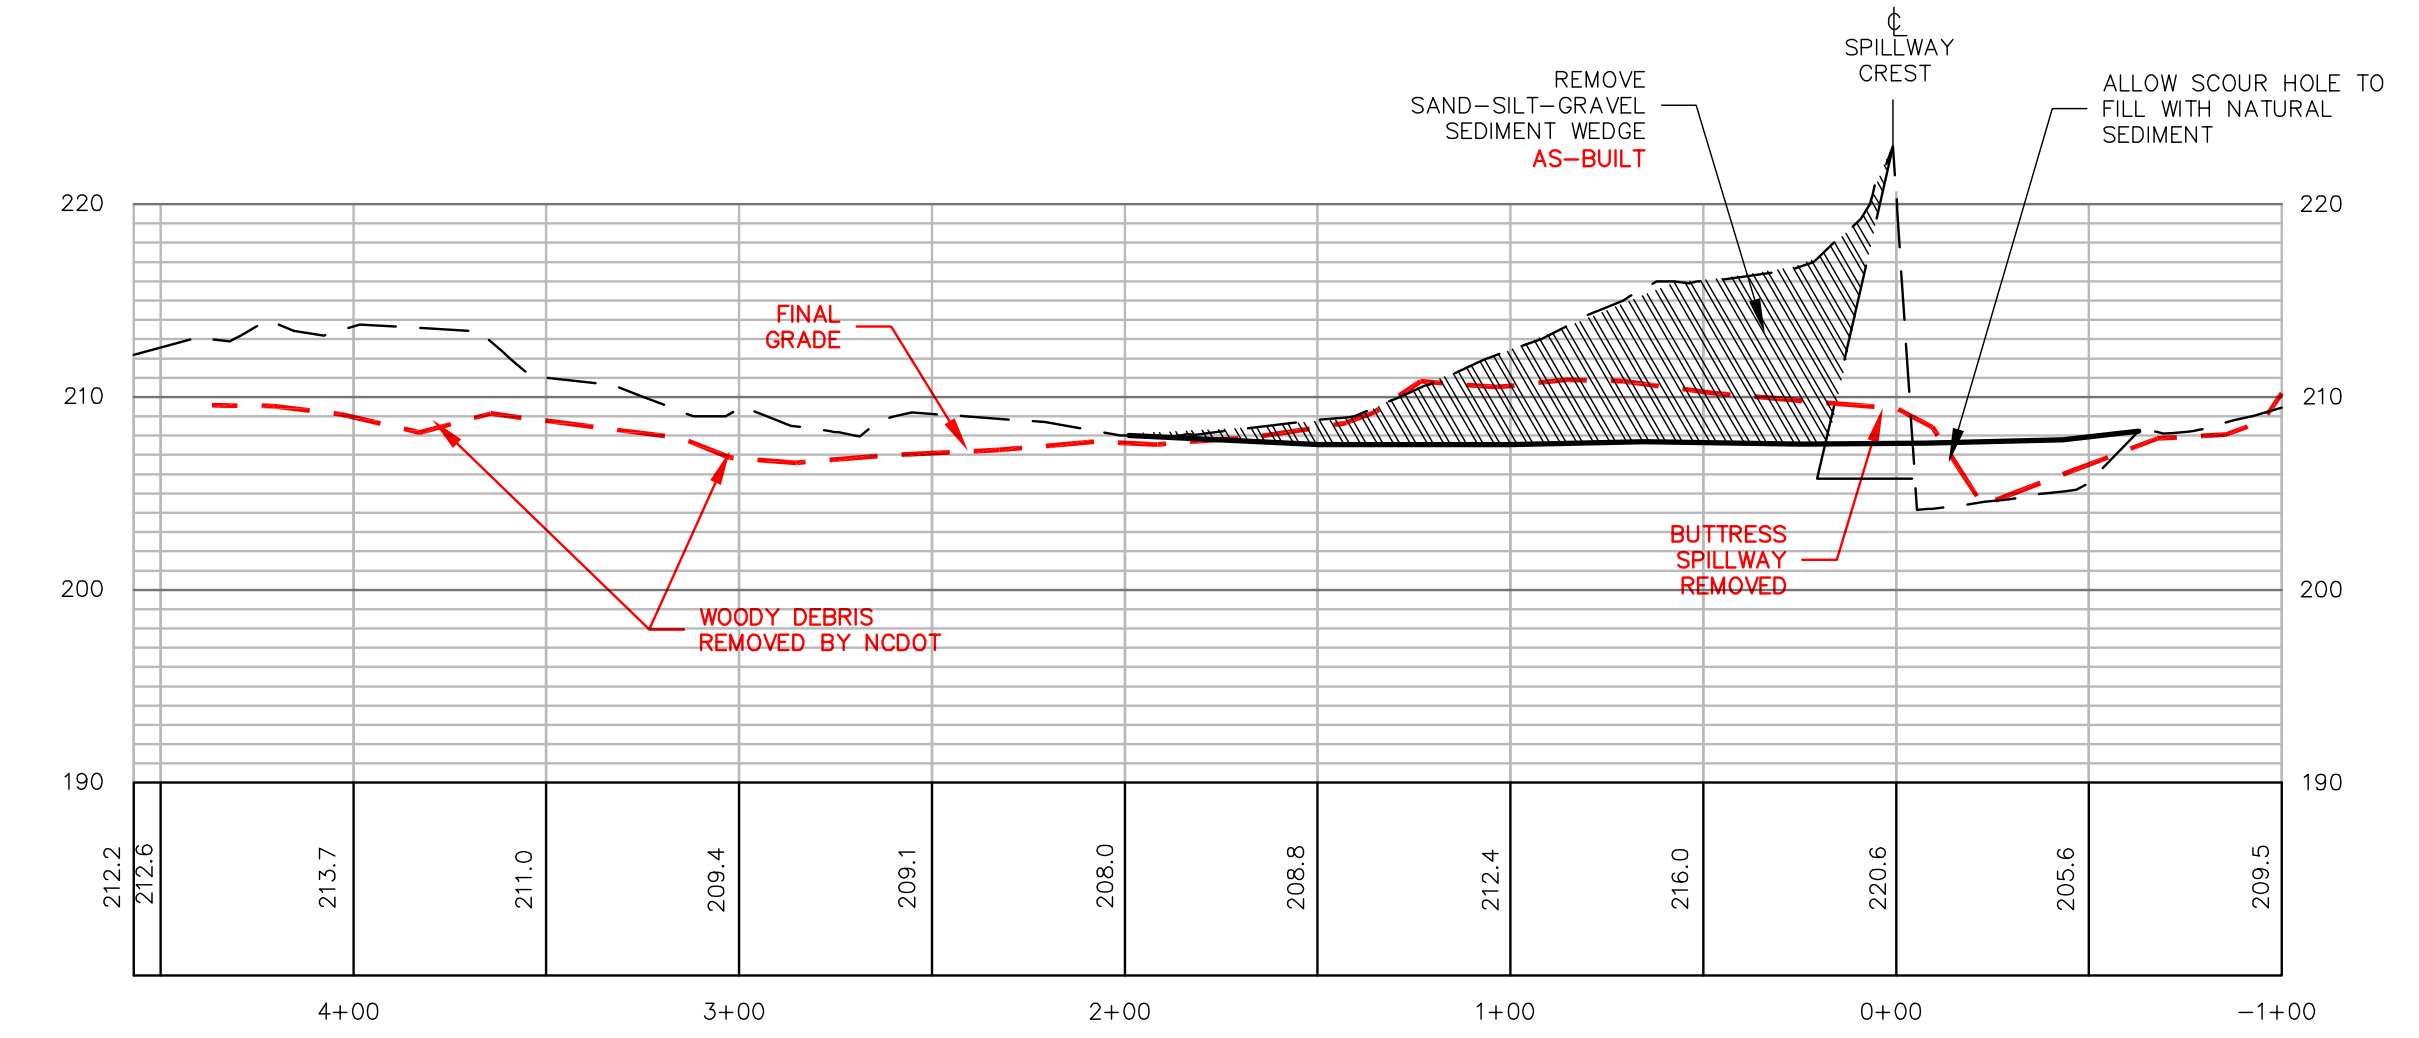
**RIVER PROFILE B-B'**  
 SCALE= 1"=50' HORZ.  
 1"=10' VERT.

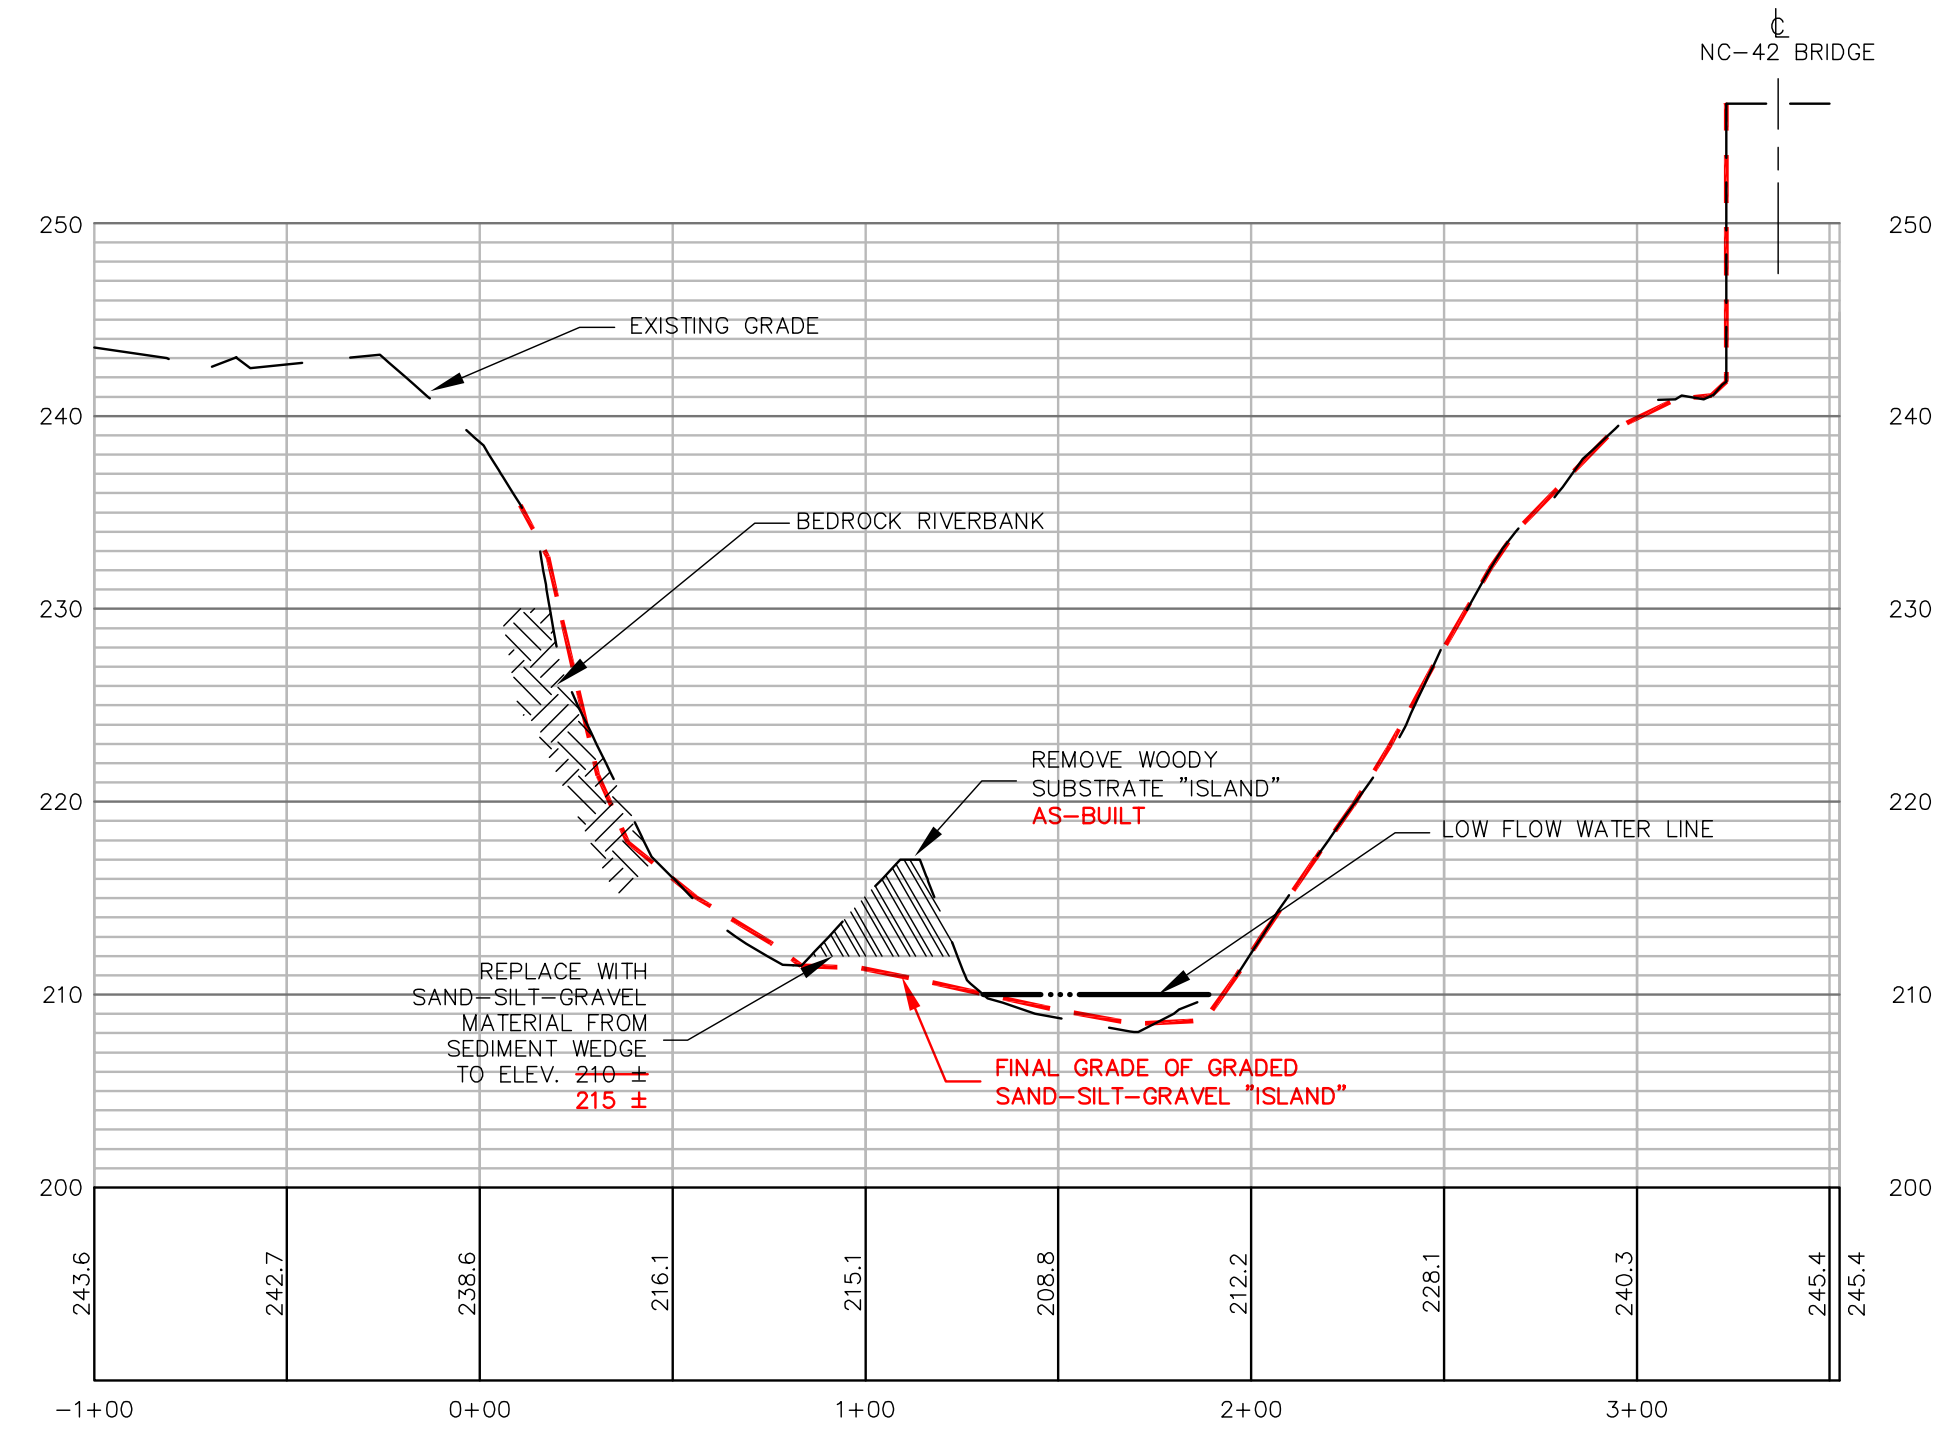
**SECTION C-C'**  
 SCALE= 1"=50' HORZ.  
 1"=10' VERT.
