**MITIGATION PLAN**

**FULL DELIVERY PROJECT TO PROVIDE STREAM RESTORATION  
CAPE FEAR RIVER BASIN CATALOGING UNIT-03030003**

**CARBONTON DAM – DEEP RIVER WATERSHED  
RESTORATION SITE**

**JUNE 2006**

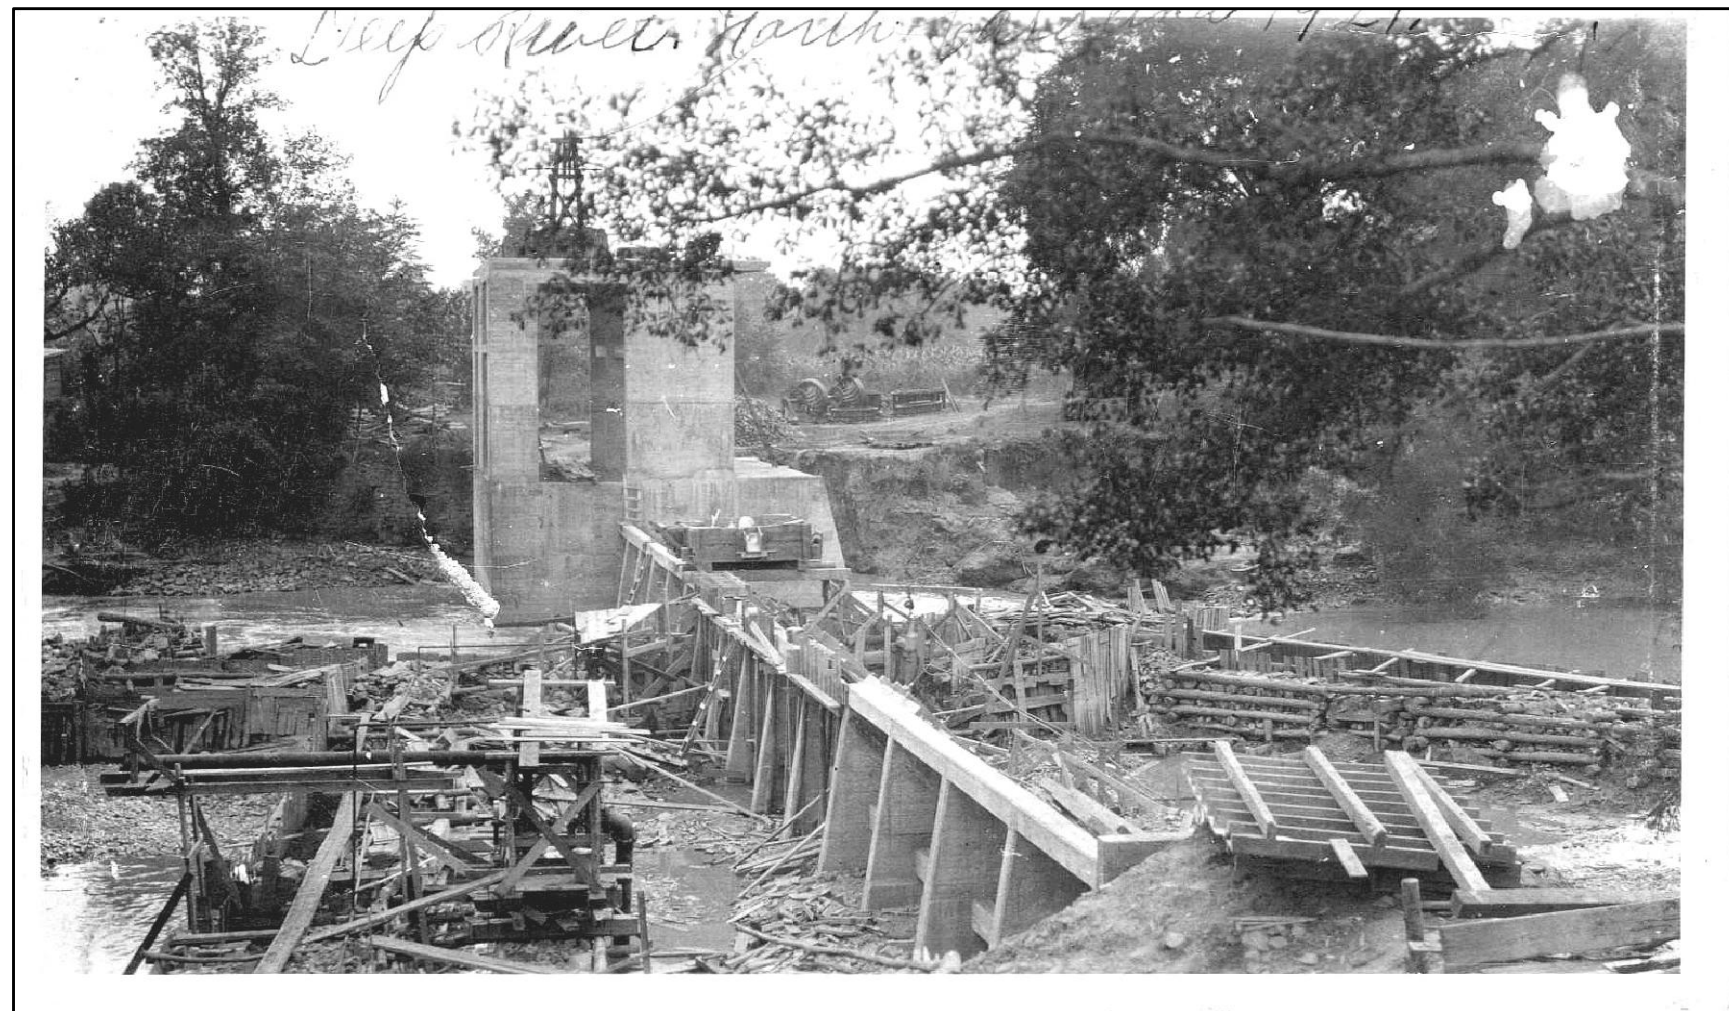
**1921 CONSTRUCTION PHOTOGRAPH**  
NOTE THAT OGEE SPILLWAY IS NOT YET CONSTRUCTED
