**CARBONTON DAM – DEEP RIVER WATERSHED
RESTORATION SITE
2007 Annual Monitoring Report (Year 2)**

**Chatham, Lee and Moore Counties, NC
EEP Project No. D-04012A
Design Firm: Milone and MacBroom, Inc.**

**Prepared for: NCDENR - ECOSYSTEM ENHANCEMENT PROGRAM
1652 Mail Service Center
Raleigh, North Carolina 27699-1619**

**Prepared by: ECOSCIENCE CORPORATION
1101 Haynes Street, Suite 101
Raleigh, North Carolina 27604**

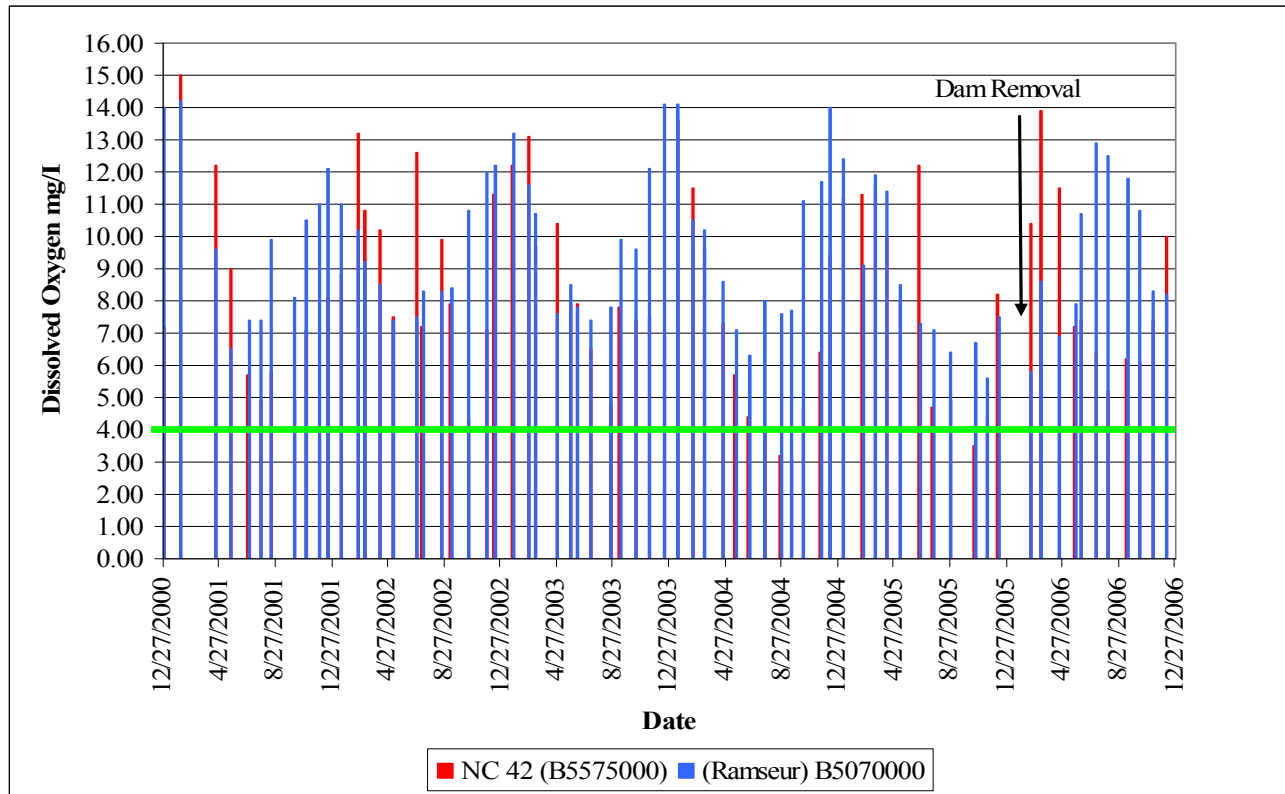
**Graph 2. Recorded Dissolved Oxygen Concentrations in the Deep River
(Green line indicates state standard of 4.0mg/L)**

Throughout the five-year monitoring period following dam removal, it is expected that mean dissolved oxygen values recorded at NC 42 will continue to demonstrate success as the river returns to lotic conditions. It is also expected that dissolved oxygen levels within the former impoundment will stay above the state standard as free-flowing conditions persist.

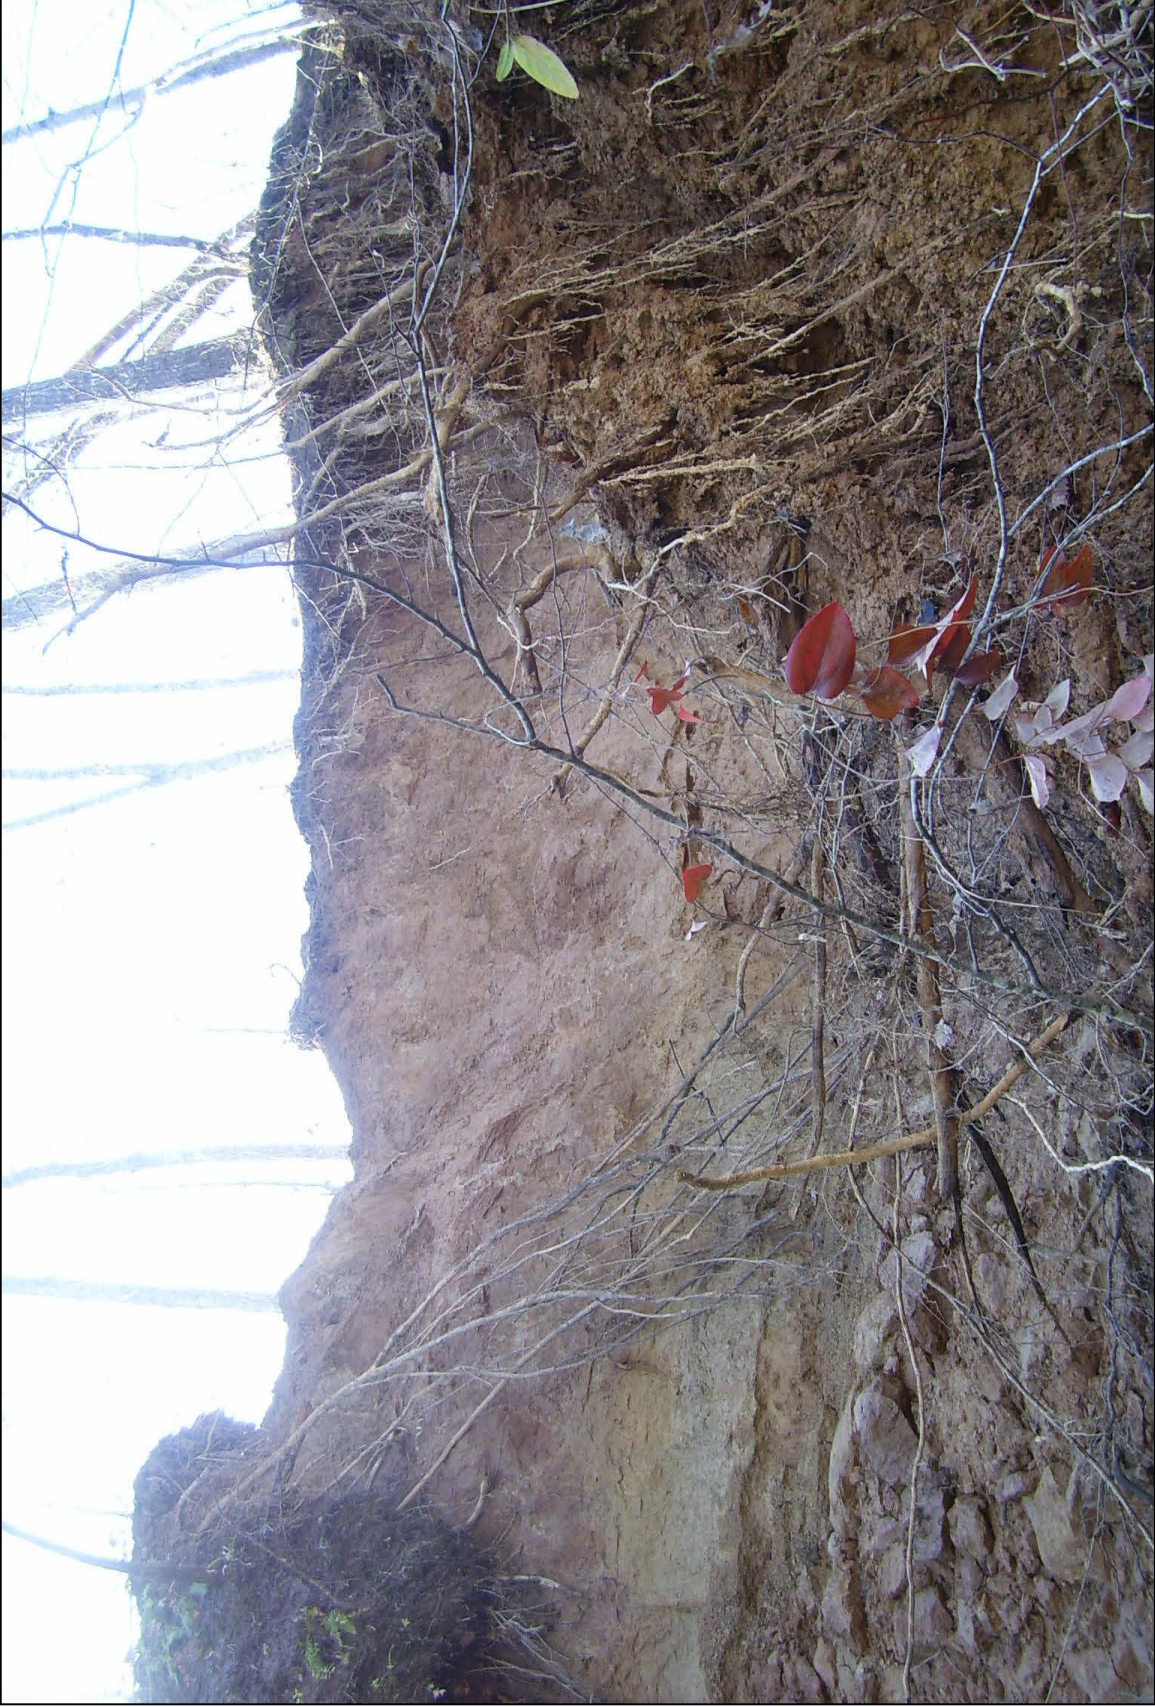
Photo 1. River Observation Point 1

Location: Deep River downstream of the Norfolk-Southern rail bridge
Description: Bank failure and continued erosion into the Deep River

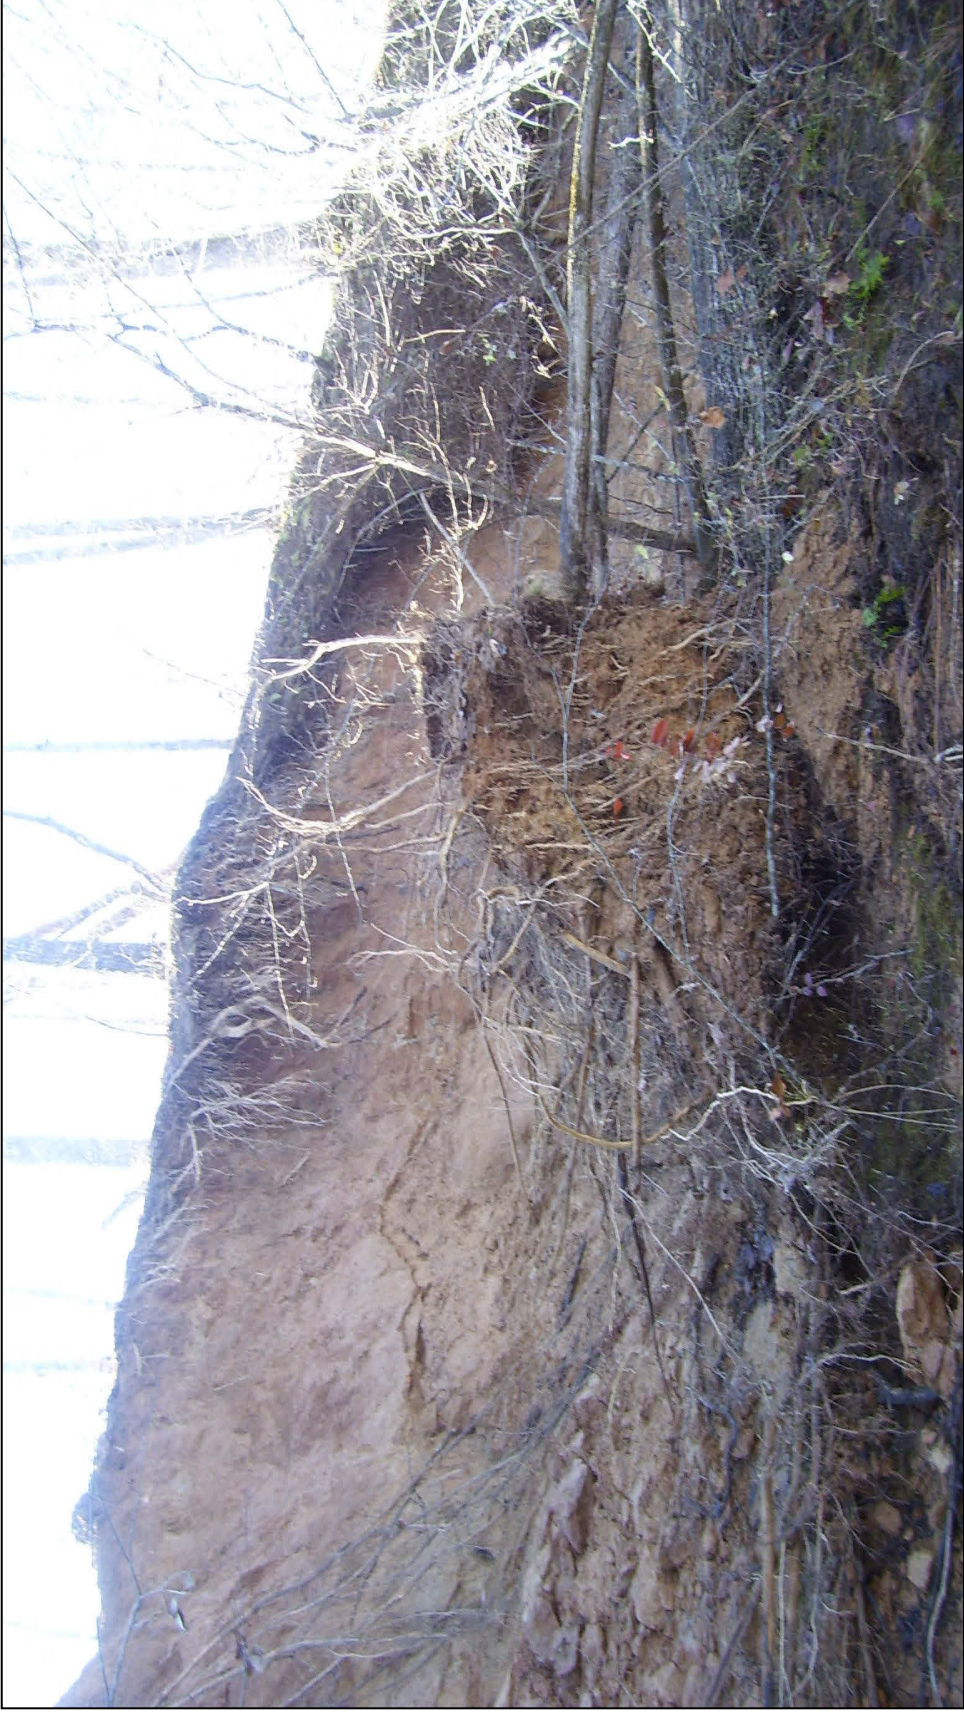
Photo 2. River Observation Point 1

Location: Deep River downstream of the Norfolk-Southern rail bridge
Description: Bank failure and continued erosion into the Deep River

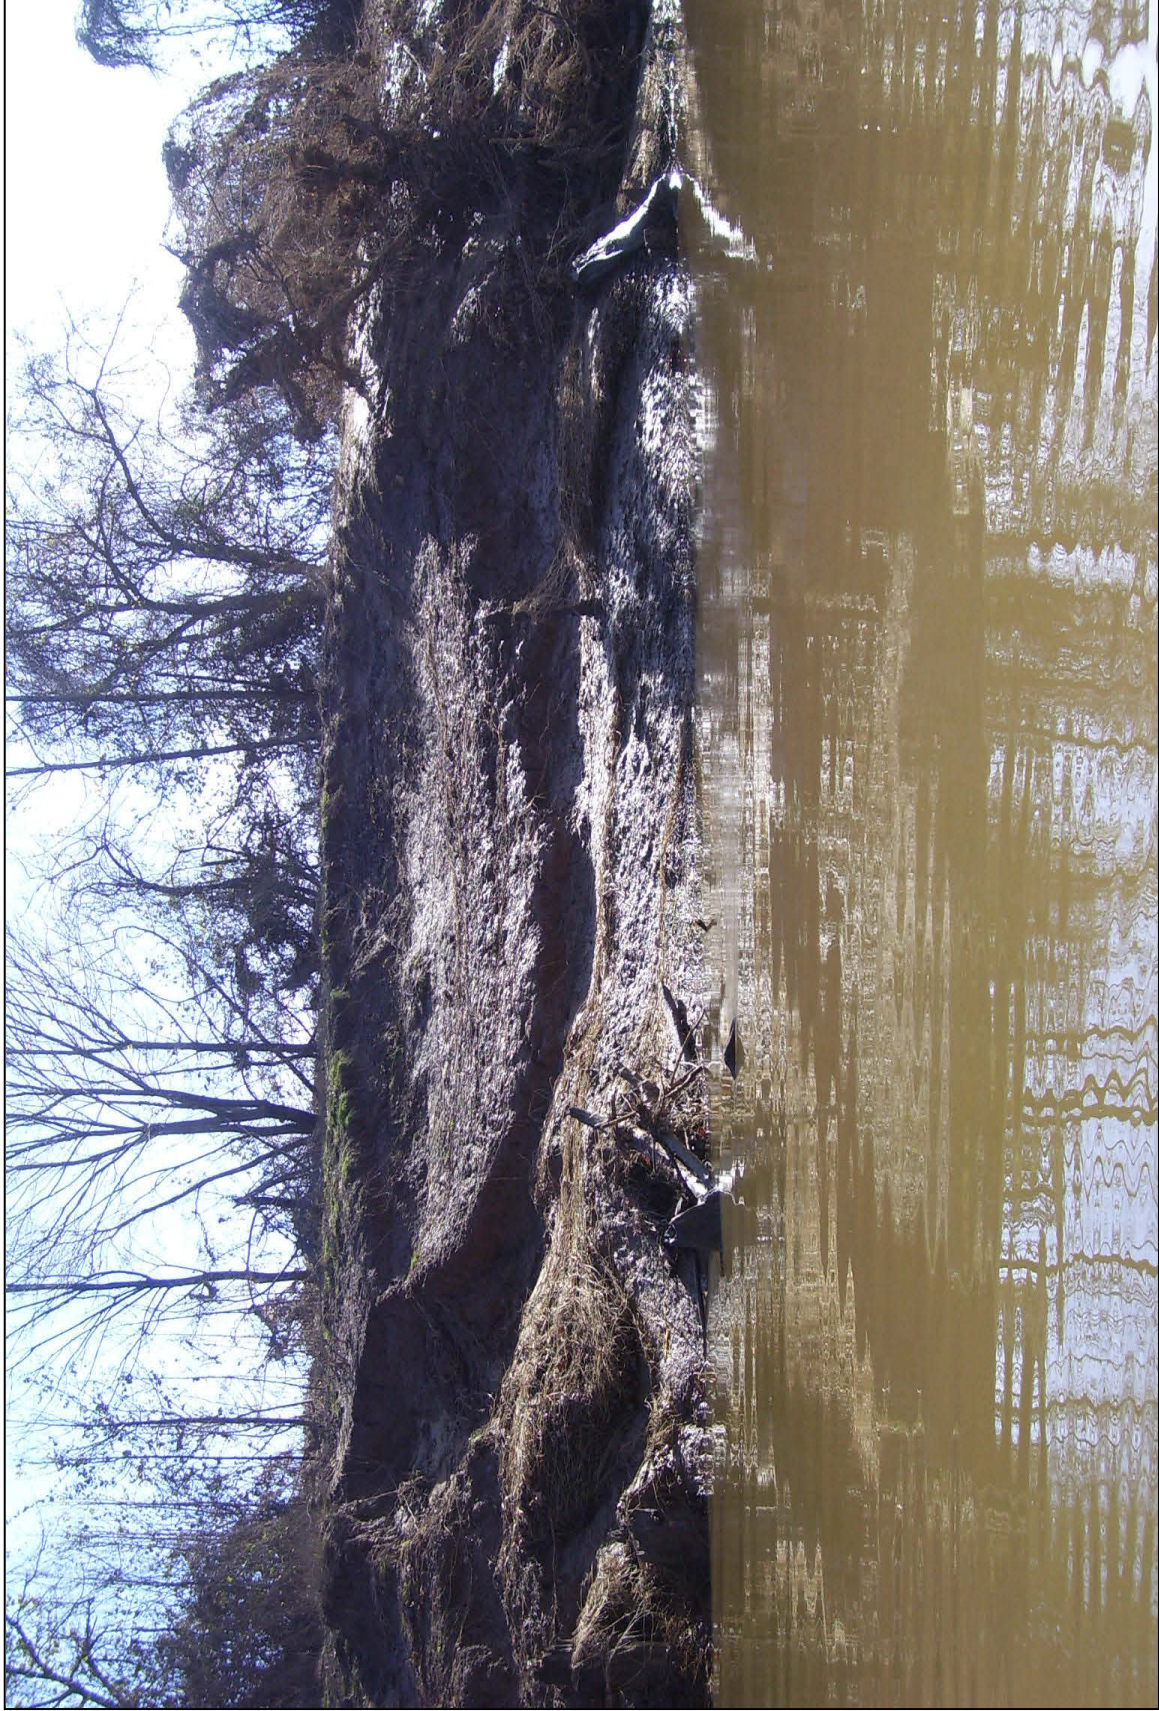
Photo 3. River Observation Point 2

Location: Deep River
Description: Bank failure and erosion into the Deep River

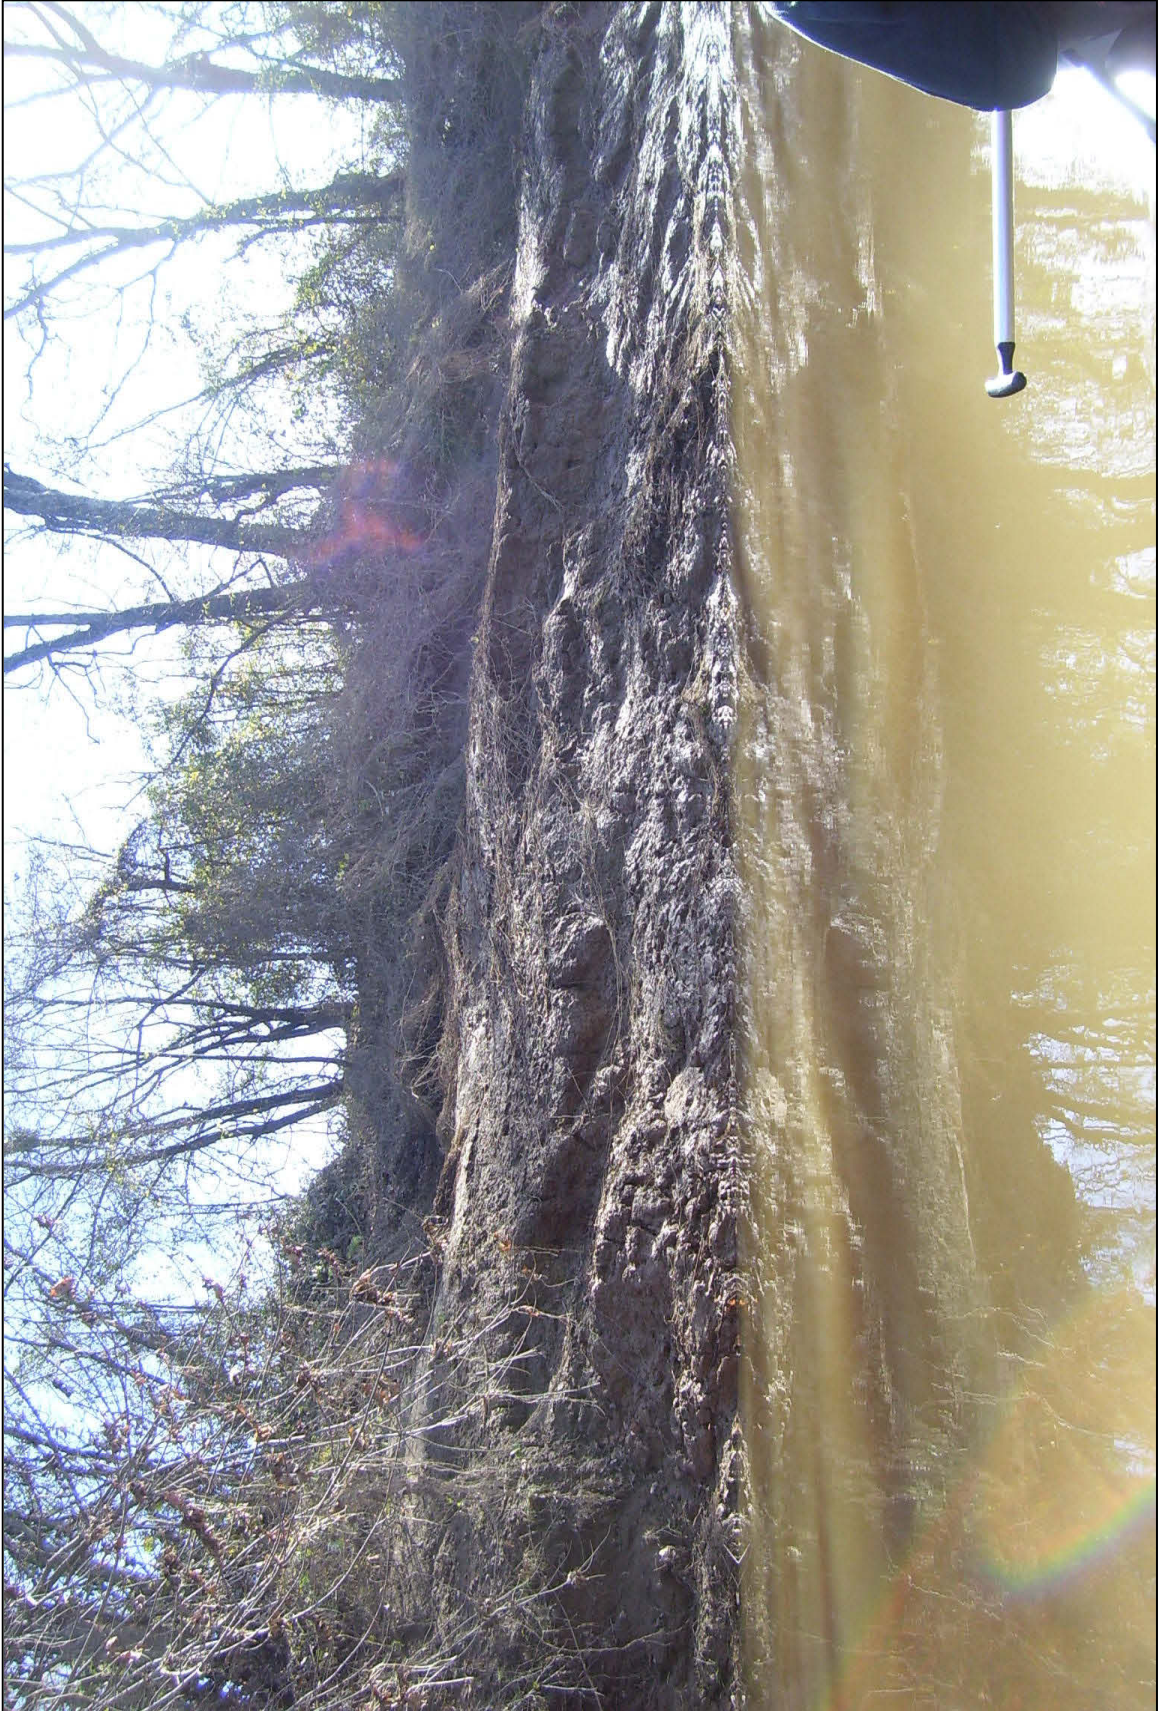
Photo 4. River Observation Point 2

Location: Deep River
Description: Bank failure and erosion into the Deep River

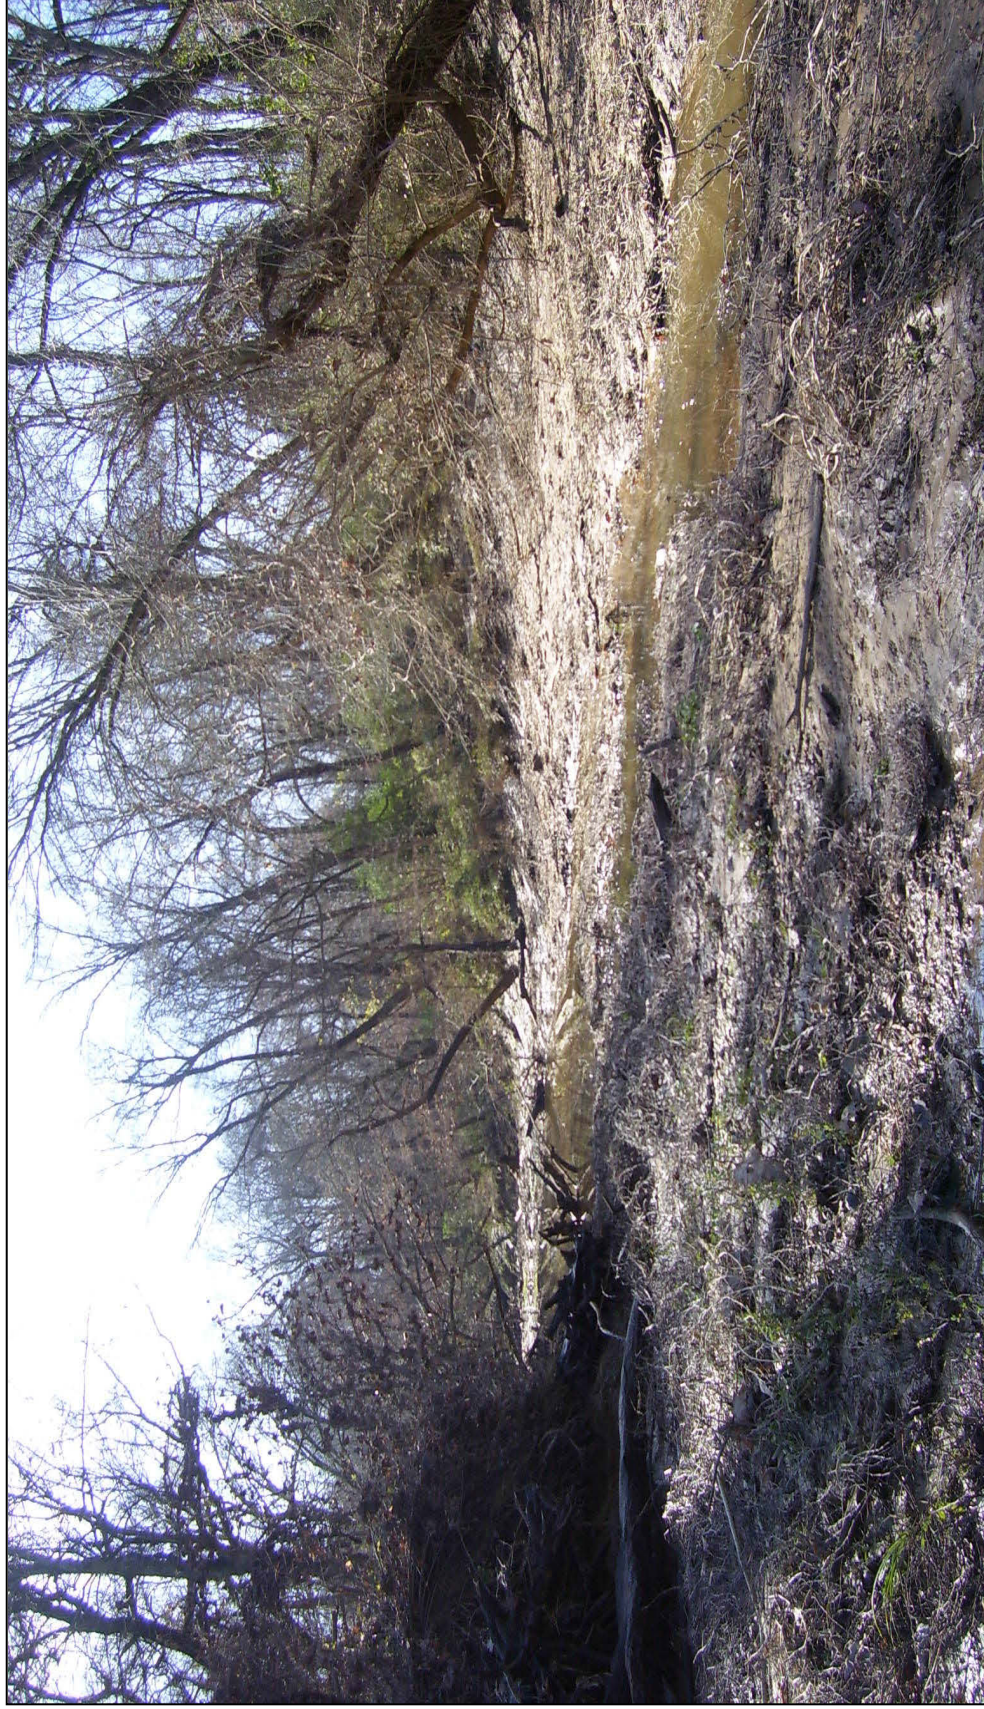
Photo 5. River Observation Point 3

Location: Confluence of the upstream end of an oxbow channel and the Deep River

Description: Overland flow and sediment transport resulting from storm surge

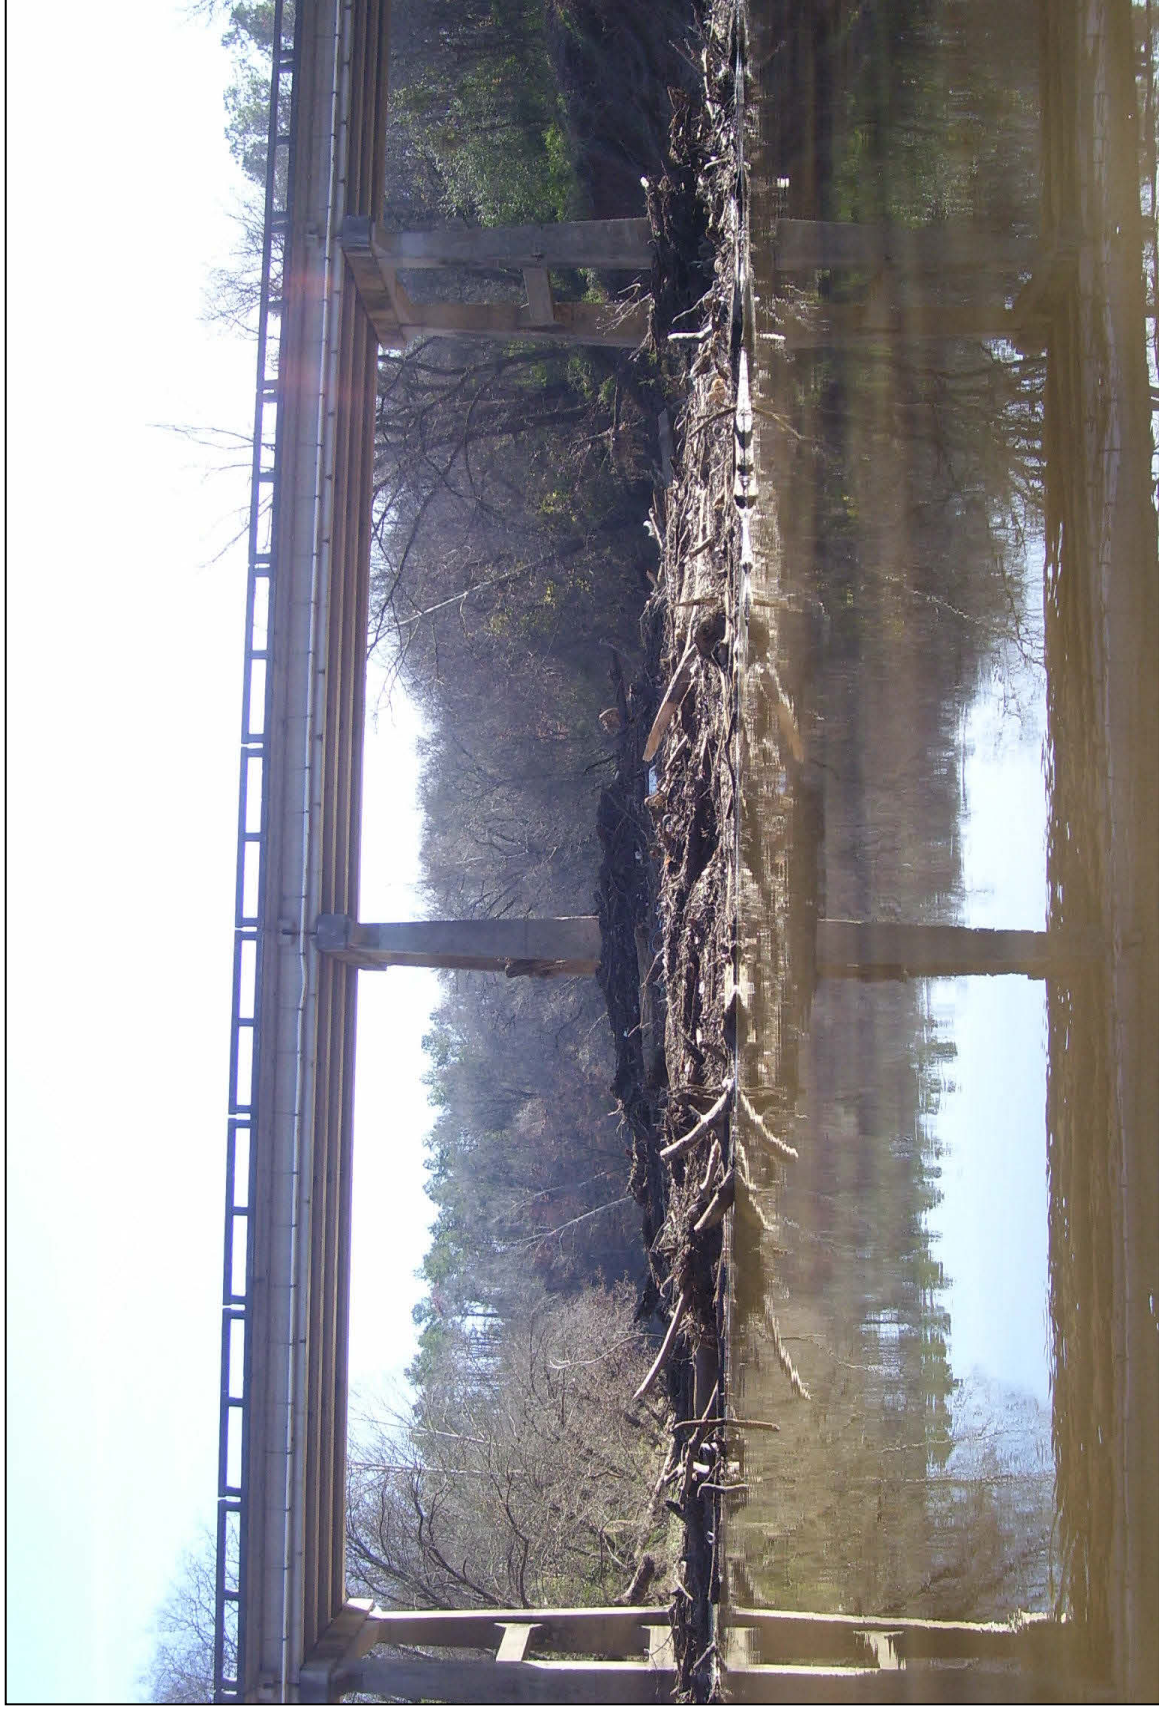
Photo 6. River Observation Point 4

Location: Carleton Road crossing of the Deep River
Description: Log jam behind bridge spans

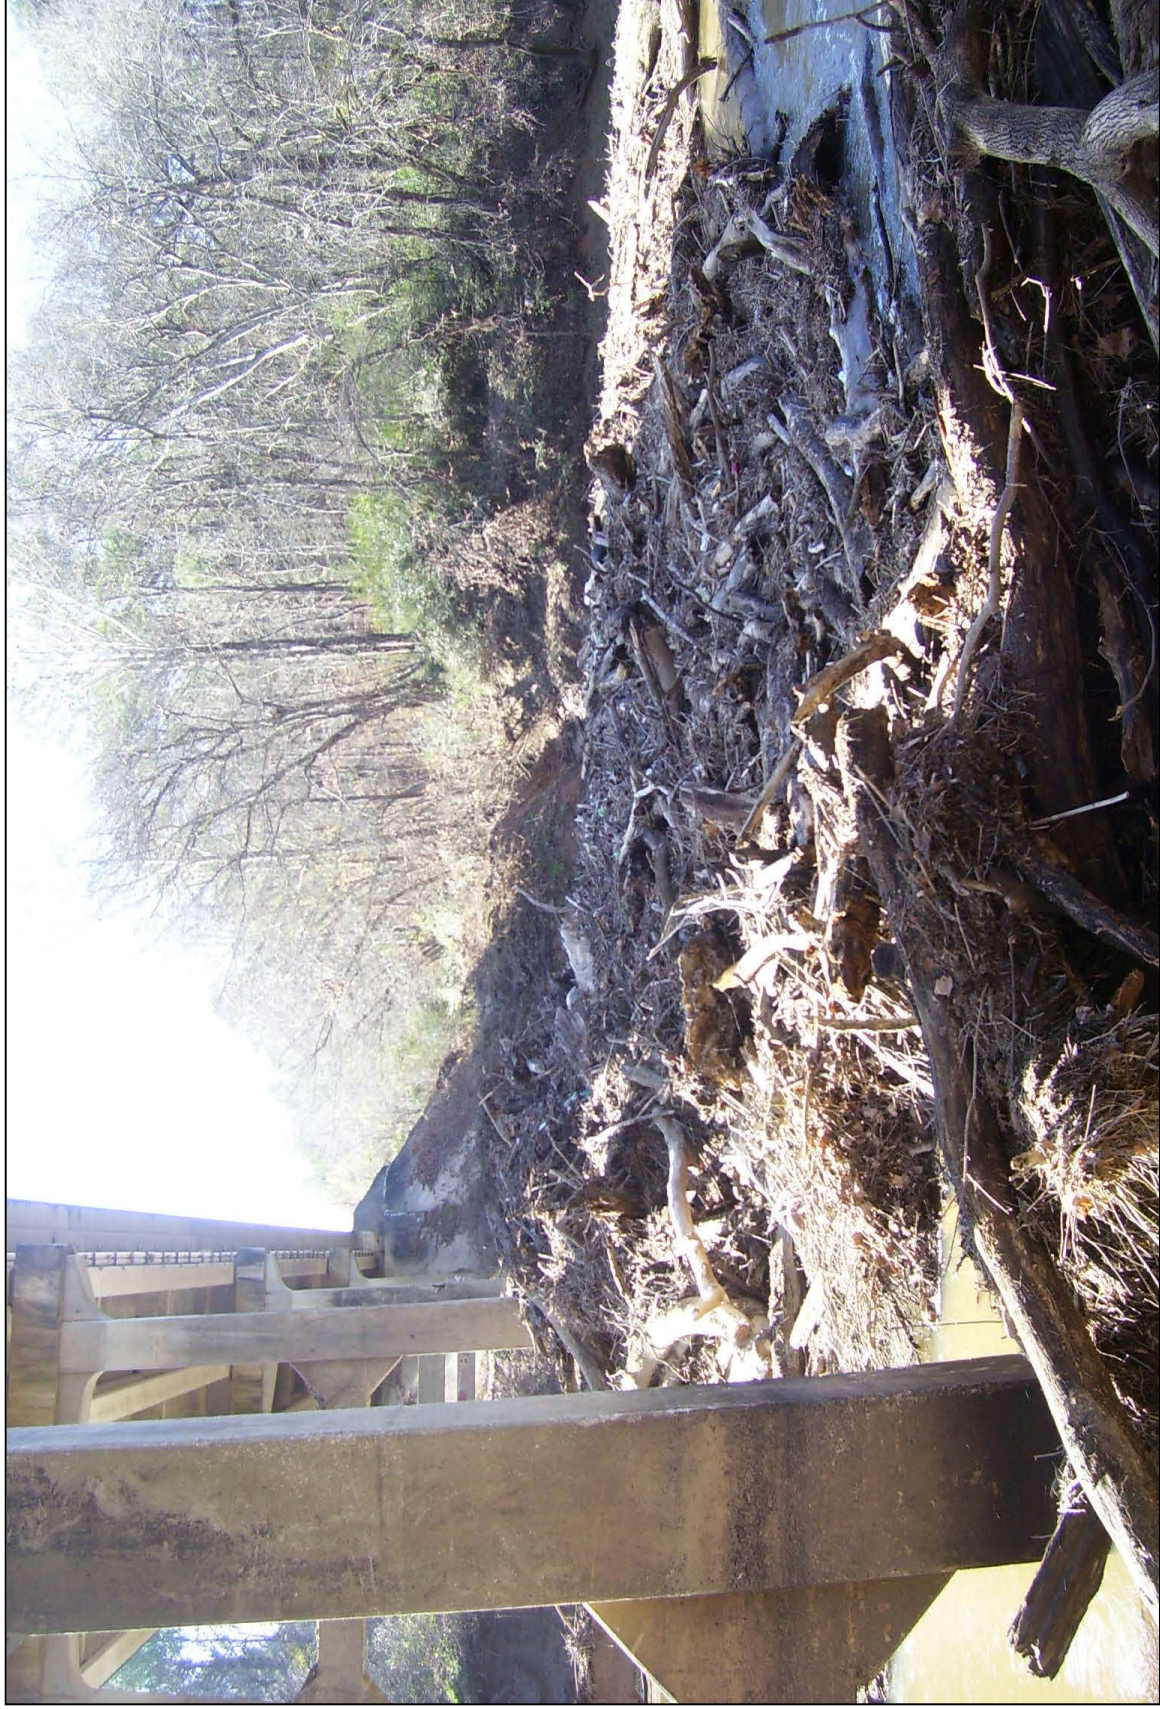
Photo 7. River Observation Point 4

Location: Carbondon Road crossing of the Deep River
Description: Log jam behind bridge spans

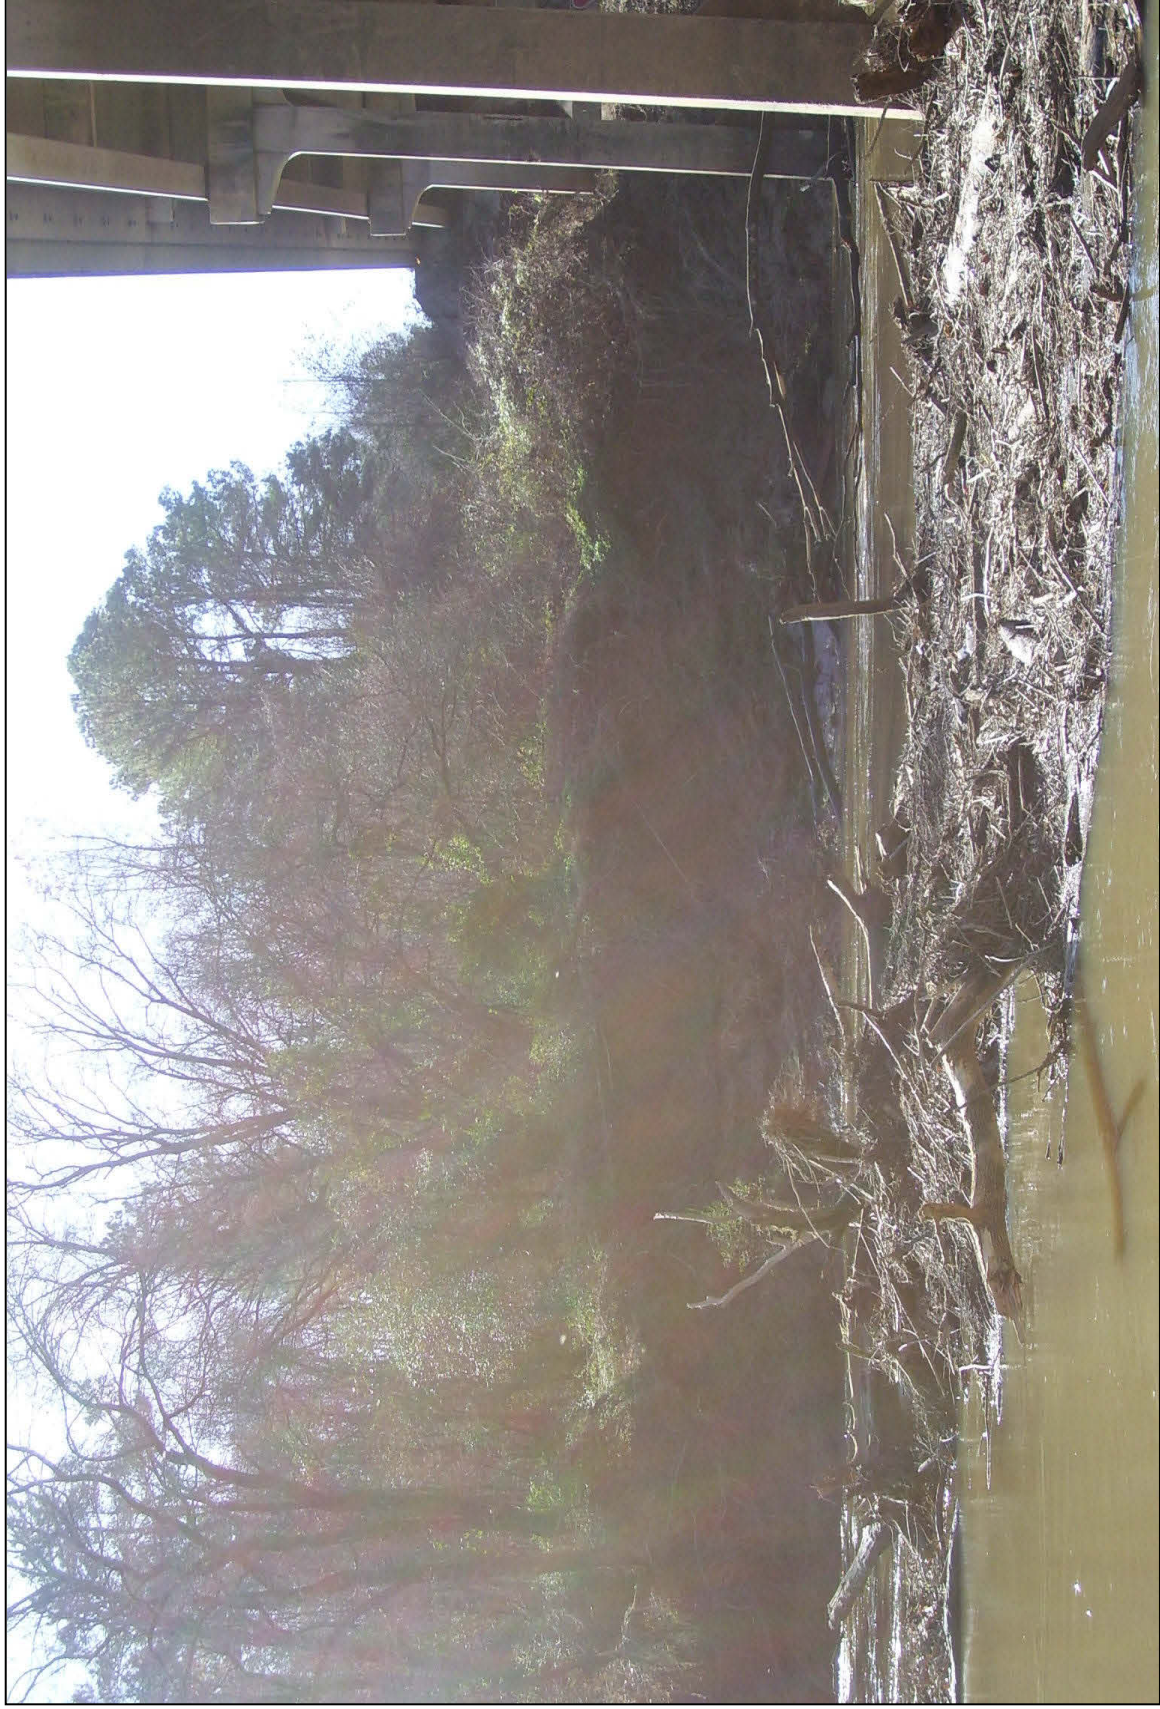
Photo 8. River Observation Point 4

Location: Carabnton Road bridge crossing of the Deep River
Description: Sloughing of bank material downstream of the bridge

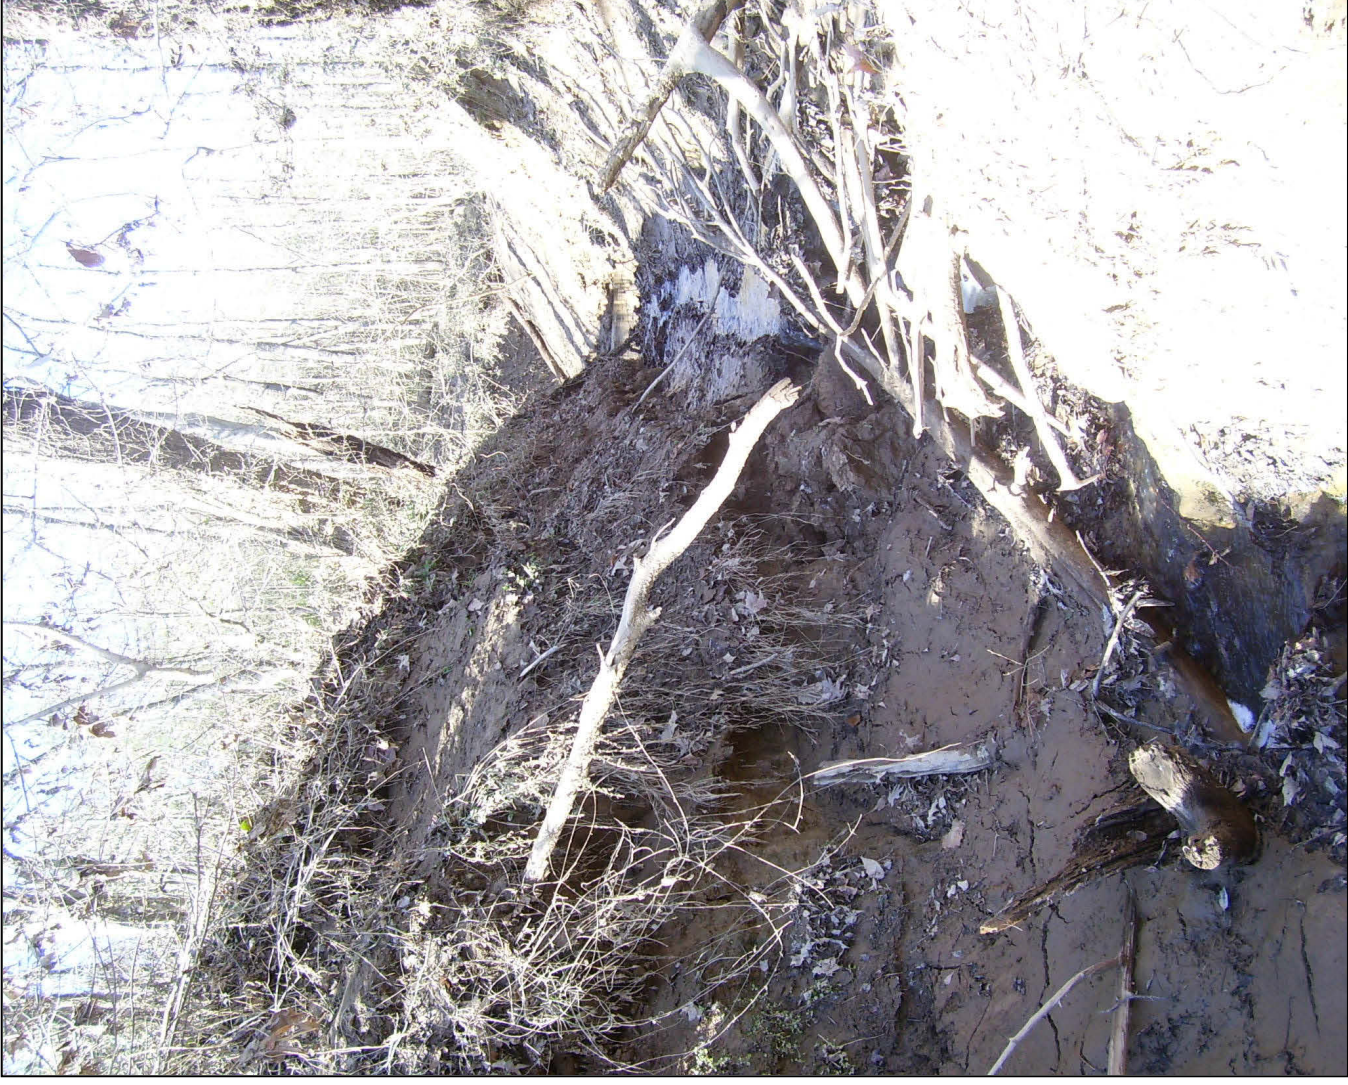
Photo 9. River Observation Point 5

Location: Confluence of the Deep River and an unnamed tributary

Description: Stream headcut and erosion of bank material

River Observation Point 5 is located on the right bank of the Deep River at the confluence with an unnamed tributary (Figure 2). At this location the rise in water level has eroded bank material, and widened the tributary channel width. A small headcut has also formed from the increased flow velocity. An accumulation of woody debris has collected at the confluence (Photo 9).

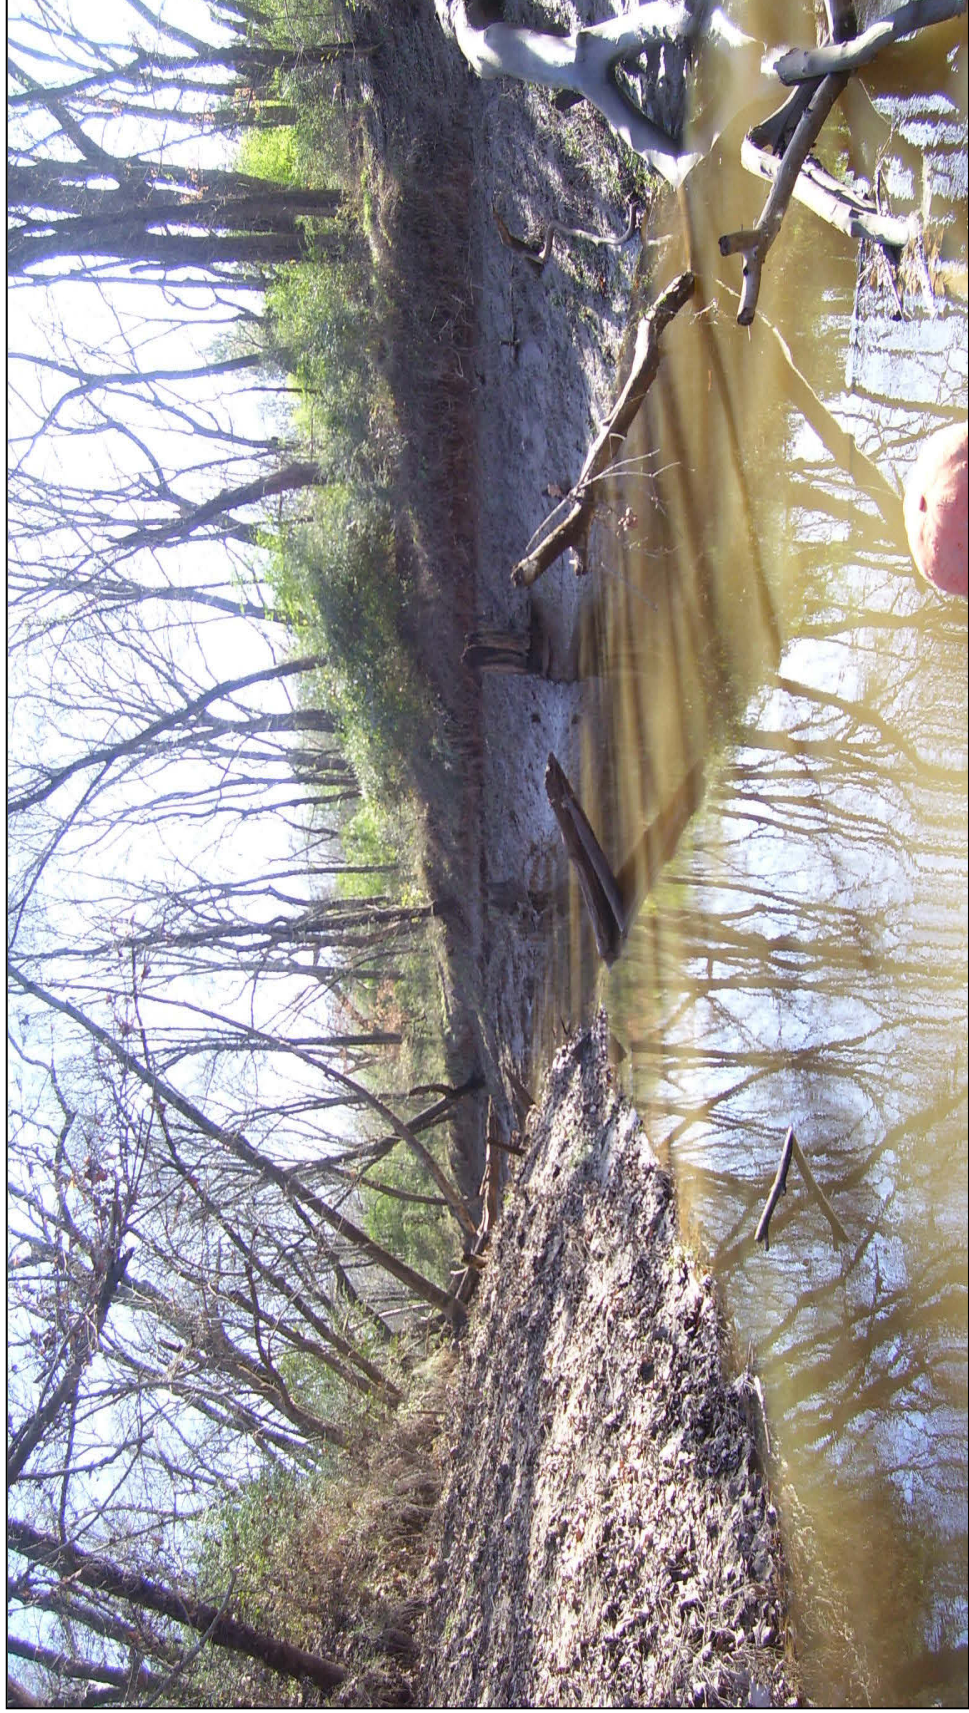
Photo 10. River Observation Point 6

Location: Confluence of the Deep River and Big Governor's Creek
Description: Stable banks with only minor erosion

River Observation Point 6 (previously evaluated on June 26, 2006) is located on the Deep River at the confluence with Big Governor's Creek (Figure 2). A few areas at waters edge showed continued scouring but the majority of the bank material appeared stable and intact despite lacking vegetative cover. A large accumulation of woody debris remains at the confluence (Photo 10).

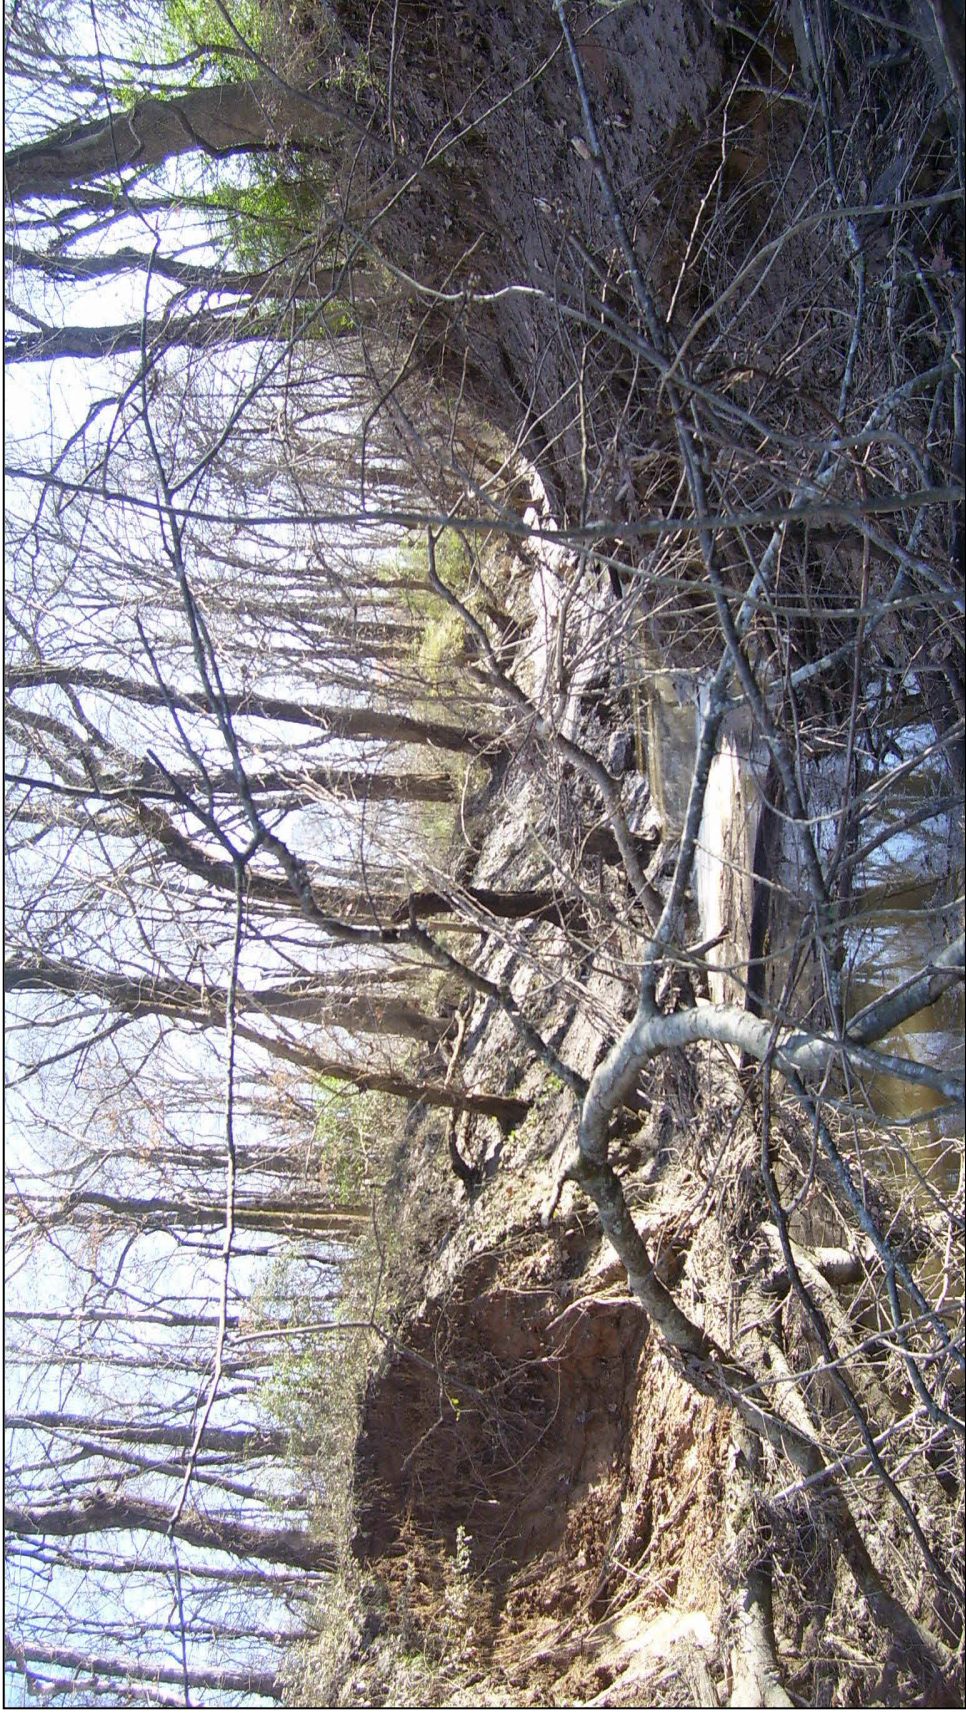
Photo 11. River Observation Point 7

Location: Confluence of the Deep River and an unnamed tributary
Description: Continued headcutting and erosion of bank material
