**CARBONTON DAM – DEEP RIVER WATERSHED
RESTORATION SITE
2007 Annual Monitoring Report (Year 2)**

**Chatham, Lee and Moore Counties, NC
EEP Project No. D-04012A
Design Firm: Milone and MacBroom, Inc.**

**Prepared for: NCDENR - ECOSYSTEM ENHANCEMENT PROGRAM
1652 Mail Service Center
Raleigh, North Carolina 27699-1619**

**Prepared by: ECOSCIENCE CORPORATION
1101 Haynes Street, Suite 101
Raleigh, North Carolina 27604**

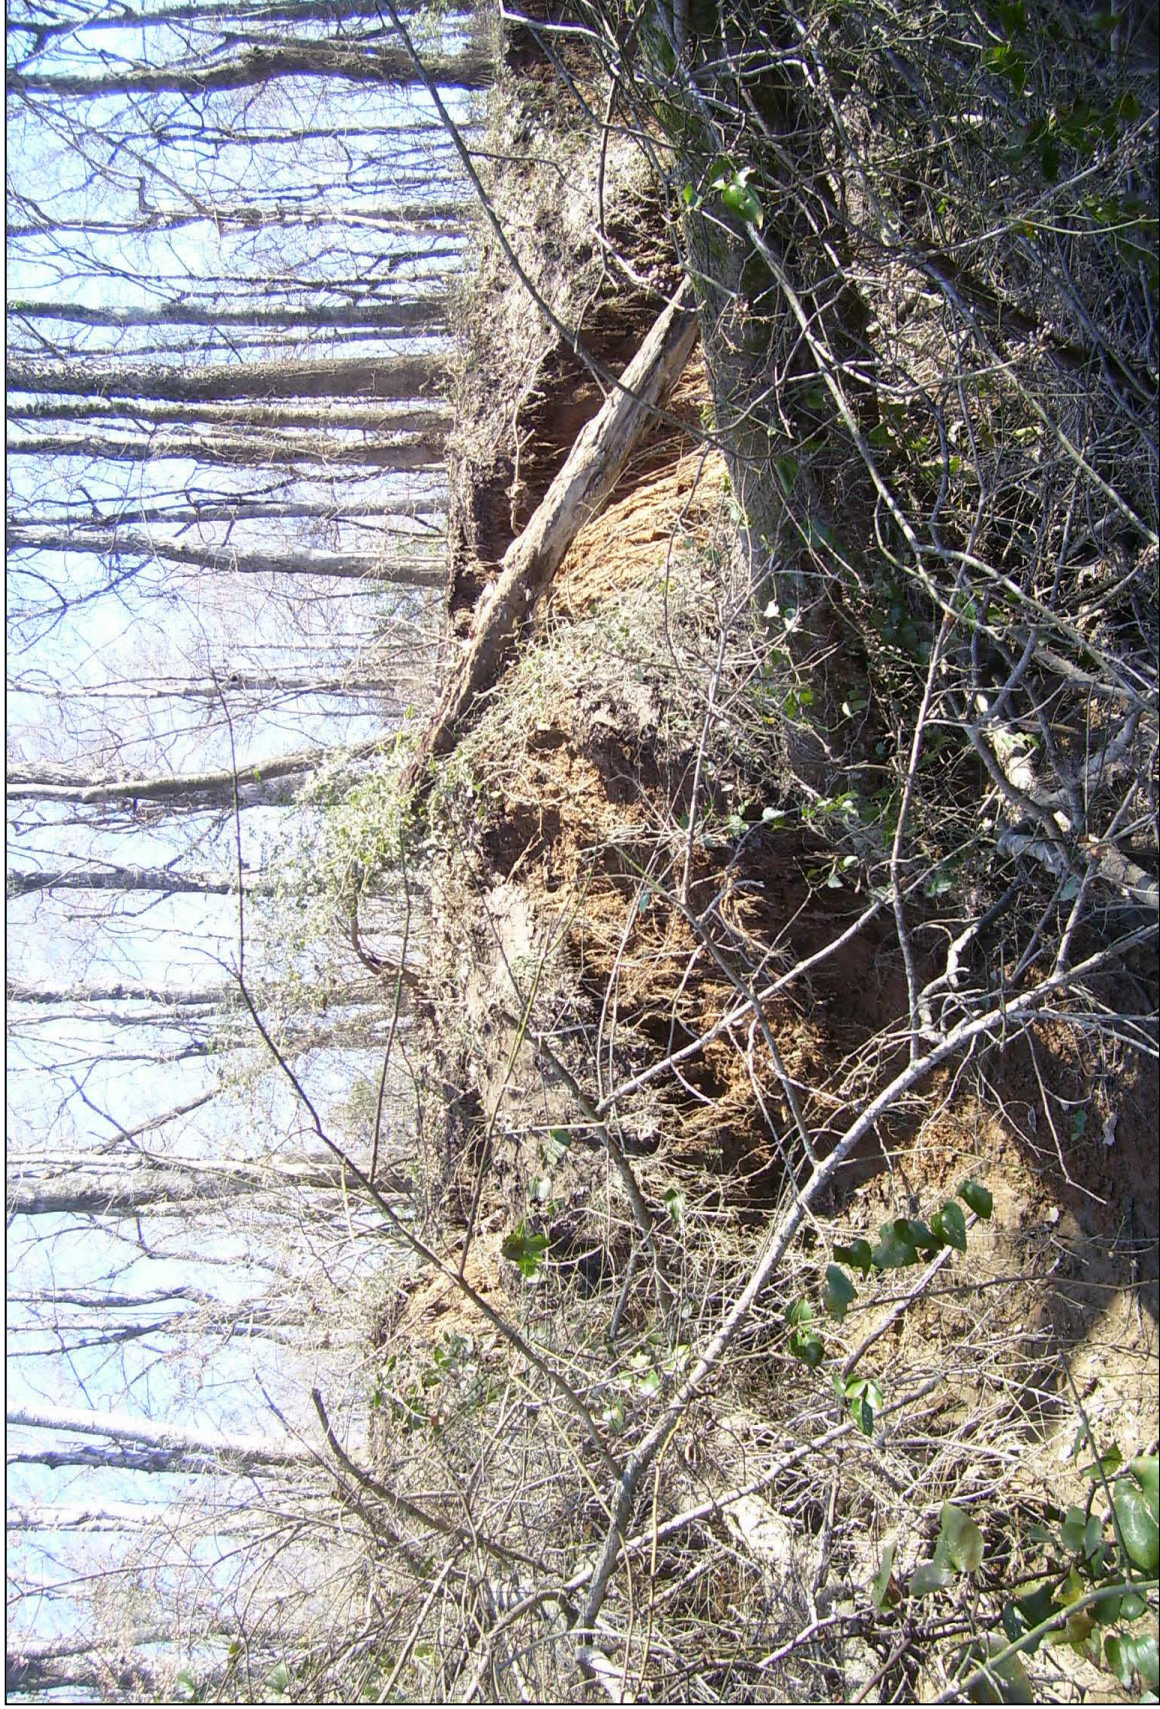
Photo 12. River Observation Point 7

Location: Confluence of the Deep River and an unnamed tributary
Description: Multiple trees fallen over as a result of undercut banks

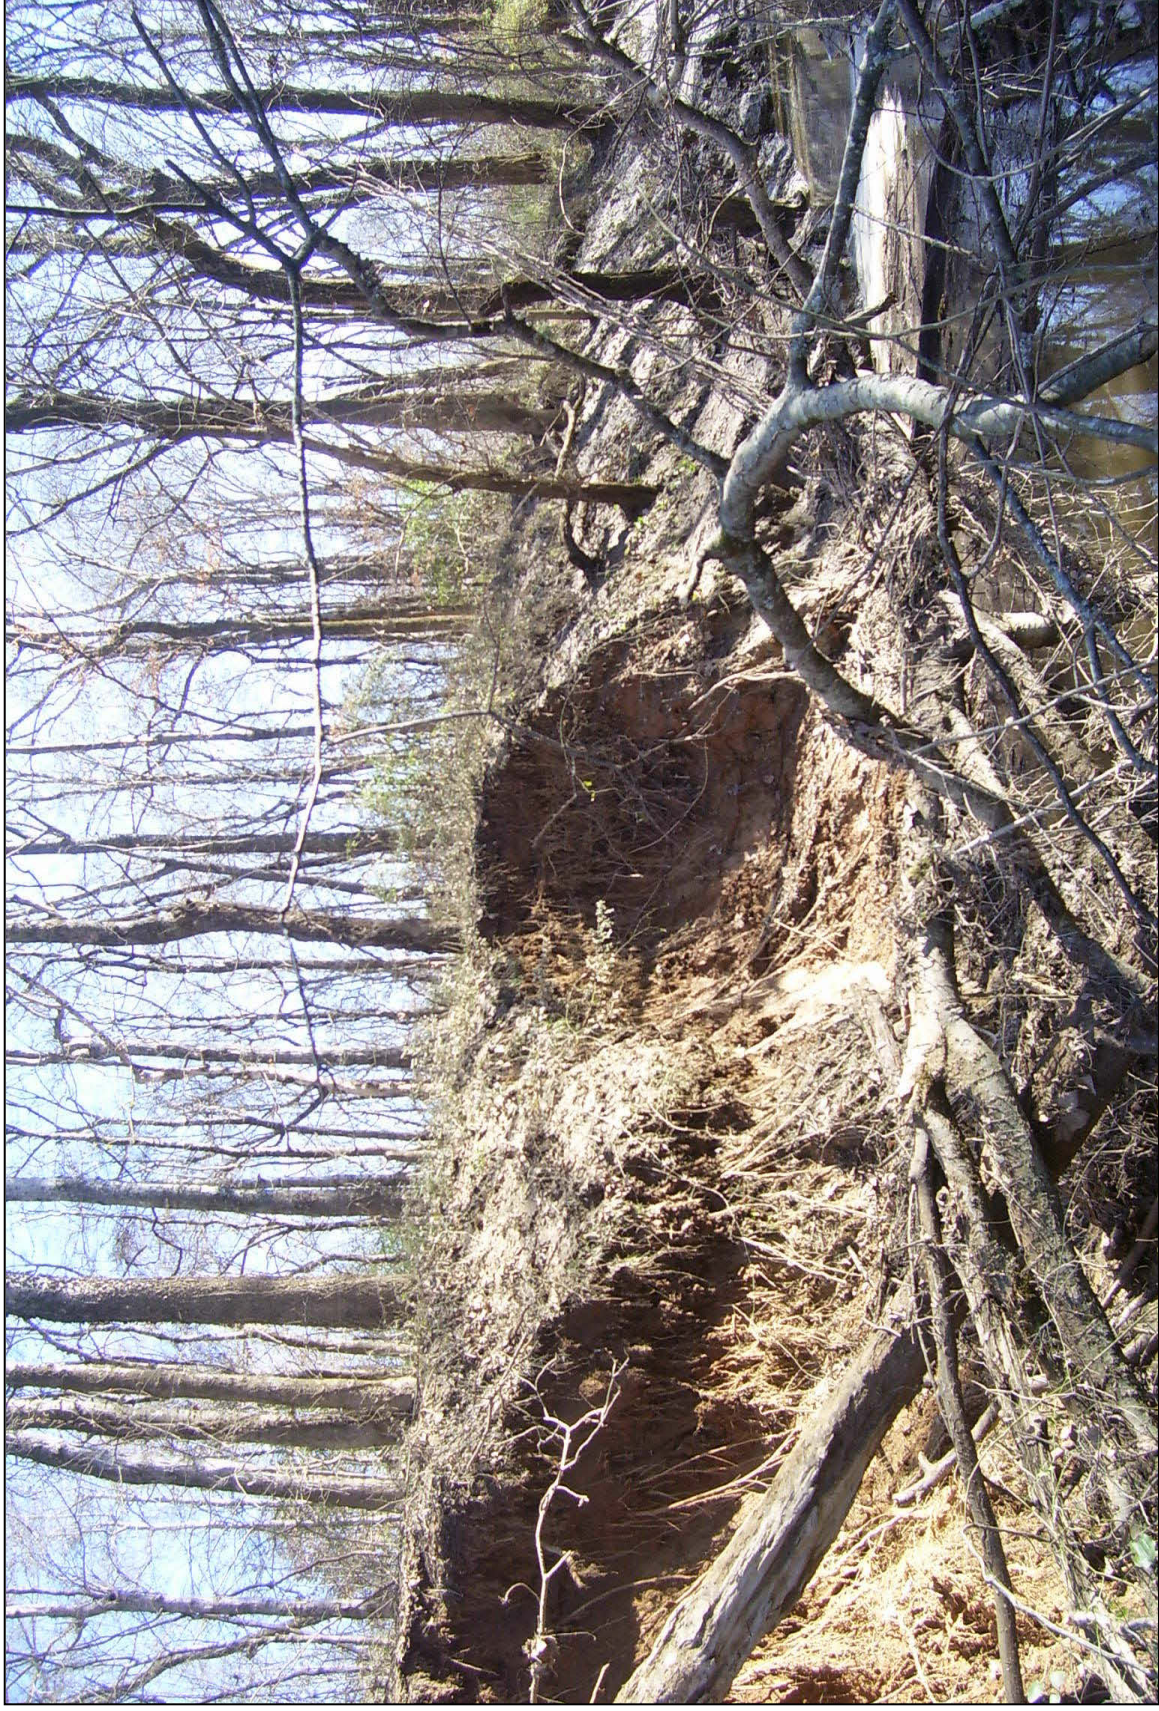
Photo 13. River Observation Point 7

Location: Confluence of the Deep River and an unnamed tributary
Description: Multiple trees fallen over as a result of undercut banks

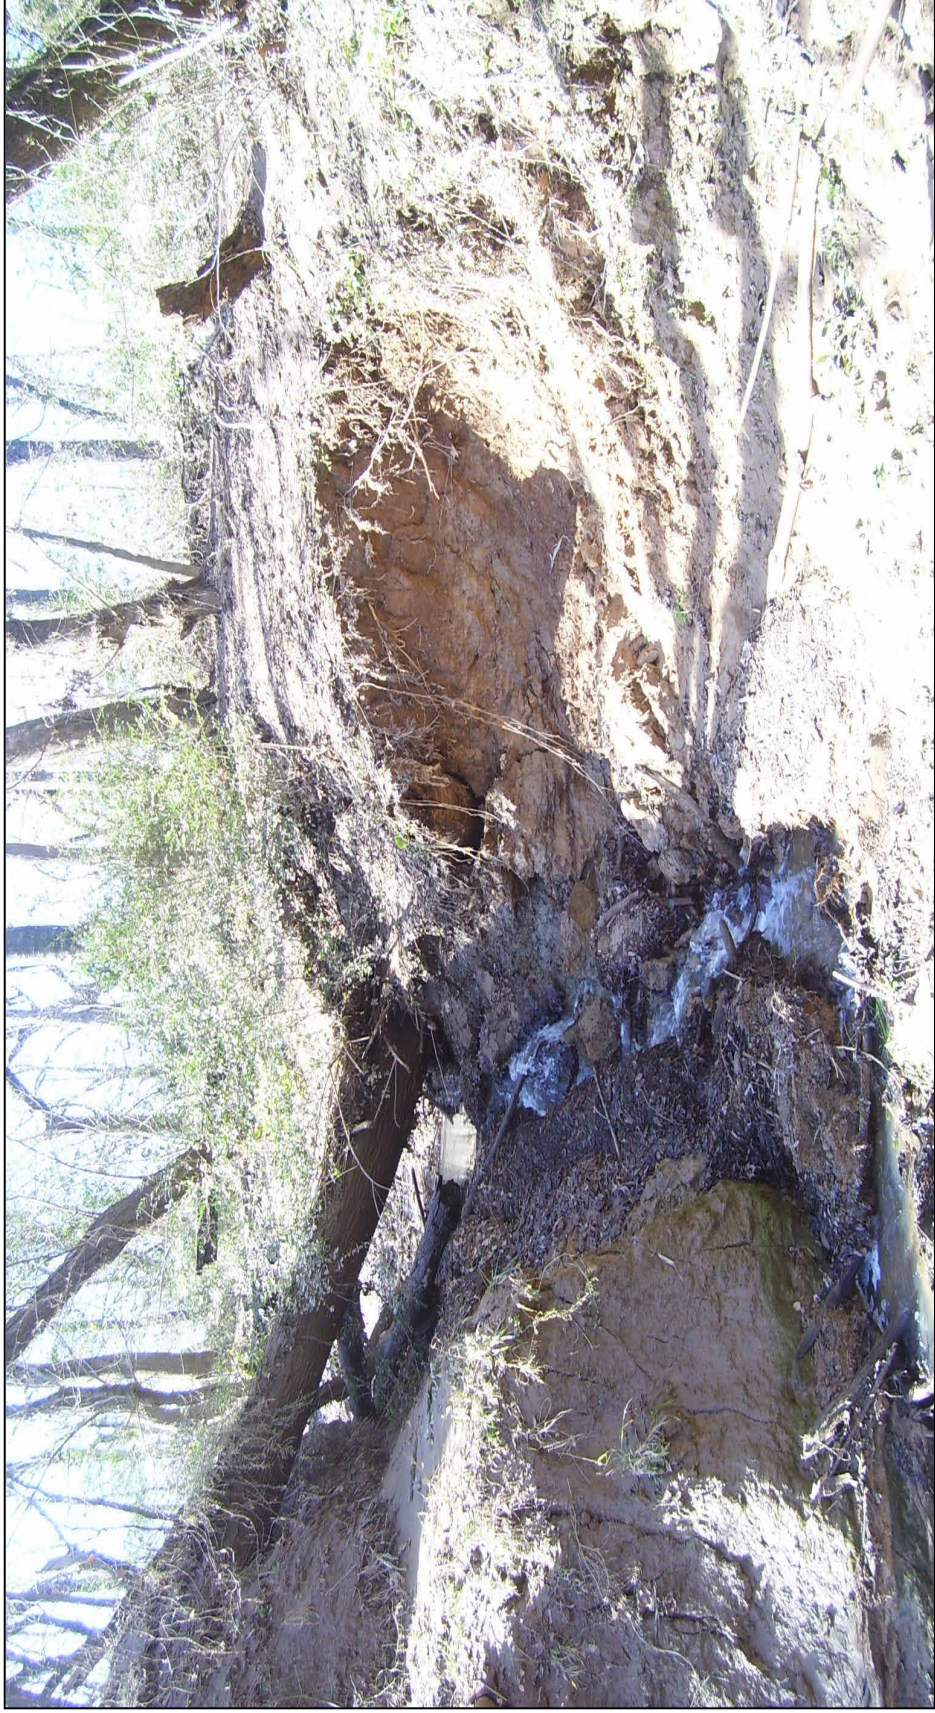
Photo 14. River Observation Point 8

Location: Confluence of the Deep River and an unnamed tributary near Monitoring Station 27
Description: Continued headcutting and erosion of bank material

River Observation Point 8 (previously evaluated on June 26, 2006) is located on the Deep River at the confluence with an unnamed tributary (Figure 2) near Monitoring Station 27. A headcut continues to transport sediment from the tributary and has eroded further upstream (Photo 14). At the mouth of the confluence the banks are steep and incised. A scoured pit remains where a tree was uprooted during the last storm on June 26 (Photo 15).

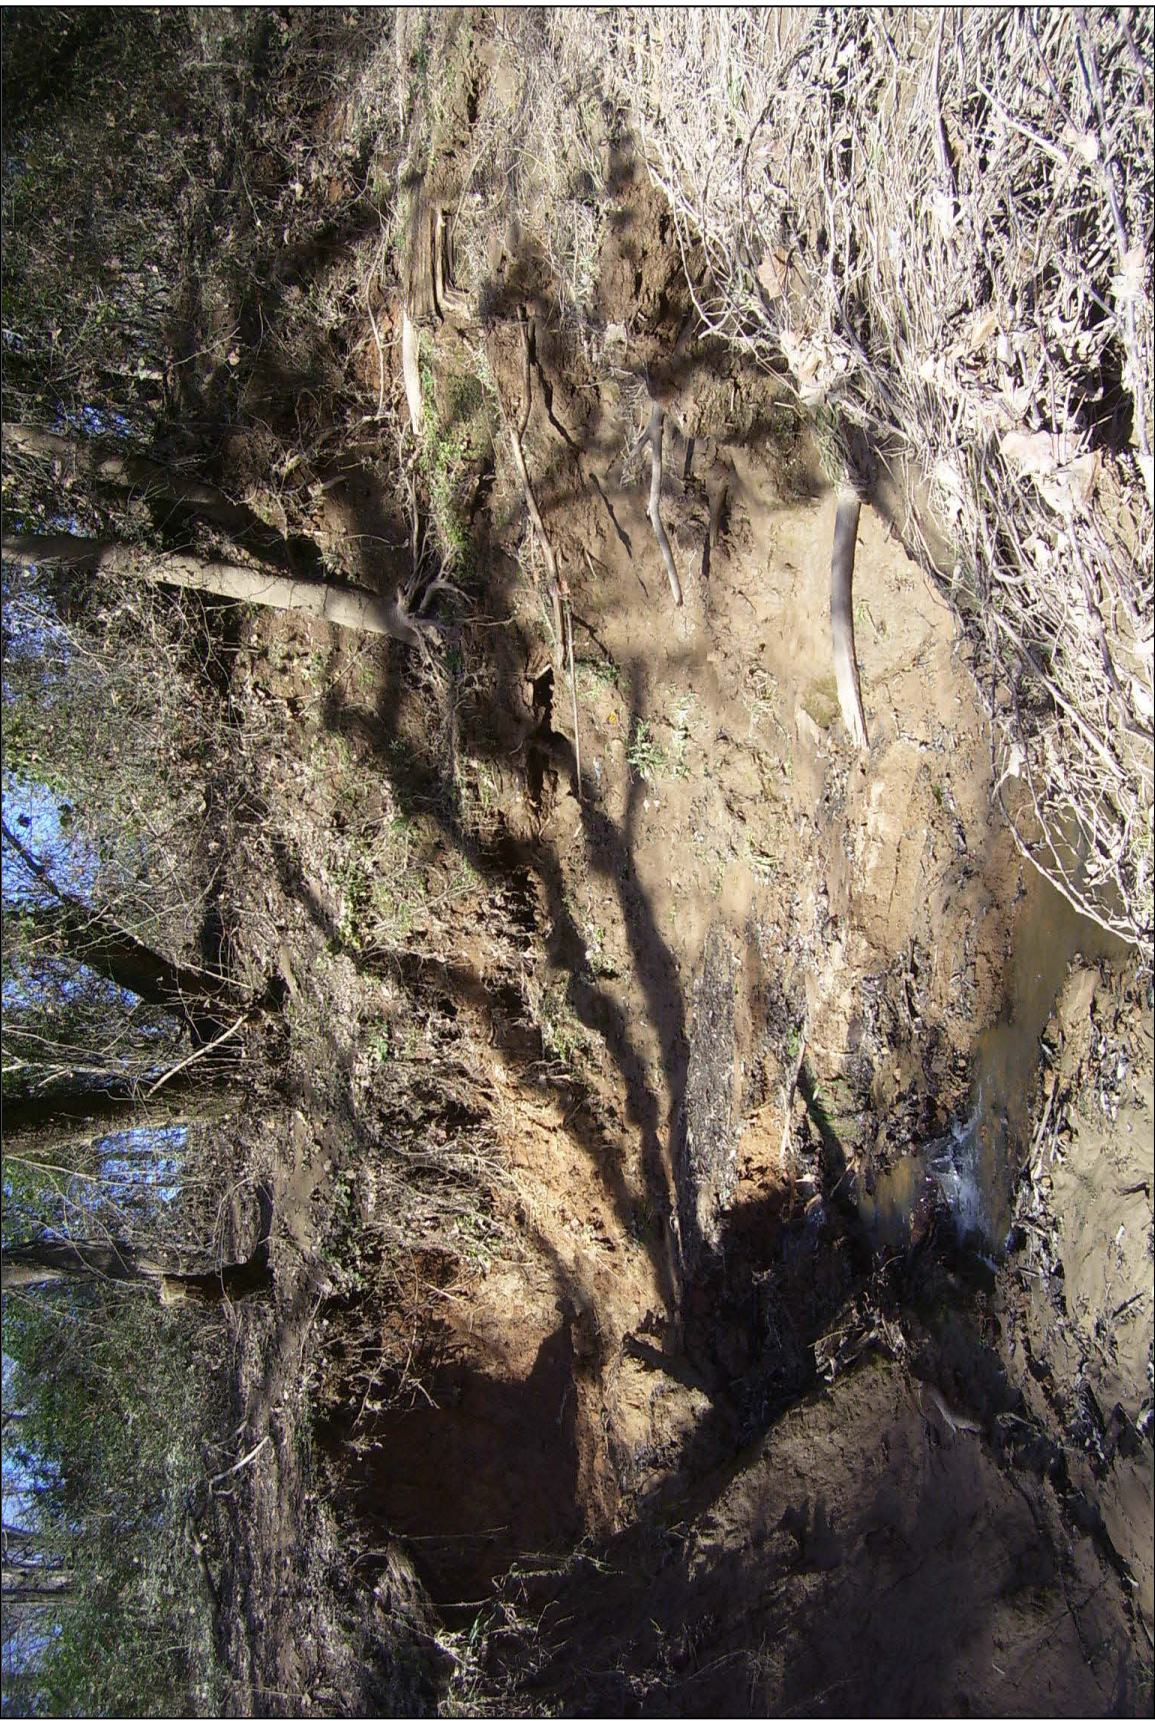
Photo 15. River Observation Point 8

Location: Confluence of the Deep River and an unnamed tributary near Monitoring Station 27
Description: Erosion of bank material from stormflow

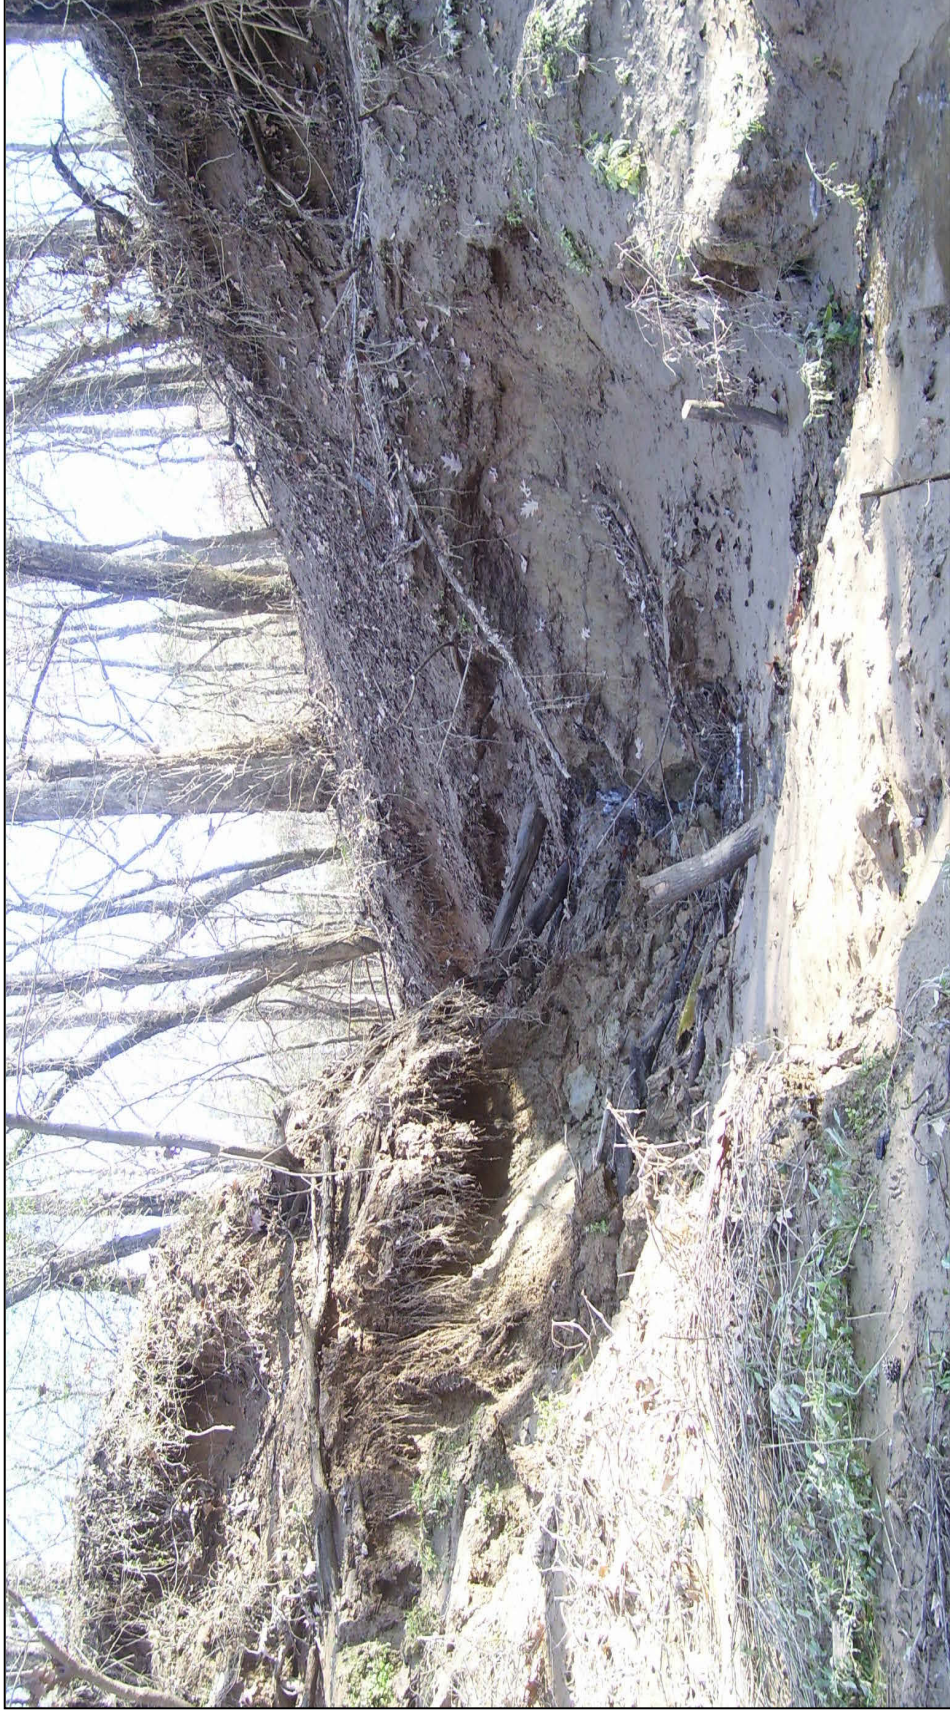
Photo 16. River Observation Point 9

Location: Confluence of the Deep River and an unnamed tributary
Description: Continued headcutting and erosion of bank material

River Observation Point 9 (previously evaluated on June 26, 2006) is located on the Deep River at the confluence with an unnamed tributary (Figure 2). A large headcut at the confluence continues to migrate upstream, and bank material continues to slough off. Limited vegetation on the banks of the confluence has allowed for continued erosion of bank material (Photo 16).

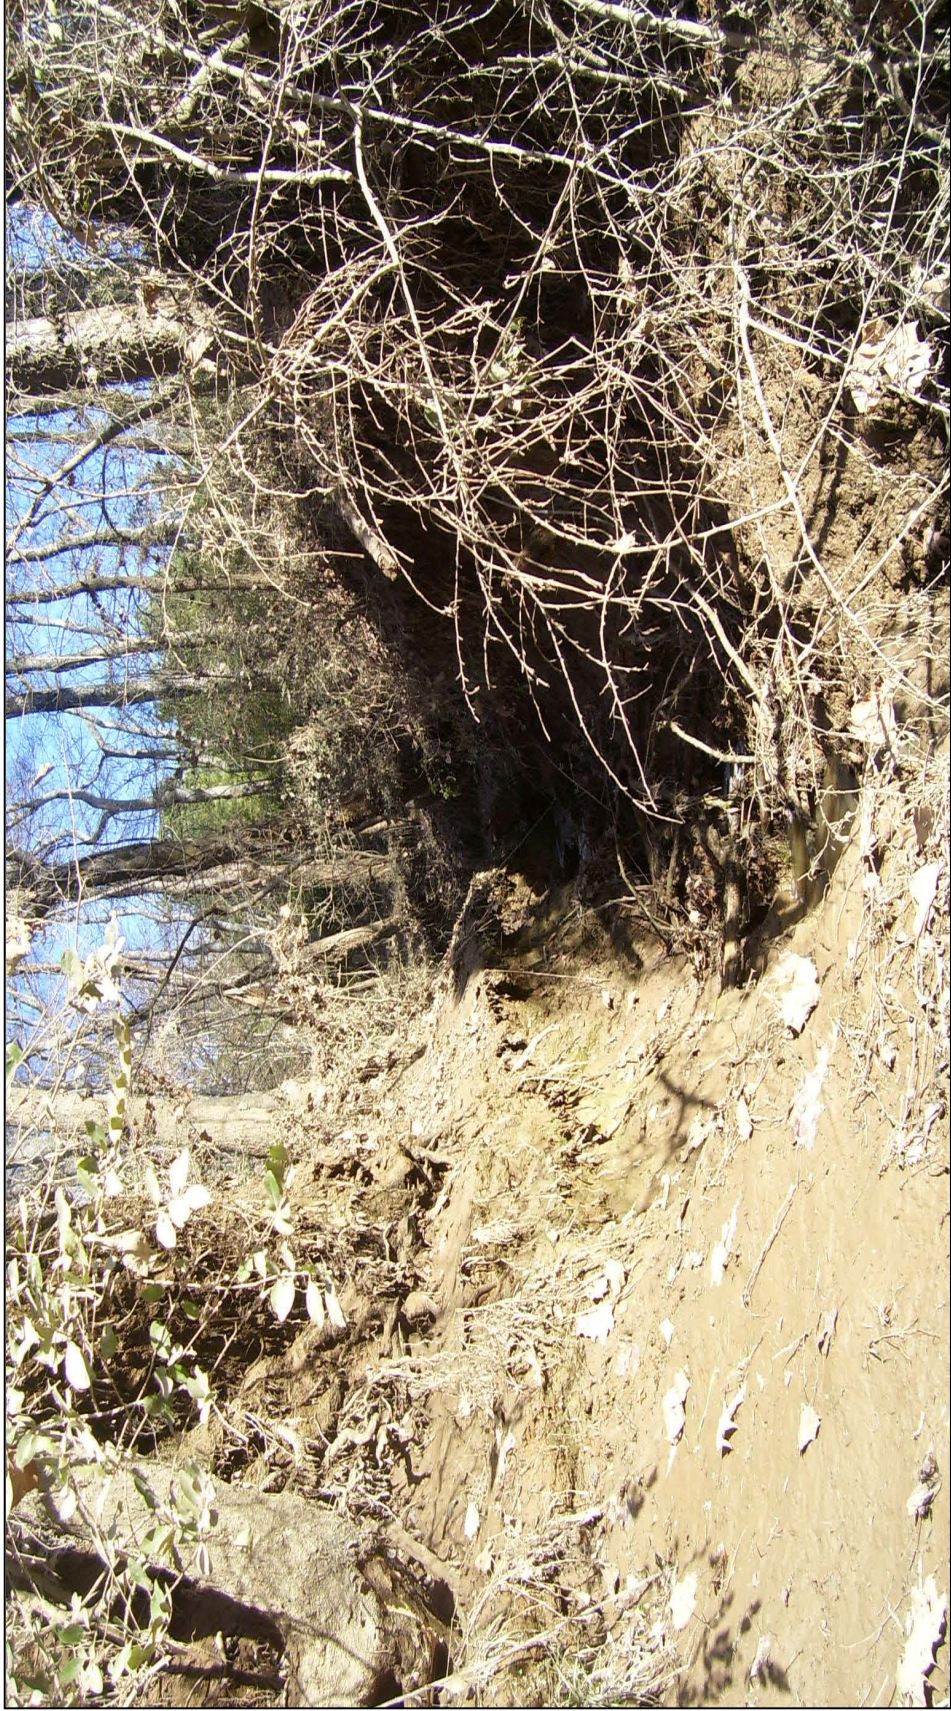
Photo 17. River Observation Point 10

Location: Confluence of the Deep River and an unnamed tributary near Monitoring Station 2
Description: Continued headcutting and sluffing of bank material

River Observation Point 10 (previously evaluated on June 26, 2006) is located on the Deep River at the confluence with an unnamed tributary (Figure 2) near Monitoring Station 2. The banks of the tributary at the confluence are very steep, and the previously observed headcut appears slightly further up the channel (Photo 17). A scour pool has formed at the base of the headcut from higher stormflow velocity (Photo 18). The majority of woody debris inside the tributary has washed into the Deep River.

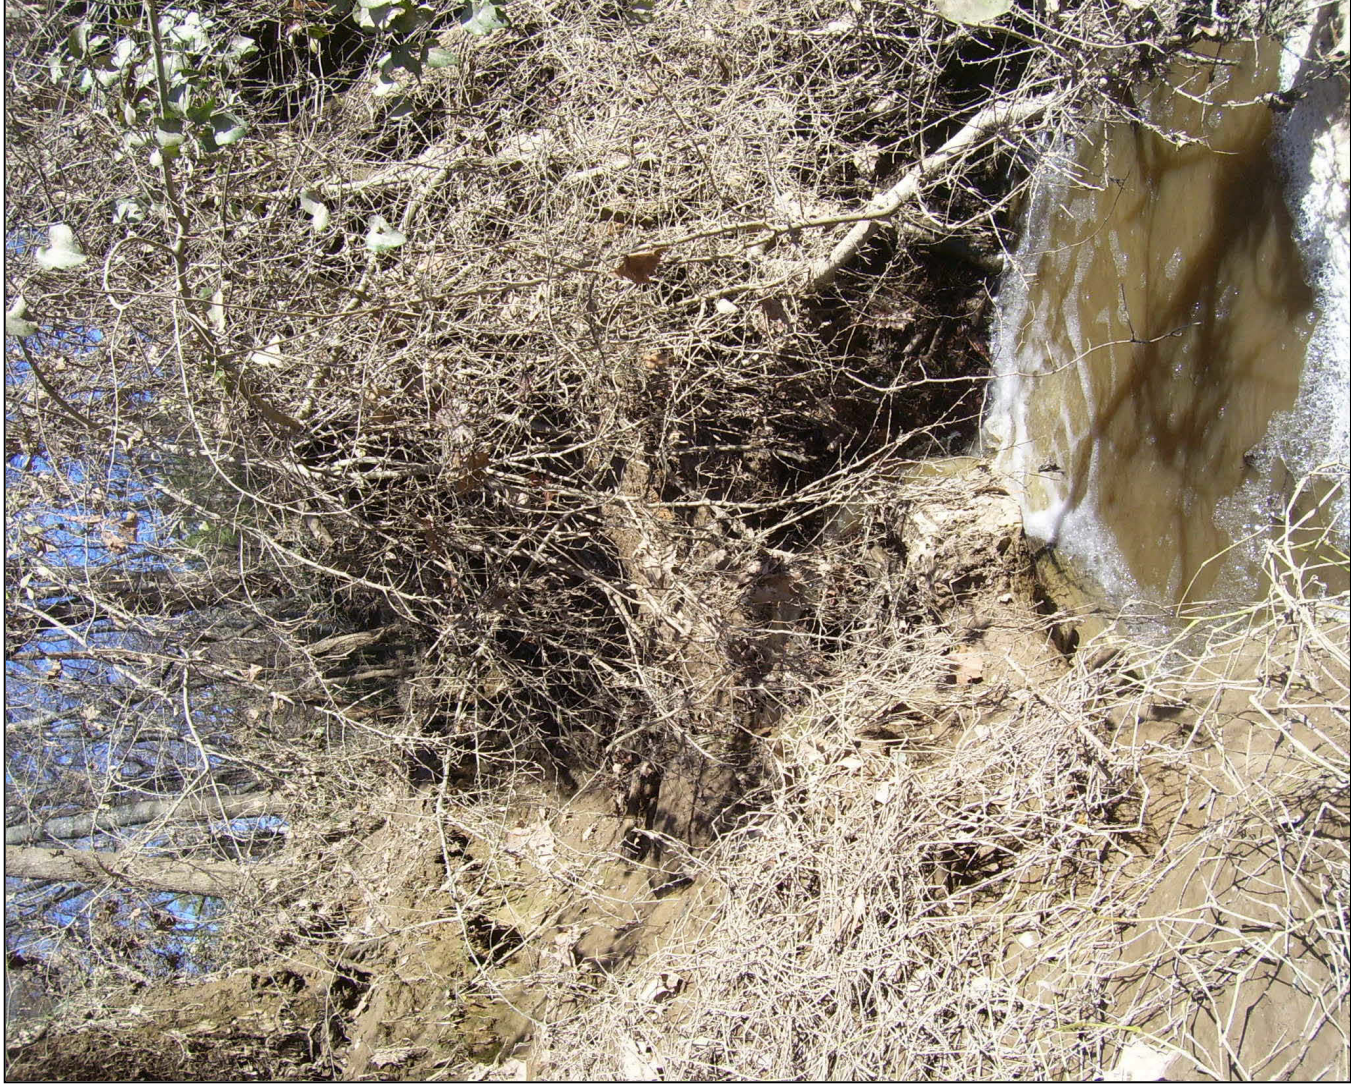
Photo 18. River Observation Point 10

Location: Confluence of the Deep River and an unnamed tributary near Monitoring Station 2

Description: Continued headcutting and erosion of bank material

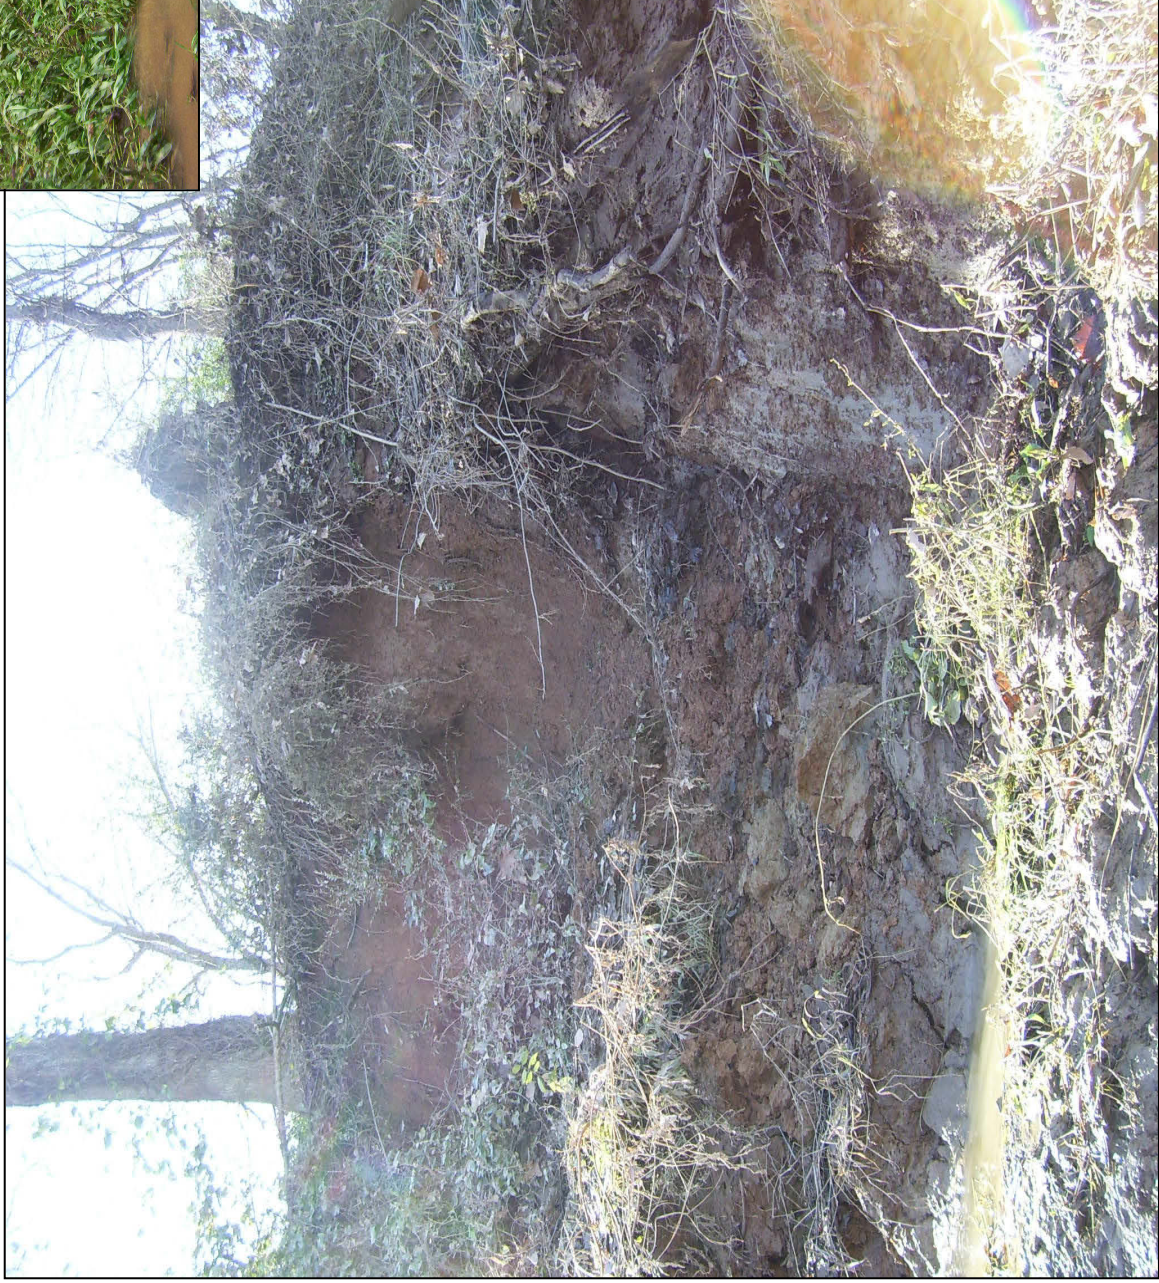
Photo 19. River Observation Point 11

Location: Confluence of the Deep River and an unnamed tributary near Monitoring Station 23
Description: Continued headcutting and erosion of right bank

has continued moving sediment out of the tributary and banks remain steep and unvegetated. Only minor signs of bank erosion near the waters edge were observed (Photo 19).

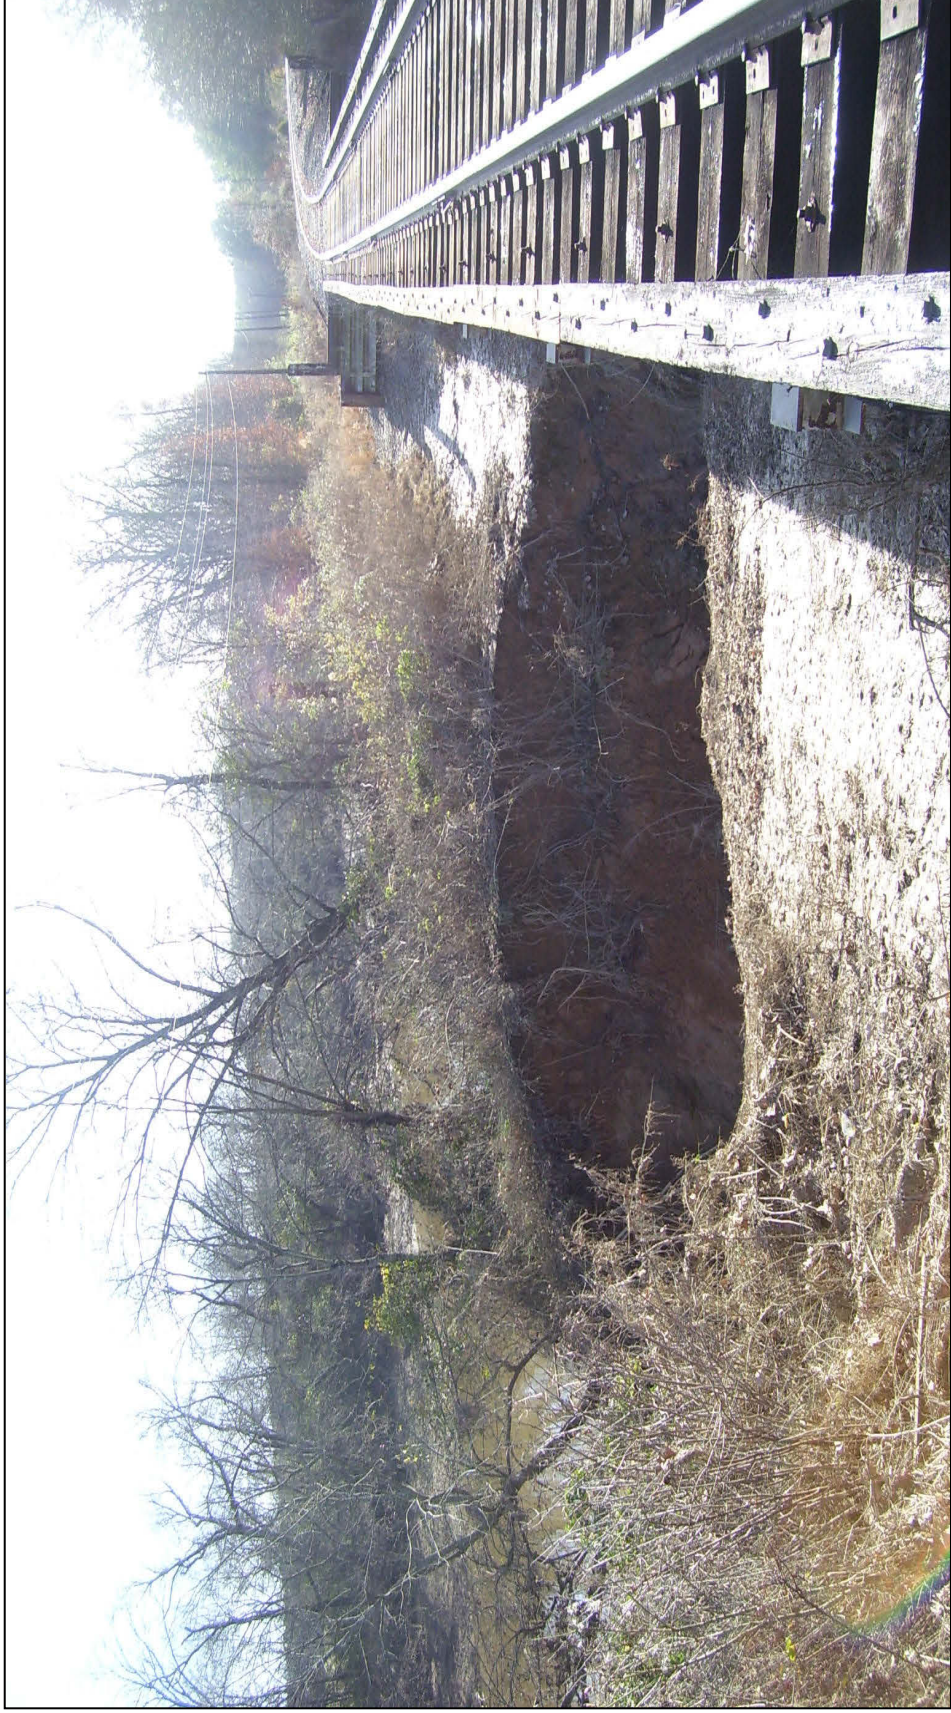
Photo 20. River Observation Point 12

Location: Confluence of the Deep River and Line Creek
Description: Continued erosion of bank material and woody debris (looking from above)

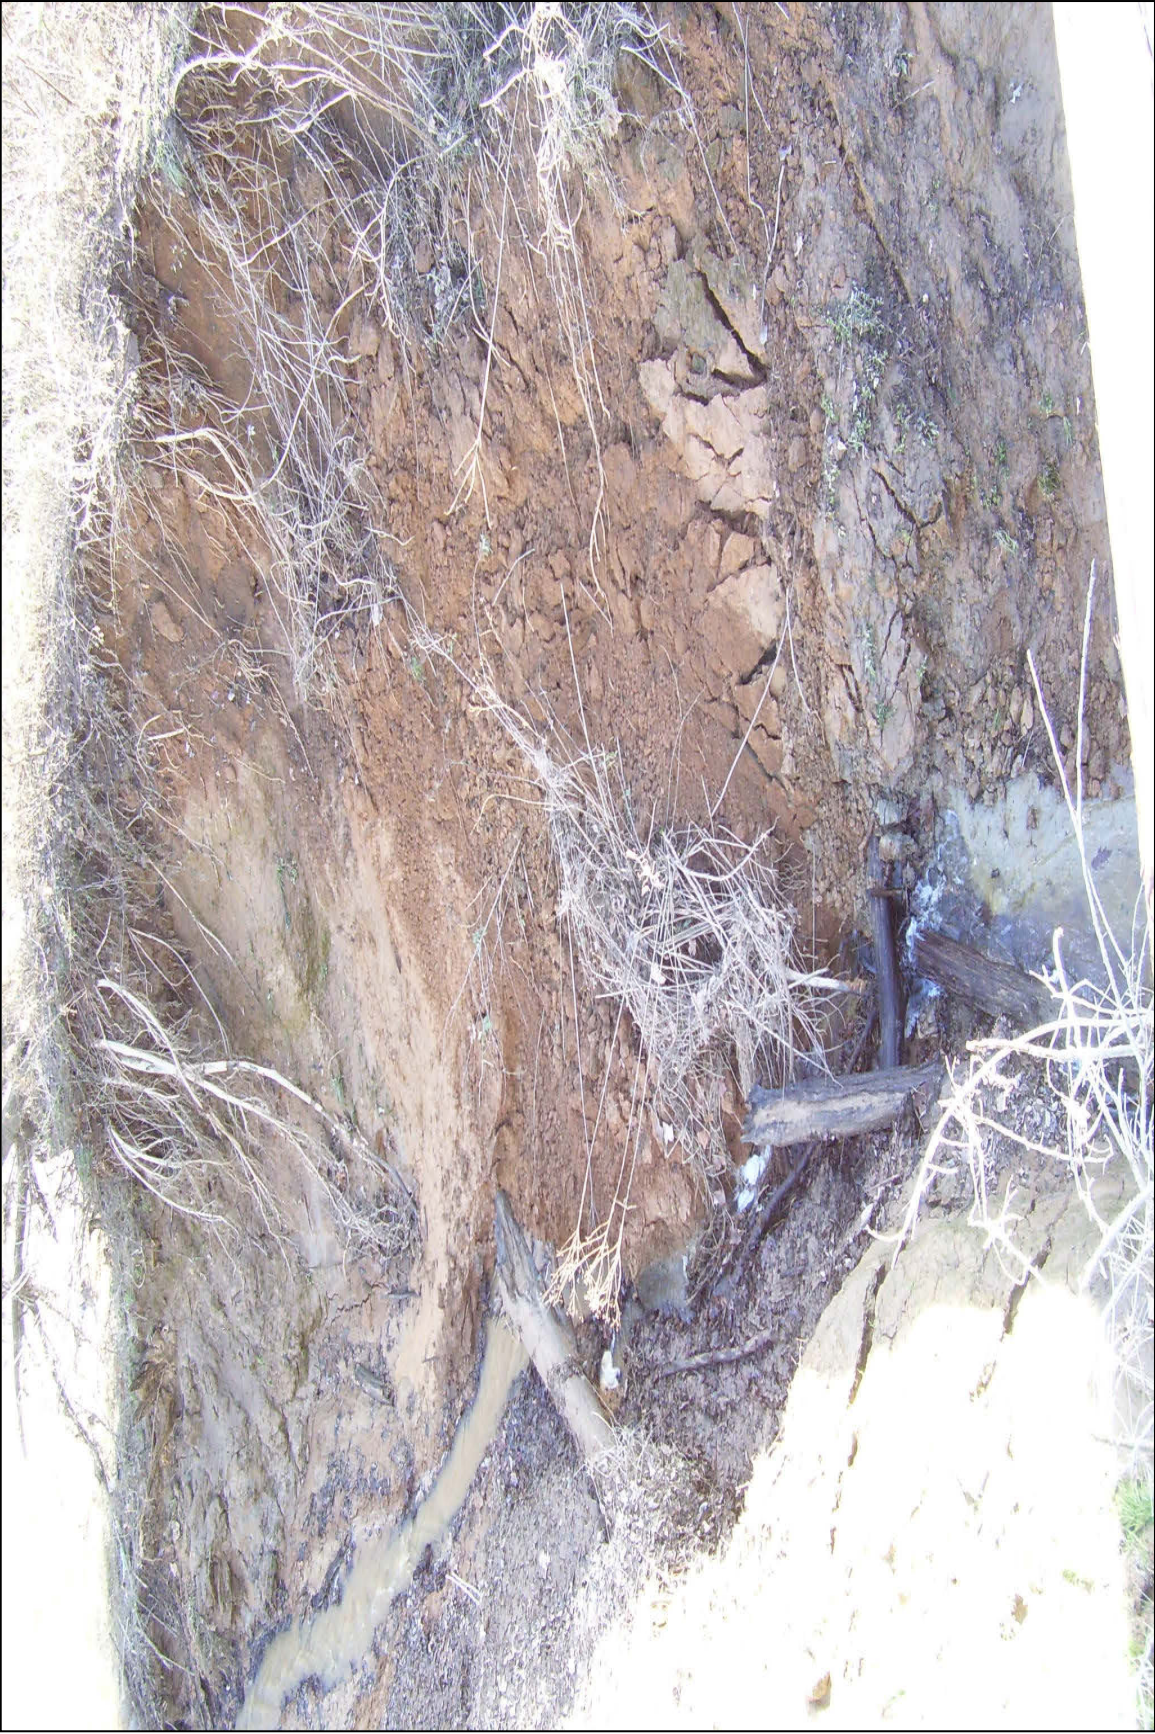
Photo 21. River Observation Point 12

Location: Confluence of the Deep River and Line Creek
Description: Continued scouring of bank material (looking from above)

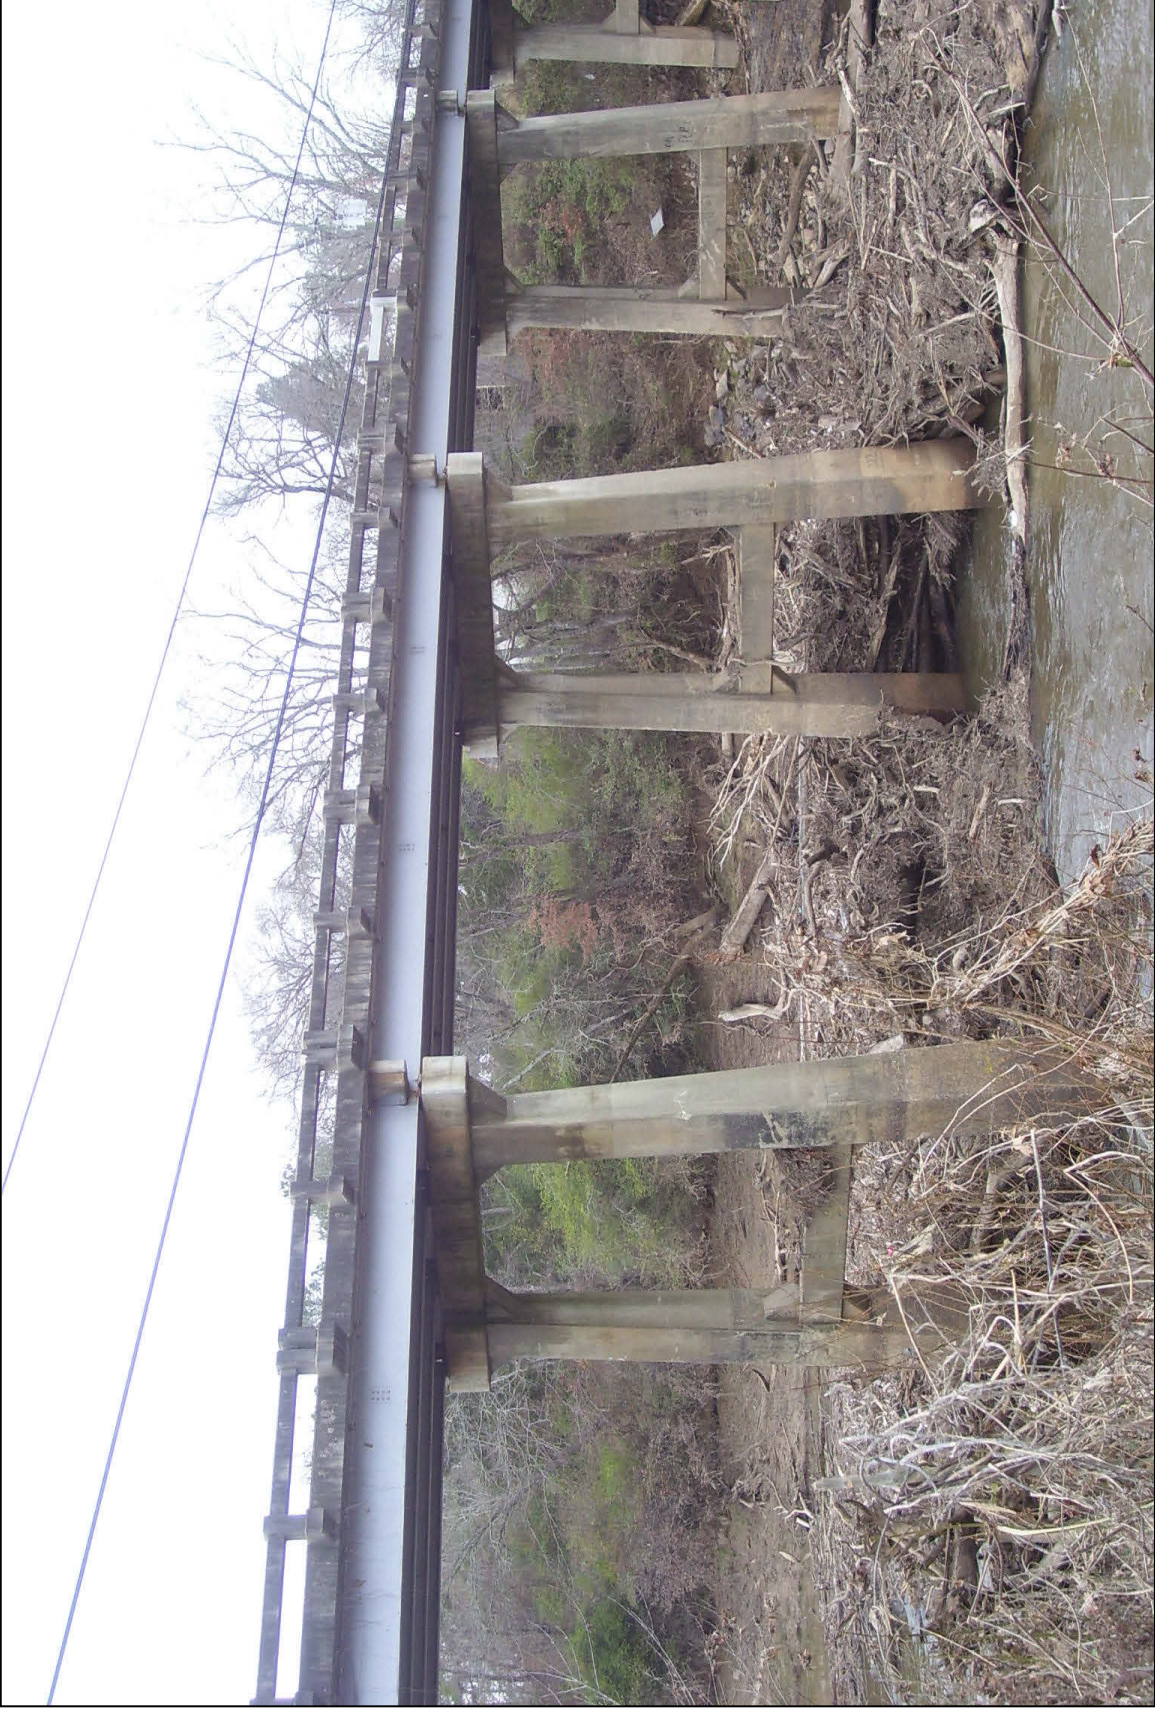
Photo 22. River Observation Point 13

Location: NC 42 bridge crossing of the Deep River

Description: Log jam behind bridge spans

River Observation Point 13 is located on the Deep River at the bridge crossing of NC 42, just upstream of the former Carbonton dam (Figure 2). At this location another massive logjam has formed on the upstream side of the bridge with woody debris spanning the entire width of the channel (Photo 22). The greatest accumulation of debris occurs between the center spans. Just below the bridge, signs of flooding and increased flow were apparent by woody debris deposited above bankfull (Photo 23). Scouring was observed near top of bank, but exposed bedrock maintained bank stability (Photo 24).

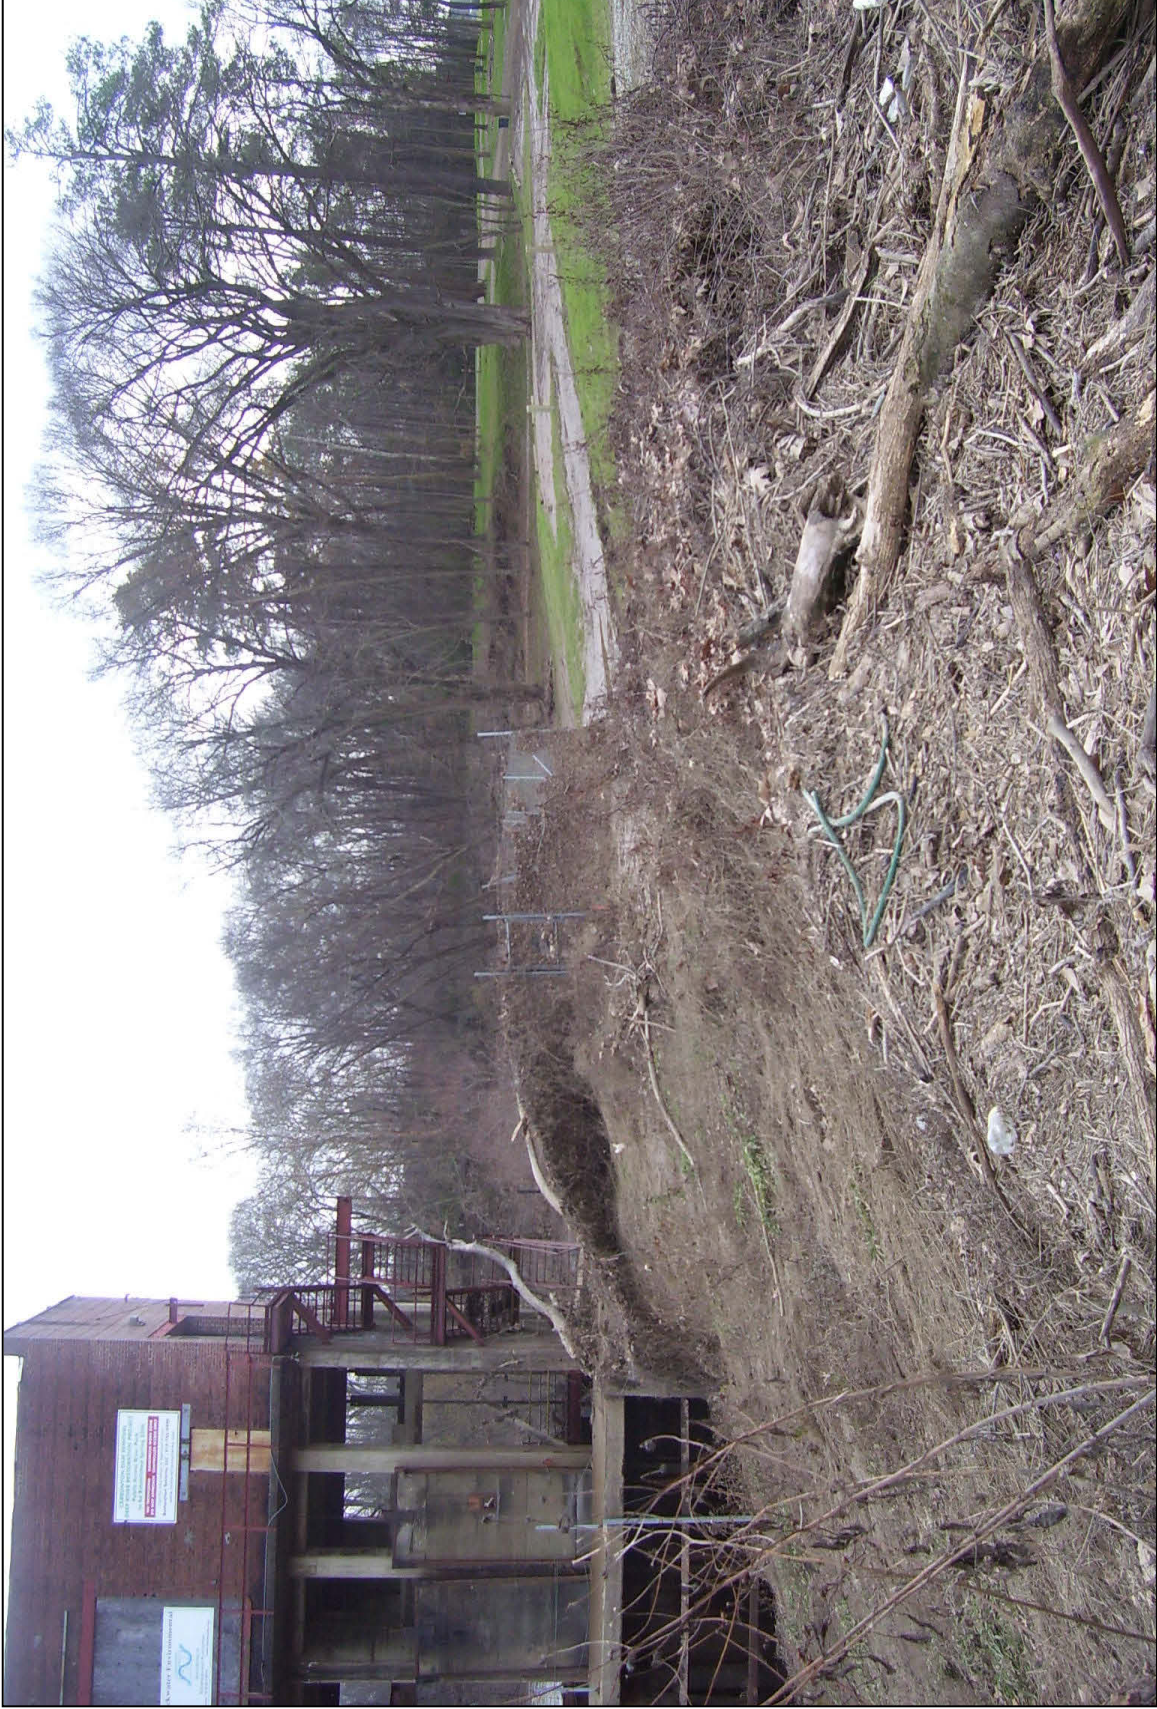
Photo 23. River Observation Point 13

Location: Deep River above the site of the former Carbondon Dam

Description: Woody debris deposition
