**CARBONTON DAM – DEEP RIVER WATERSHED
RESTORATION SITE
2007 Annual Monitoring Report (Year 2)**

**Chatham, Lee and Moore Counties, NC
EEP Project No. D-04012A
Design Firm: Milone and MacBroom, Inc.**

**Prepared for: NCDENR - ECOSYSTEM ENHANCEMENT PROGRAM
1652 Mail Service Center
Raleigh, North Carolina 27699-1619**

**Prepared by: ECOSCIENCE CORPORATION
1101 Haynes Street, Suite 101
Raleigh, North Carolina 27604**

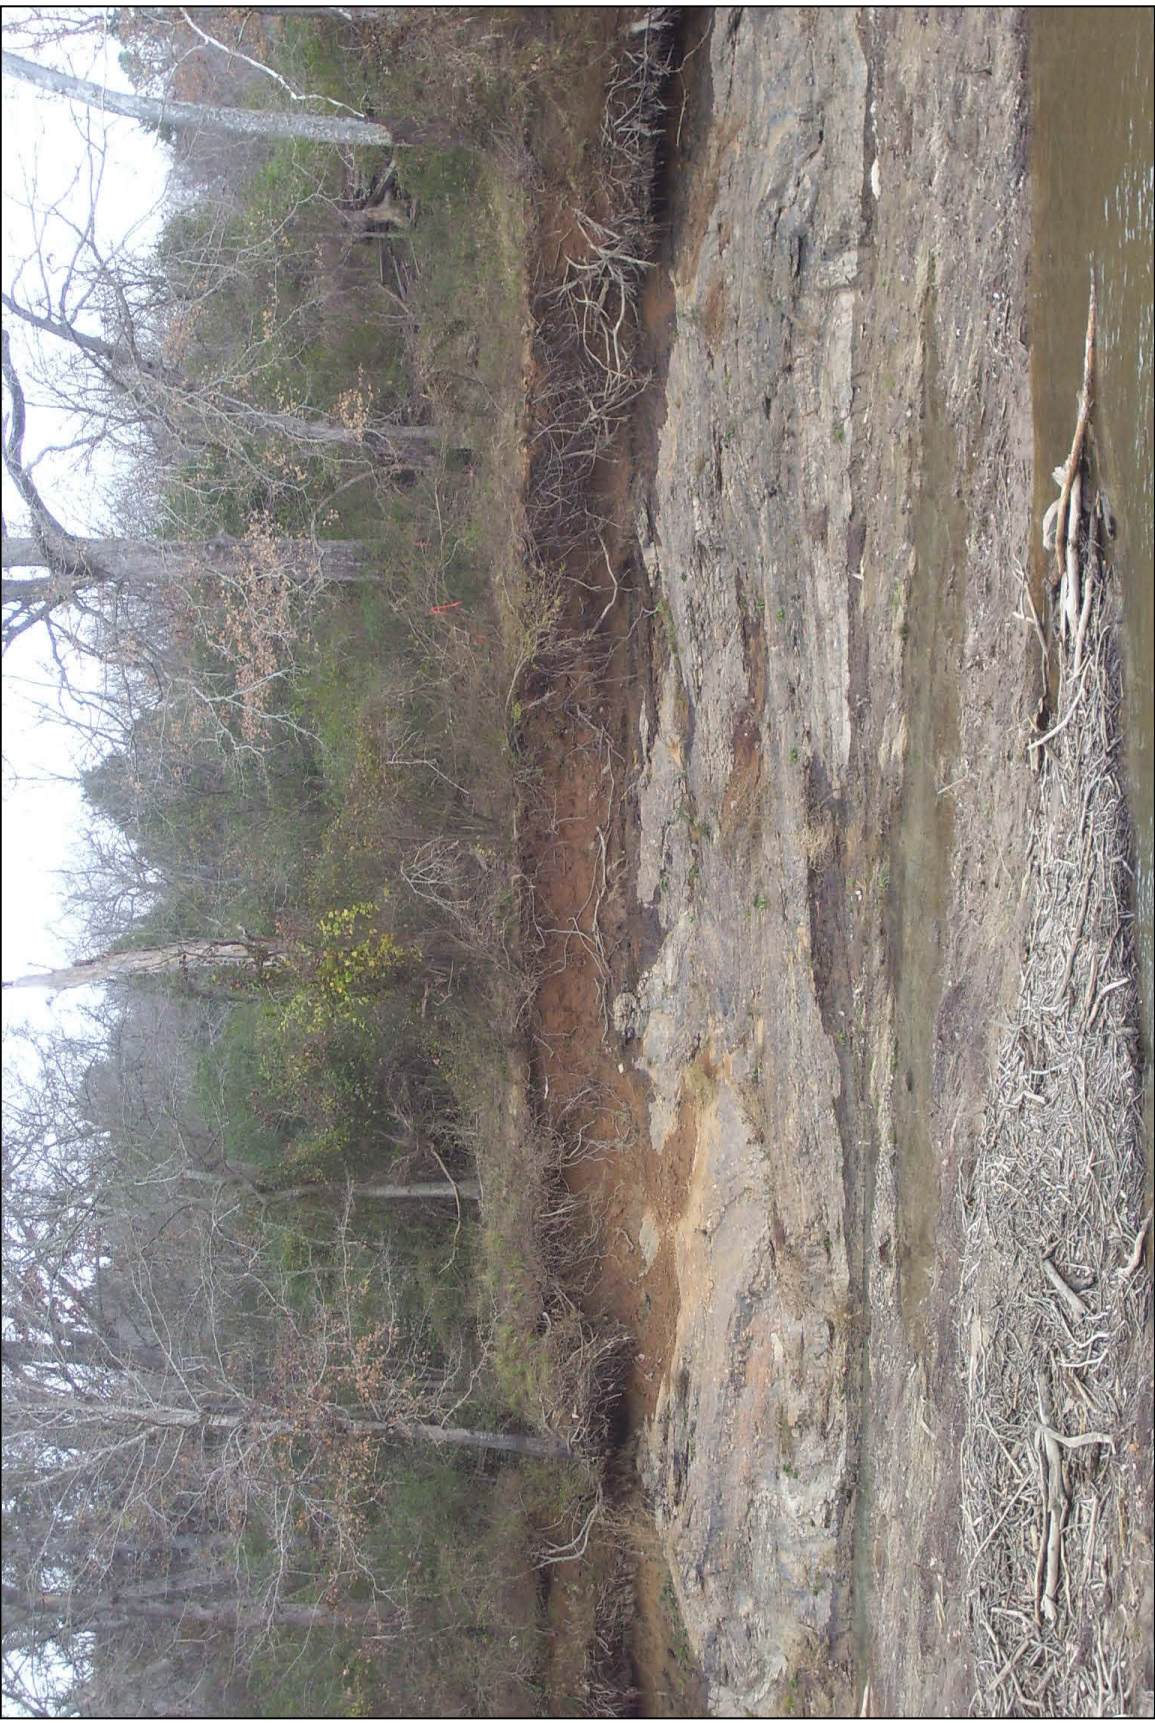
Photo 24. River Observation Point 14

Location: Deep River above the site of the former Caribton Dam

Description: Scouring of banks above a bedrock foundation

River Observation Point 13 is located on the Deep River at the bridge crossing of NC 42, just upstream of the former Carbonton dam (Figure 2). At this location another massive logjam has formed on the upstream side of the bridge with woody debris spanning the entire width of the channel (Photo 22). The greatest accumulation of debris occurs between the center spans. Just below the bridge, signs of flooding and increased flow were apparent by woody debris deposited above bankfull (Photo 23). Scouring was observed near top of bank, but exposed bedrock maintained bank stability (Photo 24).

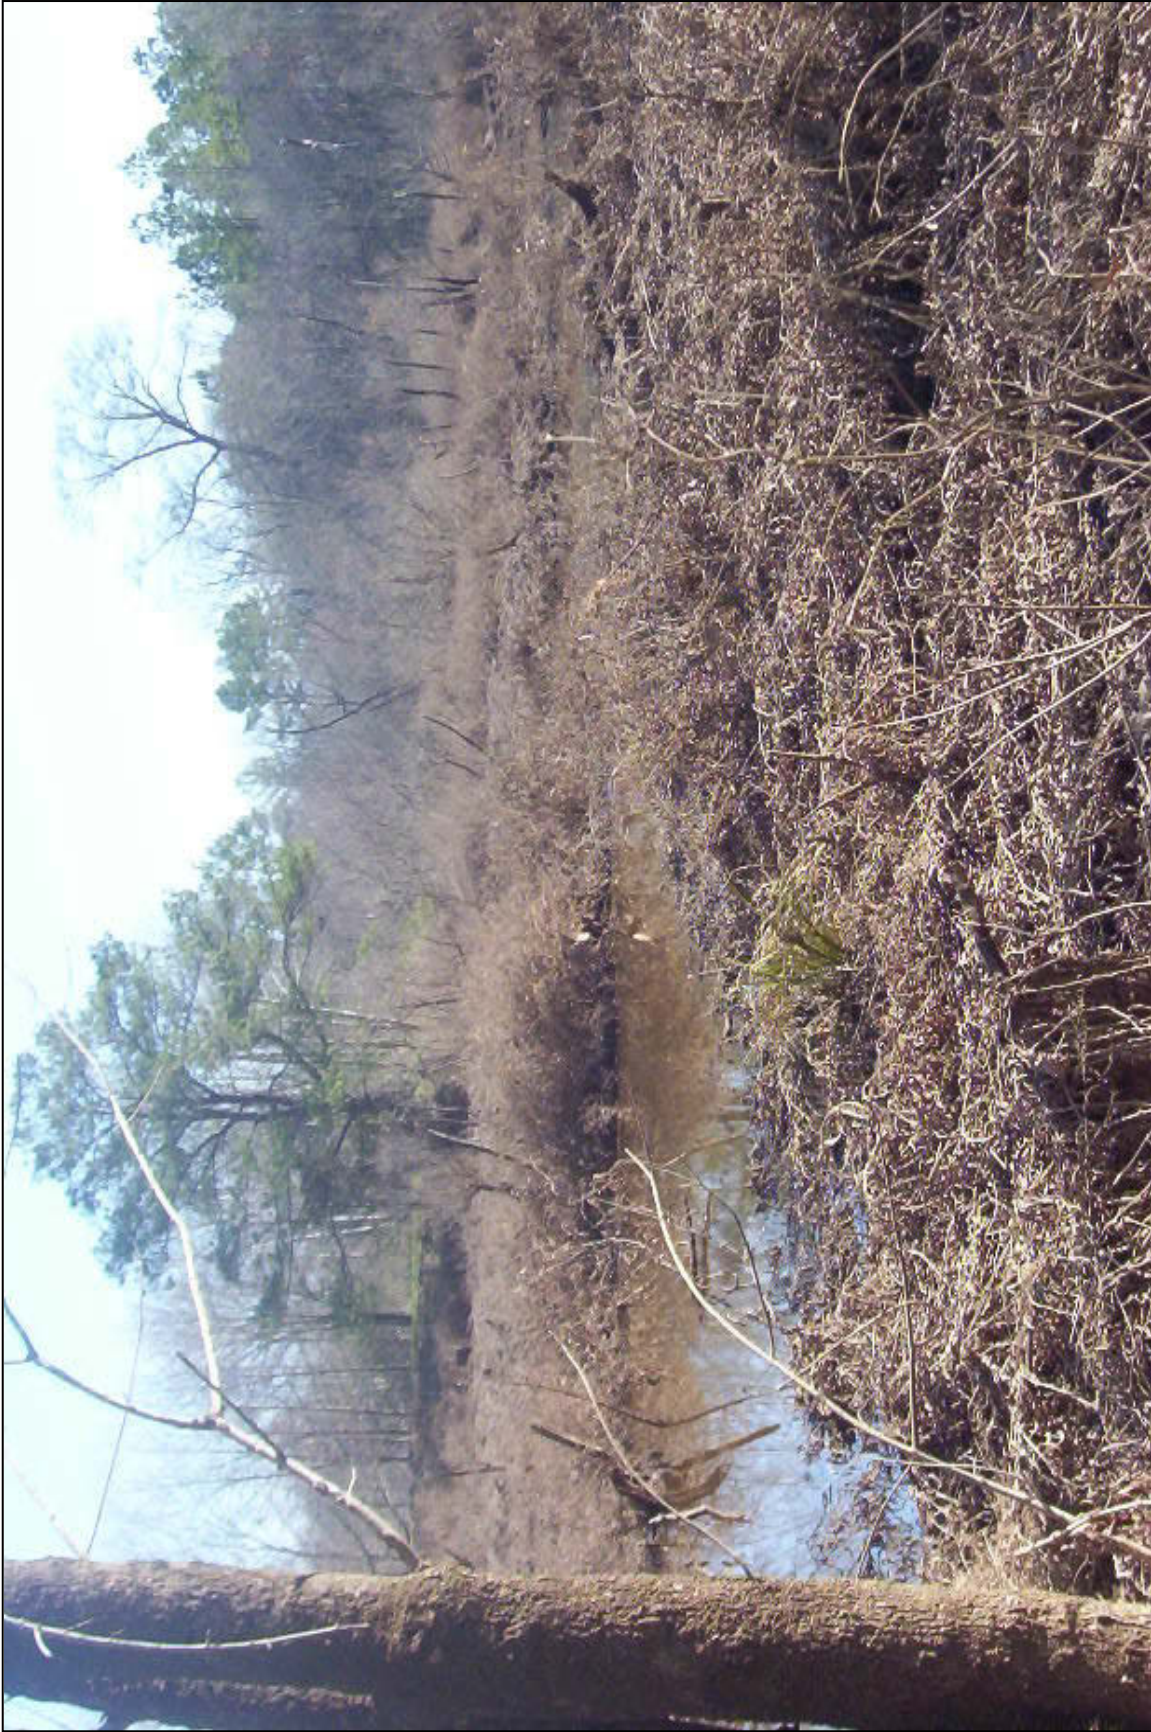
Photo 25. Land Observation Point 1

Location: Line Creek downstream of the bridge crossing of Caribton Road

Description: Overbank flooding and sediment deposition

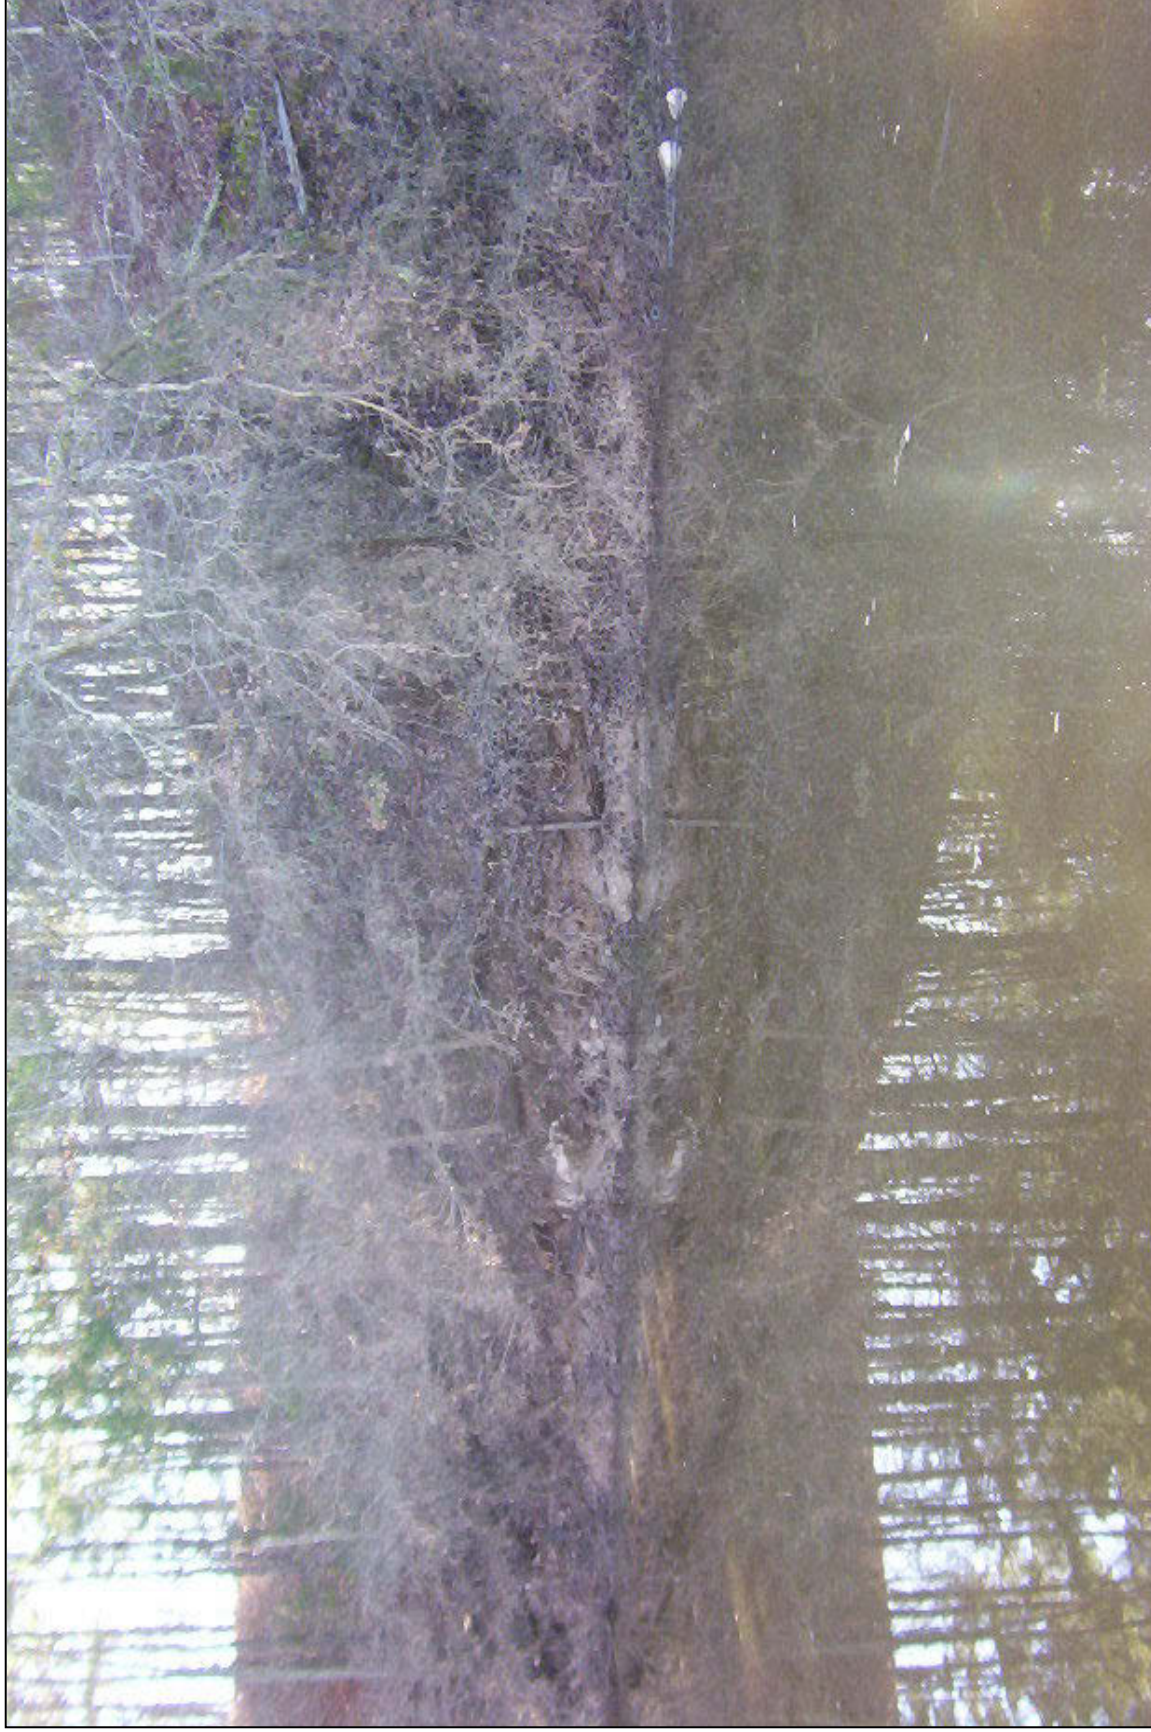
Photo 27. Land Observation Point 1

Location: Line Creek upstream of the bridge crossing of Caribnton Road
Description: Stable banks with limited erosion

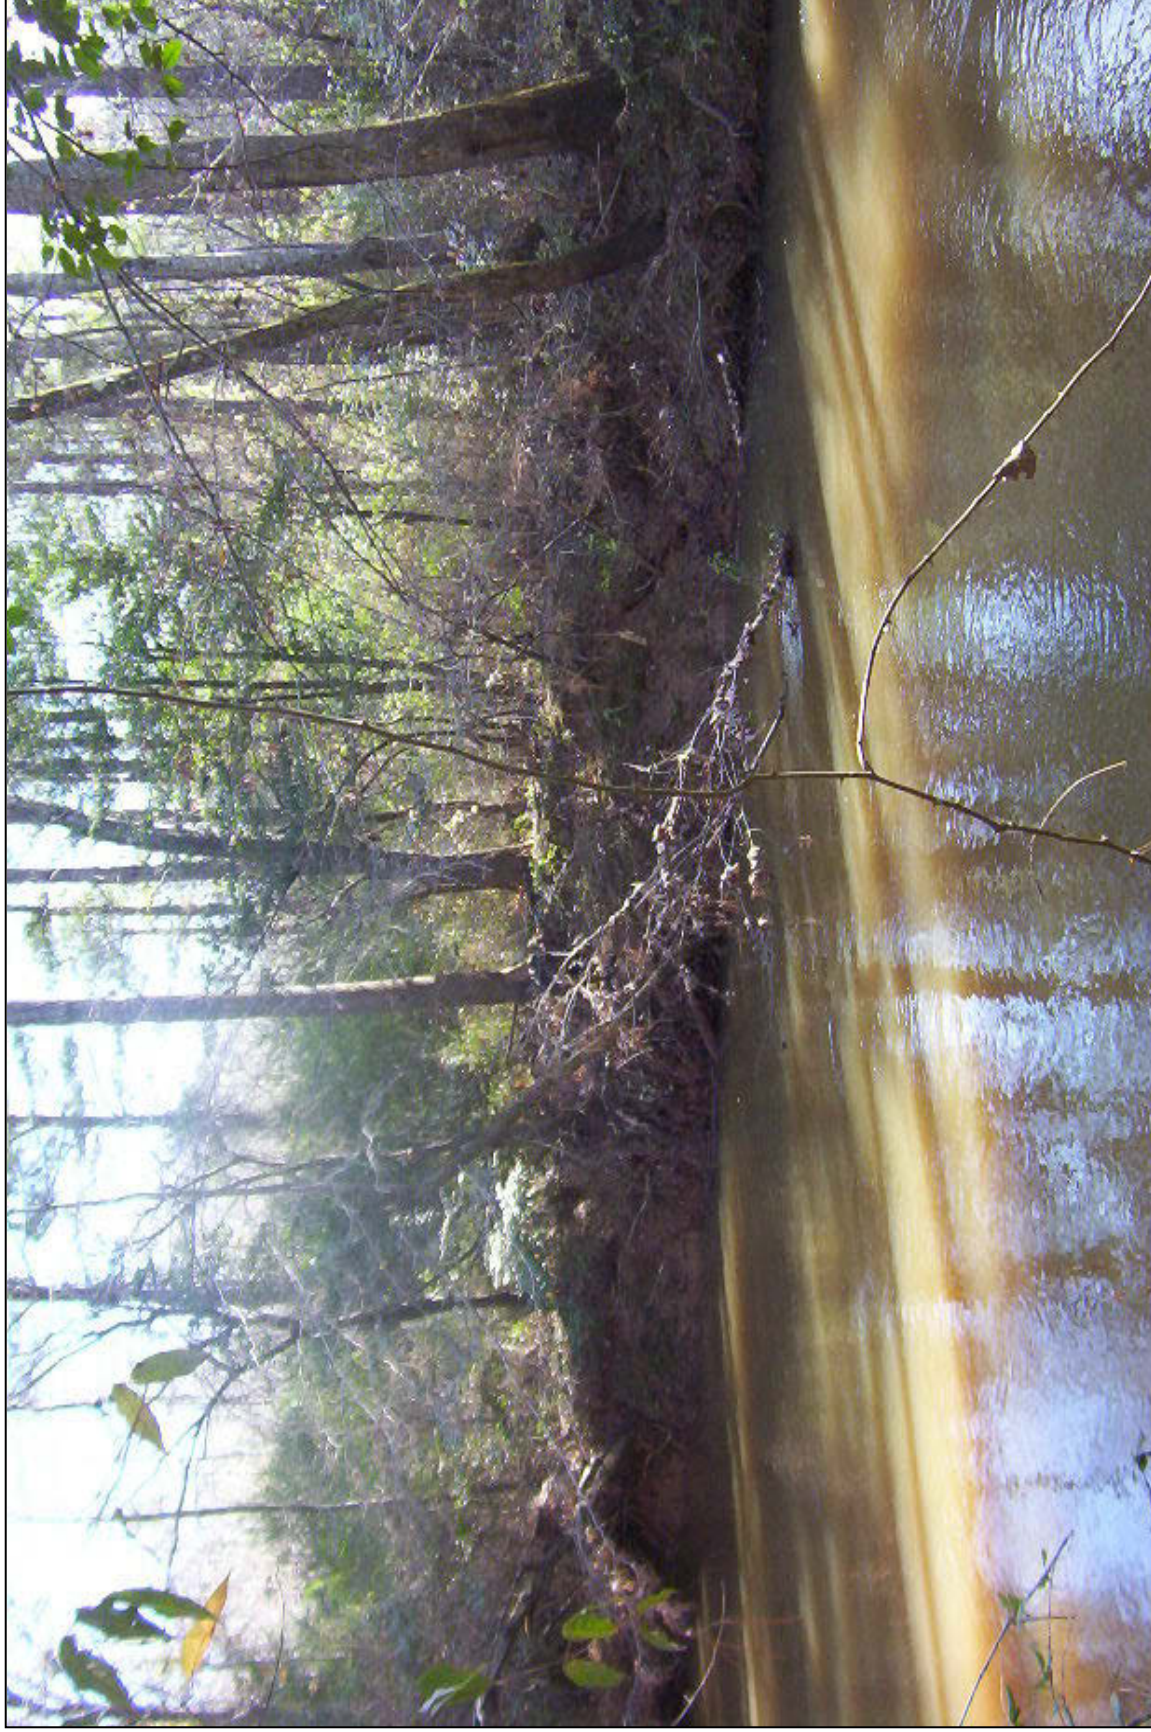
Photo 28. Land Observation Point 2

Location: McClendon's Creek near Monitoring Station 45
Description: Stable banks with limited erosion

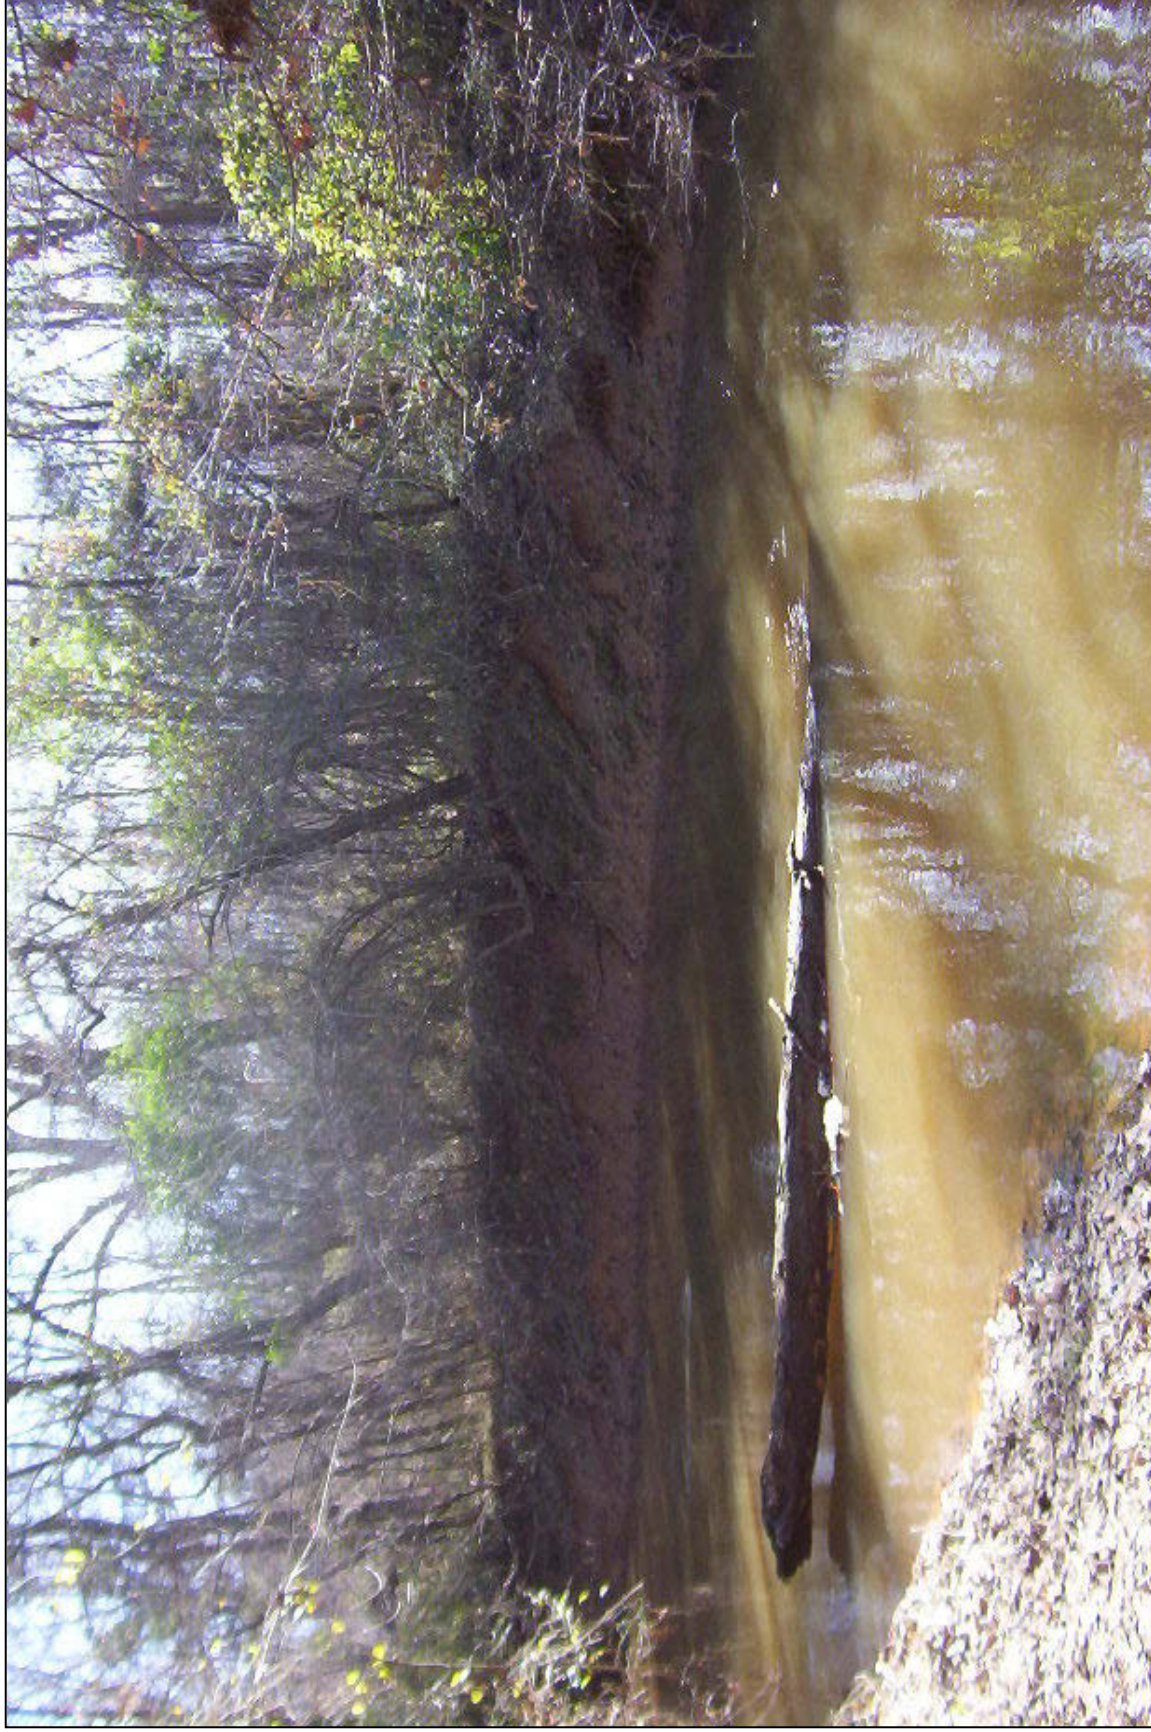
Photo 29. Land Observation Point 3

Location: McClendon's Creek near Monitoring Station 47

Description: Steep, exposed banks

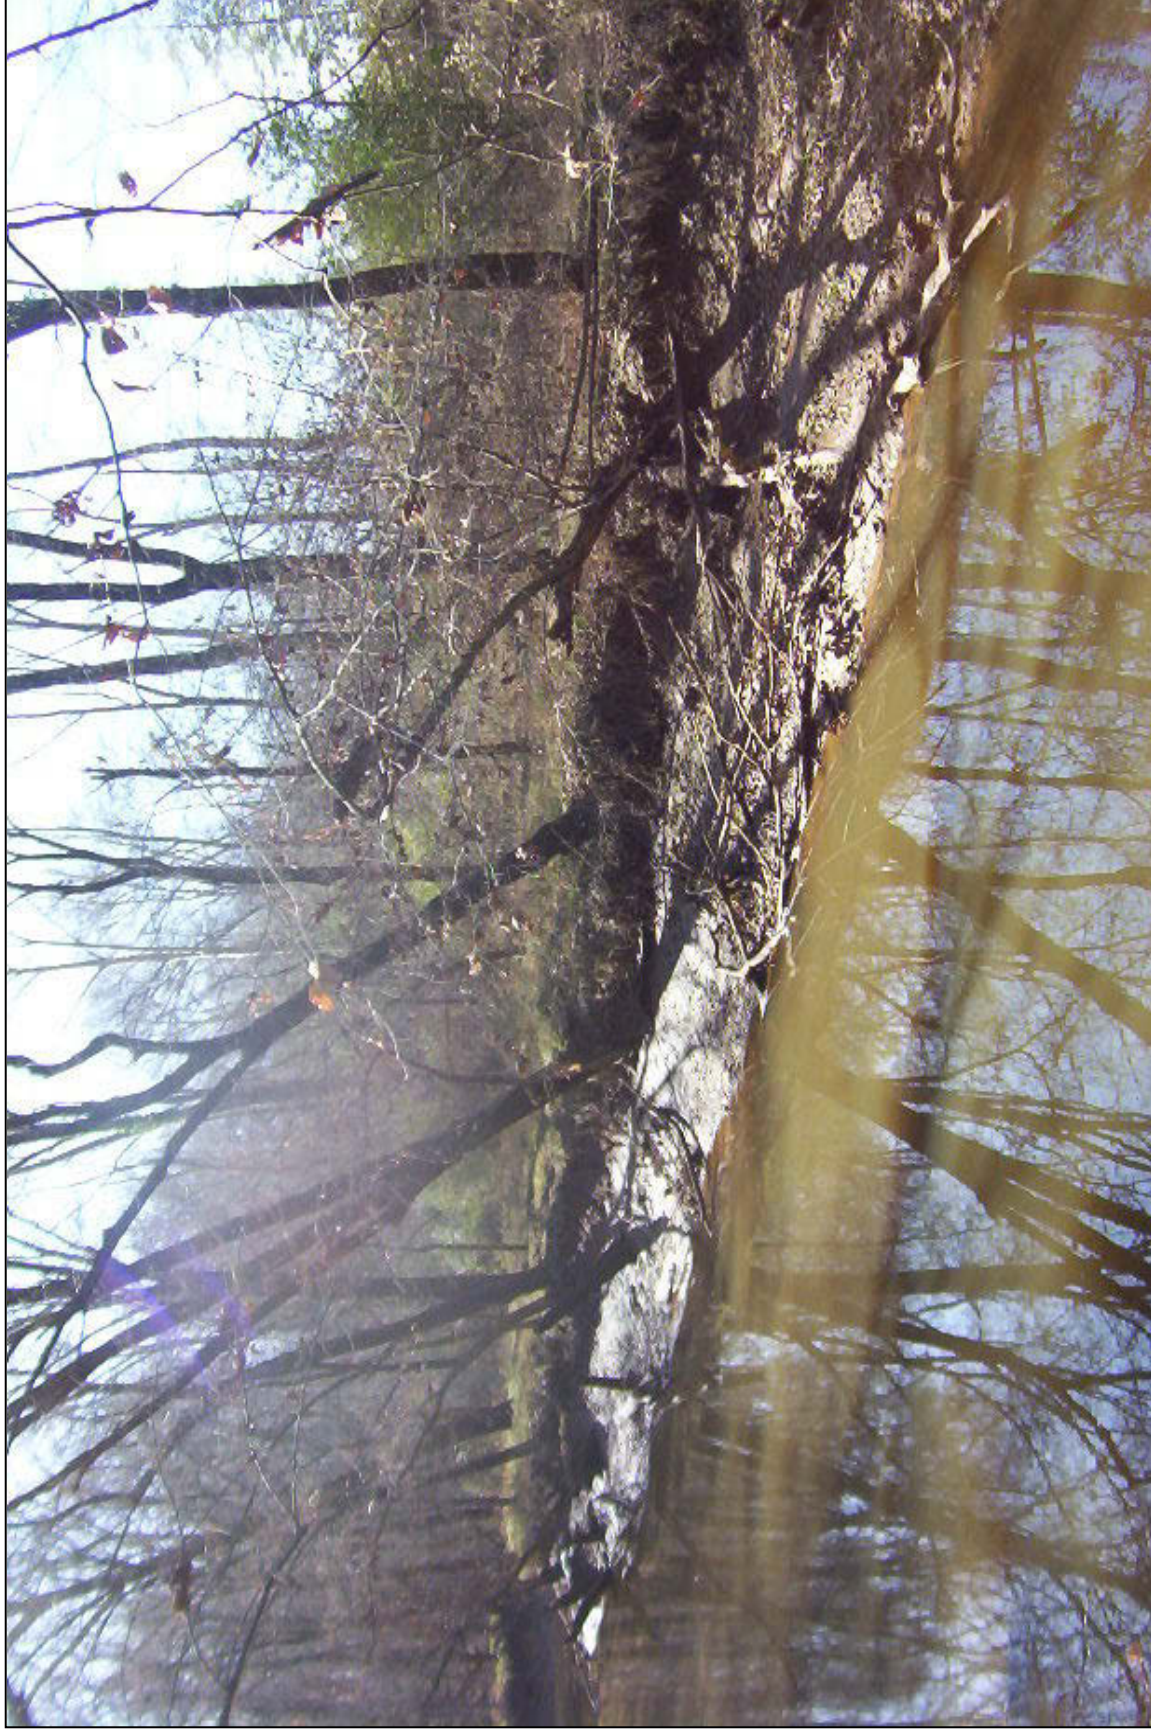
Photo 30. Land Observation Point 4

Location: Little Governor's Creek upstream of the bridge crossing of Steel Bridge Road
Description: Steep, exposed banks

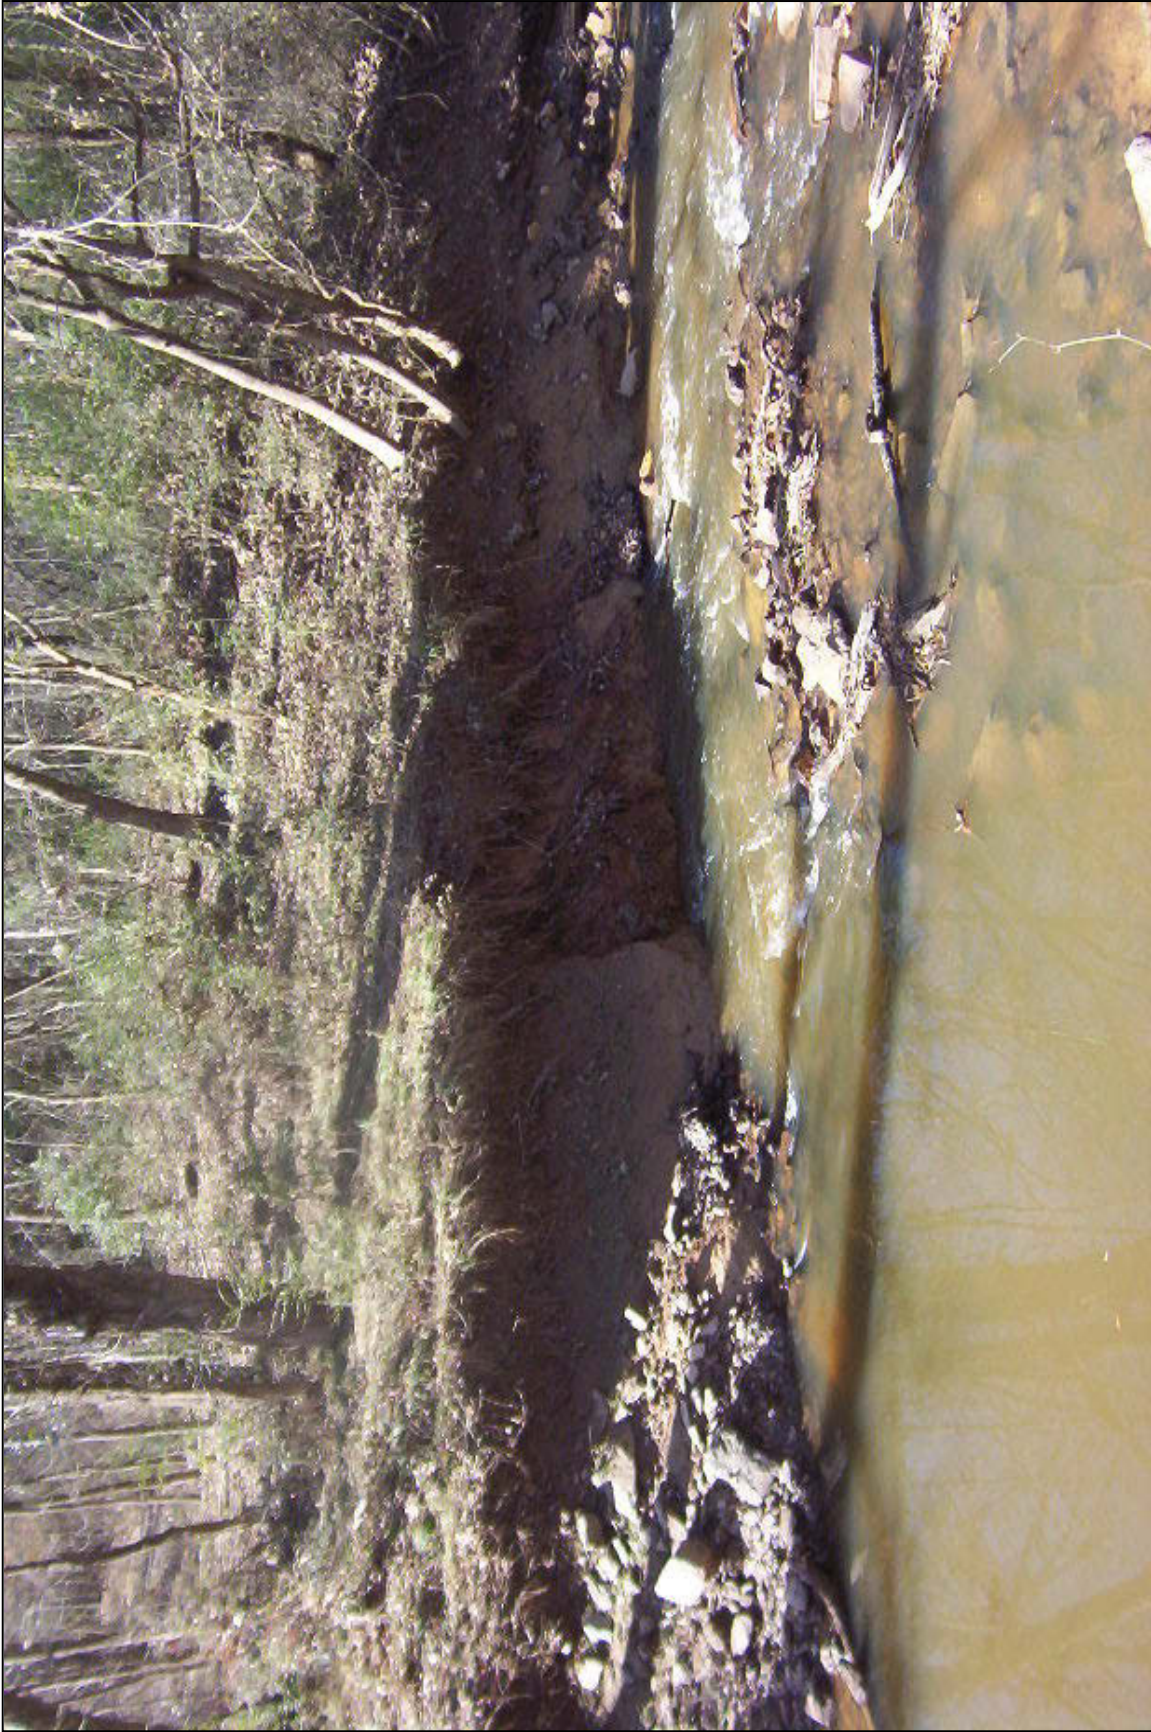
Photo 31. Land Observation Point 4

Location: Little Governor's Creek downstream of the bridge crossing of Steel Bridge Road
Description: Steep, eroded banks

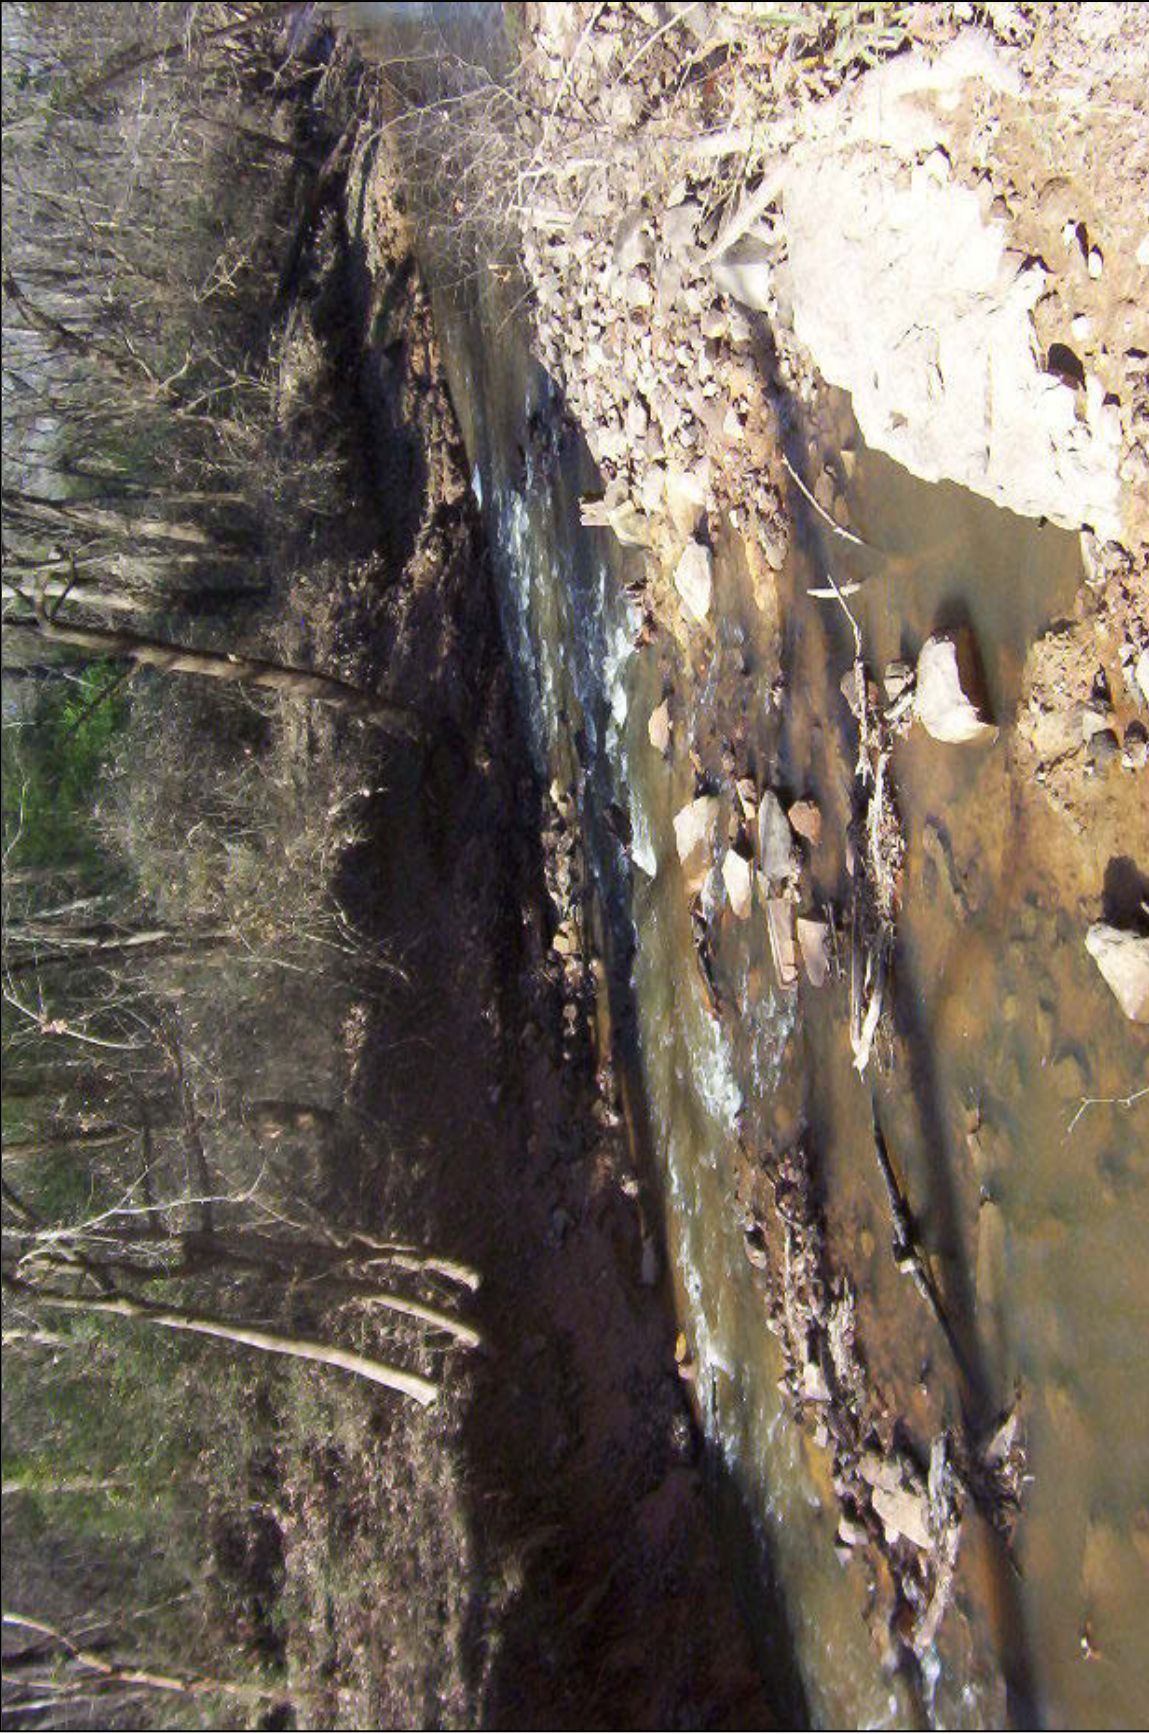
Photo 32. Land Observation Point 4

Location: Little Governor's Creek downstream of the bridge crossing of Steel Bridge Road
Description: Steep, eroded banks

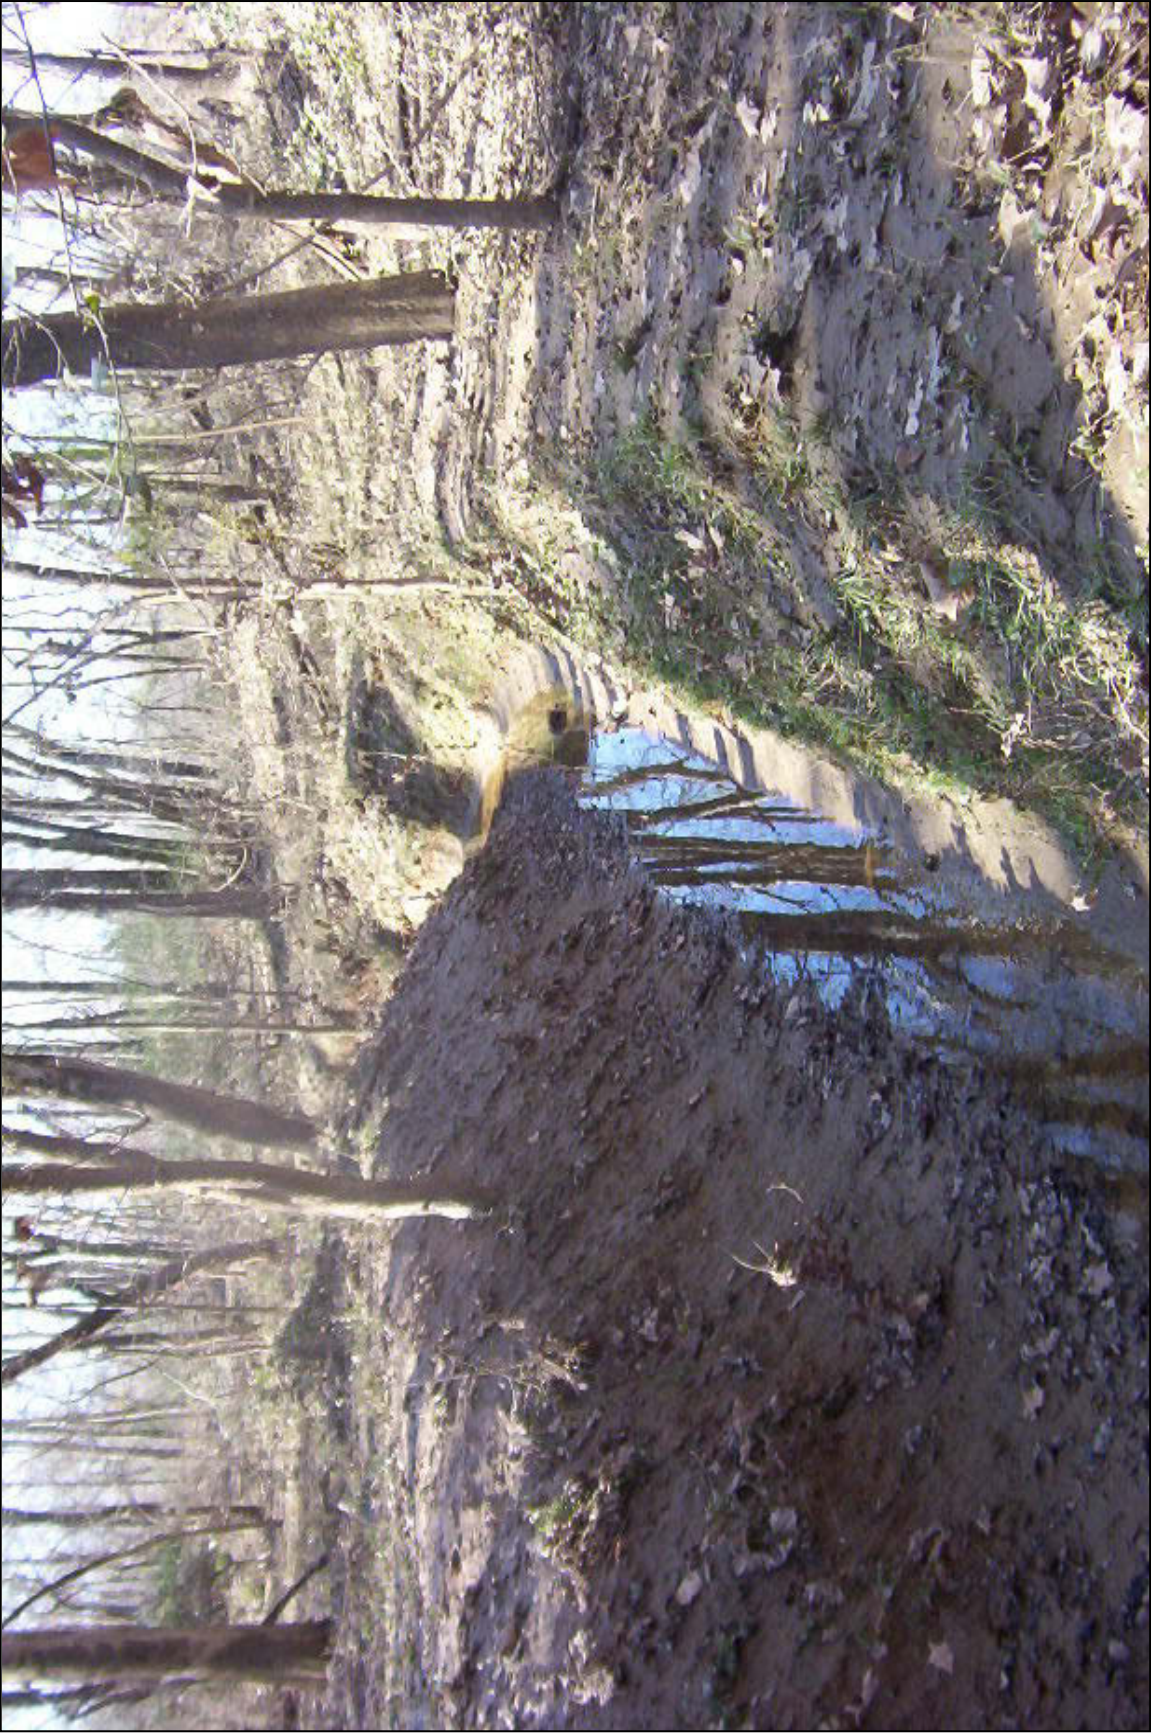
Photo 34. Land Observation Point 5

Location: Unnamed tributary on the Knight Cattle Corporation property
Description: Stable banks with signs of overbank flooding and sediment deposition

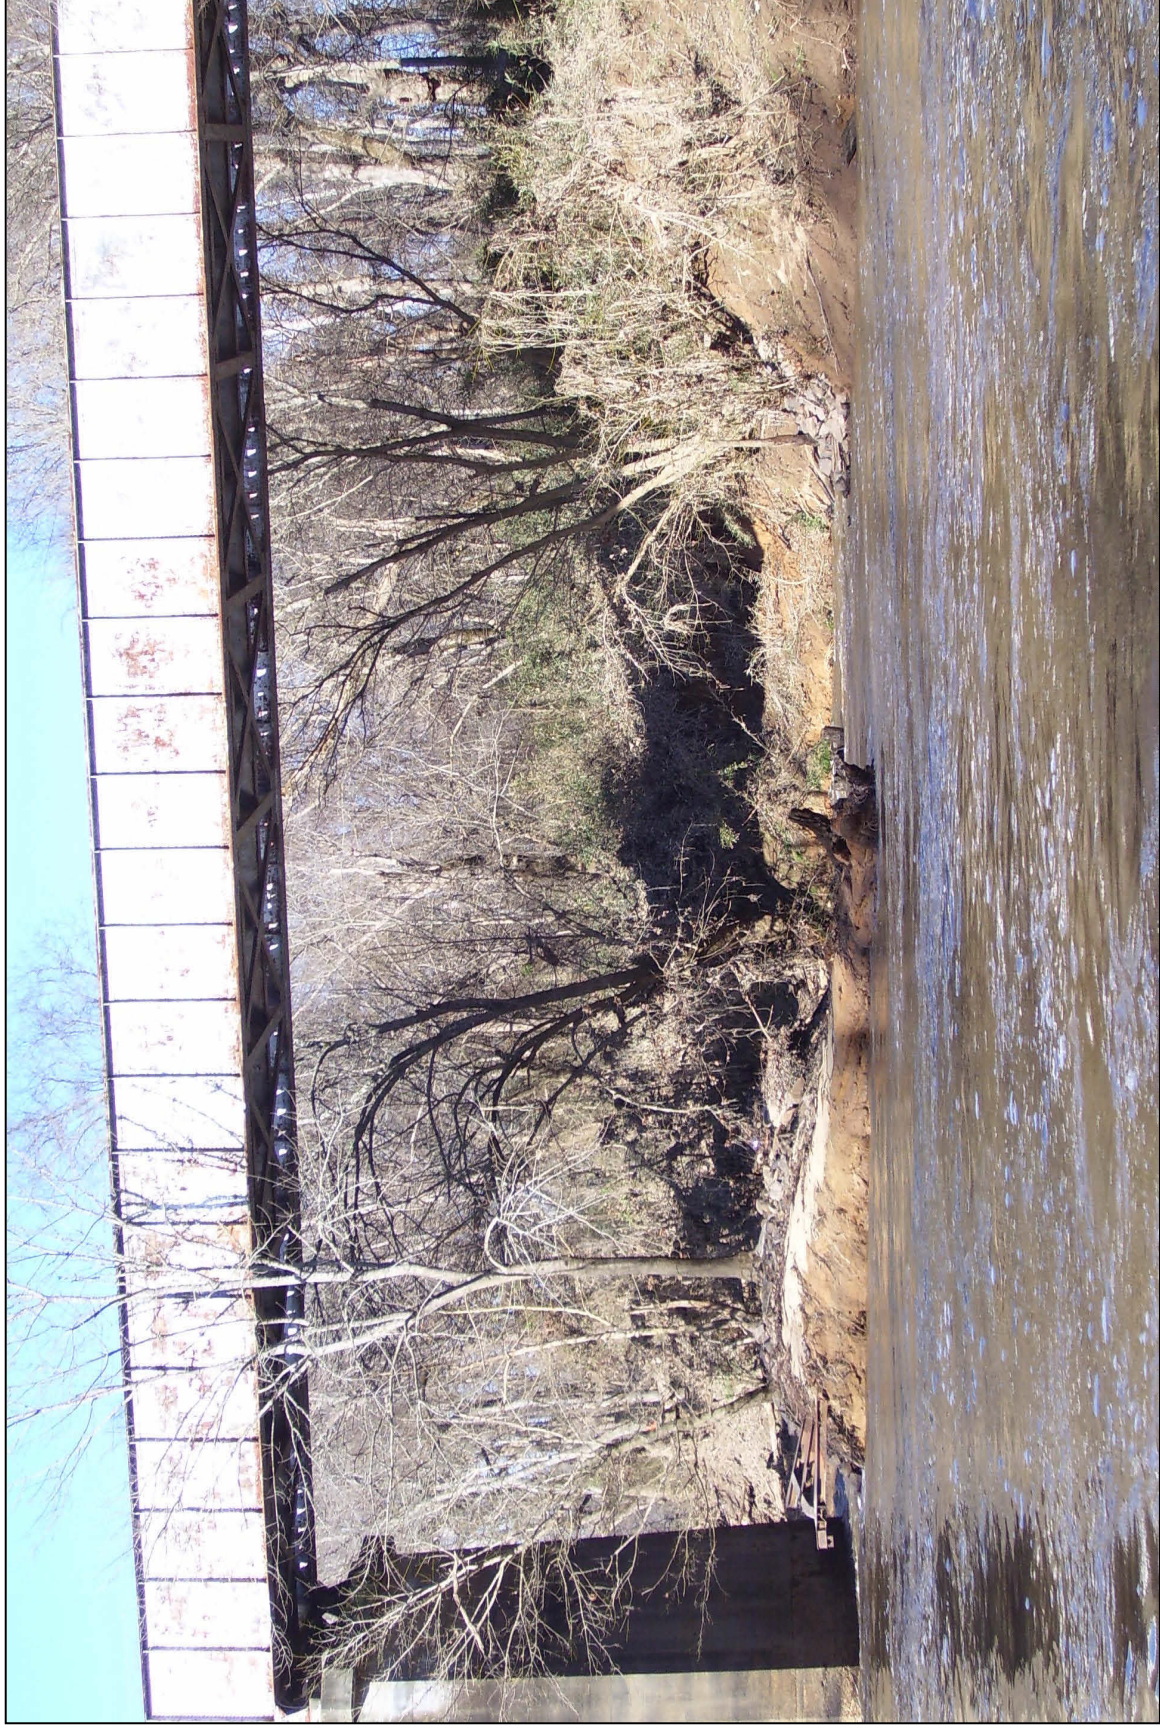
Photo 1. River Observation Point 1

Location: Deep River downstream of the Norfolk-Southern rail bridge
Description: Continued bank failure and sloughing into the Deep River

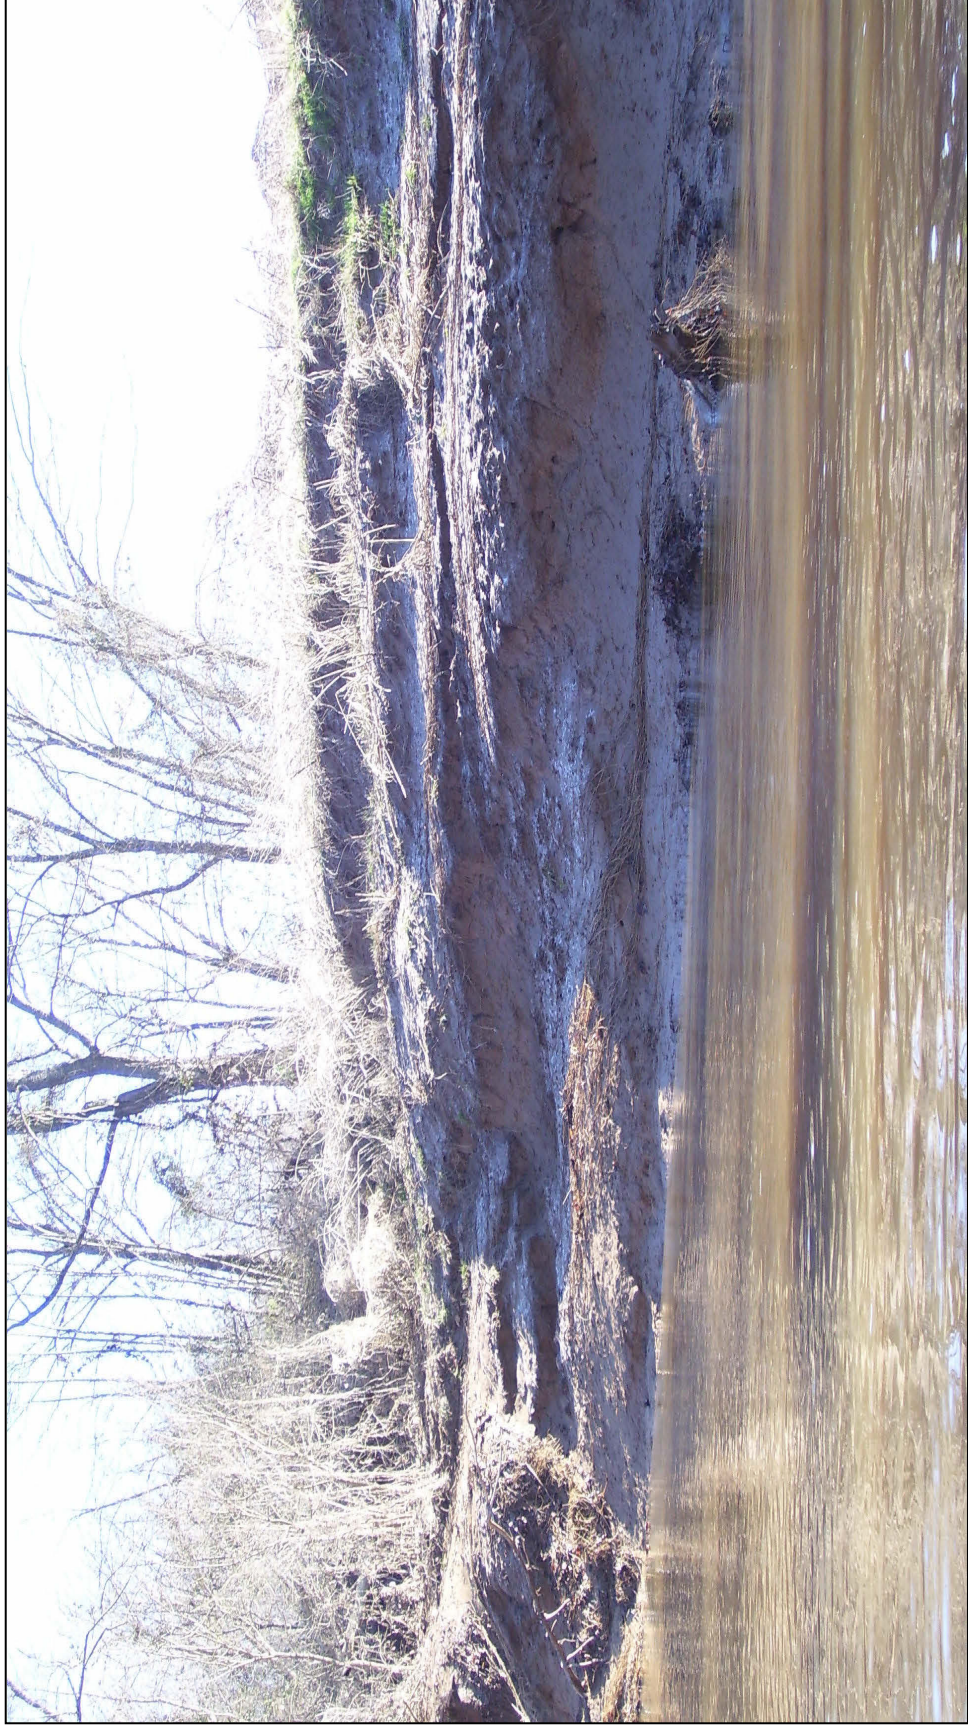
Photo 2. River Observation Point 2

Location: Approximately 1 mile downstream of Norfolk-Southern rail bridge, Deep River
Description: Bank failure and erosion from adjacent agricultural fields
