**CARBONTON DAM – DEEP RIVER WATERSHED
RESTORATION SITE
2007 Annual Monitoring Report (Year 2)**

**Chatham, Lee and Moore Counties, NC
EEP Project No. D-04012A
Design Firm: Milone and MacBroom, Inc.**

**Prepared for: NCDENR - ECOSYSTEM ENHANCEMENT PROGRAM
1652 Mail Service Center
Raleigh, North Carolina 27699-1619**

**Prepared by: ECOSCIENCE CORPORATION
1101 Haynes Street, Suite 101
Raleigh, North Carolina 27604**

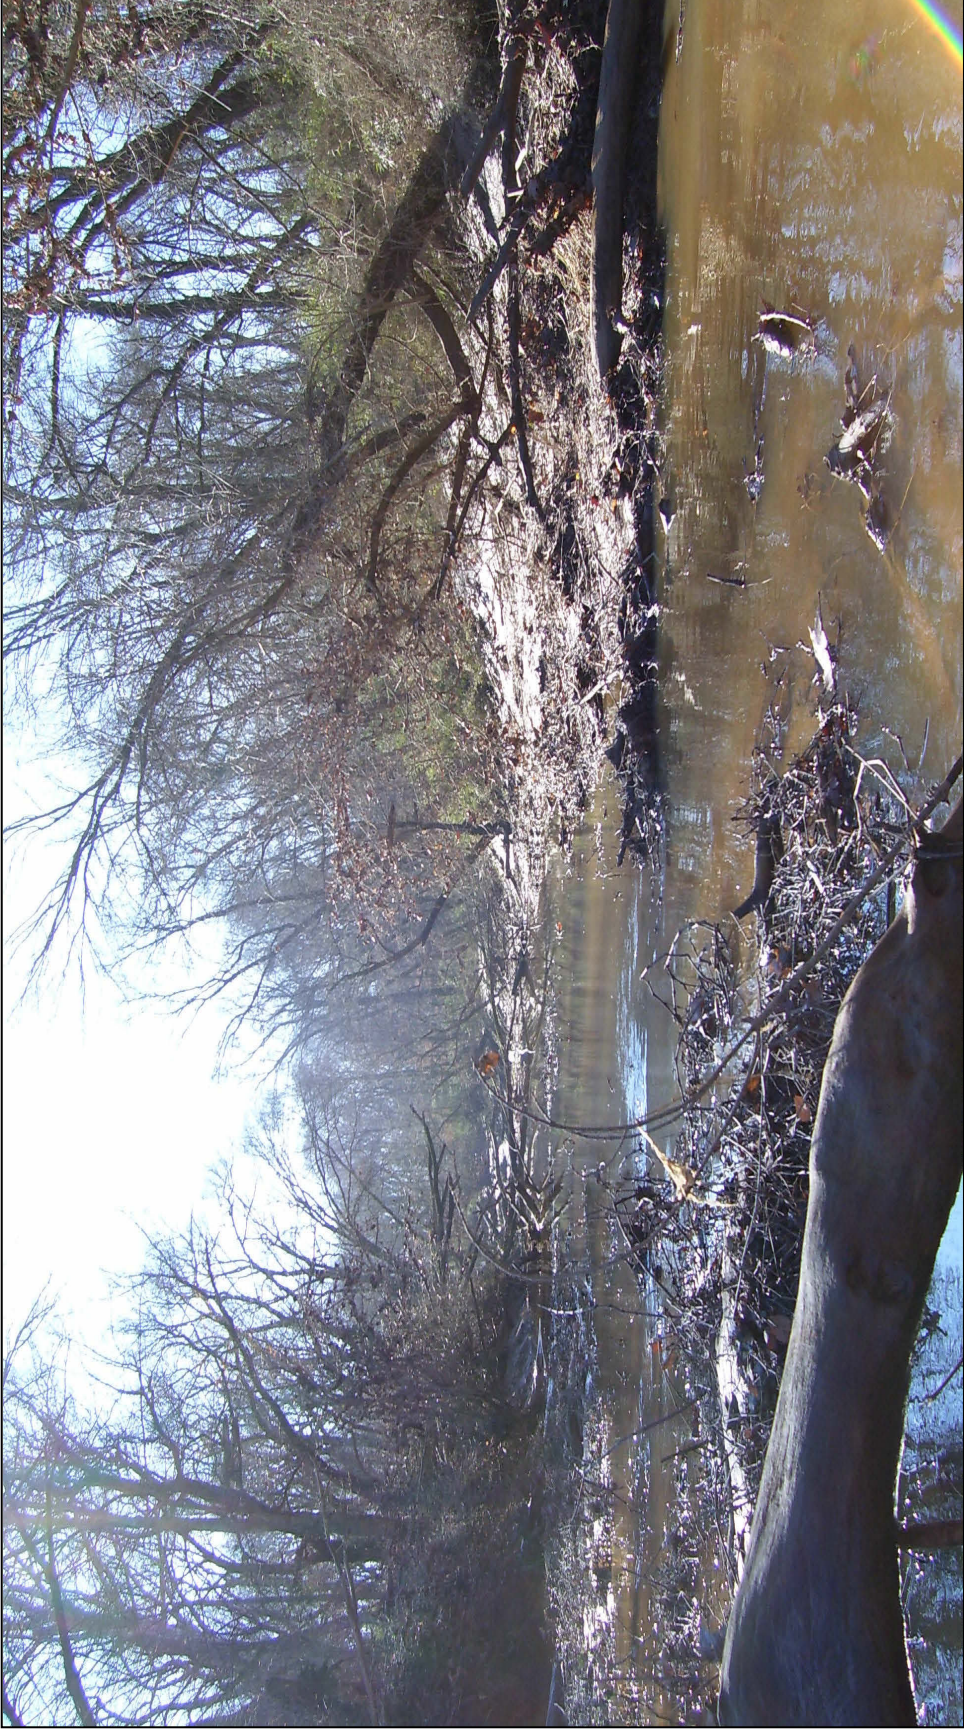
Photo 3. River Observation Point 3

Location: Confluence of the upstream end of an oxbow channel and the Deep River

Description: Overland flow and sediment transport resulting from storm surge

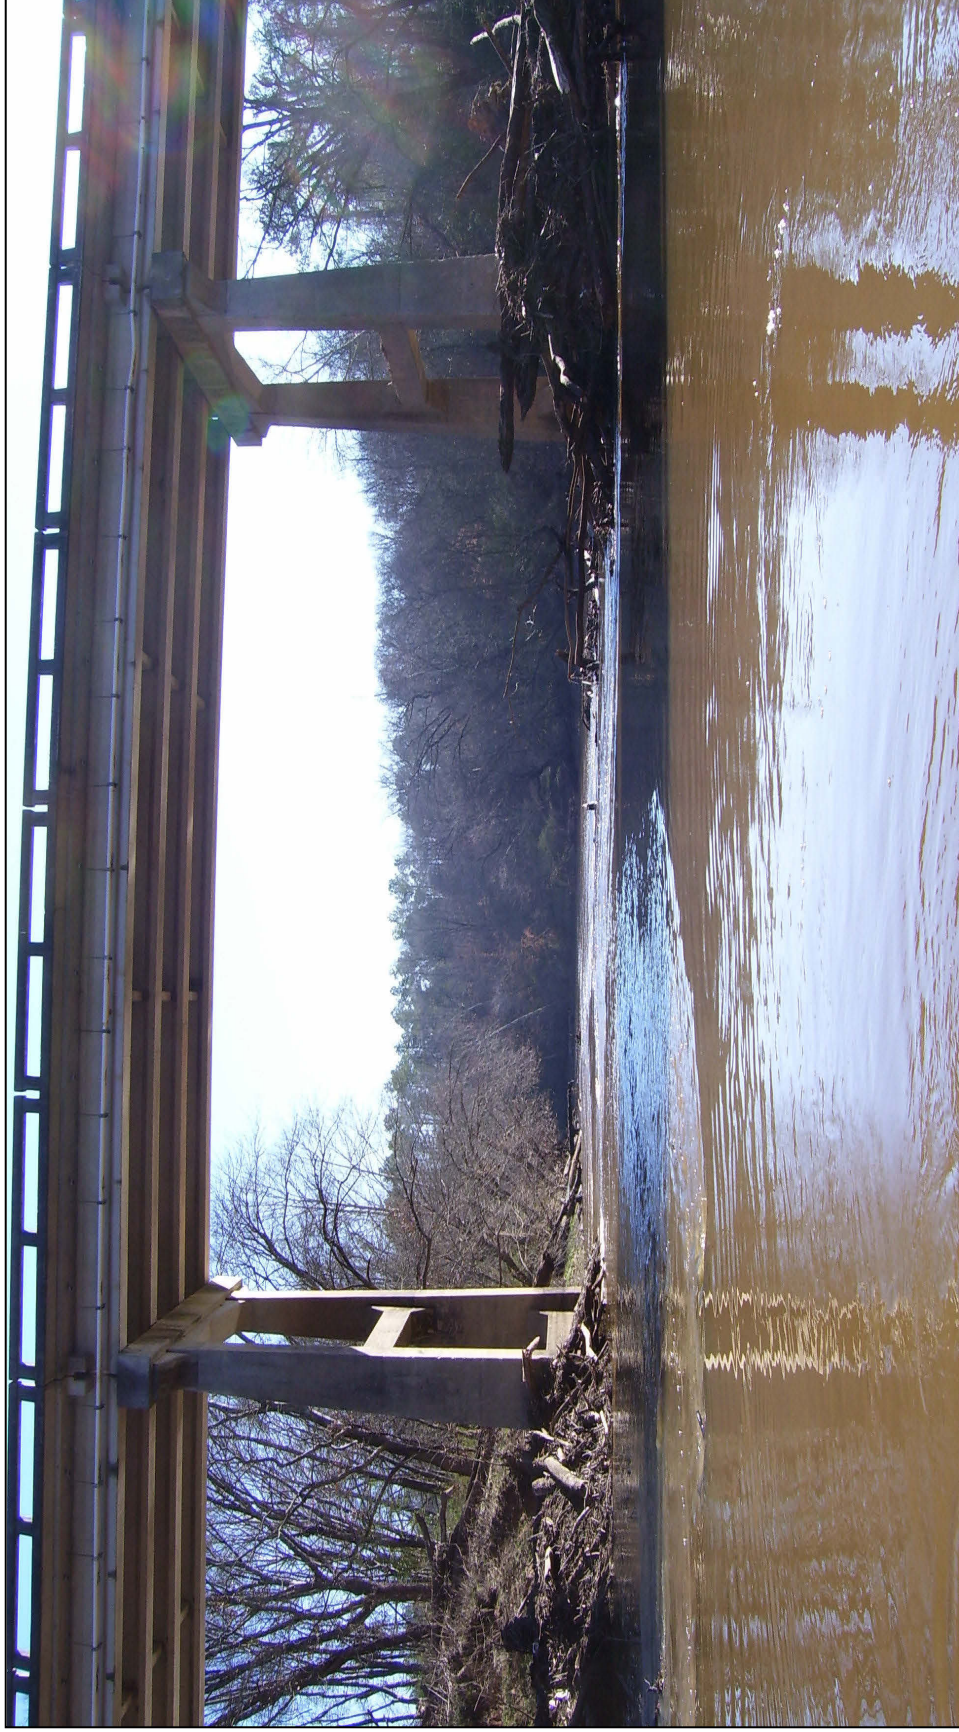
Photo 4. River Observation Point 4

Location: Carbondon Road crossing of the Deep River
Description: Cleared log jam

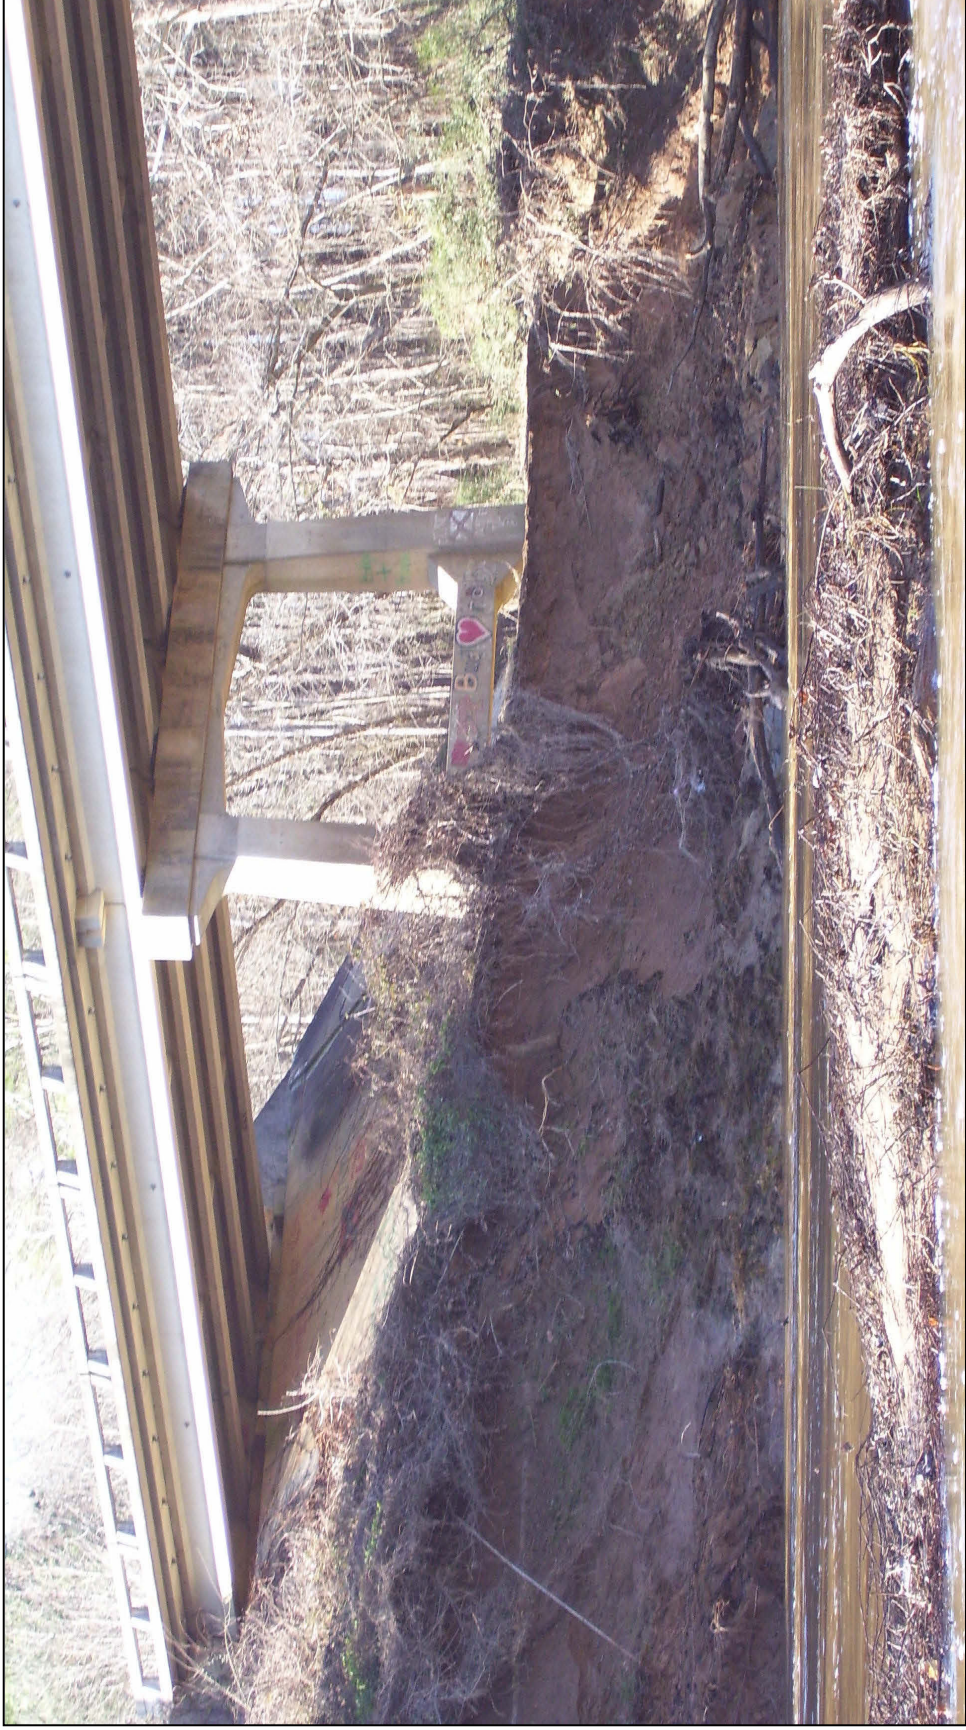
Photo 5. River Observation Point 4

Location: Carabnton Road bridge crossing of the Deep River
Description: Sloughing of bank material downstream of the bridge

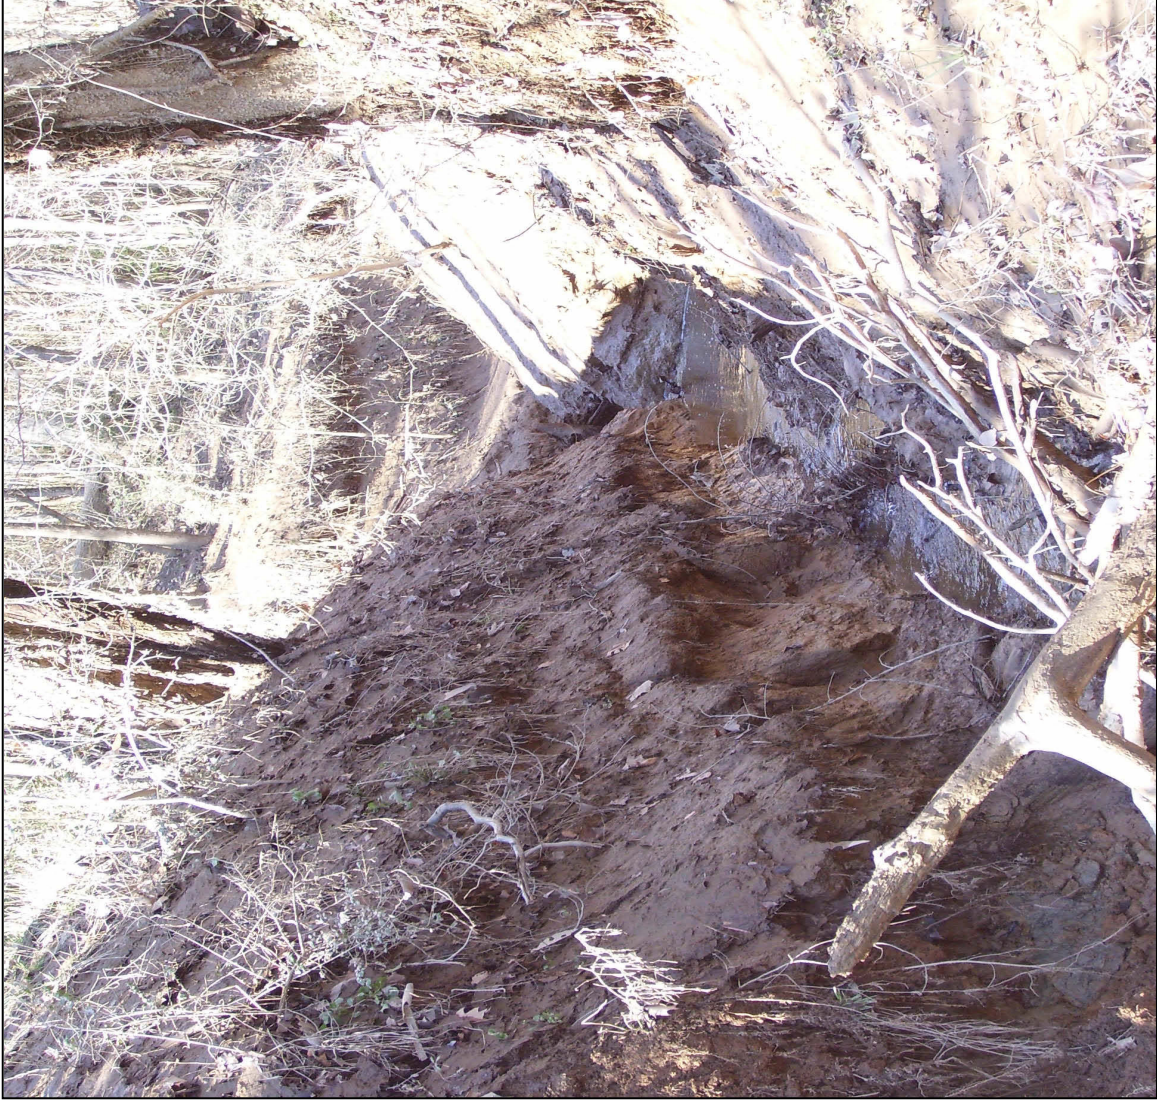
Photo 6. River Observation Point 5

Location: Confluence of the Deep River and an unnamed tributary

Description: Stream headcut and erosion of bank material

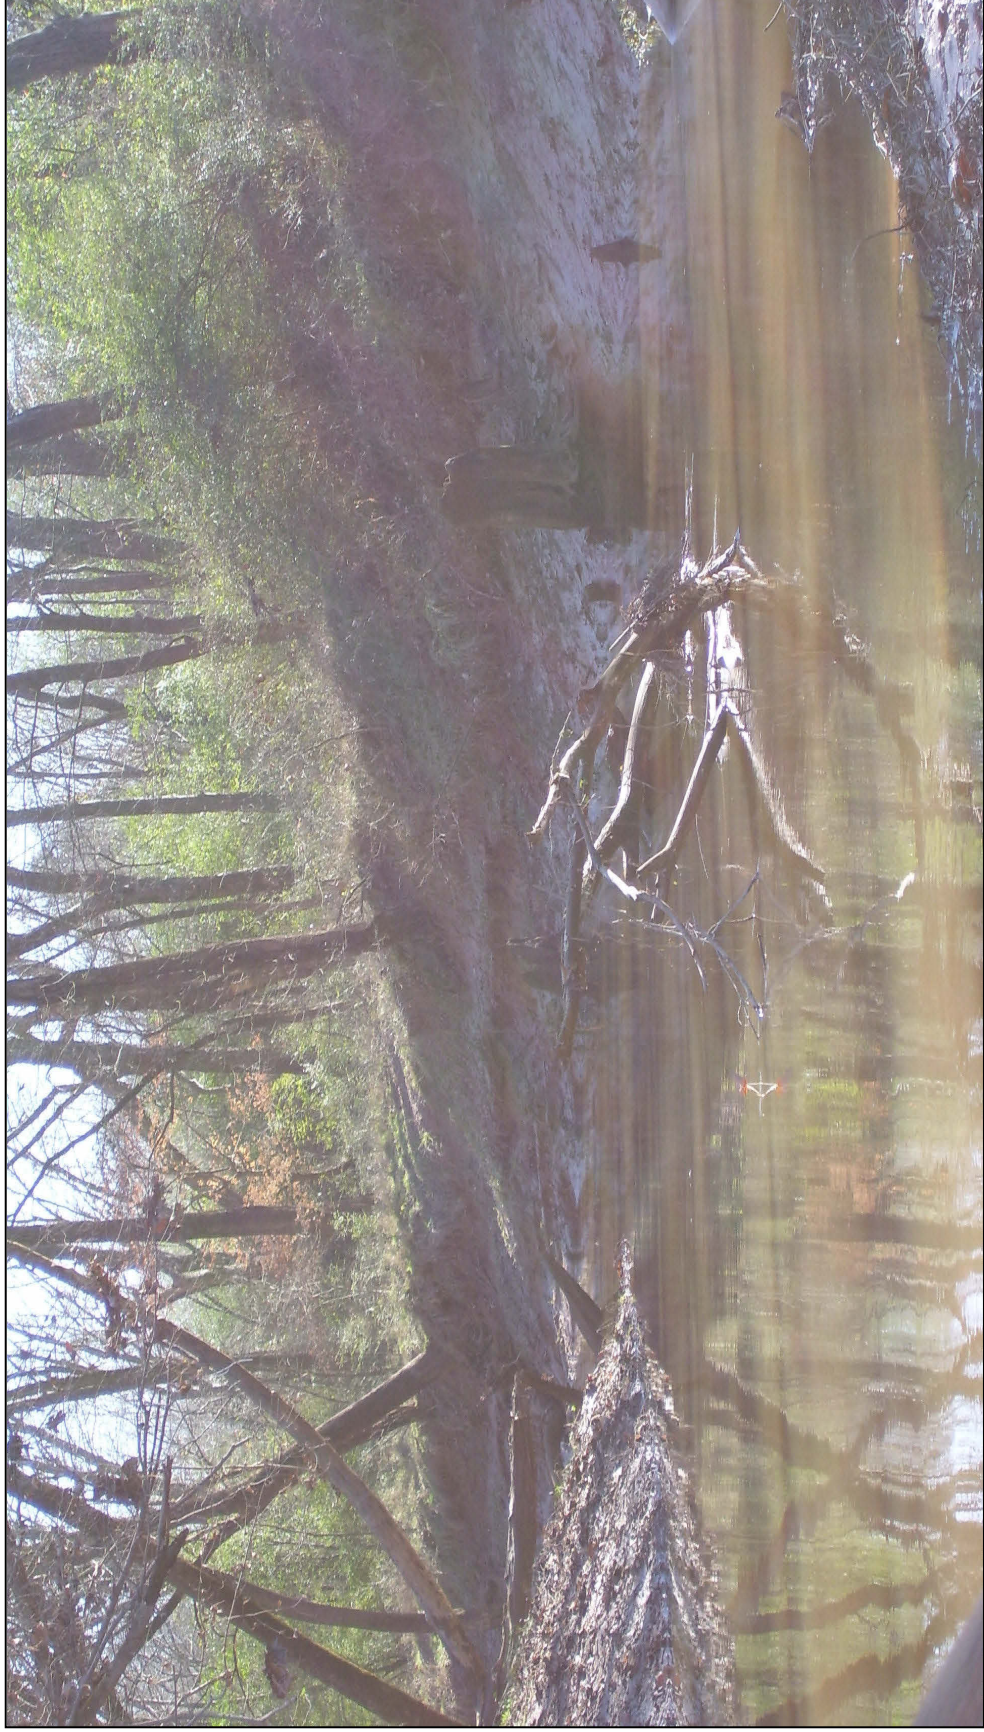
Photo 7. River Observation Point 6

Location: Confluence of the Deep River and Big Governor's Creek
Description: Stable banks with only minor erosion

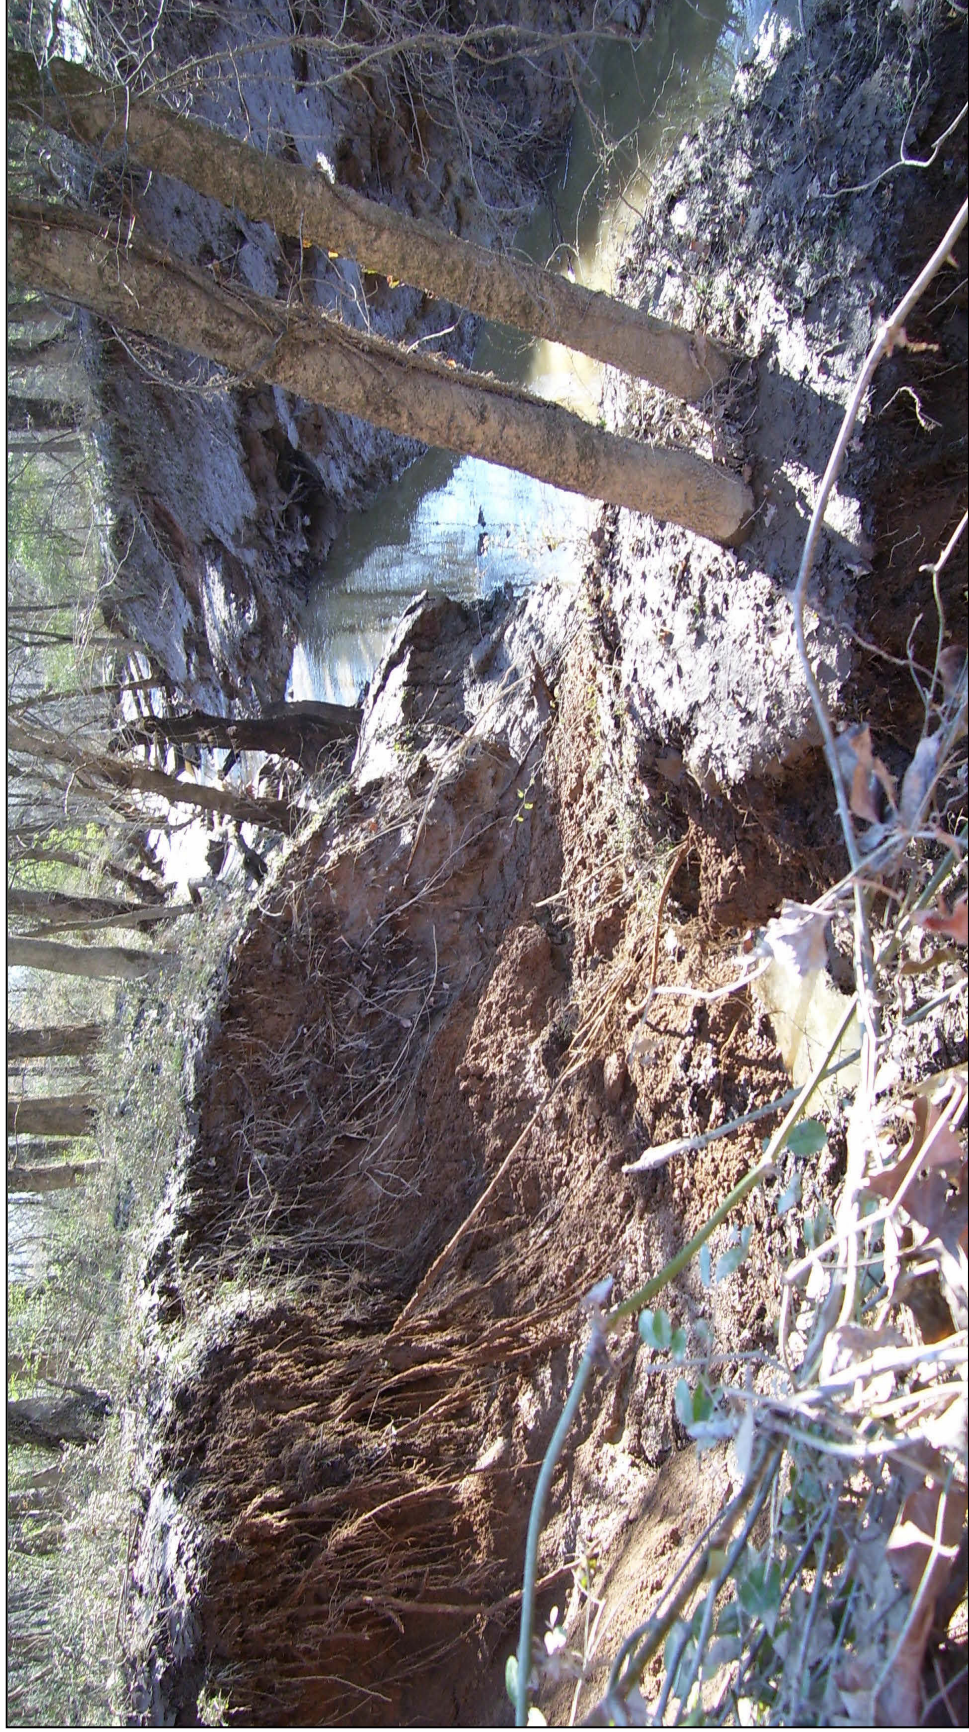
Photo 8. River Observation Point 7

Location: Confluence of the Deep River and an unnamed tributary
Description: Large scale bank sloughing and continued headcutting

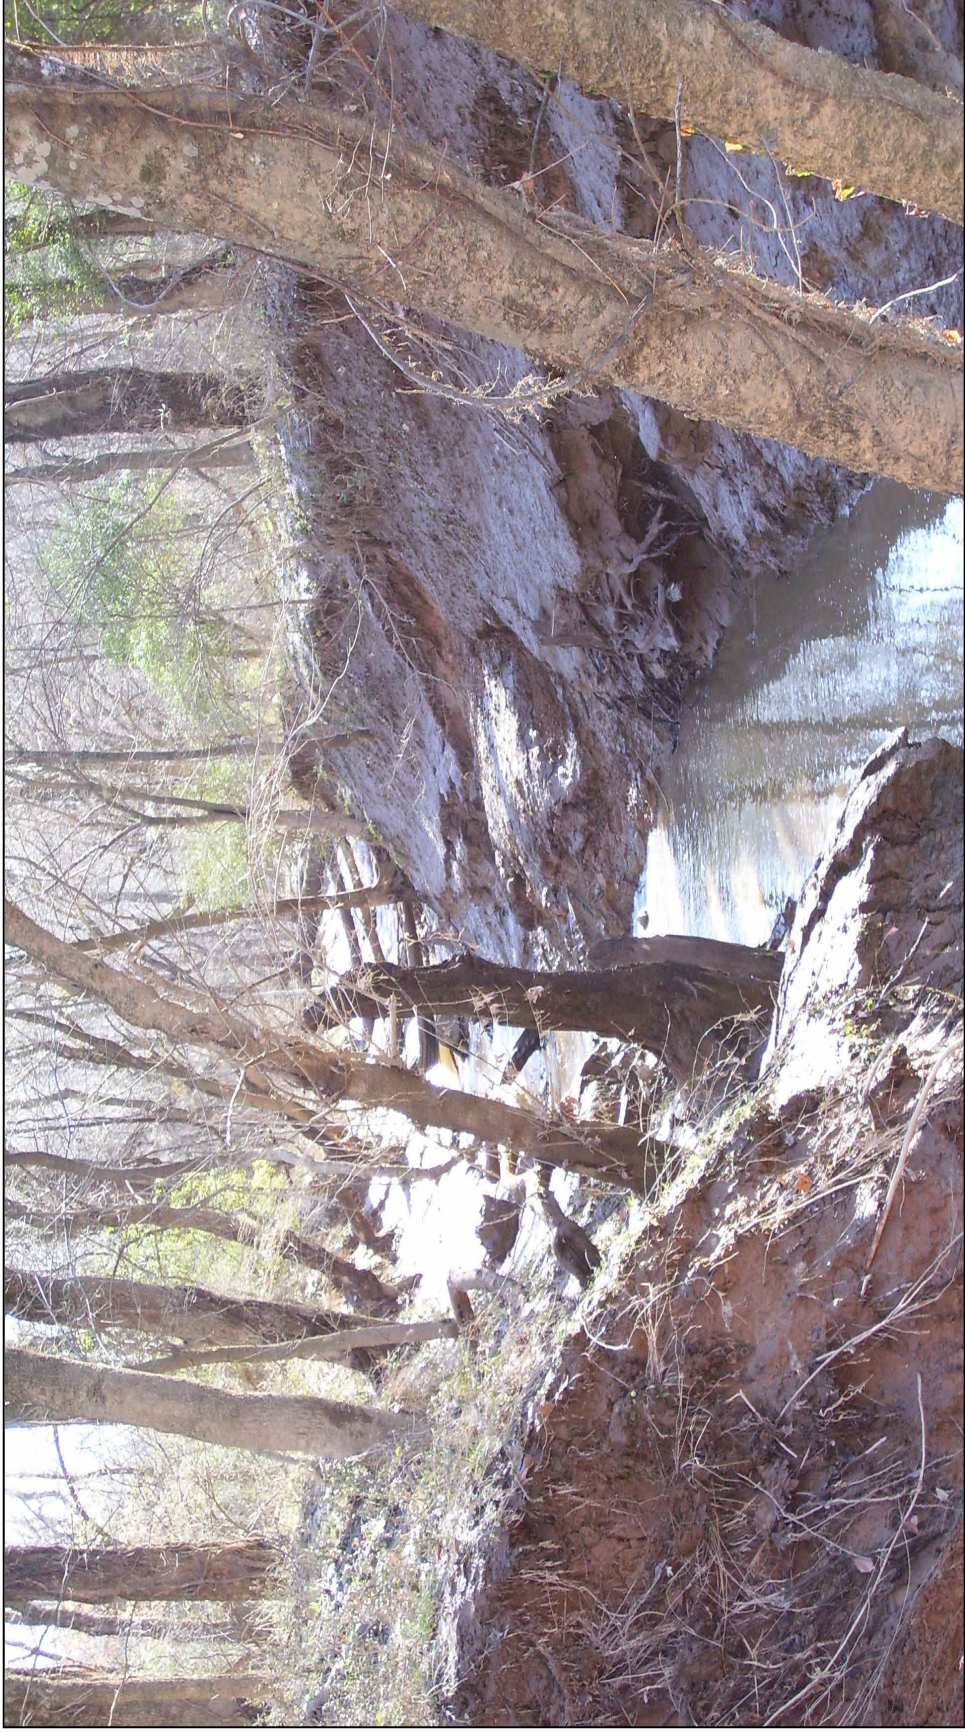
Photo 9. River Observation Point 7

Location: Confluence of the Deep River and an unnamed tributary
Description: Continued headcutting and erosion of bank material

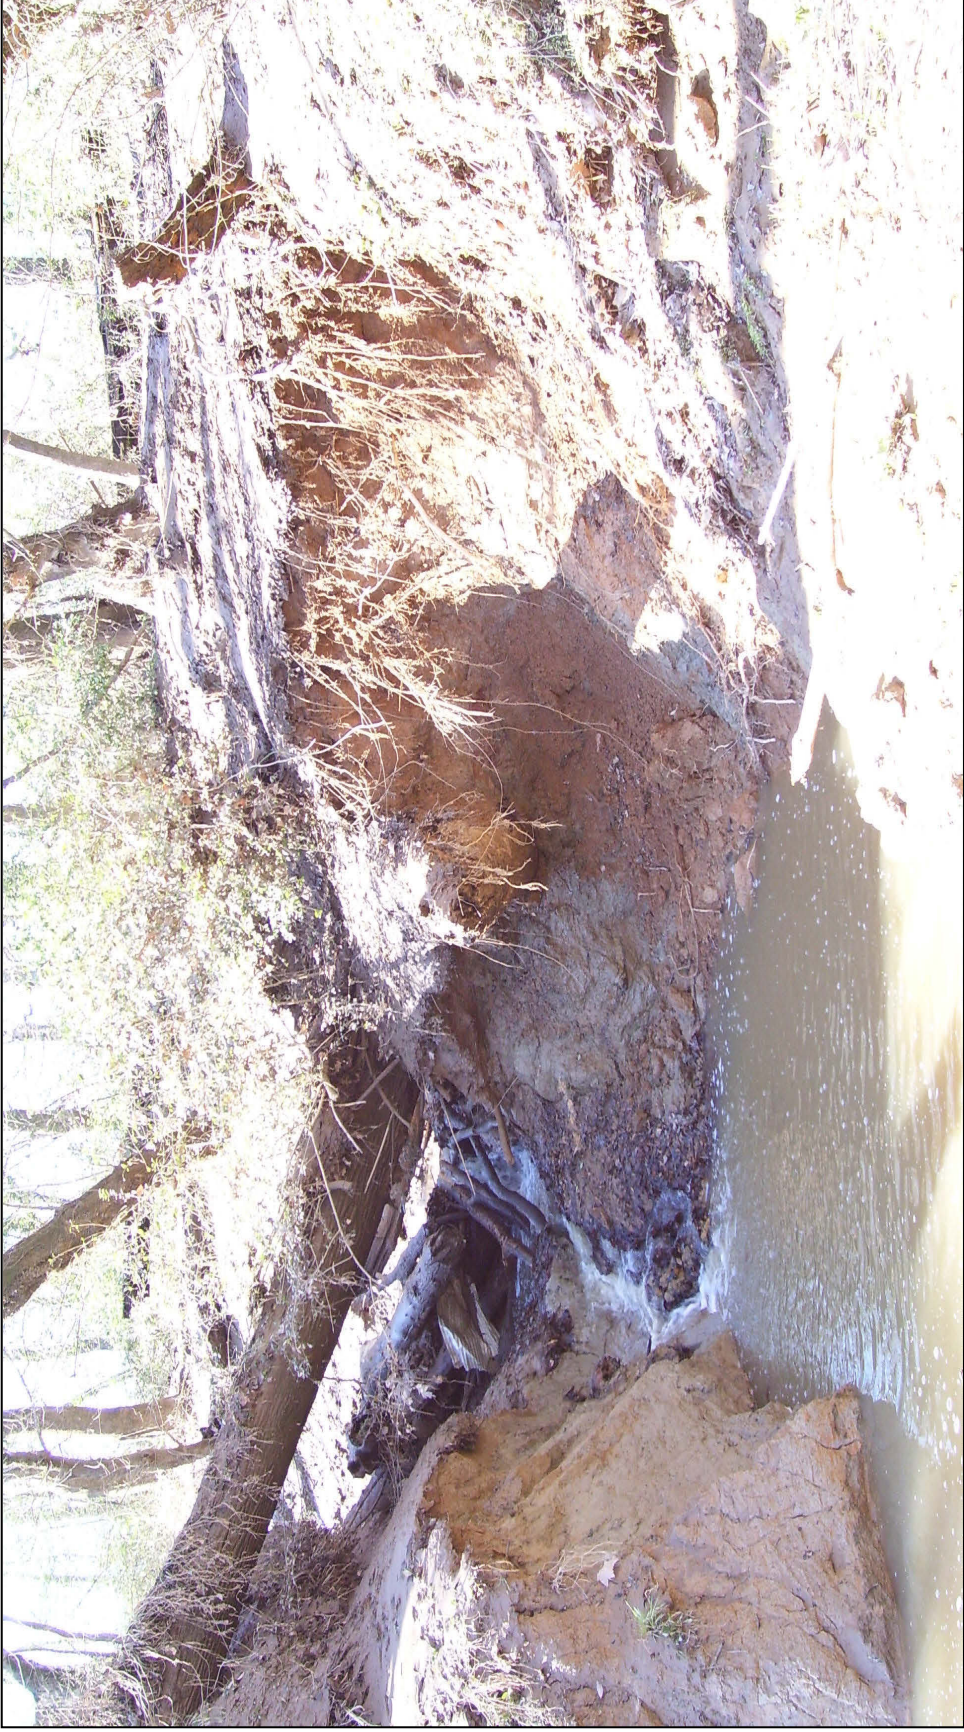
Photo 10. River Observation Point 8

Location: Confluence of the Deep River and an unnamed tributary, near Monitoring Station 27
Description: Multiple trees fallen over and roots exposed as a result of bank sloughing

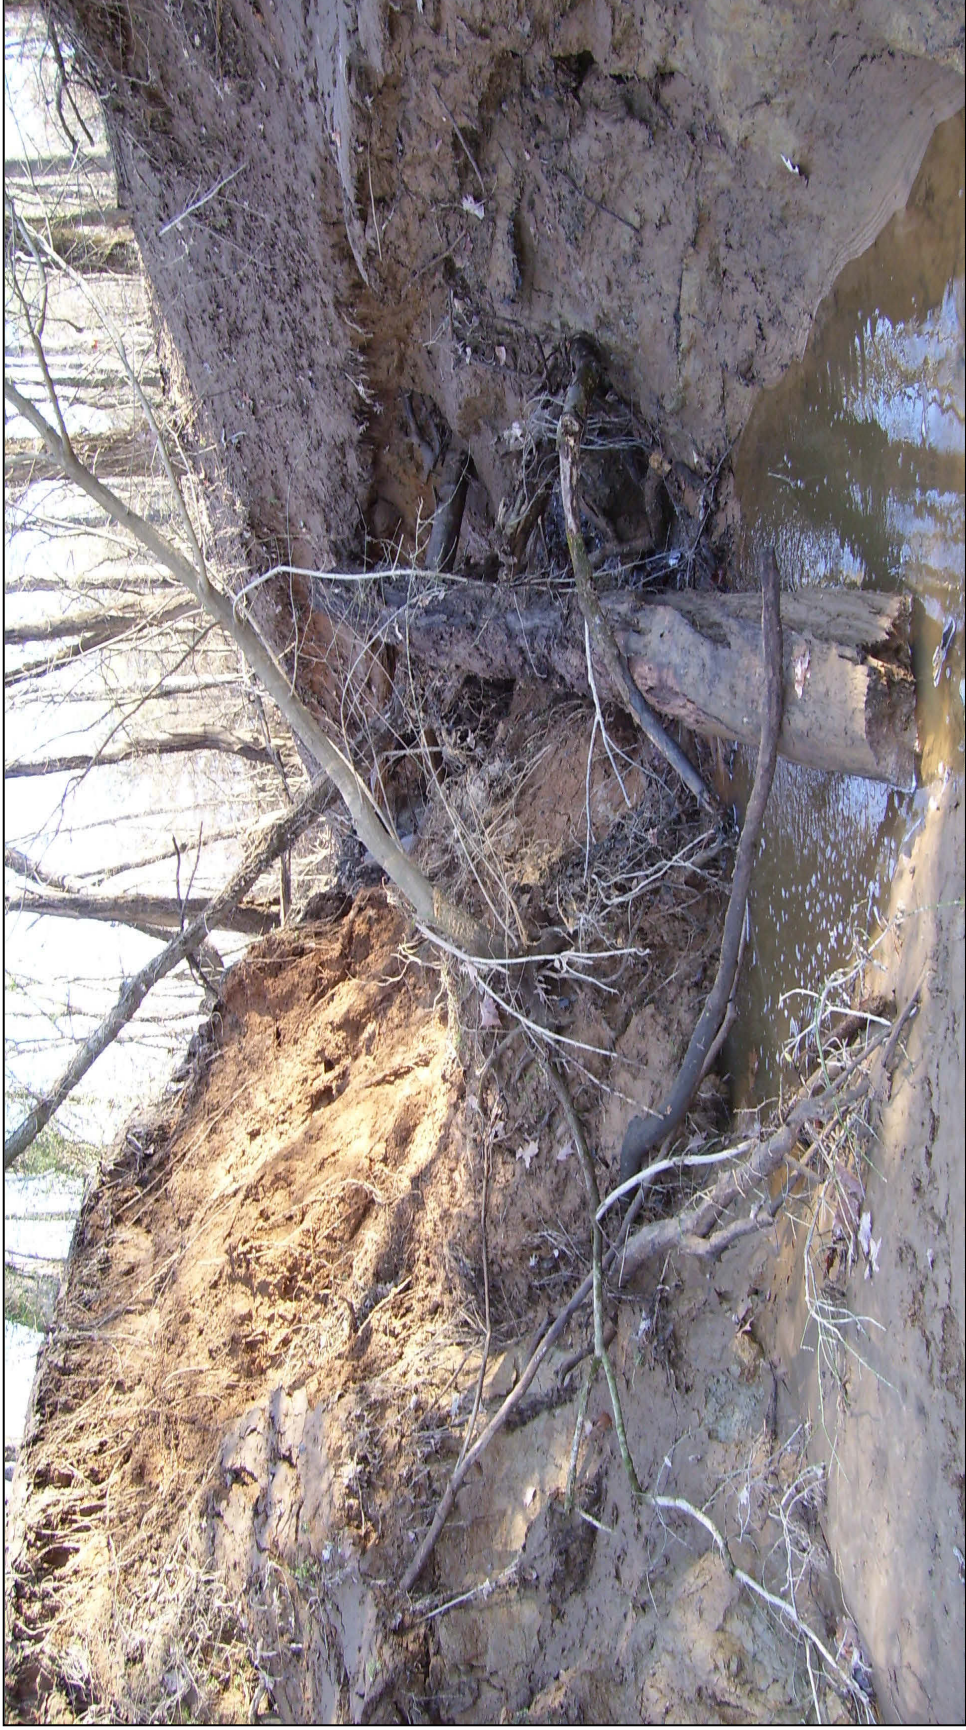
Photo 11. River Observation Point 9

Location: Confluence of the Deep River and an unnamed tributary
Description: Bank sloughing and transporting of debris into the Deep River

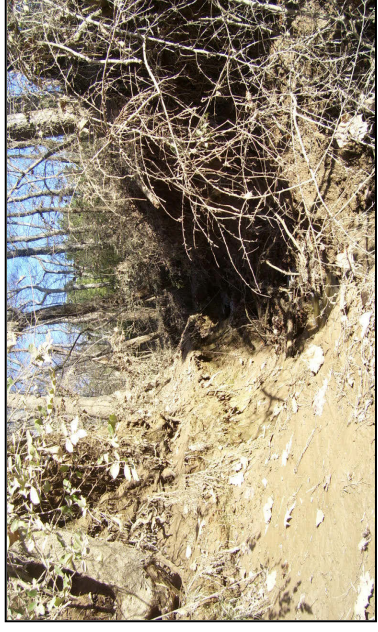
Photo 12. River Observation Point 10

River Observation Point 10 is located on the Deep River at the confluence with an unnamed tributary near Monitoring Station 2. Down cutting of the tributary was observed and large amounts of sediment has built up at the confluence with the Deep River (Photo 12).

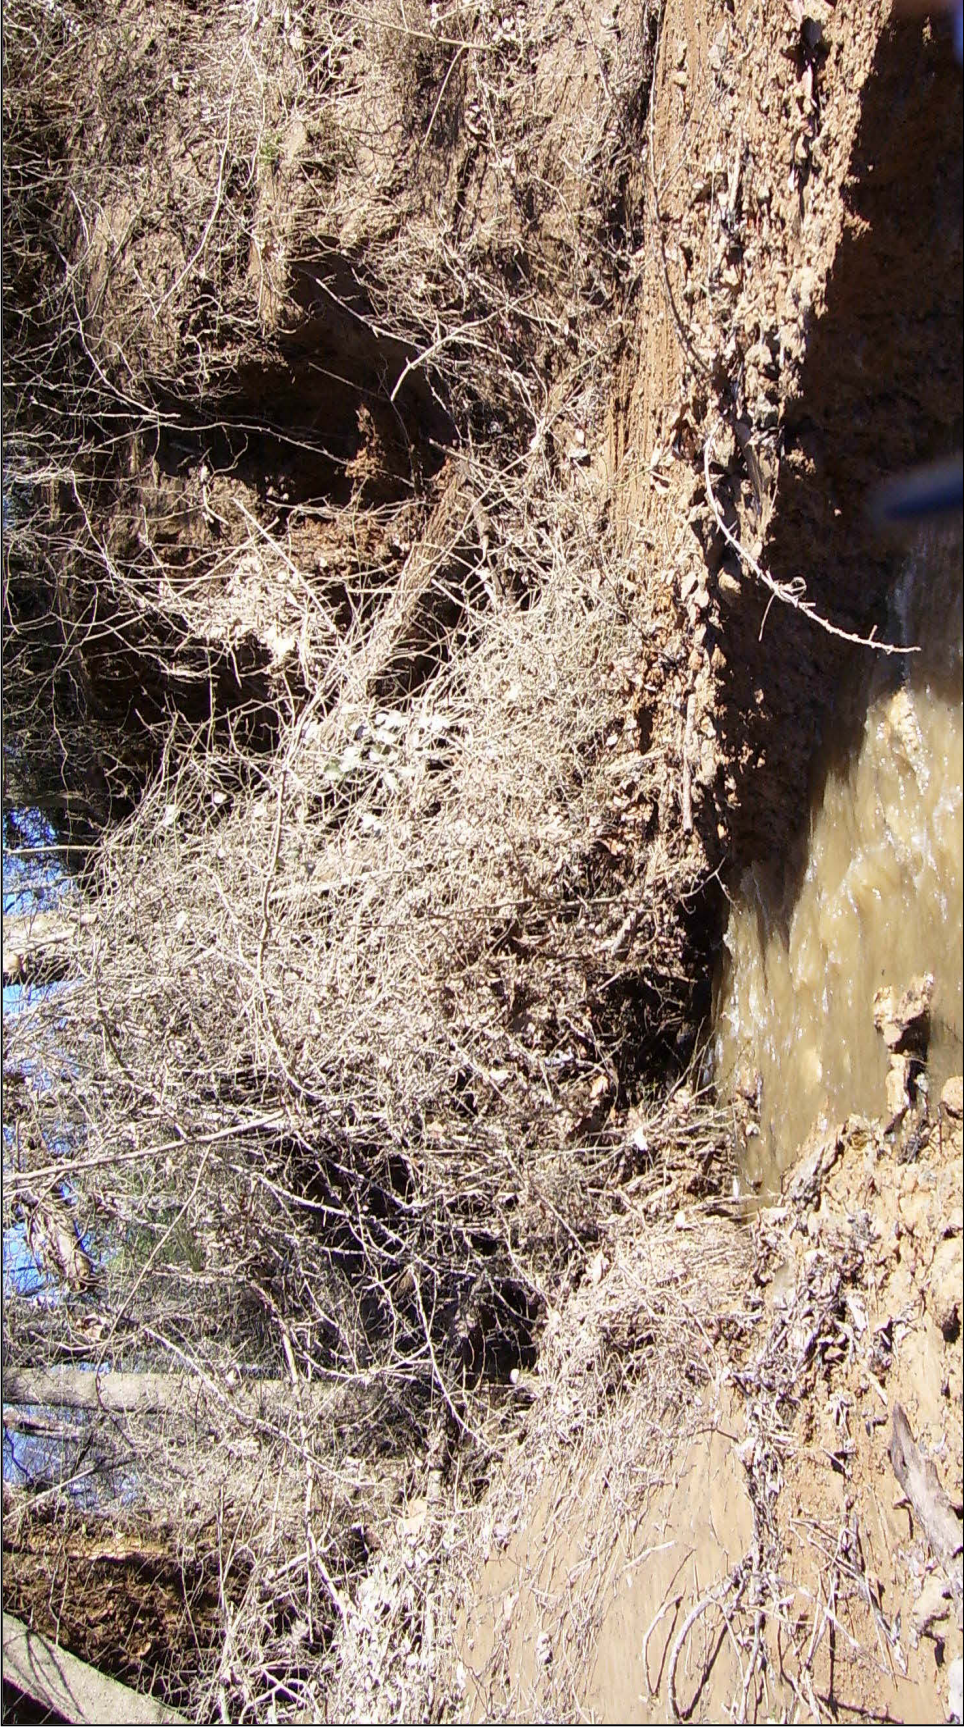
Location: Confluence of the Deep River and an unnamed tributary near Monitoring Station 2
Description: Continued movement of sediment and sloughing of bank material

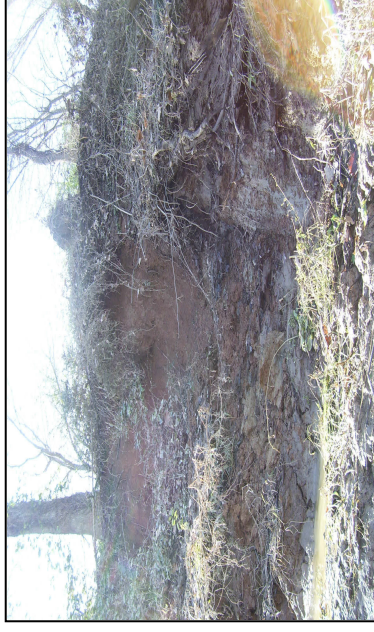
Photo 13. River Observation Point 11

River Observation Point 11 is located on the Deep River at the confluence with an unnamed tributary near Monitoring Station 23. A large head-cut has continued moving sediment out of the tributary while the banks remain steep and unvegetated. A large piece of the bank with a tree growing on it has broken off the bank and slid into the tributary (Photo 13).

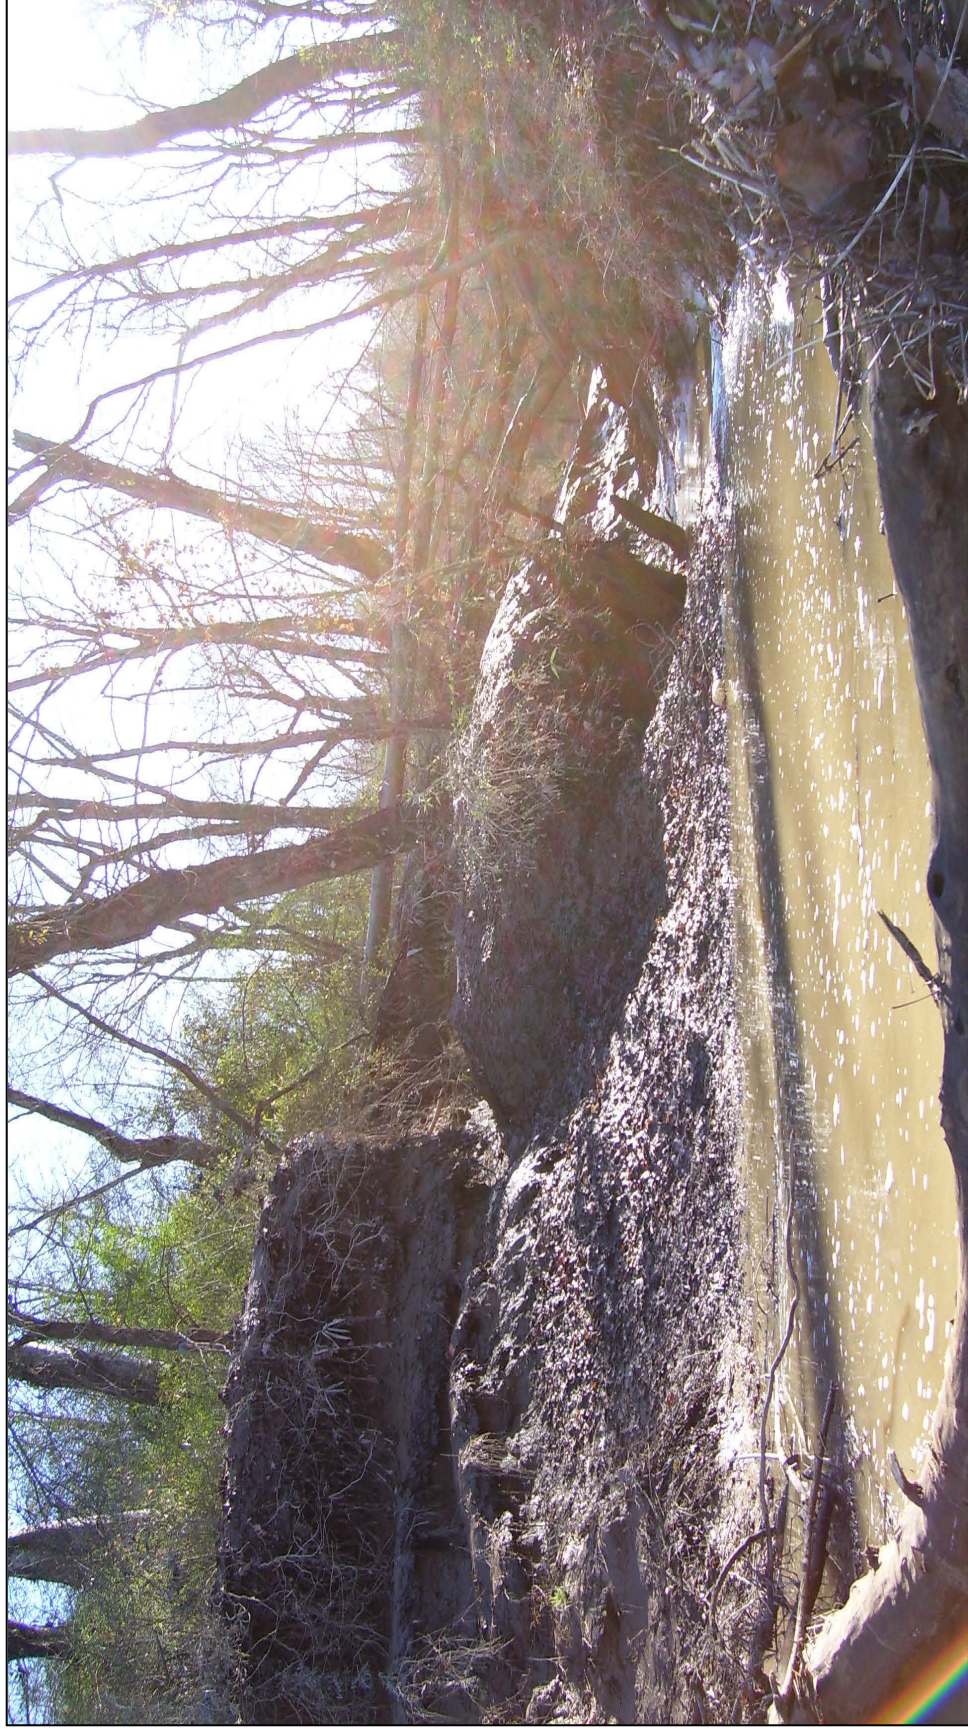
Location: Confluence of the Deep River and an unnamed tributary near Monitoring Station 23
Description: Continued headcutting and erosion of right bank

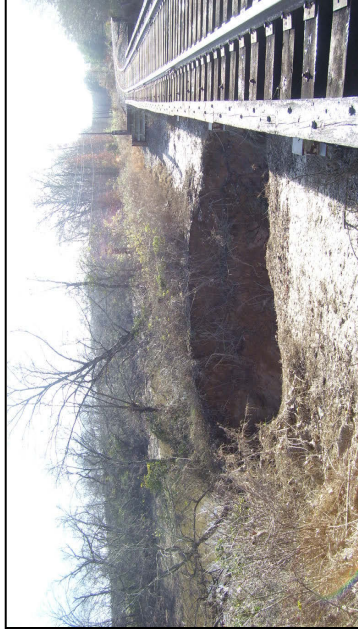
Photo 14. River Observation Point 12

Location: Confluence of the Deep River and Line Creek
Description: Continued erosion of bank material and woody debris

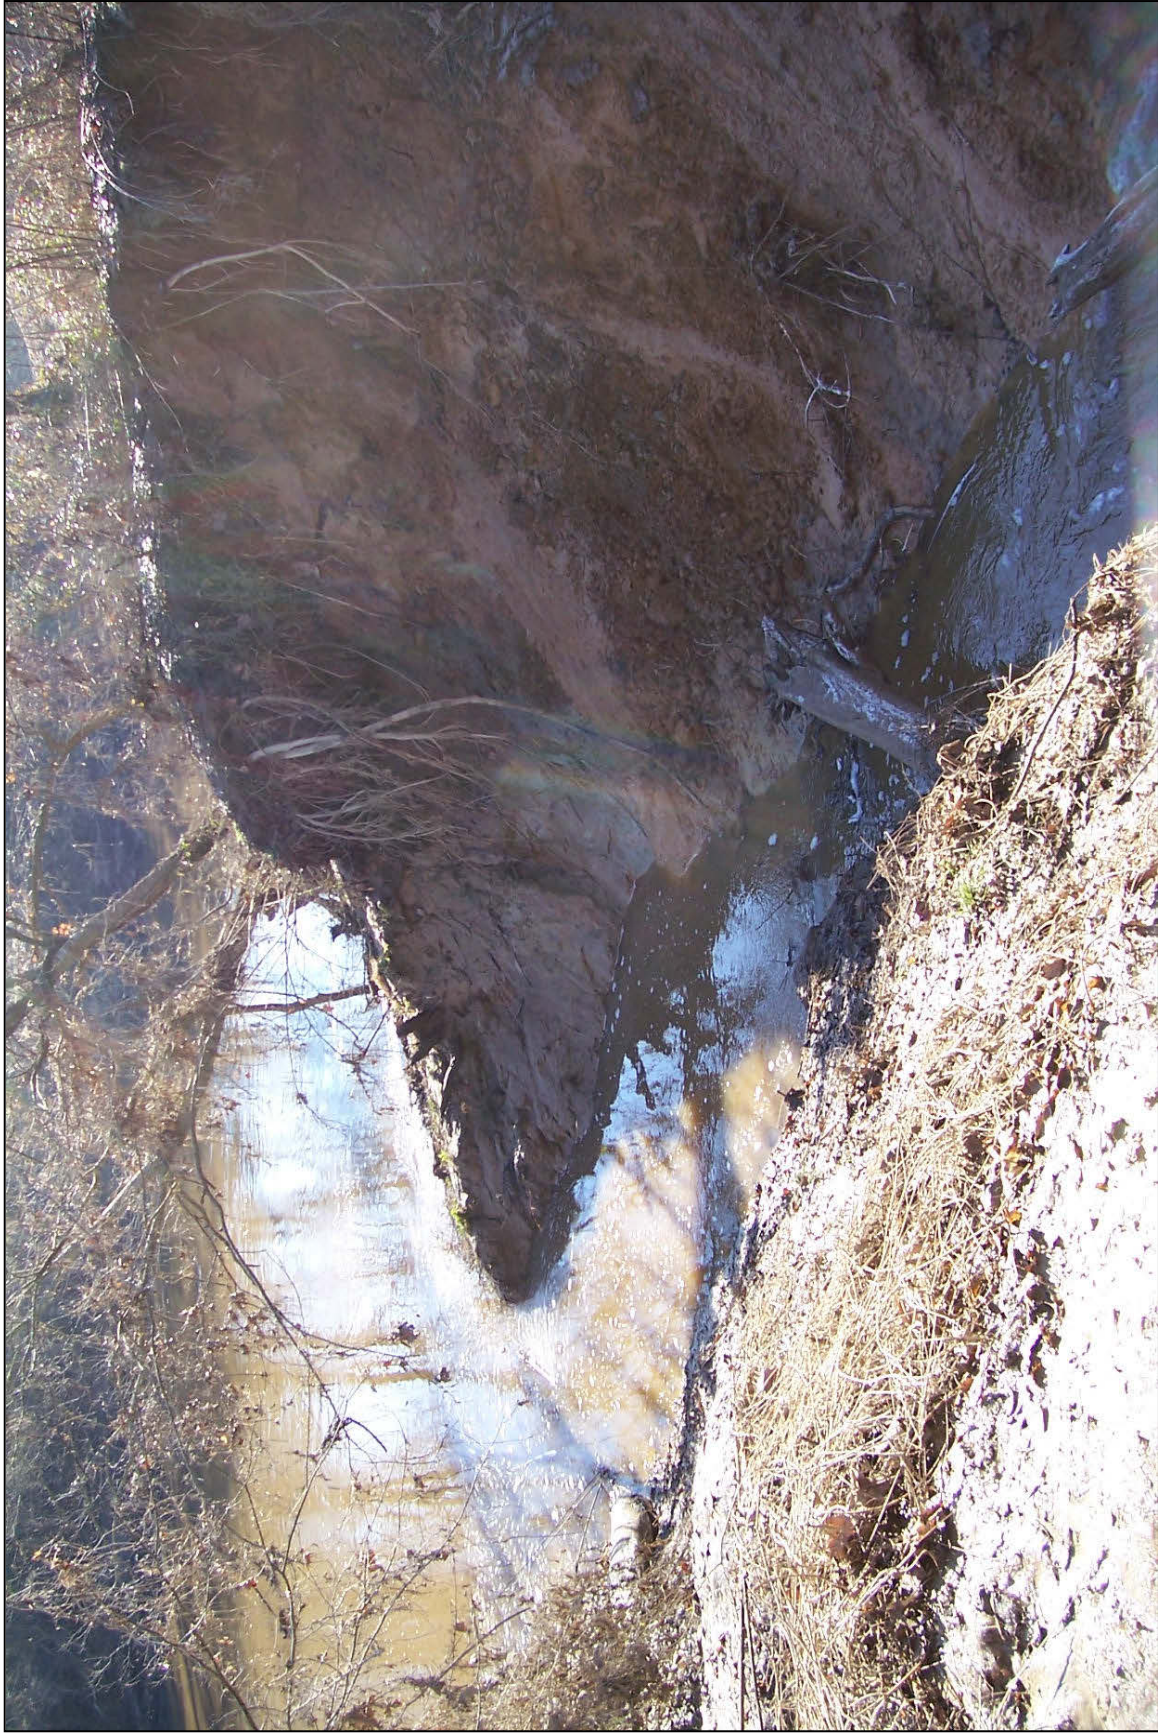
Photo 15. River Observation Point 12

Location: Confluence of the Deep River and Line Creek
Description: Continued erosion of bank material and woody debris
