**CARBONTON DAM – DEEP RIVER WATERSHED
RESTORATION SITE
2007 Annual Monitoring Report (Year 2)**

**Chatham, Lee and Moore Counties, NC
EEP Project No. D-04012A
Design Firm: Milone and MacBroom, Inc.**

**Prepared for: NCDENR - ECOSYSTEM ENHANCEMENT PROGRAM
1652 Mail Service Center
Raleigh, North Carolina 27699-1619**

**Prepared by: ECOSCIENCE CORPORATION
1101 Haynes Street, Suite 101
Raleigh, North Carolina 27604**

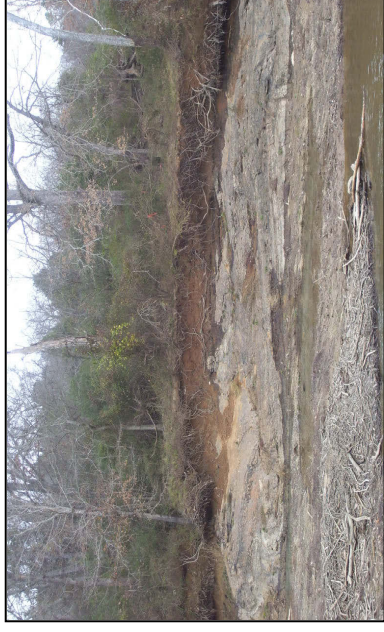
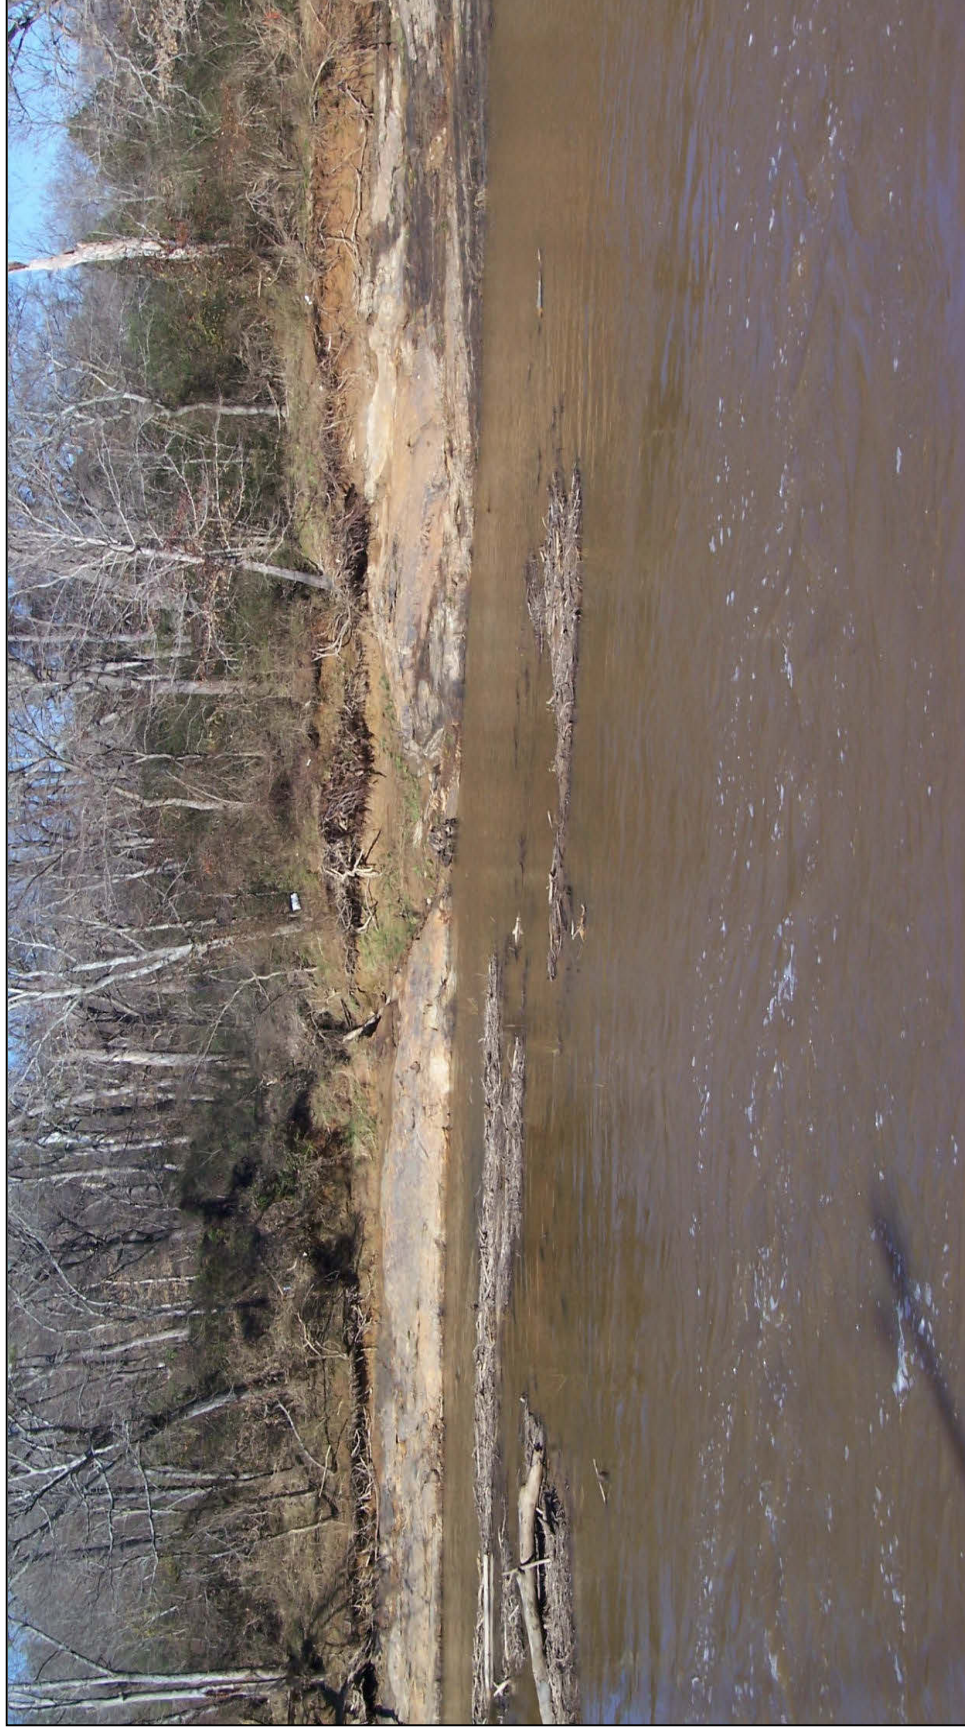
Photo 16. River Observation Point 13

River Observation Point 13 is located on the Deep River at the bridge crossing of NC 42, just upstream of the former Carbonton dam. At this location the massive logjam seen on November 27, 2006 has broken apart between the right-most two bridge supports. An accumulation of debris remains between the center-most spans. Below the bridge and above the old dam site scouring was observed near top of bank, but exposed bedrock maintains bank stability (Photo 16).

Location: Downstream of the NC 42 bridge crossing of the Deep River

Description: Scouring and erosion of left bank

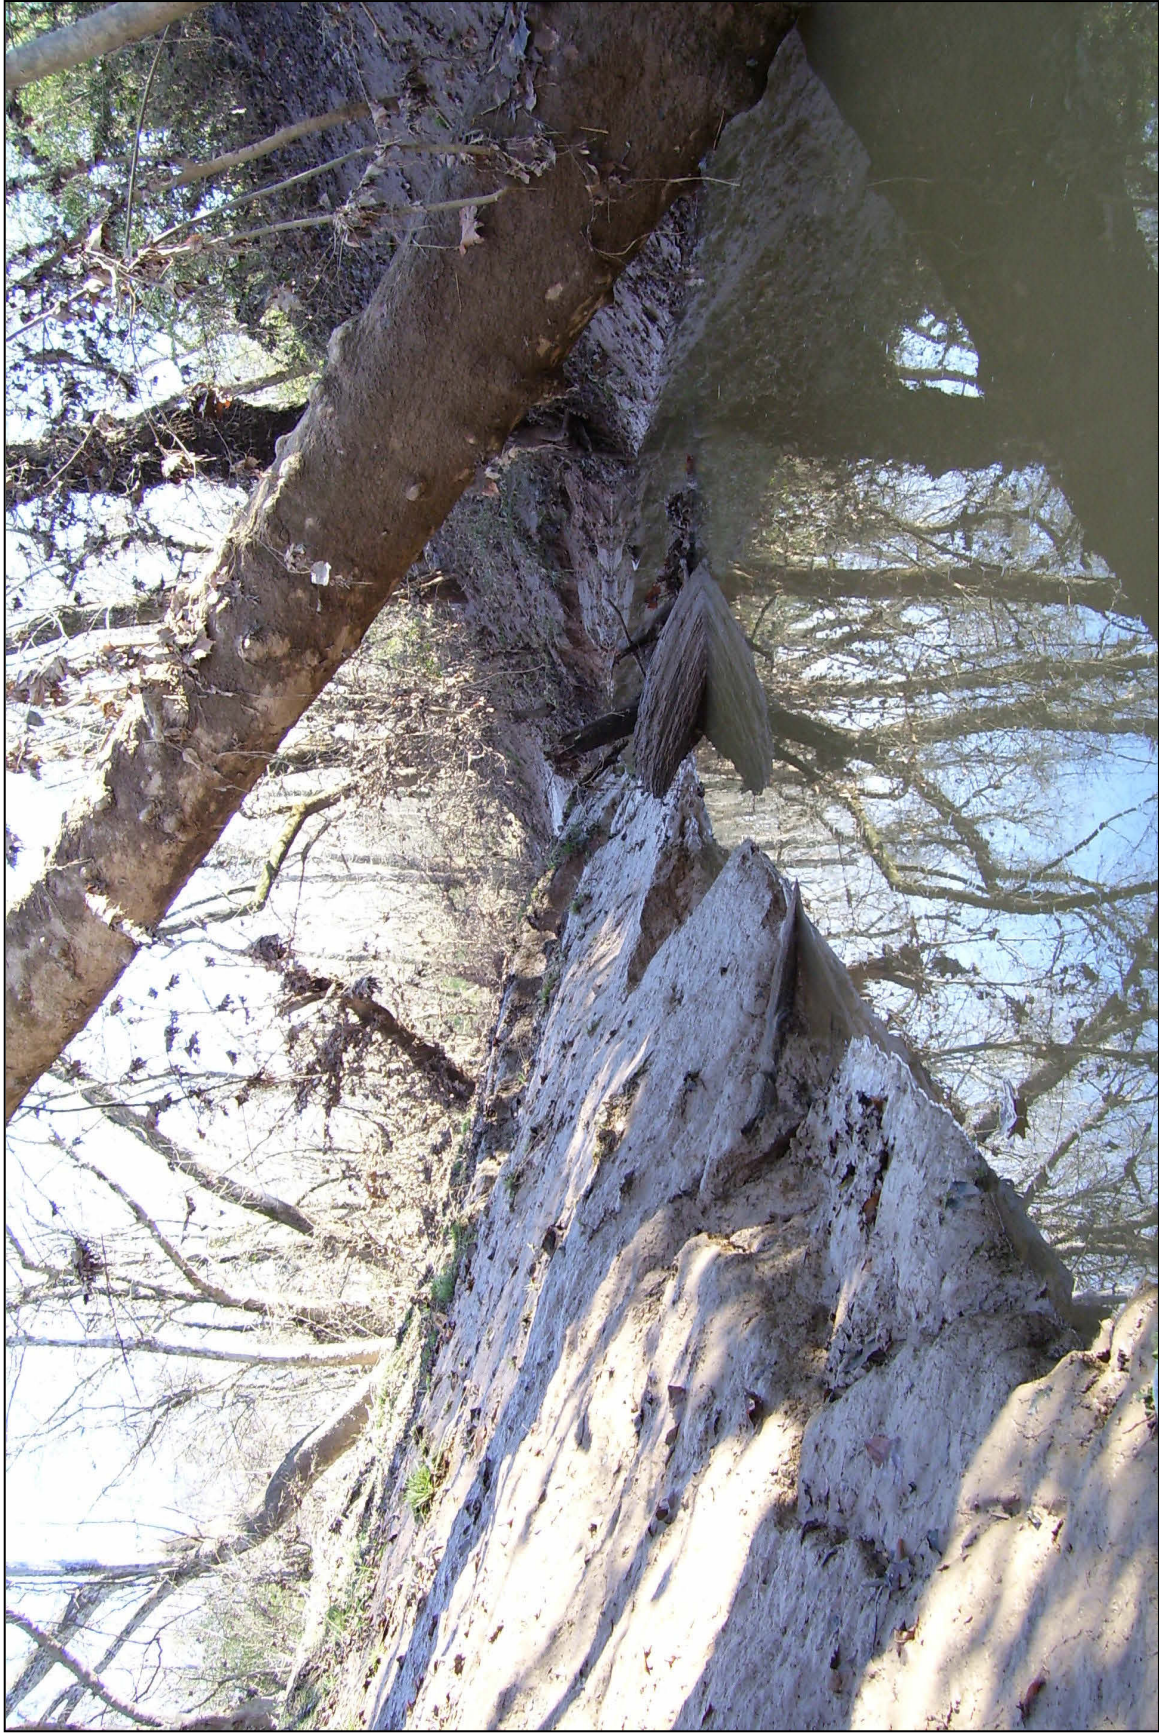
Photo 17. River Observation Point 14

Location: Deep River downstream of the Glendon-Carhage Road bridge
Description: Bank failure and continued erosion into the Deep River

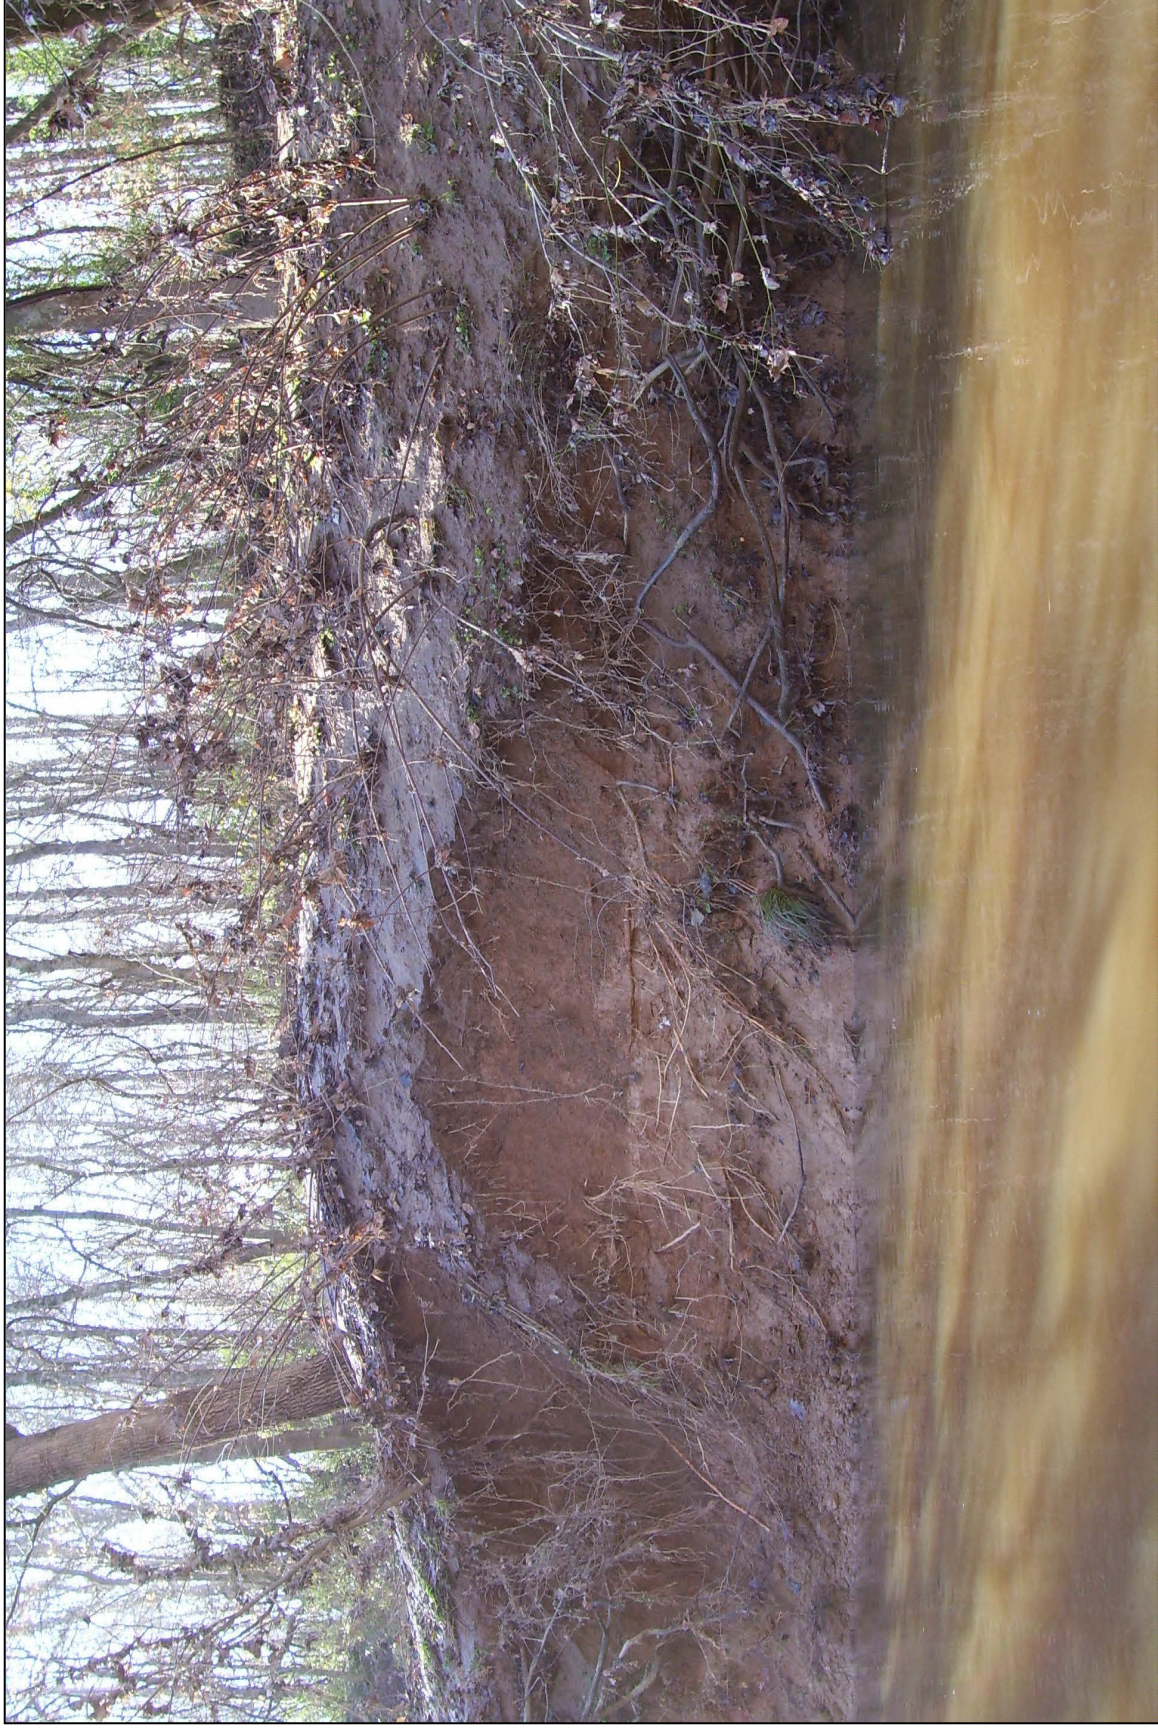
Photo 18. River Observation Point 15

Location: Deep River downstream of the Norfolk-Southern rail bridge
Description: Bank failure and continued erosion into the Deep River

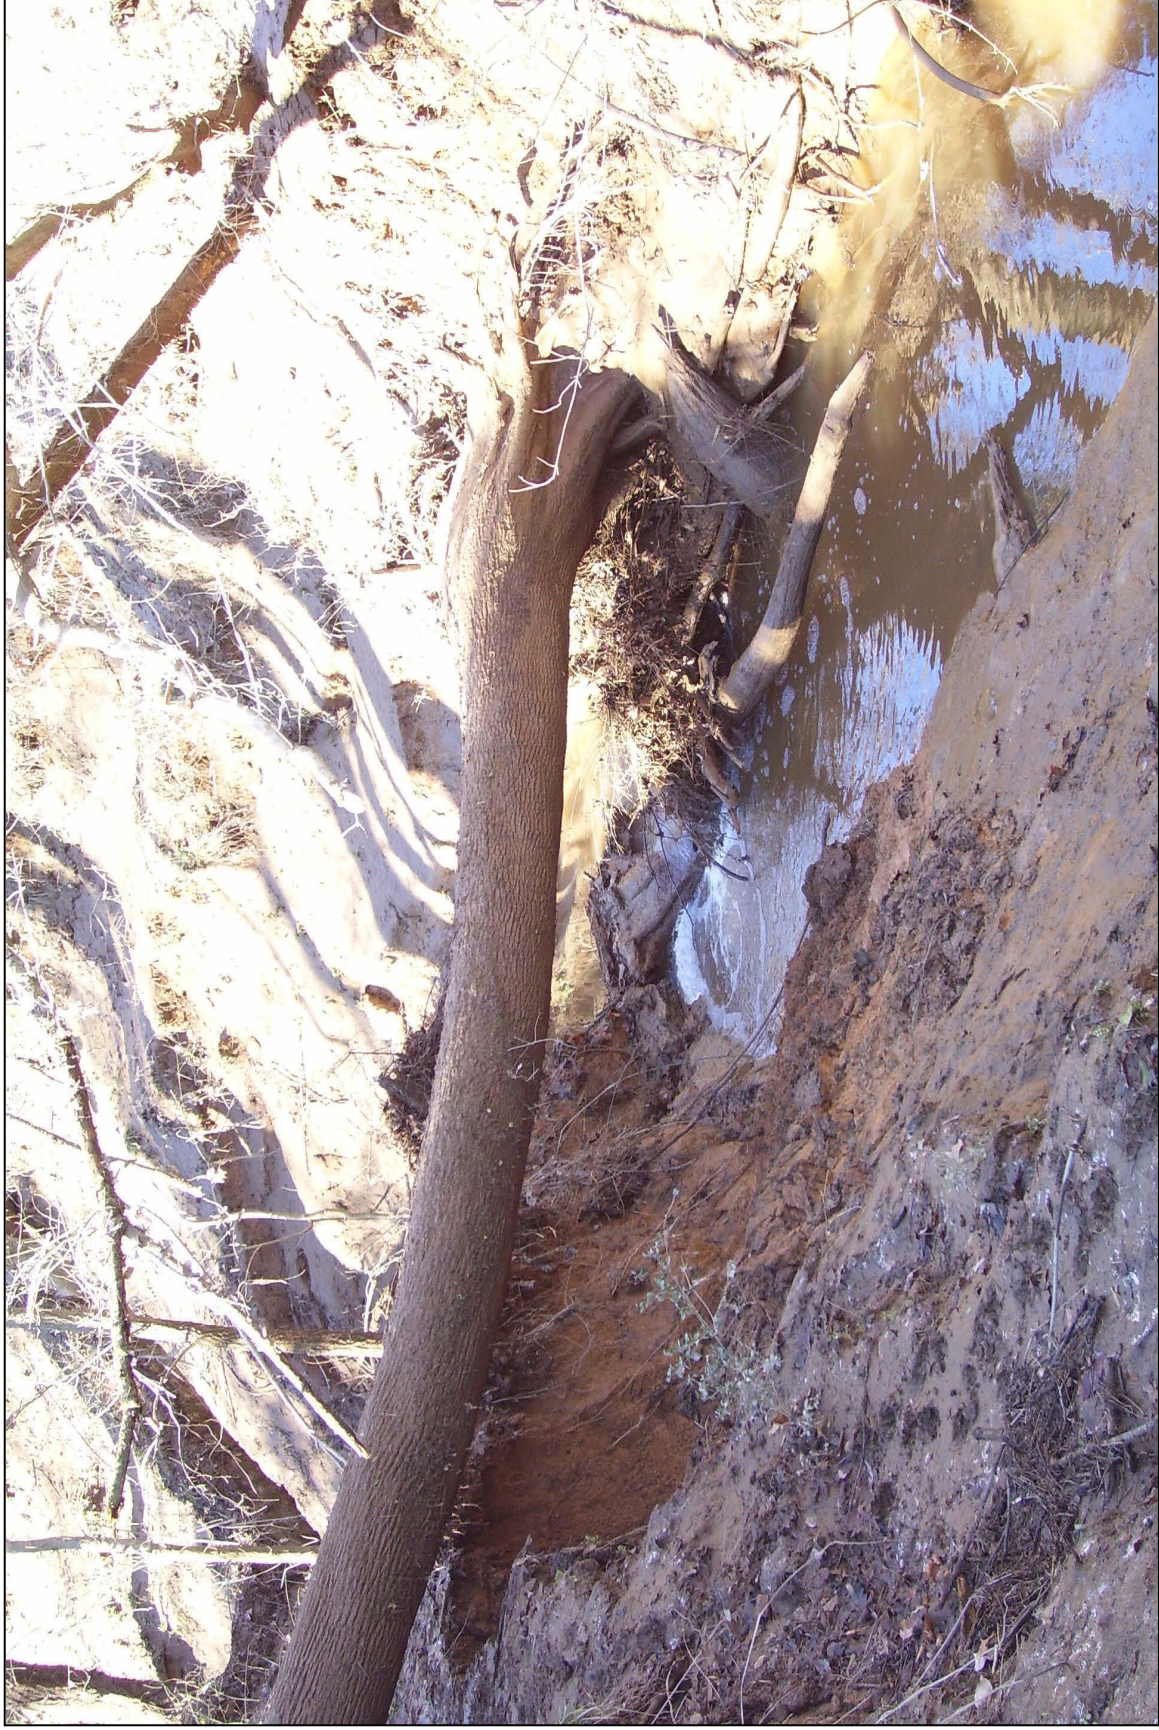
Photo 19. River Observation Point 16

Location: Mouth of Lick Creek on the Deep River
Description: Bank failure and erosion into the Deep River

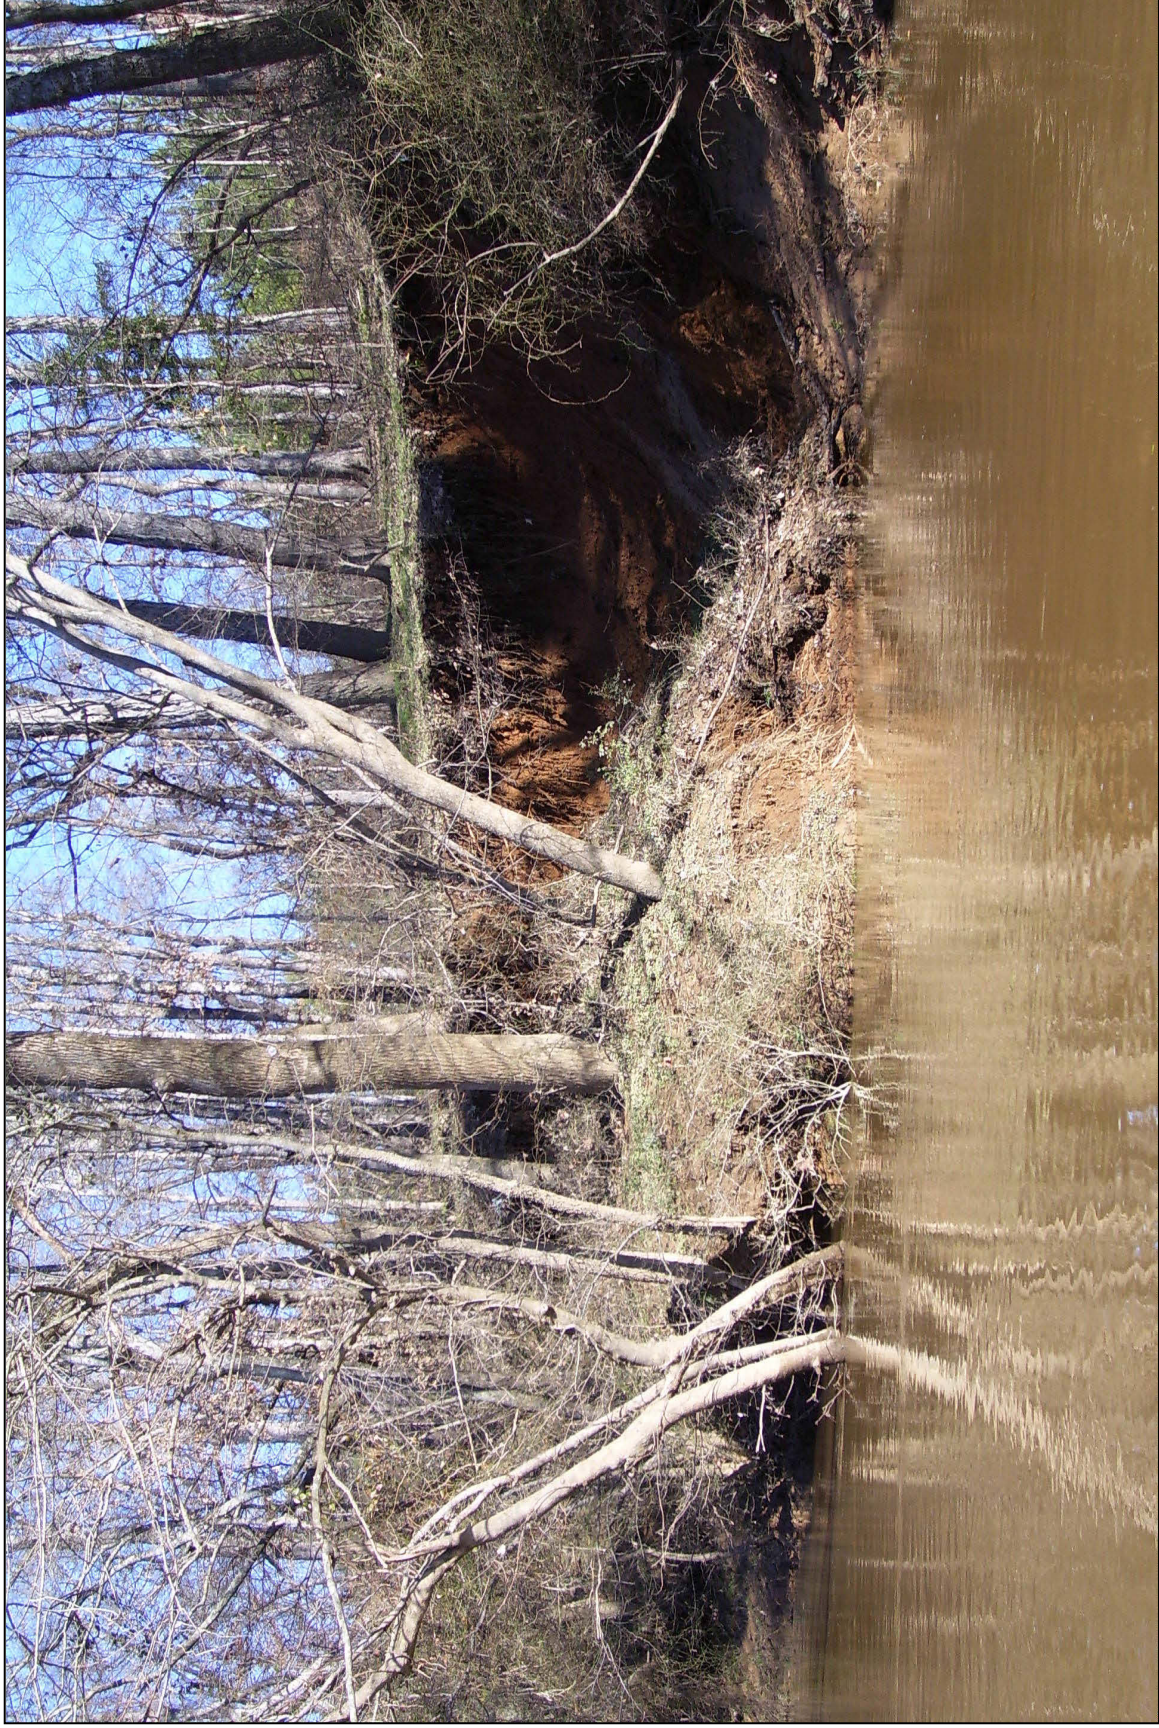
Photo 20. River Observation Point 17

Location: Approximately 2,500 ft downstream of the Carbondon Road bridge on the Deep River
Description: Bank failure and large scale sloughing into the Deep River

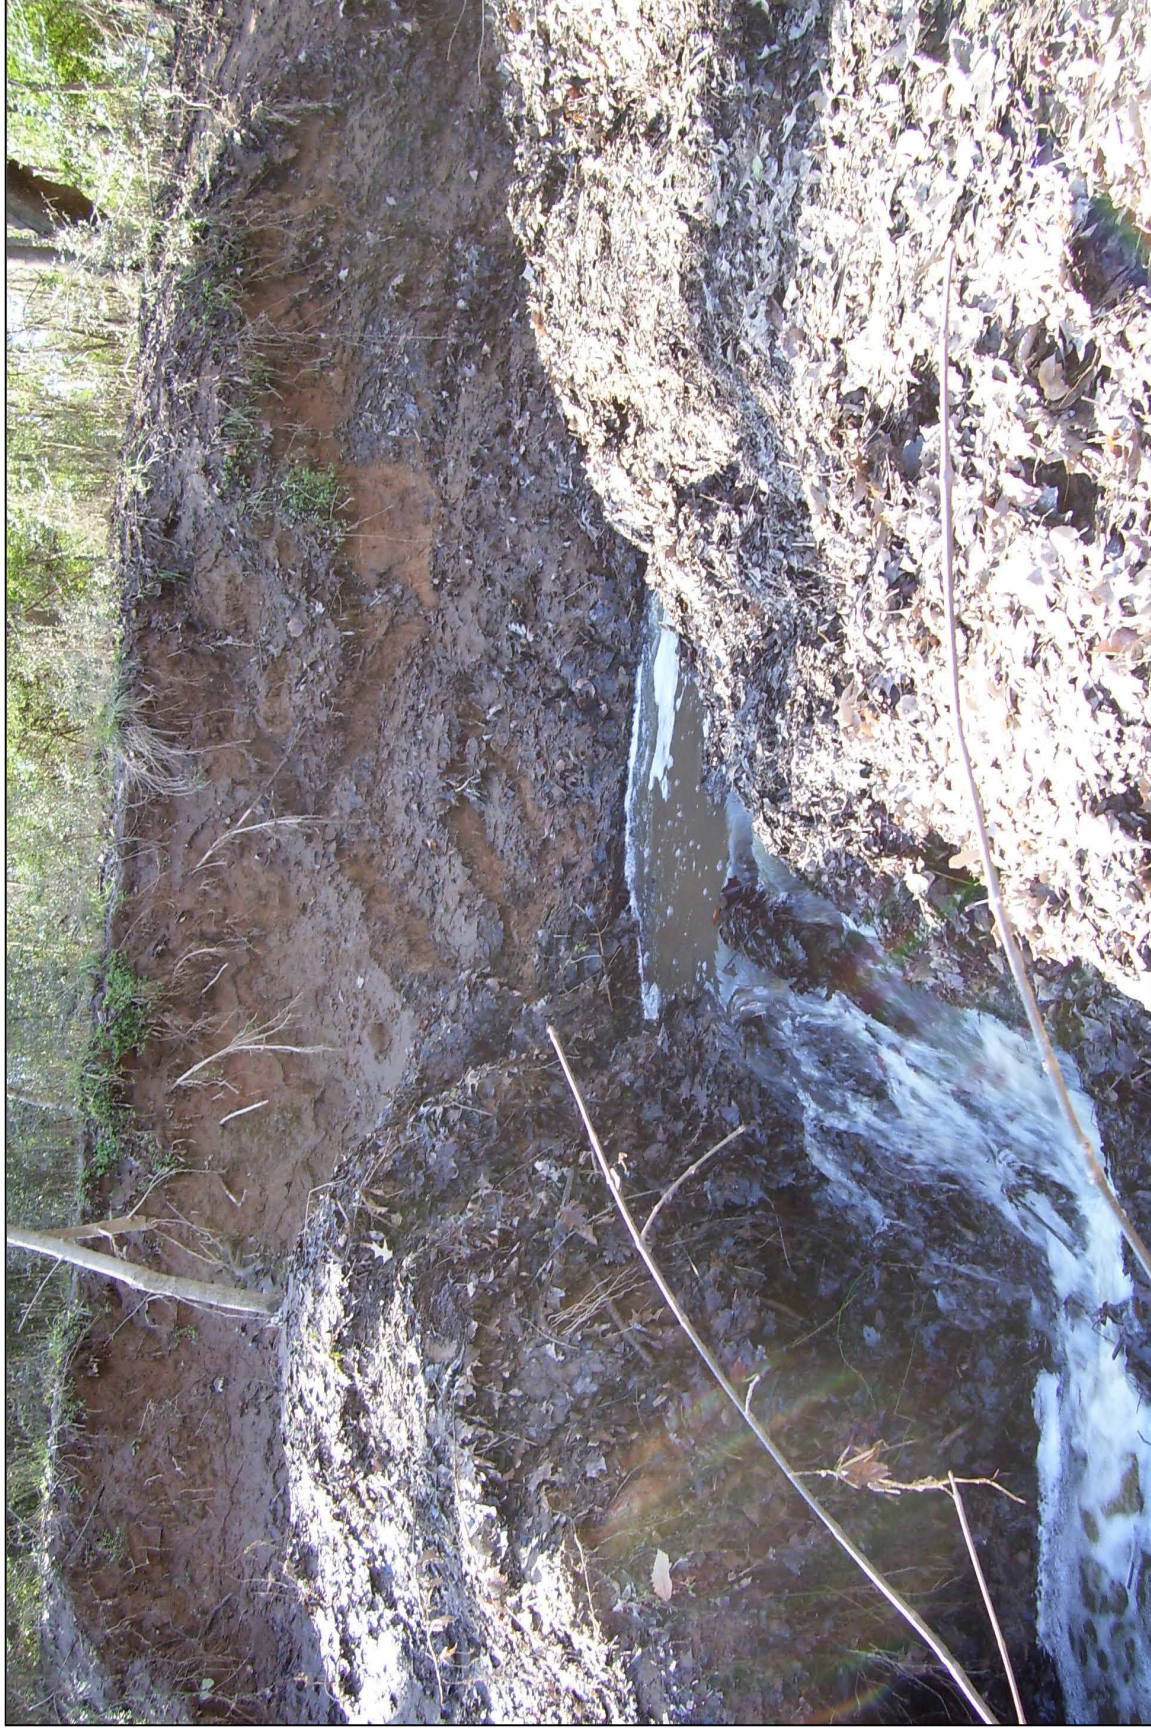
Photo 21. River Observation Point 18

Location: Approximately 2,500 feet downstream of Big Governor's Creek on the Deep River
Description: Erosion on the right bank

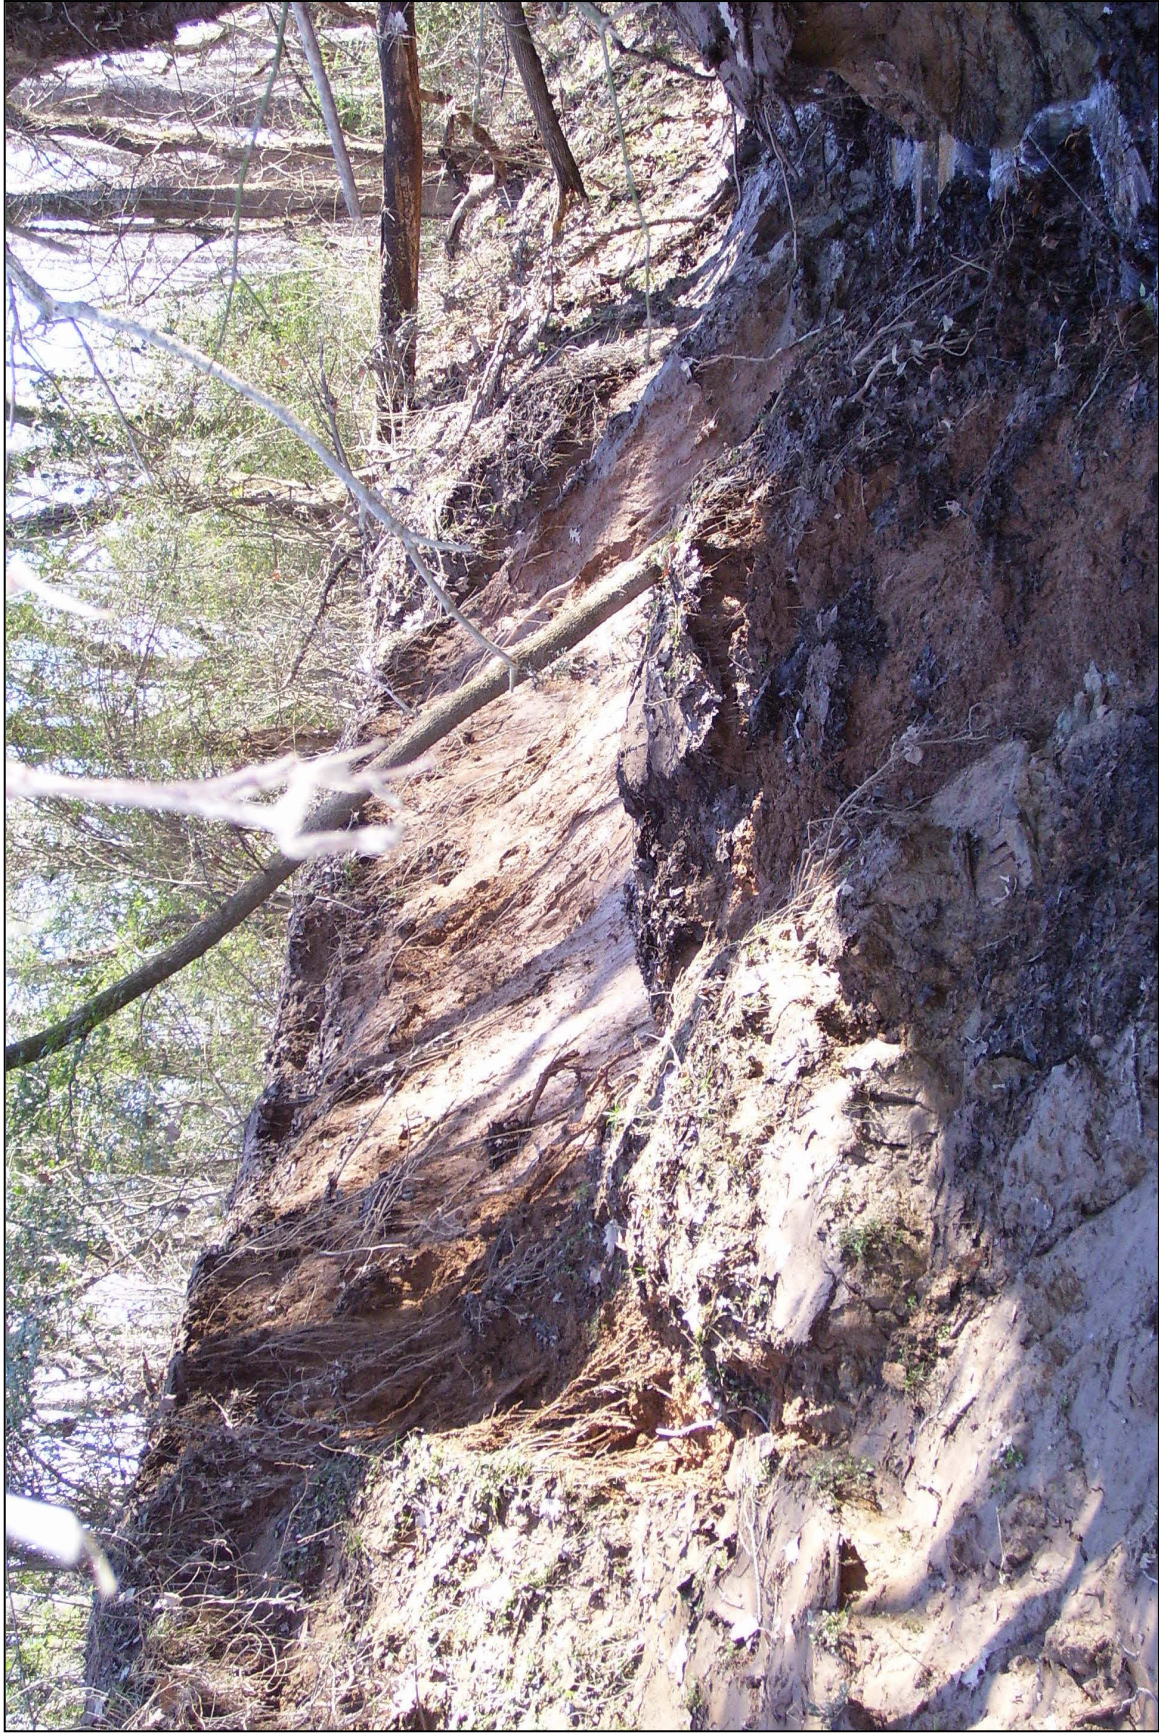
Photo 22. River Observation Point 19

Location: Confluence of the Deep River and unnamed tributary
Description: Small headcut with significant erosion of the right bank

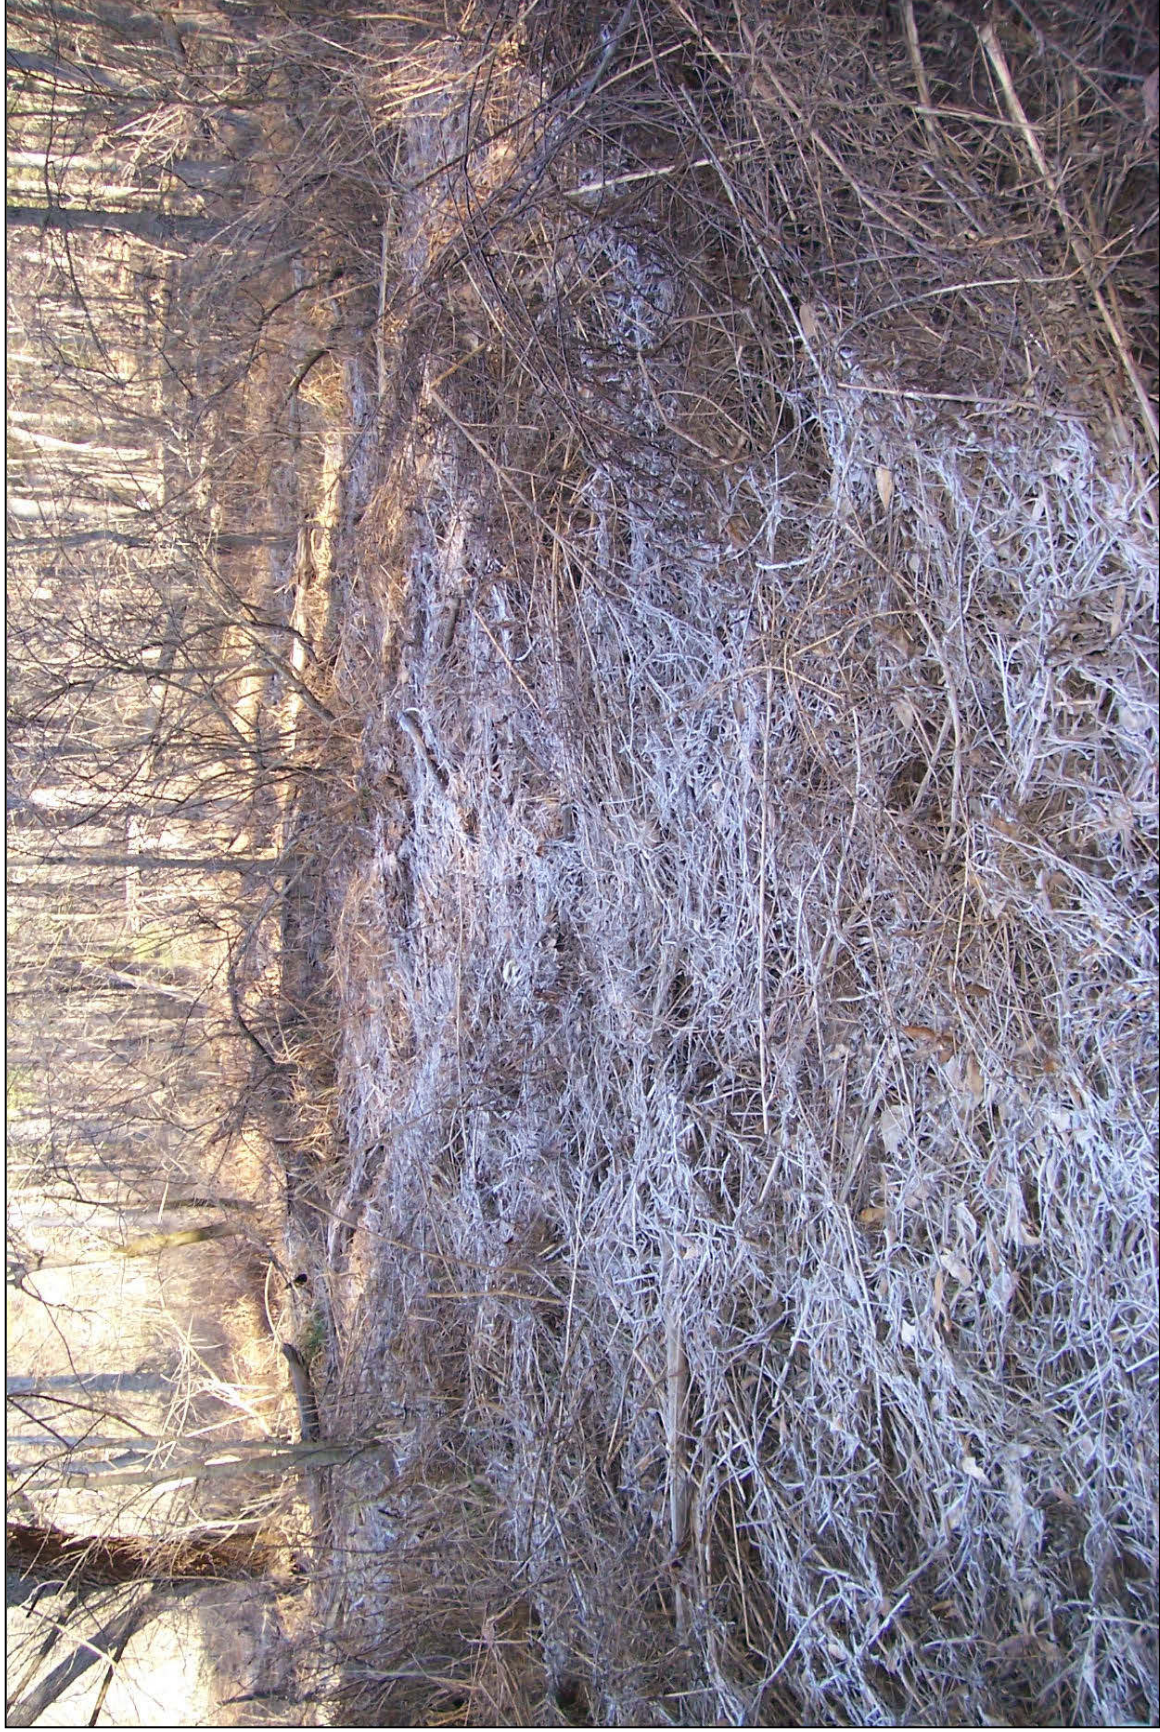
Photo 23. Land Observation Point 1

Location: Line Creek upstream of the bridge crossing of Caribton Road
Description: Sediment deposition as evidence of overbanking

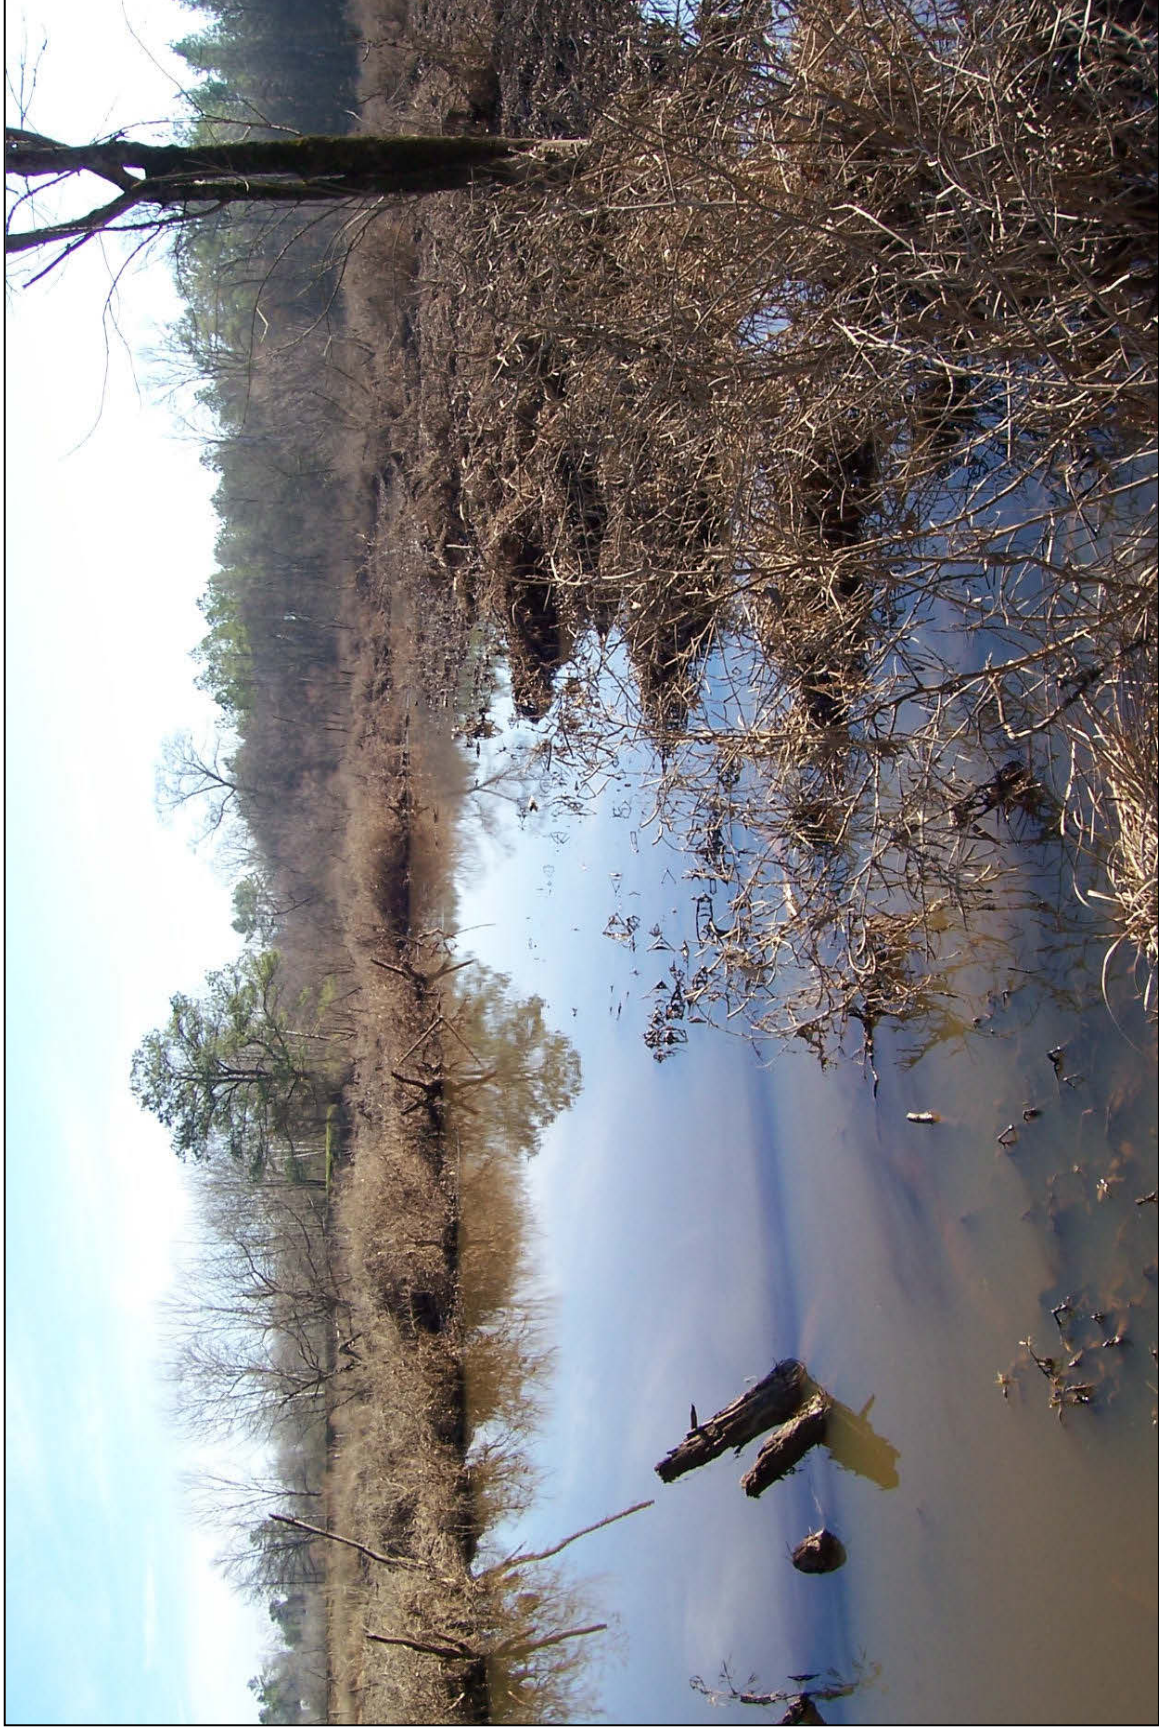
Photo 24. Land Observation Point 1

Location: Line Creek downstream of the bridge crossing of Caribton Road
Description: Overbanking into floodplain

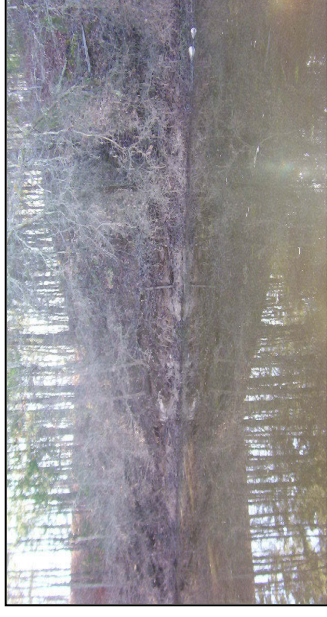
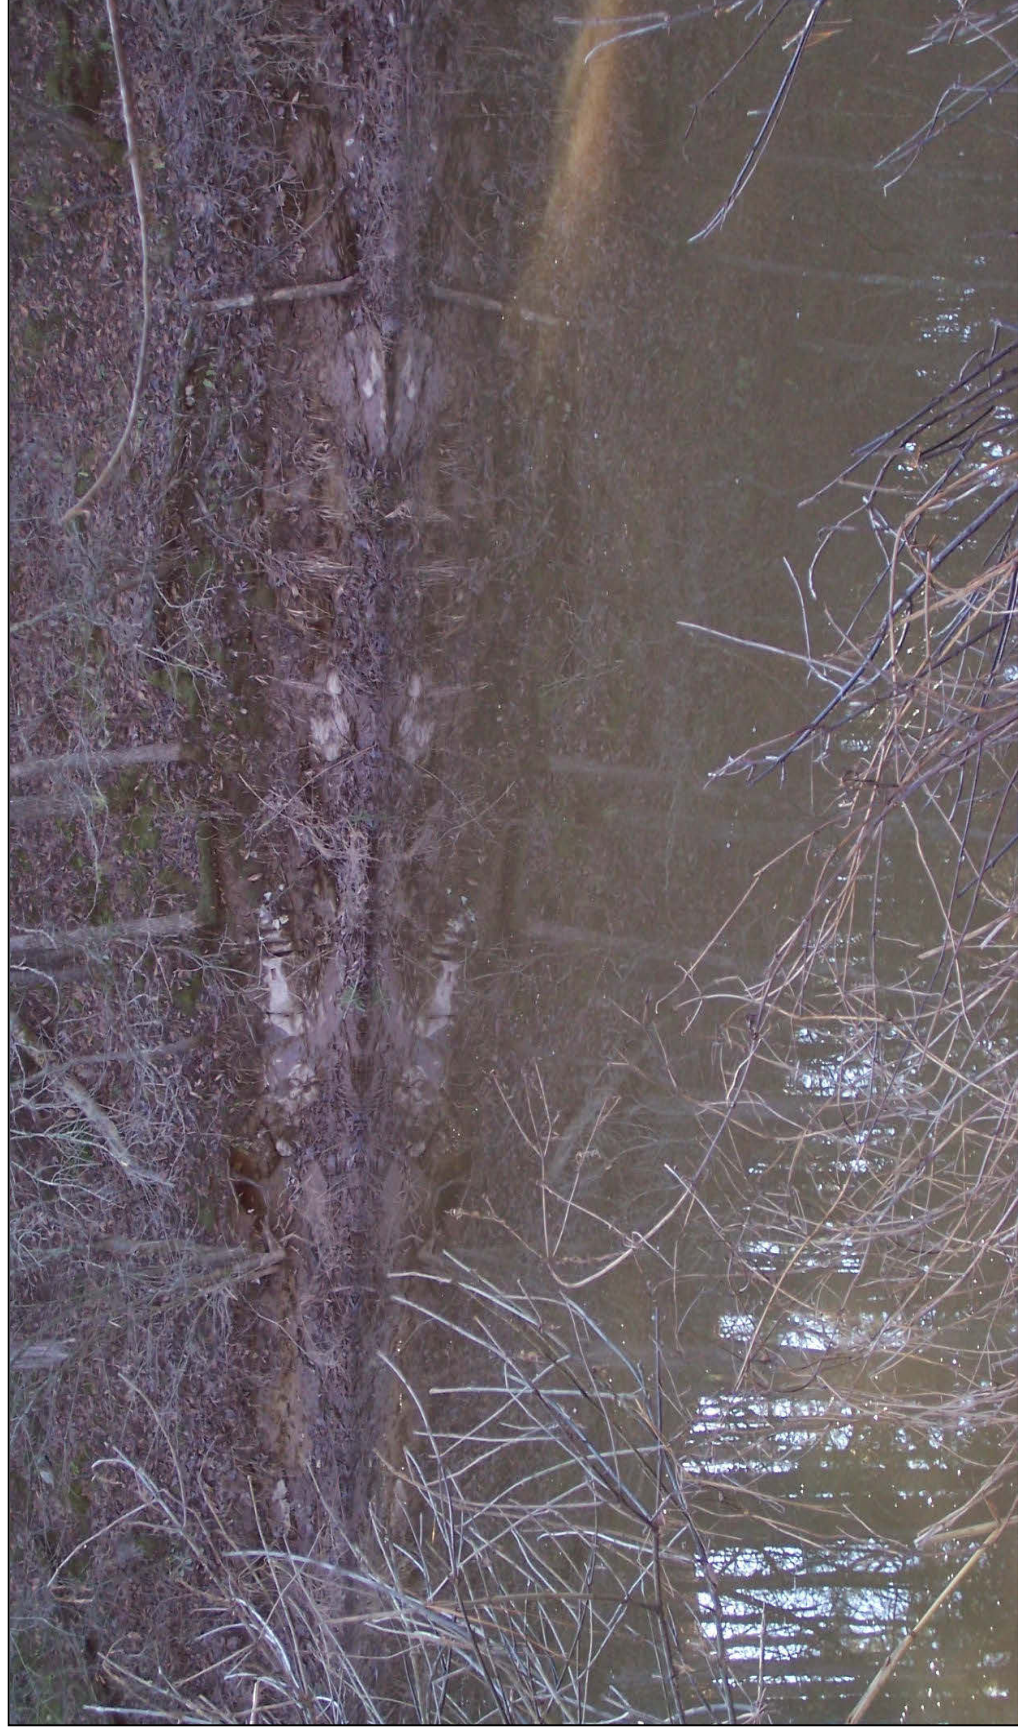
Photo 25. Land Observation Point 1

entrenchment ratio of Line Creek supports a well developed floodplain and relieves stormflow stress on stream banks (Photo 24). Both reaches above and below Carbonton Road have very low flow and the banks appear stable. Limited erosion and scouring of bank material was observed (Photo 25).

Location: Line Creek downstream of the bridge crossing of Caribton Road

Description: Stable banks with limited erosion

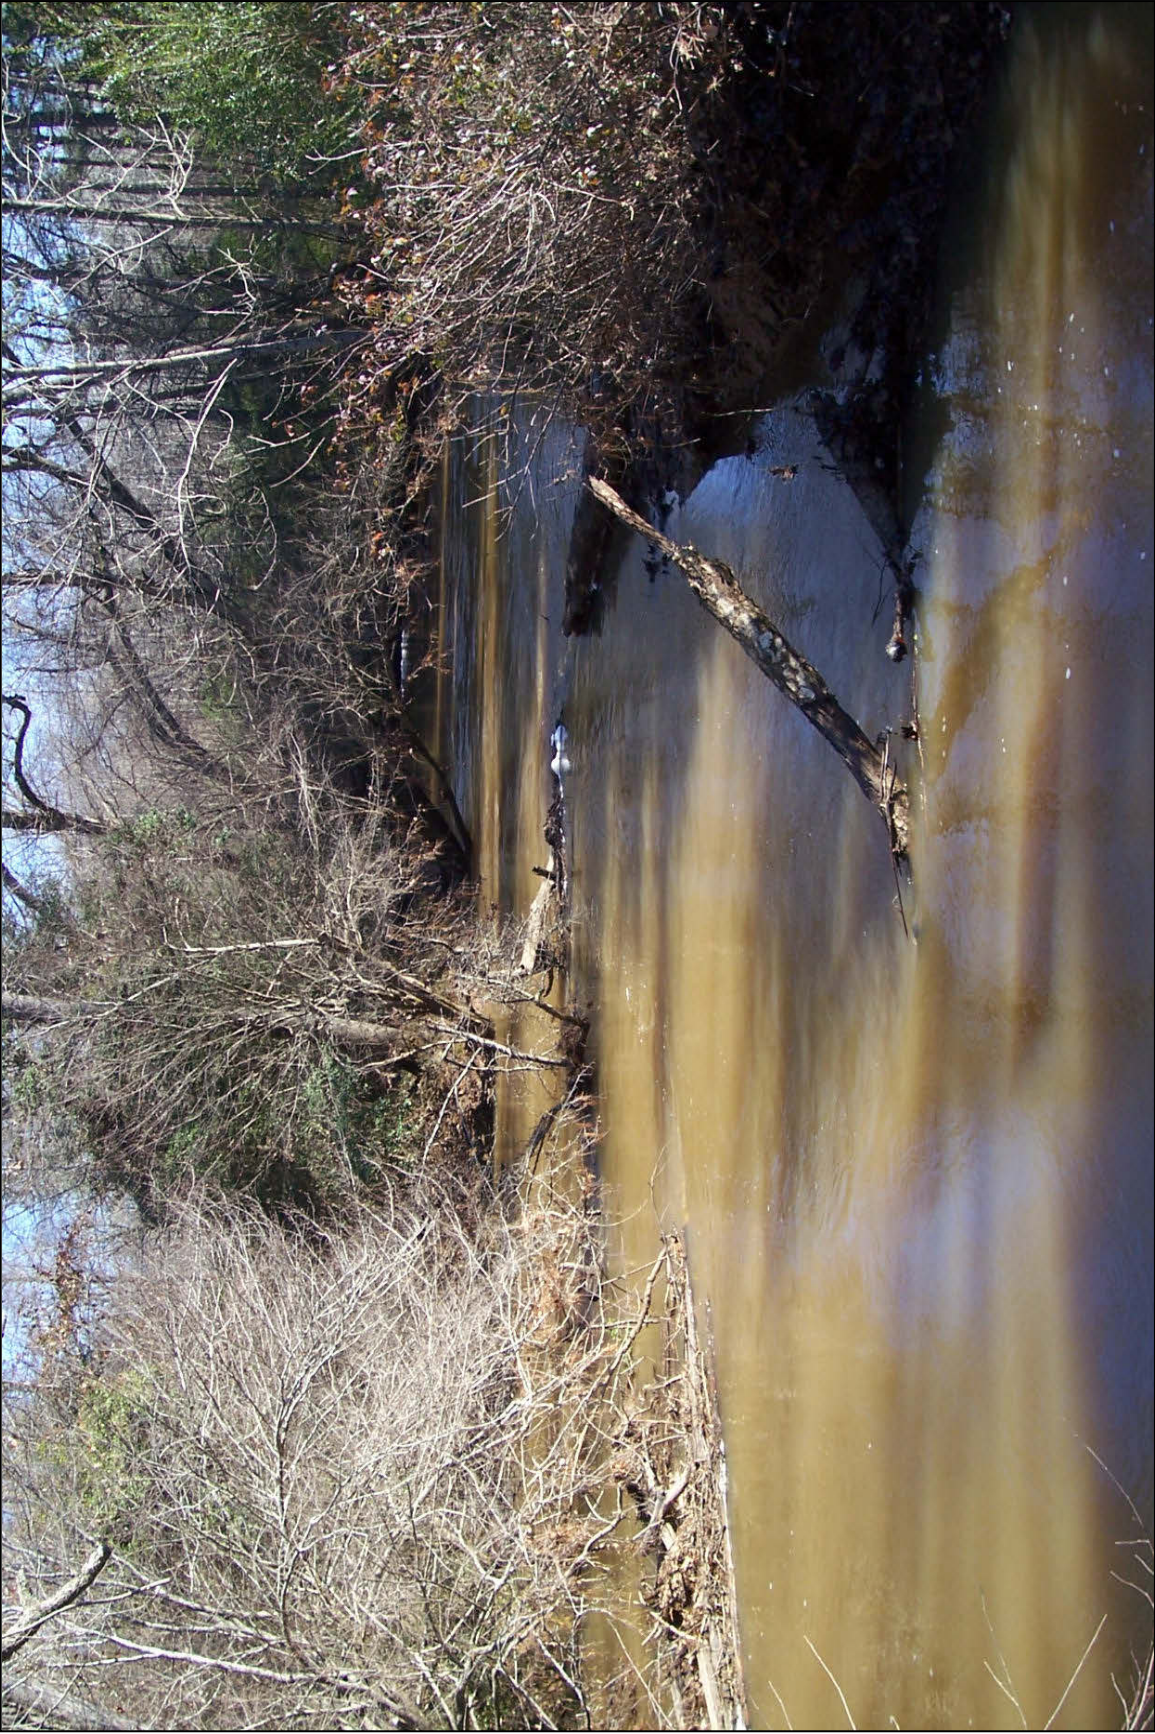
Photo 26. Land Observation Point 2

Location: McClendon's Creek at Cool Springs Road
Description: Elevated stream gage
