**CARBONTON DAM – DEEP RIVER WATERSHED
RESTORATION SITE
2007 Annual Monitoring Report (Year 2)**

**Chatham, Lee and Moore Counties, NC
EEP Project No. D-04012A
Design Firm: Milone and MacBroom, Inc.**

**Prepared for: NCDENR - ECOSYSTEM ENHANCEMENT PROGRAM
1652 Mail Service Center
Raleigh, North Carolina 27699-1619**

**Prepared by: ECOSCIENCE CORPORATION
1101 Haynes Street, Suite 101
Raleigh, North Carolina 27604**

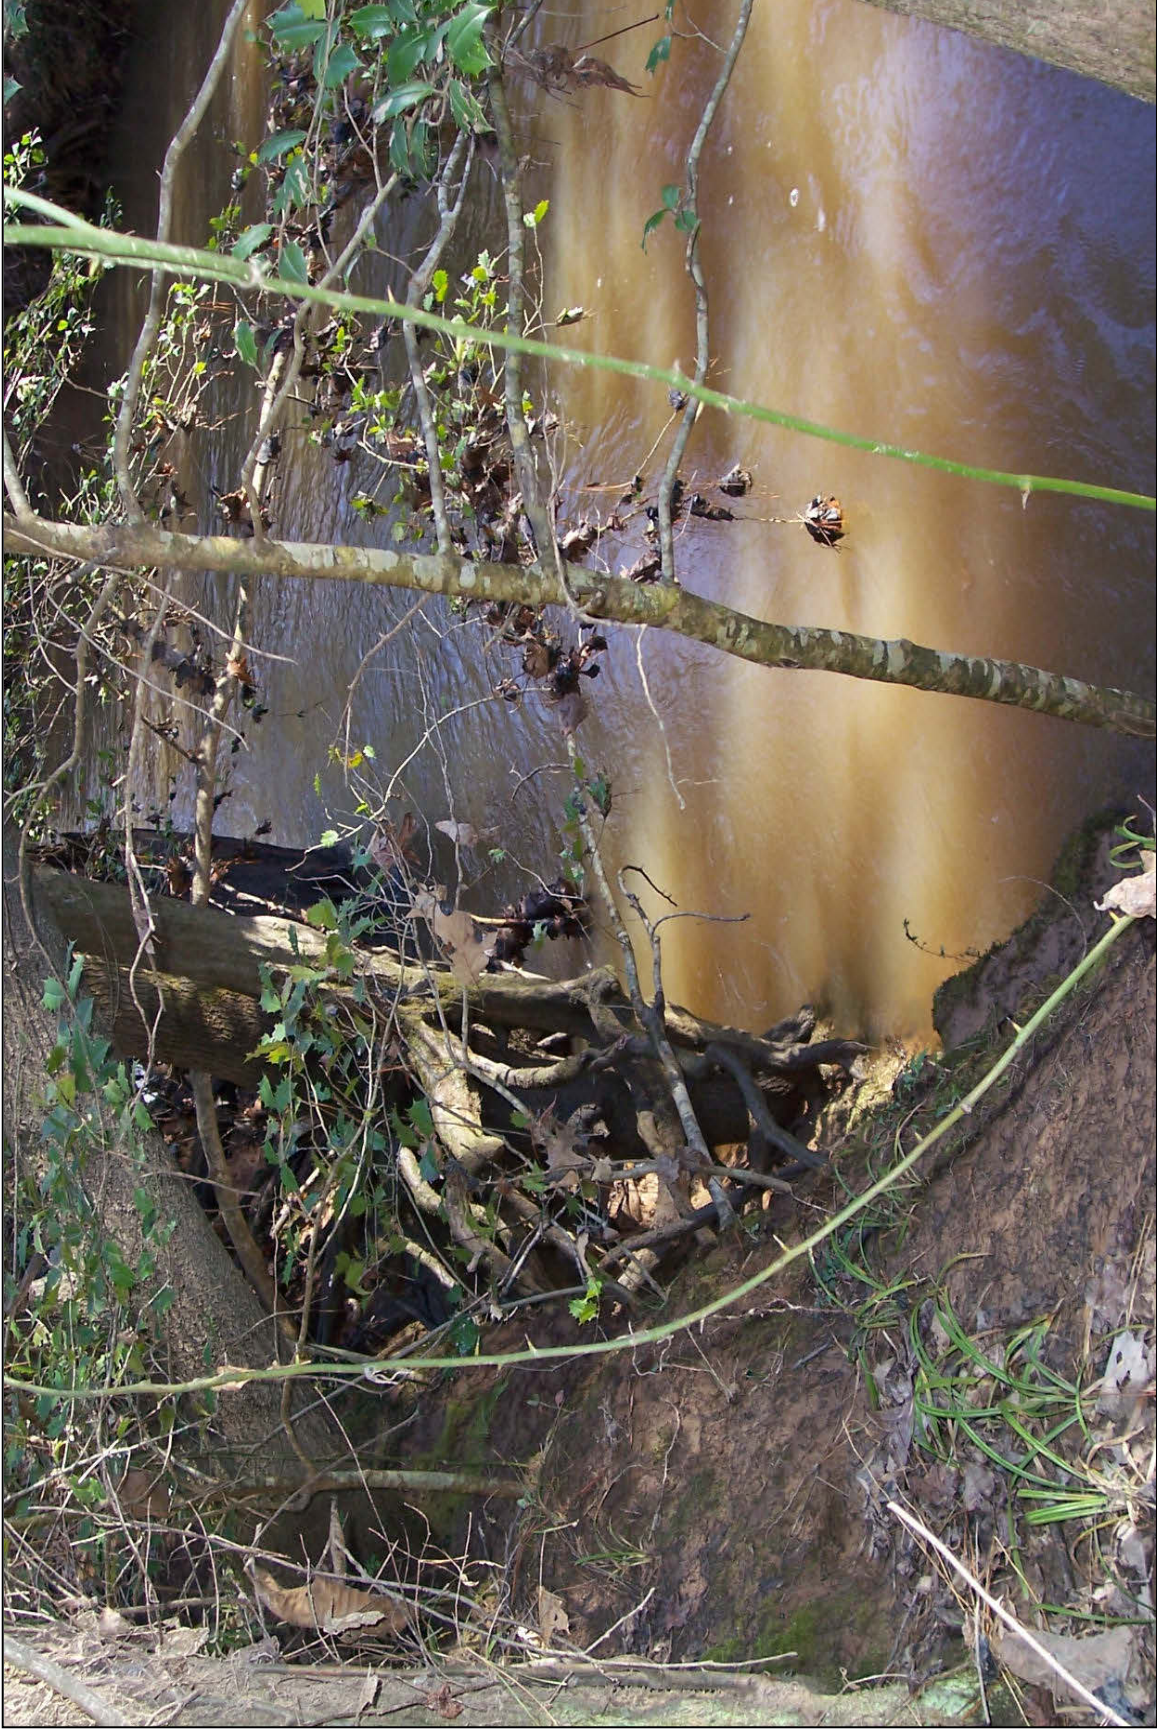
Photo 27. Land Observation Point 2

Location: McClendon's Creek at Cool Springs Road
Description: Exposed roots on scoured stream bank

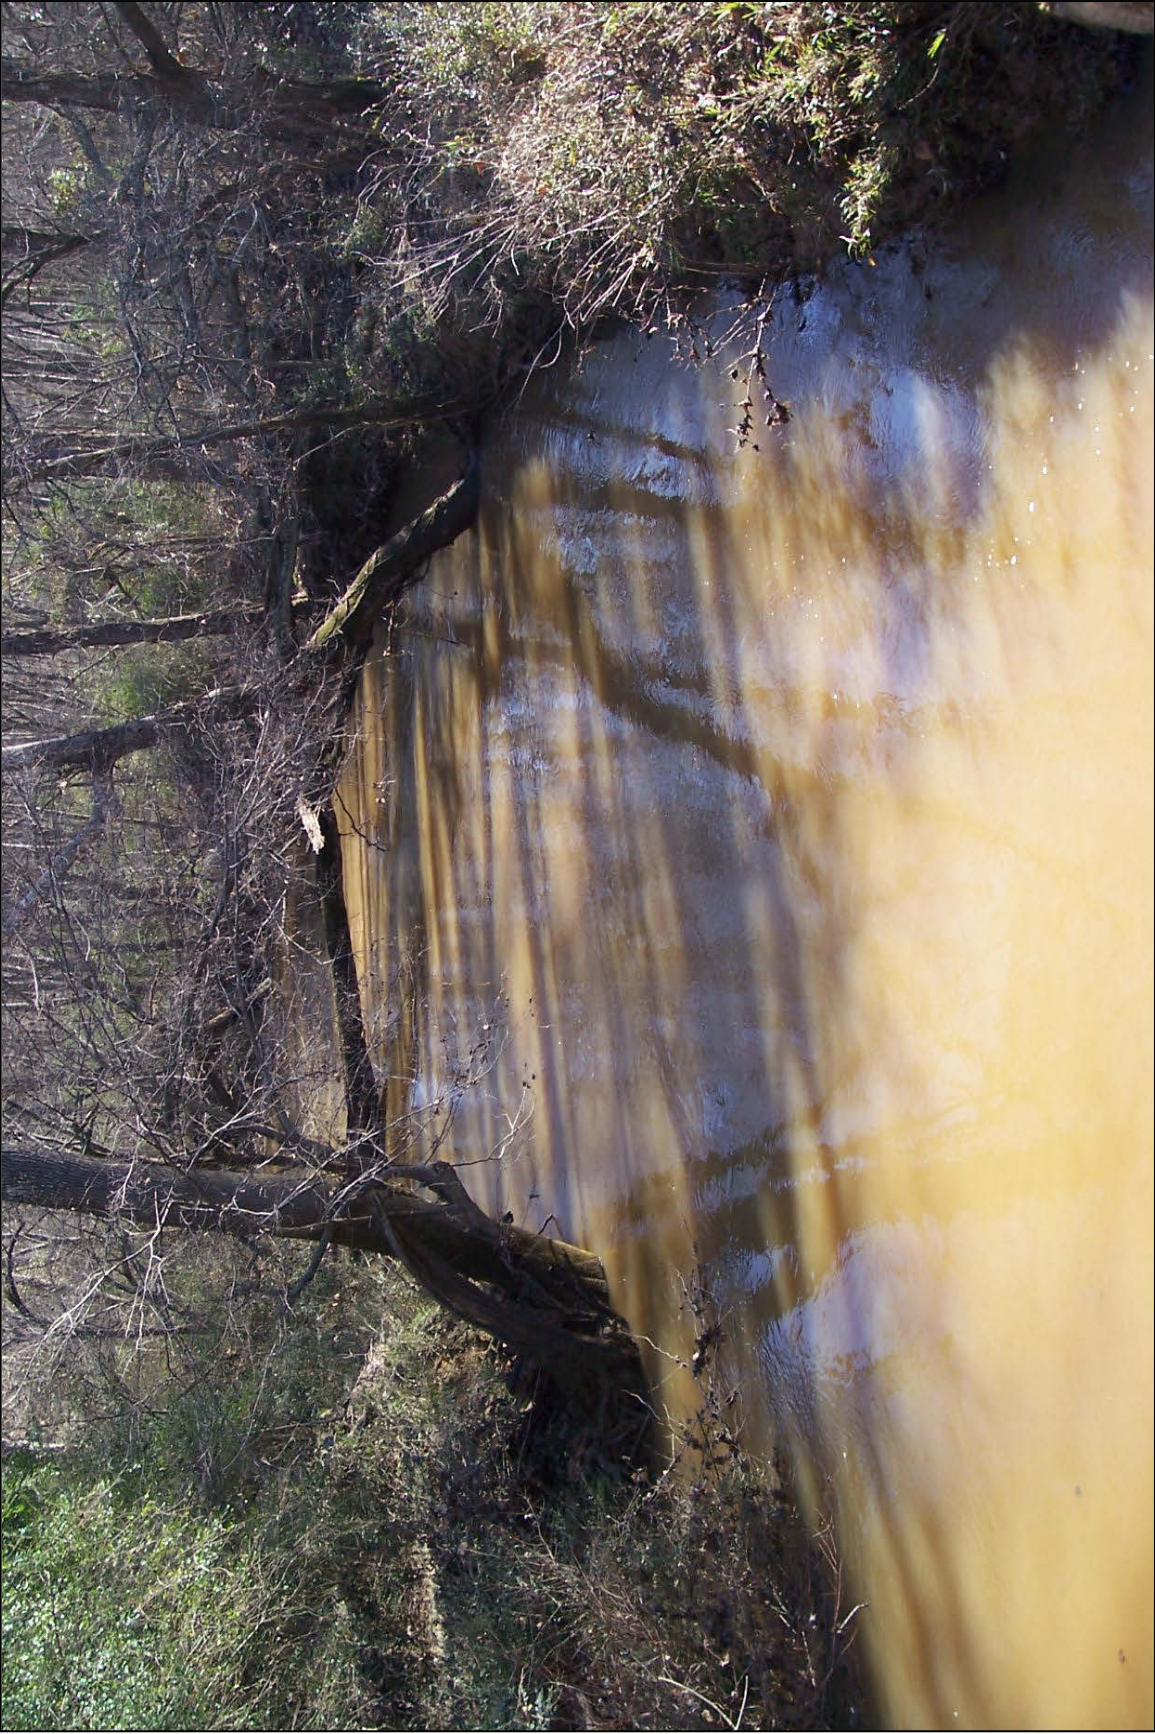
Photo 28. Land Observation Point 3

Location: McClendon's Creek at Glendon-Carthage Road
Description: Elevated stream gage

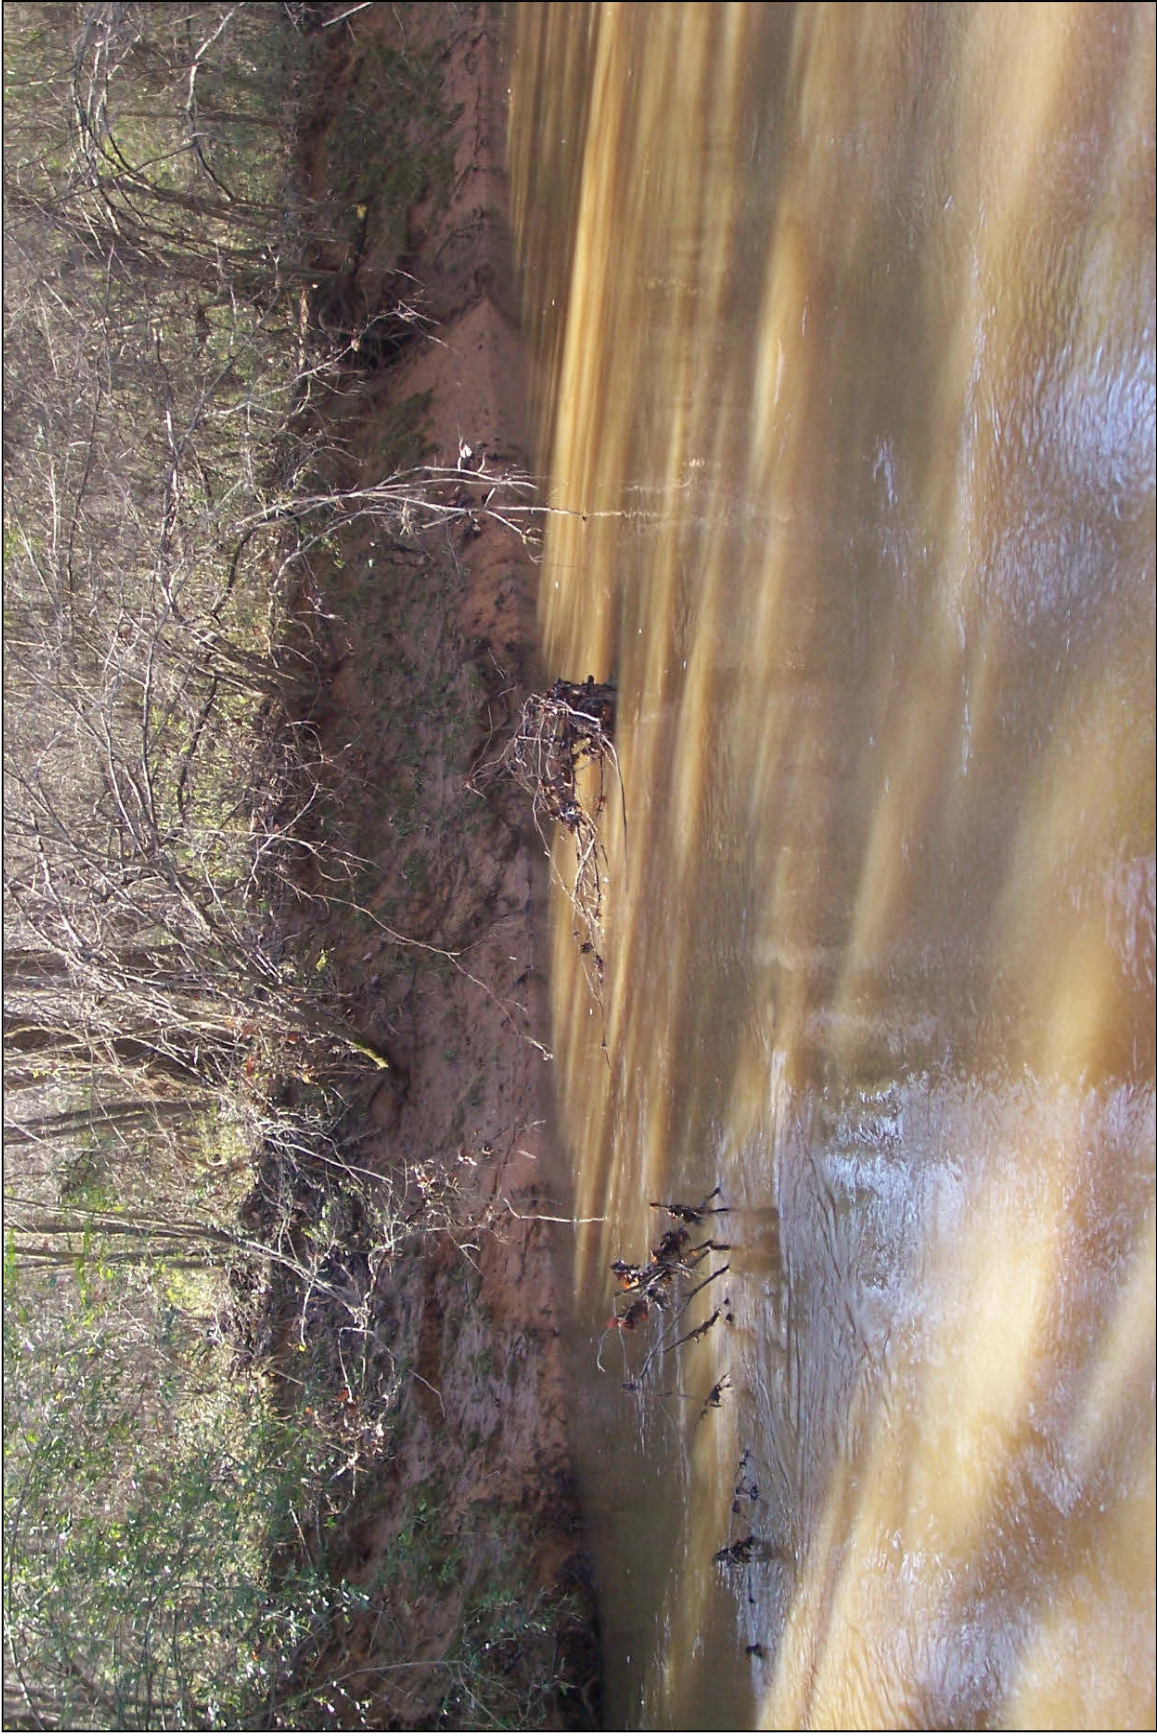
Photo 29. Land Observation Point 3

Location: McClendon's Creek at Glendon-Carriage Road
Description: Steep exposed banks

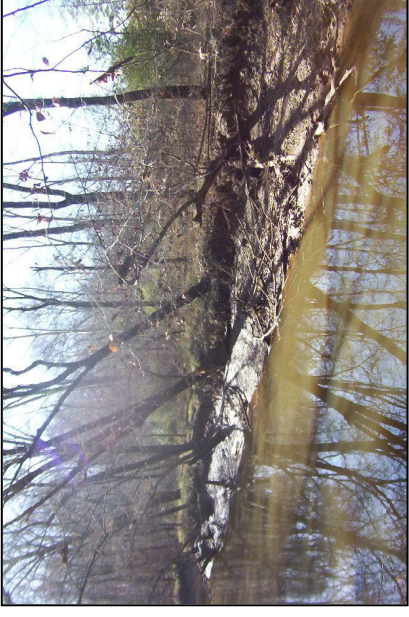
Photo 30. Land Observation Point 4

Land Observation Point 4 was taken at Monitoring Station 40 near the bridge crossing of Steel Bridge Road over Little Governor's Creek, a credited tributary to the Deep River (Figure 2). This section of Little Governor's Creek received significant stormflow with overbank flooding apparent in multiple locations. Many stretches of streambank along this reach of Little Governor's Creek are vegetated, but in several areas, portions of the banks have sloughed off (Photo 30). Just downstream from the Steel Bridge Road bridge, a large riffle complex contained severe erosion along the left streambank, where water becomes restricted by the floodplain width at the bridge (Photo 31-32).

Location: Little Governor's Creek at Steel Bridge Road
Description: Steep, eroded banks

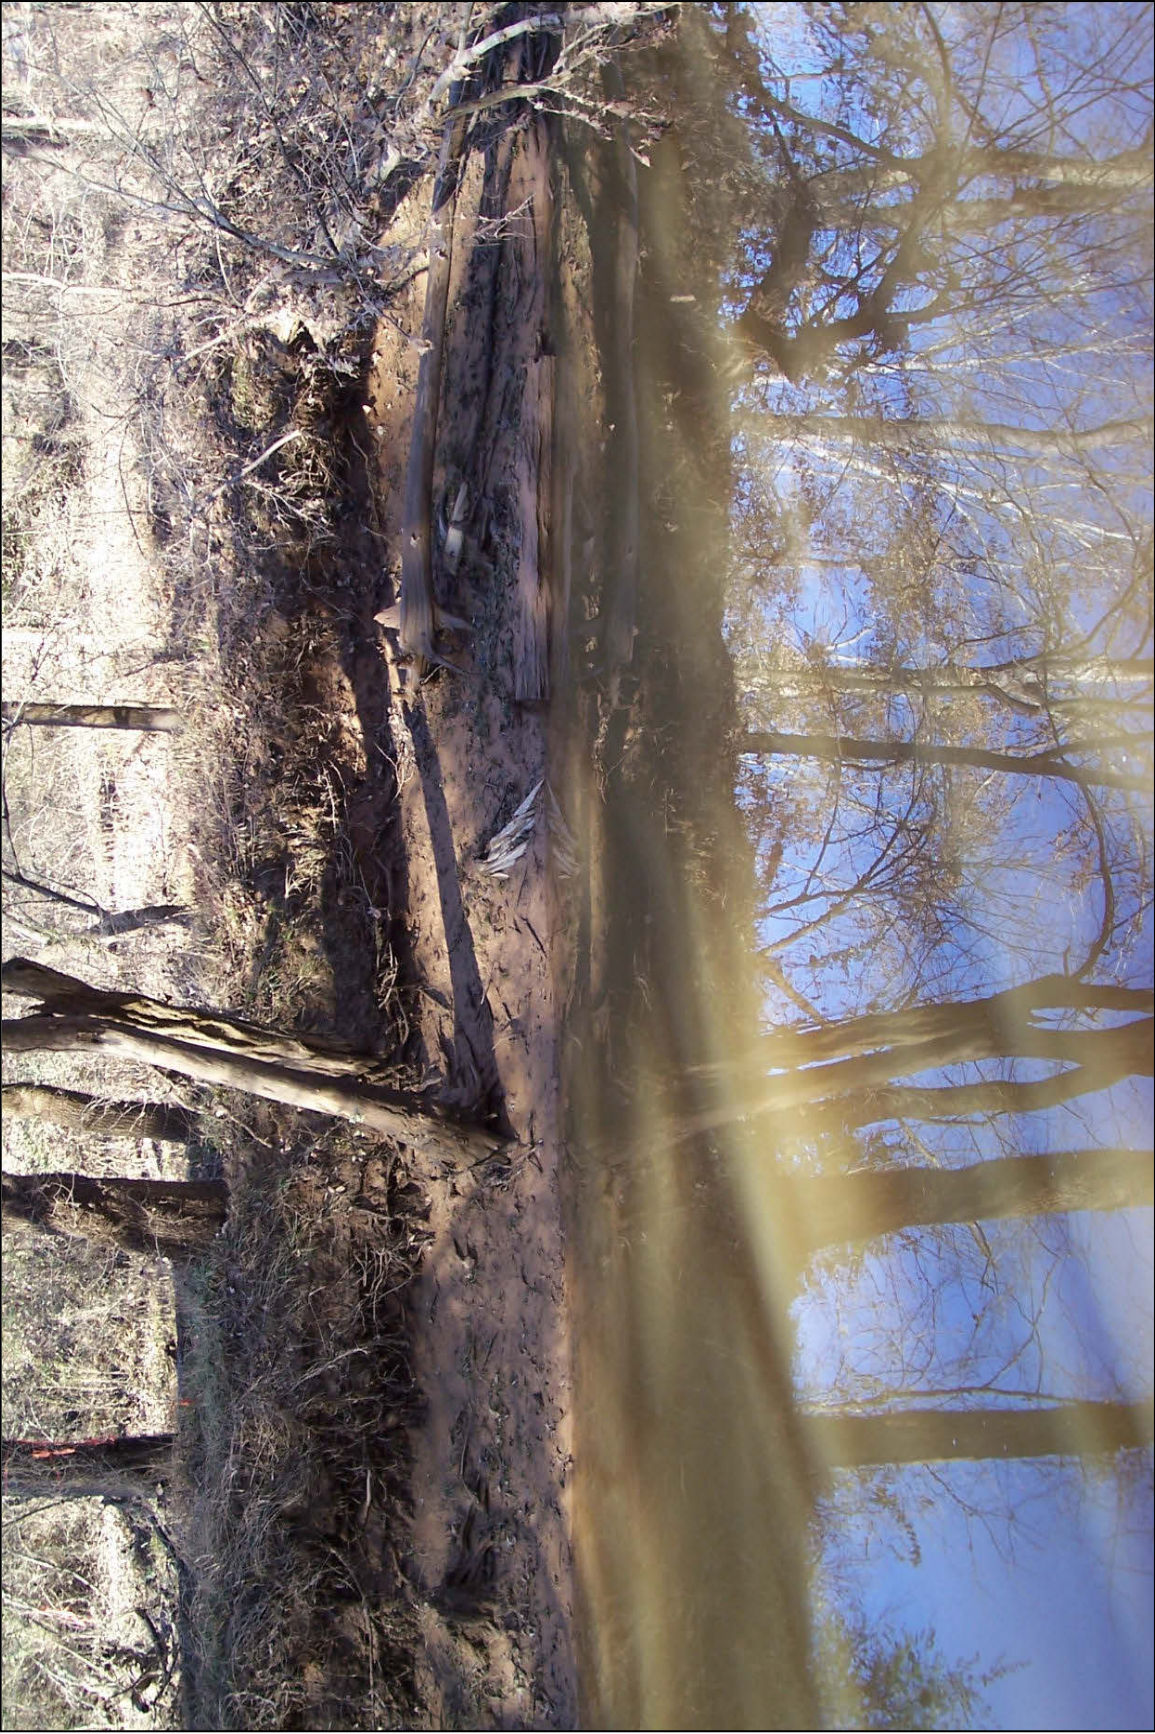
Photo 31. Land Observation Point 4

Location: Little Governor's Creek at Steel Bridge Road
Description: Steep, undercut banks

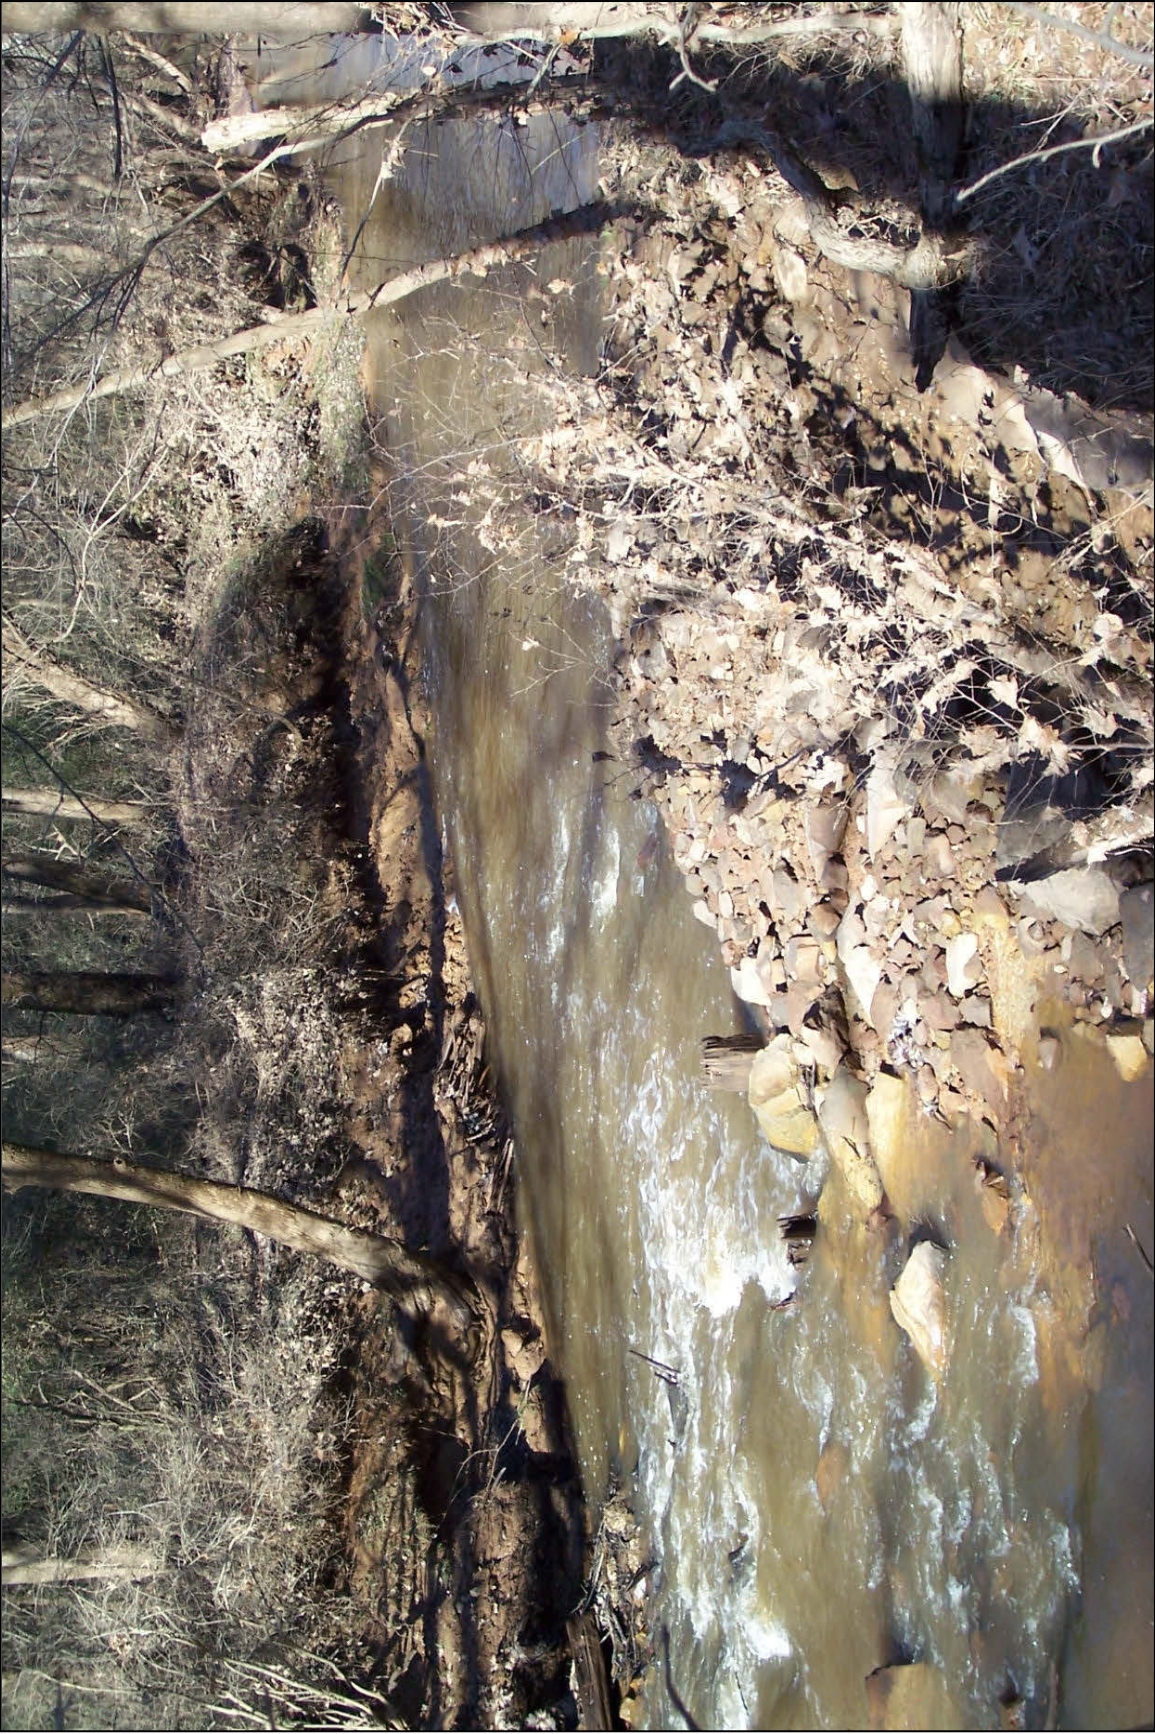
Photo 32. Land Observation Point 4

Location: Little Governor's Creek at Steel Bridge Road
Description: Riffle complex downstream of bridge

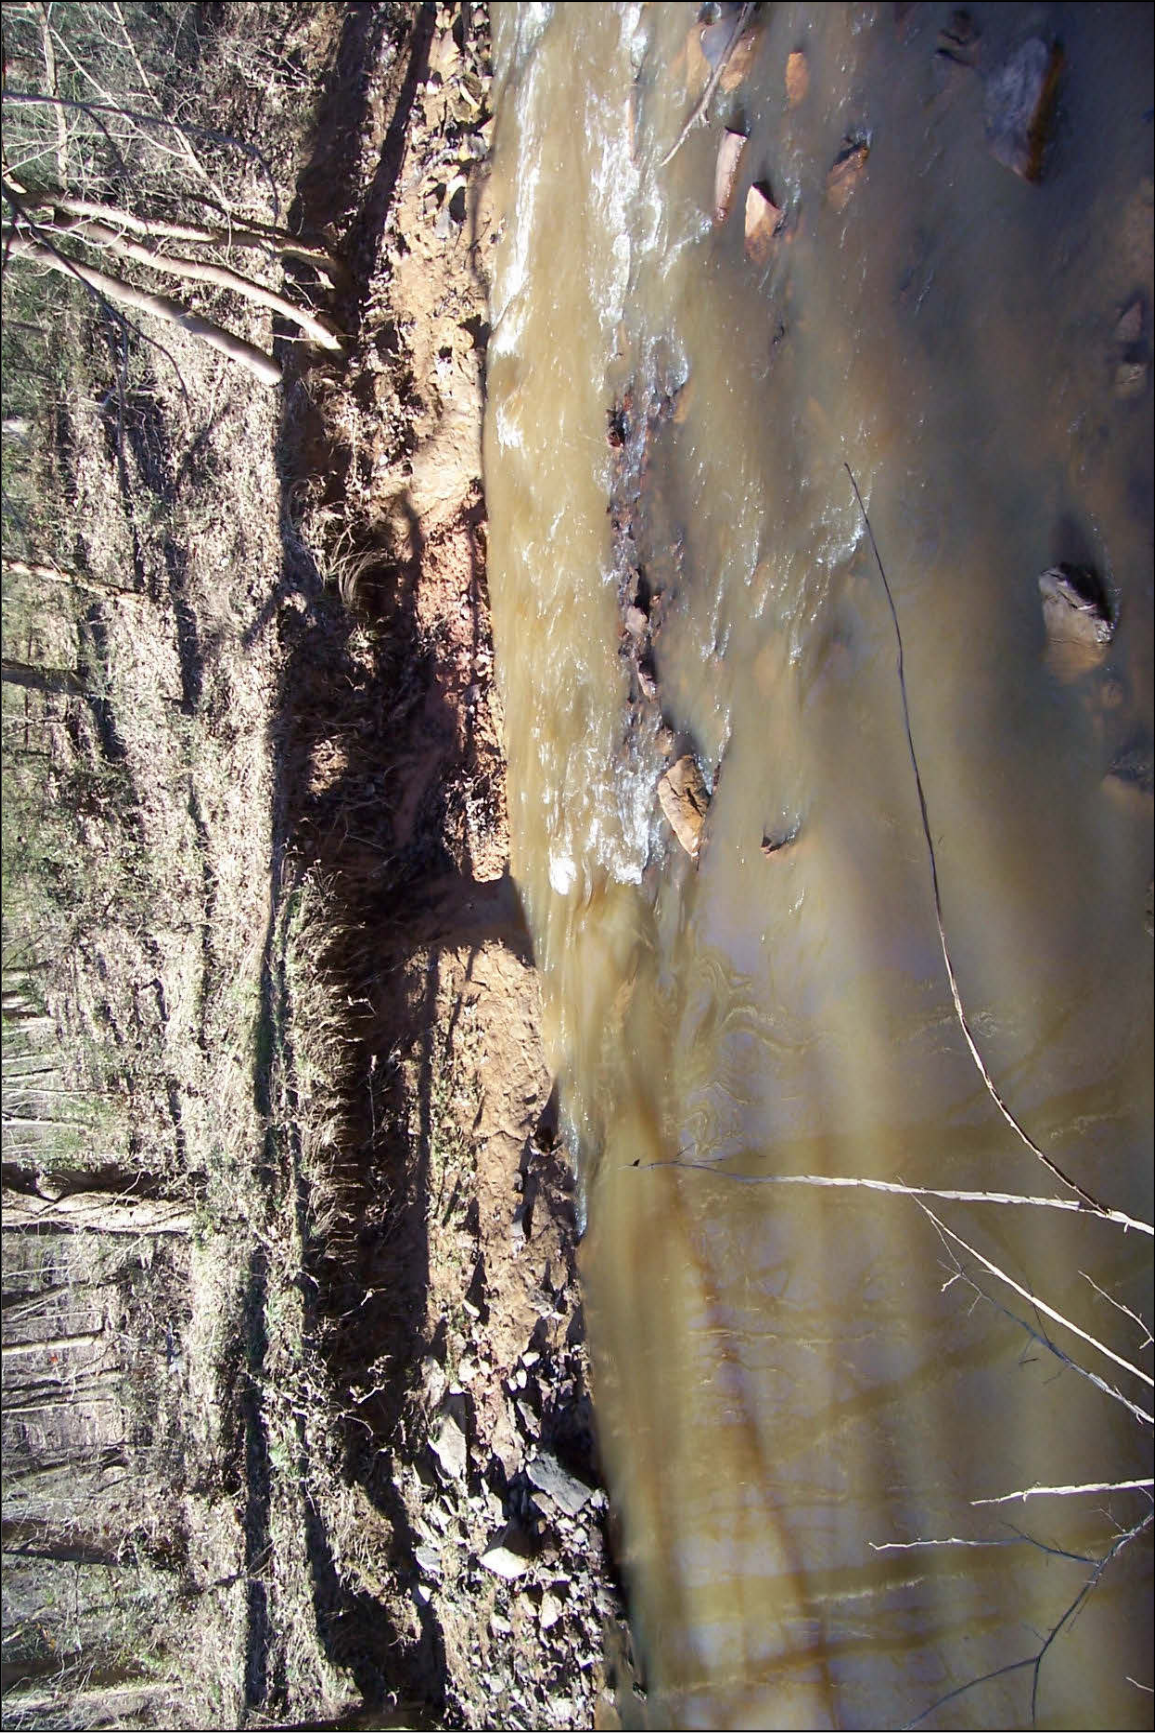
Photo 33. Land Observation Point 4

Location: Little Governor's Creek at Steel Bridge Road
Description: Bank erosion downstream of bridge
