**CARBONTON DAM – DEEP RIVER WATERSHED
RESTORATION SITE
2008 Annual Monitoring Report (Year-3)**

**Chatham, Lee and Moore Counties, NC
NCEEP Project No. D-04012A
Design Firm: Milone and MacBroom, Inc.**

November 2008

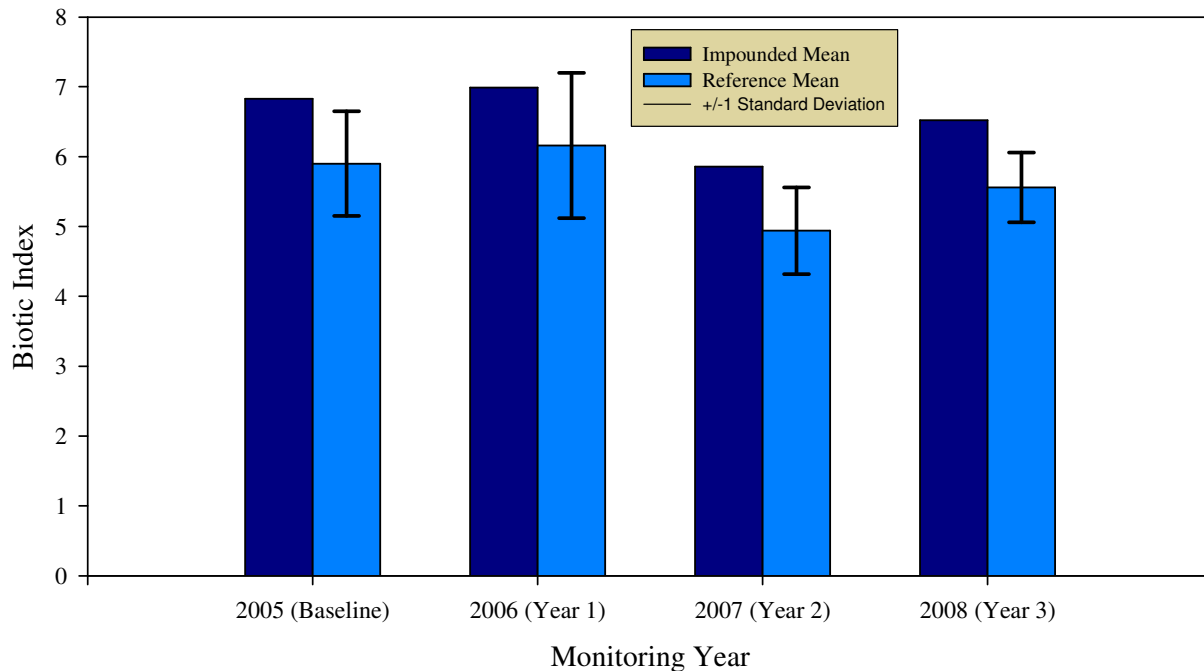
Graph 1. Mean Biotic Index of Formerly Impounded Stations vs. Reference Stations with Standard Deviation

Note: A lower index value is indicative of less tolerant species (= higher water quality)

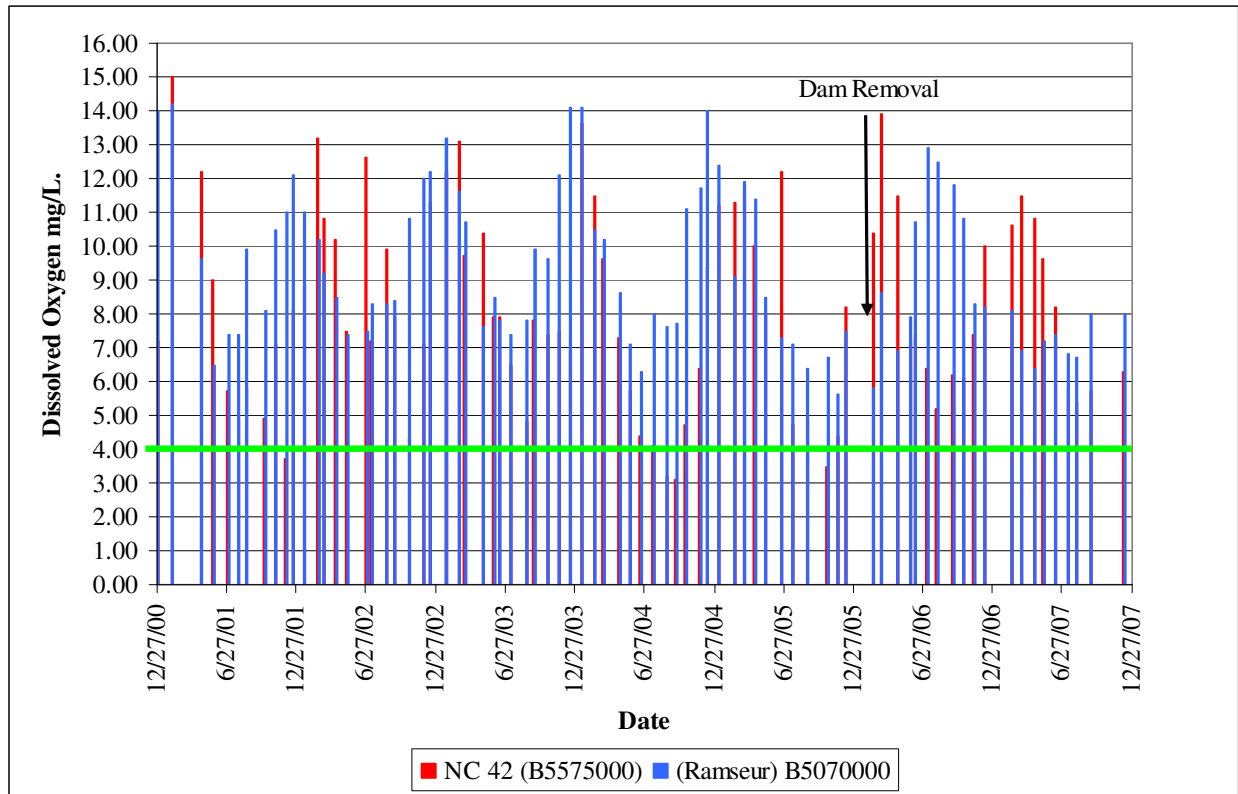
**Graph 2. Recorded Dissolved Oxygen Concentrations in the Deep River
(Green line indicates state standard of 4.0mg/L)**

Throughout the five-year monitoring period, it is expected that mean dissolved oxygen values recorded at NC 42 will continue to demonstrate success as the river has returned to its natural lotic condition. It is also expected that dissolved oxygen levels within the former impoundment will stay above the state standard as free-flowing conditions persist.

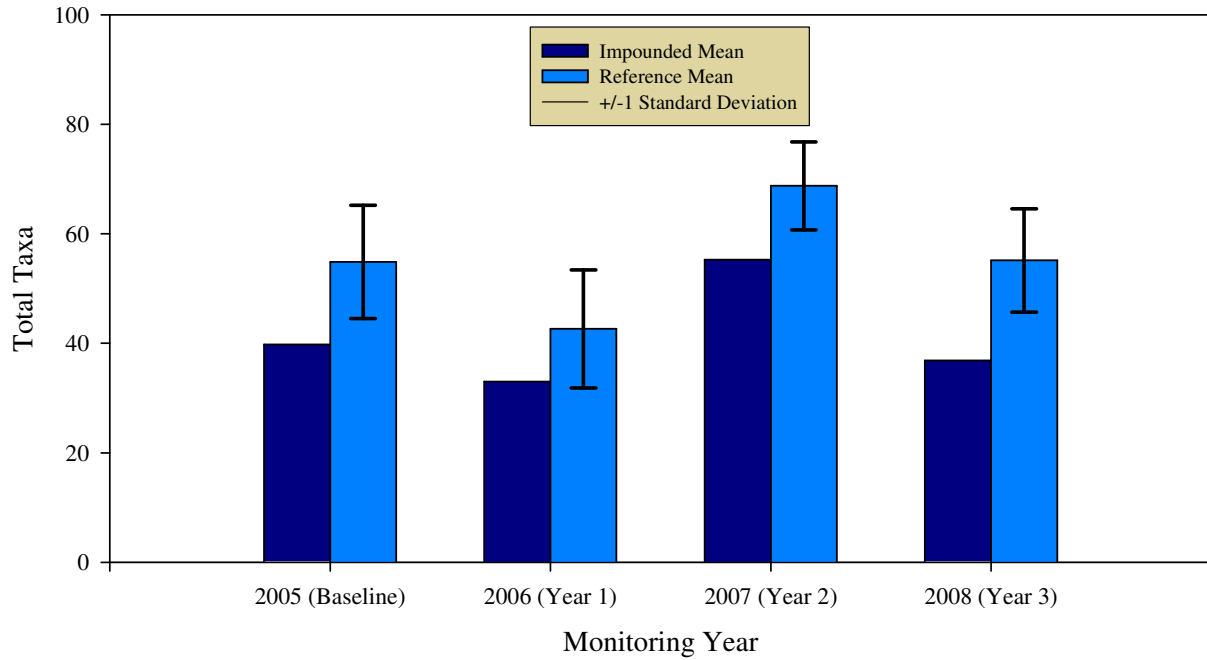
Graph 3. Mean Total Taxa of Impounded Stations vs. Reference Stations with Standard Deviation

Graph 3 and Graph 4 depict the change in mean total taxa and mean EPT richness from 2005 to present from both the formerly impounded and reference stations. The graphs show that mean total taxa and mean EPT richness decreased across all stations in the current monitoring year.

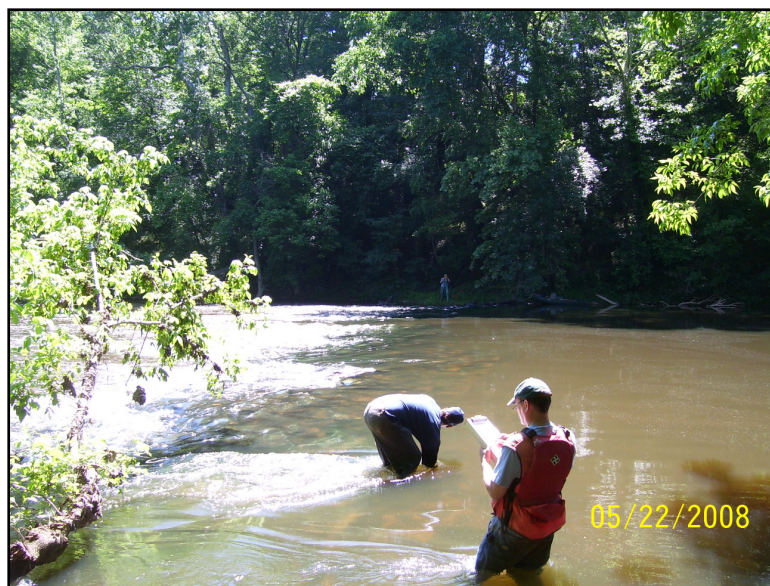
EcoScience staff performs a pebble count in a restored riffle at Station 12.

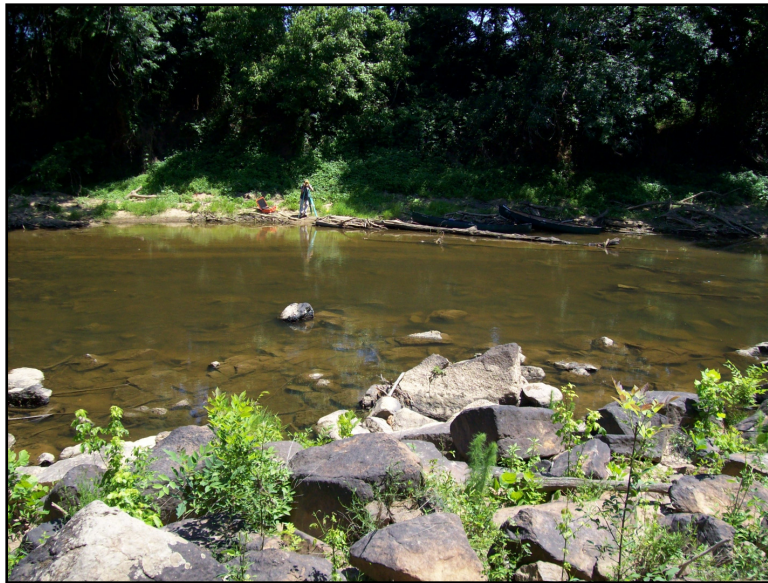
EcoScience staff prepare to perform a Total Station cross-sectional survey of the Deep River at Station 8.

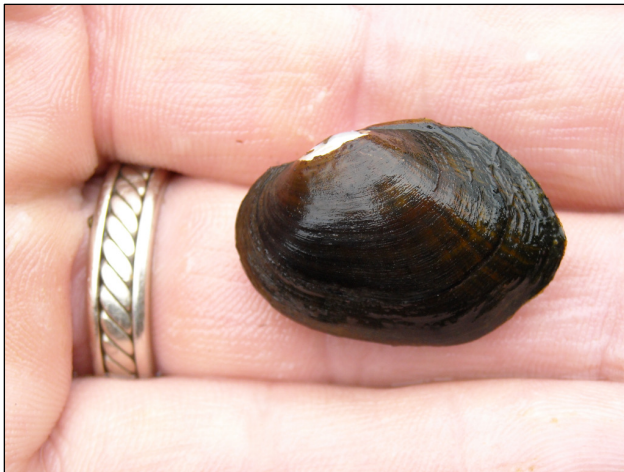
Notched rainbow individual found at Site 2.

This site is situated within a long riffle/pool/riffle run sequence, with a rocky/cobble island bar that has formed from the center of the river to the left descending bank, creating a long run along the right descending bank. The substrate is dominated by cobble and gravel overlain with coarse sand. A variety of habitat conditions occur at this site providing habitats for lotic and lentic adapted species. Five mussel species were collected including the targeted yellow lampmussel and **the notched rainbow, which**

had been collected only one other time in the Deep River within the last 100 years. The gravel elimia was very abundant in the riffle habitats, and the majority of individuals appeared to be newly recruited (small in size). Two seine net hauls were also performed and 5 individual Cape Fear shiner were captured.

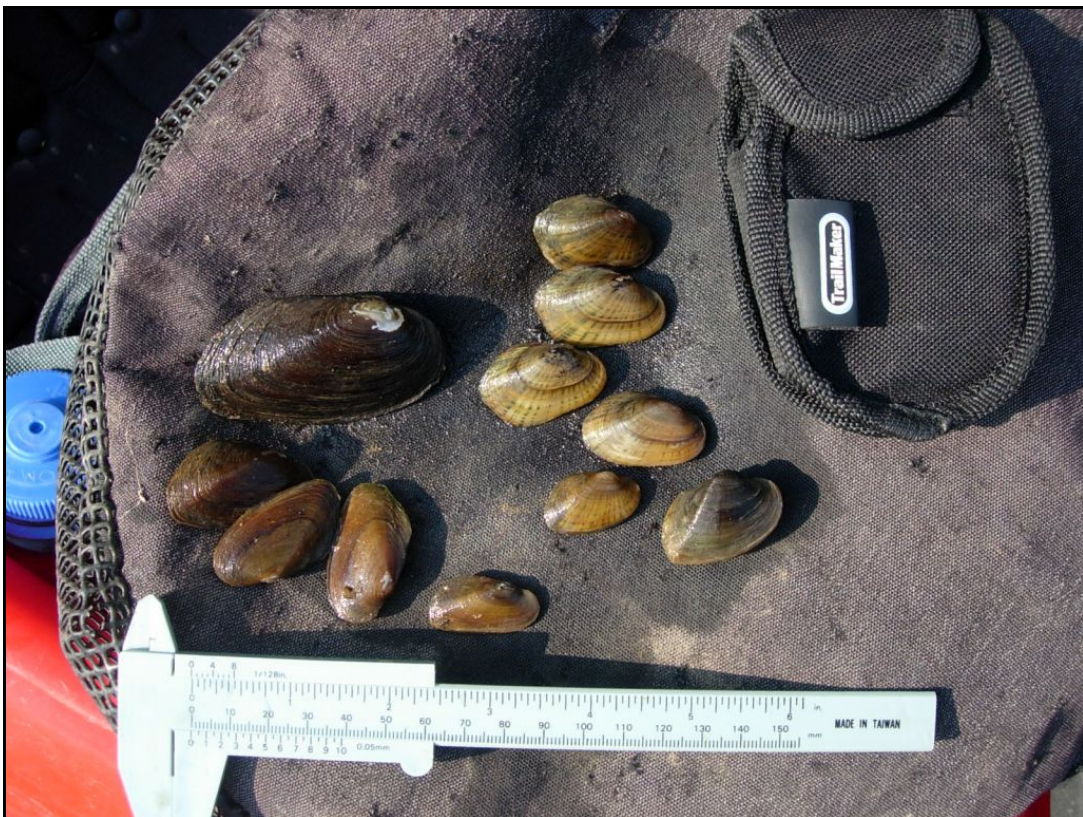
Young creeper (top left), eastern creekshell (top right), eastern elliptio (bottom left) and triangle floater (bottom right) found in Deep River within formerly impounded reach during Year-3 monitoring.

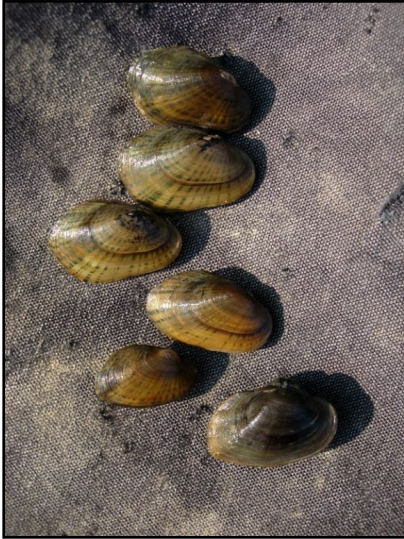
Young eastern creekshells and a triangle floater (bottom right) found in Deep River within the formerly impounded reach-3 year monitoring
