**CARBONTON DAM – DEEP RIVER WATERSHED
RESTORATION SITE
2009 Annual Monitoring Report (Year 4)**

2009 Annual Monitoring Report (Year 4)

**Chatham, Lee and Moore Counties, NC
NCEEP Project No. D-04012A
Design Firm: Milone and MacBroom, Inc.**

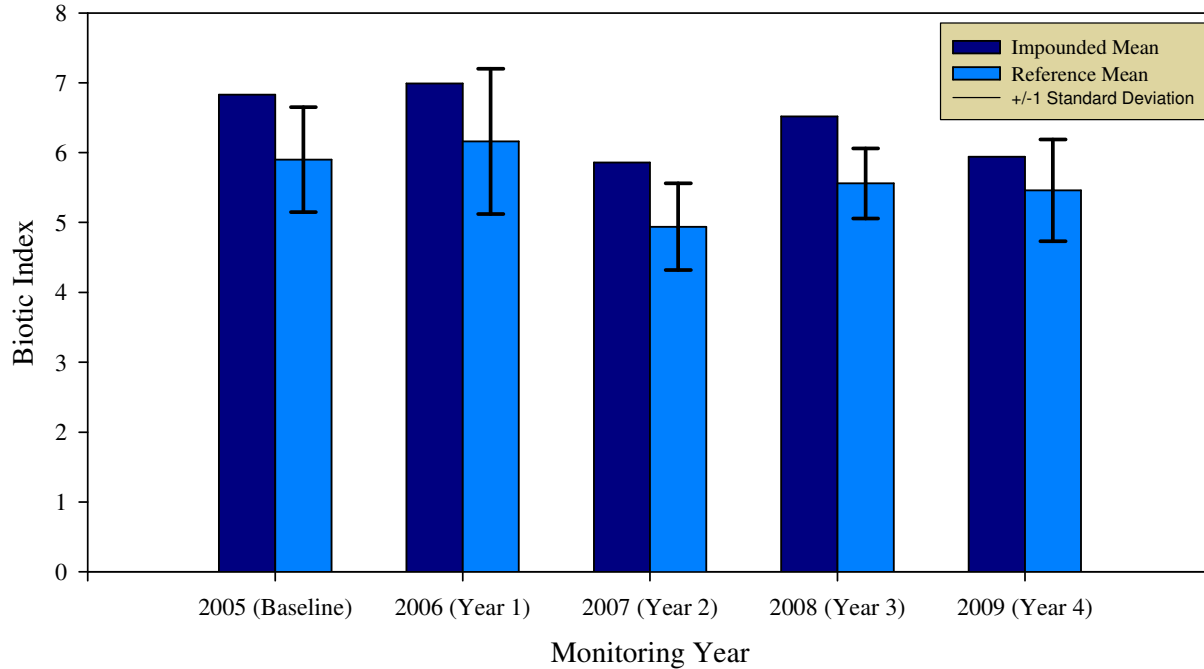
Graph 1. Mean Biotic Index of Formerly Impounded Stations vs. Reference Stations with Standard Deviation

Note: A lower index value is indicative of less tolerant species (= higher water quality)

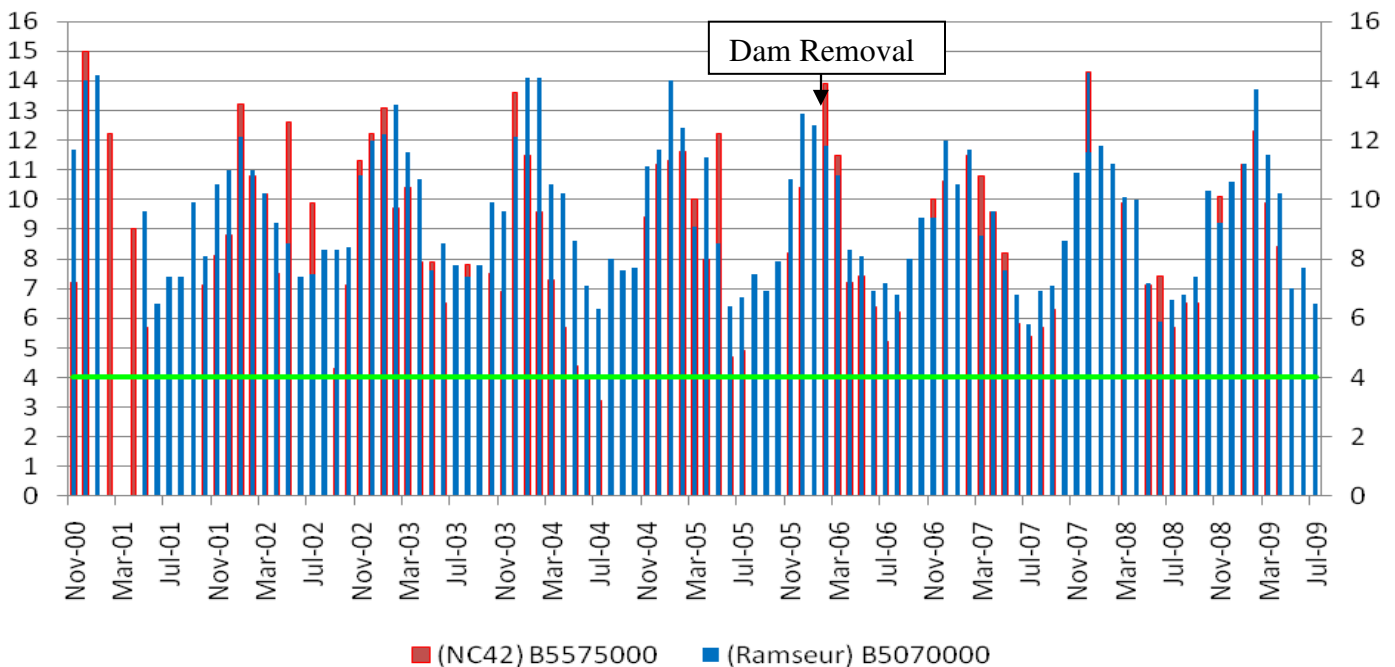
Graph 2. Recorded Dissolved Oxygen Concentrations in the Deep River

Graph 2 below depicts the AMS dissolved oxygen concentrations measured at a 0.1 meter depth within the Site Impoundment (B5575000), and at the reference location (B5070000), from December 2000 through July 2009. Since the removal of Carbonton Dam, instantaneous dissolved oxygen concentrations within the former Site Impoundment have remained at or above 4.0 mg/L. It is expected that dissolved oxygen levels within the former impoundment will stay above the state standard as free-flowing conditions persist.

Note: Green line indicates state standard of 4.0mg/L

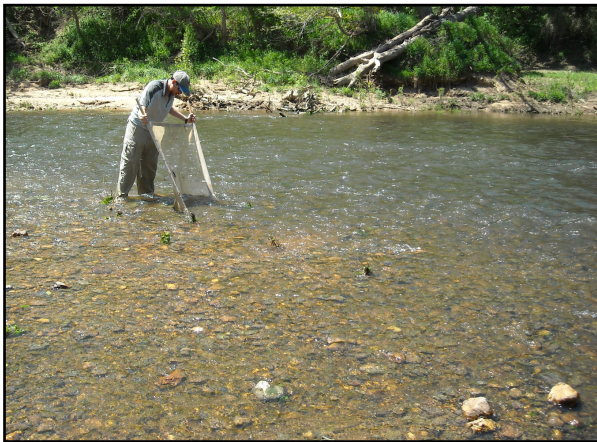
PBS&J scientist positions the kick net in a riffle of the Deep River

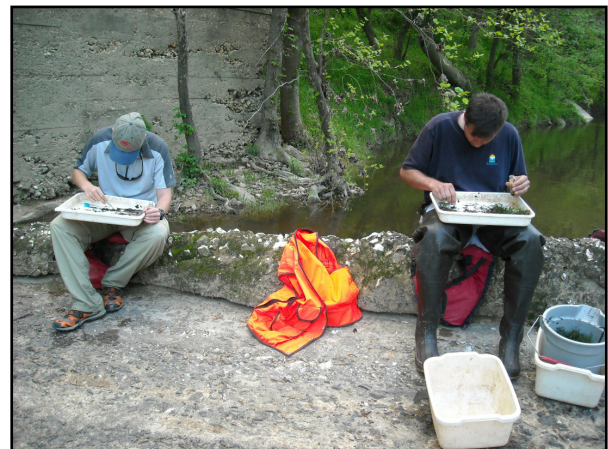
PBS&J staff collect benthic macroinvertebrates from the sample material

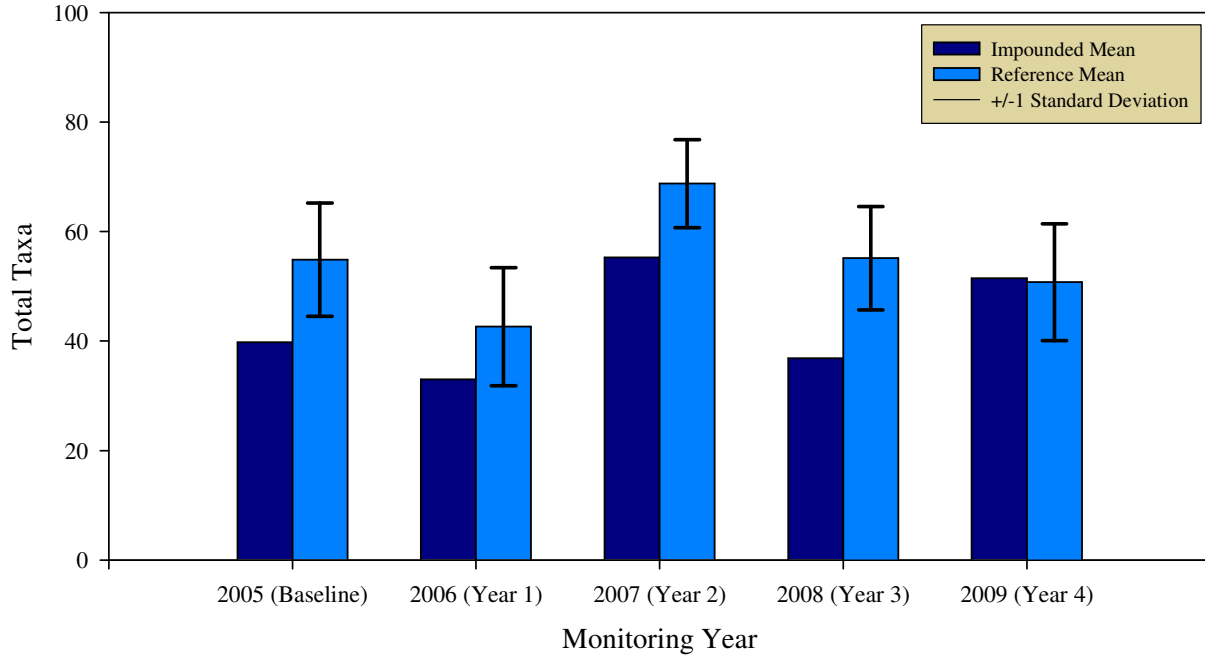
Graph 3. Mean Total Taxa of Impounded Stations vs. Reference Stations with Standard Deviation

Graph 3 and Graph 4 depict the change in mean total taxa and mean EPT richness from 2005 to present from both the formerly impounded and reference stations.

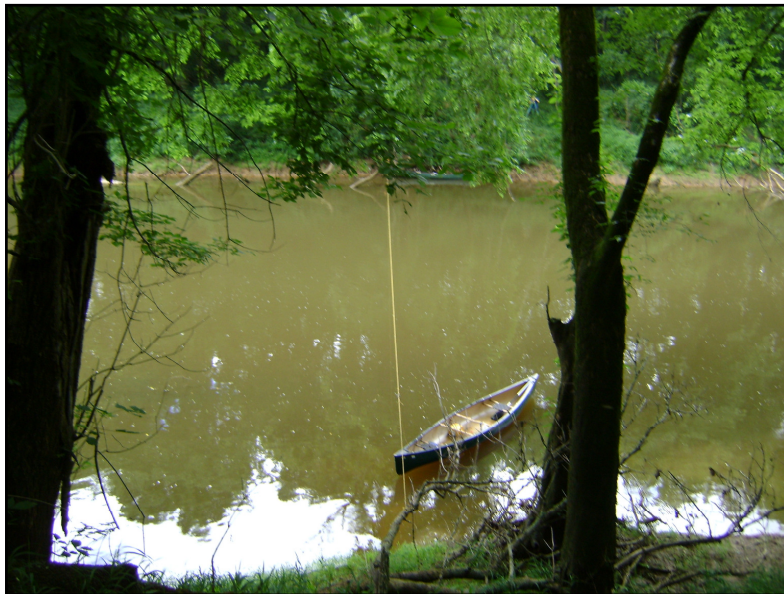
In general, bankfull channel parameters were largely unchanged compared to conditions assessed during previous monitoring years. Limited scouring and erosion of bank material was detected at formerly impounded stations, with an associated, minor change in bankfull areas. The Deep River channel is geomorphically stable, and any erosion is episodic and localized. Station 55 was established following dam removal and therefore no baseline (2005) bankfull channel geometry data are available for this station. Other stations for which pins were not found, and subsequently replaced, are noted on Figures 4A-4D. Hence, the discrepancies in cross-sectional dimensions and bankfull channel geometry between years at the locations where new pins were installed.

PBS&J staff prepares to perform a Total Station cross-sectional survey of the Deep River at Station 15.

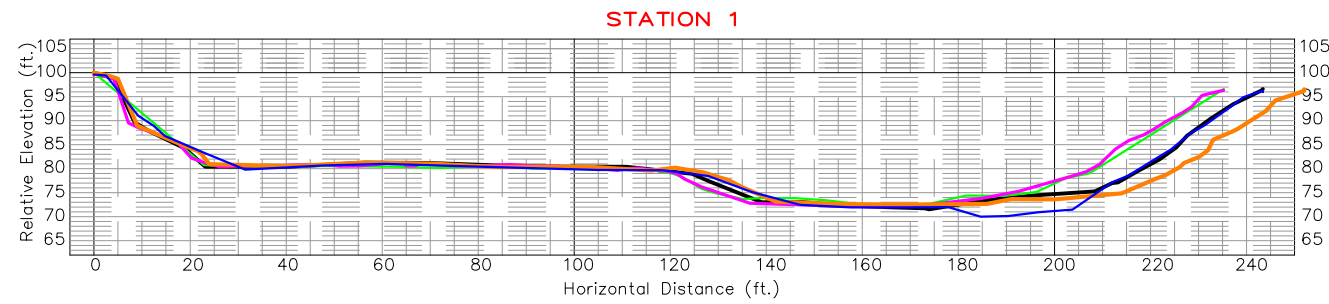
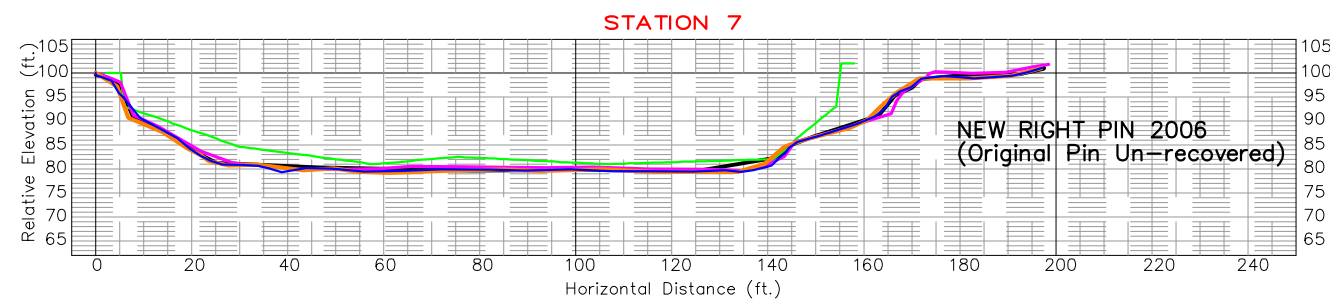
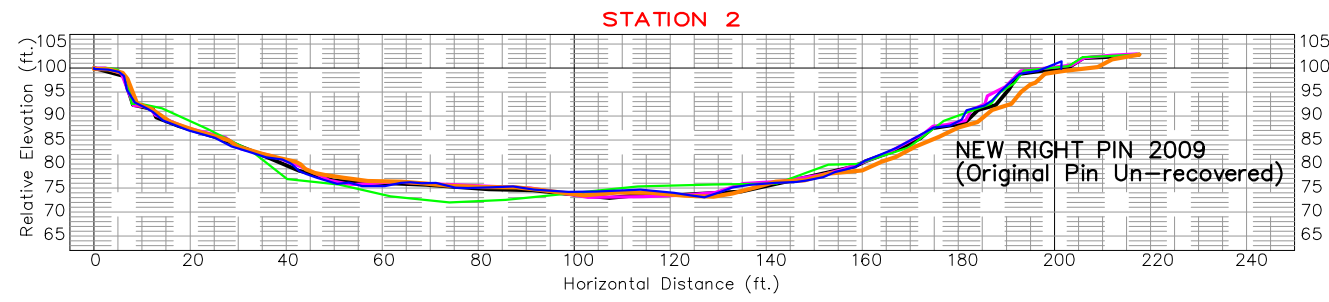
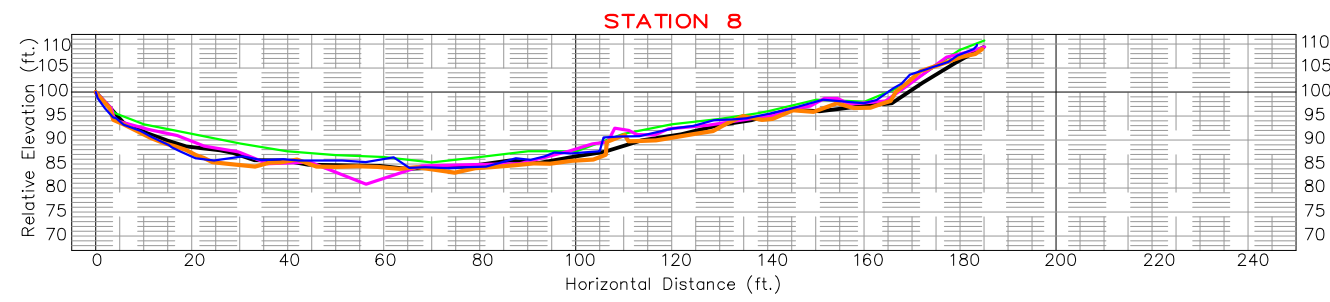
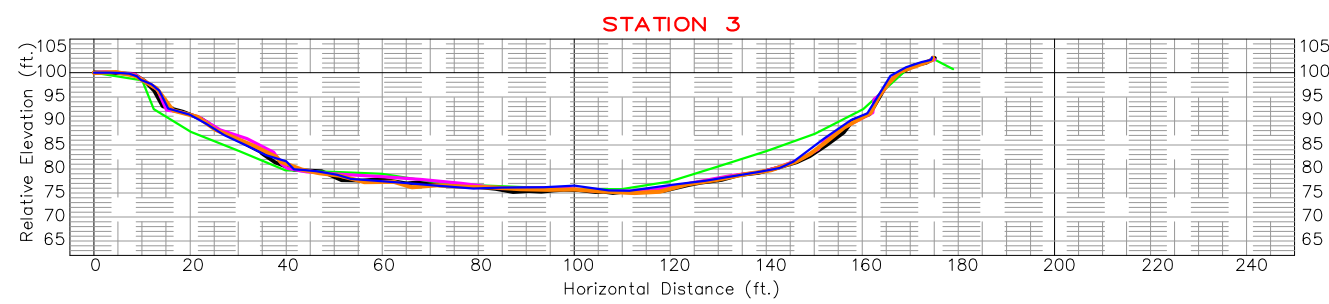
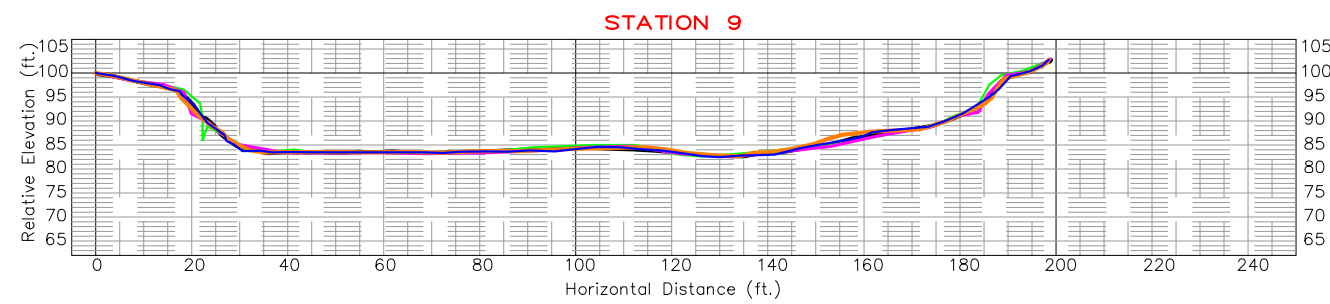
4A

Cross-sectional surveys of channel geometry were performed at all 52 monitoring stations during 2009. Thirty-four (34) permanent cross-sections were revisited throughout the former Site Impoundment and on tributaries where functional restoration is expected to occur. Eighteen (18) permanent cross-sections were revisited on reference reaches above and below the former Site Impoundment. Cross-section locations are displayed on Figure 3 (Appendix A). All monitoring years' cross-sectional surveys are displayed on Figures 4A-4D (Appendix A). Table 14 provides bankfull channel geometry including bankfull cross-sectional area (A_{bkf}), bankfull width (W_{bkf}), maximum bankfull depth (D_{max}), mean bankfull depth (D_{bkf}), and width-to-depth ratio (width/depth).

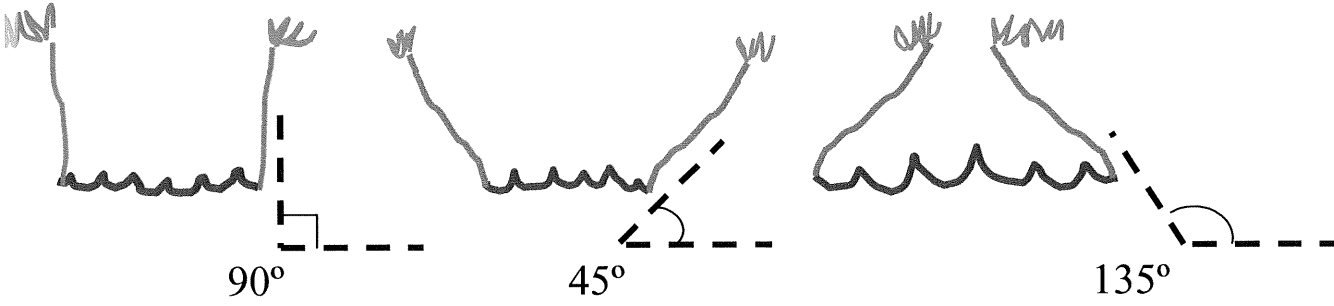
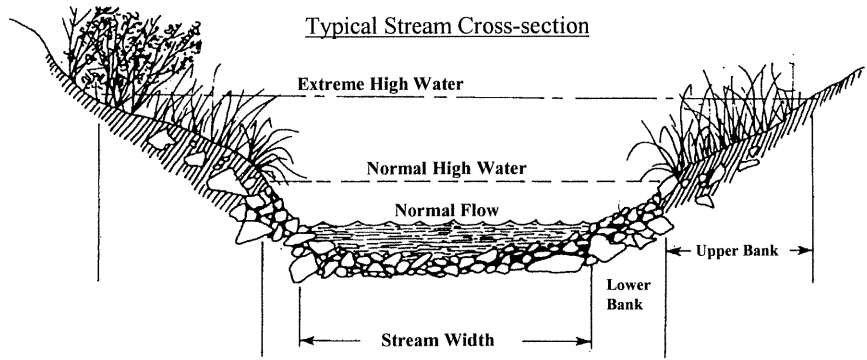
Diagram to determine bank angle:

This side is 45° bank angle.
