**CARBONTON DAM – DEEP RIVER WATERSHED
RESTORATION SITE
2010 Annual Monitoring Report (Year 5)**

**Chatham, Lee and Moore Counties, NC
NCEEP Project No. D-04012A**

October 2010

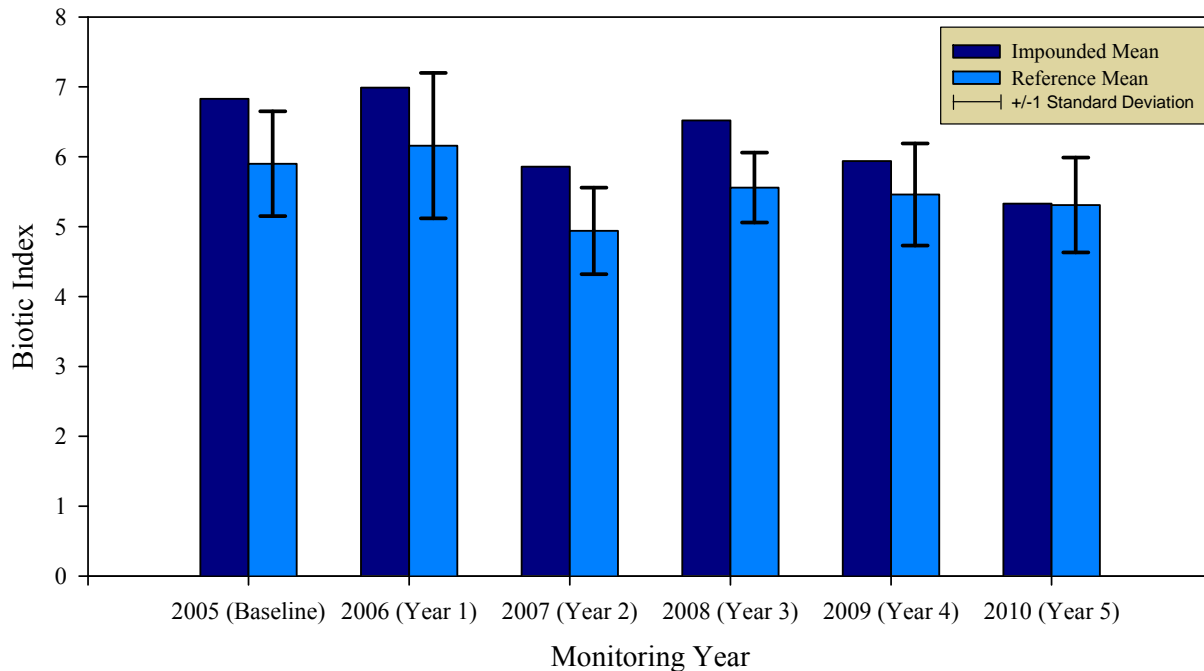
Graph 1. Mean Biotic Index of Formerly Impounded Stations vs. Reference Stations with Standard Deviation

The Year-5 mean biotic index (used as a proxy for water quality) from benthic macroinvertebrate samples within formerly impounded stations is within one standard deviation of the reference mean, therefore meeting the established success criteria. The mean biotic index from formerly impounded stations (5.33) is lower than all previous monitoring years and has decreased (improved) to within 0.02 of matching the reference stations. Success for this mitigation goal was met in three out of five monitoring years (2006, 2009, and 2010) with drought conditions likely responsible for missing the goal in years 2007 and 2008.

Note: A lower index value is indicative of less tolerant species (= higher water quality)

of matching the reference stations. The repeat success in the current monitoring year indicates that drought conditions are likely responsible for missing this goal in 2007 and 2008, and that improved water quality has persisted since dam removal. Table 5 presents the summary data for benthic biotic indices of both formerly impounded and reference stations.

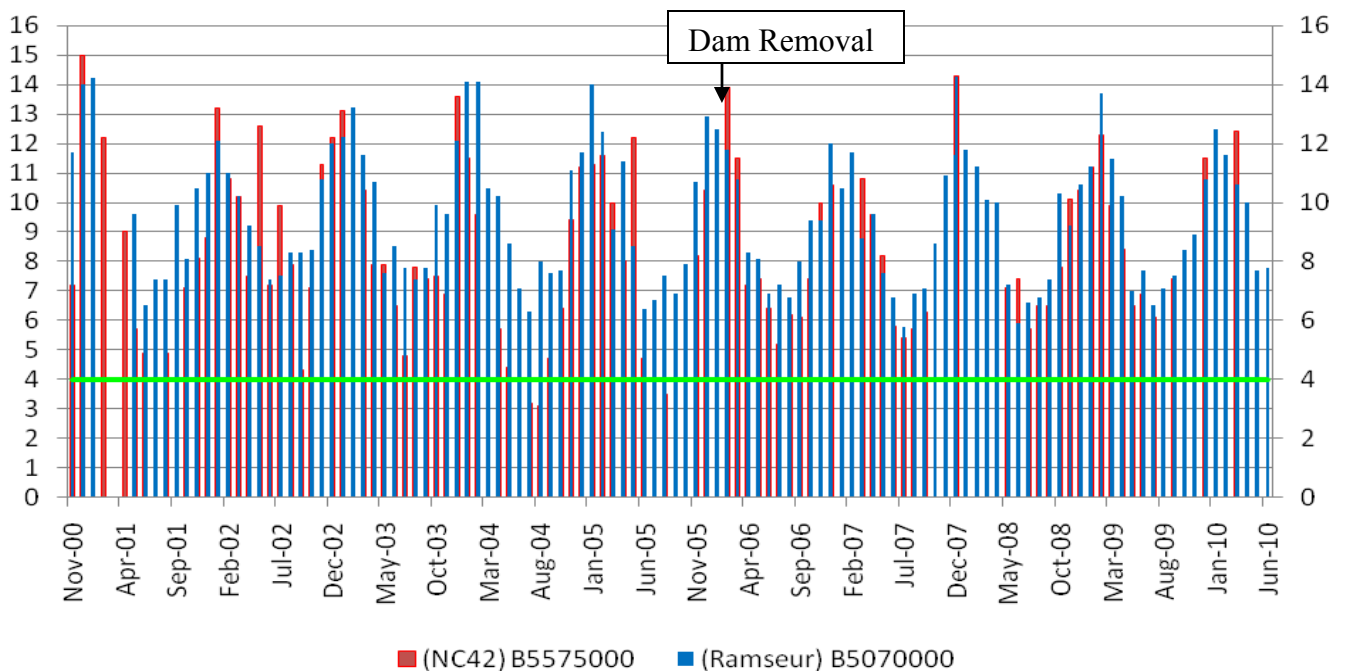
Graph 2. Recorded Dissolved Oxygen Concentrations in the Deep River

In order to achieve success, dissolved oxygen concentrations within the former Site Impoundment should not fall below the minimum NCDWQ standard for Class WS-IV waters (unless a similar failure is recorded at the reference station). The NCDWQ standard is an instantaneous value of no less than 4.0mg/L (daily average no less than 5.0 mg/L). Table 6 provides the minimum, maximum, and mean instantaneous values for dissolved oxygen recorded within the former Site Impoundment, as well as the number of samples that fell below the state standard for all monitoring years. Mean value for dissolved oxygen collected during Year-5 monitoring was 8.47 mg/L and exceeded the minimum state standard for all samples. Following dam removal, dissolved oxygen concentrations have not fallen below the minimum NCDWQ standard for any samples collected within the former Site Impoundment.

Note: Green line indicates state standard of 4.0mg/L

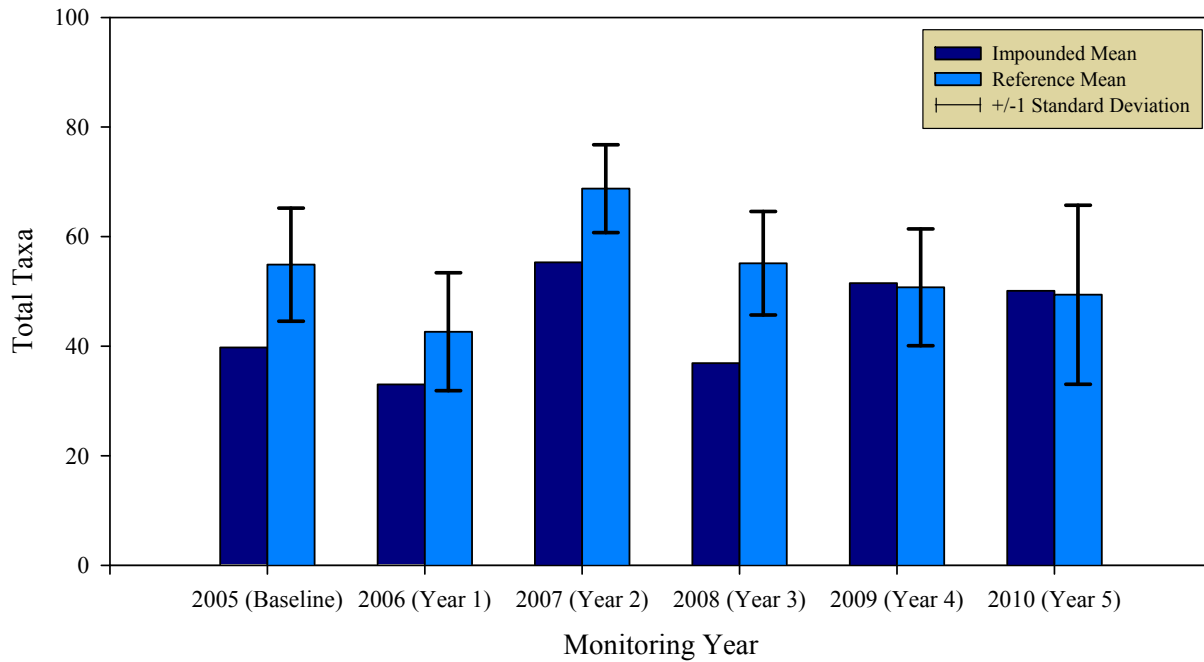
Graph 3. Mean Total Taxa of Impounded Stations vs. Reference Stations with Standard Deviation

Graph 3 and Graph 4 depict the change in mean total taxa and mean EPT richness from 2005 to 2010 from both the formerly impounded and reference stations.

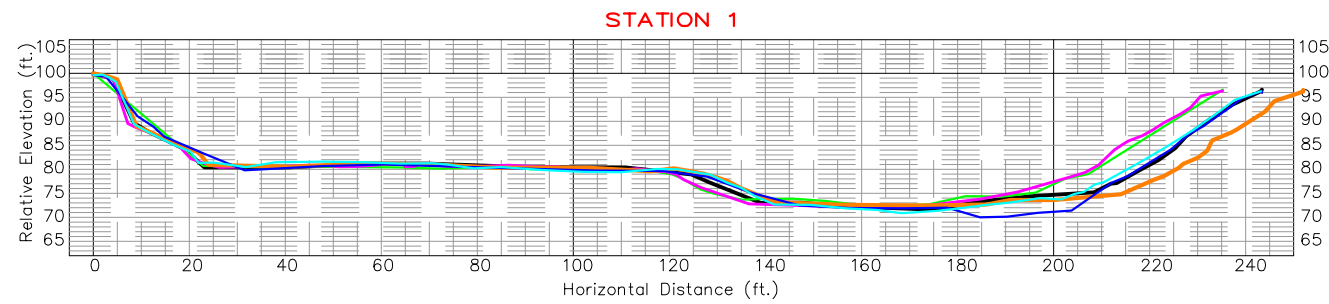
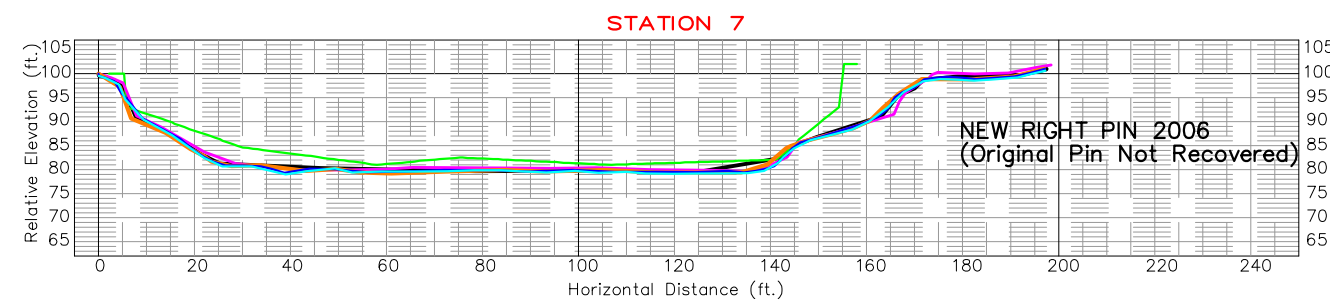
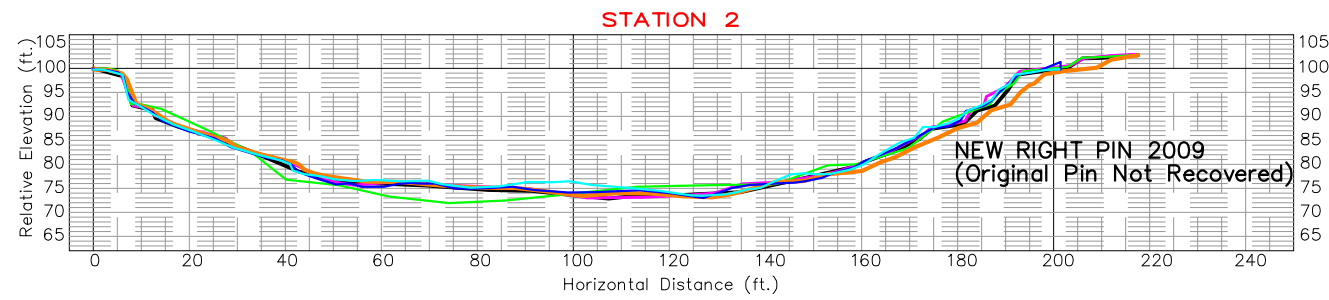
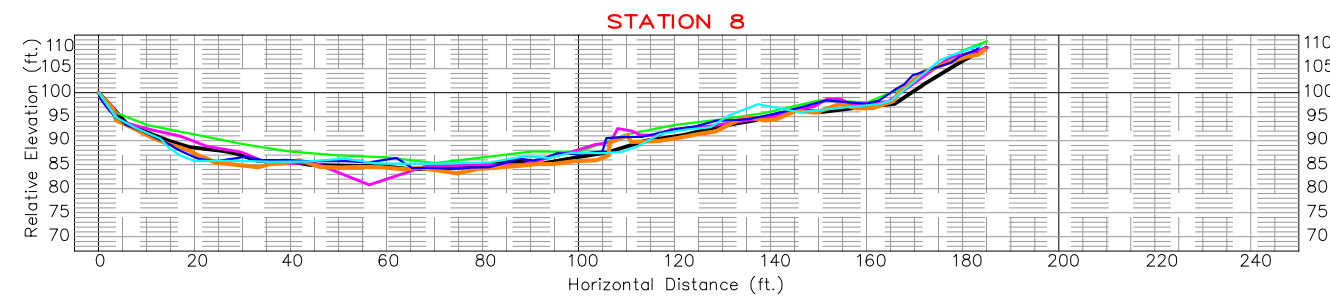
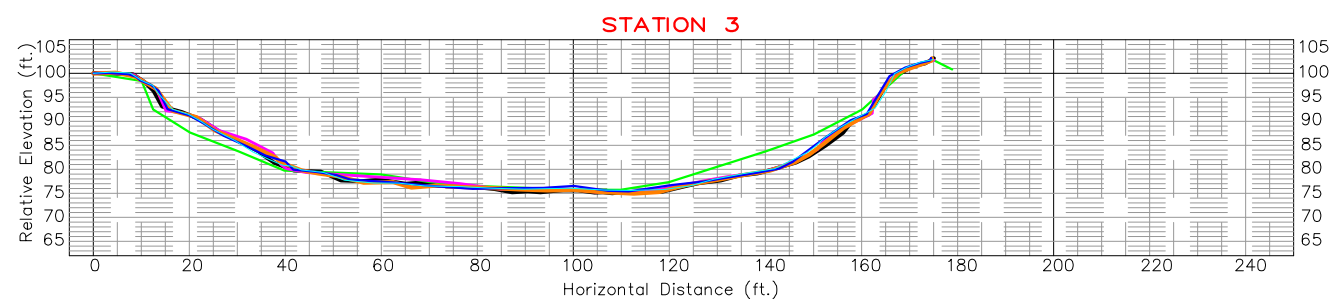
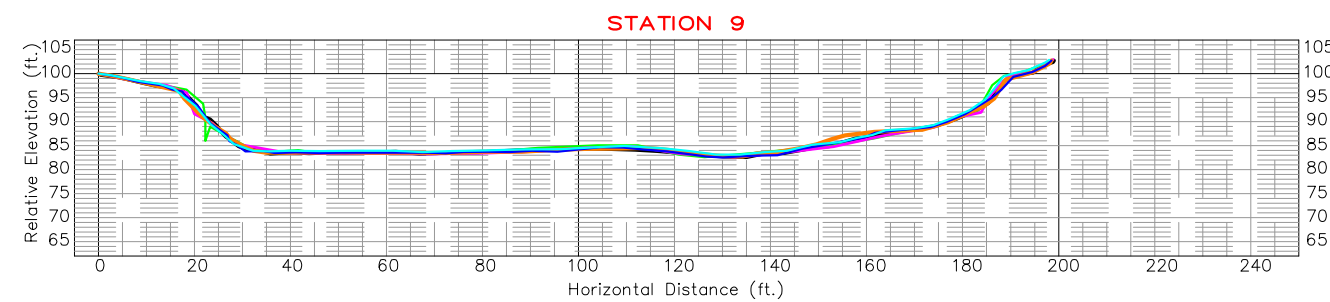
4A

In general, bankfull channel parameters were largely unchanged compared to conditions assessed during previous monitoring years. Limited scouring and erosion of bank material was detected at both impounded and reference stations, with an associated, minor change in bankfull areas. The Deep River channel is geomorphically stable, and any erosion is episodic and localized. Vegetation continues to colonize the river banks and sediment bars in the former impoundment that were previously below the reservoir pool. Station 55 was established following dam removal and therefore no baseline (2005) bankfull channel geometry data are available for this station. Other stations for which pins were not found, and subsequently replaced, are noted on Figures 4A-4D. Hence, the discrepancies in cross-sectional dimensions and bankfull channel geometry between years at the locations where new pins were installed.

Four additional cross-sections were surveyed to evaluate the substrate bar between the NC 42 bridge and the former footprint of the Carbonton Dam. All monitoring years' cross-sectional surveys and a map of their location are displayed Figure 4E (Appendix A). Annual surveys show that increased flow conditions following dam removal have had only minor impact on the substrate island and surrounding banks. The cross-section surveyed across the footprint of the former dam indicates only an initial, minor fluctuation in channel form resulting from increased sediment transport following dam removal.

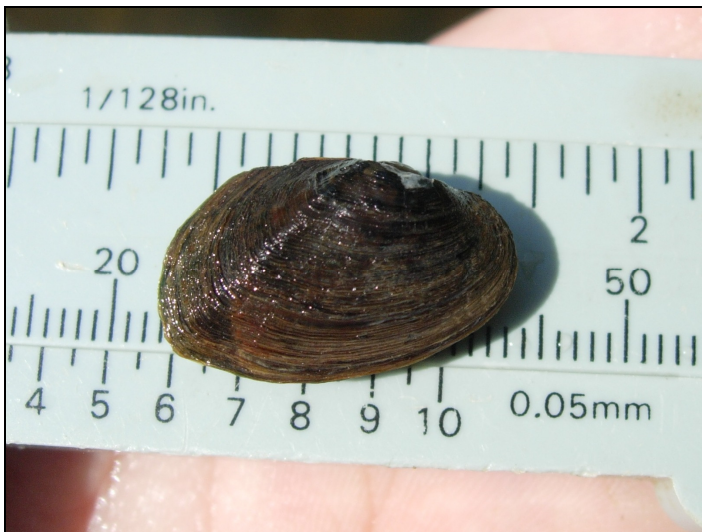
This site was selected during the pre-removal surveys due to the presence of large boulder and bedrock rock outcroppings. Since dam removal, much more of the rock outcropping has become exposed, and during Year-5 a boulder/cobble riffle/fall was noted. Newly recruited Eastern Elliptio were common and one newly recruited individual of the target Savannah Lilliput was also found, representing the first

Savannah Lilliput found at Site 9

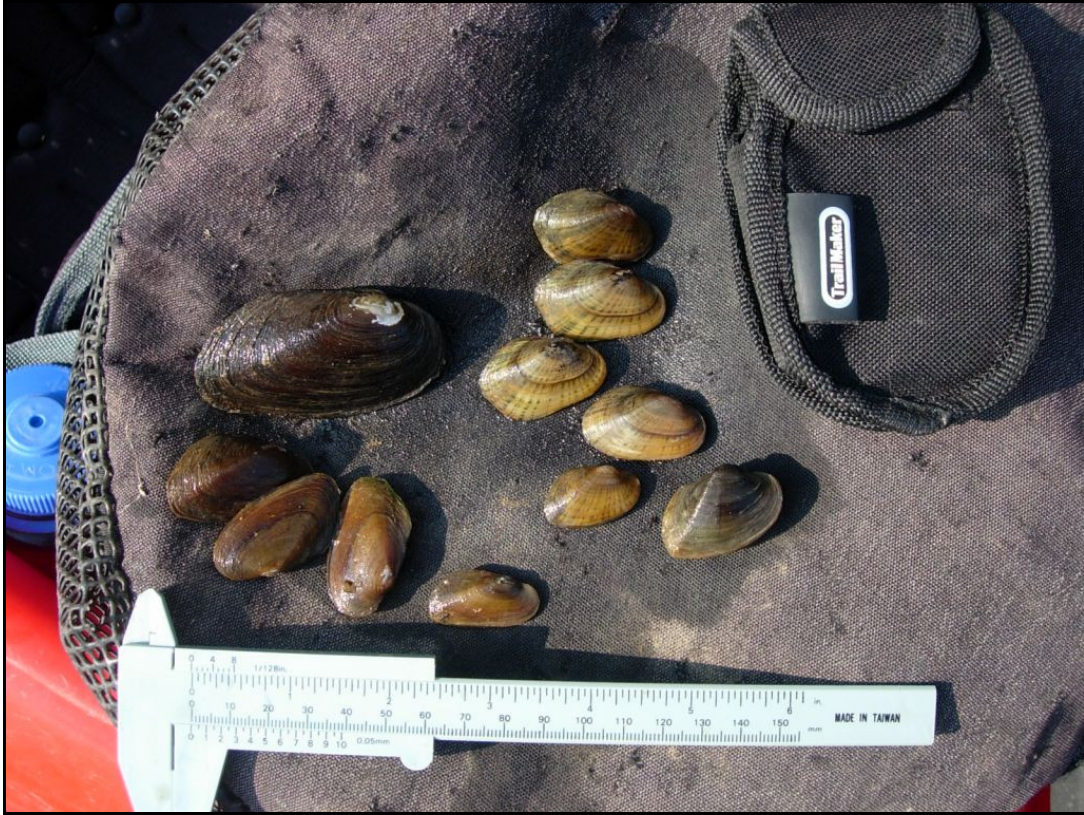
Young Creeper (top left), Eastern Creekshell (top right), Eastern Elliptio (bottom left) and Triangle Floater (bottom right) found in Deep River within formerly impounded reach during Year-3 monitoring.

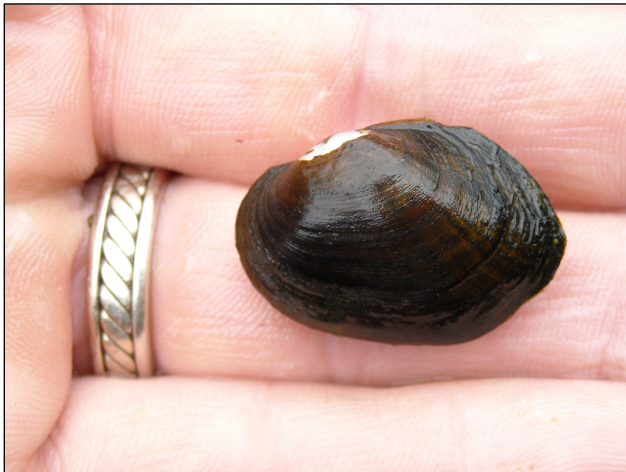
Notched Rainbow located in Year-3
