MITIGATION PLAN

CARPENTER BOTTOM MITIGATION SITE

Gaston County, NC
NCDEQ Contract No. 7731
DMS ID No. 100090

Catawba River Basin
HUC 03050102
(03050103 Expanded Service Area)

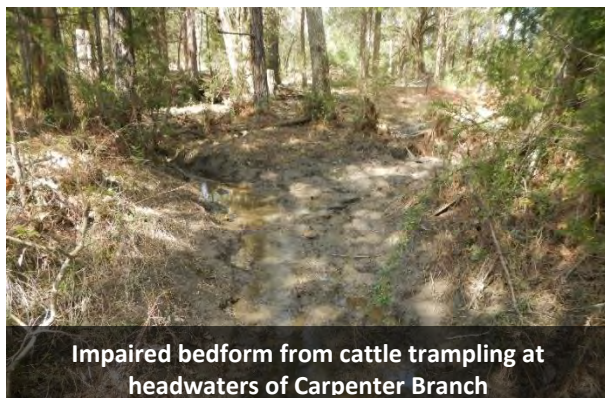
Carpenter Branch originates as an intermittent stream from an agricultural ditch that drains from wetland N. Carpenter Branch Reach 1 remains an intermittent stream until the confluence of UT2 where it becomes perennial. Carpenter Branch Reach 1 flows through an unconfined alluvial valley with moderate slope in an incised condition ($BHR > 3.0$). The stream exhibits evidence of active soil headcuts, bank erosion, and cattle activity including wallows and entry/exit runs. Bedform diversity is moderate, with some sections of riffle-pool sequences. However, much of the bedform is actively impacted by

cattle trampling. A relic road crossing maintains channel grade for a short section upstream of the confluence with UT1. The stream has one existing undersized culvert crossing. In Reach 2, the channel incision reduces and channel bedform improves. The valley slope increases and a stable step-pool channel begins to form. Cattle have access to the downstream extents, but impacts appear to be limited by established vegetation which limits cattle activity. The riparian corridor is narrow and heavily

invested with invasives species, particularly chinese privet and hardy orange.

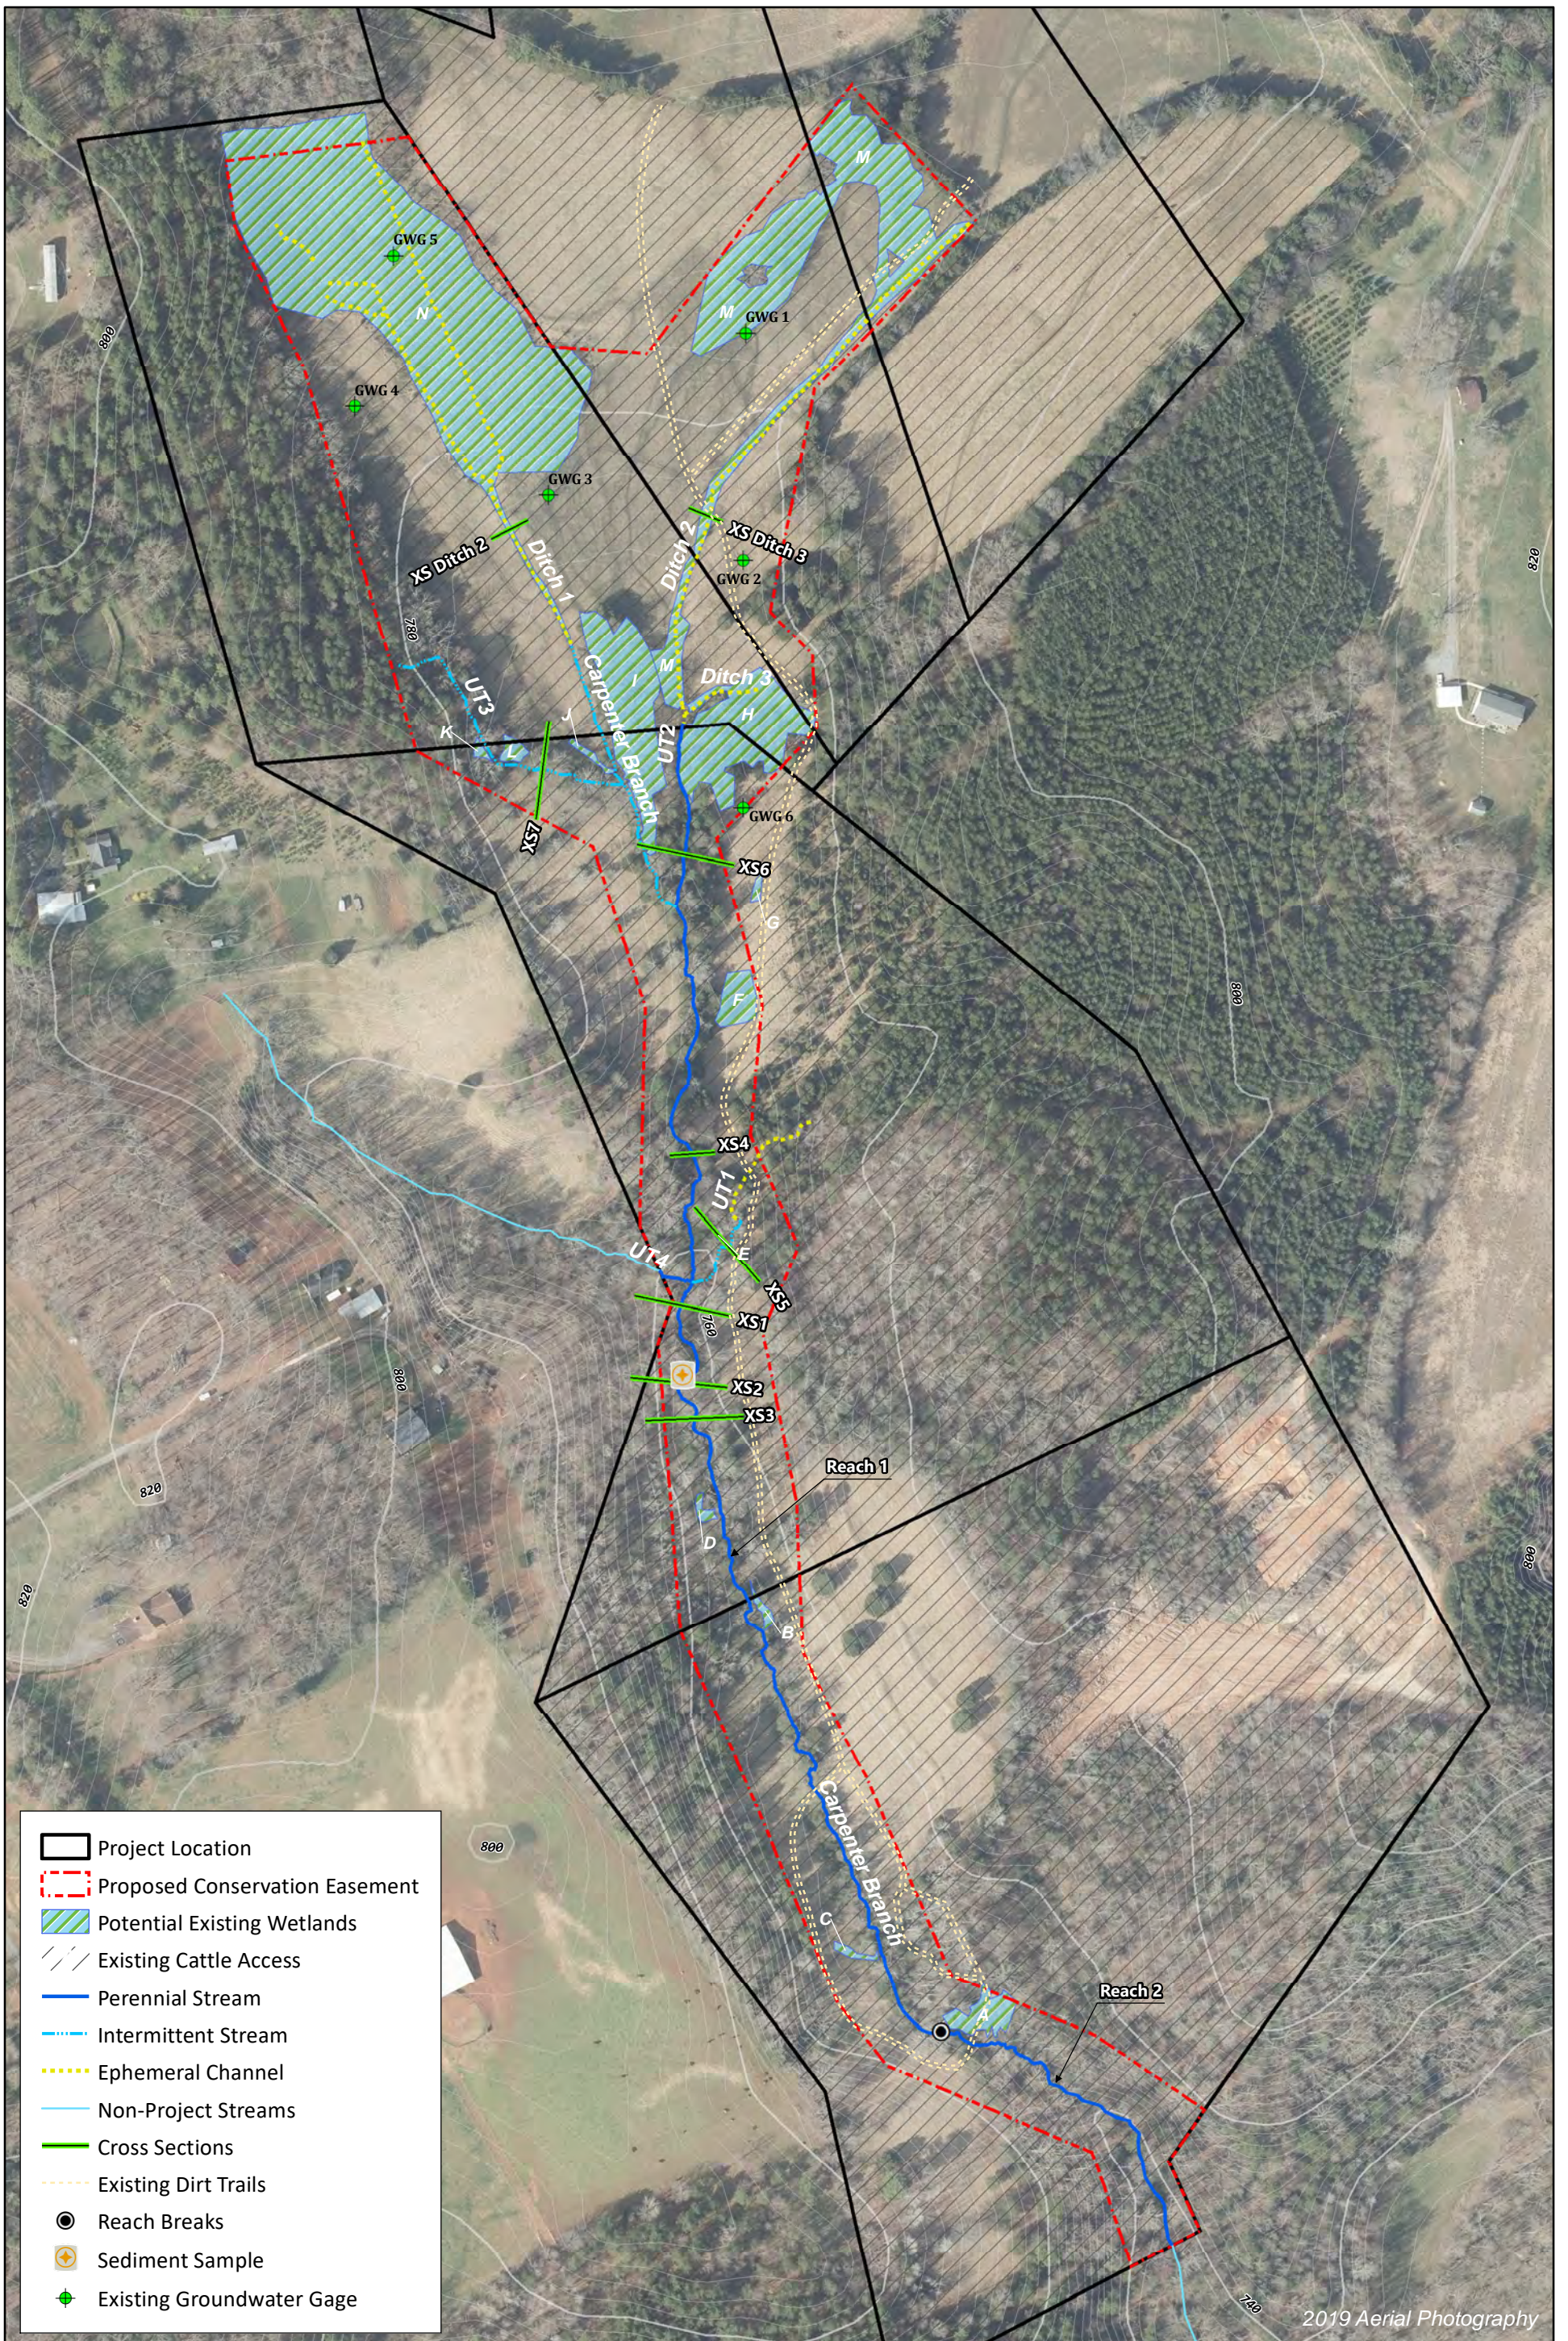
Figure 3 Site Map
 Carpenter Bottom Mitigation Site
 Catawba River Basin 03050102
 (03050103 Expanded Service Area)
 Gaston County, NC

- Project Location
- Proposed Conservation Easement
- Potential Existing Wetlands
- Existing Cattle Access
- Perennial Stream
- Intermittent Stream
- Ephemeral Channel
- Non-Project Streams
- Cross Sections
- Existing Dirt Trails
- Reach Breaks
- + Sediment Sample
- + Existing Groundwater Gage

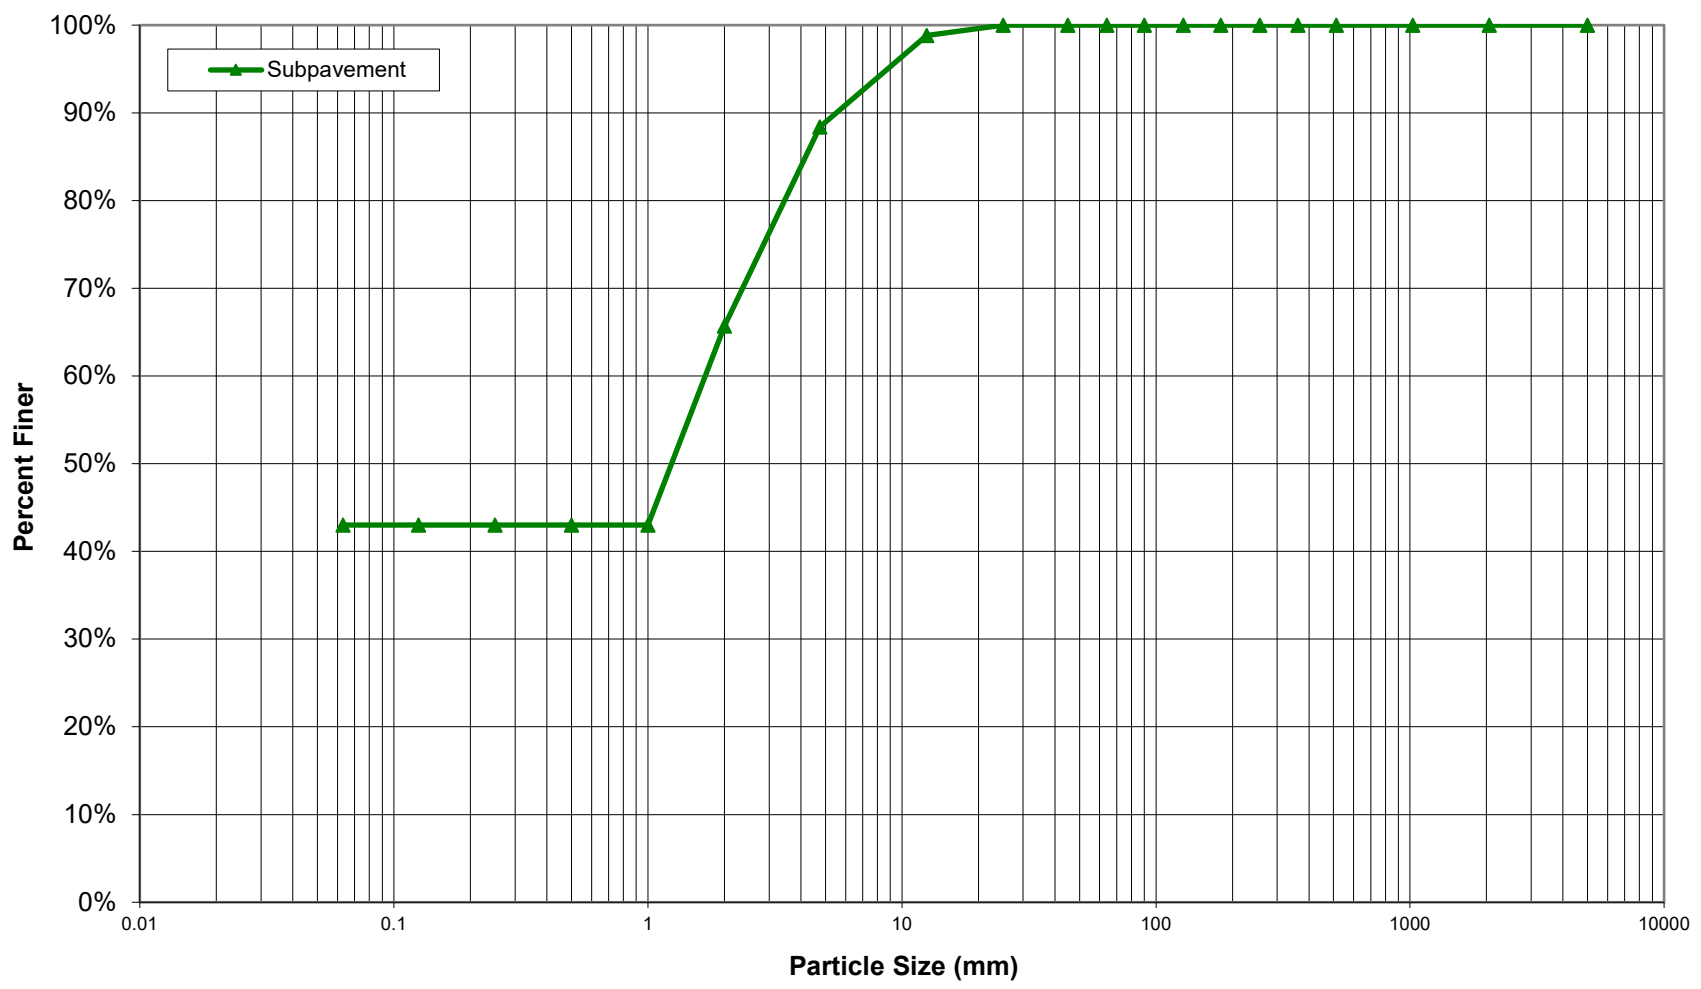
**Carpenter Bottom Mitigation Site
Carpenter Branch Reach 1
Subpavement Particle Size Distribution**

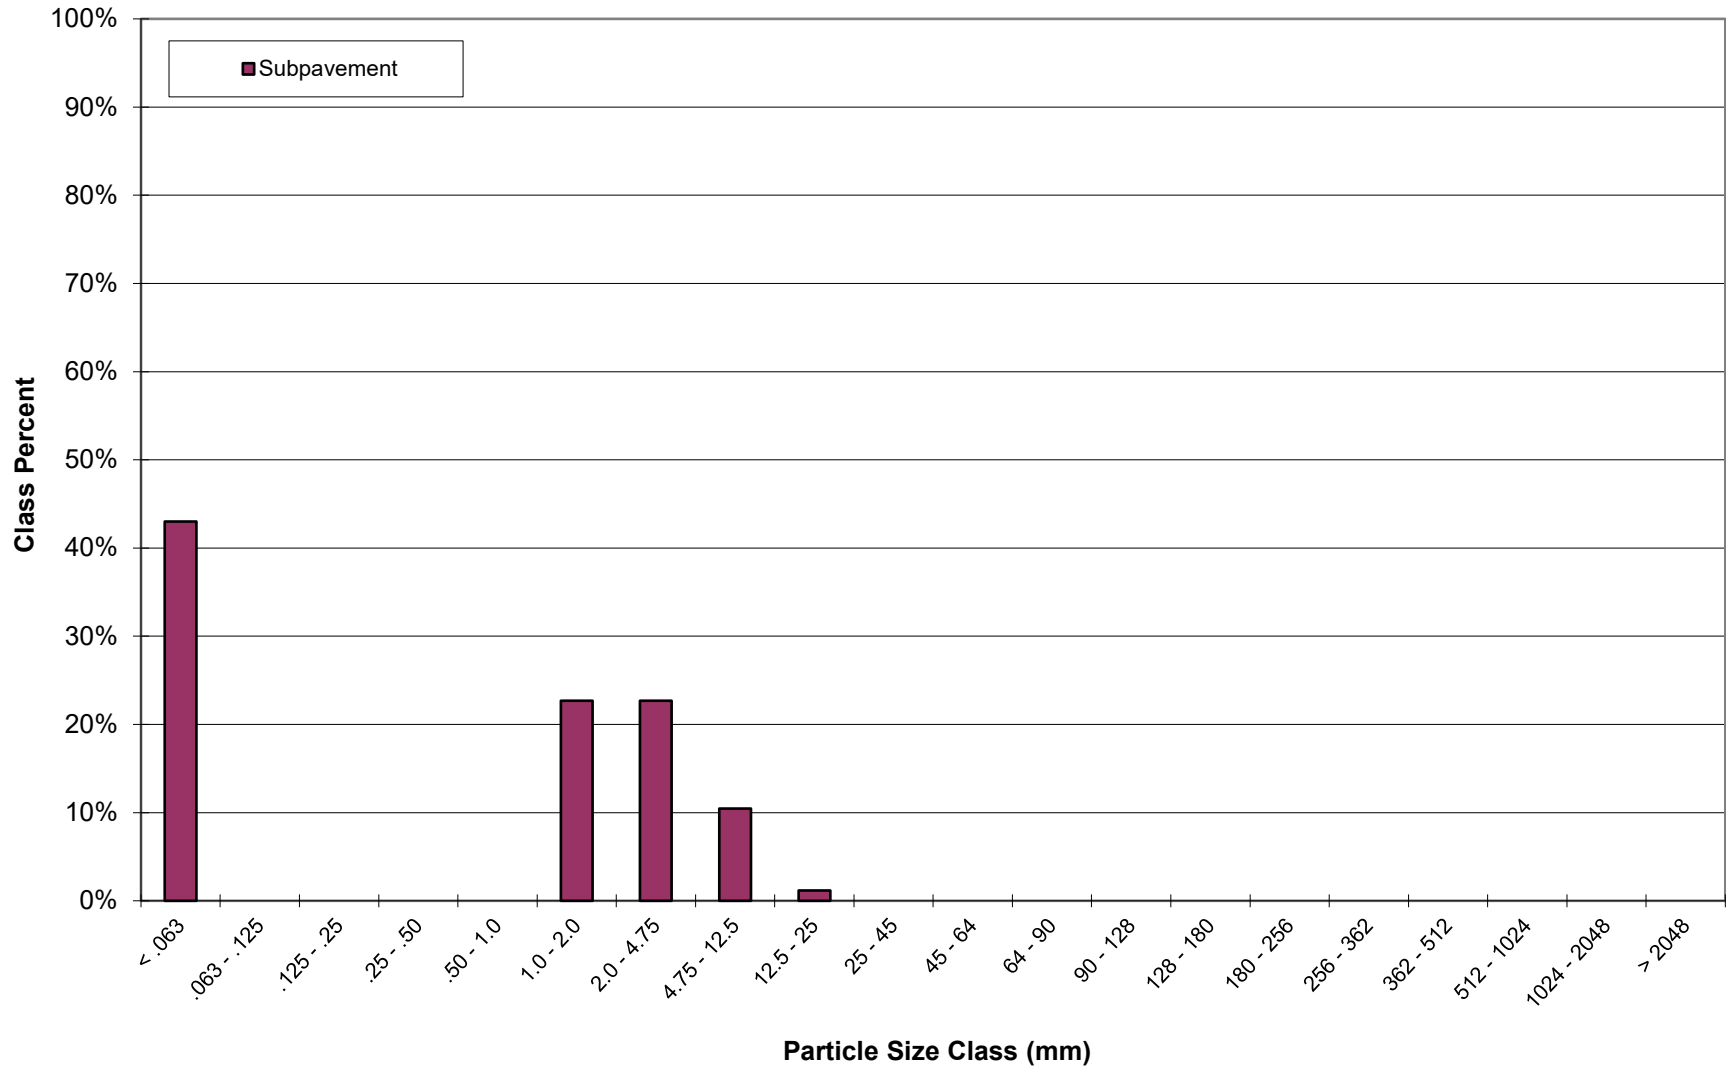
Carpenter Branch
Reach 1
Sieve Analysis Class Distribution

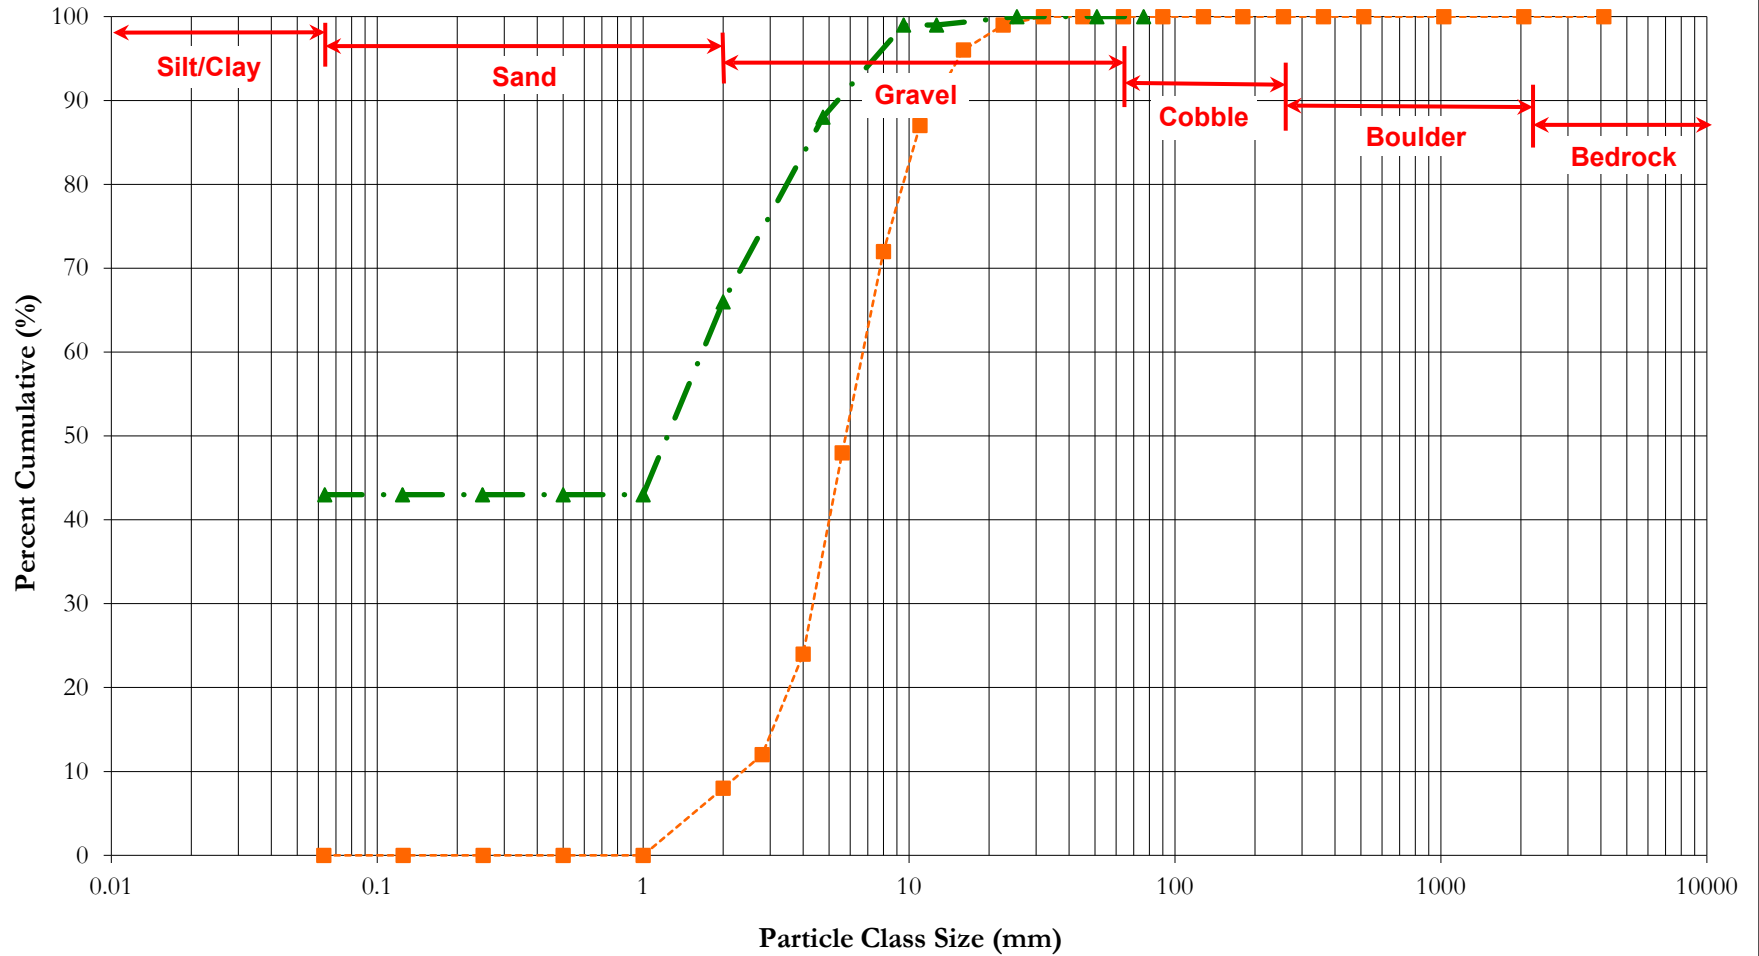
Carpenter Bottom Reach 1 - XS1 Pavement-Subpavement Particle Distribution

---■--- Pavement Summary -.-▲-.- Subpavement Summary

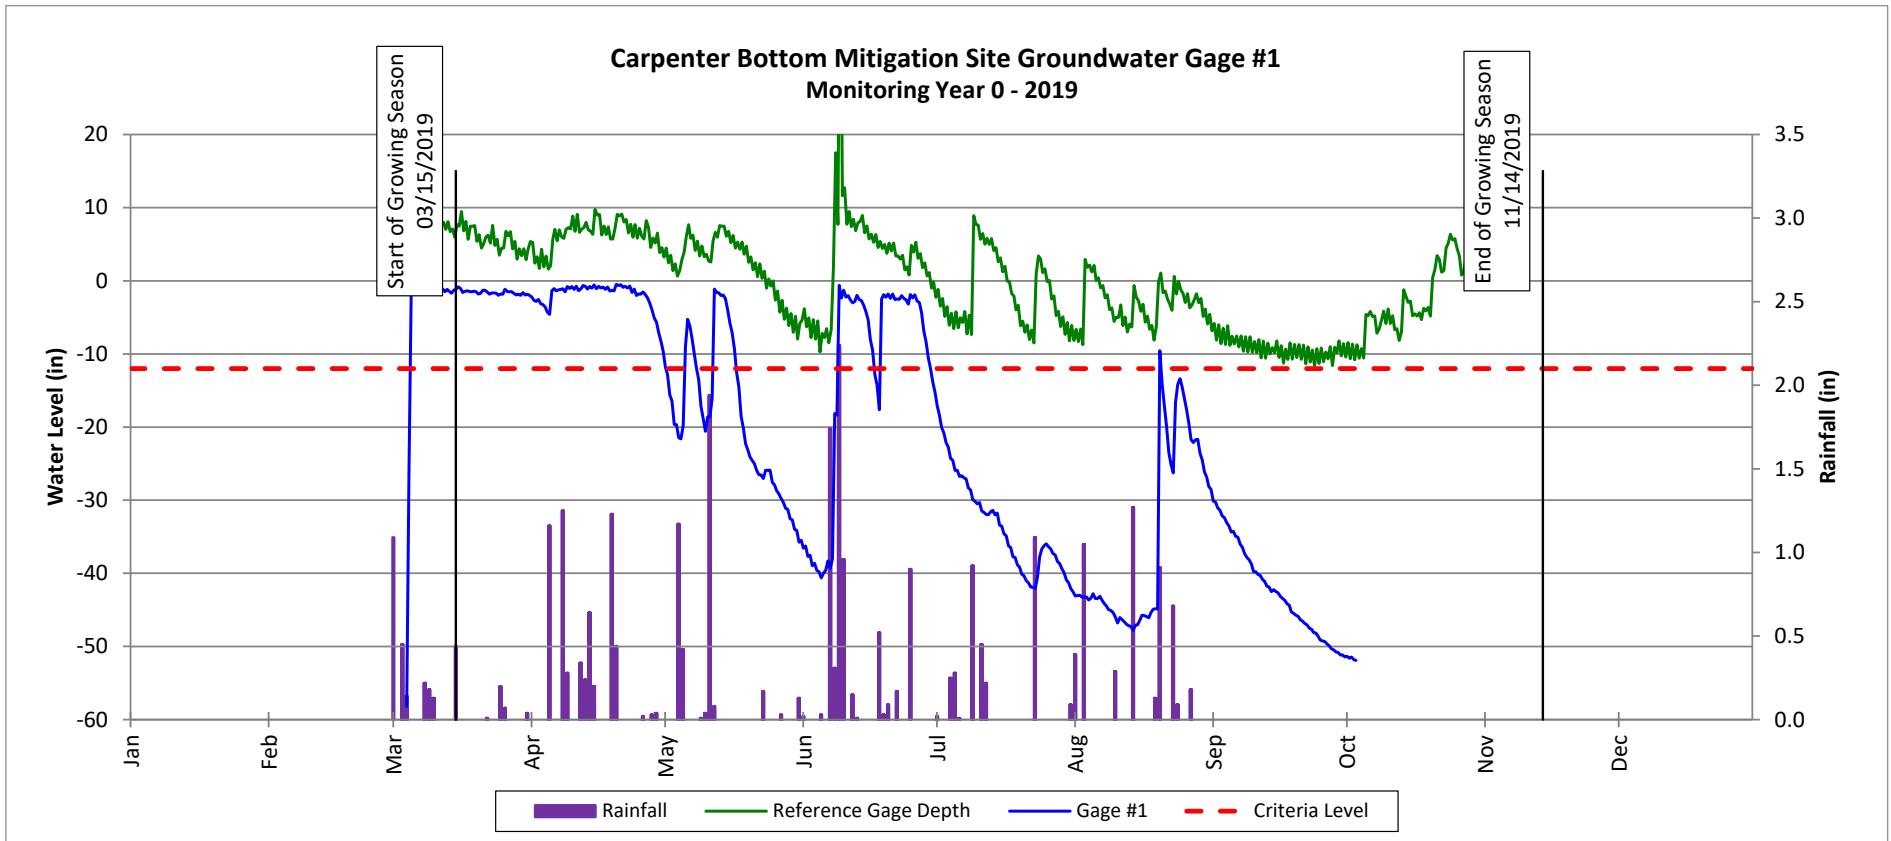
Groundwater Gage Plots

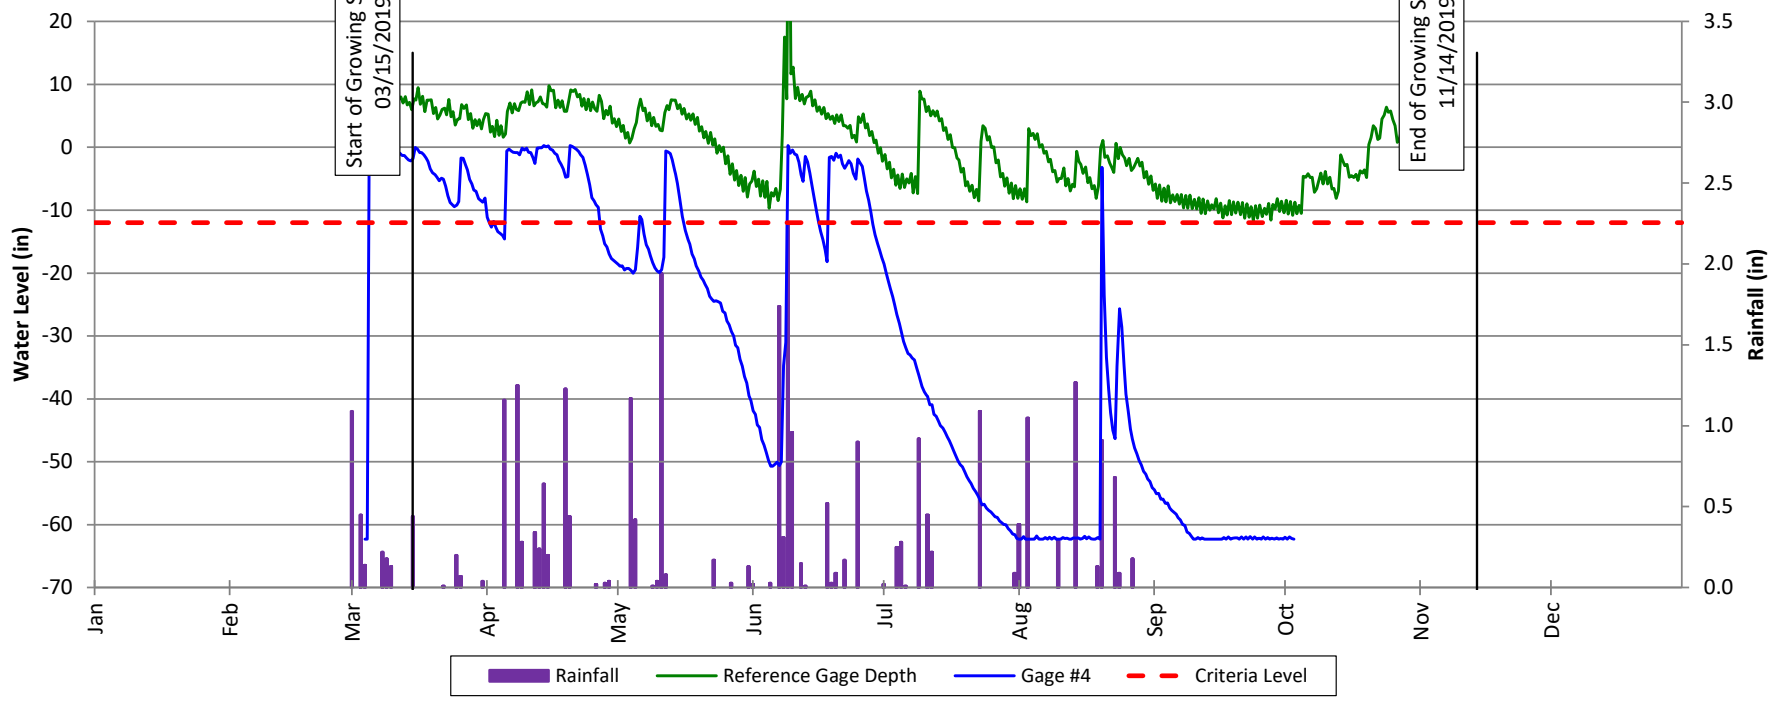
Carpenter Bottom Mitigation Site Groundwater Gage #4 Monitoring Year 0 - 2019

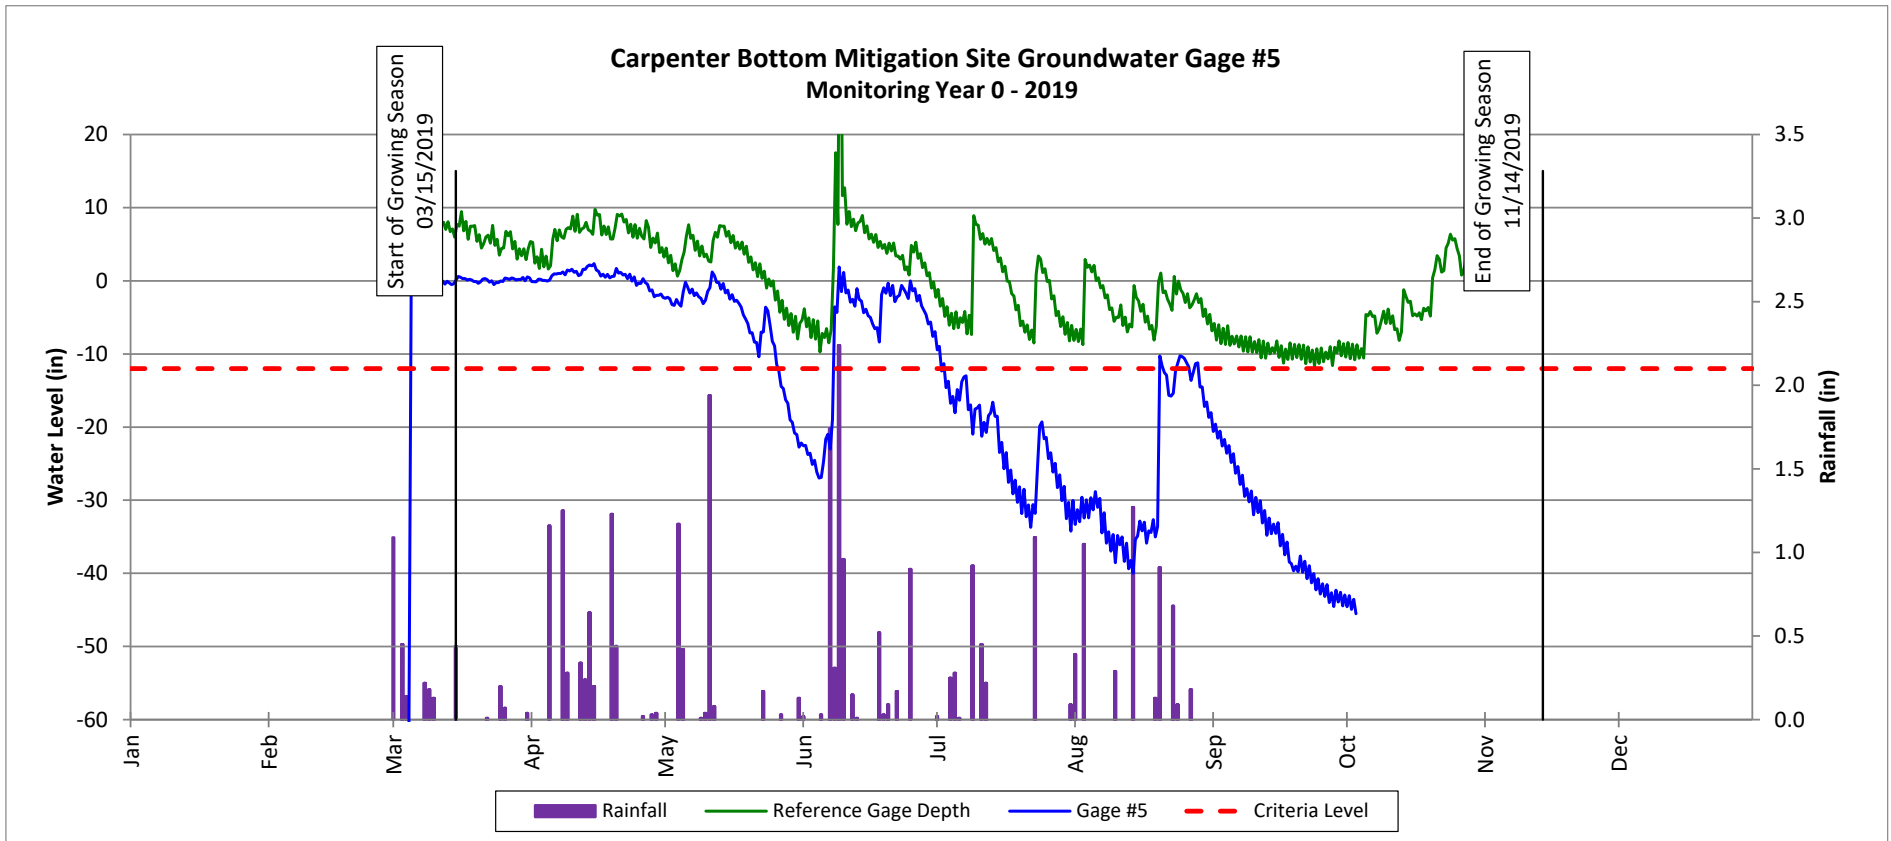
Carpenter Bottom Mitigation Site Reference Gage Monitoring Year 0 - 2019

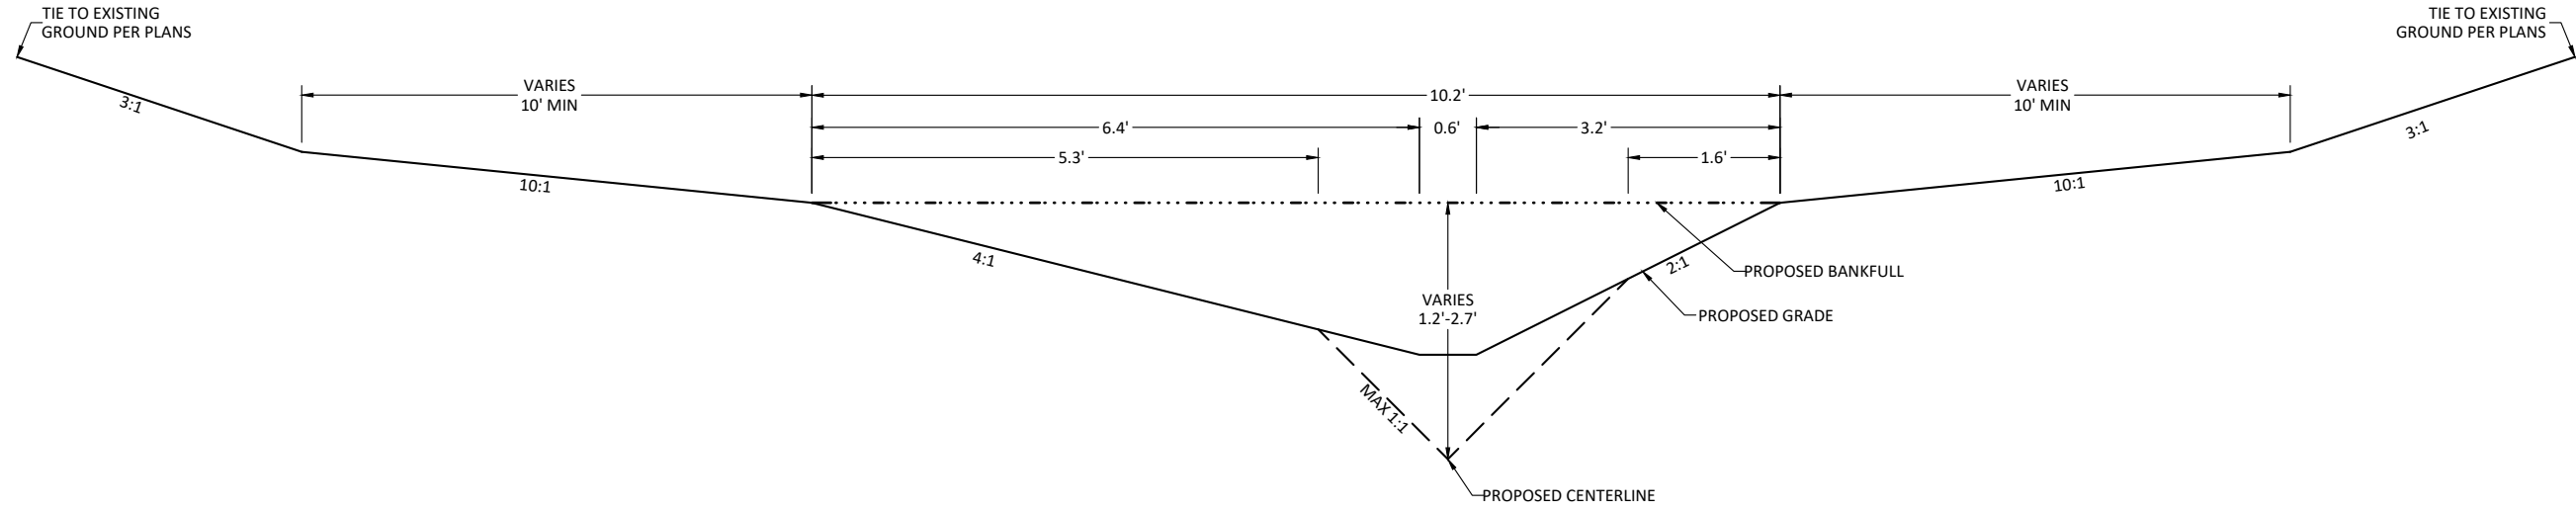
Carpenter Branch Reach 1 - Riffle
STA: 100+00 - 123+00

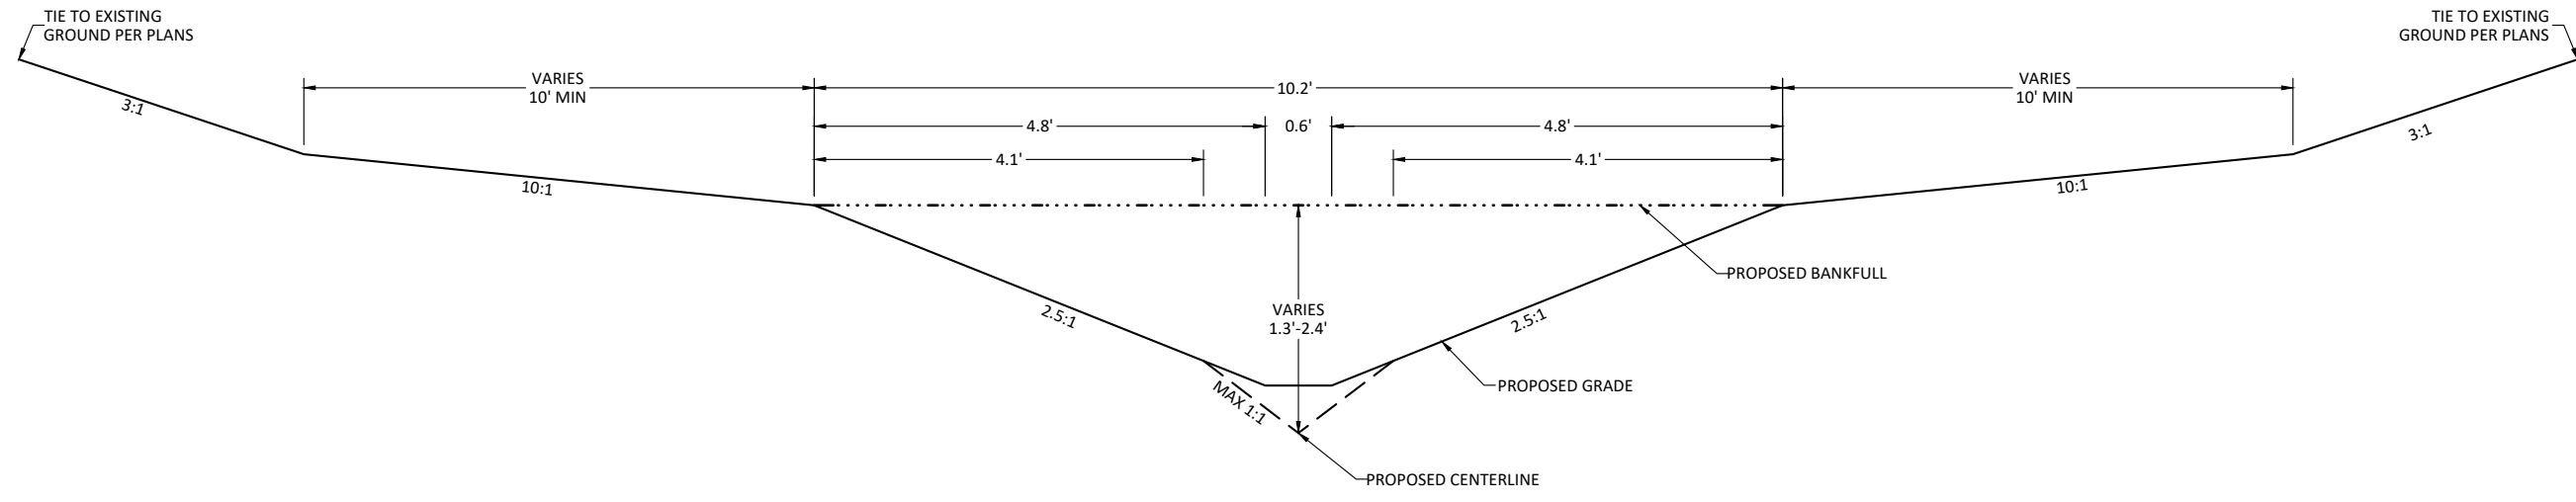
Carpenter Branch Reach 1 - Meander Pool
STA: 100+00 - 123+00

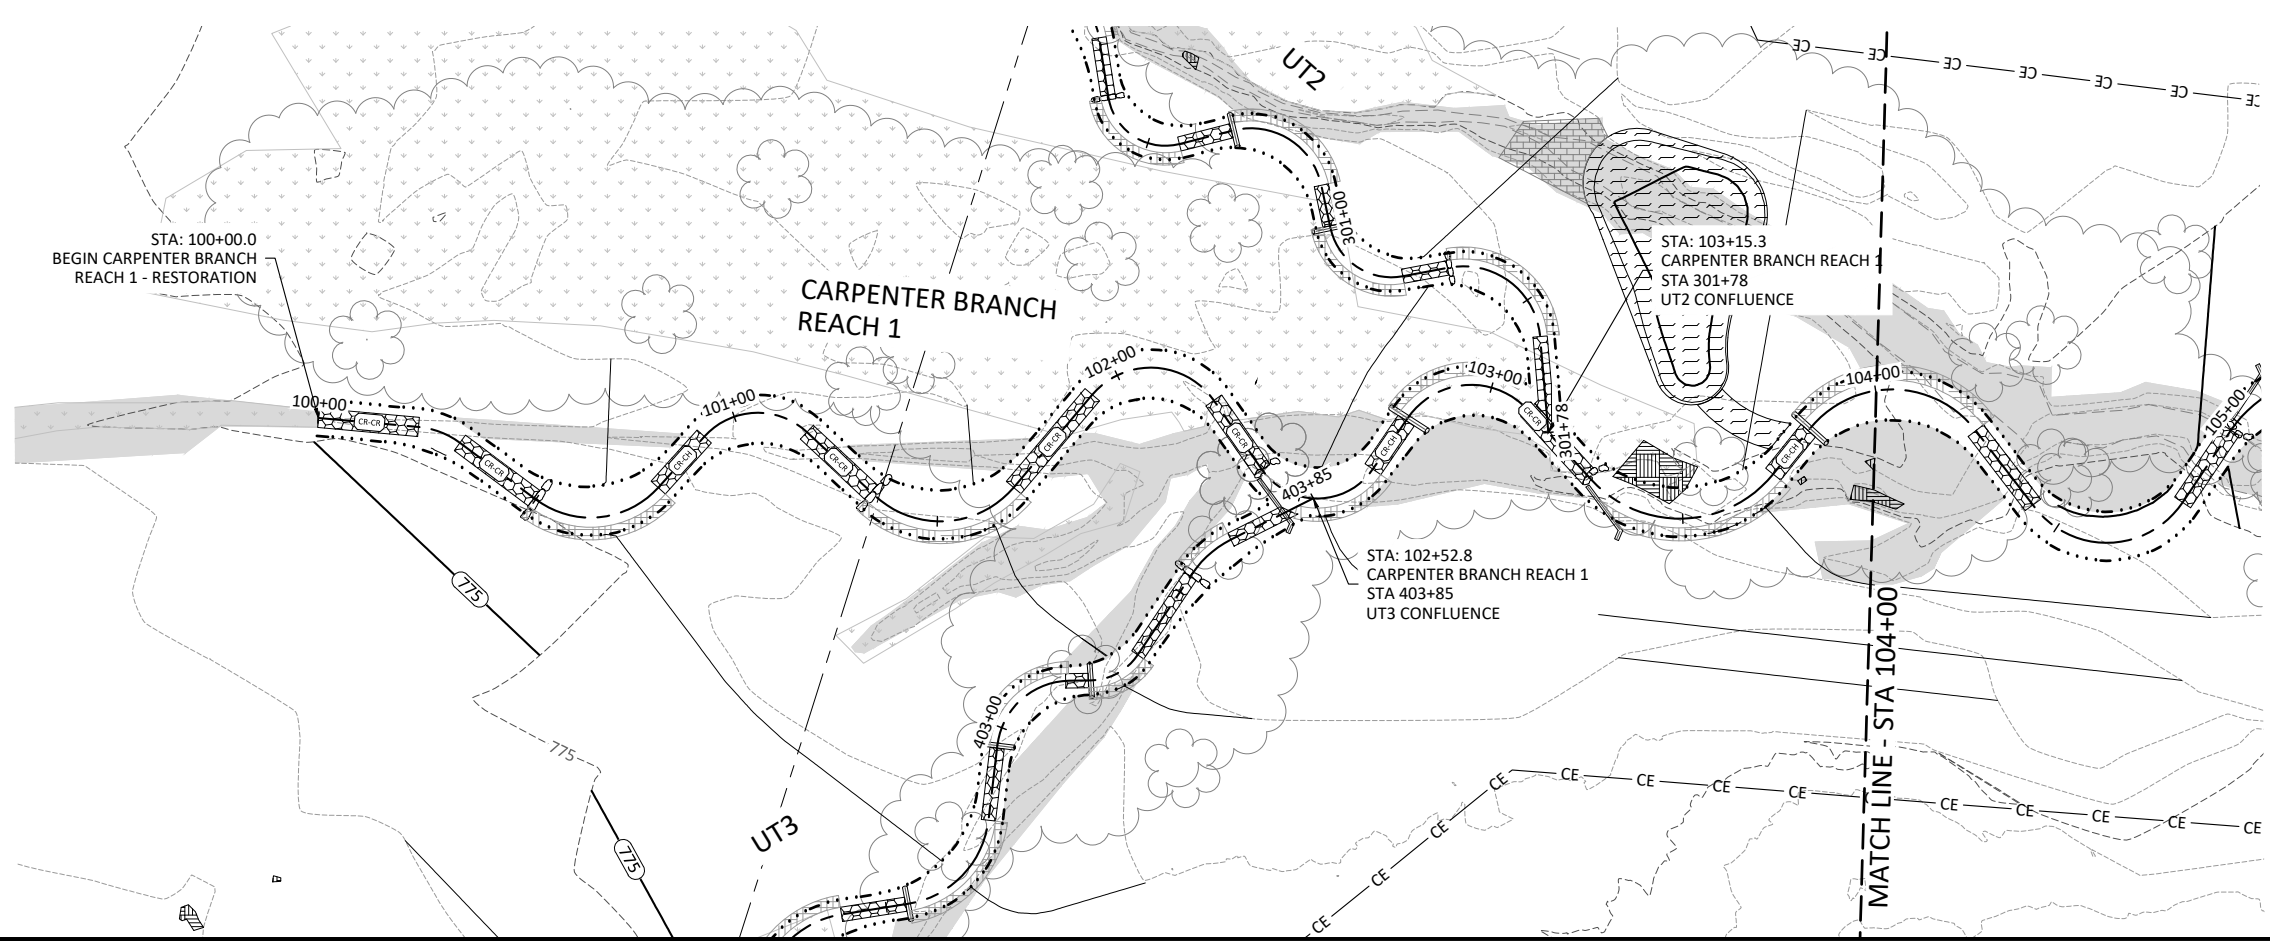
Carpenter Bottom Mitigation Site
Gaston County, North Carolina
Carpenter Branch
Stream Plan and Profile

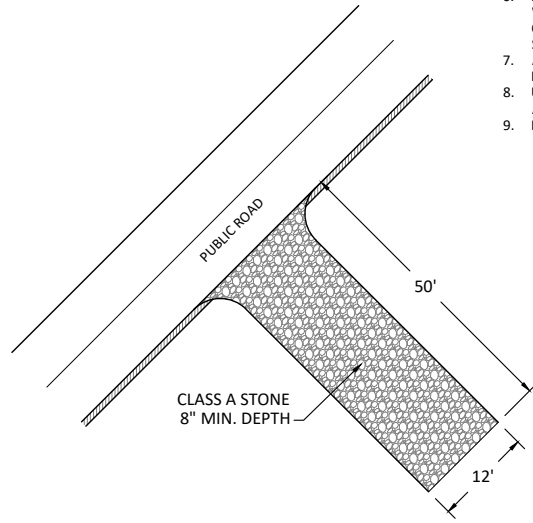
1. PROVIDE TURNING RADIUS SUFFICIENT TO ACCOMMODATE LARGE TRUCKS.
5. LOCATE CONSTRUCTION ENTRANCE AT ALL POINTS OF INGRESS AND EGRESS UNTIL SITE IS STABILIZED. PROVIDE FREQUENT CHECKS OF THE DEVICE AND TIMELY MAINTENANCE.
6. MUST BE MAINTAINED IN A CONDITION WHICH WILL PREVENT TRACKING OR DIRECT FLOW OF MUD ONTO STREETS. PERIODIC TOP DRESSING WITH STONE WILL BE NECESSARY.
7. ANY MATERIAL TRACKED ONTO THE ROADWAY MUST BE CLEANED IMMEDIATELY.
8. USE CLASS A STONE OR OTHER COARSE AGGREGATE APPROVED BY THE ENGINEER.
9. PLACE FILTER FABRIC BENEATH STONE.

1
6.5 Construction Entrance
Not to Scale

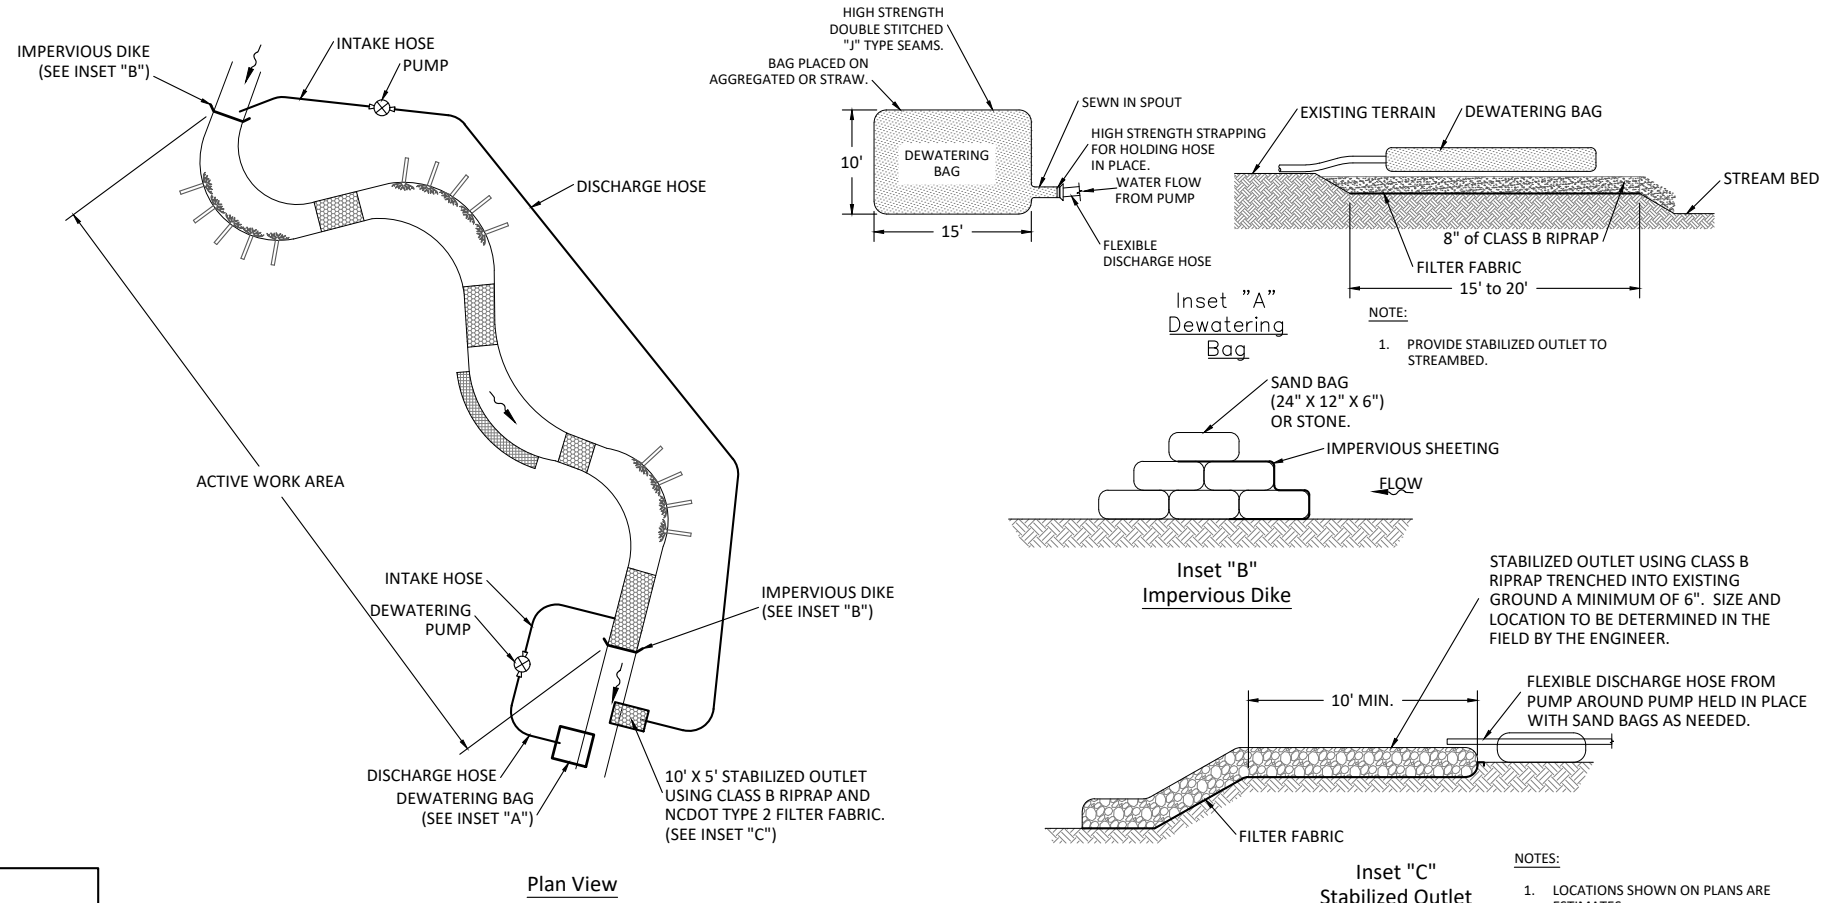
2
6.5 Pump Around System
Not to Scale

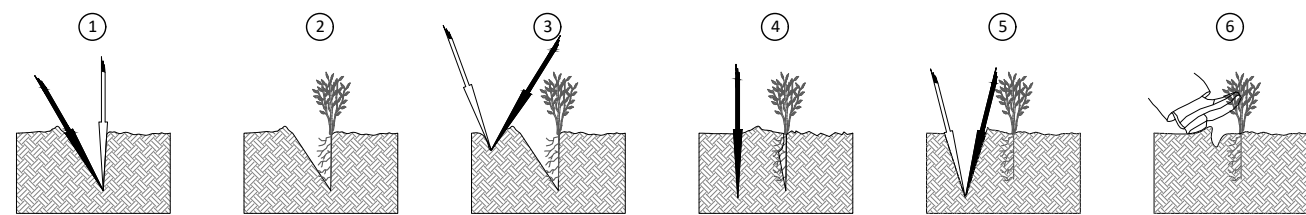
1. ALL SOILS WITHIN THE BUFFER PLANTING AREA SHALL BE DISKED, AS REQUIRED, PRIOR TO PLANTING.
2. ALL PLANTS SHALL BE PROPERLY HANDLED PRIOR TO INSTALLATION TO INSURE SURVIVAL.

INSERT THE DIBBLE, OR SHOVEL, STRAIGHT DOWN INTO THE SOIL TO THE FULL DEPTH OF THE PLANTING HOLE. (DO NOT ROCK THE SHOVEL BACK AND FORTH AS THIS CAUSES SOIL IN THE PLANTING HOLE TO BE COMPACTED, INHIBITING ROOT GROWTH.)
