**CARP MITIGATION SITE
UNNAMED TRIBUTARY TO LAXON CREEK
WATAUGA COUNTY**

The 3rd (2004) and 4th (2005) Monitoring Report

NORTH CAROLINA DEPARTMENT OF TRANSPORTATION

Period Covered: June 3, 2004 – September 27, 2005

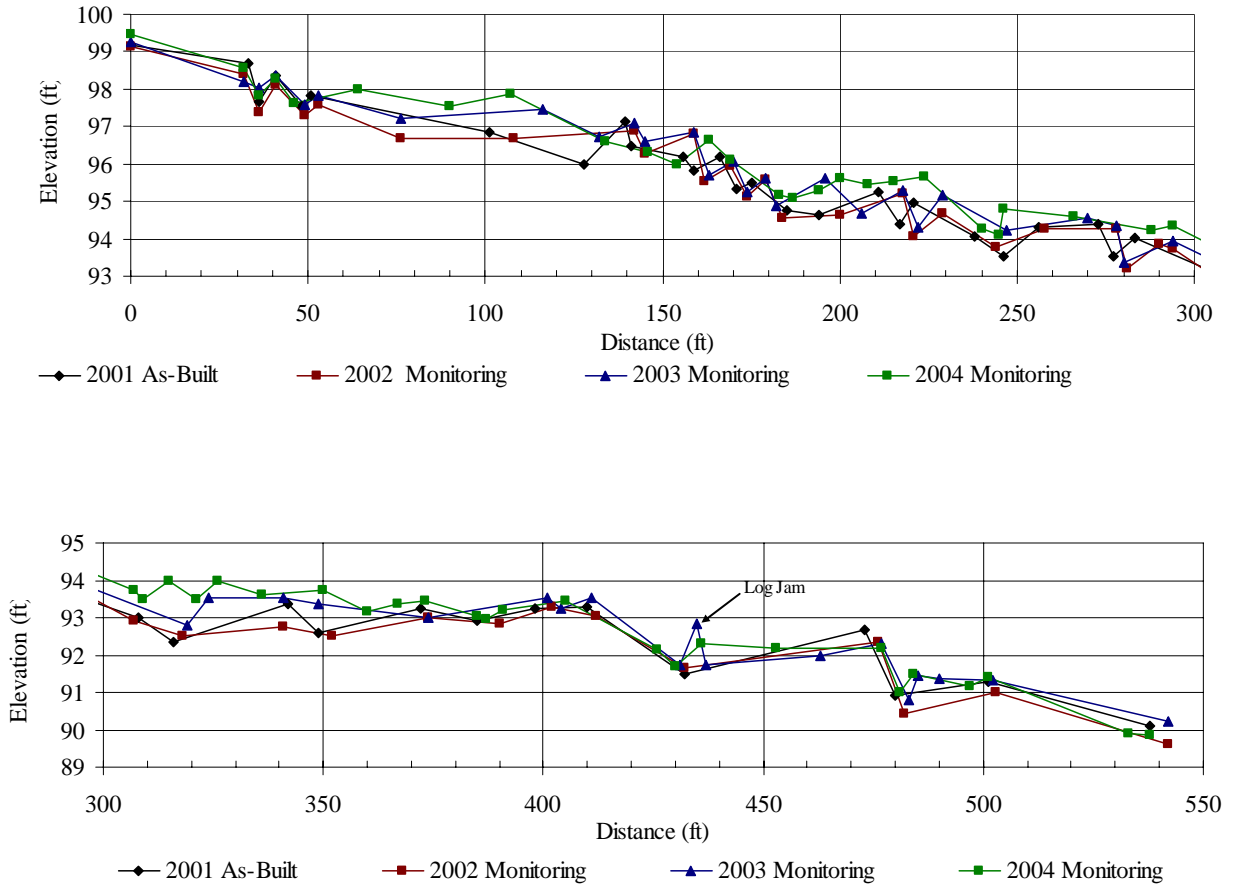
FIGURE 2.—Four longitudinal profile comparisons, Carp mitigation site, unnamed tributary to Laxon Creek, Watauga County, 2001-2004.

The 2001, 2002, and 2003 longitudinal surveys (Figure 2) show a relatively stable channel but one that is making minor natural adjustments from its original construction (Mickey and Scott 2001). Channel bed elevations show aggradation from station 0+55 to 1+42. We are uncertain as to the cause of this channel aggradation since no in-stream work was done in this area. From

stations 1+42 to 4+32, the length of fully restored, channel profile adjustments were observed as the new channel settled into it's new position and adjusted to a range of stream flows.

The 2004 longitudinal survey documented channel profile changes that occurred after the November 19, 2003 flood (Figure 1, Appendix 1). Following this flood event streambed aggradation was seen at stations 0+55 – 1+35, 2+00 – 2+30, 2+47 – 2+65, and 2+78 – 3+50. While aggradation has occurred at these locations, it has not been detrimental to the success of the project. Based on yearly visual observations, there has been no shift in the meander pattern and no bank scour or erosion is evident. These aggradations appear to be a result of substrate transported from upstream sources (unstable streambanks, pastures, construction activities, unpaved roads). Furthermore, during the 2003 flood the stream was unable to transport this material through the project reach. Flood waters from the South Fork New River backed up into this area and reduced stream sediment transport power.

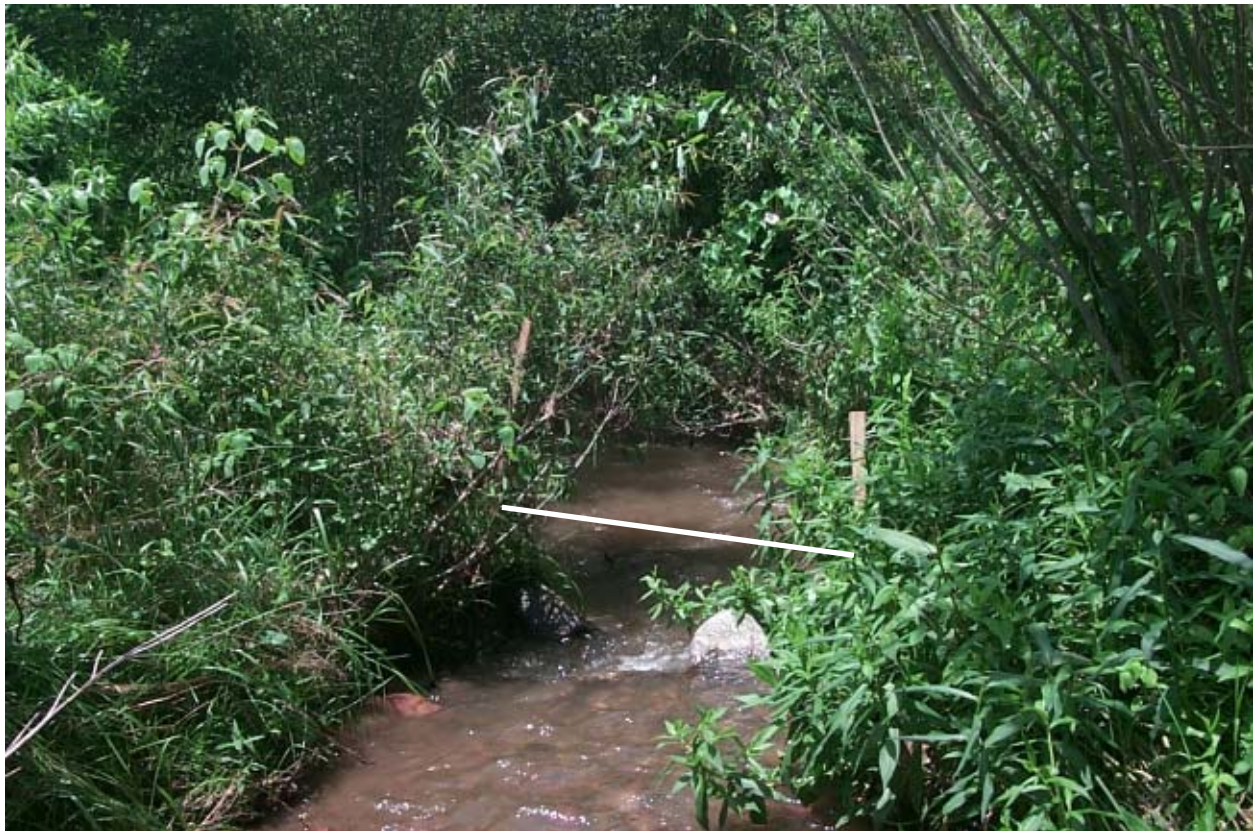
FIGURE 3.1. — Cross-section 1+69, riffle.

CROSS-SECTION 1+69 – riffle (Figure 3.1): Following construction this cross-section was a step-pool complex. Over the years, with the movement of some of the cross-vane rocks and substrate materials, this cross-section has evolved from a step-pool to a riffle complex with a few deep pockets of water. The cross-section is stable with no bank erosion or lateral movement occurring.

FIGURE 3. — Seven cross-section comparisons, Carp mitigation site, unnamed tributary to Laxon Creek, Watauga County, 2001-2005.

Seven cross-sections were surveyed during 2004 and 2005 and compared with previous cross-sections (Figure 3; Mickey and Scott 2001; Mickey and Hining 2003). Cross-section profiles indicate some major adjustments following the 2003 and 2004 hurricanes. Moderate to major adjustments in thalweg depths (aggradation) occurred at all cross-sections following these storms. All of the cross-sections exhibit build up of the streambanks due to deposition of soil materials (silt, sand, small gravel) during bankfull or greater than bankfull storm events. There has been no lateral movement of the channel as a result of the large storm events. The channel is stable (Figure 3; Appendices 1–6).

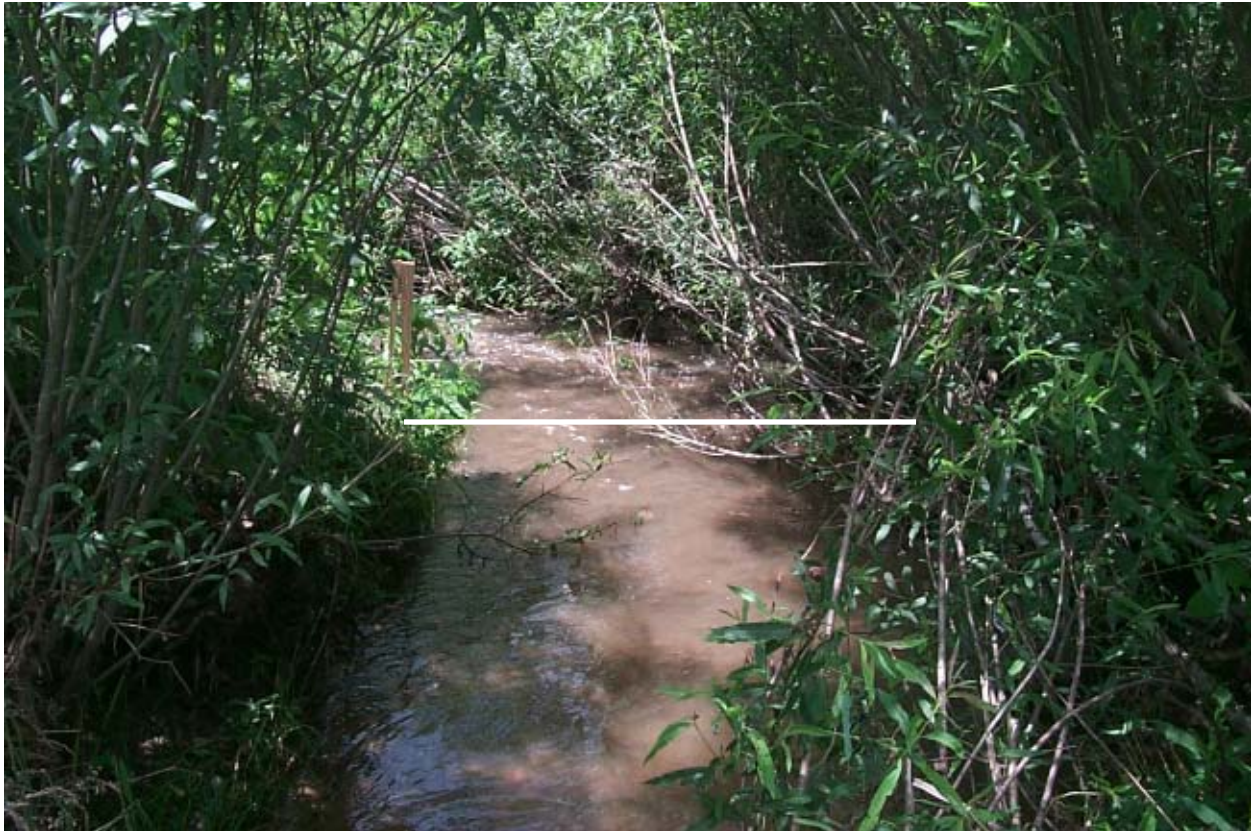
FIGURE 3.2. — Cross-section 1+94, riffle.

CROSS-SECTION 1+94 – run (Figure 3.2): Following construction this cross-section was a pool. Over the years, with the movement of substrate and location of the pool within the streambed, the cross-section has changed characteristics and is now the lower end of a run complex. The cross-section is stable with no bank erosion or lateral movement occurring.

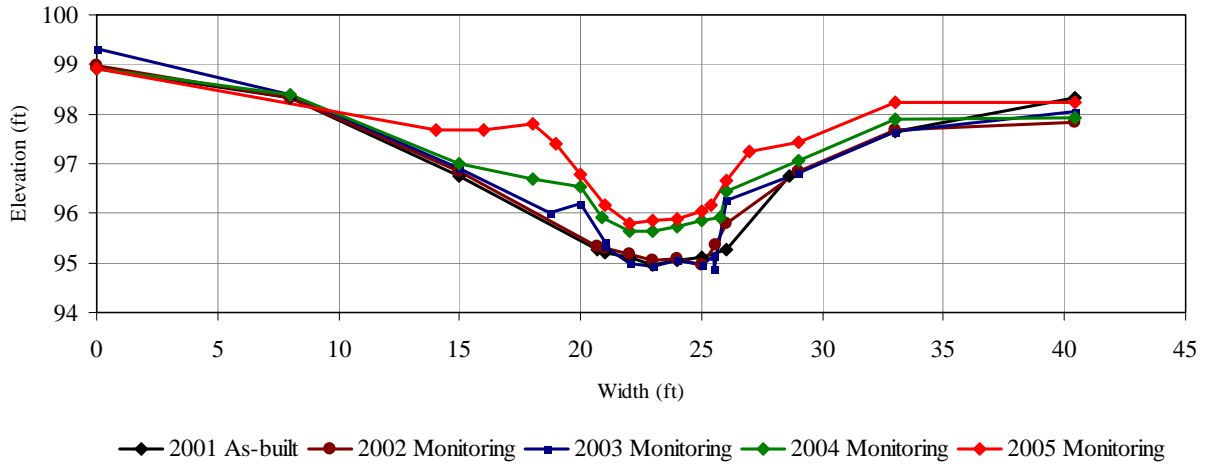
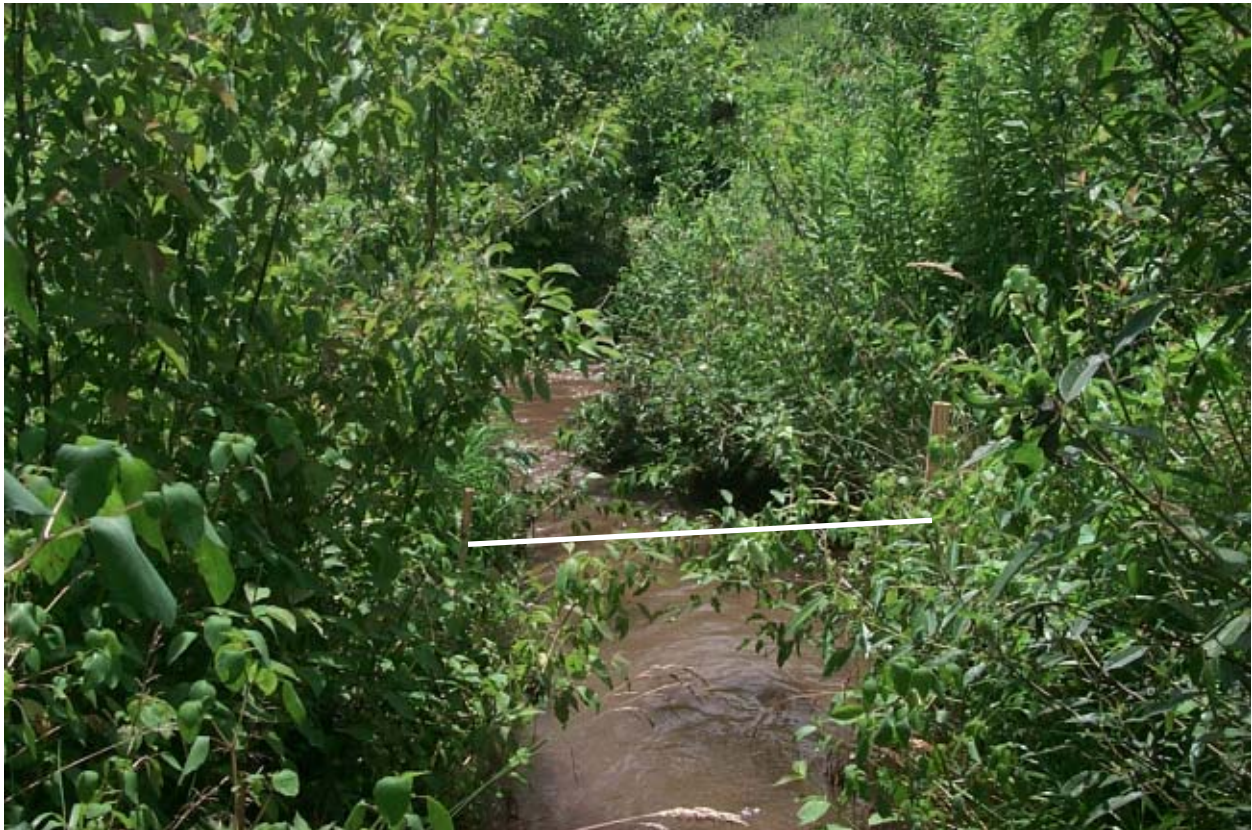
FIGURE 3.3. — Cross-section 2+24, riffle.

CROSS-SECTION 2+24 – riffle (Figure 3.3): Following construction this cross-section was a pool. Over the years, with the movement of substrate the pool has filled in and the site is a riffle. The cross-section is stable with no bank erosion or lateral movement occurring.

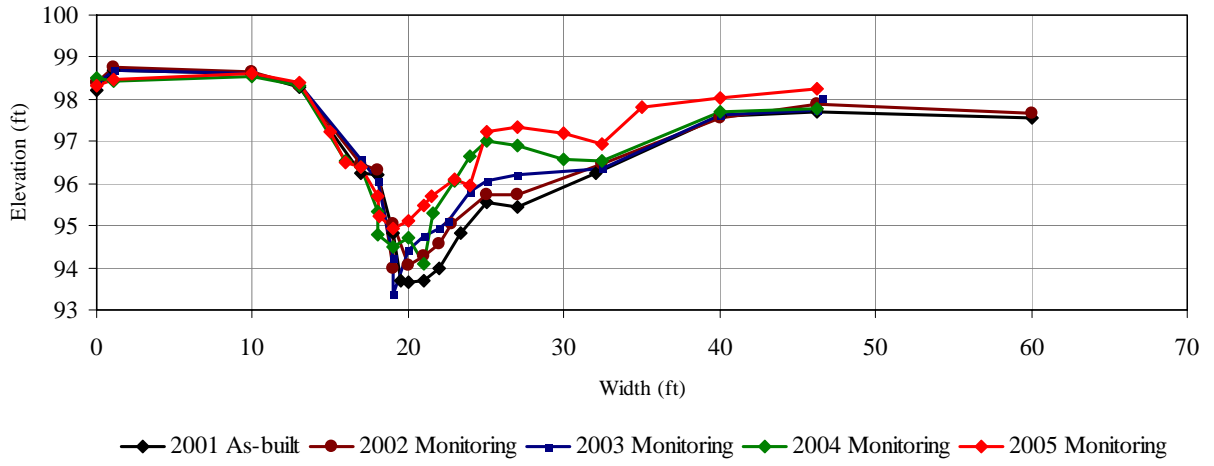
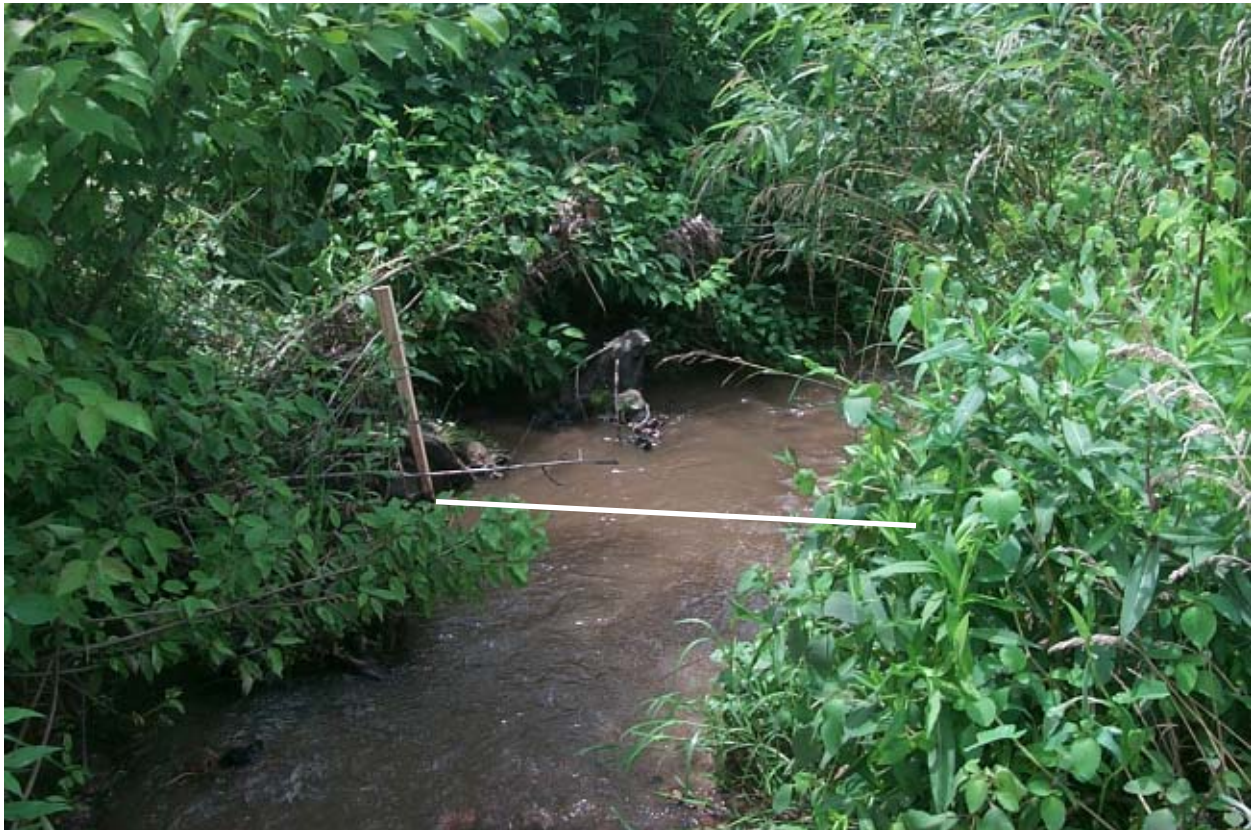
FIGURE 3.4. — Cross-section 2+45, pool.

CROSS-SECTION 2+45 – pool (Figure 3.4): This cross-section has remained a pool since construction was completed. The pool is maintained by root wads placed along the high left bank. The cross-section is stable with no bank erosion or lateral movement occurring.

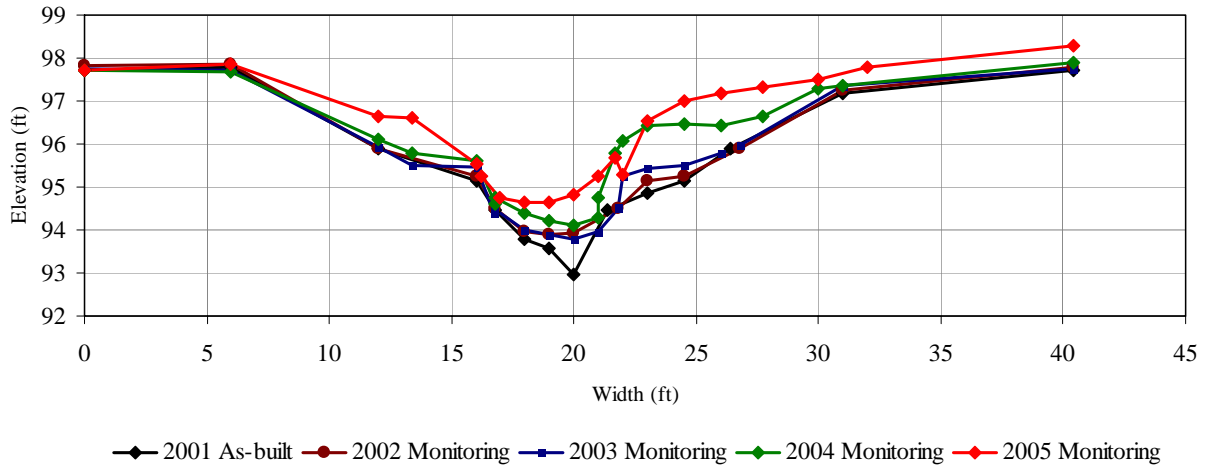
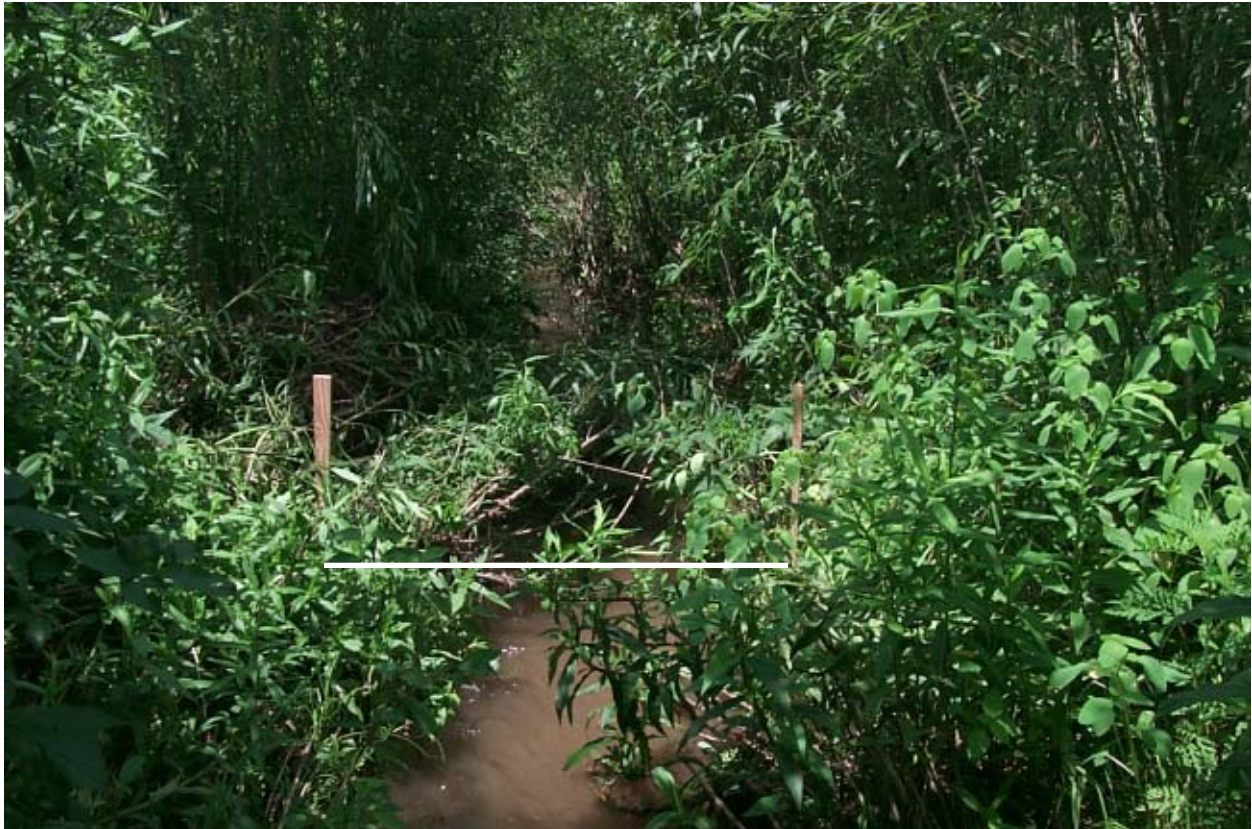
FIGURE 3.5. — Cross-section 2+79, run.

CROSS-SECTION 2+79 – run (Figure 3.5): Following construction this cross-section was considered a step-pool complex. Over time, with the movement of substrate following major storm events, it has evolved into a run complex. The cross-section is stable with no bank erosion or lateral movement occurring.

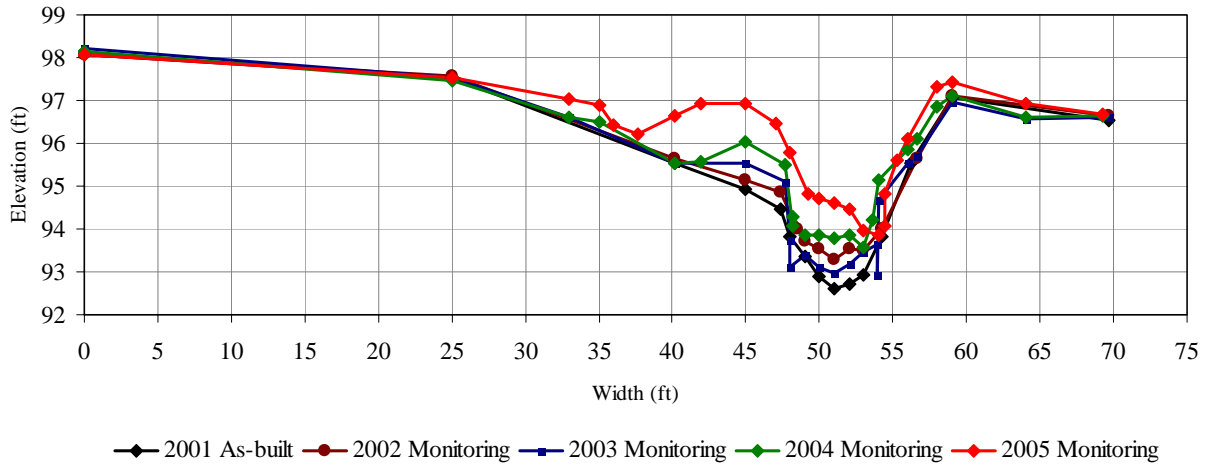
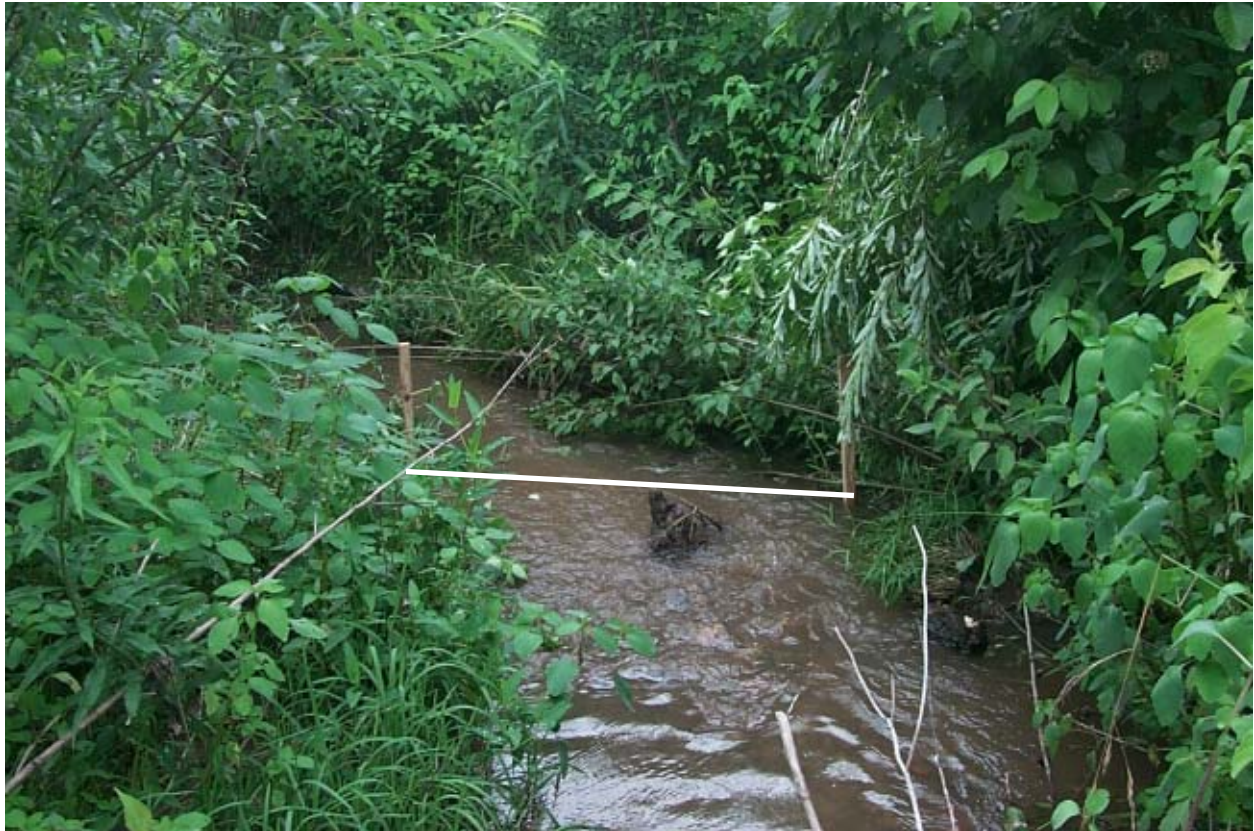
FIGURE 3.6. — Cross-section 3+16, riffle.

CROSS-SECTION 3+16 – riffle (Figure 3.6): Following construction this cross-section was located in a pool complex located below root wads. The pool has shifted upstream and the cross-section is now a riffle complex. The cross-section is stable with no bank erosion or lateral movement occurring.

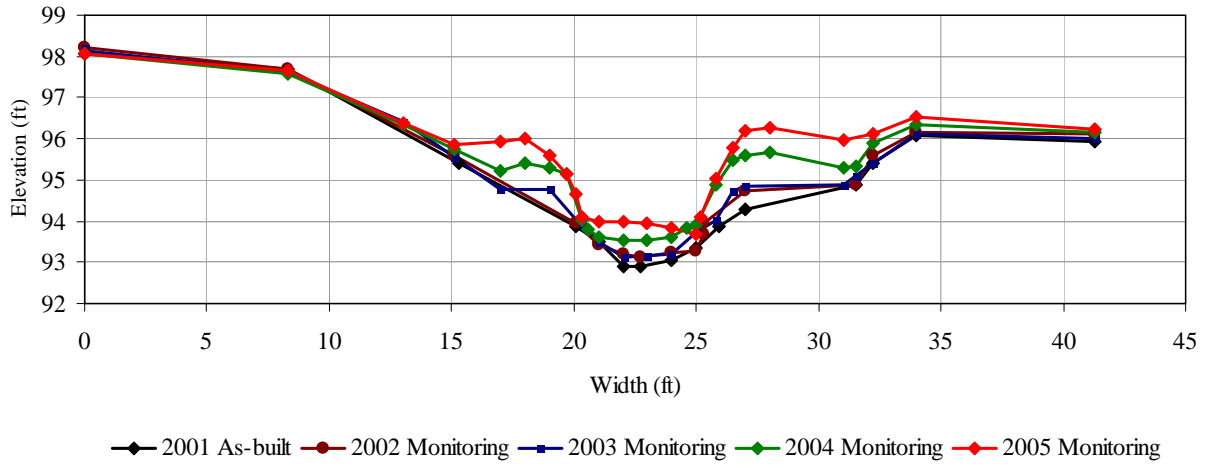
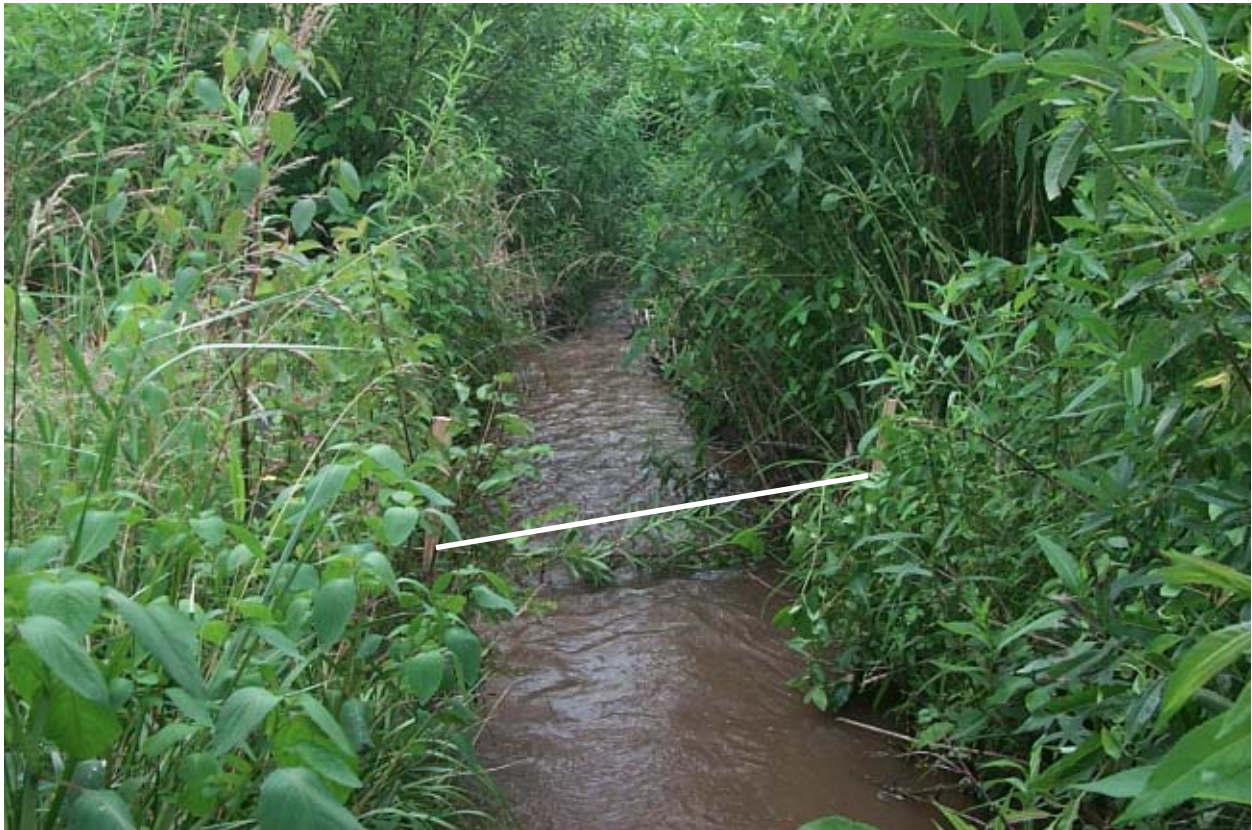
FIGURE 3.7. — Cross-section 3+76, run.

CROSS-SECTION 3+76 – run (Figure 3.7): This cross-section has remained a run complex since construction was completed. The cross-section is stable with no bank erosion or lateral movement occurring.

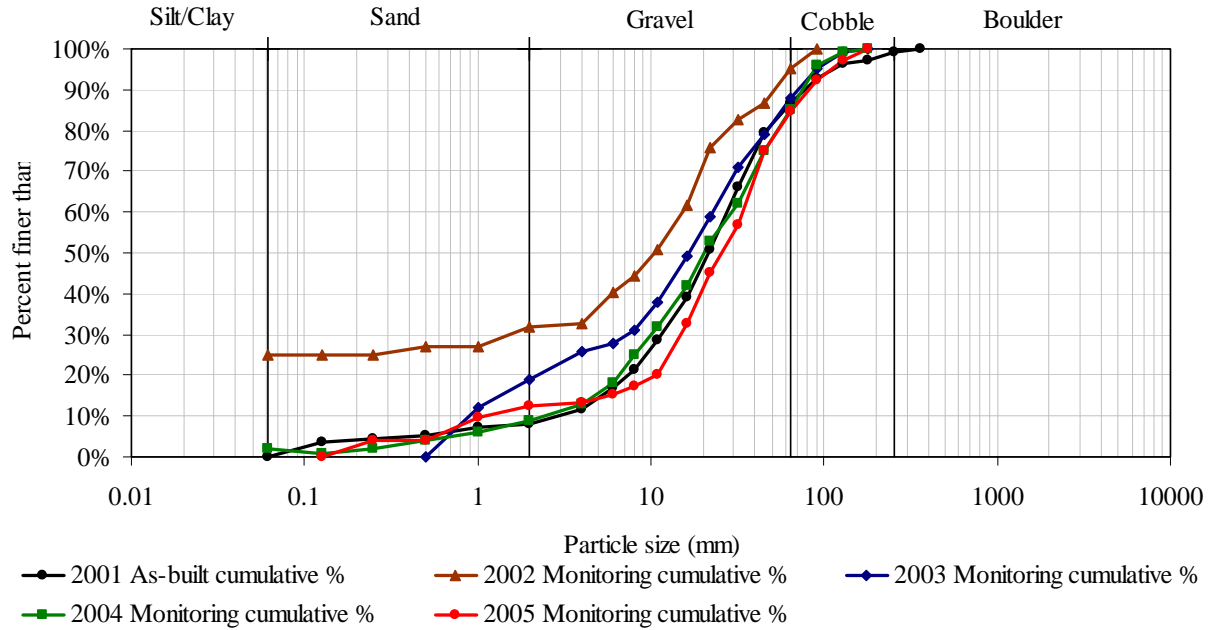
Bed material analyses (pebble counts) were conducted in the area of cross-section 2+24 (Figure 4). The D_{50} cumulative distribution particle size ranged from 11 mm (2002) – 26 mm (2005) with a mean of 19 mm. Substrate analysis remained fairly constant for all particle sizes during 2001, 2003, 2004 and 2005. However, particle sizes for all size classes were smaller in 2002 (Figure 4). The unusually small D_{16} particle size of 0.06 mm represents a large number of silt/clay particles collected in the sample. This is possibly attributed to sampling bias or an unusually heavy silt/sand load in the stream at the time of the sample.

FIGURE 4.—Pebble count comparisons, Carp mitigation site, unnamed tributary to Laxon Creek, Watauga County, 2001-2005.

Particle size (mm) in year sampled				
	2001	2002	2003	2004	2005
D 16	5.6	0.06	1.5	5.1	6.6
D 35	14.0	4.5	9.6	12.0	17.0
D 50	21.0	11.0	17.0	20.0	26.0
D 84	56.0	36.0	55.0	62.0	63.0
D 95	110.0	64.0	90.0	87.0	110.0

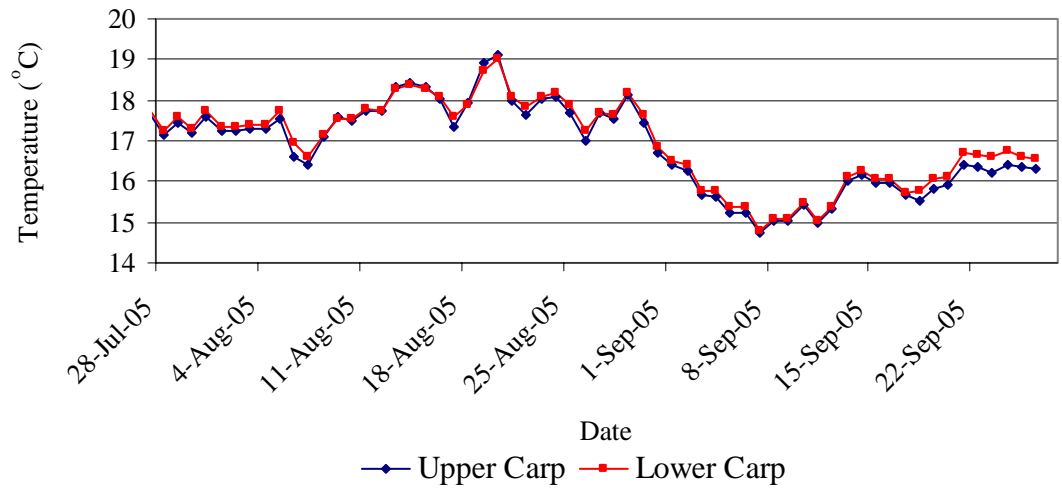
Because the unnamed tributary to Laxon Creek is classified by NCDWQ as trout water, the WRC wanted to determine if water temperatures would decrease as riparian vegetation increased to provide stream shading through the 542 ft site. Stream water temperature was recorded hourly at the upper and lower site boundaries from July 27 – September 27, 2005 (Figure 5). A comparison of temperature data collected during approximately the same time period (July 26 thru September 27) in 2001, 2002, and 2003 (Mickey and Hining 2004) revealed little change in temperatures over time. The average daily water temperatures at the upper station were 16.4°C,

17.2°C, 15.4°C, and 16.9°C in 2001, 2002, 2003, and 2005, whereas at the lower station water temperatures were 16.6°C, 17.6°C, 16.8°C, and 17.0°C in 2001, 2002, 2003, and 2005. It was hoped that from 2001 to 2005, as the density of the riparian vegetation improved, that the average daily water temperature would be cooler at the lower end than at the upper end of the project. Data shows that the upper and lower daily average water temperatures were nearly identical. During the course of the temperature studies, the differences between the upper and lower site temperatures ranged from a plus 0.1 to 0.4°C. In 2005 the temperature average daily temperature difference was a plus 0.1°C at the lower end of the site. The riparian vegetation has matured enough to provide adequate stream shading. Therefore, it is assumed that the study reach is too short (542 ft) to allow for adequate water cooling to occur.

FIGURE 5.—Comparisons of daily average water temperatures at the upper and lower boundaries of the Carp mitigation site from July 27 – September 27, 2005, unnamed tributary to Laxon Creek, Watauga County.

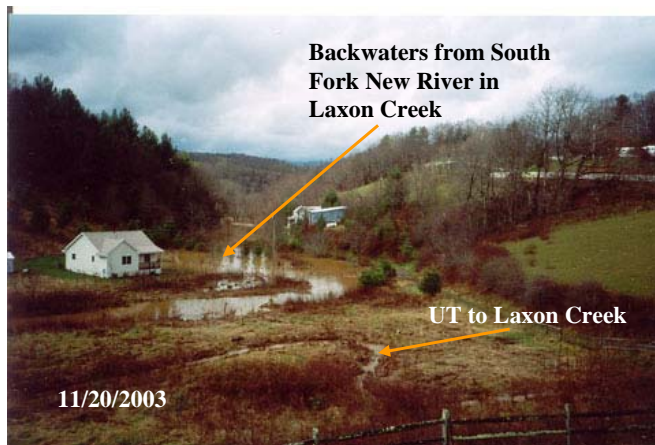
Appendix 1: — Carp and Racey sites before, during, and after the November 19, 2003 flood, Watauga County. The unnamed tributary (UT) to Laxon Creek (0.7 mi²) suffered no damage while Laxon Creek (drainage area 2.65 mi²) had some minor bank erosion and one cross-weir needed repair.

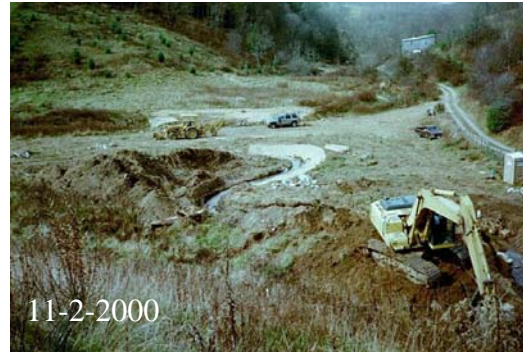
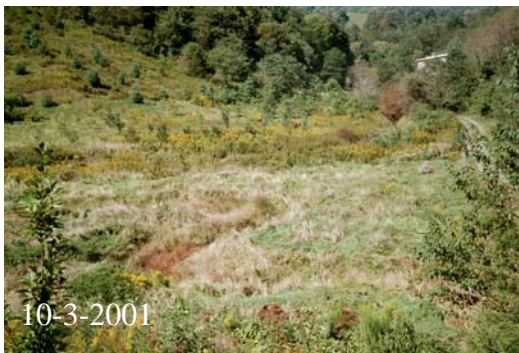
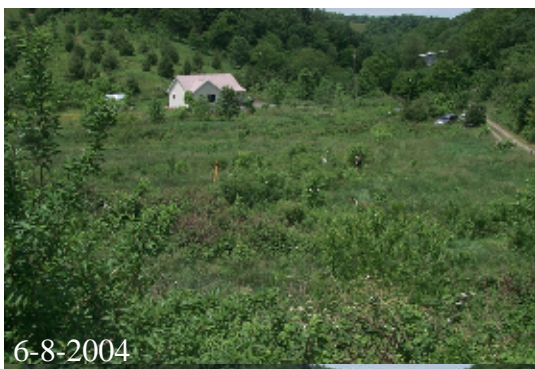
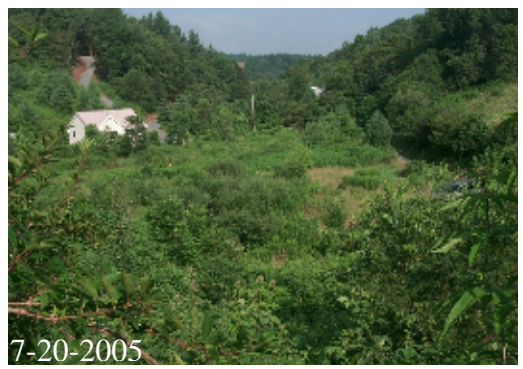
Since construction was completed on November 3, 2000, all disturbed banks have become well vegetated (Appendices 1, 2, and 3). A total of 533 stems (live stakes and rooted plants) were planted in the 0.67 acre conservation easement over a period of three years, 2001, 2002, and 2003 (Table 2). A total of 303 stems were counted in 2004 for a 57% survival rate whereas 260 stems were counted in 2005 for a 49% survival rate (Table 2). The higher stem count in 2004 is attributed to the count being conducted in winter when stems are easier to find. Also, the high survival of stems at this site is attributed to the landowner's efforts to protect newly planted stems from rodents and competing vegetation. The density of stems counted in 2005 is well above the 174 stems/acre required for woody species planted at mitigation sites through year five (USACE 2003). Vegetation has been the key factor in maintaining bank integrity and sinuosity.

Appendix 2. — Overview of Carp restored stream mitigation site, unnamed tributary to Laxon Creek, Ashe County, October 30, 2000 – July 20, 2005.

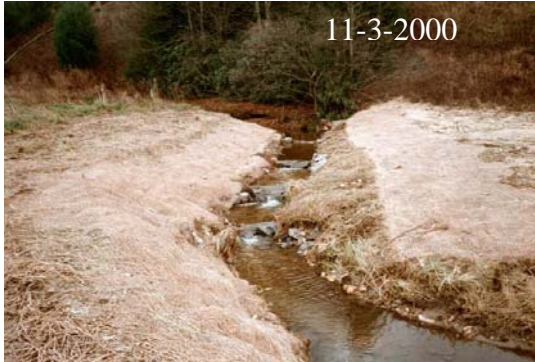
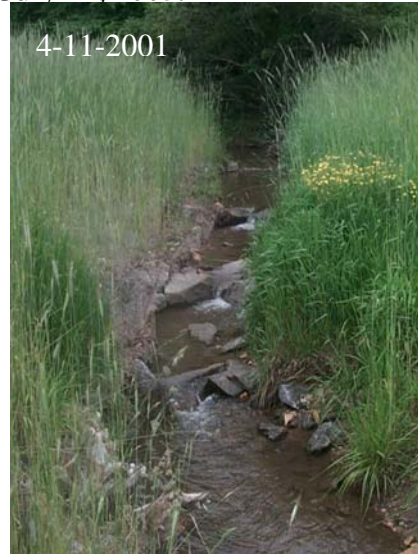
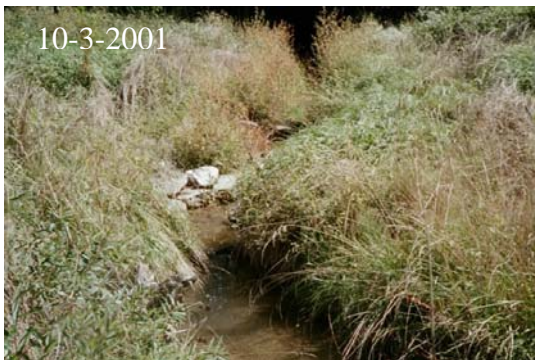
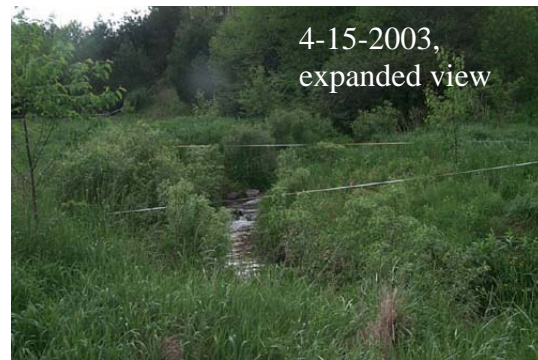
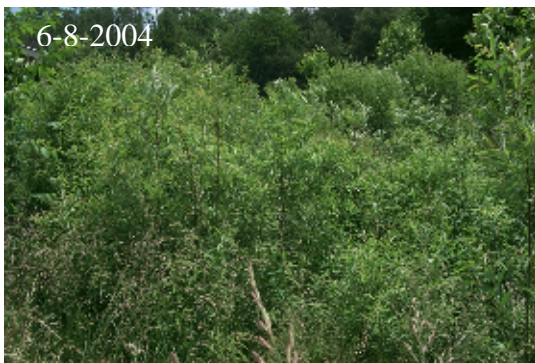
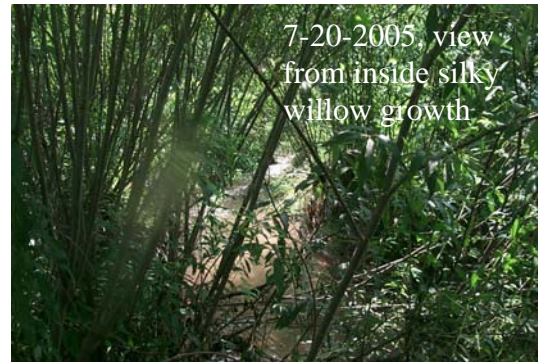
Appendix 3. — Photographic log of Carp Priority I stream mitigation site, unnamed tributary to Laxon Creek, Ashe County, looking upstream from station 1+82 to 1+32, November 3, 2000 – July 21, 2005.

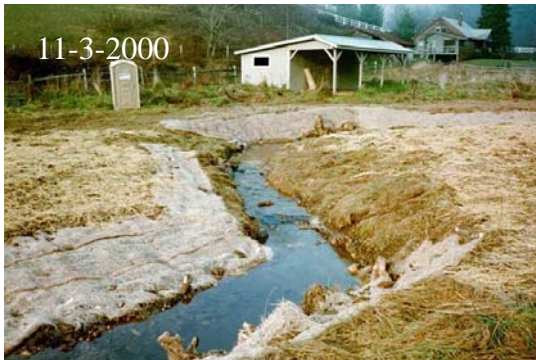
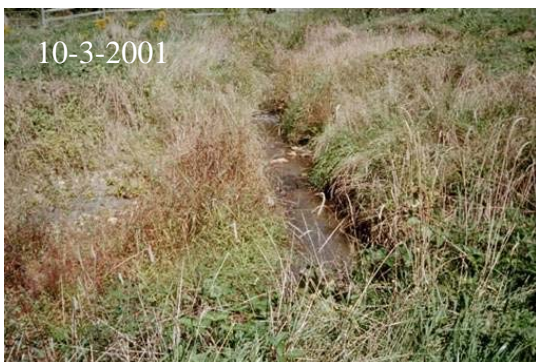
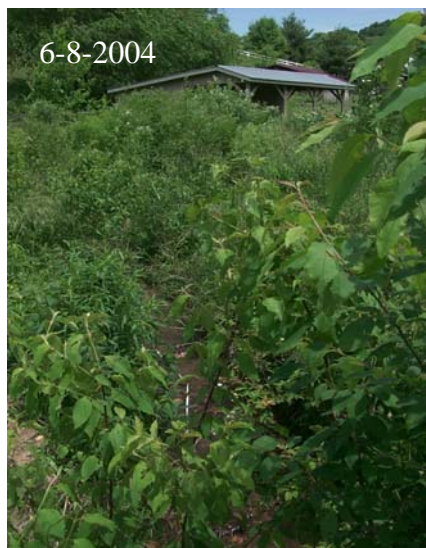
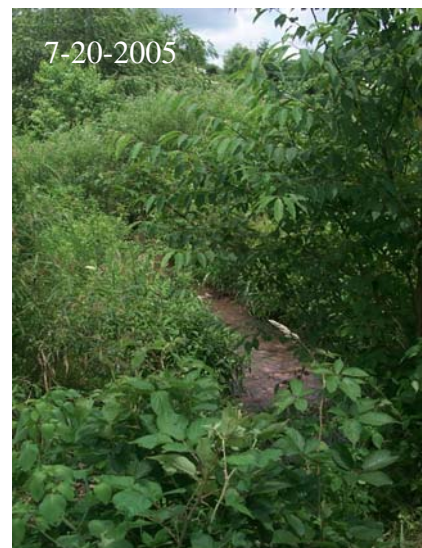
Appendix 4. — Photographic log of Carp restored stream mitigation site, unnamed tributary to Laxon Creek, Ashe County, looking upstream from station 2+45 to 1+94, November 3, 2000 – July 21, 2005.

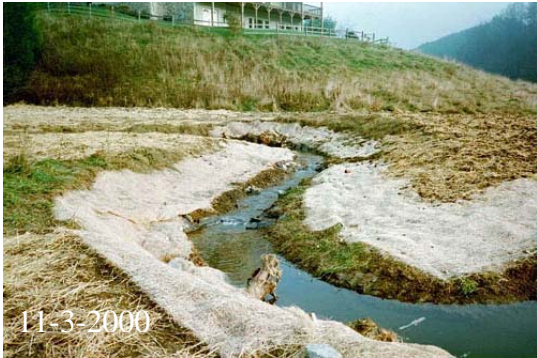
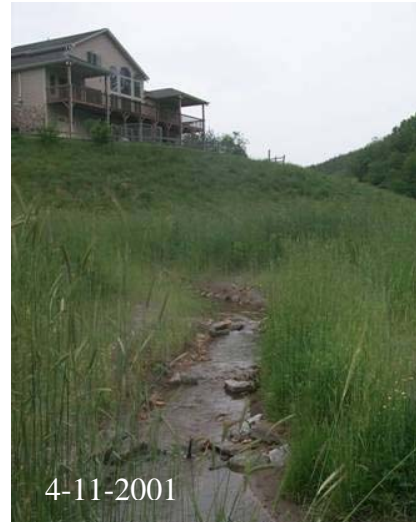
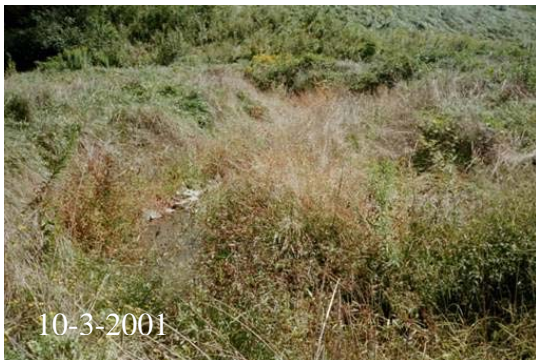
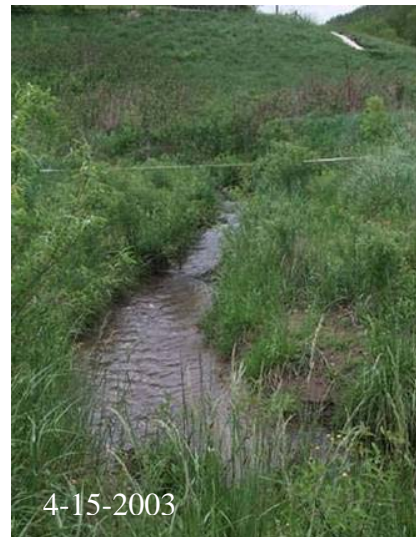
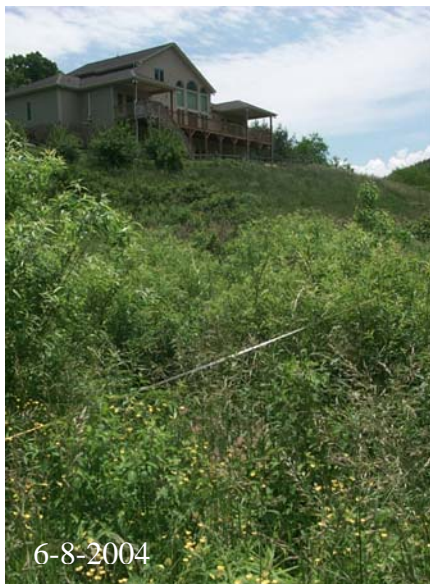
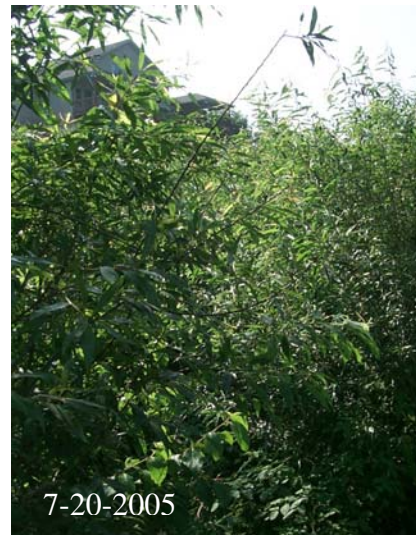
Appendix 5. — Photographic log of Carp restored stream mitigation site, unnamed tributary to Laxon Creek, Ashe County, looking upstream from station 3+16 to 2+45, November 3, 2000 – July 21, 2005.

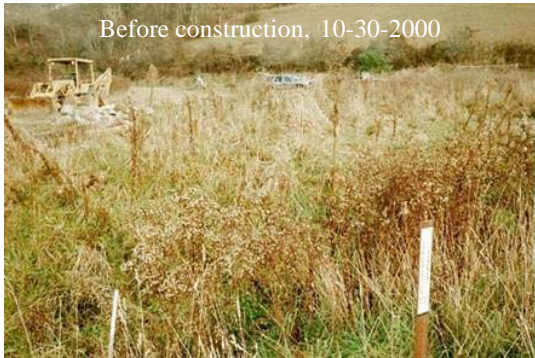
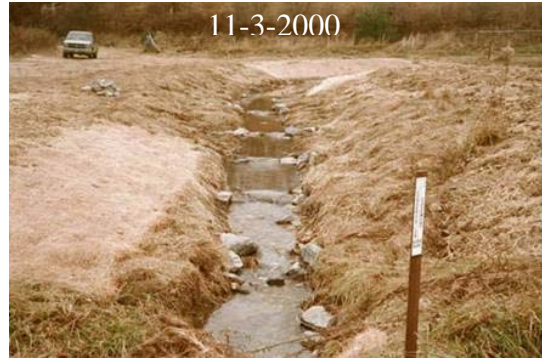
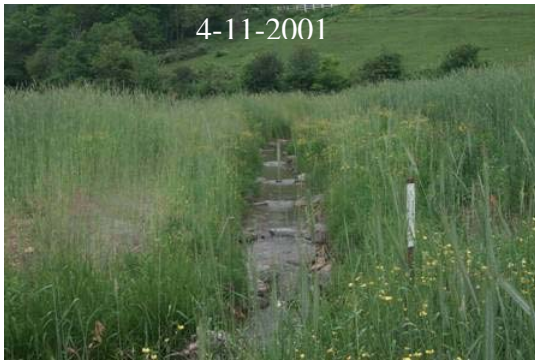
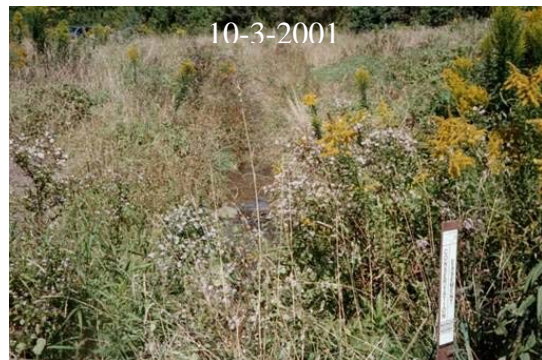
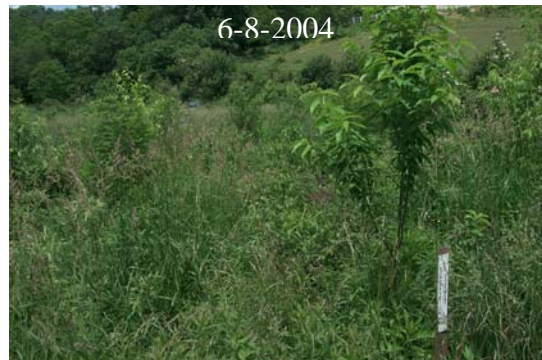
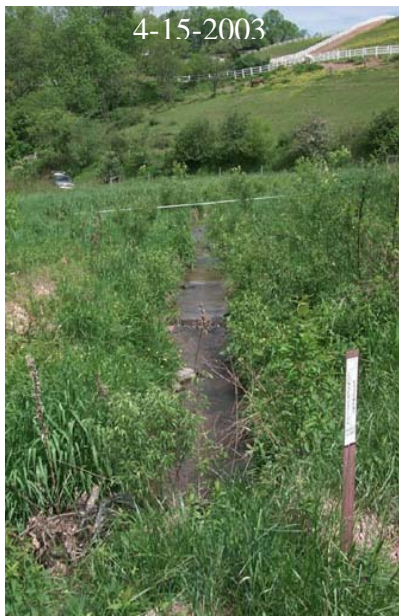
Appendix 6. — Photographic log of Carp restored stream mitigation site, unnamed tributary to Laxon Creek, Ashe County, looking upstream from station 4+30 to 3+16, October 30, 2000 – July 21, 2005.
