# MITIGATION PLAN

## Final Report for DMS

### CASEY CREEK MITIGATION SITE

Wayne County, NC

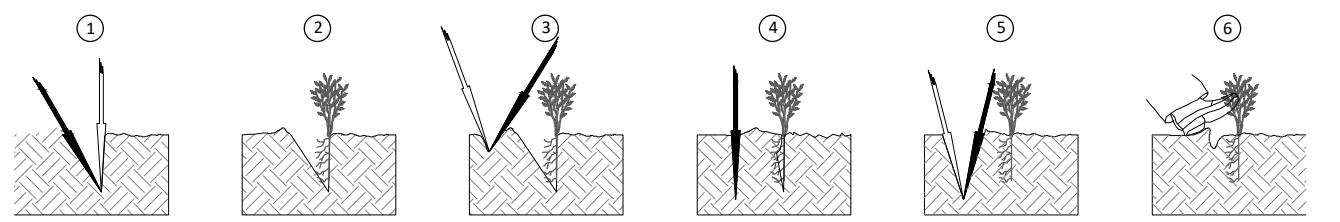
1. INSERT THE DIBBLE, OR SHOVEL, STRAIGHT DOWN INTO THE SOIL TO THE FULL DEPTH OF THE BLADE AND PULL BACK ON THE HANDLE TO OPEN THE PLANTING HOLE. (DO NOT ROCK THE SHOVEL BACK AND FORTH AS THIS CAUSES SOIL IN THE PLANTING HOLE TO BE COMPACTED, INHIBITING ROOT GROWTH.)

2. REMOVE THE DIBBLE, OR SHOVEL, AND PUSH THE SEEDLING ROOTS DEEP INTO THE PLANTING HOLE. PULL THE SEEDLING BACK UP TO THE CORRECT PLANTING DEPTH (THE ROOT COLLAR SHOULD BE 1 TO 3 INCHES BELOW THE SOIL SURFACE). GENTLY SHAKE THE SEEDLING TO ALLOW THE ROOTS TO STRAIGHTEN OUT. DO NOT TWIST OR SPIN THE SEEDLING OR LEAVE THE ROOTS J-ROOTED.

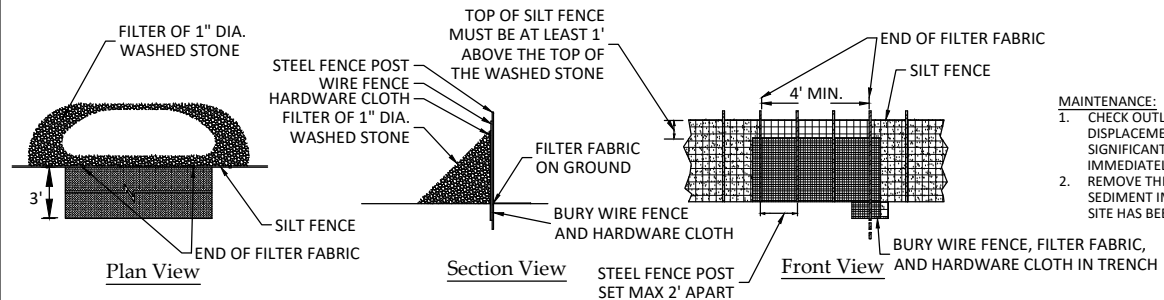
2  
5.4 Temporary Silt Fence  
Not to Scale

1. USE WIRE A MINIMUM OF 32" IN WIDTH AND WITH A MINIMUM OF 6 LINES OF WIRES WITH 12" STAY SPACING.
2. USE FILTER FABRIC A MINIMUM OF 36" IN WIDTH AND FASTEN ADEQUATELY TO THE WIRES AS DIRECTED BY THE ENGINEER.
3. PROVIDE 5' STEEL POST OF THE SELF-FASTENER ANGLE STEEL TYPE. ANGLE STEEL TYPE.
4. INSPECT AFTER EACH RAIN EVENT AND MAINTAIN ACCORDING TO NCDEQ DESIGN MANUAL.
  - 4.1. SHOULD FABRIC COLLAPSE, TEAR, DECOMPOSE, OR BECOME INEFFECTIVE, REPLACE IMMEDIATELY. REMOVE SEDIMENT DEPOSITS AS NECESSARY TO PROVIDE ADEQUATE STORAGE VOLUME FOR THE NEXT RAIN AND TO REDUCE PRESSURE ON THE FENCE. TAKE CARE TO AVOID UNDERMINING THE FENCE DURING CLEAN OUT.
  - 4.2. REMOVE ALL FENCING MATERIALS AND UNSTABLE SEDIMENT DEPOSITS AND BRING TO GRADE AND STABILIZE IT AFTER THE CONTRIBUTING DRAINAGE AREA HAS BEEN PROPERLY STABILIZED.

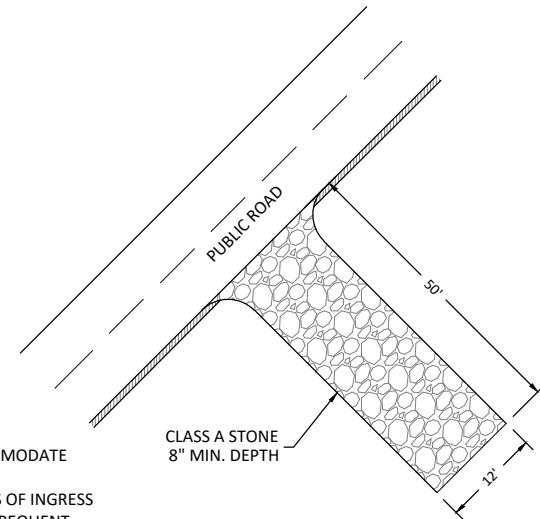
**1**  
5.5 Construction Entrance  
Not to Scale

- NOTES:**
1. PROVIDE TURNING RADIUS SUFFICIENT TO ACCOMMODATE LARGE TRUCKS.
  5. LOCATE CONSTRUCTION ENTRANCE AT ALL POINTS OF INGRESS AND EGRESS UNTIL SITE IS STABILIZED. PROVIDE FREQUENT CHECKS OF THE DEVICE AND TIMELY MAINTENANCE.

6. MUST BE MAINTAINED IN A CONDITION WHICH WILL PREVENT TRACKING OR DIRECT FLOW OF MUD ONTO STREETS. PERIODIC TOP DRESSING WITH STONE WILL BE NECESSARY.

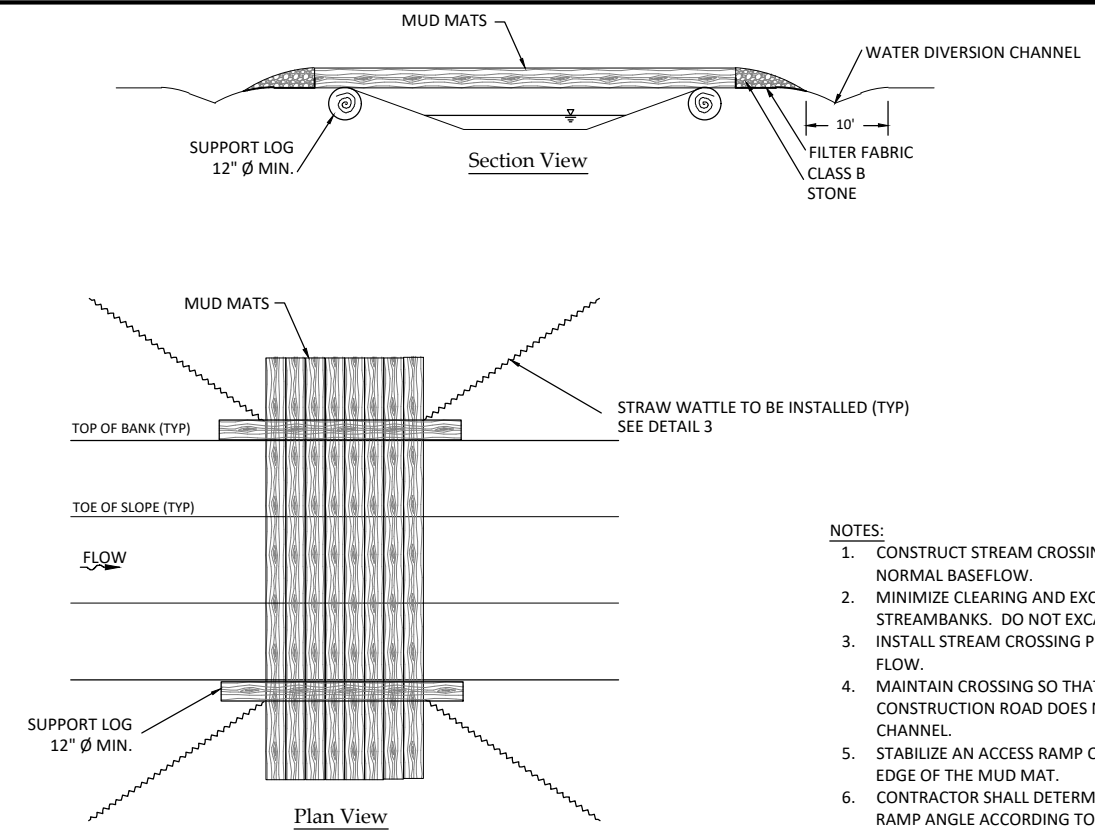
**2**  
5.5 Temporary Stream Crossing - Timber Mat  
Not to Scale

- NOTES:**
1. CONSTRUCT STREAM CROSSING WHEN FLOW IS AT NORMAL BASEFLOW.
  2. MINIMIZE CLEARING AND EXCAVATION OF STREAMBANKS. DO NOT EXCAVATE CHANNEL BOTTOM.
  3. INSTALL STREAM CROSSING PERPENDICULAR TO THE FLOW.
  4. MAINTAIN CROSSING SO THAT RUNOFF IN THE CONSTRUCTION ROAD DOES NOT ENTER EXISTING CHANNEL.
  5. STABILIZE AN ACCESS RAMP OF CLASS B STONE TO THE EDGE OF THE MUD MAT.
  6. CONTRACTOR SHALL DETERMINE AN APPROPRIATE RAMP ANGLE ACCORDING TO EQUIPMENT UTILIZED.
  7. CROSSINGS SHOULD BE MONITORED TO ASSURE CORRECT FUNCTIONING OF MATS, LOOKING FOR ANY DEFECTS OR STRUCTURAL PROBLEMS.
  8. CROSSINGS COVERED IN SOIL OR DEBRIS SHOULD BE CLEANED AND THE MATERIALS REMOVED AND DISPOSED OF IN A STABLE LOCATION.

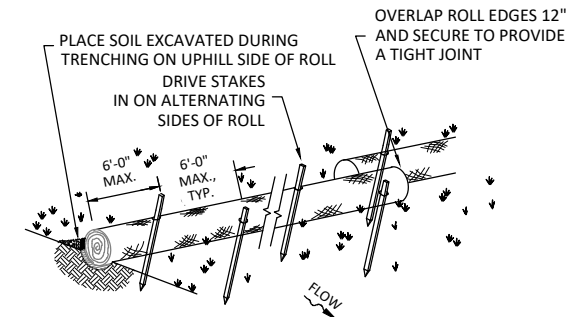
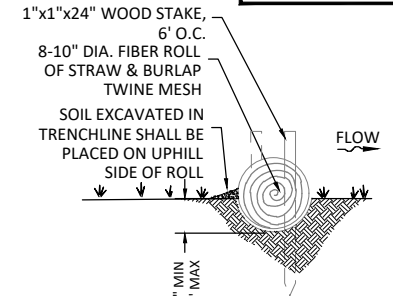
**3**  
5.5 Straw Wattle  
Not to Scale

- NOTES:**
1. INSTALL FIBER ROLL ALONG CONTOUR. RUNOFF MUST NOT BE ALLOWED TO RUN UNDER OR AROUND ROLL.
  2. INSPECT STRAW WATTLES ON A REGULAR BASIS AND AFTER EACH RAINFALL EVENT.
  3. WATTLES SHOULD BE MAINTAINED TO ALLOW THE WATER TO FLOW THROUGH, REDUCE VELOCITY AND ALLOW SEDIMENTATION TO OCCUR.
  4. WATTLES SHOULD BE REPLACED IF FIBER BECOMES TOO SATURATED.
  5. STAKES SHOULD BE USED TO ANCHOR THE STRAW WATTLE TO THE GROUND TO PREVENT SCOURING AND WASHOUT.
