Baseline Monitoring Document and As-built Baseline Report

Cat Creek Stream and Wetland Restoration Macon County, NC

**SCO Project Number 050657901
EEP Project Number 71**

**Construction Completed: May 2010
Data Collection: June 2010
Submitted March: 2011**

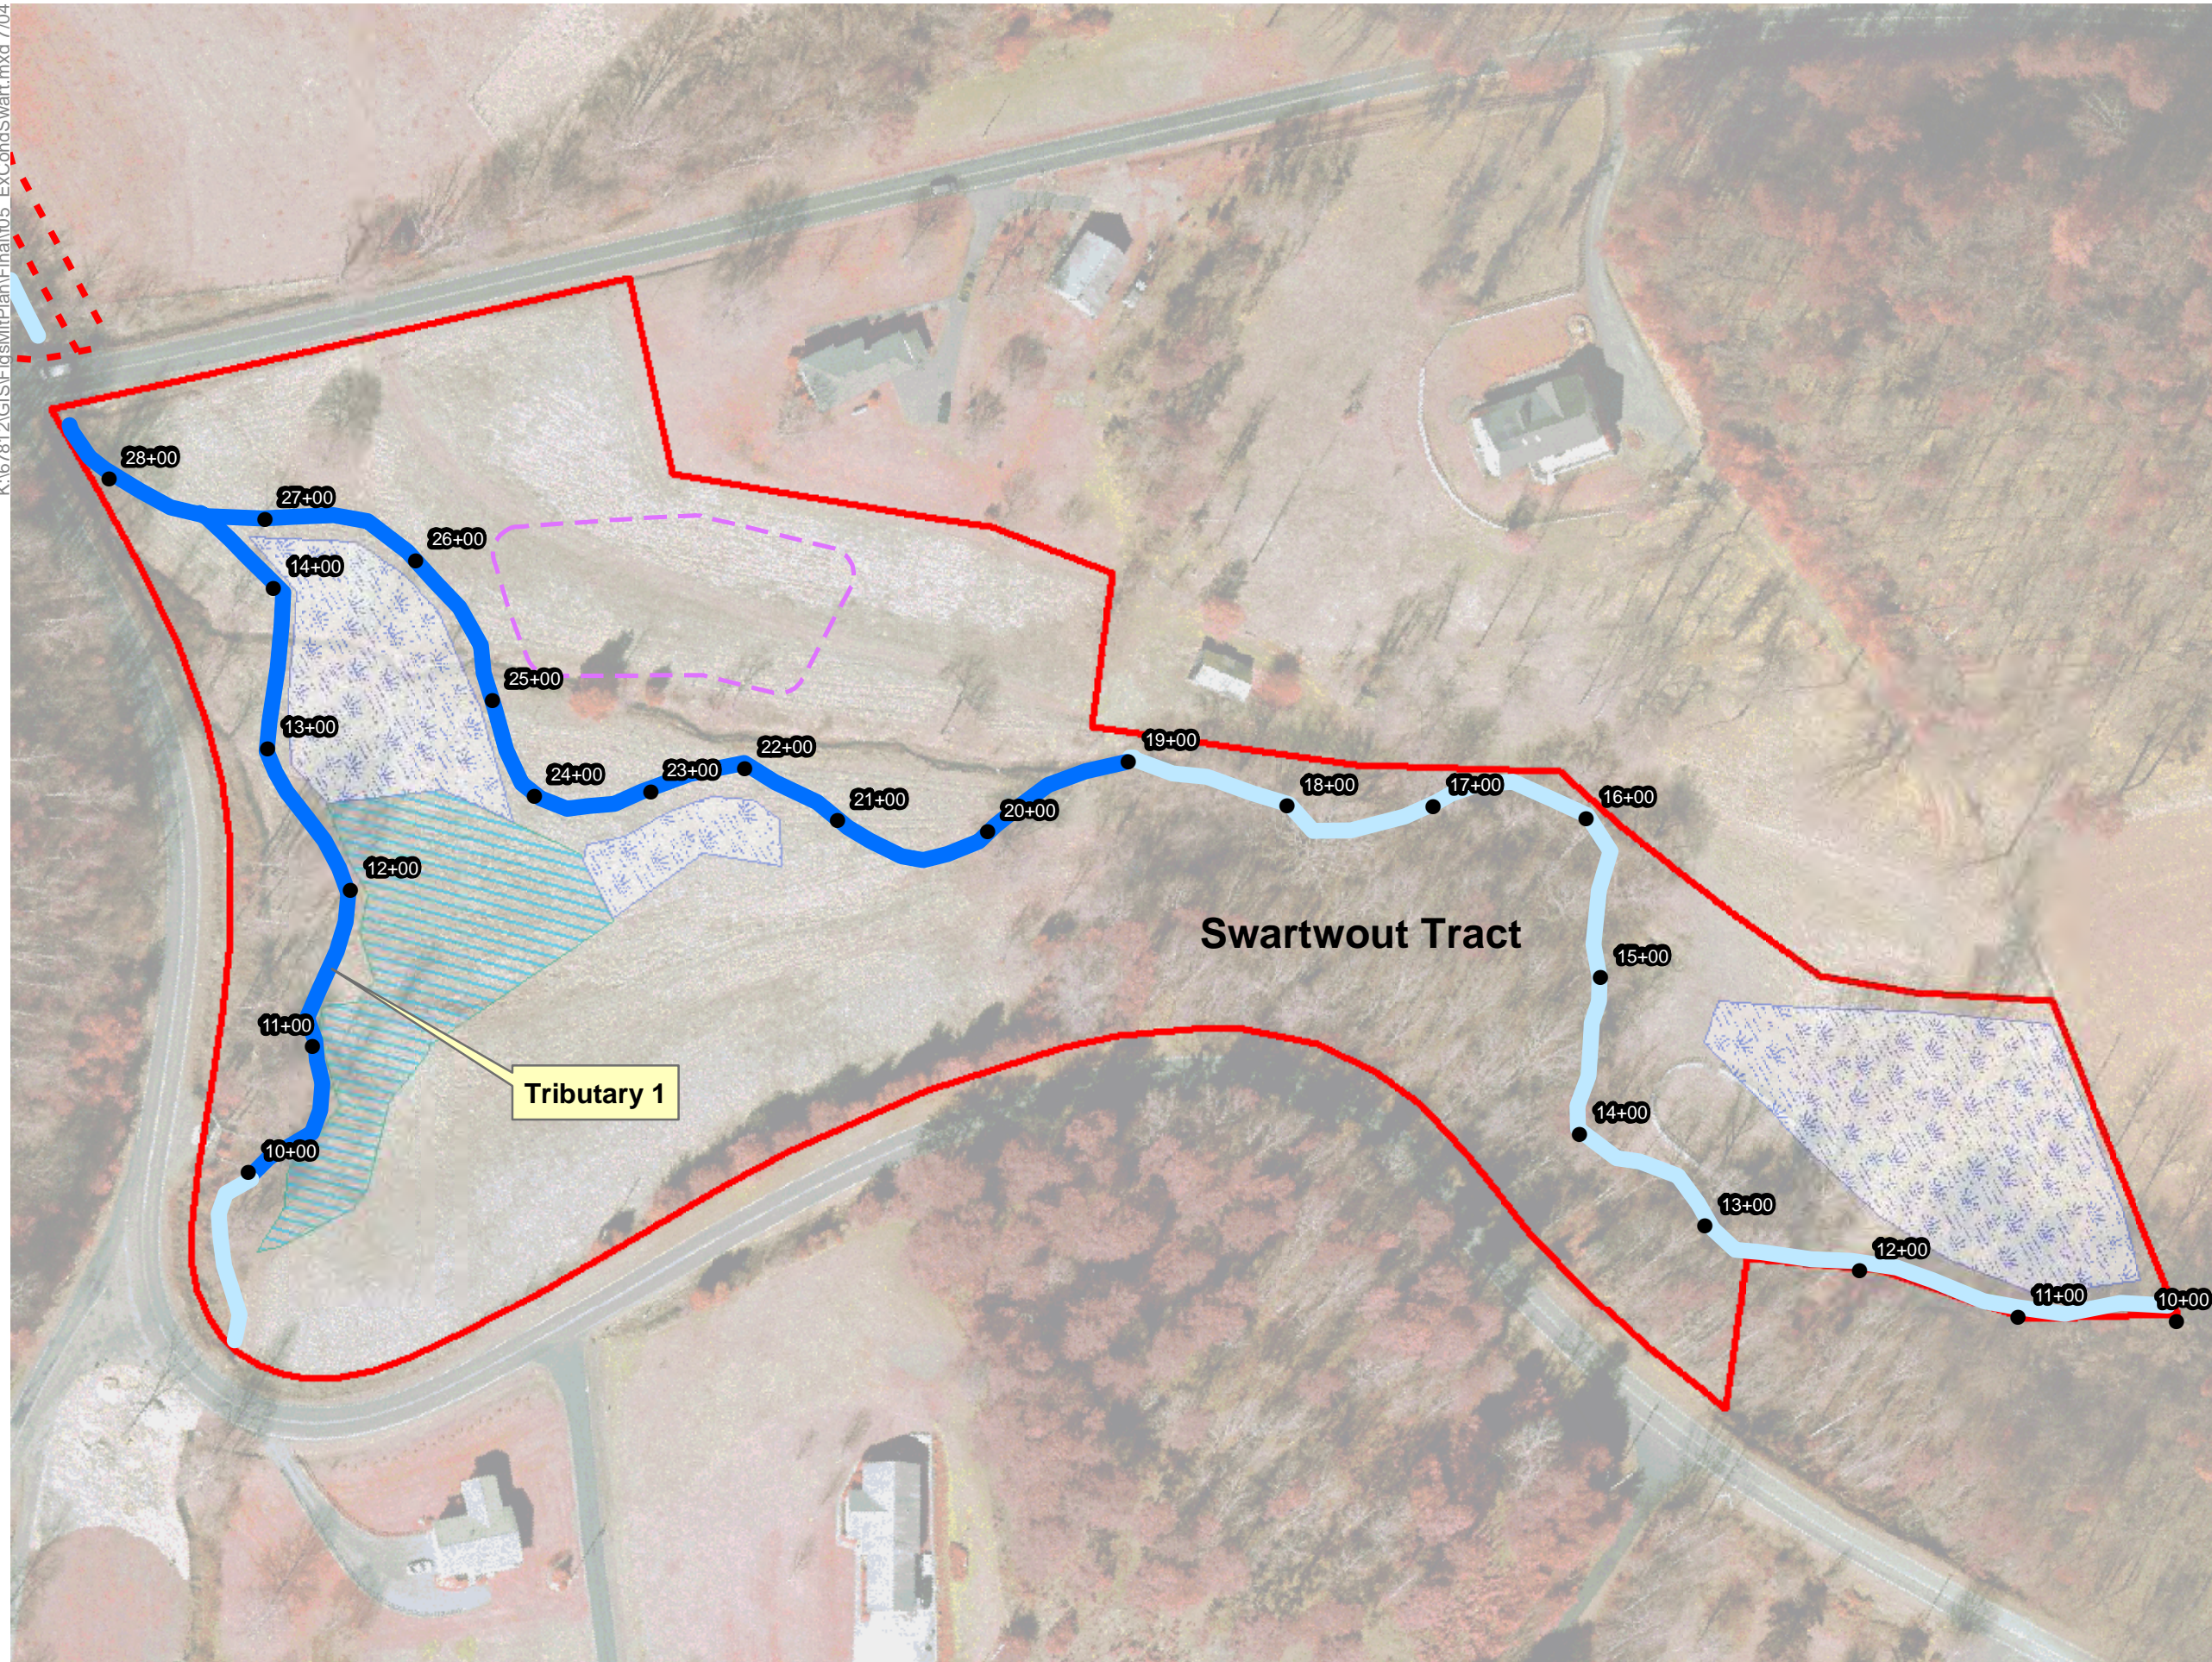
Figure 2
CAT CREEK ASSETS

The following table presents the restoration/enhancement activity by tract and by reach. **Figure 2** in **Appendix A** shows the location of each activity.
