Year 1 Monitoring Report
Cat Creek Stream and Wetland Restoration
Macon County, NC

SCO Project Number 050657901
EEP Project Number 71

Construction Completed: May 2010
Data Collection: December 2010
Submitted March: 2011

Year 1 Monitoring Report

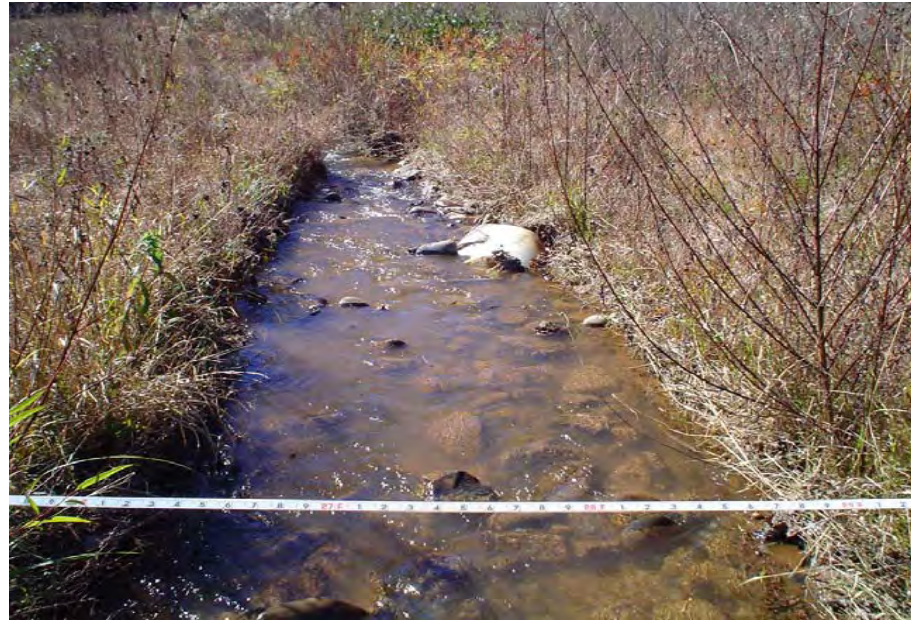
Photo: Sta. 21+40 looking downstream stream

Bankfull Elevation	2019.48
Bankfull Width (ft)	11.97
Floodprone Width (ft)	45
Bankfull Mean Depth (ft)	0.64
Bankfull Max Depth (ft)	1.16
Bankfull Cross Sectional Area (ft ²)	7.64
Bankfull Width/Depth Ratio	18.7
Bankfull Entrenchment Ratio	3.76

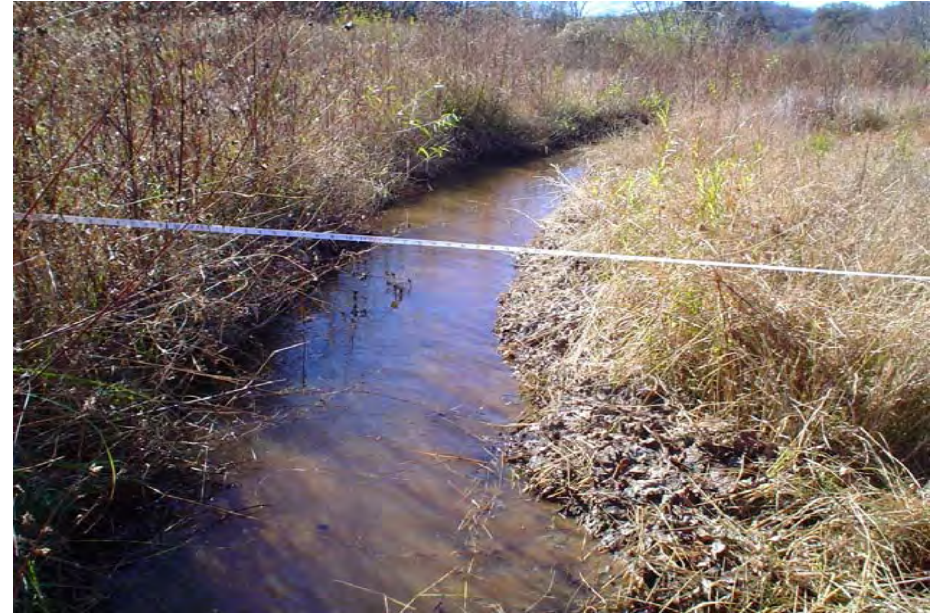
Photo: Sta. 24+00 looking downstream

Bankfull Elevation	2106.77
Bankfull Width (ft)	22.01
Floodprone Width (ft)	60
Bankfull Mean Depth (ft)	0.77
Bankfull Max Depth (ft)	2.73
Bankfull Cross Sectional Area (ft ²)	16.88
Bankfull Width/Depth Ratio	28.58
Bankfull Entrenchment Ratio	2.73

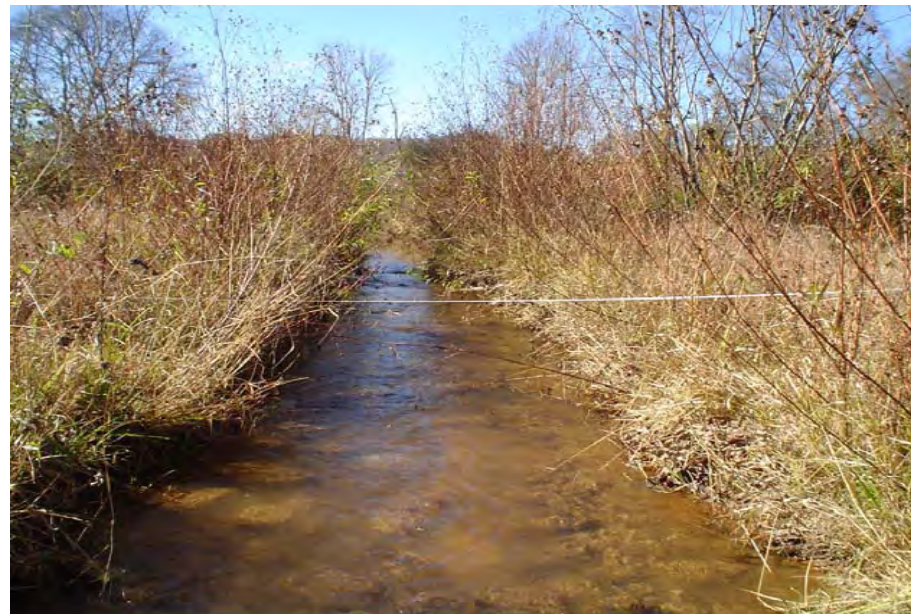
Photo: Sta. 25+00 looking downstream

Bankfull Elevation	2107.61
Bankfull Width (ft)	13.26
Floodprone Width (ft)	45
Bankfull Mean Depth (ft)	0.9
Bankfull Max Depth (ft)	1.5
Bankfull Cross Sectional Area (ft ²)	12.02
Bankfull Width/Depth Ratio	14.77
Bankfull Entrenchment Ratio	3.39

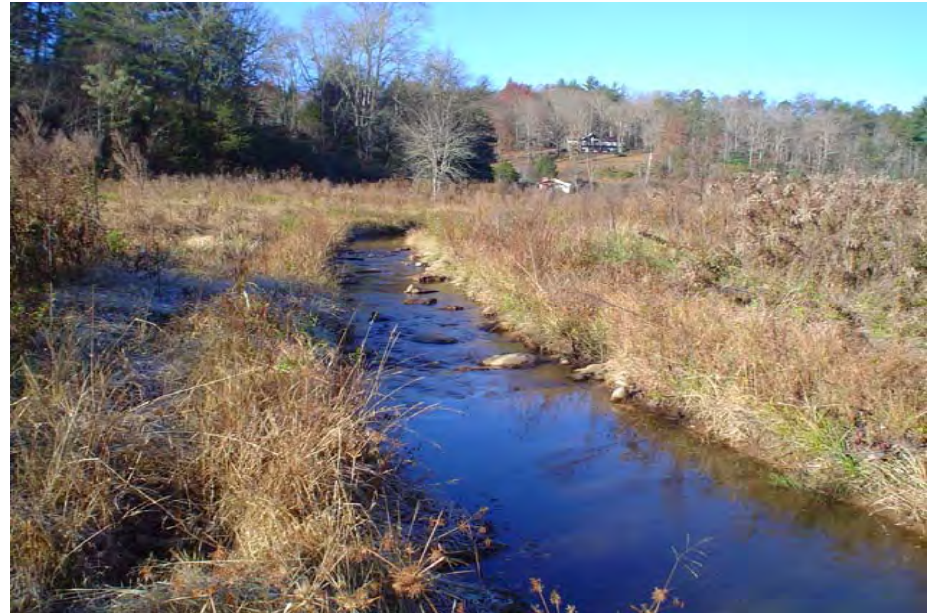
Photo: Sta. 36+50 looking downstream

Bankfull Elevation	2075.02
Bankfull Width (ft)	25.96
Floodprone Width (ft)	80
Bankfull Mean Depth (ft)	1.09
Bankfull Max Depth (ft)	2.54
Bankfull Cross Sectional Area (ft ²)	28.18
Bankfull Width/Depth Ratio	23.82
Bankfull Entrenchment Ratio	3.08

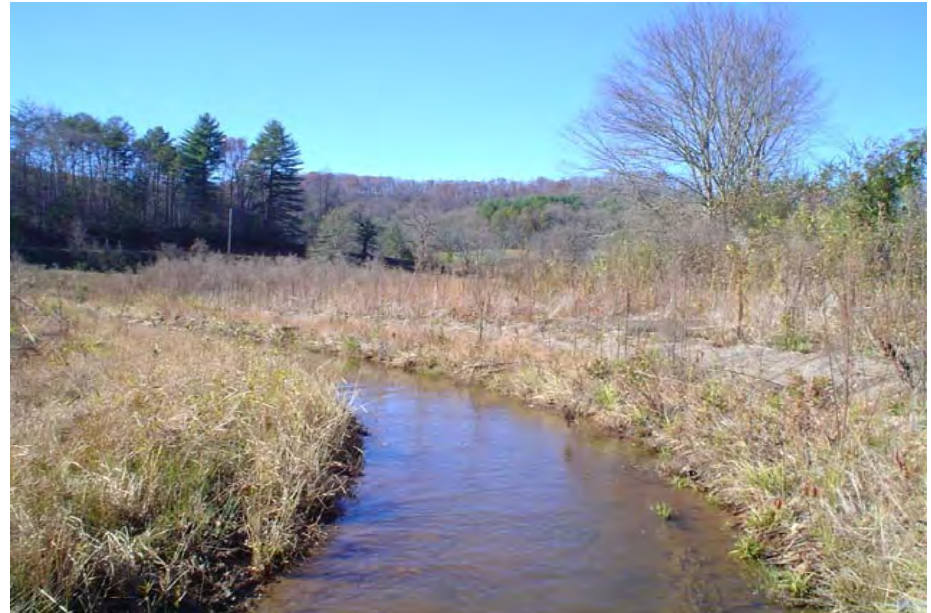
Photo: Sta. 40+70 looking downstream

Bankfull Elevation	2073.14
Bankfull Width (ft)	28.6
Floodprone Width (ft)	160
Bankfull Mean Depth (ft)	1.68
Bankfull Max Depth (ft)	3.29
Bankfull Cross Sectional Area (ft ²)	47.96
Bankfull Width/Depth Ratio	17.02
Bankfull Entrenchment Ratio	5.59

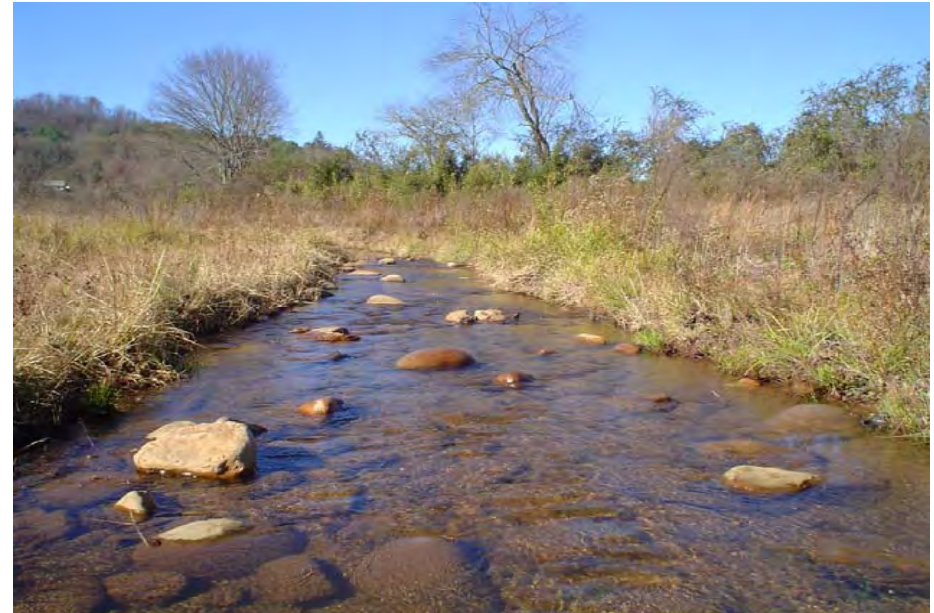
Photo: Sta. 40+70 looking downstream

Bankfull Elevation	2071.6
Bankfull Width (ft)	23.96
Floodprone Width (ft)	270
Bankfull Mean Depth (ft)	1.45
Bankfull Max Depth (ft)	2.69
Bankfull Cross Sectional Area (ft ²)	34.82
Bankfull Width/Depth Ratio	16.52
Bankfull Entrenchment Ratio	11.27

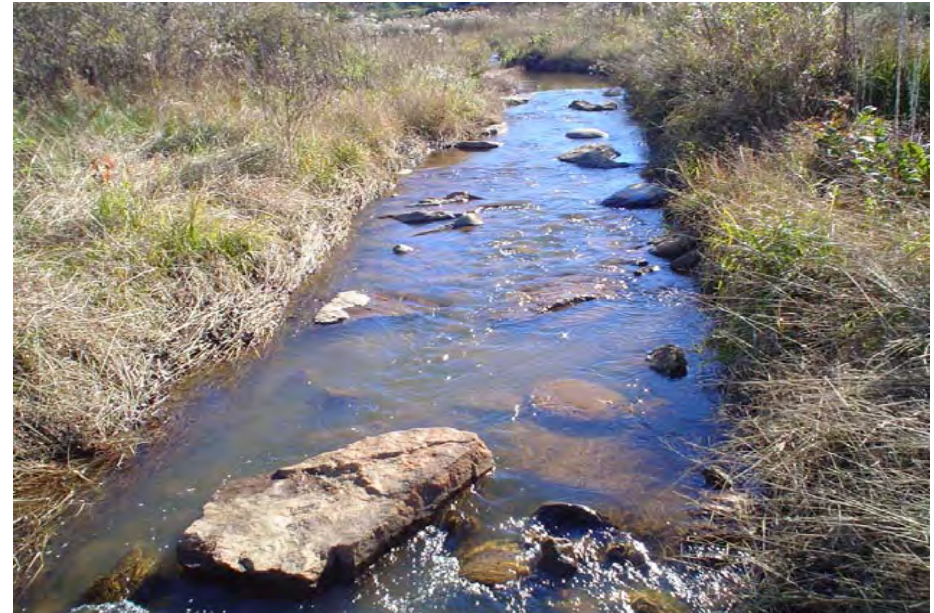
Photo: Sta. 46+50 looking downstream

River Basin	Little Tennessee
Watershed	Cat Creek
X-Sec ID	8
Feature	Riffle
Drainage Area (sq mi)	2.5
Date	Dec-10
Field Crew	Ron Johnson, Ian Jewell

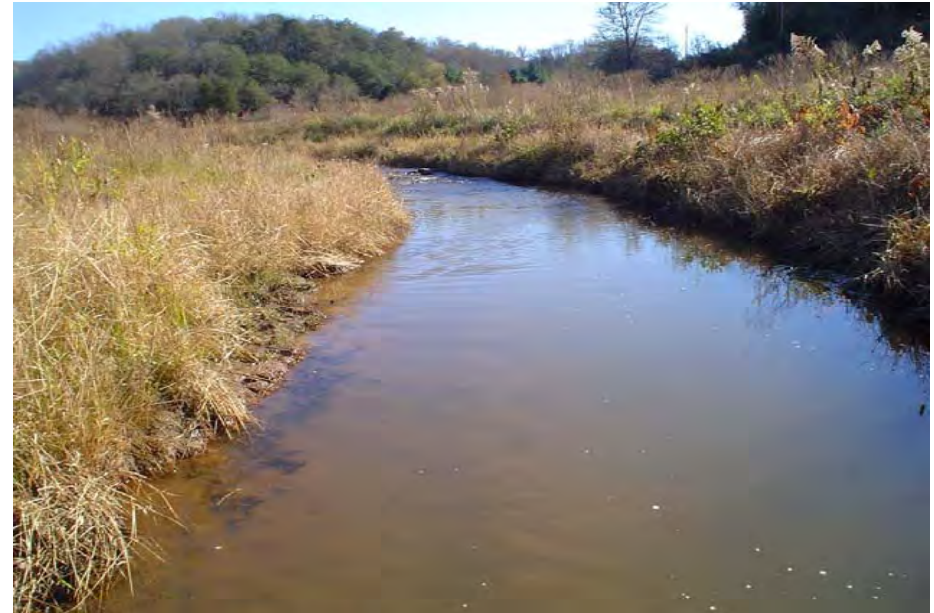
Photo: Sta. 49+60 looking downstream

River Basin	Little Tennessee
Watershed	Cat Creek
X-Sec ID	9
Feature	Pool
Dranage Area (sq mi)	2.5
Date	Dec-10
Field Crew	Ron Johnson, Ian Jewell

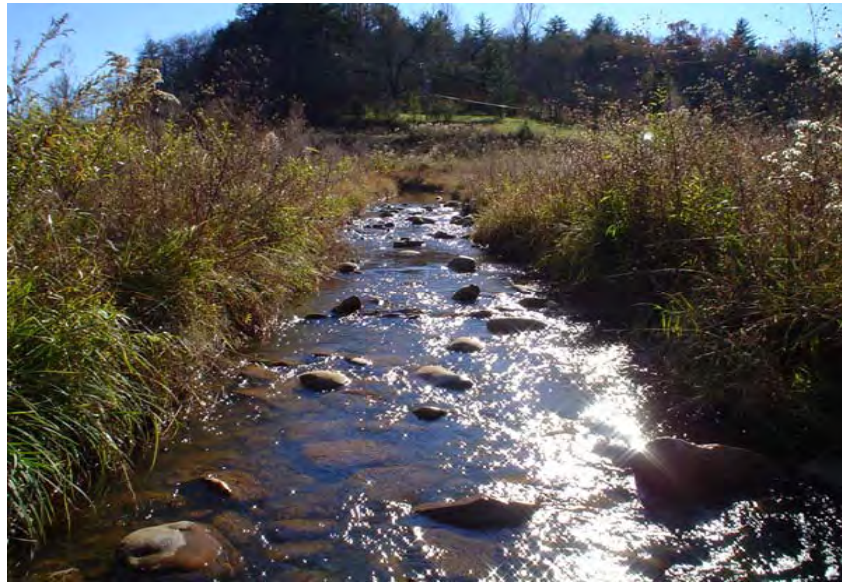
Photo: Sta. 51+00 looking downstream

River Basin	Little Tennessee
Watershed	Cat Creek
X-Sec ID	10
Feature	Riffle
Drainage Area (sq mi)	2.5
Date	Dec-10
Field Crew	Ron Johnson, Ian Jewell

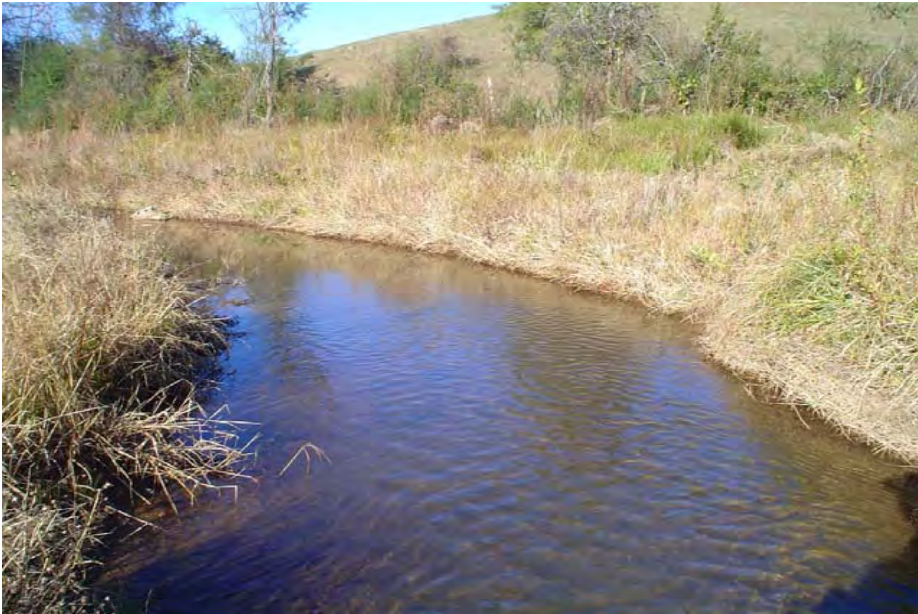
Photo: Sta. 51+70 looking downstream

River Basin	Little Tennessee
Watershed	Cat Creek
X-Sec ID	11
Feature	Pool
Drainage Area (sq mi)	2.5
Date	Dec-10
Field Crew	Ron Johnson, Ian Jewell

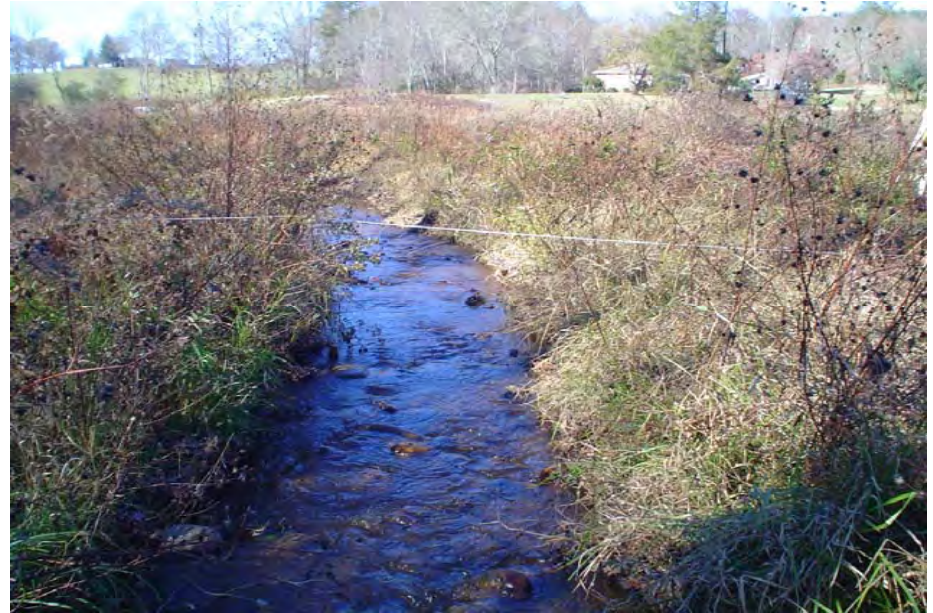
Photo: Sta. 11+50 looking downstream

Bankfull Elevation	2107.94
Bankfull Width (ft)	20.91
Floodprone Width (ft)	85
Bankfull Mean Depth (ft)	0.76
Bankfull Max Depth (ft)	1.78
Bankfull Cross Sectional Area (ft ²)	15.83
Bankfull Width/Depth Ratio	27.51
Bankfull Entrenchment Ratio	4.07

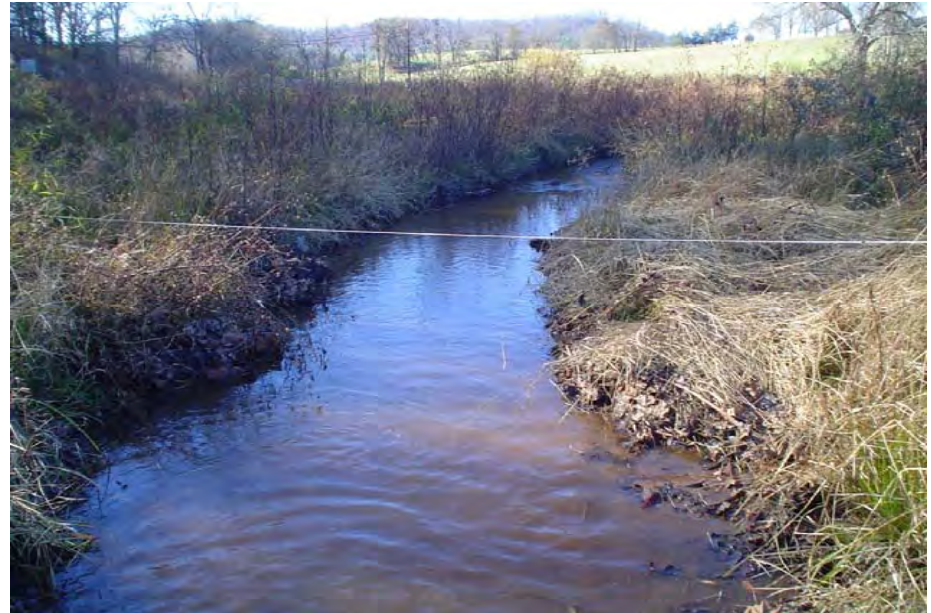
Photo: Sta. 12+95 looking downstream

Bankfull Elevation	2105.84
Bankfull Width (ft)	17.9
Floodprone Width (ft)	200
Bankfull Mean Depth (ft)	0.62
Bankfull Max Depth (ft)	1.71
Bankfull Cross Sectional Area (ft ²)	11.05
Bankfull Width/Depth Ratio	28.87
Bankfull Entrenchment Ratio	11.17

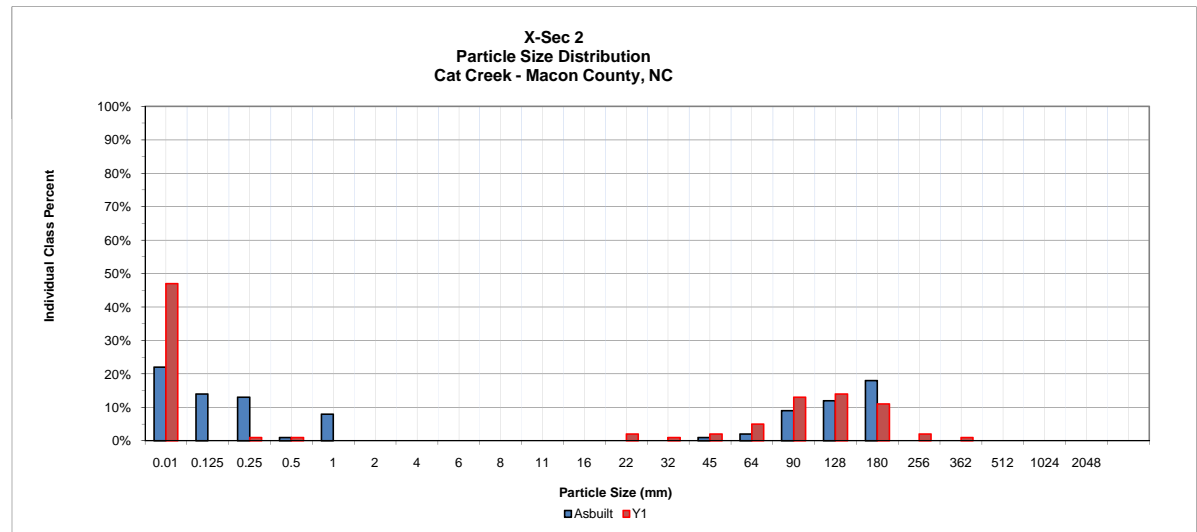
Cross - Section Pebble Count

Project Name : Cat Creek Swartwout Tract
 Cross Section: 2
 Feature: Pool

Summary Data	
D50	0.06
D84	41.56
D95	77.43
