**Cat Creek
Stream and Wetland Restoration
NCEEP Project Number: 71
Monitoring Contract Number: 004490
Monitoring Year 4
2013 Final Report**

**Submitted to
North Carolina Ecosystem Enhancement Program
North Carolina Department of Environment and Natural Resources
January 2014**

**Cat Creek Stream and Wetland Restoration
2013 Monitoring Report (MY 4)**

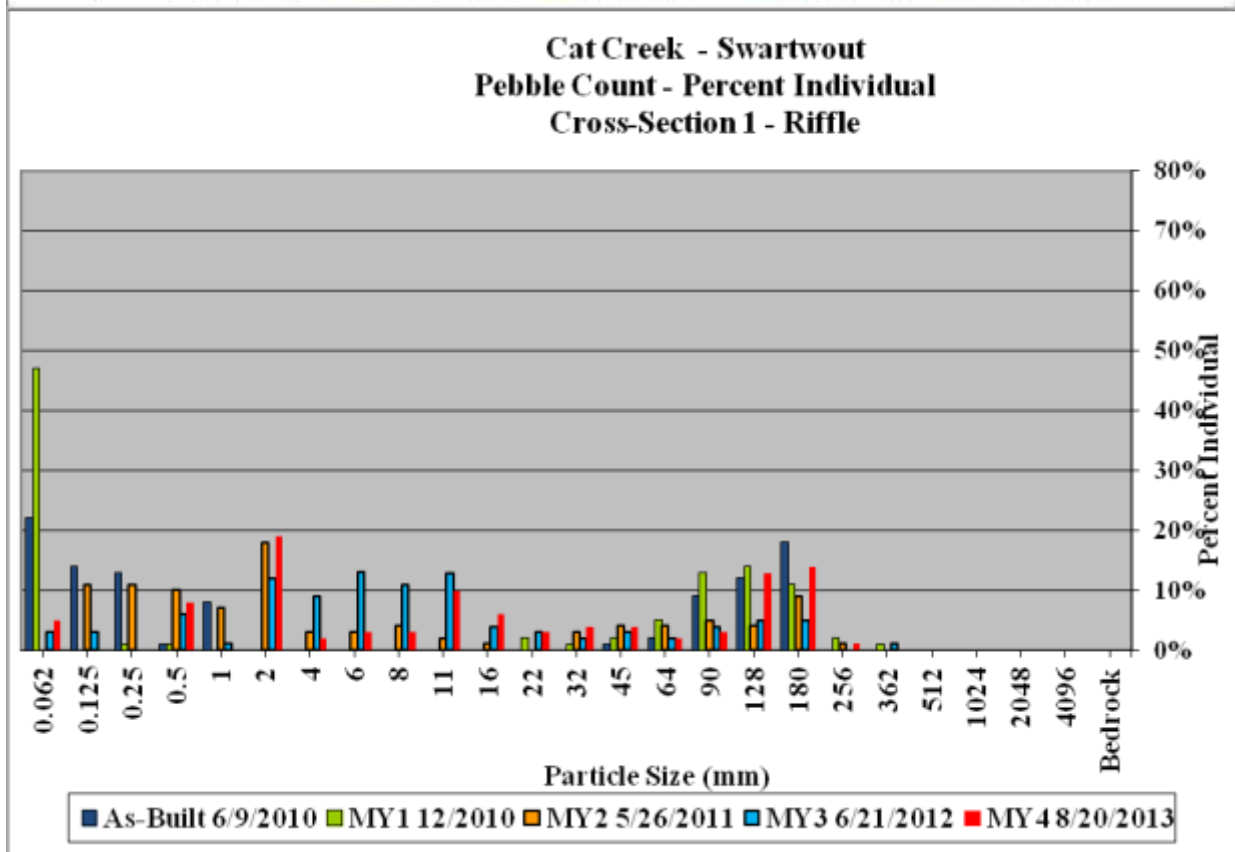
Cat Creek Stream & Wetland / Project No. 71					
Cat Creek - Swartwout - Cross-Section 1 - Riffle					
Pebble Count Summary					
			Monitoring Year 4		
Description	Material	Size (mm)	Total #	Item %	Cum %
Silt/Clay	silt/clay	0.062	5	5.0%	5%
Sand	very fine sand	0.125	0	0.0%	5%
	fine sand	0.25	0	0.0%	5%
	medium sand	0.50	8	8.0%	13%
	coarse sand	1.00	0	0.0%	13%
	very coarse sand	2.00	19	19.0%	32%
Gravel	very fine gravel	4.0	2	2.0%	34%
	fine gravel	5.7	3	3.0%	37%
	fine gravel	8.0	3	3.0%	40%
	medium gravel	11.3	10	9.9%	50%
	medium gravel	16.0	6	5.9%	56%
	coarse gravel	22.3	3	3.0%	59%
	coarse gravel	32	4	4.0%	63%
	very coarse gravel	45	4	4.0%	67%
Cobble	very coarse gravel	64	2	2.0%	69%
	small cobble	90	3	3.0%	72%
	medium cobble	128	13	12.9%	85%
	large cobble	180	14	13.9%	98%
Boulder	very large cobble	256	1	1.0%	99%
	small boulder	362	0	0.0%	99%
	small boulder	512	0	0.0%	99%
	medium boulder	1024	0	0.0%	99%
	large boulder	2048	0	0.0%	99%

Summary Data	
D50	11
D84	120
D95	160

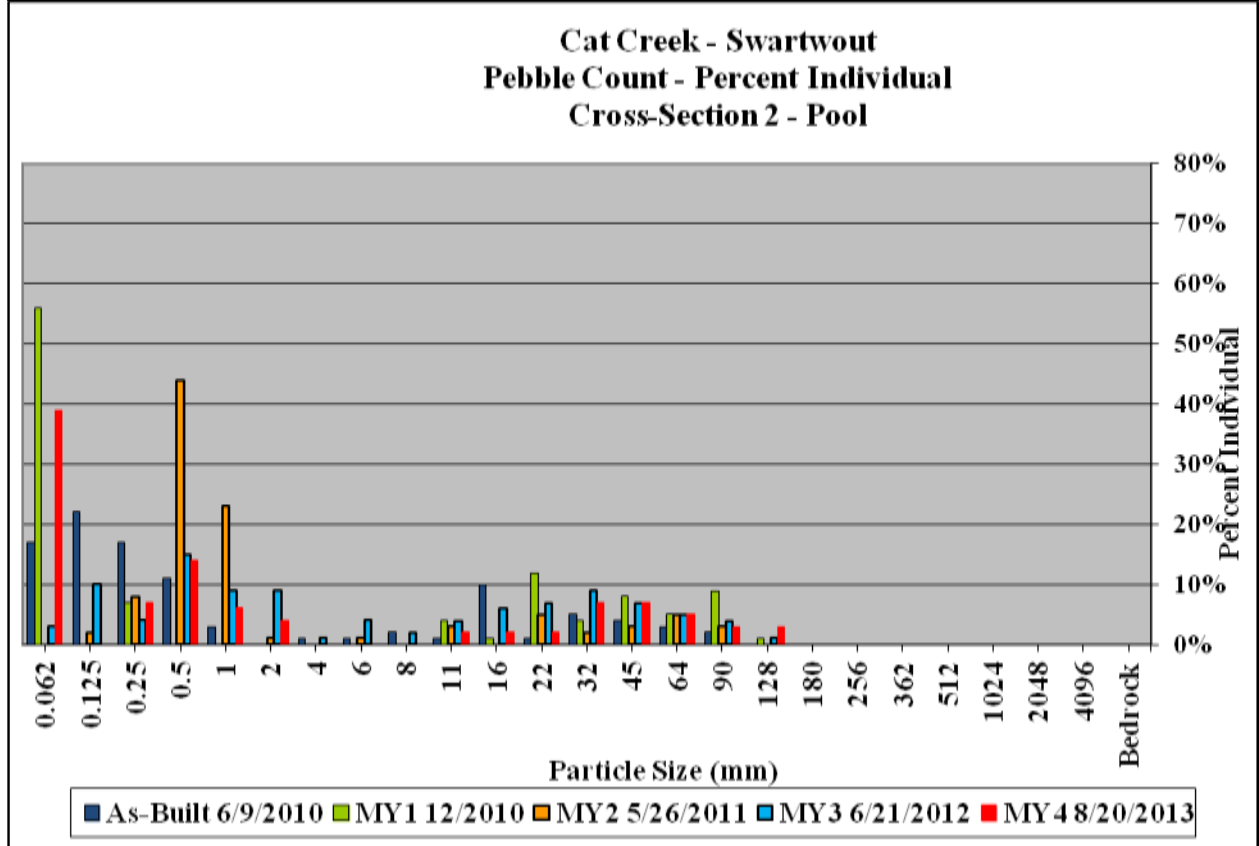
Cat Creek Stream & Wetland / Project No. 71					
Cat Creek - Swartwout - Cross-Section 2 - Pool					
Pebble Count Summary					
			Monitoring Year 4		
Description	Material	Size (mm)	Total #	Item %	Cum %
Silt/Clay	silt/clay	0.062	39	39.0%	39%
Sand	very fine sand	0.125	0	0.0%	39%
	fine sand	0.25	7	7.0%	46%
	medium sand	0.50	14	14.0%	60%
	coarse sand	1.00	6	6.0%	66%
	very coarse sand	2.00	4	4.0%	70%
Gravel	very fine gravel	4.0	0	0.0%	70%
	fine gravel	5.7	0	0.0%	70%
	fine gravel	8.0	0	0.0%	70%
	medium gravel	11.3	2	2.0%	72%
	medium gravel	16.0	2	2.0%	74%
	coarse gravel	22.3	2	2.0%	76%
	coarse gravel	32	7	6.9%	83%
	very coarse gravel	45	7	6.9%	90%
Cobble	very coarse gravel	64	5	5.0%	95%
	small cobble	90	3	3.0%	98%
	medium cobble	128	3	3.0%	101%
	large cobble	180	0	0.0%	101%
Boulder	very large cobble	256	0	0.0%	101%
	small boulder	362	0	0.0%	101%
	small boulder	512	0	0.0%	101%
	medium boulder	1024	0	0.0%	101%
	large boulder	2048	0	0.0%	101%

Summary Data	
D50	0.062
D84	35
D95	71

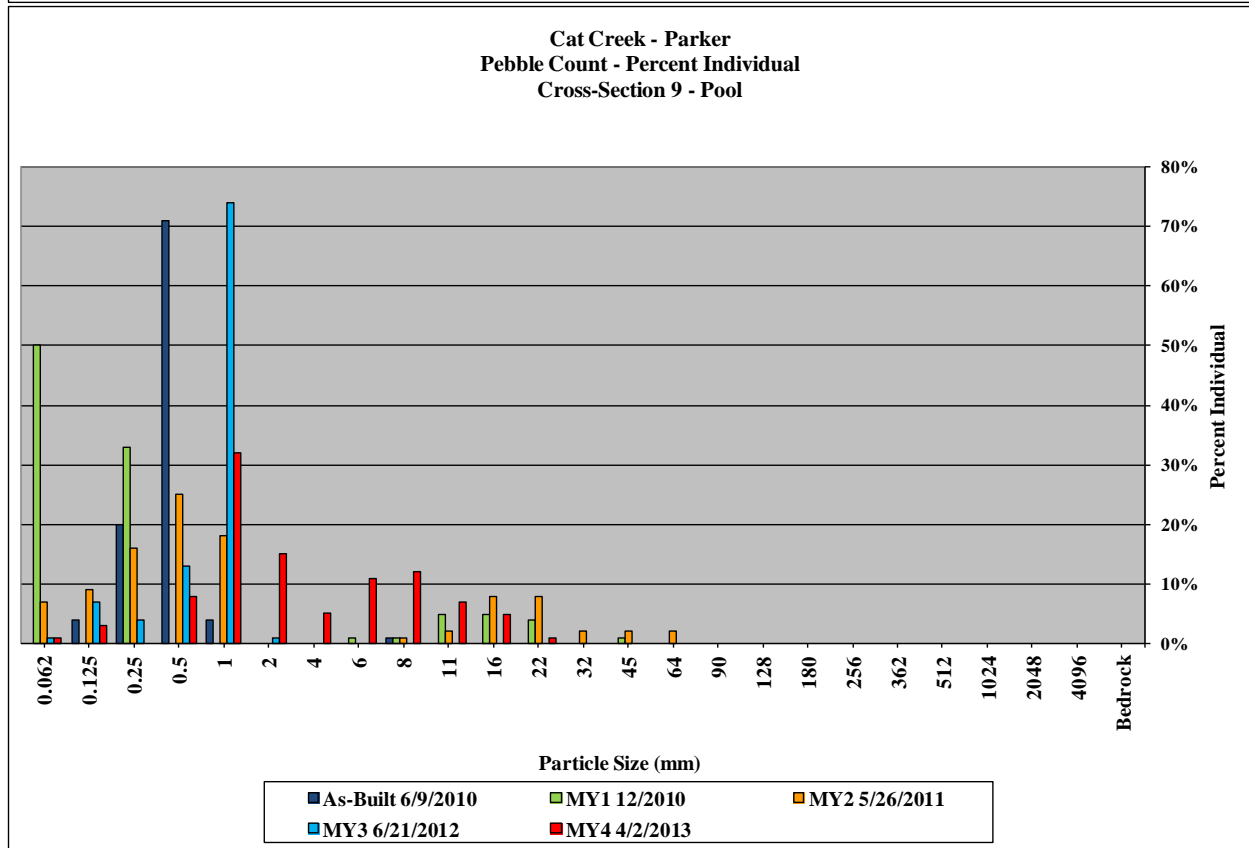
Cat Creek Stream & Wetland / Project No. 71					
Cat Creek - Parker - Cross-Section 9 - Pool					
Pebble Count Summary					
			Monitoring Year 4		
Description	Material	Size (mm)	Total #	Item %	Cum %
Silt/Clay	silt/clay	0.062	1	1%	1%
Sand	very fine sand	0.125	3	3%	4%
	fine sand	0.25	0	0%	4%
	medium sand	0.50	8	8%	12%
	coarse sand	1.00	32	32%	44%
	very coarse sand	2.00	15	15%	59%
Gravel	very fine gravel	4.0	5	5%	64%
	fine gravel	5.7	11	11%	75%
	fine gravel	8.0	12	12%	87%
	medium gravel	11.3	7	7%	94%
	medium gravel	16.0	5	5%	99%
	coarse gravel	22.3	1	1%	100%
	coarse gravel	32	0	0%	100%
	very coarse gravel	45	0	0%	100%
Cobble	very coarse gravel	64	0	0%	100%
	small cobble	90	0	0%	100%
	medium cobble	128	0	0%	100%
	large cobble	180	0	0%	100%
Boulder	very large cobble	256	0	0%	100%
	small boulder	362	0	0%	100%
	small boulder	512	0	0%	100%
	medium boulder	1024	0	0%	100%
	large boulder	2048	0	0%	100%
Bedrock	very large boulder	4096	0	0%	100%

Summary Data	
D50	1.3
D84	7.4
D95	12
