**Cat Creek
Stream and Wetland Restoration
NCEEP Project Number: 71
Monitoring Contract Number: 004490
Monitoring Year 5
2014 Report**

**Submitted to
North Carolina Ecosystem Enhancement Program
North Carolina Department of Environment and Natural Resources
January 2015**

Cat Creek Stream and Wetland Restoration 2014 Monitoring Report (MY 5)

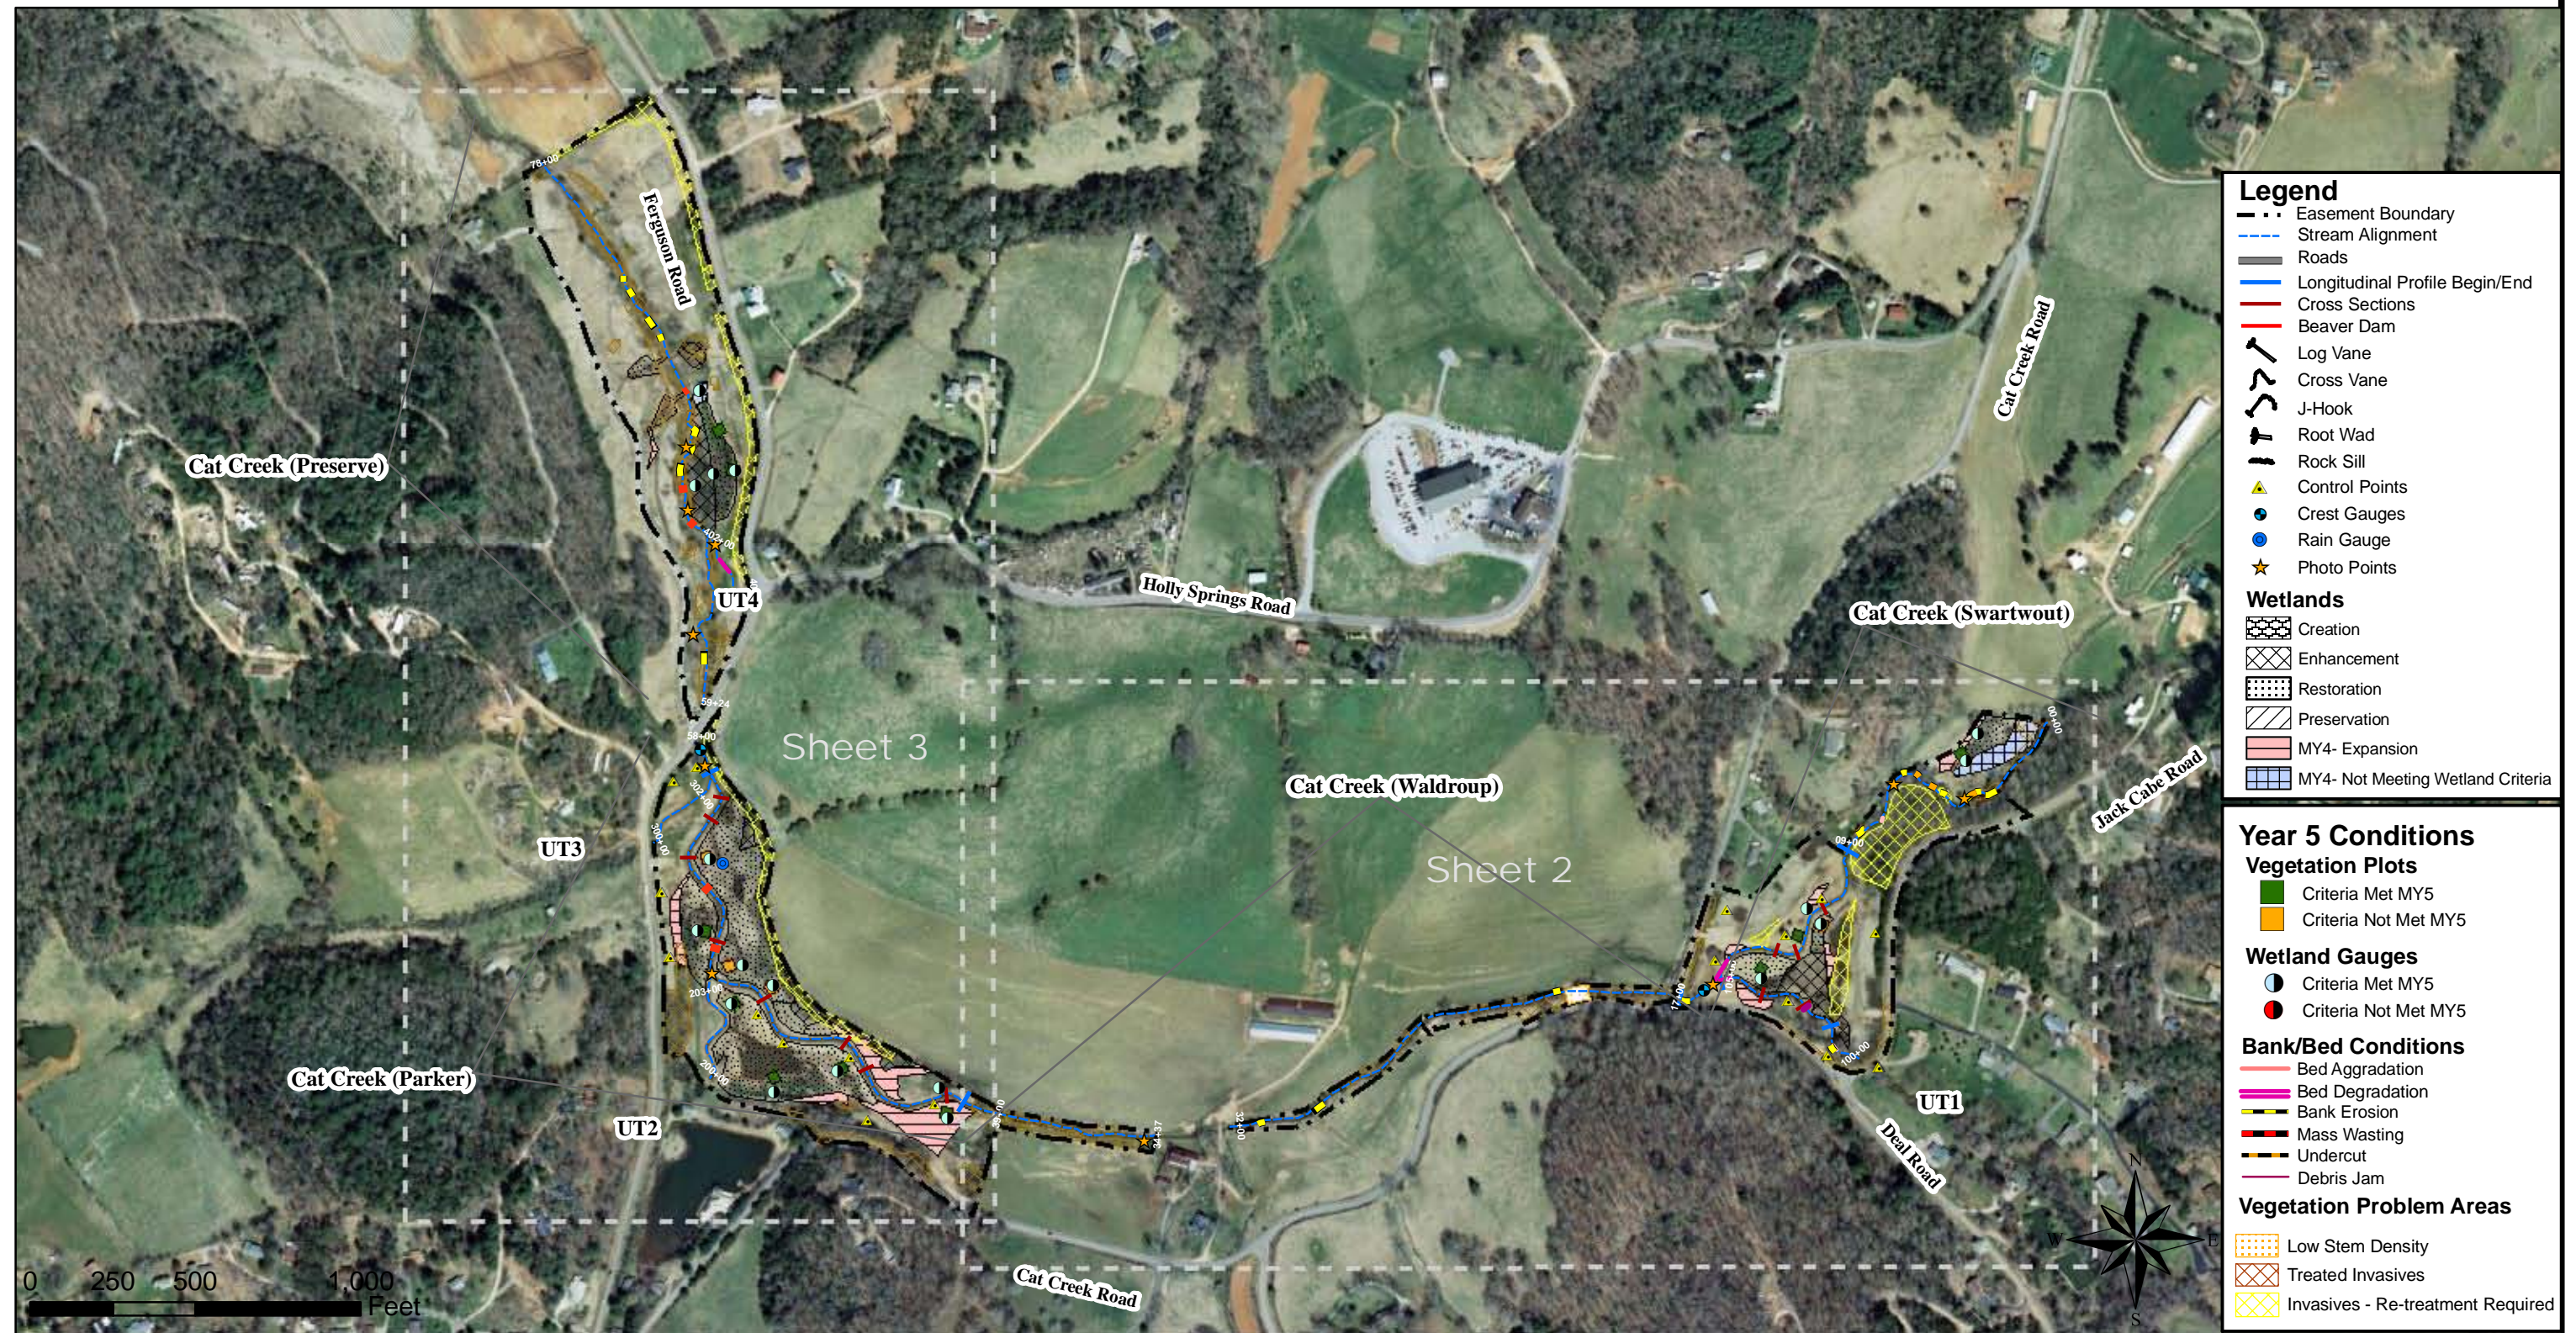
Figure 2. Integrated Current Condition Plan View Draft

Prepared for	Project: Cat Creek Stream and Wetland Restoration	Notes: 1) 2010 Aerial Photo	Prepared by

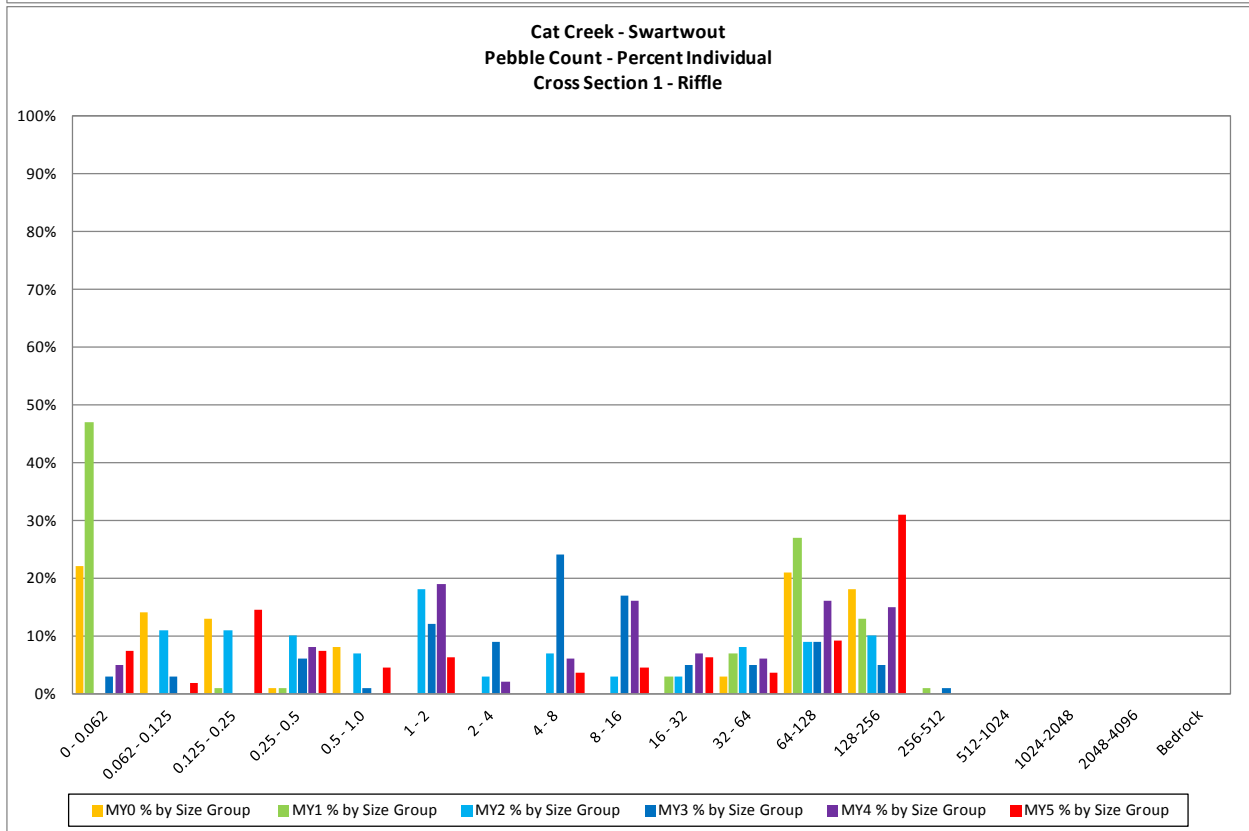
Cat Creek Stream & Wetland / Project No. 71			
Swartwout Cross Section 1 - Riffle			
Monitoring Year - 2014; MY5			
Bed Surface Material Particle Size Class (mm)	Number	% Individual	% Cumulative
0 - 0.062	8	7.3%	7%
0.062 - 0.125	2	1.8%	9%
0.125 - 0.25	16	14.5%	24%
0.25 - 0.5	8	7.3%	31%
0.5 - 1.0	5	4.5%	35%
1 - 2	7	6.4%	42%
2 - 4	0	0.0%	42%
4 - 8	4	3.6%	45%
8 - 16	5	4.5%	50%
16 - 32	7	6.4%	56%
32 - 64	4	3.6%	60%
64-128	10	9.1%	69%
128-256	34	30.9%	100%
256-512	0	0.0%	100%
512-1024	0	0.0%	100%
1024-2048	0	0.0%	100%
2048-4096	0	0.0%	100%
Bedrock	0	0.0%	100%
Total	110	100%	100%
		Summary Data	
		D50	16
		D84	160
		D95	180

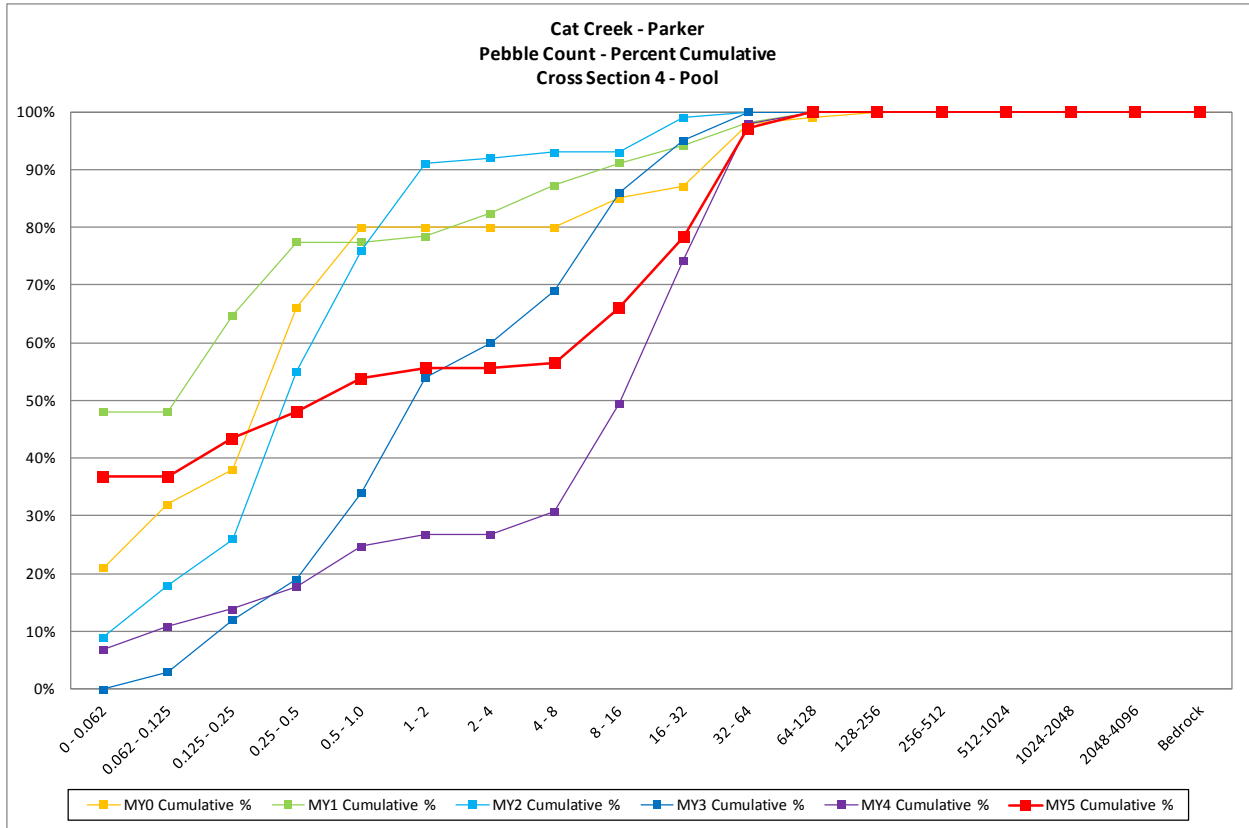
Cat Creek Stream & Wetland / Project No. 71			
Parker Cross Section 4 - Pool			
Monitoring Year - 2014; MY5			
Bed Surface Material Particle Size Class (mm)	Number	% Individual	% Cumulative
0 - 0.062	39	36.8%	37%
0.062 - 0.125	0	0.0%	37%
0.125 - 0.25	7	6.6%	43%
0.25 - 0.5	5	4.7%	48%
0.5 - 1.0	6	5.7%	54%
1 - 2	2	1.9%	56%
2 - 4	0	0.0%	56%
4 - 8	1	0.9%	57%
8 - 16	10	9.4%	66%
16 - 32	13	12.3%	78%
32 - 64	20	18.9%	97%
64-128	3	2.8%	100%
128-256	0	0.0%	100%
256-512	0	0.0%	100%
512-1024	0	0.0%	100%
1024-2048	0	0.0%	100%
2048-4096	0	0.0%	100%
Bedrock	0	0.0%	100%
Total	106	100%	100%
		Summary Data	
		D50	0.63
		D84	40
		D95	59
