Re: NCIRT Review and USACE Approval of the Catfish Pond Mitigation Plan; SAW-2018-00424;
NCDMS Project # 100039

RE: Response to IRT comments on Draft Final Mitigation Plan Submittal
Catfish Pond Mitigation Site, Durham County, NC
Neuse River Basin - 03020201
DMS Project ID No. 100039 / DEQ Contract #007424

Catfish Pond Mitigation Site
Durham County, North Carolina
Plan and Profile
Catfish Creek

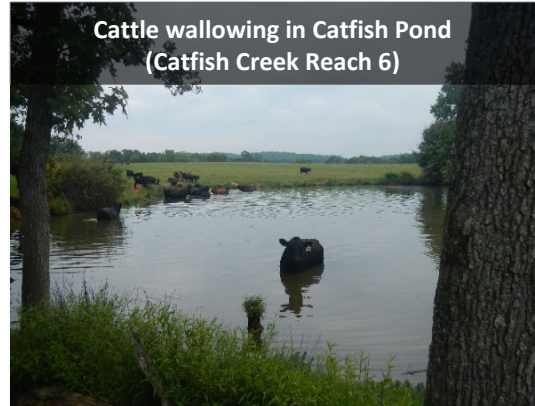
Catfish Creek Reach 6 flows through Catfish Pond. Currently, all of Reach 6 is contained within Catfish Pond or the pond embankment, which was installed sometime between 1940 and 1955. Cattle have unlimited access and were seen wallowing within the farm pond on multiple occasions during Wildlands' site visits. Vegetation around the pond is limited to pasture grasses and some trees.

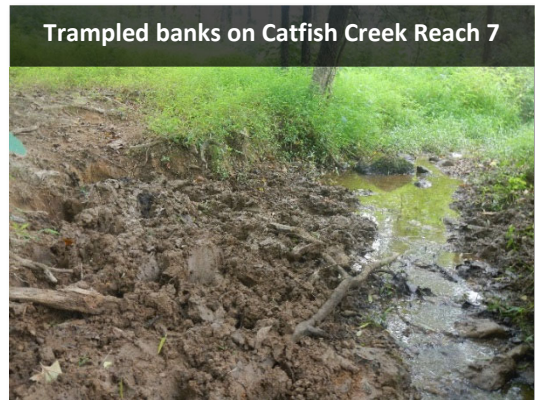
Catfish Creek Reach 7 begins at the confluence with UT1 and continues to the confluence of Mountain Creek and Catfish Creek. Catfish Creek Reach 7 has a bedform dominated by bedrock features (35% of reach) which have limited vertical instability. However, livestock access throughout the site has caused areas of lateral instability and widening. At multiple locations along the reach there is evidence of cattle wallows and trampled banks. Cattle impacts have caused instability including mass wasting and scour in isolated areas along the reach.

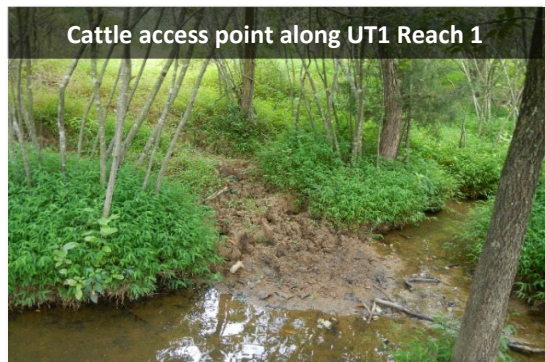
UT1 Reach 1 begins at the southern project boundary and flows northeast to the confluence with an ephemeral tributary. Along UT1 Reach 1 there is a narrow buffer with some woody and herbaceous vegetation. Throughout the reach there are cattle entry and exit points which have resulted in unstable banks leading to scour and incision. Multiple headcuts are present along the reach. In addition, cattle impacts have caused the degradation of channel bedform diversity and instream habitat.

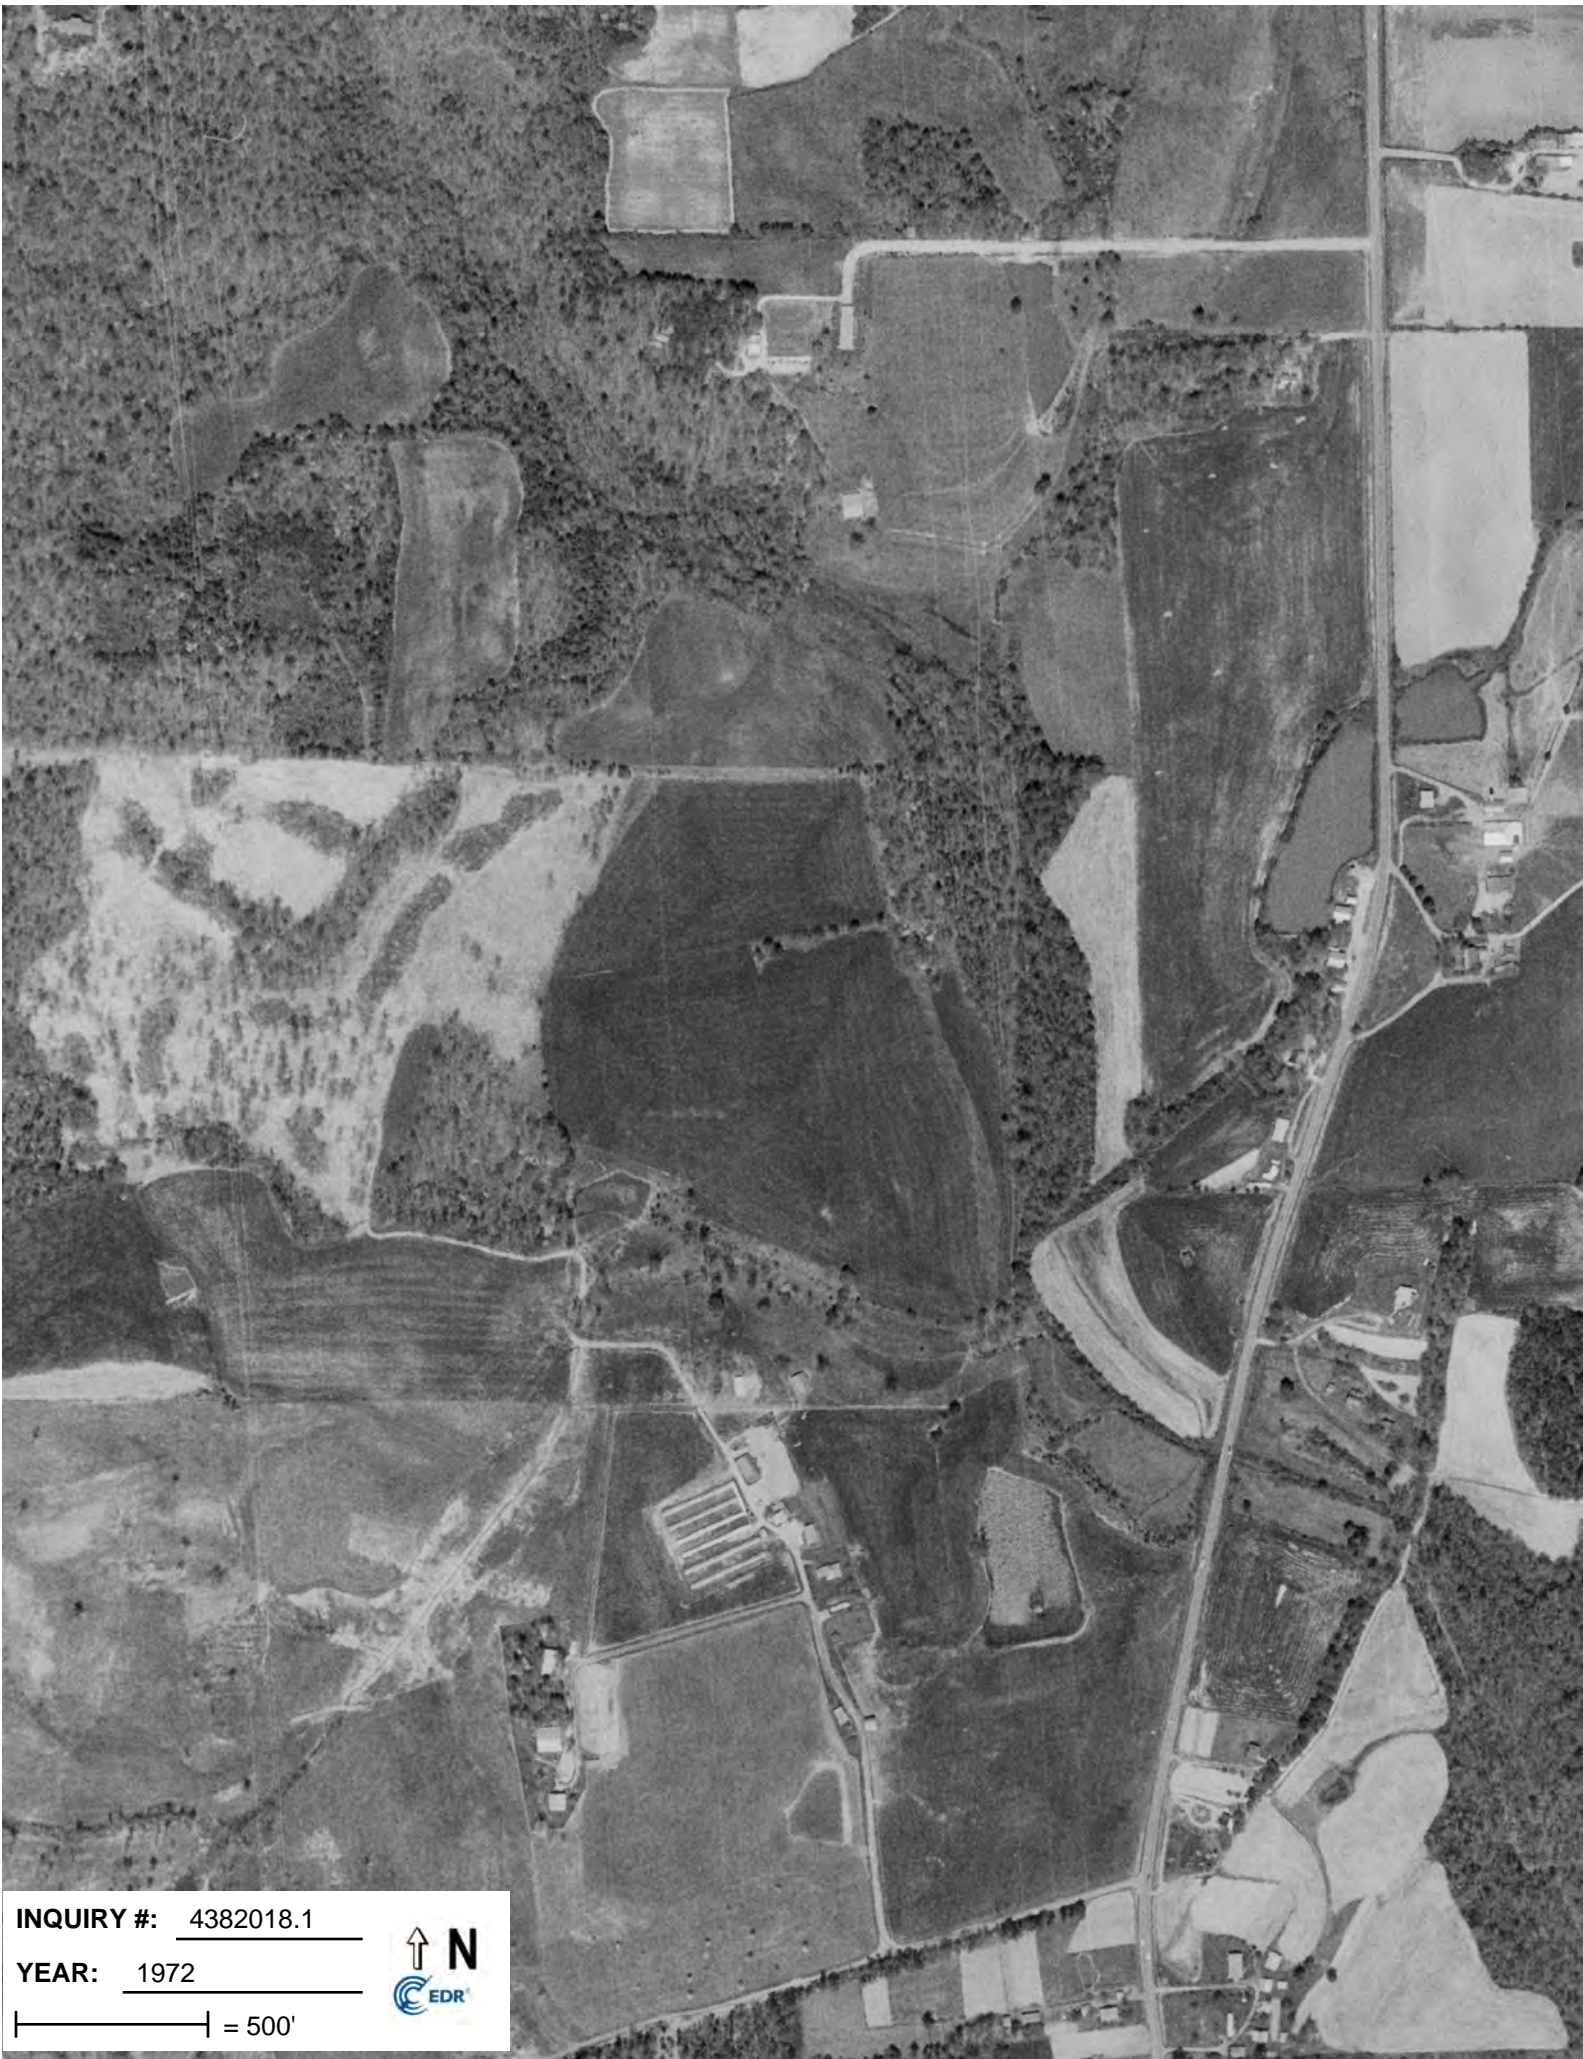
YEAR: 1972

Aerial photographs from 1972 show the area around UT1 in a cleared condition. This imagery and the lack of sinuosity on UT1 suggest that the channel was straightened for agricultural purposes prior to 1972. There were essentially no riparian buffers on UT1 until the 2005 photo when a narrow corridor of trees are visible. Catfish Creek, UT2, and Mountain Tributary do not show signs of channel manipulation.

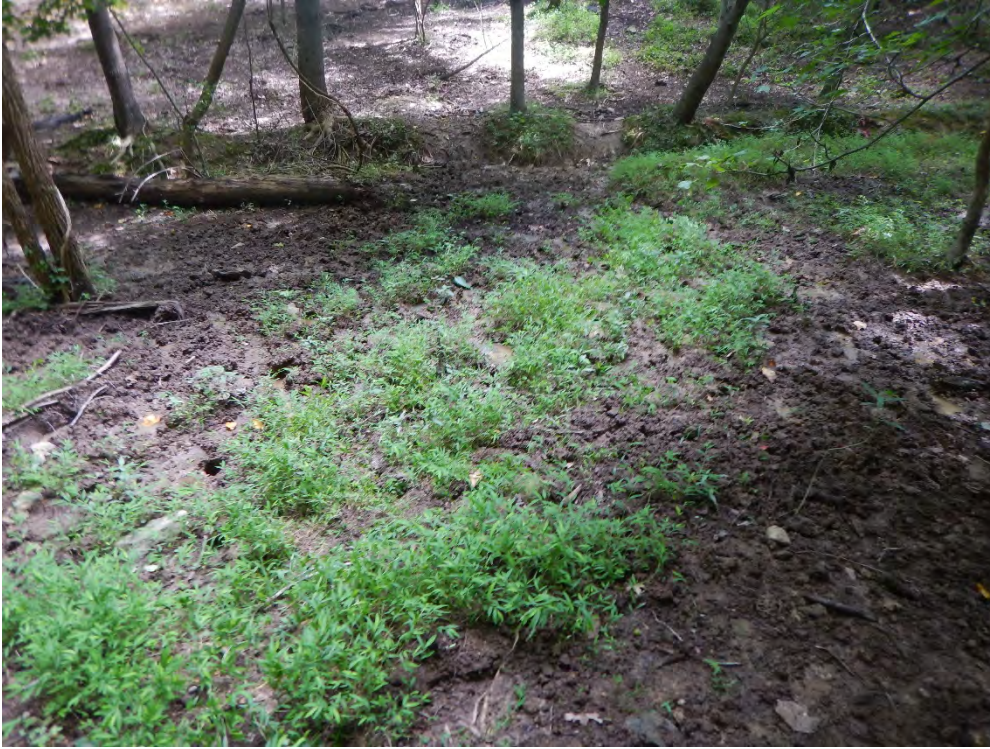
Catfish Creek (R1-R2)

Catfish Creek Reach 1 begins at a small groundwater seep on the west end of the Site and flows east as an intermittent channel. Reach 2 is a perennial channel that continues to the confluence with UT2. A headcut is present on Reach 2. Catfish Creek Reach 3 begins at the confluence of UT2. Catfish Creek Reaches 1, 2, and 3 are very similar in their current condition. These reaches are moderately to steeply sloped and flow through confined valleys. Riparian vegetation is primarily comprised of a mature overstory with limited understory and herbaceous vegetation due to cattle grazing. Cattle access and riparian buffer grazing are the major limiting factors in the overall health and stability of Catfish Creek Reaches 1, 2, and 3. Isolated areas of over widening and instability exist along these project reaches, which can be directly correlated to cattle access. Bedform within these reaches is more stable and diverse compared to other project reaches.

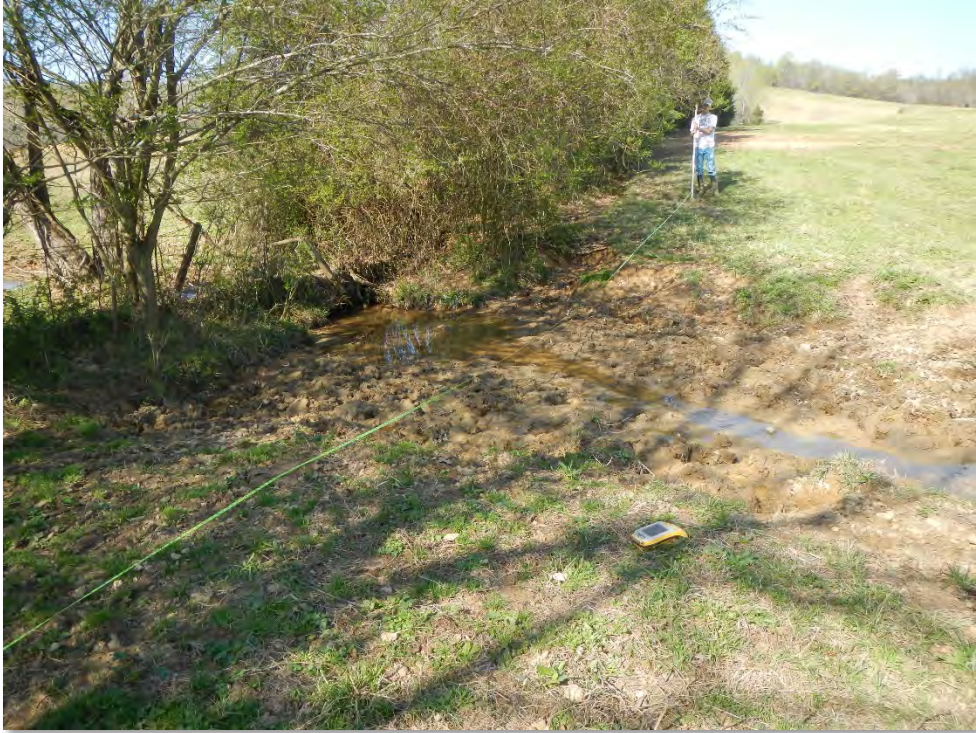
UT1 (R2-R3)

UT1 Reach 2 begins at the confluence of UT1 and the ephemeral tributary and flows northeast until an existing farm crossing. A fence line associated with the parcel boundary bisects UT1 Reach 2. Downstream of the fence line, there is no woody or herbaceous vegetation within the floodplain and vegetation is dominated by pasture grasses. The channel is incised in this section. Upstream of the fence line, the woody vegetation is limited with some areas of hazel alder and green ash. The stream banks are cattle trampled, resulting in an overwide dimension; it is difficult to identify the main stem of the channel because cattle trampling has resulted in poorly-defined stream channel. The channel exhibits very little to no bedform throughout the reach and fecal material is present along the entire reach.

UT1 Reach 3 begins just upstream of the existing farm crossing and continues through it. The downstream end of the existing farm crossing drops approximately 10 vertical feet at a stacked rock retaining wall. The valley is narrow with steep walls downstream of the crossing.

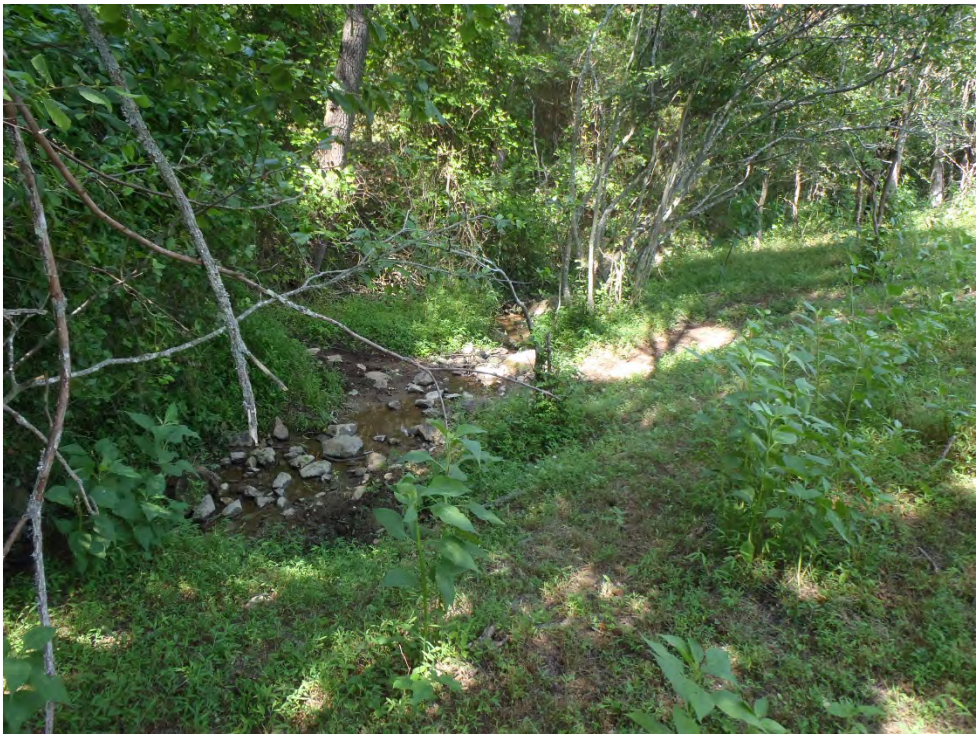
UT1 (R4)

UT1 Reach 4 begins at the existing farm crossing and continues until the confluence with Catfish Creek. UT1 Reach 4 is vertically stable due to widespread bedrock in the channel. Just downstream of the farm crossing there is a small area of incision. Similar to other project reaches the major limiting ecological factor for UT1 Reach 4 is livestock access. Grazing areas in the floodplain have limited understory vegetation and cattle fecal material is prevalent.

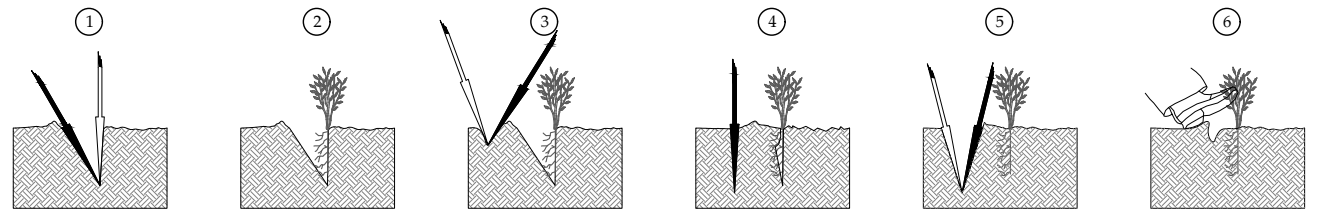
1
Bare Root Planting
 6.4 Not to Scale

- NOTES:**
1. ALL SOILS WITHIN THE BUFFER PLANTING AREA SHALL BE DISKED, AS REQUIRED, PRIOR TO PLANTING.
 2. ALL PLANTS SHALL BE PROPERLY HANDLED PRIOR TO INSTALLATION TO INSURE SURVIVAL.

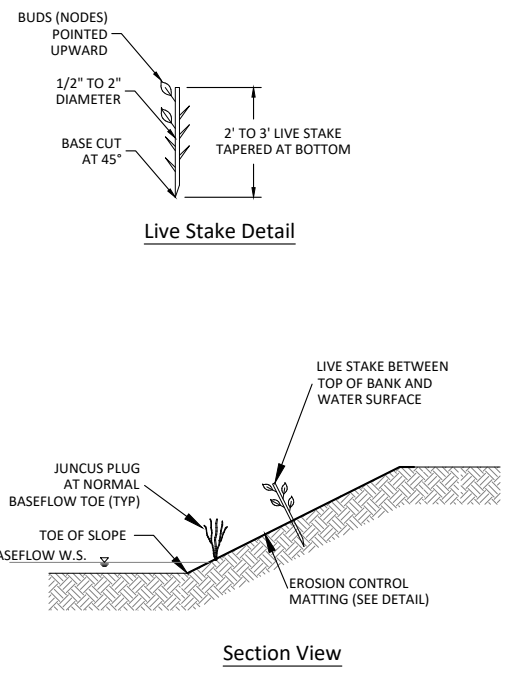
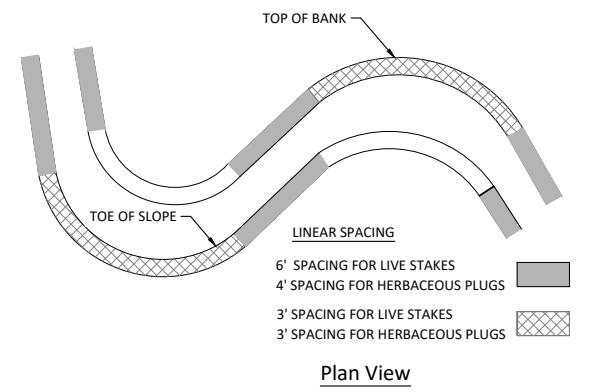
4
Streambank Planting
 6.5 Not to Scale

- NOTES:**
1. BOARD FOR STAKES SHALL BE 2" X 2" X 24" OR 2" X 2" X 36" AS DIRECTED BY THE ENGINEER.
 2. ROOTED/LEAFED CONDITIONS OF THE LIVING PLANT MATERIAL IS NOT REPRESENTATIVE AT THE TIME OF INSTALLATION.

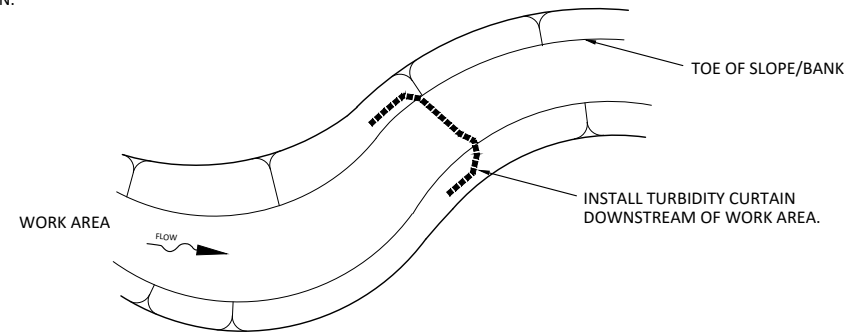
2 Turbidity Curtain
6.6 Not to Scale

1. TURBIDITY CURTAIN SHOULD BE INSTALLED DIRECTLY DOWNSTREAM OF WORK AREA AND INSTALLED IN STREAM TO CAPTURE ANY STREAM FLOW THAT CONTACTS WORK AREA.
2. TURBIDITY CURTAIN SHOULD BE SUITABLE FOR USE IN MOVING WATER AND INSTALLED ACCORDING TO MANUFACTURER'S RECOMMENDATIONS.
3. RECOMMENDED USE OF ELASTEC TYPE II DOT FASTWATER SCREEN OR SIMILAR REPLACEMENT.
4. TURBIDITY CURTAIN SHOULD BE INSPECTED, MAINTAINED, AND ADJUSTED DAILY TO ENSURE PROPER FUNCTION.

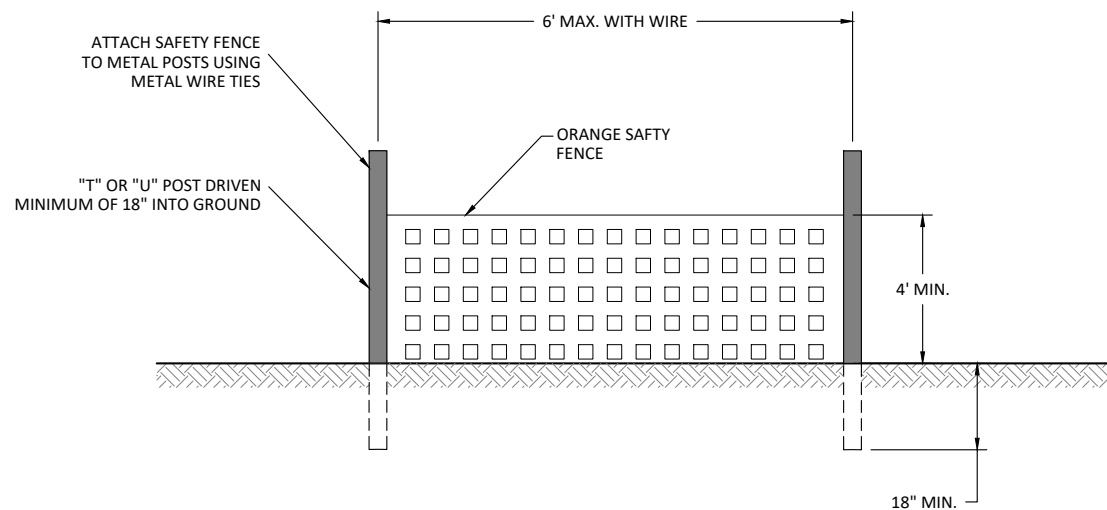
3 Safety Fence
6.6 Not to Scale

MATERIAL SPECIFICATIONS		
PHYSICAL PROPERTY	TESTS	REQUIREMENTS
MATERIAL	N/A	POLYETHYLENE
RECOMMENDED COLOR	N/A	"INTERNATIONAL ORANGE"
TENSILE YIELD	ASTM D638	AVE. 2000 LBS. PER 4' WIDE
ULTIMATE TENSILE STRENGTH	ASTM D638	AVE. 2900 LBS. PER 4' WIDE
ELONGATION AT BREAK (%)	ASTM D638	GREATER THAN 1000%
CHEMICAL RESISTANCE	N/A	INERT TO MOST CHEMICALS AND ACIDS

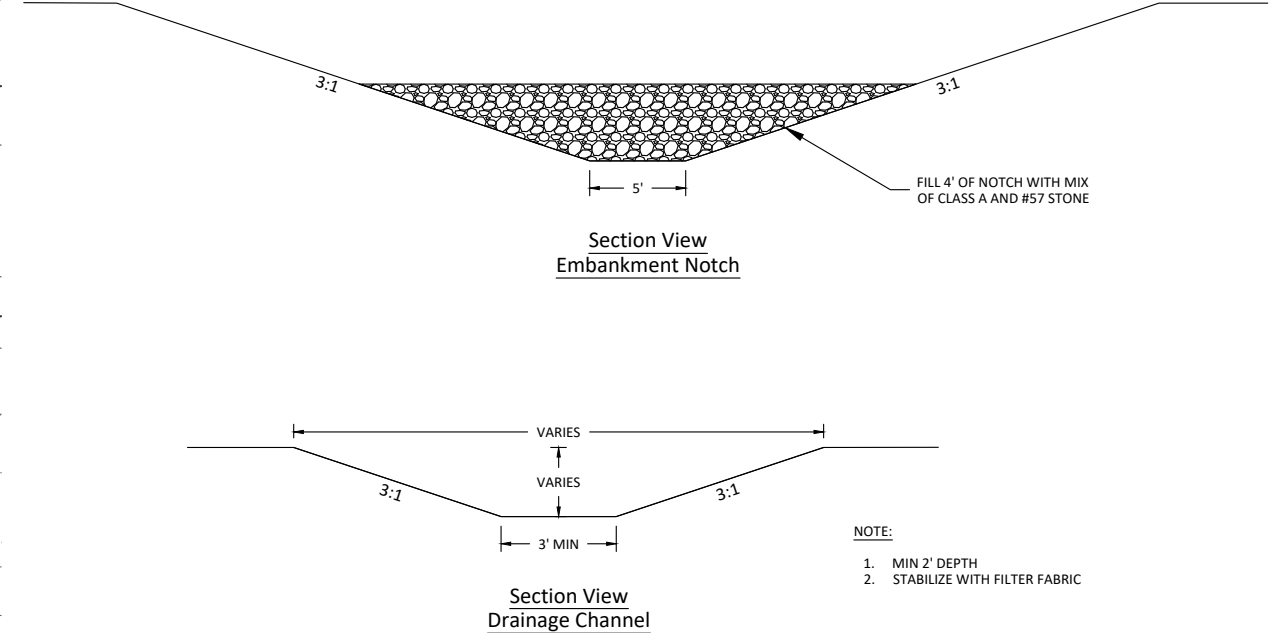
1 Catfish Pond Removal
6.10 Not to Scale

- NOTE:**
1. ALL DEWATERING SHALL BE DONE THROUGH A SILT BAG.
 2. POND SHALL BE DEWATERED BEFORE NOTCH OR DRAINAGE CHANNEL IS CONSTRUCTED.
 3. POND WILL BE DEWATERED WITH A PUMP AS SHOWN IN THE PUMP AROUND DETAIL (SEE DETAIL 3, 6.6). THE POND WATER LEVEL WILL BE DRAWN DOWN AT A RATE OF APPROXIMATELY ONE FOOT PER DAY.
 4. EXCAVATE NOTCH AND DRAINAGE CHANNEL.
 5. PUMP AROUND SHALL BE IN PLACE AND FUNCTIONING WHILE PROPOSED CHANNEL IS CONSTRUCTED.
 6. ALLOW POND BED TO DRY BEFORE PLACING FILL.
 7. REMOVE UNSUITABLE SOILS AND REPLACE WITH SELECT FILL AS DIRECTED.
 8. CONSTRUCT NEW CHANNEL.
 9. REMOVE NOTCH UPON COMPLETION.
