**MONITORING YEAR 1  
ANNUAL BUFFER REPORT  
FINAL**

**CATFISH POND MITIGATION SITE**

Durham County, NC  
NCDEQ Contract No. 007424  
DMS Project No. 100039  
NCDWR Project No. 2018-0196  
RFP No. 16-007279

Data Collection Period: October 2020  
Draft Submission Date: December 2020  
Final Submission Date: February 2021

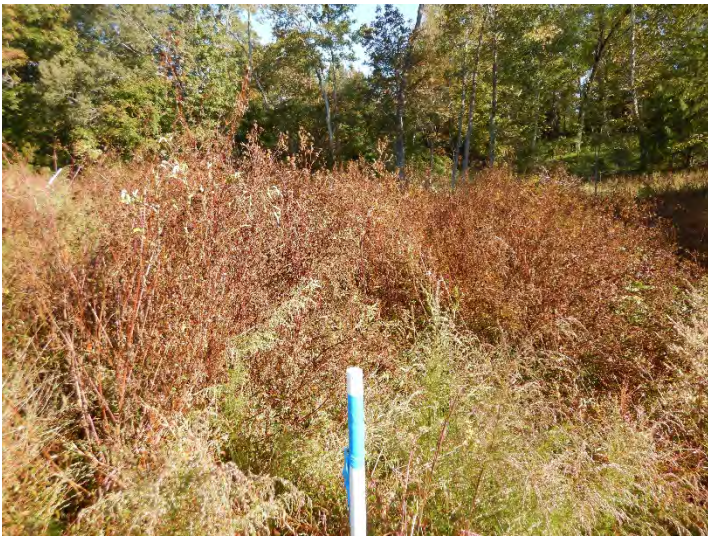
**VEG PLOT 1** (10/06/2020)

Plot	Success Criteria Met*	Tract Mean
1	Yes	100%
2	Yes	
3	Yes	
4	Yes	
5	Yes	
6	Yes	
7	Yes
