Restoration Report

Cato Farm Stream Restoration Project

Prepared for
North Carolina Wetlands Restoration Program

July 2002

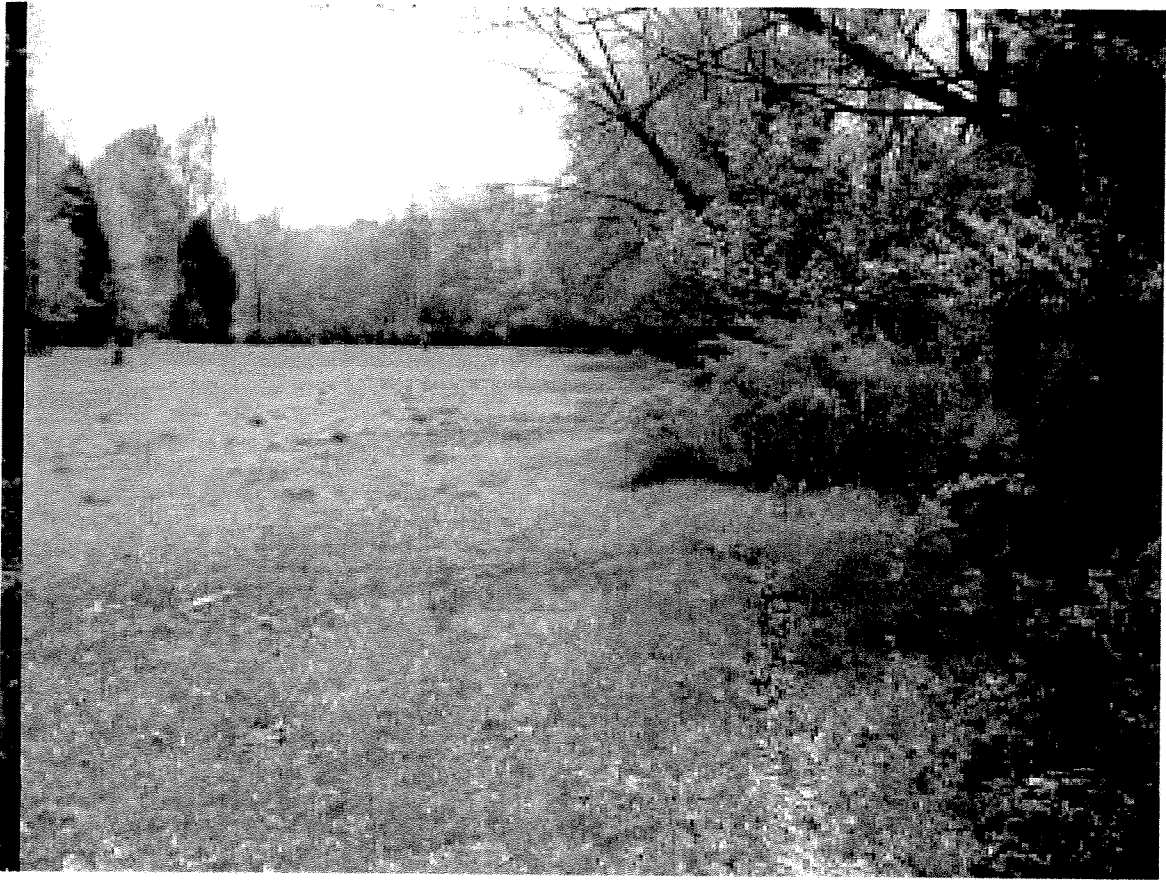
Photo 1. Land has been cleared adjacent to stream to provide pasture

Several activities in the vicinity of the stream have caused/are causing degradation to the stream and its riparian zone. First, the land has been cleared to provide open pasture for the cattle (see Photo 1). Secondly, the cows are not prevented from entering the stream (see Photo 2). Also, the stream channel appears to have been moved (straightened) from its original course (see Photo 3). Finally, at least three ditches have been graded to the stream for the purpose of drying out a marshy area adjacent to the stream (see Photo 4). These activities have created a straight, actively eroding and incising stream channel adjacent to a drying area of hydric soil which was once likely a wetland.

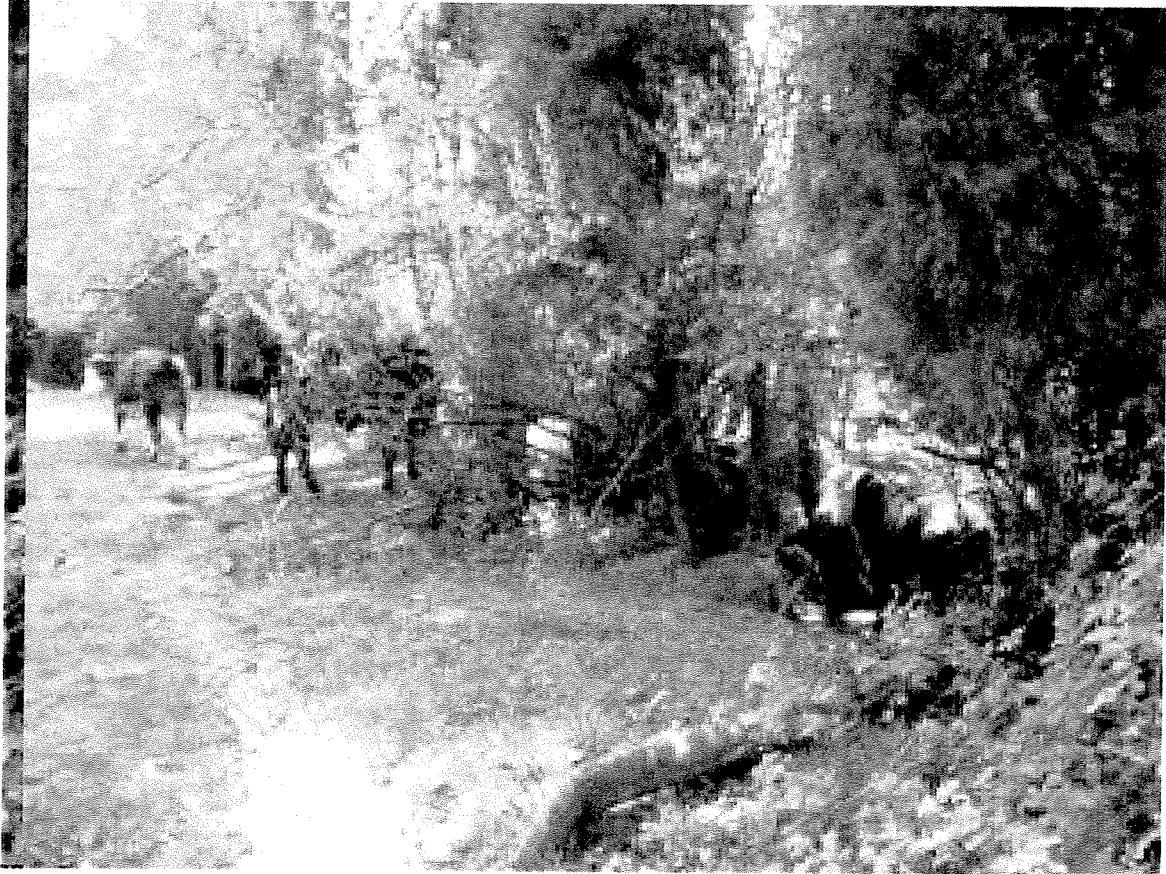
Photo 2. Cattle are not prevented from entering stream

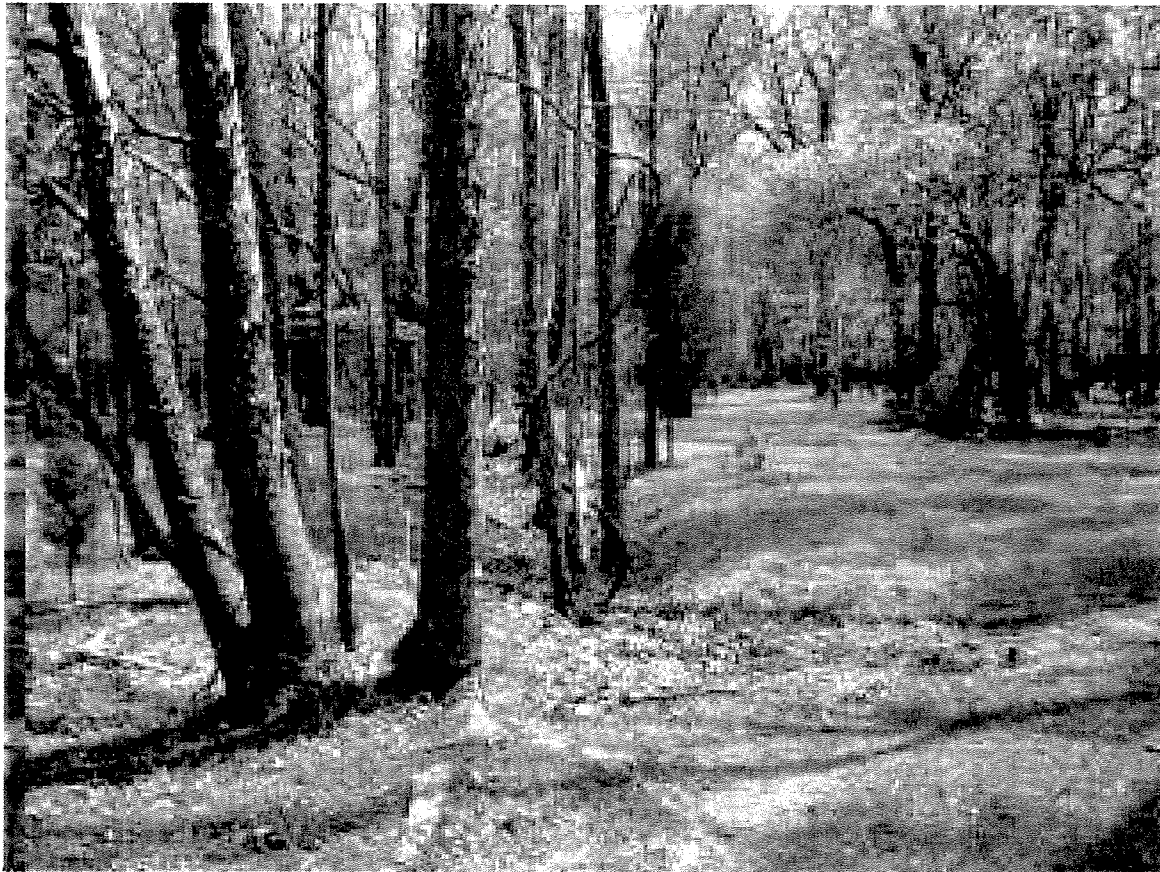
Photo 3. Evidence of old stream bed exist in the floodplain adjacent to the channel indicating the channel has been realigned

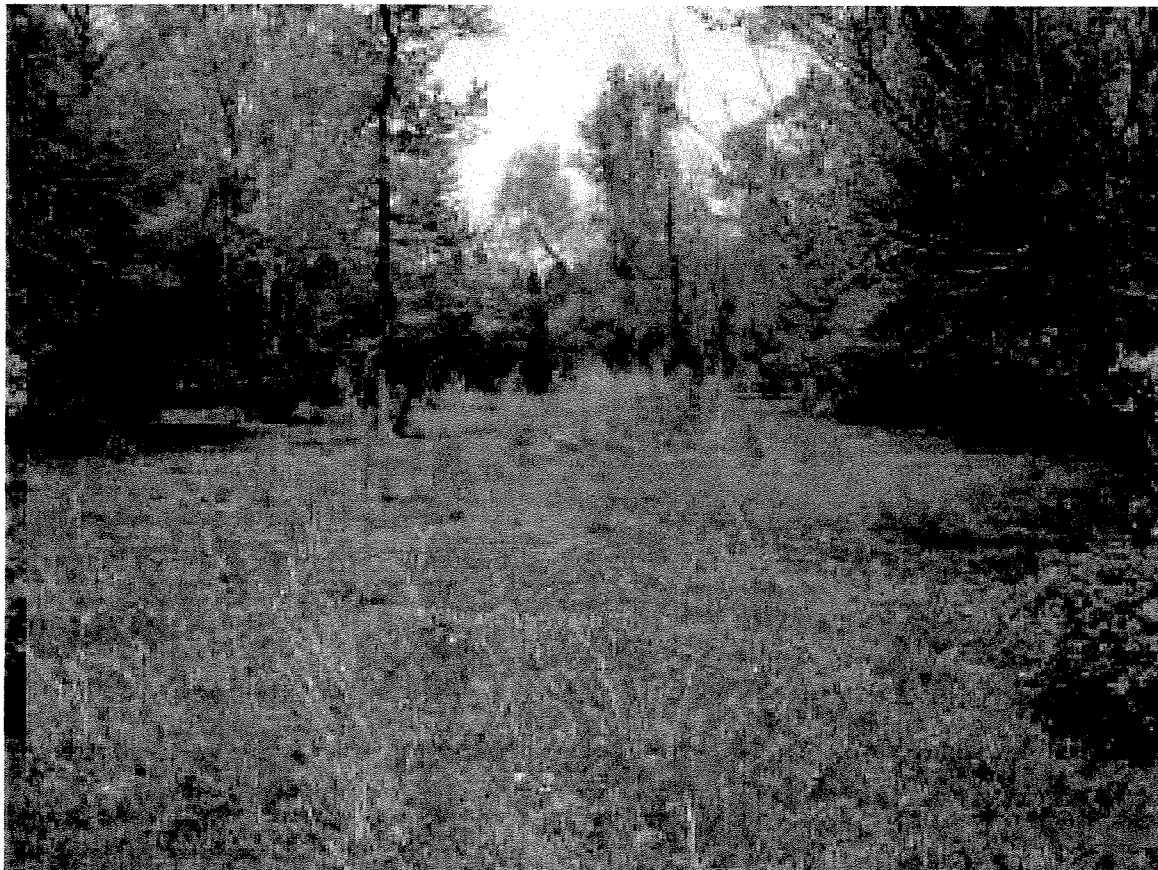
Photo 4. Swales like the one in the center of this photograph were constructed to drain the pasture

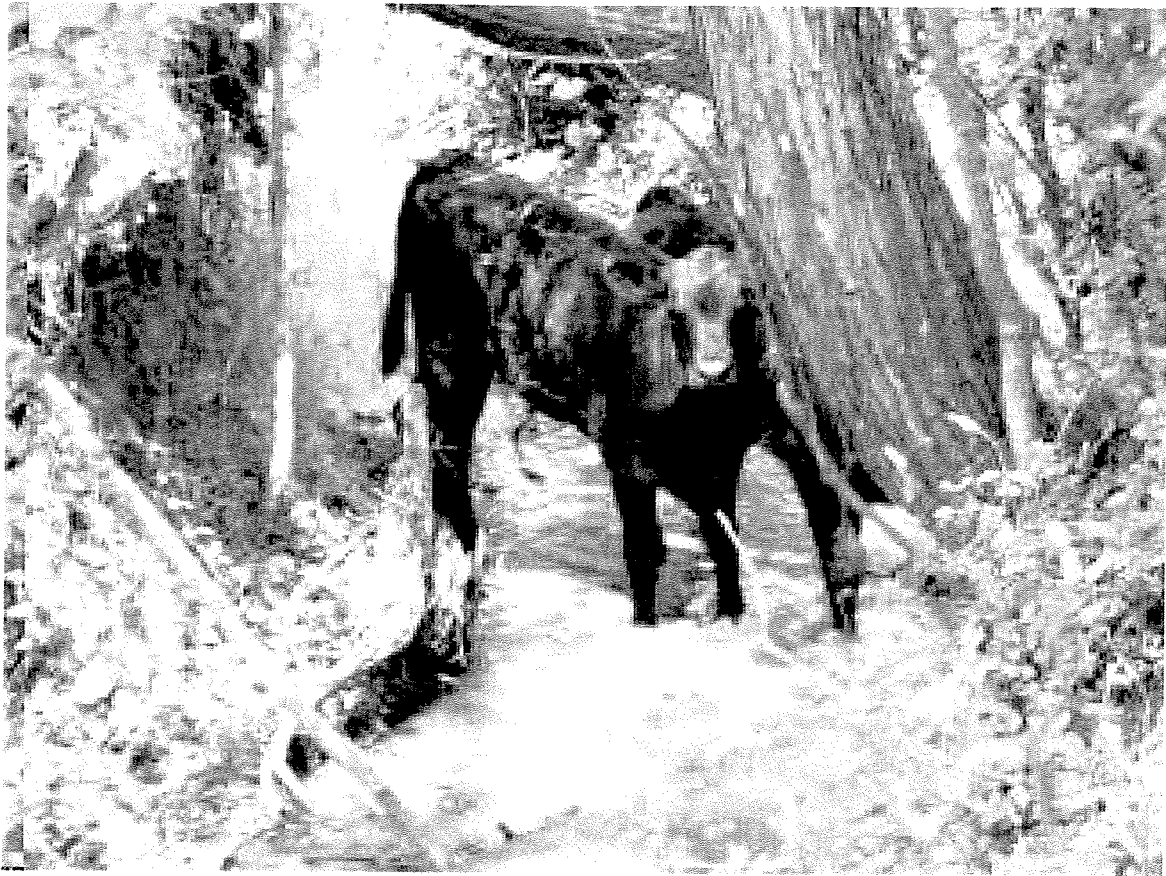
Photo 9. Cows browse woody vegetation along stream banks

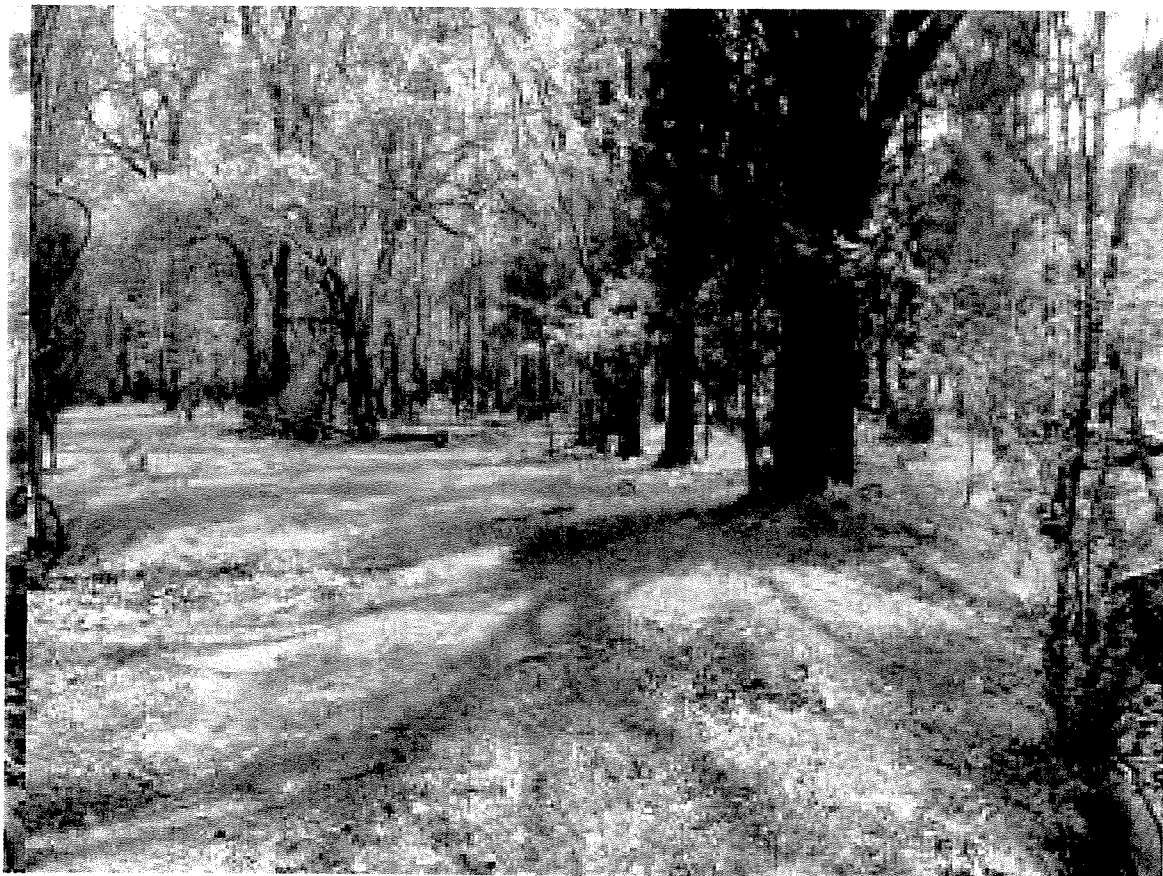
Photo 10. Understory is largely absent from riparian zone at the downstream end of the Cato Farm project site

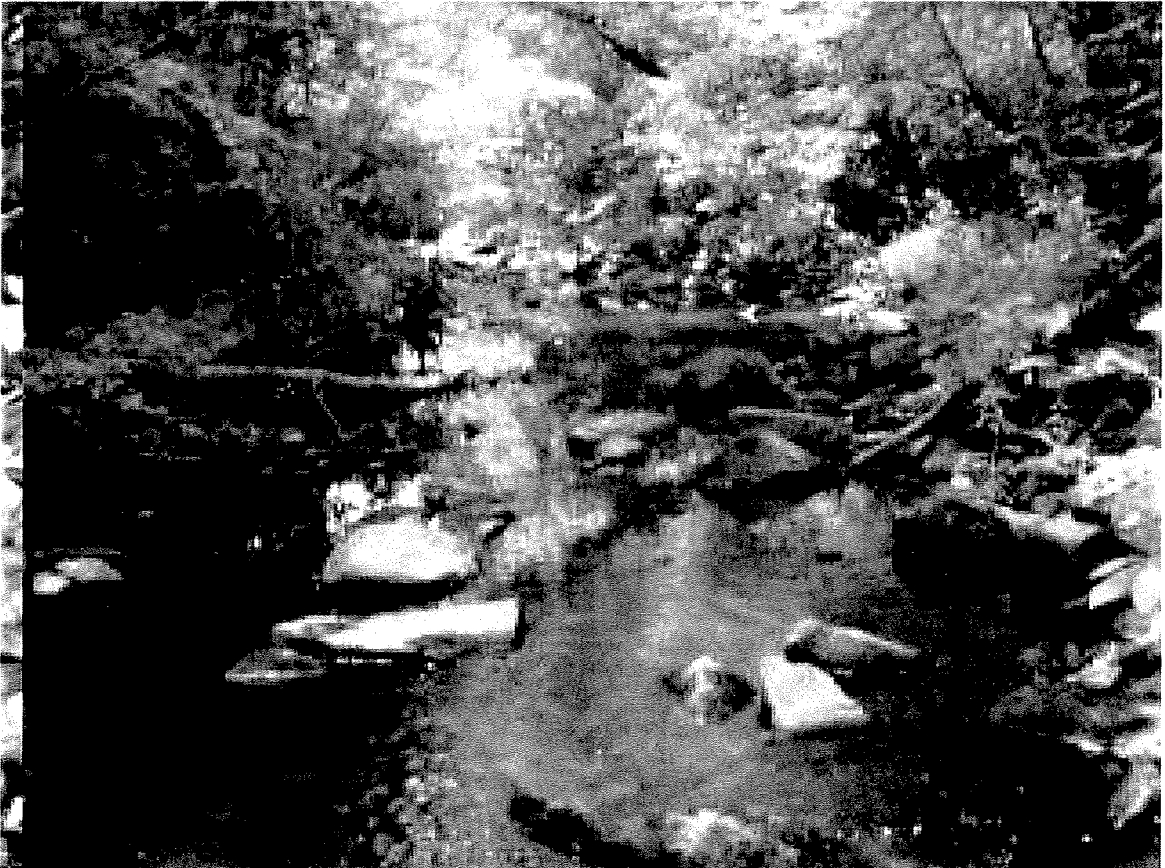
Photo 12. Coffey Creek Rosgen B5c stream type reference reach

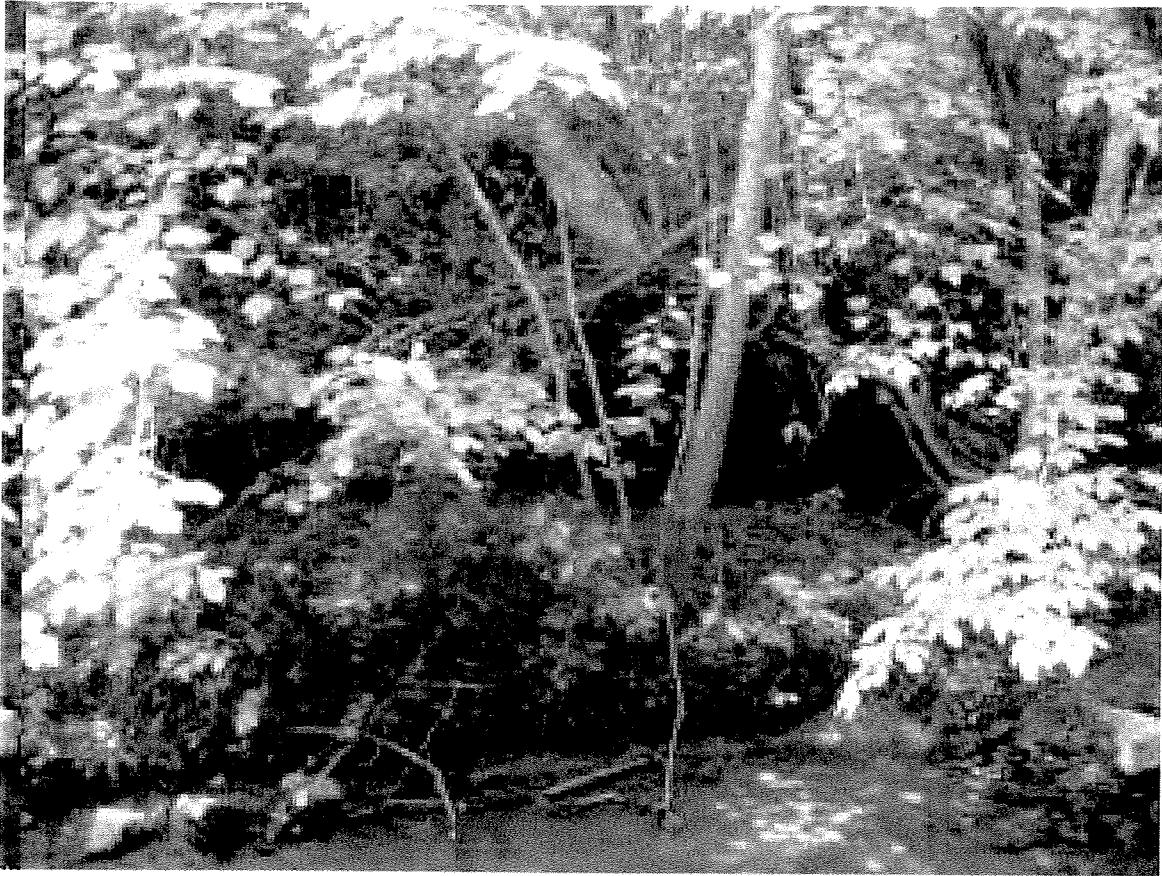
Photo 13. Change in slope on the stream bank indicates the bankfull stage

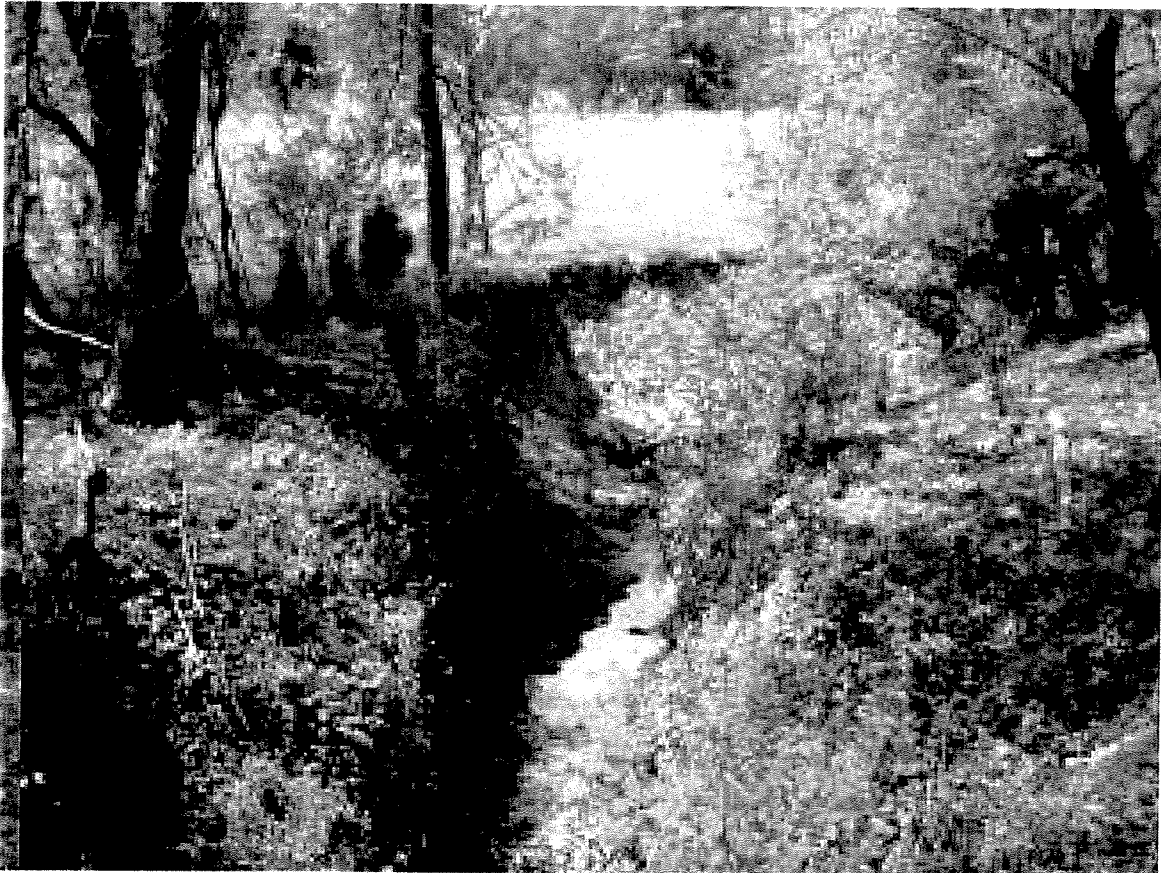
Photo 16. Stream bank erosion is pronounced at the Lower Reach at Cato Farm

The existing channel dimension is unstable at spot locations throughout the project area due to trampling of the stream bed and banks by cattle. The degradation of the stream cross section at the lower portion of the existing stream is especially pronounced however. The stream banks in this section of channel are eroding along the entire length (see Photo 16). To address the erosion throughout the project, the stream cross-section (dimension) will be adjusted to mimic stable reference conditions.
