Re: NCIRT Review and USACE Approval of the Cedar Branch Restoration Site Draft Mitigation Plan; SAW-2003-21395; DMS Project #97009

**PROPOSED MITIGATION
CEDAR BRANCH RESTORATION SITE
RANDOLPH COUNTY, NC**

**Lower Yadkin River Basin
Cataloging Unit 03040103**

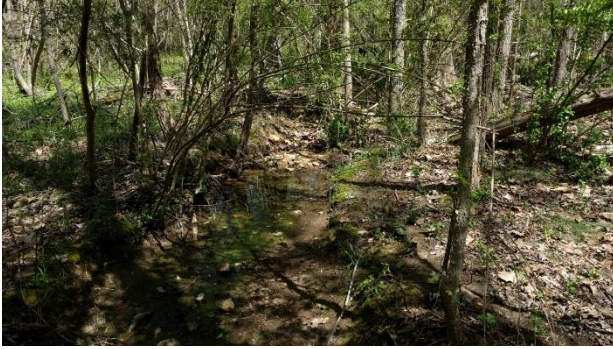
KCI has removed Tributary 5 from the credit calculations. We do feel that T5 is an intermittent stream. It emanates from a spring seep in the woods. KCI was not planning to do anything to the stream in the woods other than to stabilize a few headcuts where T5 entered UTCC. KCI was only requesting restoration credit for the extension of this channel from the woods line to the proposed location of UTCC (in the current ag. Field). Since this stream was not investigated as part of the JD walk with John Thomas and given the fact that site visits will likely delay project acceptance, we have removed T5 from the credit table. We will still design and construct the T5 extension, we just will not request credits for it. A photo is provided below for your reference. We would be happy to collect video footage of the channel in the woods if the IRT sees any justification in the attached photo for T5 credits.

6. Tributary 5 was not reviewed during the 2015 site visit. DWR suggests that this tributary should be visited by an IRT member to confirm the proposed plan and credits for this tributary.

4. Page 20, Table 5: The mitigation plan includes an additional resource (Tributary 5) that was not proposed at the technical stage or discussed/reviewed during the site visit. We recommend a site visit to review this resource and the proposed treatment.

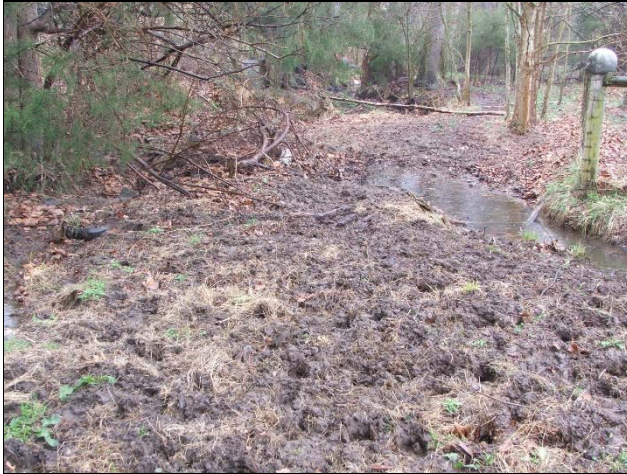
View looking south at the confluence of T1 and T1-1. Livestock access has degraded the bed and bank and impaired water quality. 3/19/15

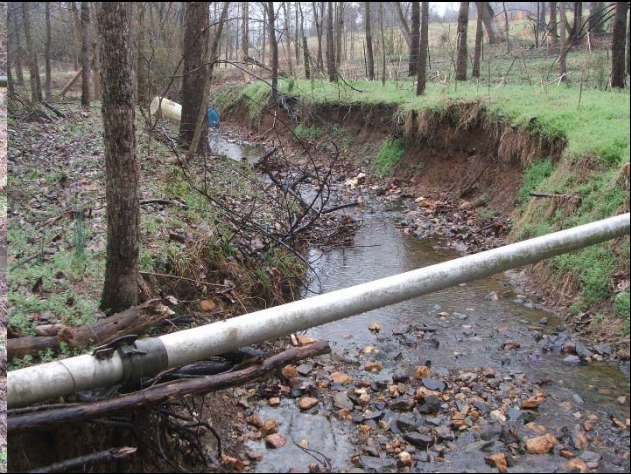
View looking south and downstream at T1. Elevating the channel will increase floodplain connection and hydrology. 3/19/15

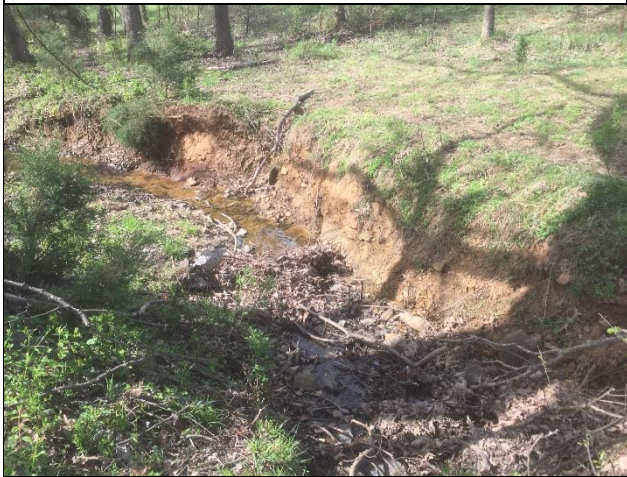
View north and upstream on UTCC. Restoration will integrate the stream with its floodplain. 4/13/15

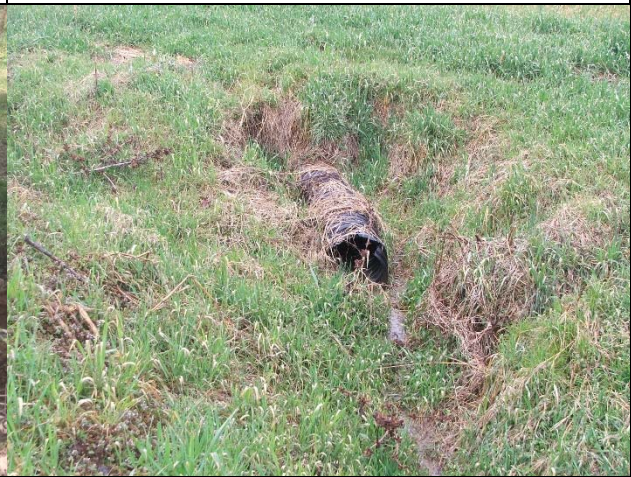
Drain emptying into the top of T3. On-site drainage will be directed into BMP's to mitigate nutrient and soil loading. 3/19/15

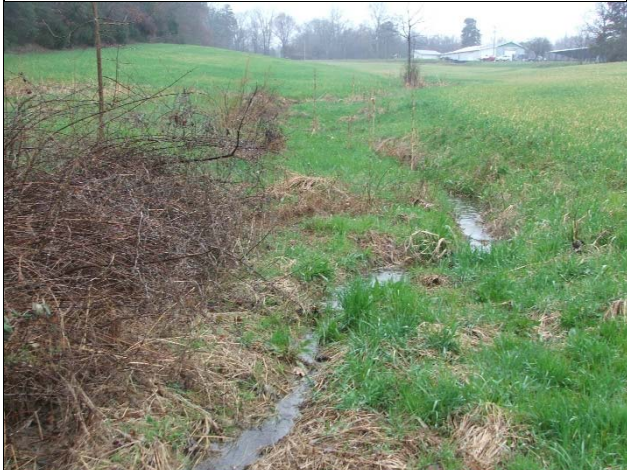
View north and upstream on T3. Streams will be buffered with a native vegetative buffer to limit soil and nutrient runoff from adjacent row crop operations. 3/19/15

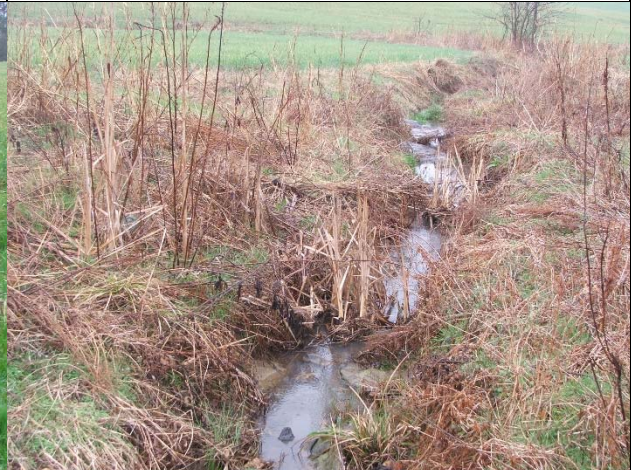
View south and downstream on T3 towards its confluence with UTCC where enhancement will restore a vegetative buffer. 3/19/15

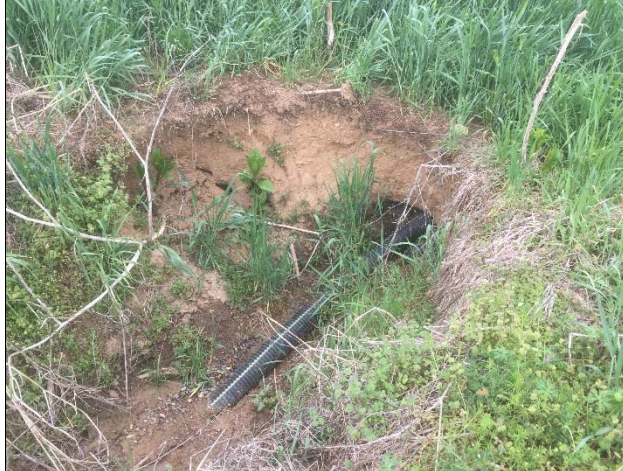
Tile drain emptying into T4. On-site drainage will be directed into BMP's to mitigate nutrient and soil loading. 4/13/15

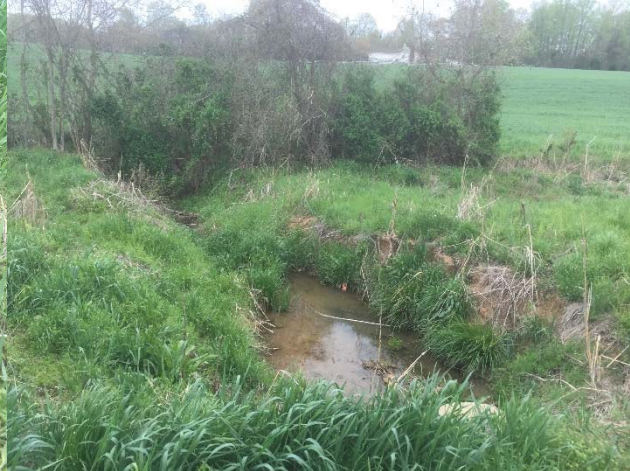
Looking west and downstream on T4 at its confluence with UTCC. Restoration will integrate T4 with its floodplain. 4/13/15

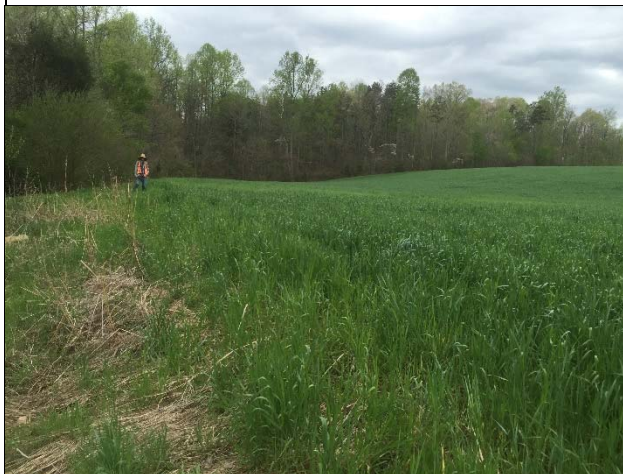
View looking south at the relic floodplain, where the lower portion of UTCC and its planted riparian buffer will be relocated. 4/13/15

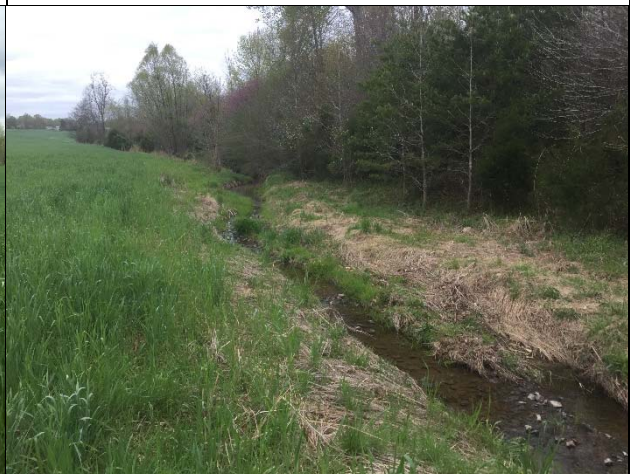
Looking north and upstream at the lower portion of UTCC that is to be relocated. 4/13/15

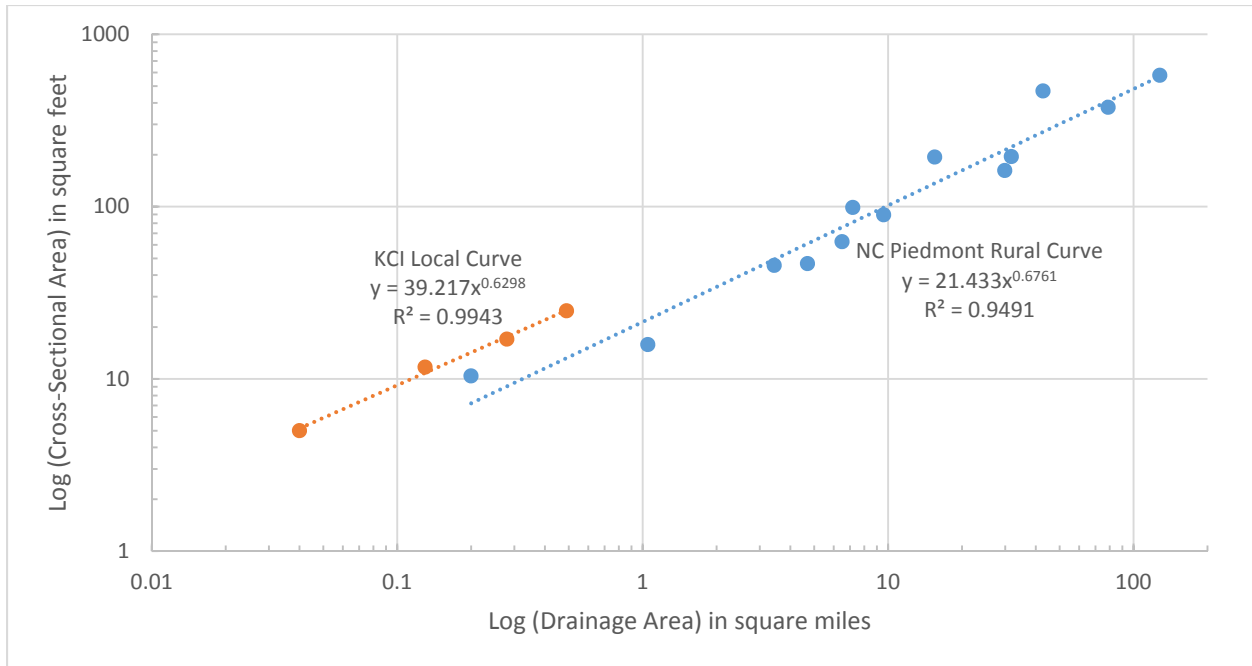
Figure 7. Local Curve for Bankfull Determination

KCI conducted bankfull verification by locating two stable cross-sections found immediately outside of the project area (UTCC Upstream and UTCC Downstream), along with two cross-sections within the project that had stable bankfull indicators (UTCC On-Site and UT1 On-Site) (see Appendix B). A local regional curve was created using these cross-sections as shown below to compare with the Piedmont Regional Curve (Harman et al 1999). The local curve showed that the Piedmont Curve was underestimating the cross-sectional area compared to the data collected from the local project streams. Based on this analysis, we used the local bankfull data to determine bankfull elevations and cross-sectional areas for the proposed channel sizing.

Cross-Section Location	Acres	Drainage Area (Sq. Miles)	Field XS Area (sf)	XS Area Estimate (sf) from Local Regional Curve	Q (cfs)
Onsite T1	25.2	0.04	5.0	5.1	14.4
UTCC Upstream	84.3	0.13	11.7	10.9	40.5
Onsite UTCC	177.9	0.28	17.0	17.5	96.2
UTCC Downstream	313.3	0.49	24.8	25.0	111.2

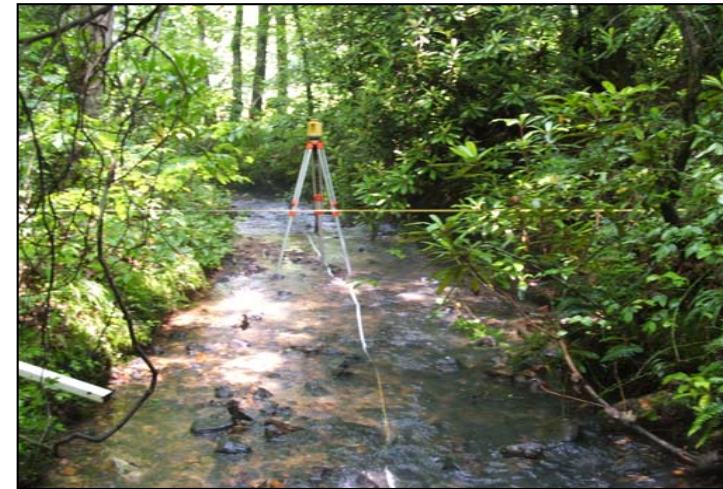
Yadkin River Basin, UT to Fisher River, XS#1 Riffle

Station	Rod Ht.	Elevation
0.0	2.22	100.00
3.0	2.15	100.07
5.0	2.50	99.72
7.0	2.98	99.24
8.0	3.49	98.73
8.8	4.00	98.22
9.0	4.96	97.26
12.0	5.03	97.19
14.0	5.25	96.97
16.0	5.16	97.06
17.0	5.20	97.02
18.0	5.06	97.16
18.7	4.00	98.22
19.5	2.65	99.57
20.0	1.66	100.56

SUMMARY DATA	
Bankfull Elevation:	98.22
Bankfull Cross-Sectional Area:	10.40
Bankfull Width:	10.00
Flood Prone Area Elevation:	99.47
Flood Prone Width:	13.10
Max Depth at Bankfull:	1.25
Mean Depth at Bankfull:	1.04
W / D Ratio:	9.6
Entrenchment Ratio:	1.30
Bank Height Ratio:	2.08
Slope (ft/ft):	0.013
Discharge (cfs)	42

Stream Type:	B4c
---------------------	-----

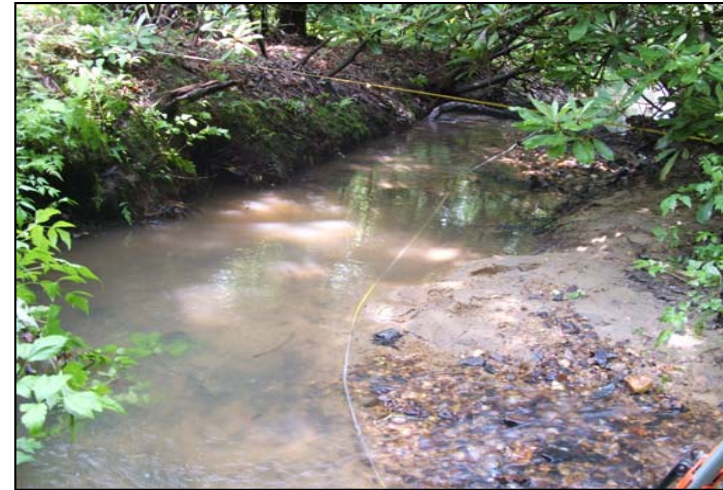
Yadkin River Basin, UT to Fisher River, XS#3 Pool

Station	Rod Ht.	Elevation
0.0	1.33	100.00
3.0	1.78	99.55
5.0	2.35	98.98
5.5	2.82	98.51
5.7	3.81	97.52
6.0	4.52	96.81
6.5	5.79	95.54
8.0	5.82	95.51
9.0	5.50	95.83
10.0	5.02	96.31
11.5	4.80	96.53
13.0	3.90	97.43
14.0	3.55	97.78
16.0	3.03	98.30
20.0	2.66	98.67

SUMMARY DATA	
Bankfull Elevation:	97.78
Bankfull Cross-Sectional Area:	11.60
Bankfull Width:	8.35
Flood Prone Area Elevation:	100.05
Flood Prone Width:	
Max Depth at Bankfull:	2.27
Mean Depth at Bankfull:	1.39
W / D Ratio:	6.0
Entrenchment Ratio:	
Bank Height Ratio:	0.85
Slope (ft/ft):	0.001
Discharge (cfs)	52

Stream Type: B4c

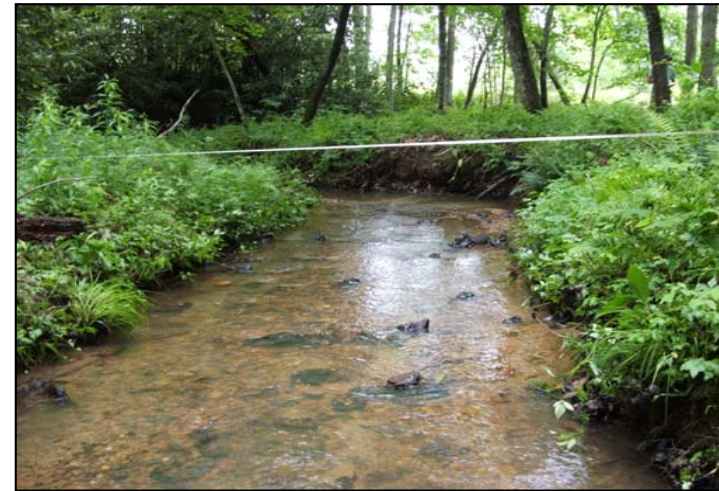
River Basin:	Yadkin
Watershed:	UT to Fisher River
XS ID	XS#4 Riffle
Drainage Area (sq mi):	0.38
Date:	6/9/2005
Field Crew:	G. Mryncza, A. Spiller

Station	Rod Ht.	Elevation
0.0	4.62	100.00
3.0	5.54	99.08
7.0	6.01	98.61
8.5	6.34	98.28
9.0	7.04	97.58
9.5	7.66	96.96
11.0	7.67	96.95
12.0	7.79	96.83
14.0	7.58	97.04
16.0	7.57	97.05
17.0	7.51	97.11
17.5	6.34	98.28
19.0	5.90	98.72
21.0	5.06	99.56
25.0	4.37	100.25

SUMMARY DATA	
Bankfull Elevation:	98.28
Bankfull Cross-Sectional Area:	10.70
Bankfull Width:	9.00
Flood Prone Area Elevation:	99.73
Flood Prone Width:	20.50
Max Depth at Bankfull:	1.45
Mean Depth at Bankfull:	1.19
W / D Ratio:	7.6
Entrenchment Ratio:	2.30
Bank Height Ratio:	1.00
Slope (ft/ft):	0.013
Discharge (cfs)	46

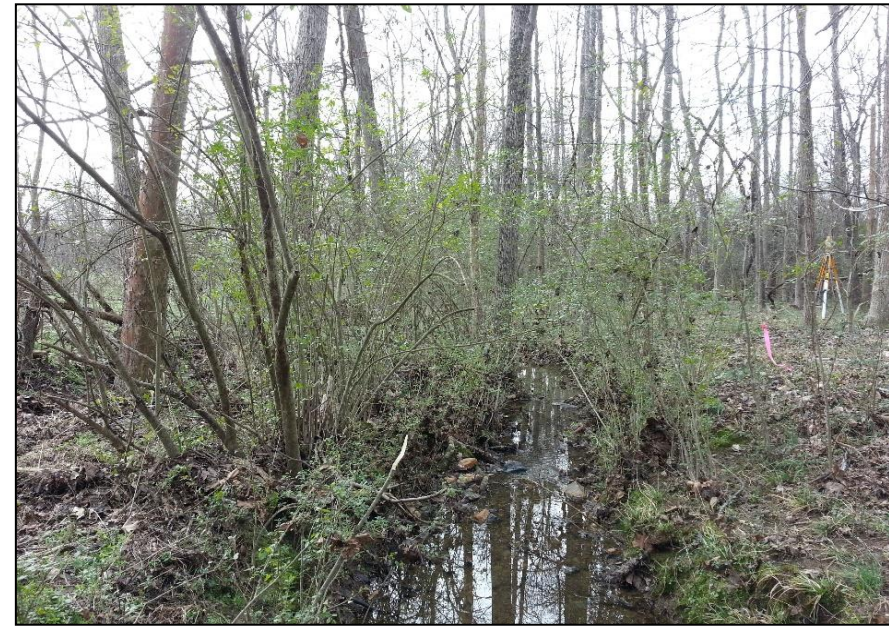
River Basin:	Yadkin
Watershed:	Caraway Creek
XS ID	Upstream XS-1
Drainage Area (sq mi):	84 acres
Date:	1/6/2016
Field Crew:	A. French, T. Seelinger

Station	Elevation
0.0	500.39
3.9	499.90
8.2	499.62
12.3	498.79
14.9	498.45
17.6	498.52
19.4	498.64
21.7	498.70
23.0	498.28
24.1	497.19
25.1	497.04
26.7	497.04
28.0	497.10
28.5	497.18
30.1	498.10
32.1	498.99
34.1	499.64
36.6	500.01
40.1	500.07
45.9	500.22
49.3	500.32

SUMMARY DATA	
Bankfull Elevation:	498.70
Top of Bank Elevation:	498.69
Bankfull Cross-Sectional Area:	11.7
Bankfull Width:	18.2
Flood Prone Area Elevation:	500.36
Flood Prone Width:	49.0
Max Depth at Bankfull:	1.7
Mean Depth at Bankfull:	0.6
W / D Ratio:	9.0
Entrenchment Ratio:	5.1
Bank Height Ratio:	1.0

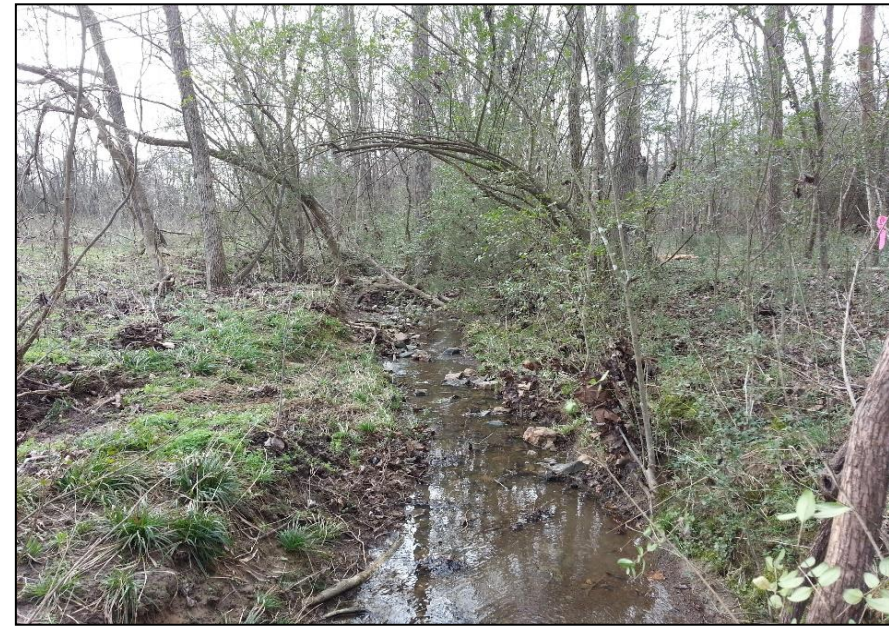
River Basin:	Yadkin
Watershed:	Caraway Creek
XS ID	Upstream XS-2
Drainage Area (sq mi):	84 acres
Date:	1/6/2016
Field Crew:	A. French, T. Seelinger

Station	Elevation
0.0	499.13
8.1	499.16
10.9	498.79
14.3	497.94
17.4	497.74
21.2	497.72
23.0	497.56
25.0	496.99
26.4	496.65
27.5	496.13
28.5	495.98
29.4	496.07
30.2	496.05
30.8	496.18
31.8	496.83
33.2	497.63
35.5	498.09
38.0	498.67
41.6	499.04
46.5	499.28
51.3	499.36

SUMMARY DATA	
Bankfull Elevation:	497.70
Top of Bank Elevation:	497.69
Bankfull Cross-Sectional Area:	10.9
Bankfull Width:	12.1
Flood Prone Area Elevation:	499.40
Flood Prone Width:	50.0
Max Depth at Bankfull:	1.7
Mean Depth at Bankfull:	0.9
W / D Ratio:	13.4
Entrenchment Ratio:	>5
Bank Height Ratio:	1.0

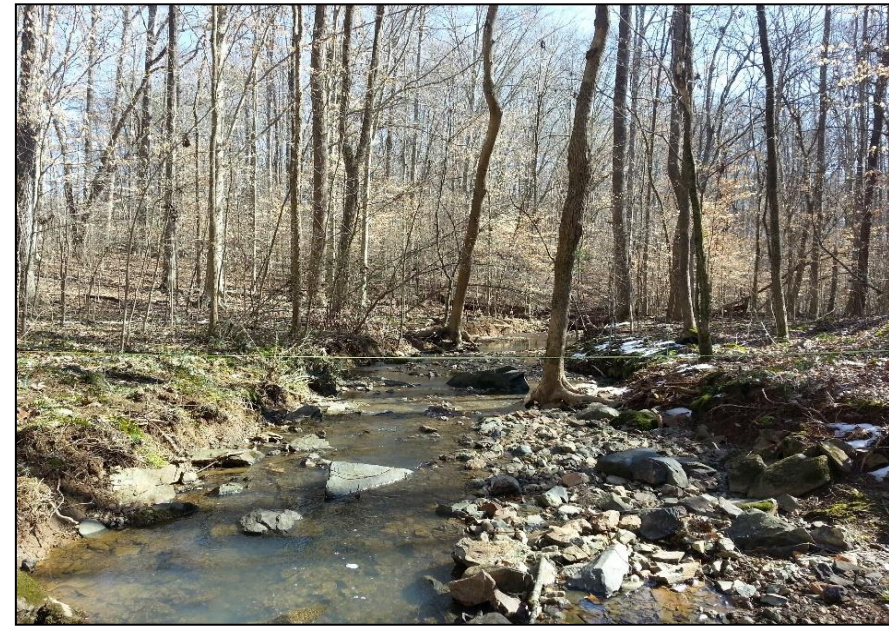
River Basin:	Yadkin
Watershed:	Caraway Creek
XS ID	Downstream XS
Drainage Area (sq mi):	313 acres
Date:	1/6/2016
Field Crew:	A. French, T. Seelinger

Station	Elevation
0.0	10499.77
2.4	10499.60
4.4	10499.48
8.3	10499.19
10.6	10499.11
12.9	10498.46
15.1	10498.31
16.1	10496.73
18.5	10496.71
20.4	10496.65
23.0	10496.75
24.5	10496.82
27.2	10496.99
30.0	10496.79
32.0	10497.34
32.8	10498.31
33.8	10499.22
37.8	10499.33
41.0	10499.67
44.0	10500.35

SUMMARY DATA	
Bankfull Elevation:	10498.30
Top of Bank Elevation:	10498.29
Bankfull Cross-Sectional Area:	24.7
Bankfull Width:	17.7
Flood Prone Area Elevation:	10500.00
Flood Prone Width:	100.0
Max Depth at Bankfull:	1.7
Mean Depth at Bankfull:	1.4
W / D Ratio:	12.7
Entrenchment Ratio:	5.6
Bank Height Ratio:	1.0

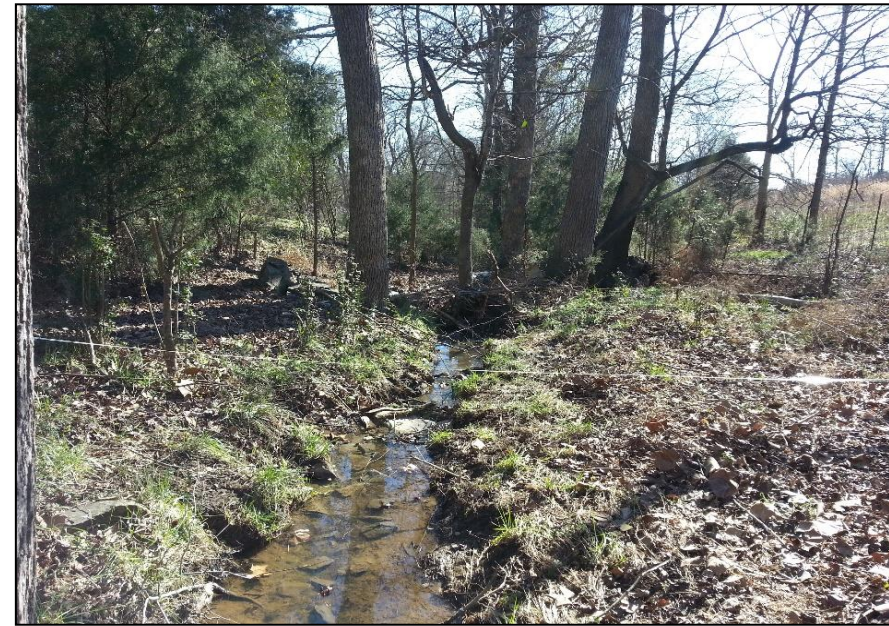
River Basin:	Yadkin
Watershed:	Caraway Creek
XS ID	Onsite-T1
Drainage Area (sq mi):	25 acres
Date:	1/6/2016
Field Crew:	A. French, T. Seelinger

Station	Elevation
0.0	692.00
2.7	691.35
4.7	690.85
7.3	690.27
8.9	690.04
9.7	689.81
10.2	689.18
11.1	688.93
12.0	688.99
12.9	689.15
13.9	689.57
14.7	689.79
15.7	689.90
17.6	690.12
23.2	690.22
25.7	690.46

SUMMARY DATA	
Bankfull Elevation:	690.12
Top of Bank Elevation:	690.11
Bankfull Cross-Sectional Area:	5.0
Bankfull Width:	9.2
Flood Prone Area Elevation:	691.32
Flood Prone Width:	30.0
Max Depth at Bankfull:	1.2
Mean Depth at Bankfull:	0.5
W / D Ratio:	16.8
Entrenchment Ratio:	3.3
Bank Height Ratio:	1.0

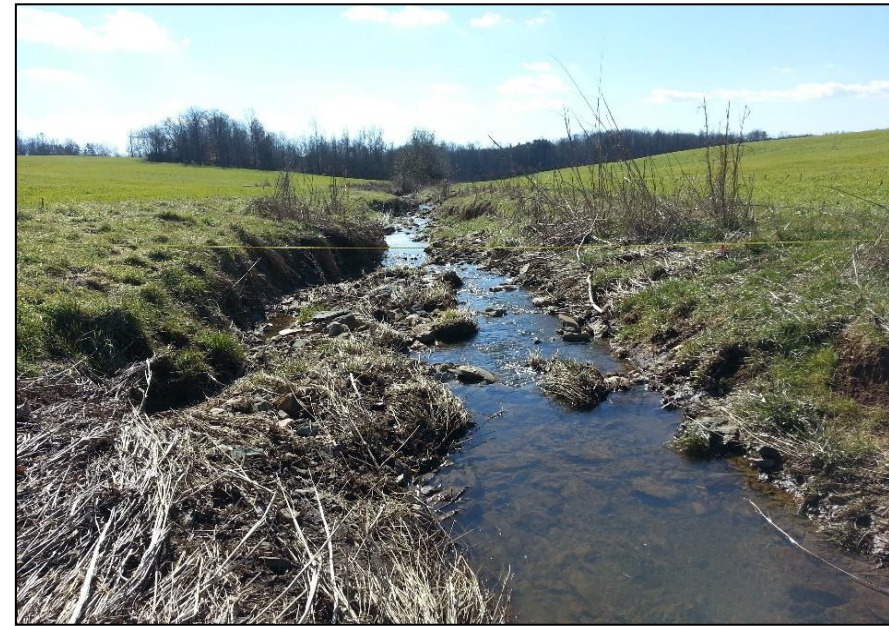
River Basin:	Yadkin
Watershed:	Caraway Creek
XS ID	Onsite-UTCC
Drainage Area (sq mi):	178 acres
Date:	1/6/2016
Field Crew:	A. French, T. Seelinger

Station	Elevation
0.0	660.04
4.5	659.87
9.5	659.75
12.3	659.37
14.5	658.89
15.7	658.52
16.6	658.20
17.7	657.48
18.6	656.78
20.6	657.02
22.2	656.57
23.4	656.33
24.5	656.13
25.8	656.36
27.2	656.34
28.2	657.36
29.5	657.81
30.7	658.13
33.8	658.49
37.4	658.71
41.6	658.82
45.5	658.85

SUMMARY DATA	
Bankfull Elevation:	658.13
Top of Bank Elevation:	658.12
Bankfull Cross-Sectional Area:	17.0
Bankfull Width:	14.0
Flood Prone Area Elevation:	660.13
Flood Prone Width:	>50
Max Depth at Bankfull:	2.0
Mean Depth at Bankfull:	1.2
W / D Ratio:	11.5
Entrenchment Ratio:	3.6
Bank Height Ratio:	1.0

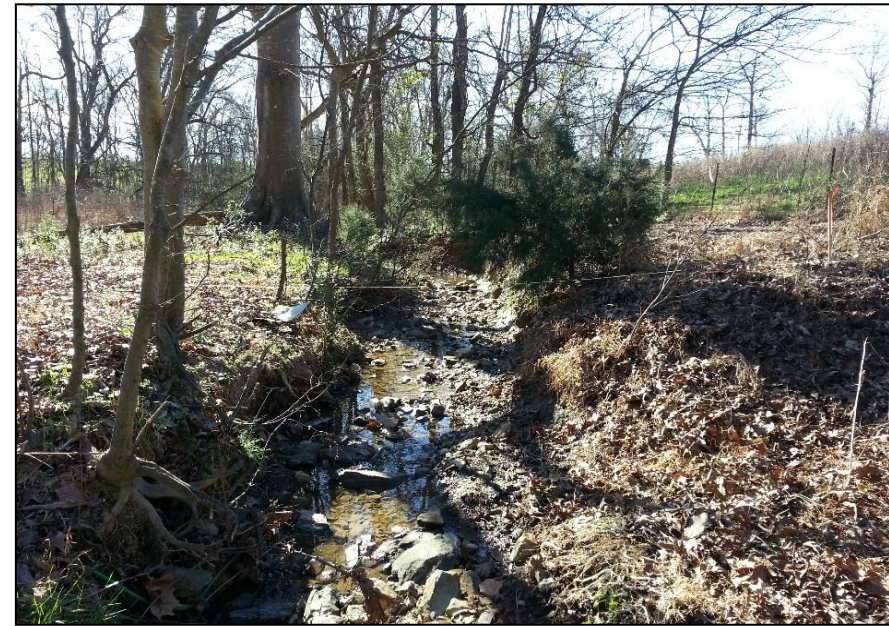
River Basin:	Yadkin
Watershed:	Caraway Creek
XS ID	XS-1
Drainage Area (sq mi):	16 acres
Date:	1/6/2016
Field Crew:	A. French, T. Seelinger

Station	Elevation
0.0	684.57
3.4	684.60
6.5	684.64
10.0	684.77
12.4	684.79
14.7	684.65
15.6	683.98
16.5	683.48
17.4	682.16
18.3	681.97
20.0	682.21
21.8	682.25
22.8	683.46
23.9	684.16
25.5	684.82
28.0	685.34
30.2	685.42
32.7	685.68
36.3	685.96
39.4	686.17

SUMMARY DATA	
Bankfull Elevation:	683.13
Top of Bank Elevation:	684.65
Bankfull Cross-Sectional Area:	5.0
Bankfull Width:	5.8
Flood Prone Area Elevation:	684.29
Flood Prone Width:	9.0
Max Depth at Bankfull:	1.2
Mean Depth at Bankfull:	0.9
W / D Ratio:	6.7
Entrenchment Ratio:	1.5
Bank Height Ratio:	2.3

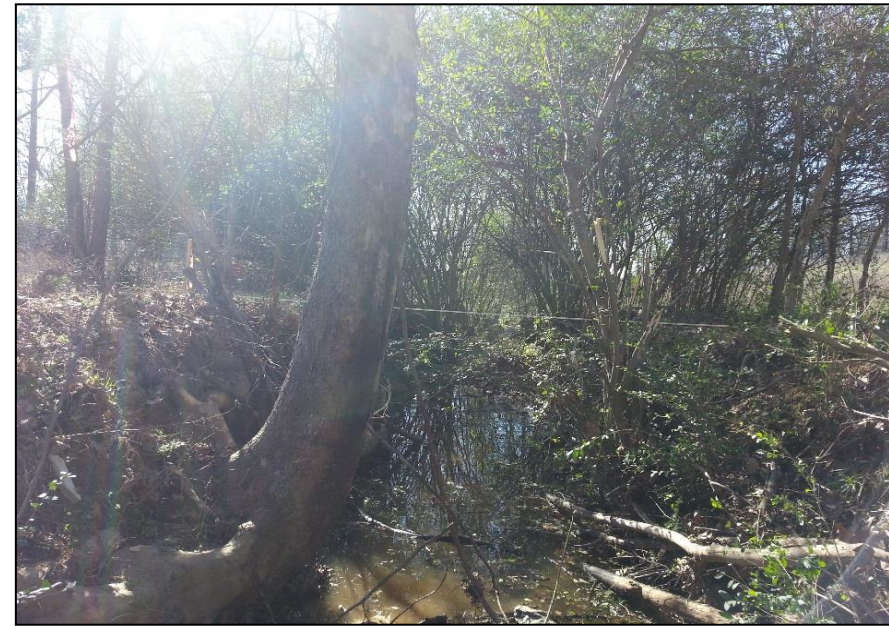
River Basin:	Yadkin
Watershed:	Caraway Creek
XS ID	XS-2
Drainage Area (sq mi):	88 acres
Date:	1/6/2016
Field Crew:	A. French, T. Seelinger

Station	Elevation
0.0	676.67
4.8	676.79
9.4	676.87
14.2	676.66
17.2	676.59
18.8	674.72
20.3	672.20
22.3	671.84
23.6	671.82
25.2	671.90
26.8	671.93
27.8	675.10
29.3	675.88
31.4	676.15
36.4	676.03
40.7	676.15
46.0	676.27
51.6	676.51

SUMMARY DATA	
Bankfull Elevation:	673.52
Top of Bank Elevation:	676.15
Bankfull Cross-Sectional Area:	11.3
Bankfull Width:	7.8
Flood Prone Area Elevation:	675.22
Flood Prone Width:	9.6
Max Depth at Bankfull:	1.7
Mean Depth at Bankfull:	1.5
W / D Ratio:	5.3
Entrenchment Ratio:	1.2
Bank Height Ratio:	2.5

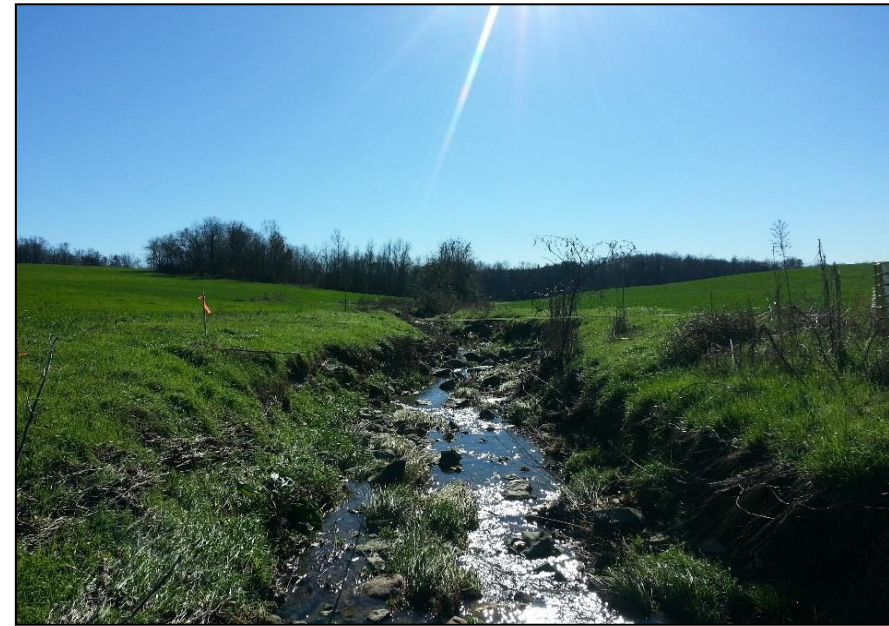
River Basin:	Yadkin
Watershed:	Caraway Creek
XS ID	XS-3
Drainage Area (sq mi):	294 acres
Date:	1/6/2016
Field Crew:	A. French, T. Seelinger

Station	Elevation
0.0	658.98
4.6	658.72
7.8	658.64
11.3	658.36
14.5	657.73
16.3	657.24
17.4	655.72
19.3	654.70
20.1	654.58
22.0	654.18
22.7	654.18
24.1	654.17
25.4	654.09
26.7	654.73
27.3	655.25
27.7	656.60
30.5	657.37
33.2	657.89
37.4	658.02
41.8	657.85
45.5	657.79
48.9	657.83

SUMMARY DATA	
Bankfull Elevation:	655.86
Top of Bank Elevation:	658.00
Bankfull Cross-Sectional Area:	13.2
Bankfull Width:	10.1
Flood Prone Area Elevation:	657.66
Flood Prone Width:	17.0
Max Depth at Bankfull:	1.8
Mean Depth at Bankfull:	1.3
W / D Ratio:	7.8
Entrenchment Ratio:	1.7
Bank Height Ratio:	2.2

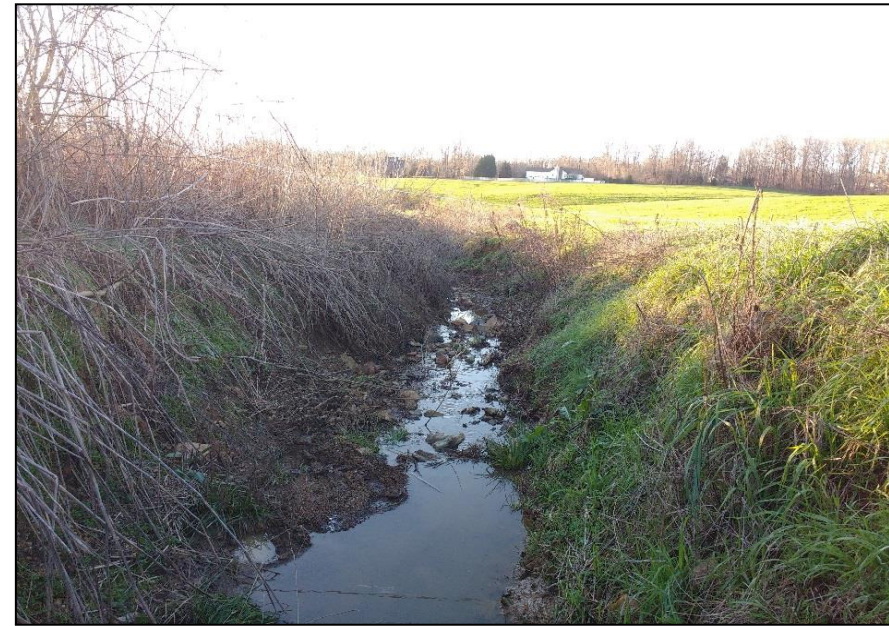
River Basin:	Yadkin
Watershed:	Caraway Creek
XS ID	XS-4
Drainage Area (sq mi):	30 acres
Date:	1/6/2016
Field Crew:	A. French, T. Seelinger

Station	Elevation
0.0	673.24
5.1	672.89
11.0	672.49
18.5	672.06
24.8	671.52
26.9	670.89
28.1	669.83
29.1	667.88
30.3	667.40
31.2	667.28
31.7	667.28
32.4	667.21
33.4	667.20
34.2	667.17
35.0	667.46
36.5	669.45
39.0	671.33
41.0	671.98
43.8	672.35
50.1	672.55
55.8	672.88

SUMMARY DATA	
Bankfull Elevation:	668.15
Top of Bank Elevation:	671.52
Bankfull Cross-Sectional Area:	5.0
Bankfull Width:	6.5
Flood Prone Area Elevation:	669.15
Flood Prone Width:	7.8
Max Depth at Bankfull:	1.0
Mean Depth at Bankfull:	0.8
W / D Ratio:	8.5
Entrenchment Ratio:	1.2
Bank Height Ratio:	4.5

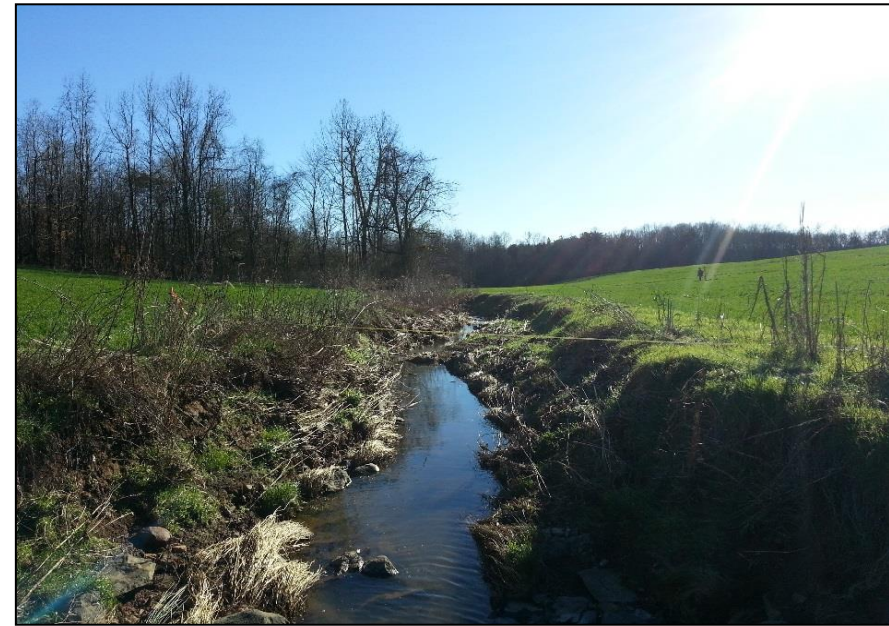
River Basin:	Yadkin
Watershed:	Caraway Creek
XS ID	XS-5
Drainage Area (sq mi):	294 acres
Date:	1/6/2016
Field Crew:	A. French, T. Seelinger

Station	Elevation
0.0	651.08
4.2	650.97
7.7	651.05
12.1	651.27
14.8	651.46
17.9	651.11
19.2	649.19
20.5	646.85
21.0	647.00
22.0	647.05
22.5	646.96
23.0	646.19
24.4	646.40
26.3	646.57
27.4	647.34
29.6	648.87
30.8	649.56
32.0	650.57
35.0	650.52
40.5	650.68
46.2	650.49
52.4	650.63

SUMMARY DATA	
Bankfull Elevation:	648.76
Top of Bank Elevation:	650.57
Bankfull Cross-Sectional Area:	16.9
Bankfull Width:	10.0
Flood Prone Area Elevation:	651.36
Flood Prone Width:	>50
Max Depth at Bankfull:	2.6
Mean Depth at Bankfull:	1.7
W / D Ratio:	5.9
Entrenchment Ratio:	5.0
Bank Height Ratio:	1.7

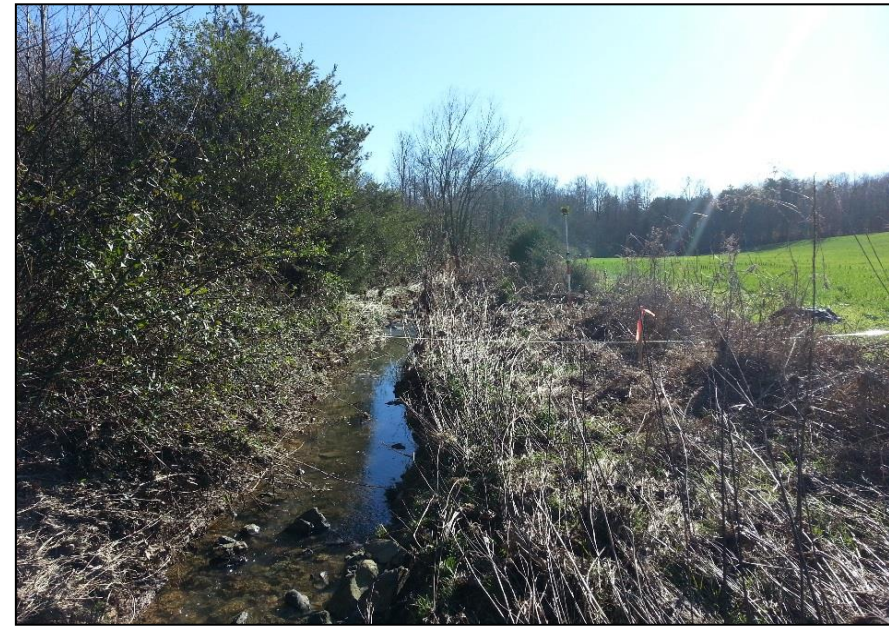
River Basin:	Yadkin
Watershed:	Caraway Creek
XS ID	XS-6
Drainage Area (sq mi):	294 acres
Date:	1/6/2016
Field Crew:	A. French, T. Seelinger

Station	Elevation
0.0	646.36
1.5	645.84
5.2	644.73
8.6	644.32
12.7	644.35
14.3	644.06
14.9	643.54
15.7	642.71
16.3	641.91
17.8	641.46
19.6	641.59
20.4	642.01
21.5	643.48
22.2	643.87
24.7	643.99
28.0	644.44
30.0	644.70
33.8	645.34
39.1	645.58
44.6	645.60
48.7	645.64

SUMMARY DATA	
Bankfull Elevation:	644.30
Top of Bank Elevation:	644.35
Bankfull Cross-Sectional Area:	16.9
Bankfull Width:	13.9
Flood Prone Area Elevation:	647.10
Flood Prone Width:	>50
Max Depth at Bankfull:	2.8
Mean Depth at Bankfull:	1.2
W / D Ratio:	11.4
Entrenchment Ratio:	3.5
Bank Height Ratio:	1.0

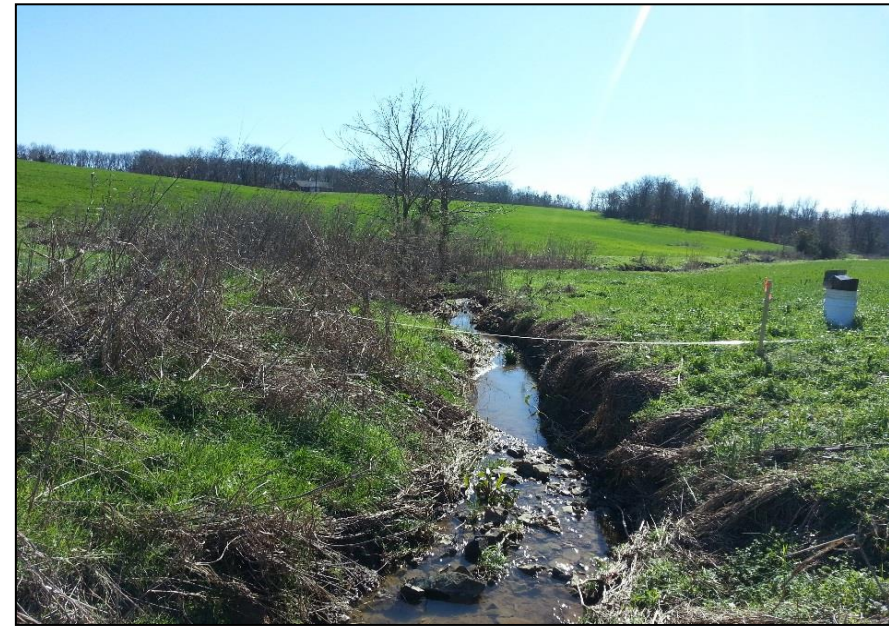
River Basin:	Yadkin
Watershed:	Caraway Creek
XS ID	XS-7
Drainage Area (sq mi):	28 acres
Date:	1/6/2016
Field Crew:	A. French, T. Seelinger

Station	Elevation
0.0	663.16
3.7	663.14
7.0	663.29
10.5	663.10
13.4	662.37
15.5	661.70
16.8	661.27
18.1	660.61
19.4	660.20
20.0	660.02
20.9	660.02
21.5	660.01
22.4	660.76
23.4	662.38
26.0	662.93
29.4	663.34
34.3	663.56
38.0	663.85

SUMMARY DATA	
Bankfull Elevation:	661.27
Top of Bank Elevation:	663.29
Bankfull Cross-Sectional Area:	5.0
Bankfull Width:	6.0
Flood Prone Area Elevation:	662.57
Flood Prone Width:	11.3
Max Depth at Bankfull:	1.3
Mean Depth at Bankfull:	0.8
W / D Ratio:	7.1
Entrenchment Ratio:	1.3
Bank Height Ratio:	2.6

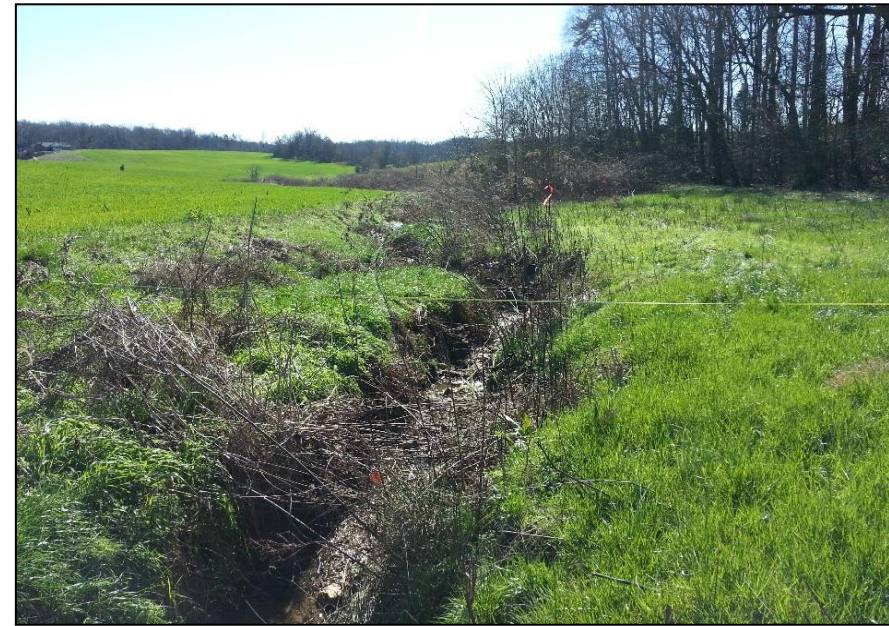
River Basin:	Yadkin
Watershed:	Caraway Creek
XS ID	XS-8
Drainage Area (sq mi):	7 acres
Date:	1/6/2016
Field Crew:	A. French, T. Seelinger

Station	Elevation
0.0	685.45
3.7	685.23
7.7	684.30
11.9	683.69
15.4	683.90
17.0	683.84
17.6	682.60
18.0	681.75
19.4	681.89
20.9	682.20
22.5	683.26
24.2	684.54
27.2	684.79
31.0	685.07
35.2	685.26

SUMMARY DATA	
Bankfull Elevation:	683.00
Top of Bank Elevation:	683.80
Bankfull Cross-Sectional Area:	3.9
Bankfull Width:	4.7
Flood Prone Area Elevation:	684.30
Flood Prone Width:	15.7
Max Depth at Bankfull:	1.3
Mean Depth at Bankfull:	0.8
W / D Ratio:	5.6
Entrenchment Ratio:	3.4
Bank Height Ratio:	1.6

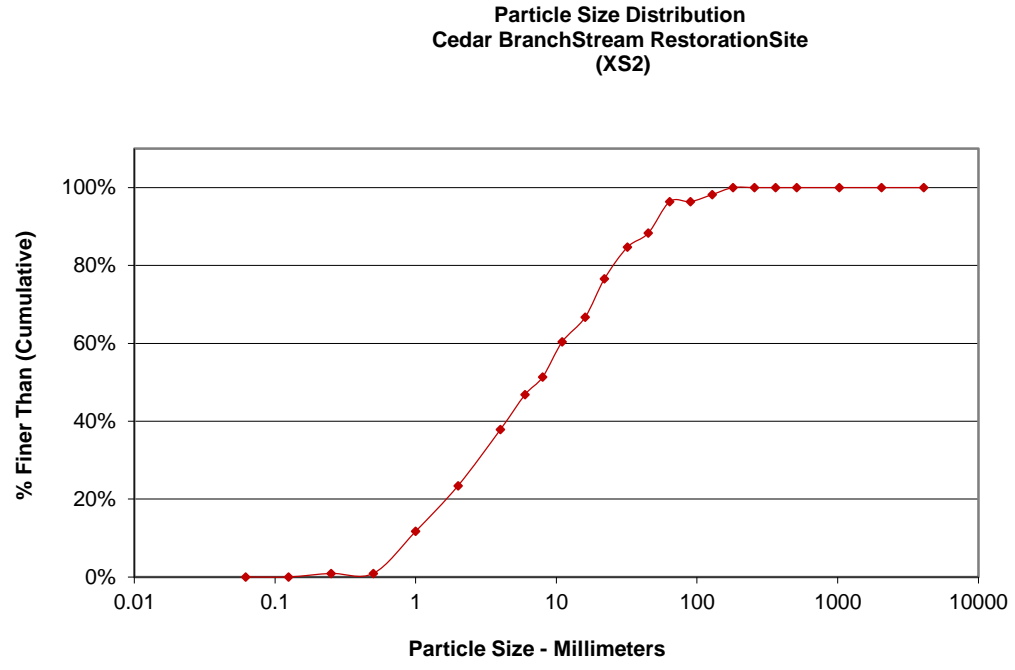
Cross-Section 2			
Particle	Millimeter		Count
Silt/Clay	< 0.062	S/C	
Very Fine	.062 - .125	S	
Fine	.125 - .25	A	1
Medium	.25 - .50	N	
Coarse	.50 - 1	D	12
Very Coarse	1 - 2	S	13
Very Fine	2 - 4		16
Fine	4 - 5.7	G	10
Fine	5.7 - 8	R	5
Medium	8 - 11.3	A	10
Medium	11.3 - 16	V	7
Coarse	16 - 22.6	E	11
Coarse	22.6 - 32	L	9
Very Coarse	32 - 45	S	4
Very Coarse	45 - 64		9
Small	64 - 90	C	
Small	90 - 128	O	2
Large	128 - 180	B	2
Large	180 - 256	L	
Small	256 - 362	B	
Small	362 - 512	L	
Medium	512 - 1024	D	
Lrg- Very Lrg	1024 - 2048	R	
Bedrock	>2048	BDRK	
		Total	111
Note:

Size (mm)	
D16	1.3
D35	4
D50	7
D65	14
D84	31
D95	60

Size Distribution	
mean	6.3
dispersion	4.9
skewness	-0.09

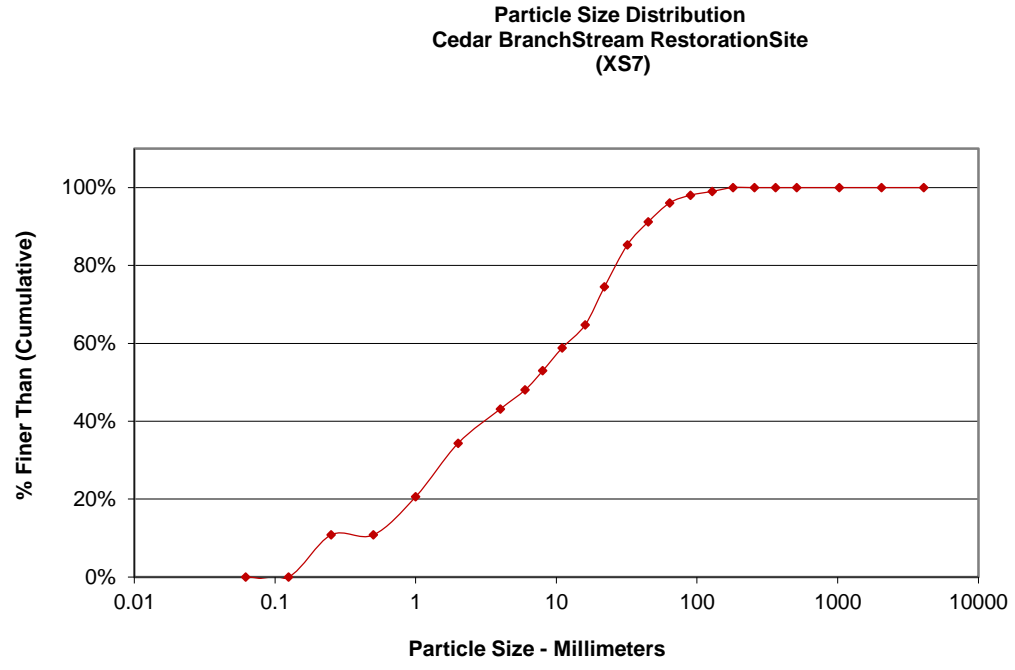
Cross-Section 7			
Particle	Millimeter		Count
Silt/Clay	< 0.062	S/C	
Very Fine	.062 - .125	S	
Fine	.125 - .25	A	11
Medium	.25 - .50	N	
Coarse	.50 - 1	D	10
Very Coarse	1 - 2	S	14
Very Fine	2 - 4		9
Fine	4 - 5.7	G	5
Fine	5.7 - 8	R	5
Medium	8 - 11.3	A	6
Medium	11.3 - 16	V	6
Coarse	16 - 22.6	E	10
Coarse	22.6 - 32	L	11
Very Coarse	32 - 45	S	6
Very Coarse	45 - 64		5
Small	64 - 90	C	2
Small	90 - 128	O	1
Large	128 - 180	B	1
Large	180 - 256	L	
Small	256 - 362	B	
Small	362 - 512	L	
Medium	512 - 1024	D	
Lrg- Very Lrg	1024 - 2048	R	
Bedrock	>2048	BDRK	
		Total	102
Note:

Size (mm)	
D16	0.72
D35	2.1
D50	6.7
D65	16
D84	31
D95	59

Size Distribution	
mean	4.7
dispersion	6.6
skewness	-0.19

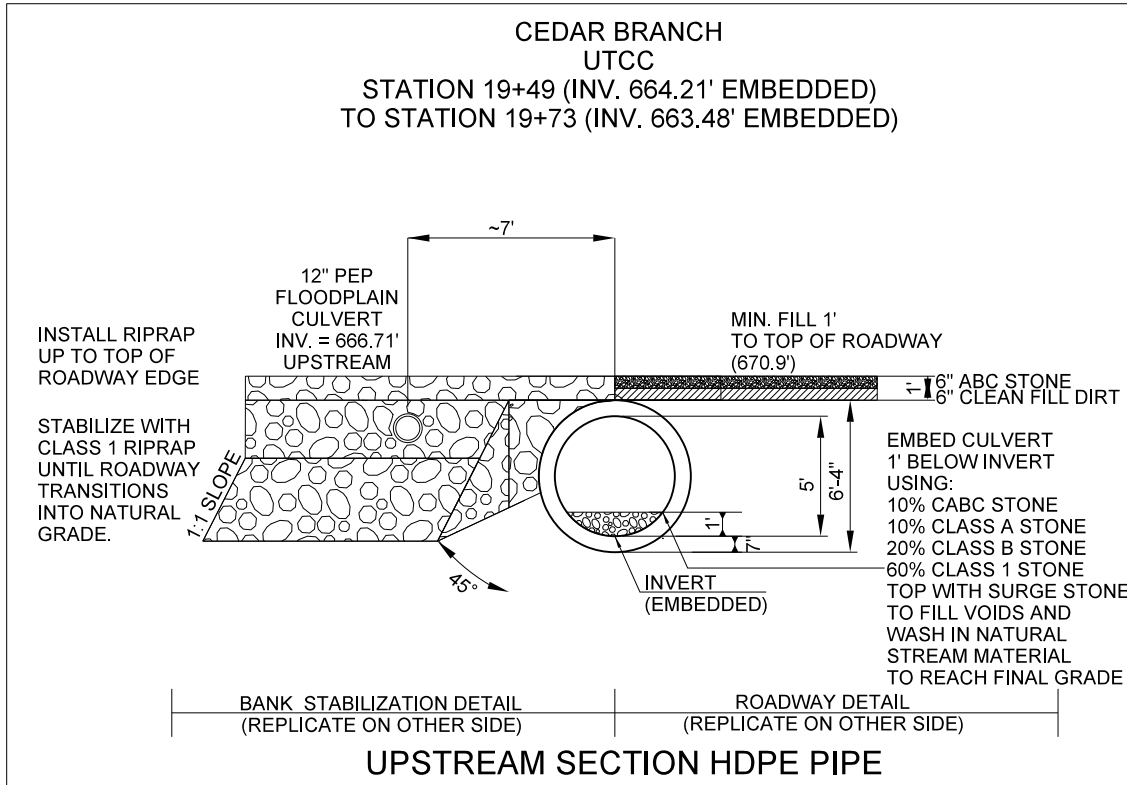
NOTES:
CULVERT THICKNESSES ASSUMED TO BE 7". ACTUAL THICKNESSES TO BE DETERMINED BY DESIGNER/FABRICATOR.
DESIGN FILL IS 1.0' AT ALL CULVERTS.
ALL CULVERTS ARE 24' LINEAR FEET;
NO WINGWALLS REQUIRED.

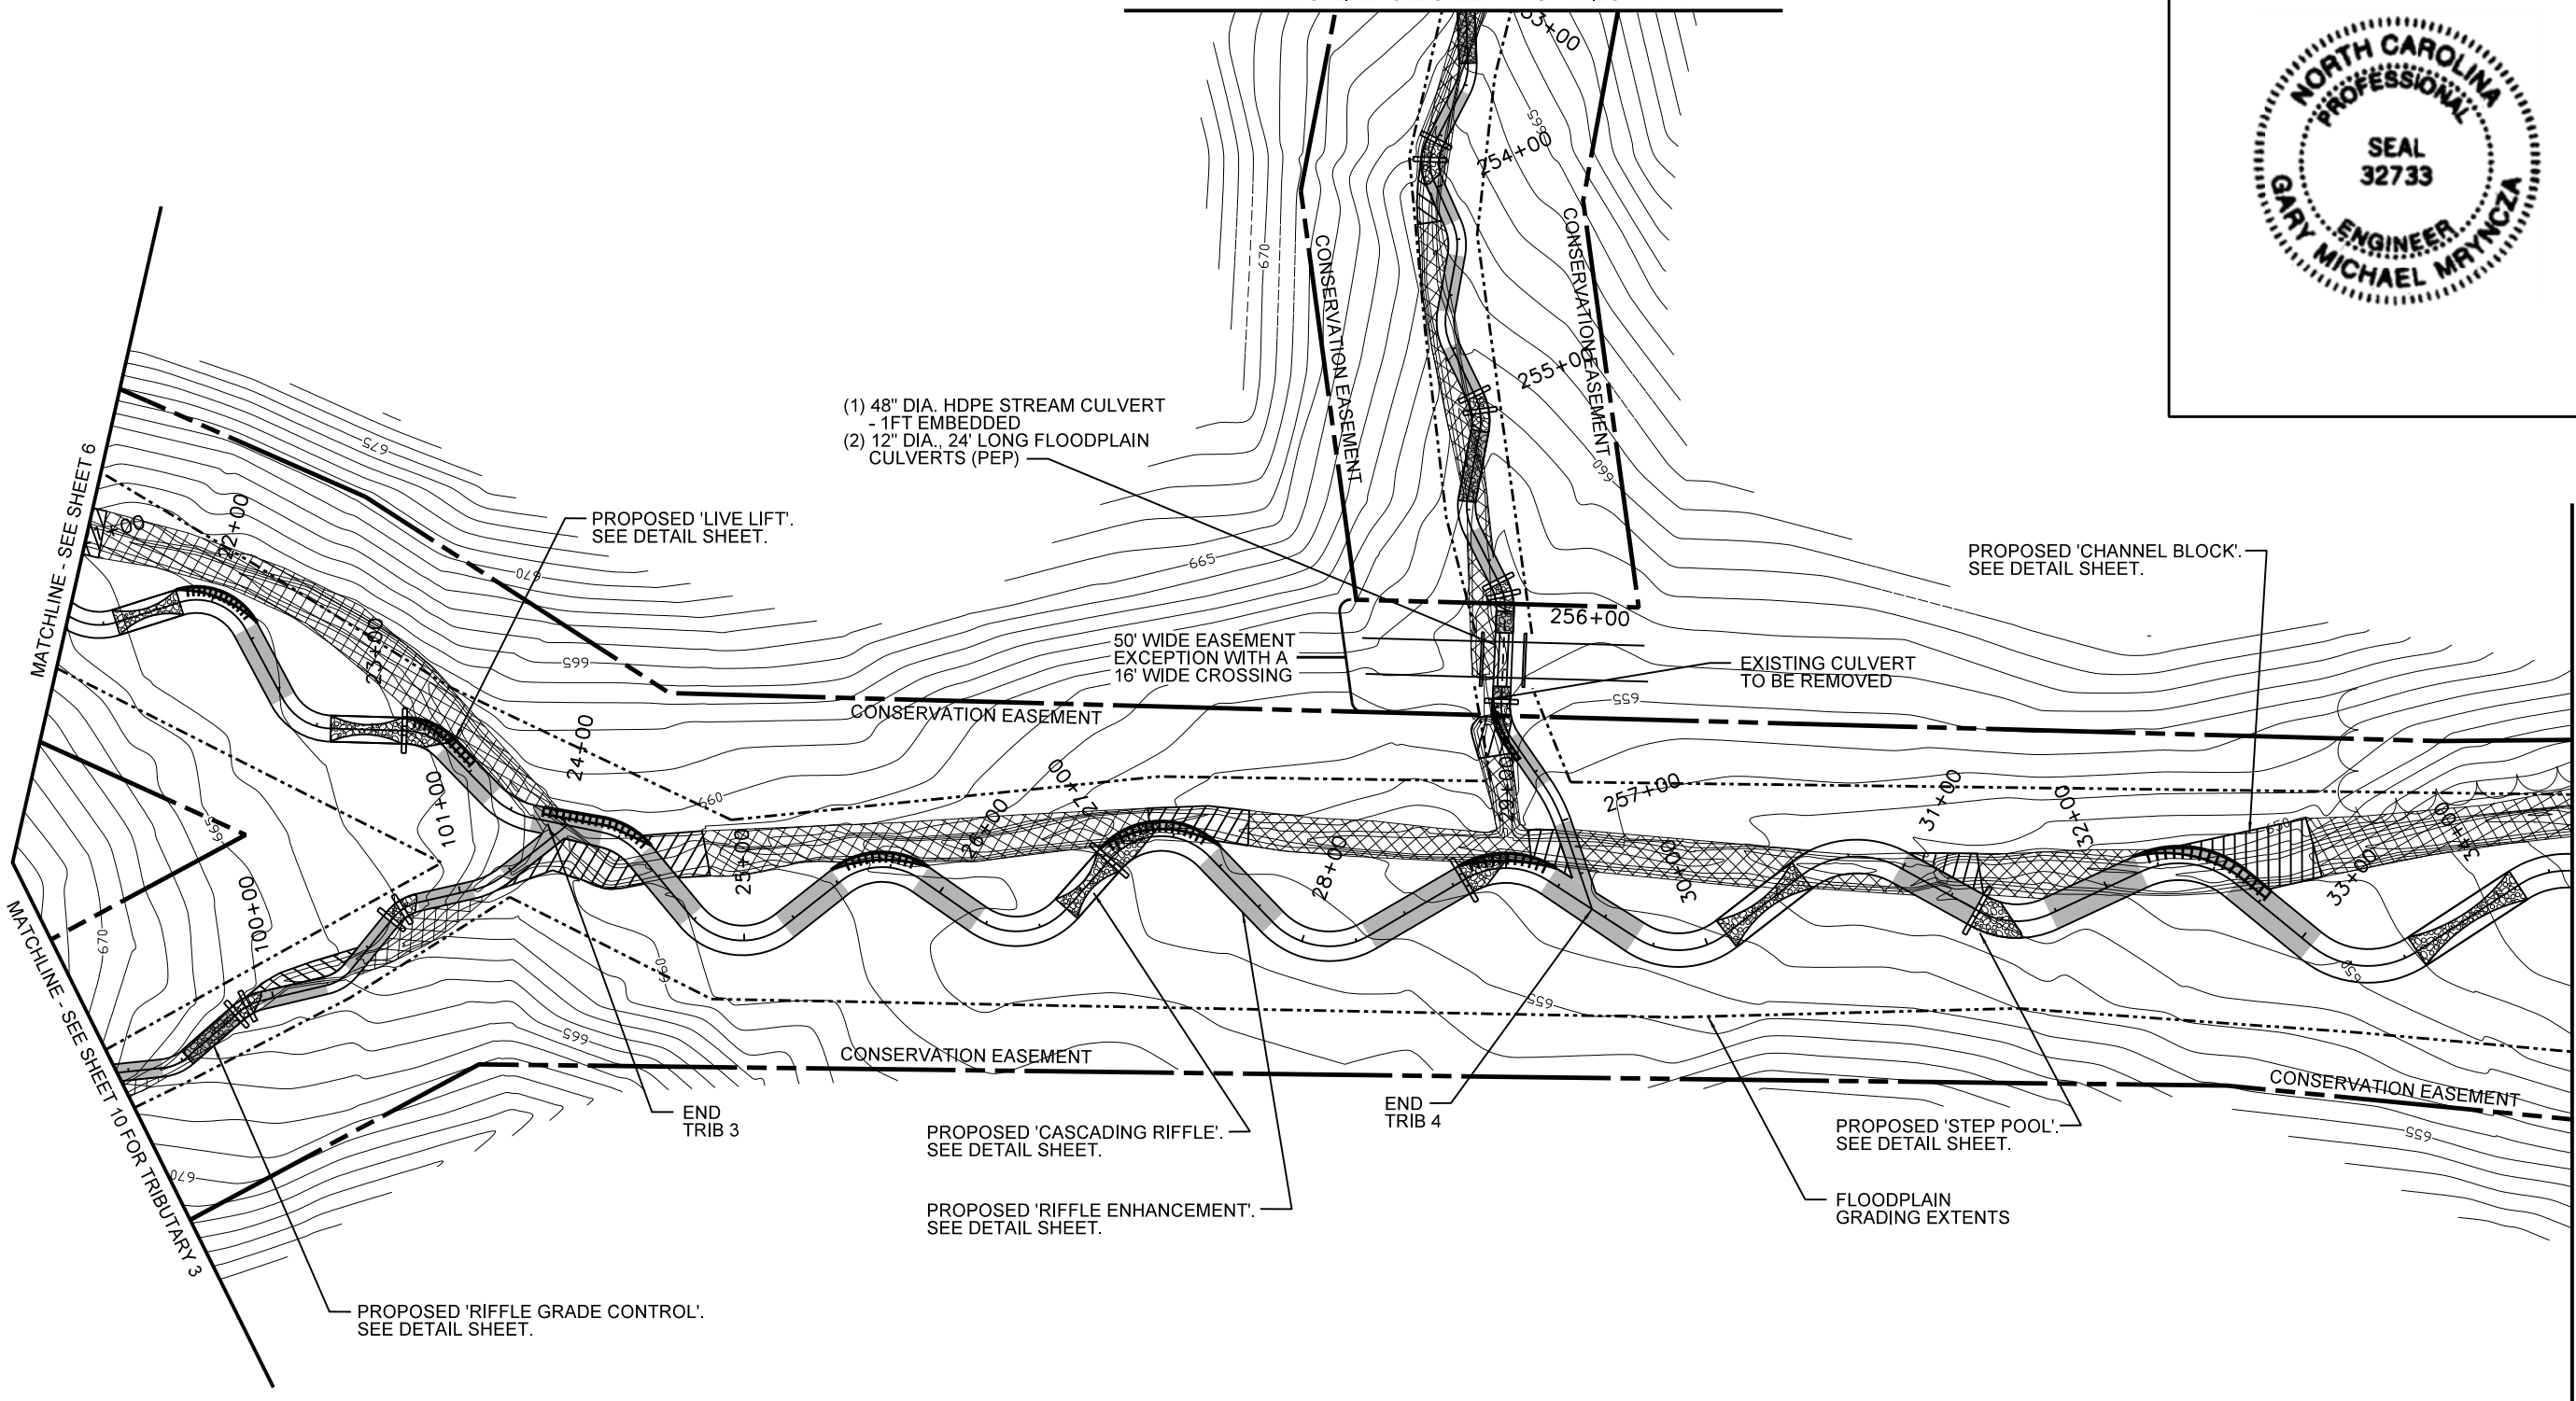
- (1) 48" DIA. HDPE STREAM CULVERT - 1FT EMBEDDED
- (2) 12" DIA., 24' LONG FLOODPLAIN CULVERTS (PEP)
