Re: NCIRT Review and USACE Approval of the Cedar Branch Restoration Site Draft Mitigation Plan; SAW-2003-21395; DMS Project #97009

**PROPOSED MITIGATION
CEDAR BRANCH RESTORATION SITE
RANDOLPH COUNTY, NC**

**Lower Yadkin River Basin
Cataloging Unit 03040103**

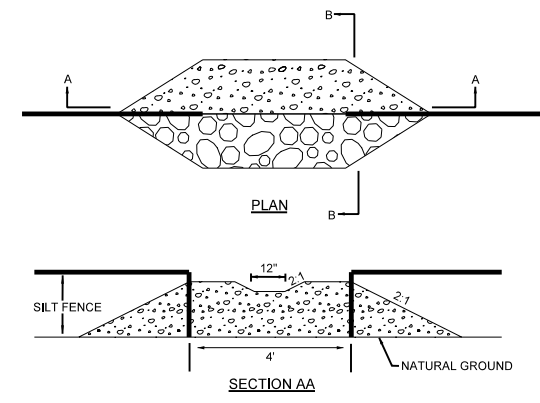
SILT FENCE ROCK OUTLET MAINTENANCE:
 1. REMOVE SEDIMENT WHEN IT ACCUMULATES TO ONE-HALF THE DESIGN VOLUME.
 2. CHECK STRUCTURE AND ABUTMENTS FOR EROSION, PIPING, OR ROCK DISPLACEMENT. REPAIR IMMEDIATELY.
 3. REMOVE ROCK OUTLET WHEN CONTRIBUTING DRAINAGE AREA HAS BEEN PERMANENTLY STABILIZED AND APPROVED. REMOVE ALL WATER AND SEDIMENT PRIOR TO REMOVING SCREEN. DISPOSE OF WASTE MATERIAL IN DESIGNATED DISPOSAL AREA.

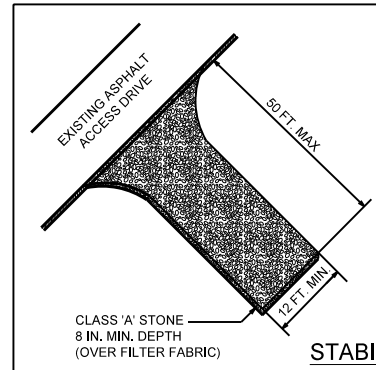
NOTES:
 1. TURNING RADIUS SUFFICIENT TO ACCOMMODATE LARGE TRUCKS SHALL BE PROVIDED.
 2. ENTRANCE(S) SHOULD BE LOCATED TO PROVIDE FOR UTILIZATION BY ALL CONSTRUCTION VEHICLES.
 3. MUST BE MAINTAINED IN A CONDITION WHICH WILL PREVENT TRACKING OR DIRECT FLOW OF MUD ONTO STREETS. PERIODIC TOPDRESSING WITH STONE WILL BE NECESSARY.
 4. ANY MATERIAL TRACKED ONTO THE ROADWAY MUST BE CLEANED UP IMMEDIATELY.
 5. GRAVEL CONSTRUCTION ENTRANCE SHALL BE LOCATED AT ALL POINTS OF INGRESS AND EGRESS UNTIL SITE IS STABILIZED. FREQUENT CHECKS OF THE DEVICE AND TIMELY MAINTENANCE MUST BE PROVIDED.

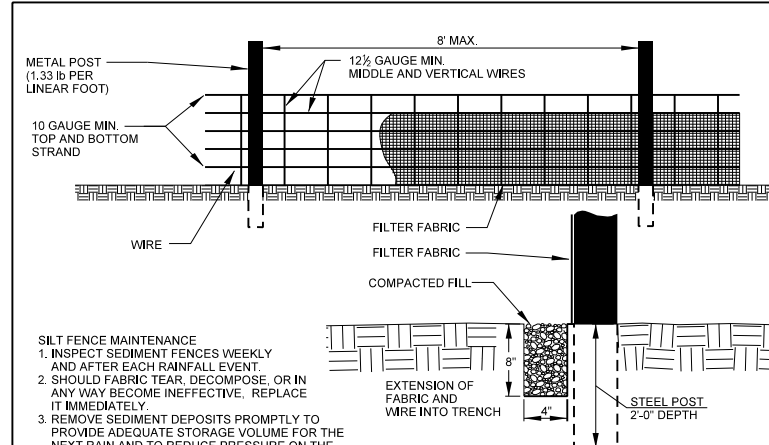
SILT FENCE MAINTENANCE
 1. INSPECT SEDIMENT FENCES WEEKLY AND AFTER EACH RAINFALL EVENT.
 2. SHOULD FABRIC TEAR, DECOMPOSE, OR IN ANY WAY BECOME INEFFECTIVE, REPLACE IT IMMEDIATELY.
 3. REMOVE SEDIMENT DEPOSITS PROMPTLY TO PROVIDE ADEQUATE STORAGE VOLUME FOR THE NEXT RAIN AND TO REDUCE PRESSURE ON THE FENCE. TAKE CARE TO AVOID UNDERMINING FENCE DURING CLEANOUT.
 4. REMOVE ALL FENCING MATERIALS AND UNSTABLE SEDIMENT DEPOSITS AFTER THE CONTRIBUTING DRAINAGE AREA HAS BEEN PROPERLY STABILIZED, INSPECTED AND APPROVED. BRING THE DISTURBED AREA TO GRADE AND STABILIZE AS SHOWN IN THE VEGETATION PLAN.
