Year 1 Monitoring Report

CHAPPELS CREEK MITIGATION PROJECT

NCDMS Project #100179 (Contract #0402-06)
DWR Project #2021-0755v2 | RFP #16-20200402

Person County, North Carolina
Neuse River Basin
HUC 03020201

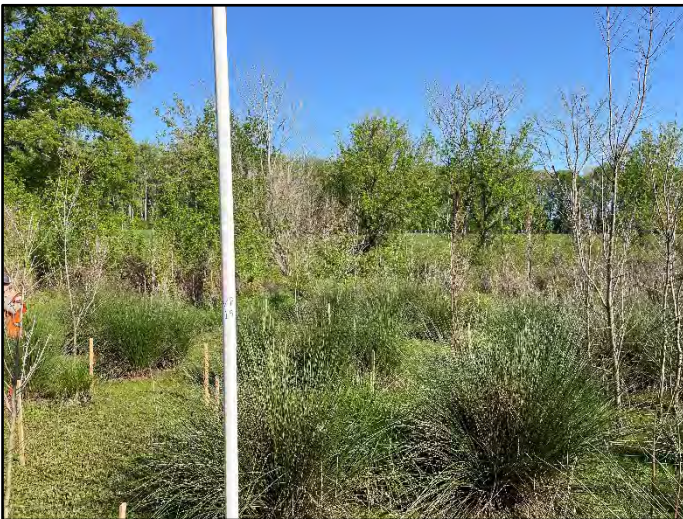
Vegetation Plot 19 (4/18/2023)

11. Appendix C: Vegetation Plot 19 photo is from a previous survey and date is incorrect; please update the appendix and digital submission.
The monitoring team failed to take a photo of VP 19 during MY1, therefore the photo is from MY0. There is a photo included of the supplemental planting around VP 19 included in the maintenance photos. The monitoring team will make sure to get an updated photo in 2024.

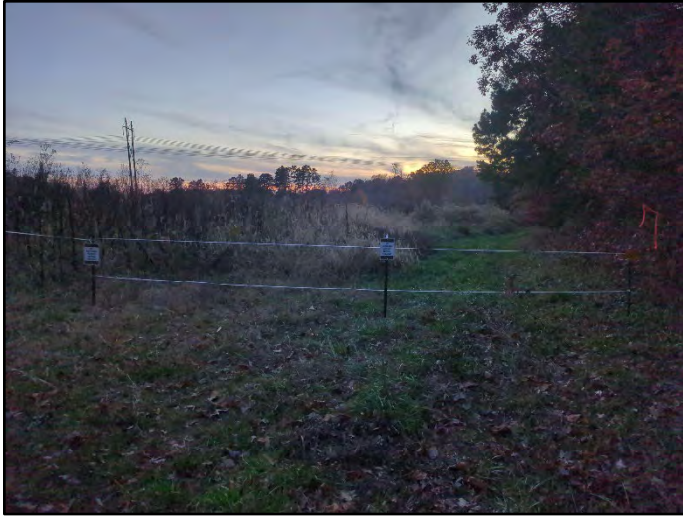
No Motorized Vehicle Signs (11/13/2023)

In 2023 11 encroachment areas were noted totaling .48 acres, in these areas the types of encroachment included corn being planted, mowing, and signs of driving within the easement. In response to these encroachment areas RES removed the corn inside the easement in August 2023, added additional signage and horse tape in September and November 2023, and supplementally planted in December of 2023. All of the encroachment areas have been addressed as of December 2023. The Project boundary will continue to be monitored for encroachment and conservation easement markings will be replaced if damaged.

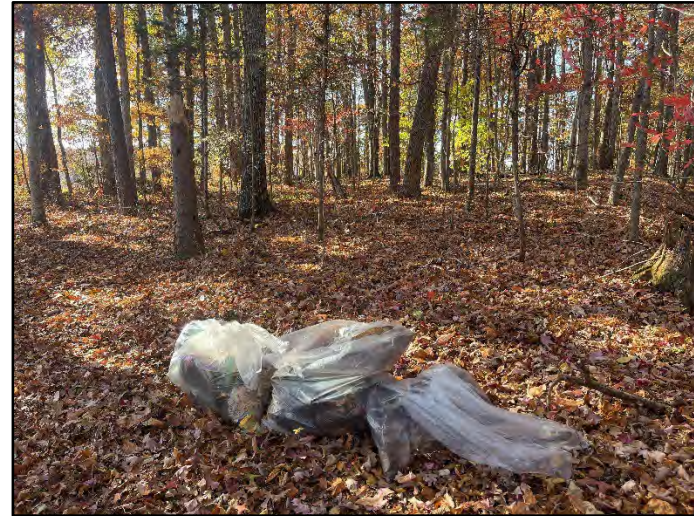
Debris Cleanup (11/9/2023)

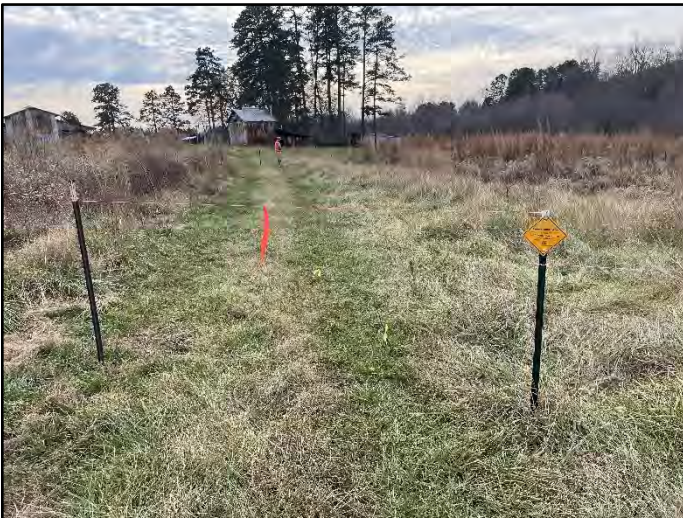
Easement Signage on Encroachment (12/21/2023)

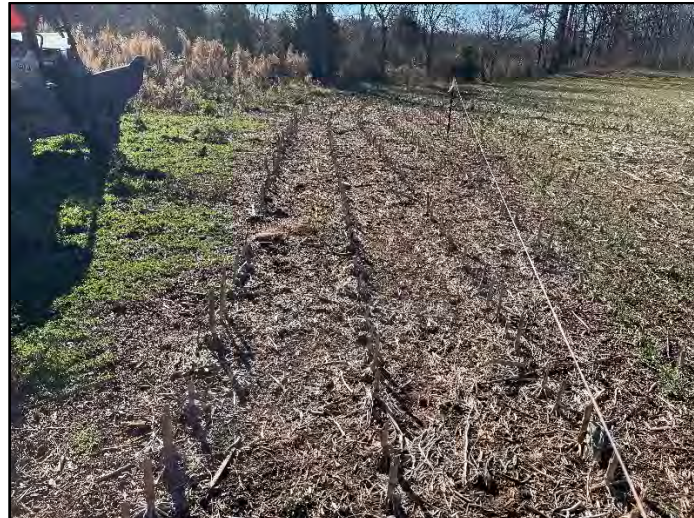
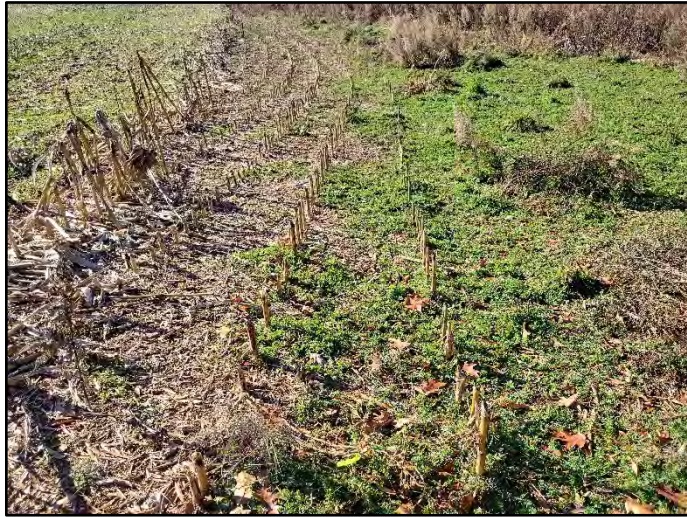
Supplemental Planting on Encroachment (12/18/2023)

[The following statement has been added to Section 4.4 "In 2023 11 encroachment areas were noted totaling .48 acres, in these areas the types of encroachment included corn being planted, mowing, and signs of driving within the easement. In response to these encroachment areas RES removed the corn inside the easement in August 2023, added additional signage and horse tape in September and November 2023, and supplementally planted in December of 2023. All of the encroachment areas have been addressed as of December 2023."](#)

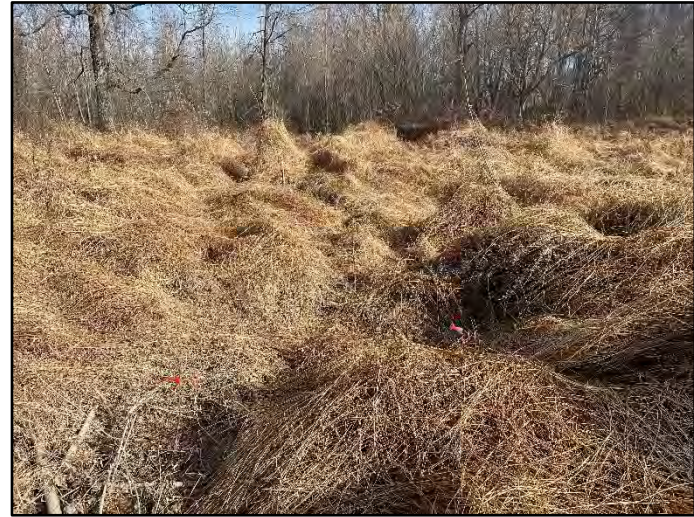
Supplemental Planting near VP19 (12/20/2023)

[The following statement has been added to Section 4.4 "Included within the supplemental planting was the area surrounding VP 19 which needed supplemental planting due to extensive box elder treatment within the vicinity. Due to the nuisance species outcompeting the planted stems as well as treatments towards the box elder causing higher mortality to the initial planting supplemental planting took place in the area."](#)

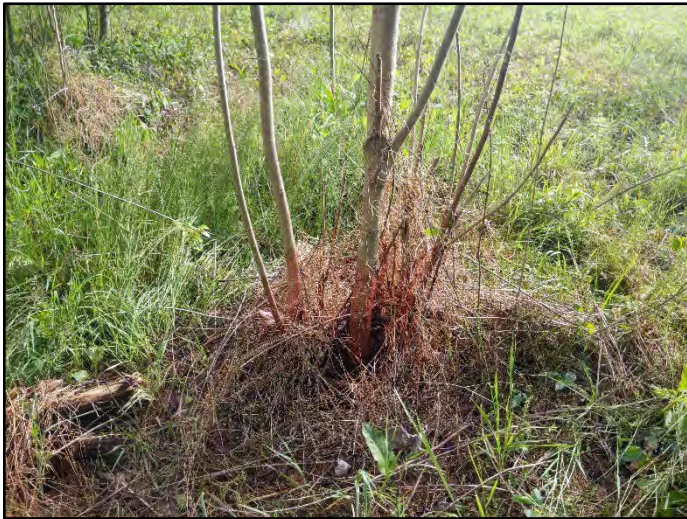
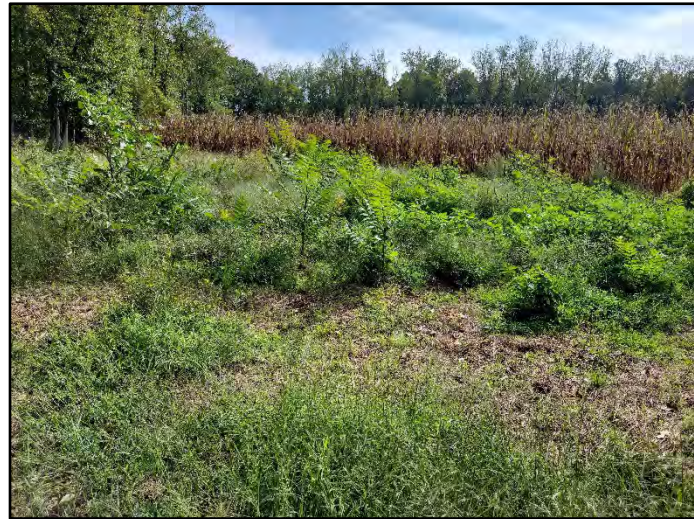
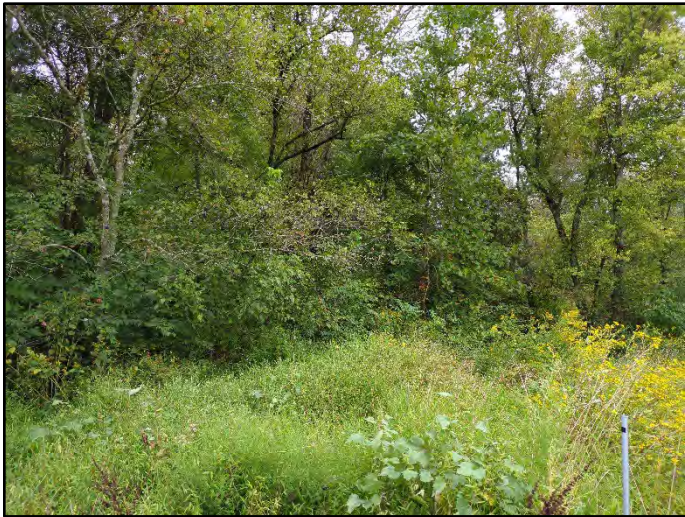
Invasives Treated (5/1/2023)

Invasives Treated (9/25/2023)

Invasives Treated (9/26/2023)

Invasive species observed on site include tree-of-heaven (*Ailanthus altissima*), Chinese privet (*Ligustrum sinense*), Callery pear (*Pyrus calleryana*), and multiflora rose (*Rosa multiflora*). Other nuisance species including box elder and sweet gum were also observed throughout the Project, but largely within the middle of the site. Treatment for these species was completed in March, April, and September 2023, and mainly involved hack-and-squirt and basal bark treatment methods; some larger trees were removed via chainsaw to limit light competition for the newly planted bare root trees. In total 27.87 acres were treated for invasives. Out of the total invasives treated area (27.87 acres), 10.01 acres is preservation, 15.91 acres is restoration 1.38 acres is enhancement, and .57 acres is non-crediting. Out of these areas the heaviest invasives treatments were within the 10.01 acres of preservation and 1.33 acres of enhancement. Supplemental planting within the preservation areas is not necessary and the 1.33 acres of enhancement area was already supplementally planted in December of 2023. The rest of the 16.53 acres of invasives treatments were spot treatments on sporadic invasives throughout. Invasives are not dominant in the 16.53 acres and supplemental planting is not anticipated in those areas.

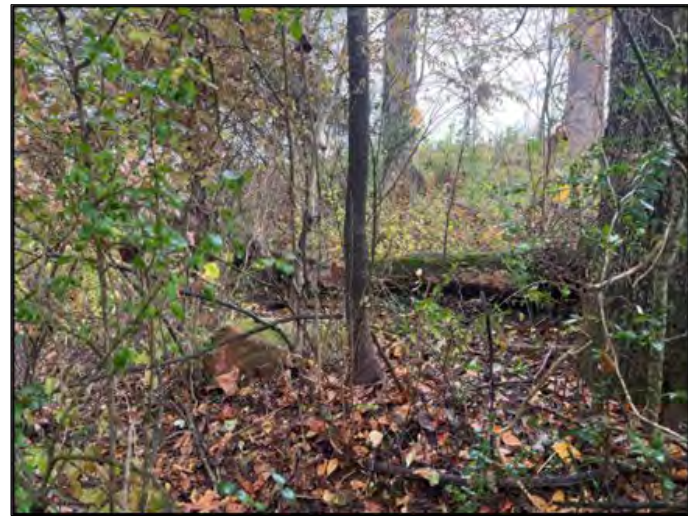
Old Fence Removed (10/31/2023)
