ANNUAL MONITORING REPORT CHARLES CREEK PARK

WETLAND RESTORATION PASQUOTANK COUNTY, NORTH CAROLINA (EEP Project Number 79)

Monitoring Year 2 of 5 (2008)

December 2008

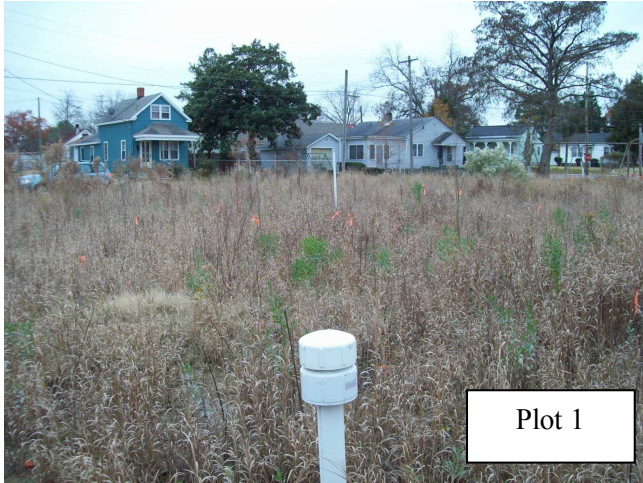
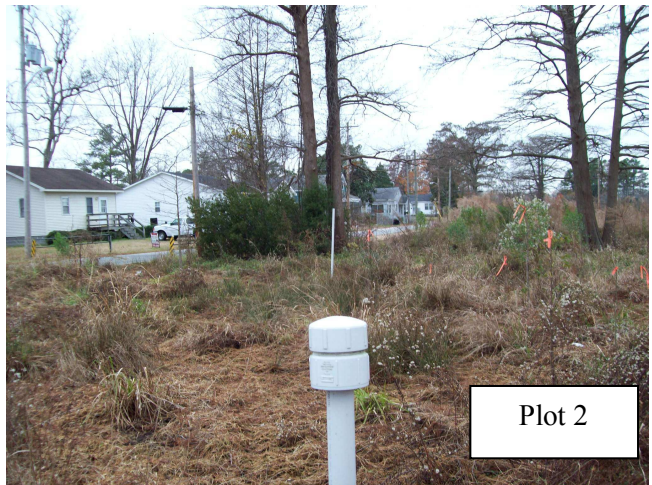
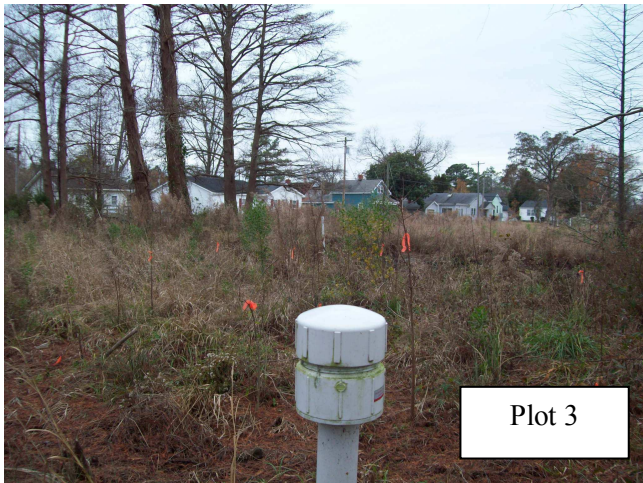
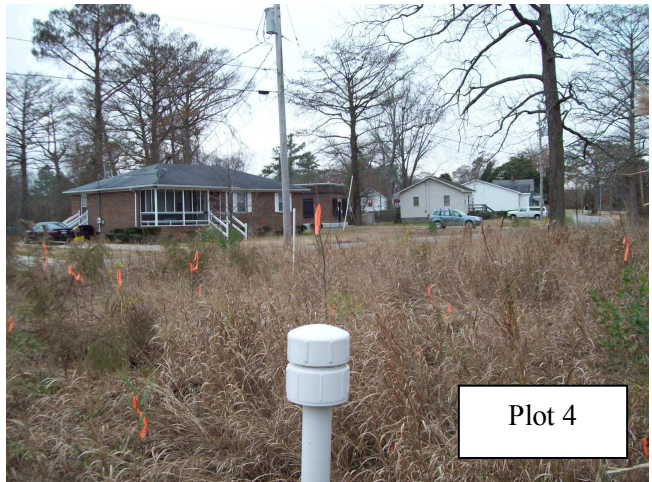
Vegetation Monitoring Photographs
Taken December 5, 2008

Based on the number of stems counted, average densities were measured at 738 stems per acre surviving in year 2 (2008). The dominant species identified at the Site were planted stems of bald cypress (*Taxodium distichum*), swamp blackgum (*Nyssa aquatica*), and swamp titi (*Cyrilla racemiflora*). In addition, each individual vegetation plot met success criteria. No vegetation problem areas were present within the Site during year 2 (2008) monitoring.
