ANNUAL MONITORING REPORT CHARLES CREEK PARK

WETLAND RESTORATION PASQUOTANK COUNTY, NORTH CAROLINA (EEP Project Number 79)

Monitoring Year 3 of 5 (2009)

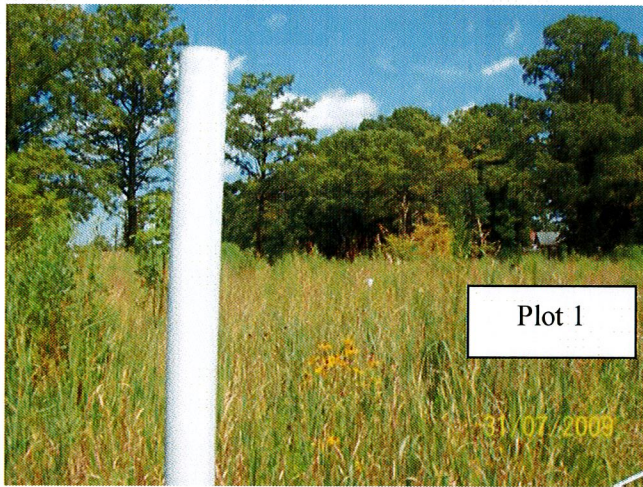
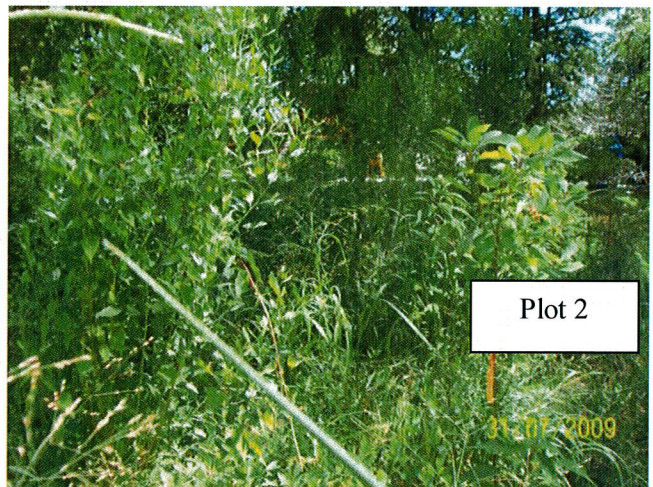
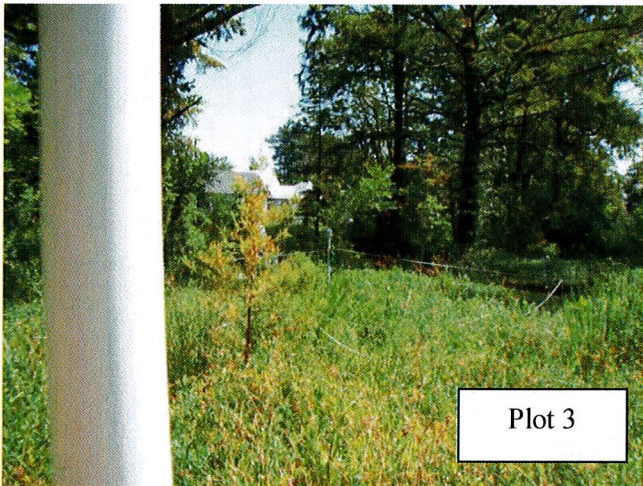
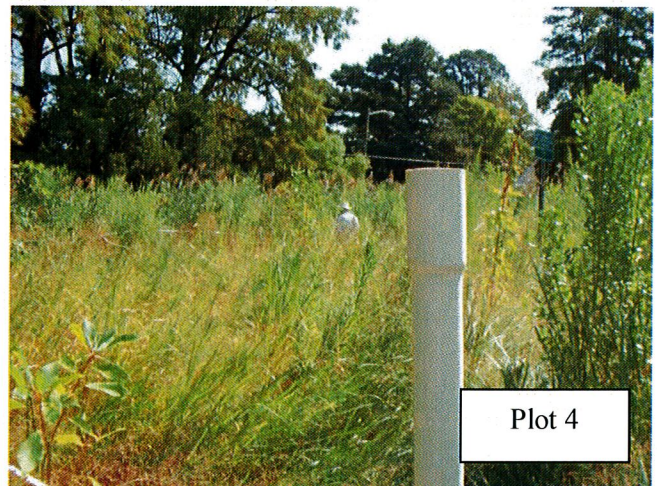
**Vegetation Monitoring Photographs
Taken July 2009**

Vegetation Plot ID	Vegetation Survival Threshold Met?	Tract Mean
1	Yes	100%
2	Yes	
3	Yes	
4	Yes

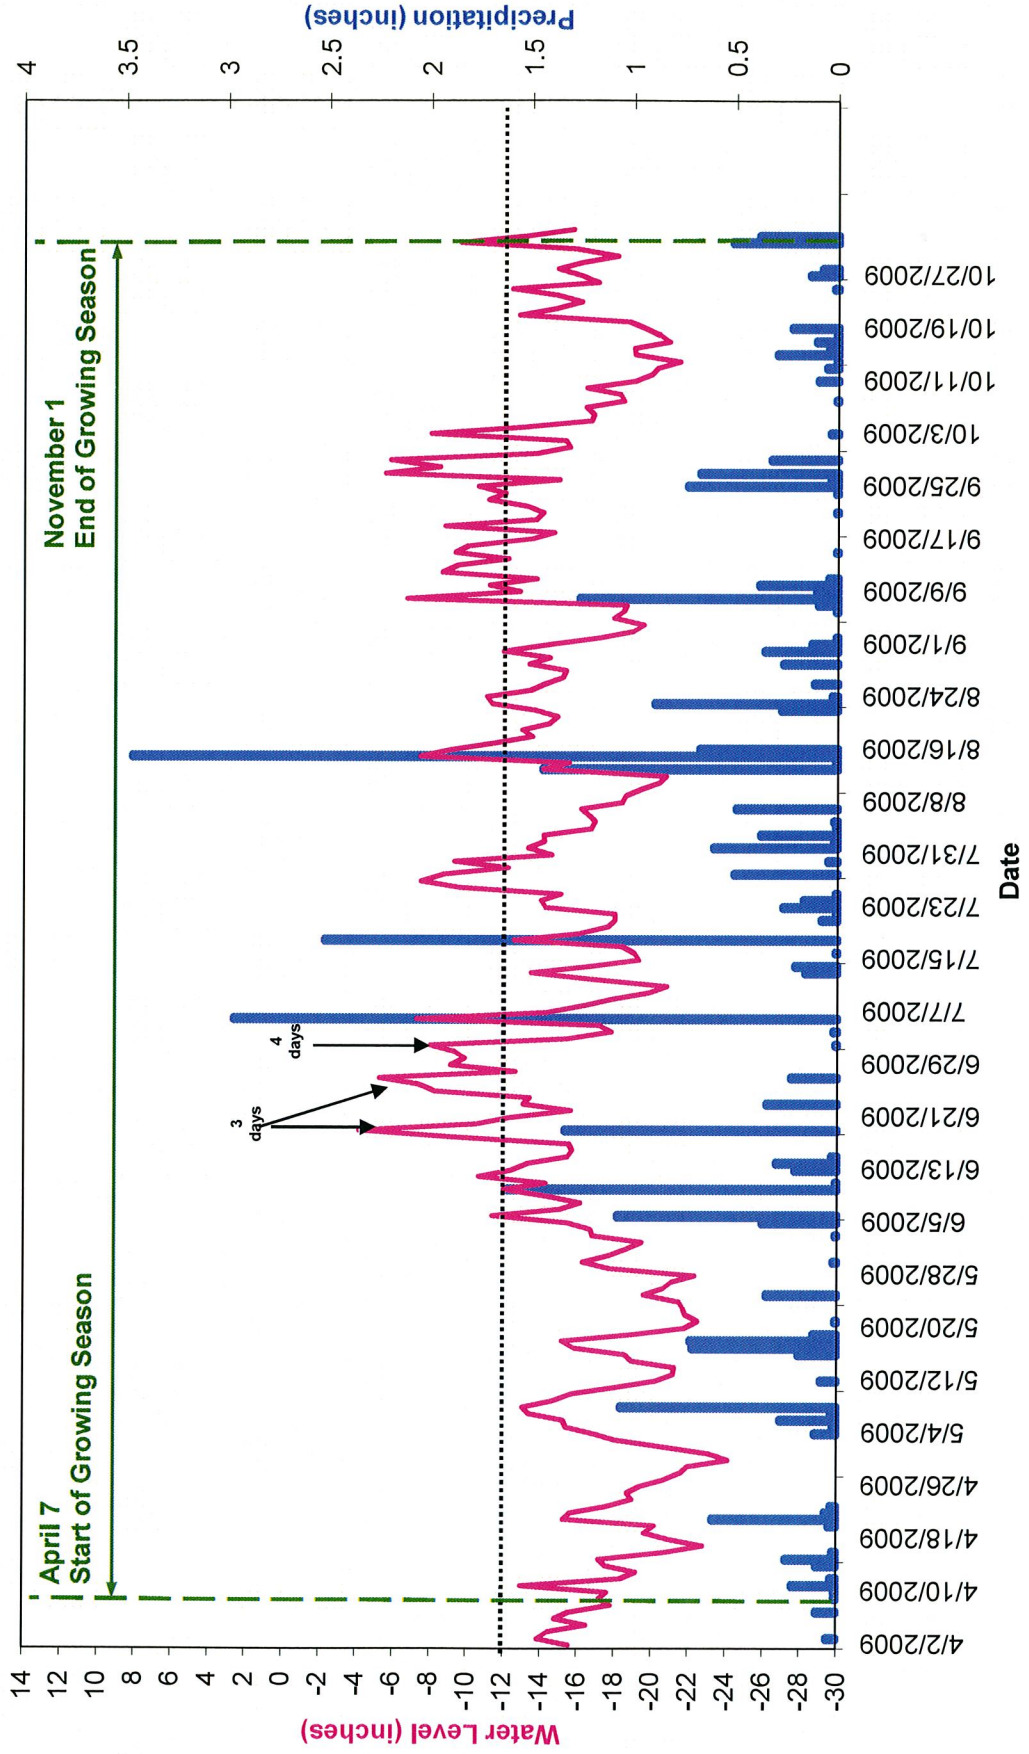
Gauge 1 Charles Creek Park Year 3 (2009 Gauge Data)

Gauge	Success Criteria Achieved/Max Consecutive Days During Growing Season (Percentage)				
	Year 1 (2007)	Year 2 (2008)	Year 3 (2009)	Year 4 (2010)	Year 5 (2011)
1	No/4 days (1.9%)	Yes/34 days (16.3%)	No/4 days (1.9%)		
2	Yes/50 days (23.9%)	Yes/50 days (23.9%)	Yes/78 days (37.3%)		
3	Yes/51 days (24.4%)	Yes/141 days (67.5%)	Yes/164 days (78.5%)		
4	No/7 days (3.3%)	Yes/40 days (19.1%)	No/4 days (1.9%)
