**FINAL
ANNUAL MONITORING REPORT
CHARLES CREEK PARK**

**WETLAND RESTORATION
PASQUOTANK COUNTY, NORTH CAROLINA
(EEP Project Number 79)**

Monitoring Year 4 of 5 (2010)

Prepared by:
Axiom Environmental, Inc.
20 Enterprise Street, Suite 7
Raleigh, North Carolina 27607

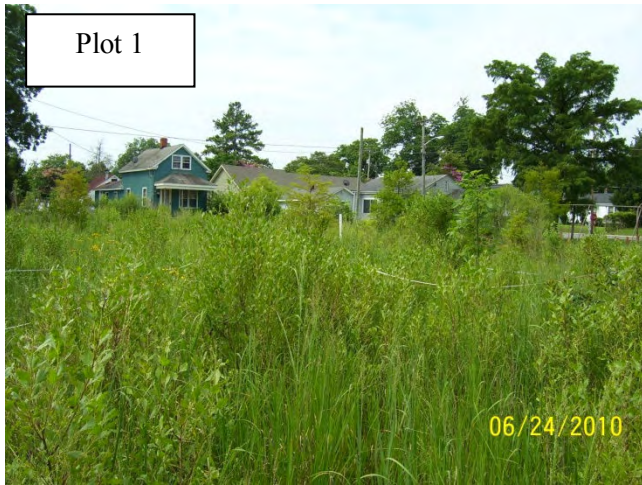
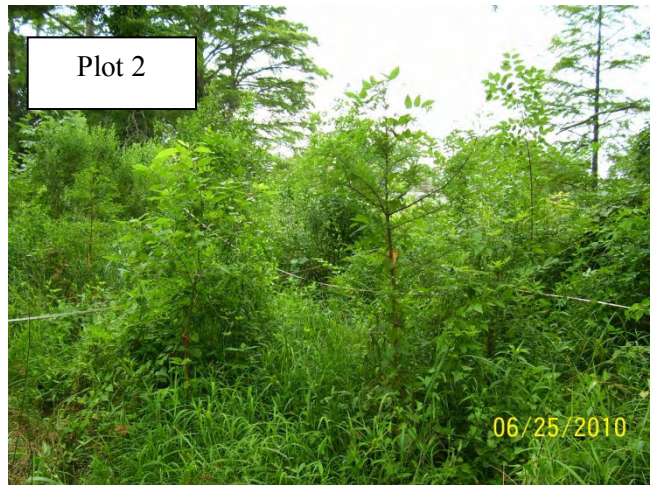
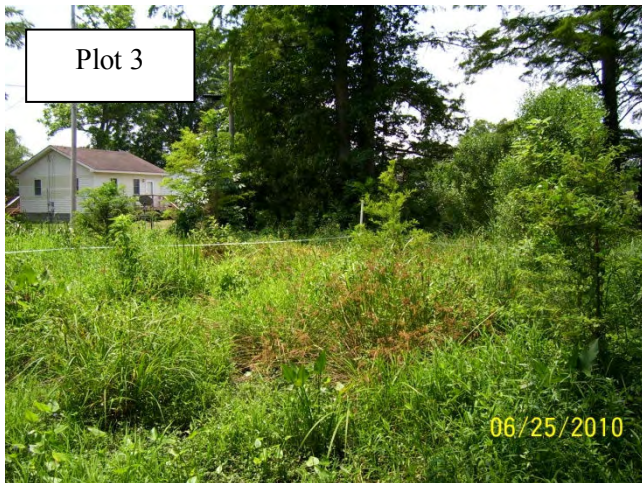
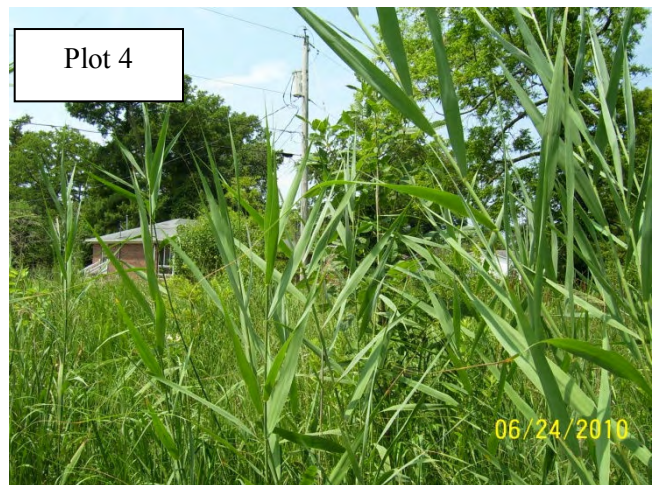
**Charles Creek Park
Vegetation Monitoring Photographs
Taken June 2010**

Vegetation Plot ID	Vegetation Survival Threshold Met?	Tract Mean
1	Yes	100%
2	Yes	
3	Yes	
4	Yes
